Restoration of some small loess streams – a contribution of organic farming to nature conservation and management

Ulrich Braukmann, Bastian Rupp, Werner Haaß, Ulf Stein and Achim Schütte

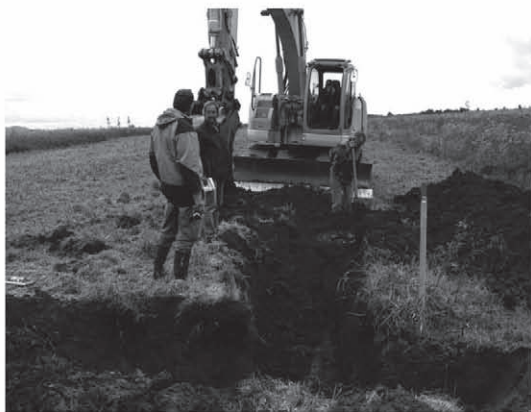
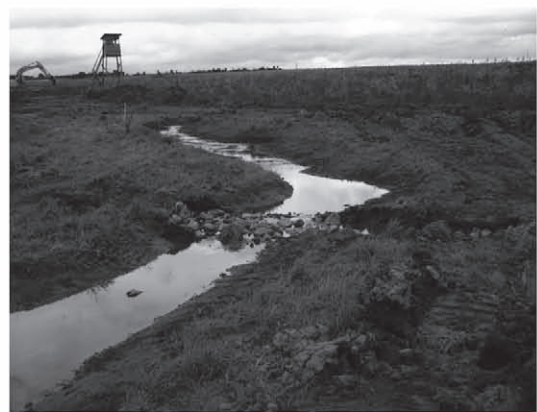
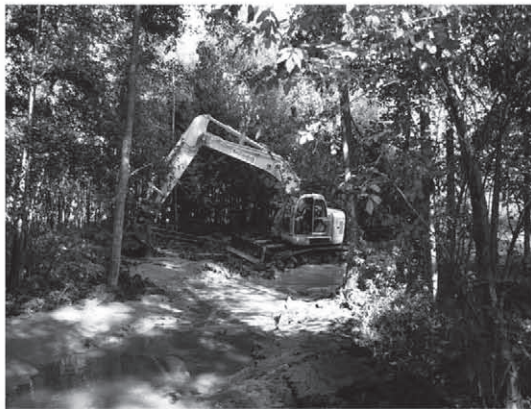
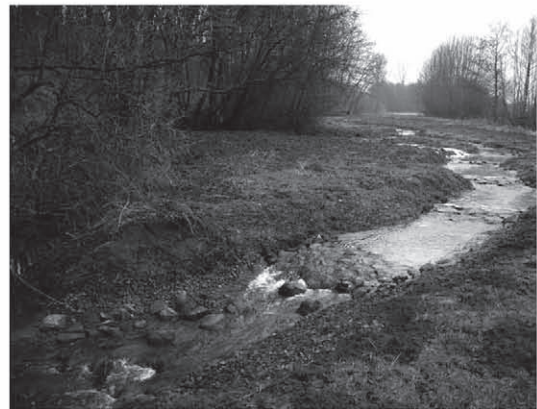
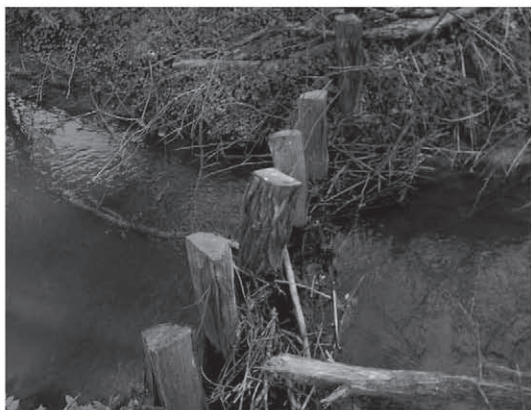
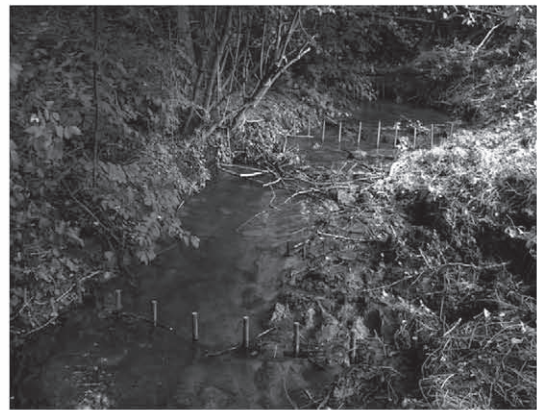
Fig. 5: Main restoration measures: **a)** Daylighting of the formerly piped brook at Totenhof; **b)** Newly built brook at Totenhof. Goals included restitution of biological passability and of a flat bed structure with the potential for dynamic development and early inundation; **c)** Relocation of the Jungfernbach into the middle of the flood-plain; **d)** Newly built section of the Jungfernbach, the shallow bed has been partly stabilised by stone bars; **e)** Lifting of the stream bed by racks made of wooden bars; **f)** Lifting of the stream bed by groups of iron bars (Photos: a, e) Rupp; b, c) Haaß; d, f) Braukmann).
