Structural Engineering Documents

**Engineering History  
and Heritage  
Structures – Viewpoints  
and Approaches**

## Frost Damage and Restoration of Limestone Domes and Spheres in a Heritage Building

**Philippe Van Bogaert**, Prof., PhD; Ghent University, Ghent, Belgium

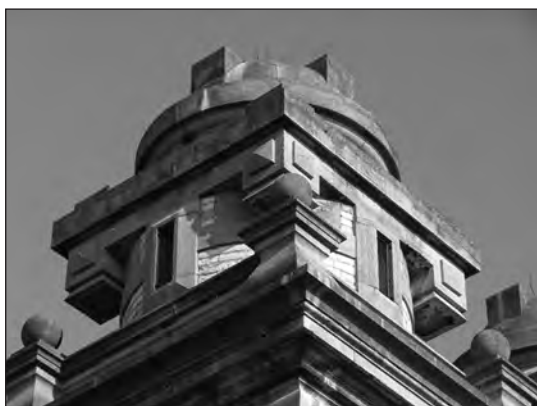
Figure 2 Top of the vertical part with the dome

The front view of the building clearly shows the two vertical parts containing the water accumulators. The entrance door and ground level appear rather massive; the twin columns are richly decorated, suggesting the cylindrical accumulators inside, and the narrow openings underline the vertical orientation of the building. Both towers are covered by domes carved from single limestone blocks. An individual dome is shown in *Fig. 2*. The domes are supported by white sandstone cylindrical masonry. The total height of the structure reaches 24.5 m. *Figure 2* also shows some of the heavy cornices, column capitals and decorating spheres. The highly decorated industrial building was highly appreciated in the second half of 19th century and displays the wealth and prosperity of the port of Antwerp in industrial times. The style of this building may appear to be excessively heavy, but the exterior form clearly shows the particular purpose of the building. In addition, the domes entirely correspond to the inside equipment.

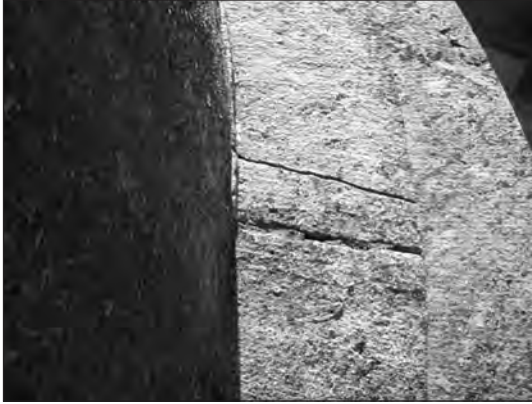
*Fig. 3: Degradation of the dome*

activities include seminars, smaller concerts, receptions, discussions and workshops, as well as art studios. During the inspection of the heritage building in January 2012, several limestone ornaments and blocks were found to be heavily cracked. In addition, during the 1985 restoration, inferior products were used at some locations. After some of the limestone debris fell, a second inspection was organized in December 2012. As both inspections were conducted in winter, it was hoped that frost was at maximum and recent degradation would be detected. Cracks reached

a width of 10 mm, and some parts needed immediate removal as there was a threat of debris falling on to the footpath below. The inspections also showed that some parts of the structure were already missing. These findings have urged the owners to apply for necessary funding for a restoration program and to install safety measures in order to avoid endangering passers-by below the building. However, the largest concern applies to the domes as these also suffer from cracking. *Figure 3* shows a detail of the cracked state of the domes. It is clearly seen that the limestone surface is eroded in horizontal layers. This seems to be characteristic of domes and spheres.

As the present state of deterioration of the domes and other limestone parts of the Southern Pressure House in Antwerp cannot be due to frost, the cause must reside in chemical attack due to increase of CO<sub>2</sub>, thus favouring the dissolution of the material. Due to the nature of limestone, the calcium carbonate may dissolve if the pH of rainwater is sufficiently low because of CO<sub>2</sub> content. Therefore, refurbishment should preferably make use of soft lime mortar to close the surface cracking. Deeper and larger cracks, endangering further decay and disintegration of the parts, may be treated by injection of epoxy-based products. Former calculations have shown that injection pressure may easily reach 5 bars (0.5 MPa). However, these epoxy-based products are harmful to the limestone as they have little permeability and can become rather rigid in the stone. Hence, they should be used in-depth only and after the surface treatment of cracks with lime cement is complete. After successive inspections and temporary measures to avoid accidents, the restoration of the Pressure House is presently being considered. The project will require more extensive evaluation of the various repair methods. However, it may have become clear that water ingress and frost are not the main reasons for the degradation.
