THE ANALYSIS OF CONTAMINATION DERIVING FROM THE LEAKAGE OF SUBSURFACE PIPELINE NETWORKS USING REMOTE SENSING

MUCSI, László – KISS, Richárd – SZATMÁRI, József – BÓDIS, Katalin –
KÁNTOR, Zoltán – DABIS, Gábor – DZSUPIN, Mihály

Abstract

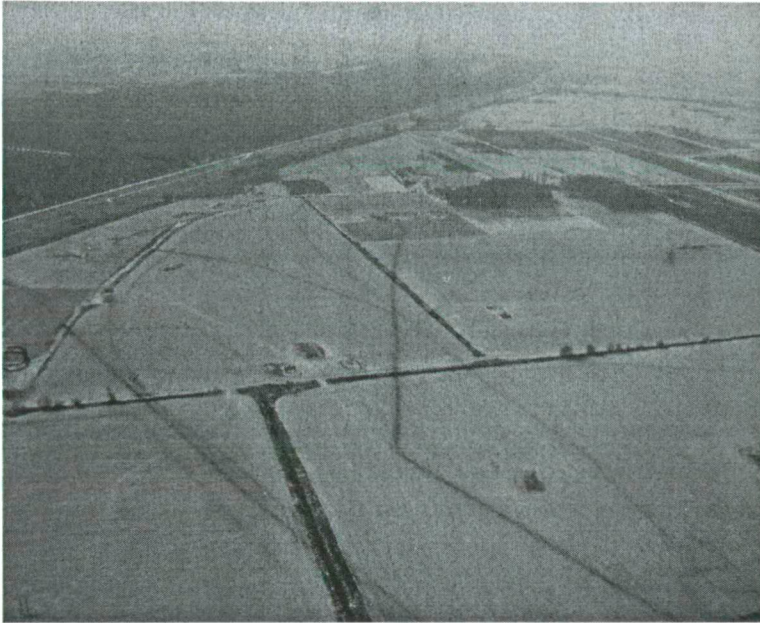
Figure 4. Patches of melted snow clearly indicate the path of subsurface pipes as photographed on the 26th of November 2000 (by: M. Dzsupin)

The thin layer of snow covering the ground during winter very often melts above the pipelines as it can be seen on the photograph taken in 2000 (Fig. 4).

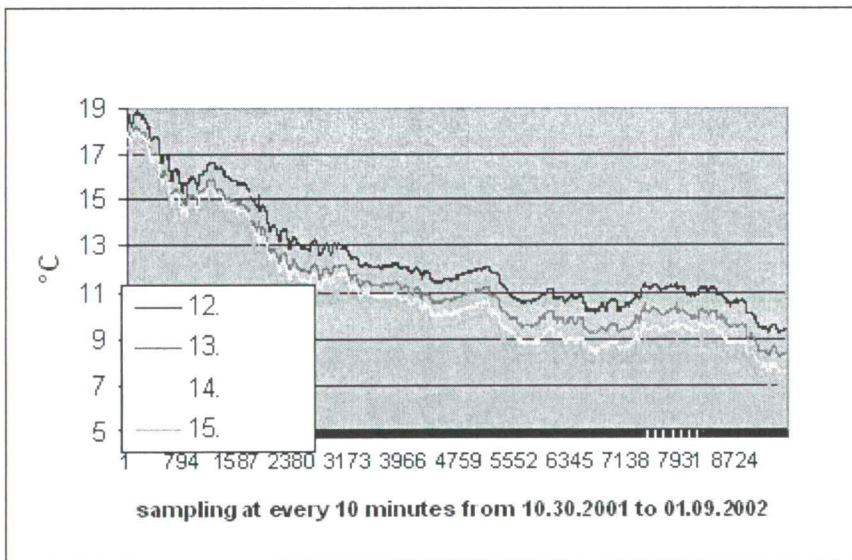
Figure 6. Soil temperatures at a depth of 40 cm on the right hand side of the pipeline

Data series recorded between 30/10/2001 and 09/01/2002 are depicted on Fig. 6. After evaluation the following conclusions can be drawn:

- a, there is a decrease in soil temperatures during the winter months, temperatures are well above zero with a well-observable daily cycle
- b, the highest temperatures were recorded by the thermometer located directly above the pipeline in all cases
- c, the marginal thermometers recorded successively lower values their distances from the pipe increased
- d, there was an average difference of 2° C between the central (12.) and marginal (15.) thermometers (located at a distance of 90 cm)

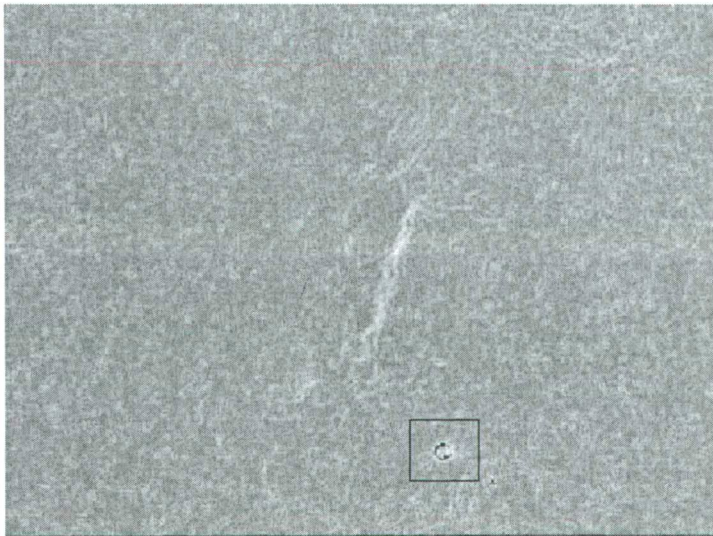
Figure 13. The image on Fig. 11. further filtered with a Sobel filter (darker spot marking the site of leakage)

The thermal images can be processed further by the application of various filters and image analysis procedures making the spots of leakages more accentuated in the images, more contrastive compared to their neighborhood as it can be seen on the 3D image of Fig. 12. or the filtered images of Fig. 13, (the image on Fig. 11. was further filtered with a Sobel filter).
