# Natural and anthropogenic agents in the present geomorphological dynamics of the Torrent Corlo mountain catchment (Northern Apennines, Italy)

**Doriano CASTALDINI<sup>1</sup>, Paola CORATZA<sup>1</sup>, Giovanni TOSATTI<sup>1</sup>**

<sup>1</sup> Department of Chemical and Geological Sciences, University of Modena and Reggio Emilia, Italy

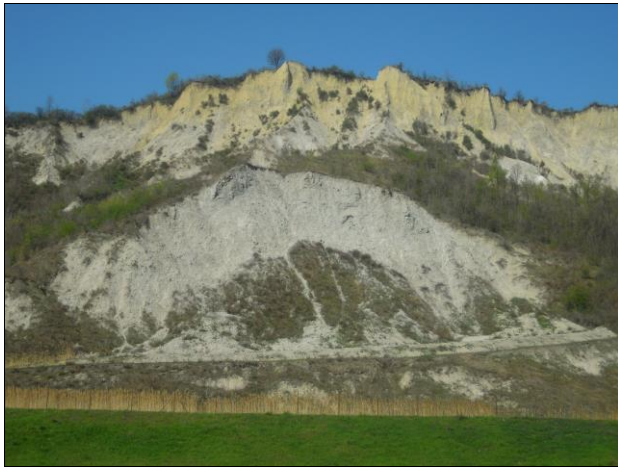
**Figure 2** Argille Azzurre Formation (FAA) cropping out on the left-hand slope of the T. Corlo upper valley. In the top part of the cliff, ochre coloured sand layers are visible.

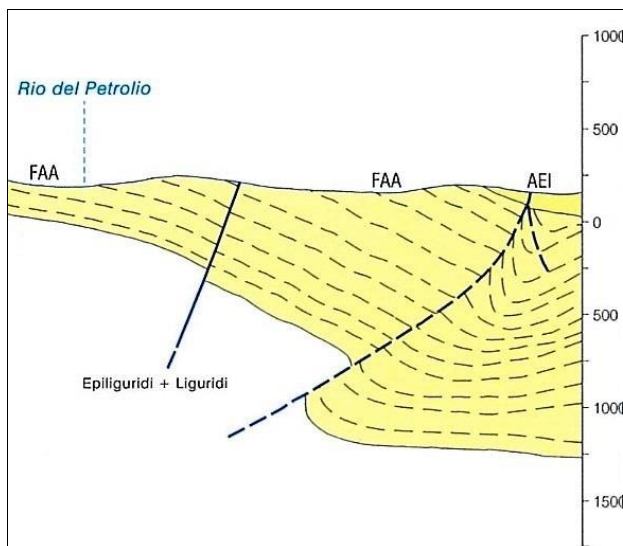
**Figure 3** Geological section of the eastern sector of the study area. Legend. FAA: Argille Azzurre Formation (Lower Pliocene - Lower Pleistocene); AEI: Emilia-Romagna lower synthem of the Middle Pleistocene (after Gasperi *et al.*, 2005). In stratigraphy a "synthem" is a chronostratigraphic unit that defines an unconformity-bounded regional body of sediments and represents a cycle of sedimentation in response to changes in relative sea level or tectonics.

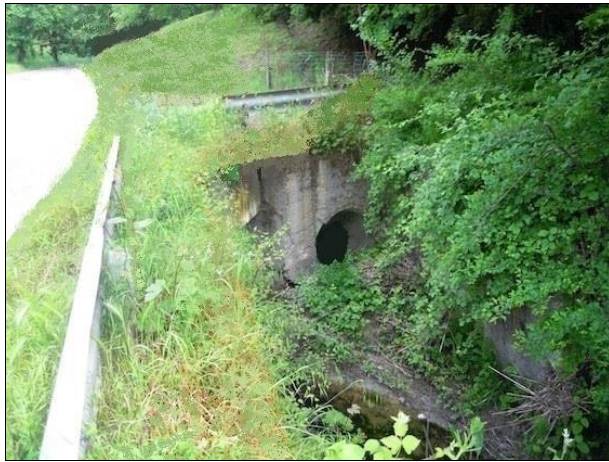
**Figure 5** Submersion point of T. Corlo south of the village of Fiorano Modenese.

The T. Corlo and its tributary Rio delle Vigne are very small watercourses, with an intermittent regime, and in the summer they are practically devoid of water. In particular, in several stretches of its course the T. Corlo was artificially covered and therefore flows underground (Fig. 5).

Other anthropogenic hydrographic landforms are the emergence and submersion points of the T. Corlo (Fig. 5).

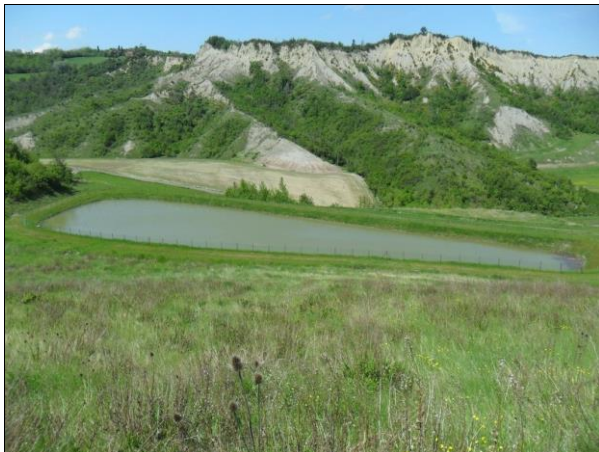
**Figure 6** Artificial pond on the right hand-side of the T. Corlo mid-valley, which was produced from an abandoned clay pit. In the background, the badlands.

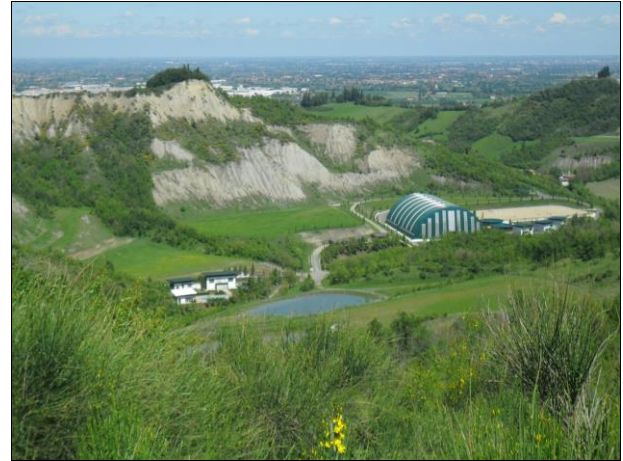
**Figure 7** Panoramic view of Mt. Ave southern slope, which was heavily affected by quarrying. The clay pit area was reclaimed and the structures of the Riola Valley Horse Riding Circle were built on it. Notice the remodelling of the pit scarp by runoff waters. In the background the Modena alluvial plain.

The reclaimed clay pits are mainly found on the valley floor, where the structures making up the Riola Valley Horse Riding Centre are located (Fig. 7).

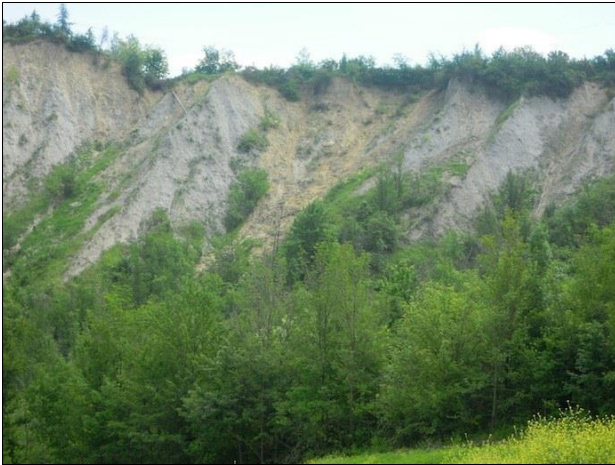
**Figure 8** Example of badlands' head retrogression owing to slope movements. The ochre-coloured sandy tongues correspond to landslide deposits.

In particular, typical examples of badlands can be observed in the T. Corlo upper and mid-valley. They are one of the most spectacular erosion landforms which affect the clayey soils of the Apennine northern margin. They are characterised by a high-density hydrographic network in which the single stream channels are separated by thin, blade-like crests. Runoff waters tend to have a thinning effect on the crests, also with the fundamental contribution of earth flows and earth slides, which have their crowns in the upper parts of the slopes. At present badland evolution affects many areas, owing also to the landslides which cause a rapid retrogression of the badlands' heads. Consequently, landslides from the crests that separate badlands located on contiguous slopes fill up the runoff channels with their deposits (Fig. 8). Generally speaking, the situation represented in the Geomorphological Map is merely indicative since it is practically impossible to map in detail all the landslide deposits which fill up the badlands' stream channels.

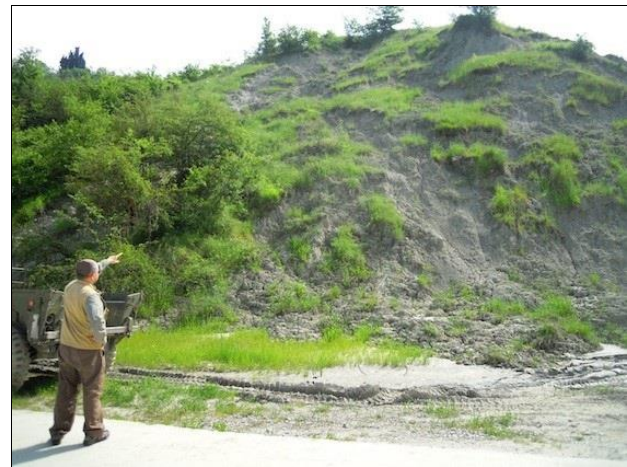
**Figure 9** Active soil slip in the lower stretch of the T. Corlo valley.

Gravity-induced slope landforms and deposits are common in both the T. Corlo valley and the Rio delle Vigne valley and are in great part due to earth flows, earth slides and soil slips (cf. Cruden & Varnes, 1996), which are the typical landslides affecting silty-clayey rock types (Fig. 9).

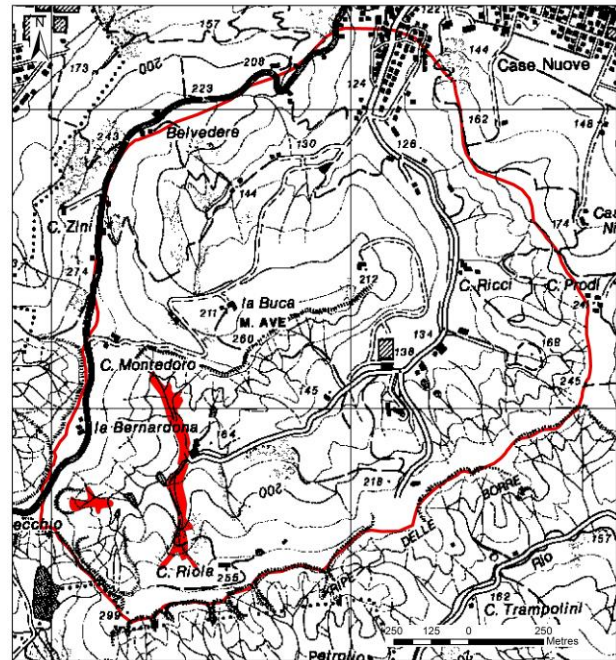
**Figure 10** PTCP Hydrological Hazard Map (Provincia di Modena, 2009) of the T. Corlo mountain catchment. For the legend, see Table 2.

Notwithstanding this, the instability situation in the T. Corlo mountain catchment represented in the PTCP Hydrological Hazard Maps of Provincia di Modena (2009) is certainly underestimated (Fig. 10).

Consequently, the areas affected by active landslides and those affected by dormant landslides shown in our updated version of the PTCP Hydrological Hazard Map (Fig. 11) are much more numerous than those mapped in the PTCP Hydrological Hazard Map of Provincia di Modena (2009) (Fig. 10).

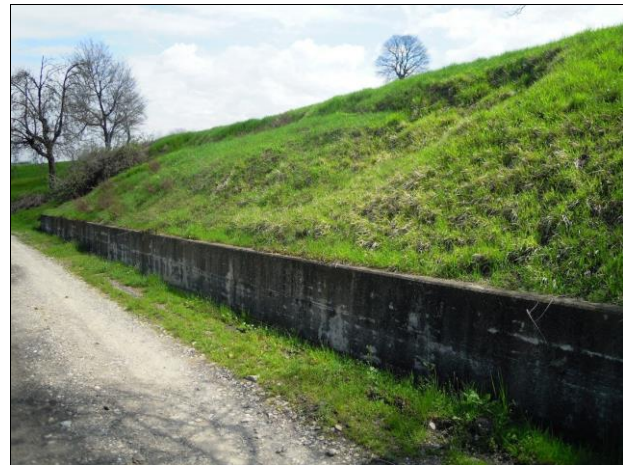
**Figure 12** Upper Rio delle Vigne valley: eastern branch of the landslide which affected the road.

In the Rio delle Vigne valley some houses are located at the foot of dormant landslides, which so far have not caused instability problems. The large active landslide in the valley's upper part, which according to local inhabitants is periodically reactivated following intense precipitation, affects only superficial deposits and a stretch of the road (Fig. 12).
