Damage evaluation during installation of geosynthetics used in asphalt pavements

I. Gonzalez-Torre¹, M. A. Calzada-Perez², A. Vega-Zamanillo³ and D. Castro-Fresno⁴

REFERENCE: Gonzalez-Torre, I., Calzada-Perez, M. A., Vega-Zamanillo, A. & Castro-Fresno, D. (2014). Damage evaluation during installation of geosynthetics used in asphalt pavements. *Geosynthetics International*, **21**, No. 6, 377–386. [<http://dx.doi.org/10.1680/gein.14.00025>]

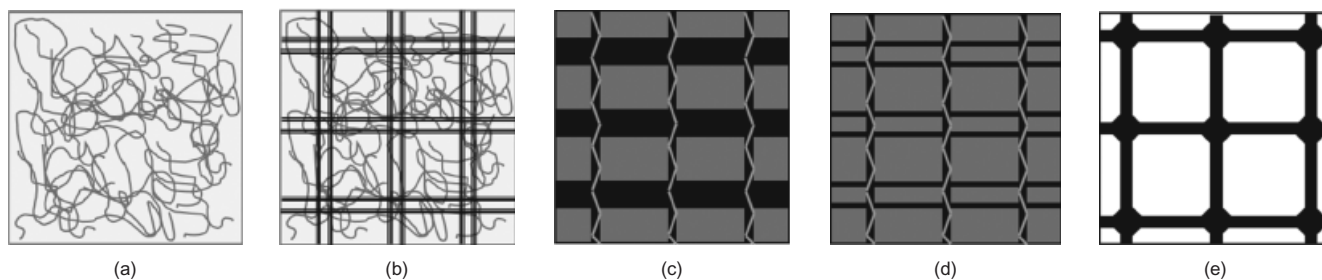
Figure 1. Structure of the geosynthetics: (a) G1, nonwoven geotextile; (b) G2, nonwoven geotextile reinforced with glass fibre filaments; (c) G3 and (d) G4, geogrid bonded to a light nonwoven geotextile and (e) G5, stiff monolithic geogrid bonded to a fabric

In comparing the CV values of the different materials (Table 2) it can be seen that geosynthetics G3, G4 and G5 presented generally lower CV (range: 1 to 21%) than geosynthetics G1 and G2 (range: 2 to 51%). This difference may be due to the structure of the materials (see description in Section 3 and Figure 1). Geosynthetics G3, G4 and G5 had a grid structure, whereas geosynthetics G1 and G2 had a structure formed by a polypropylene non-woven geotextile which is more prone to damage and can present a more heterogeneous behaviour. It is also important to note that geosynthetic G5 presented the lowest CV value. Geosynthetic G5 had a monolithic structure (see Figures 1e and 4b) and was only slightly affected by the deterioration procedures.

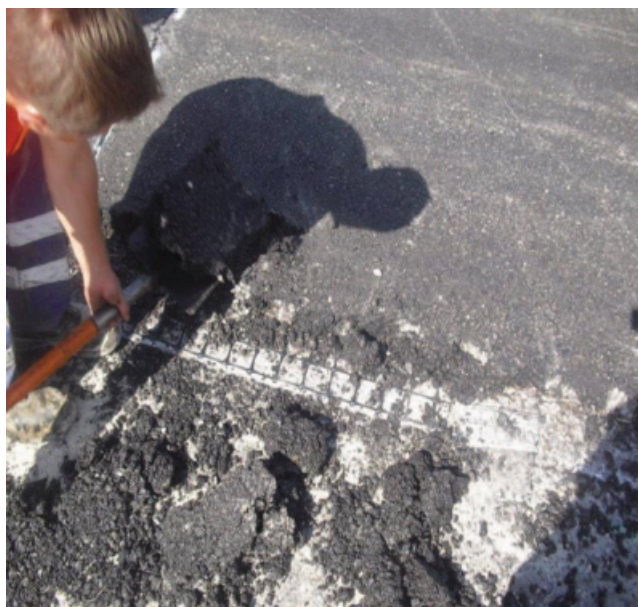
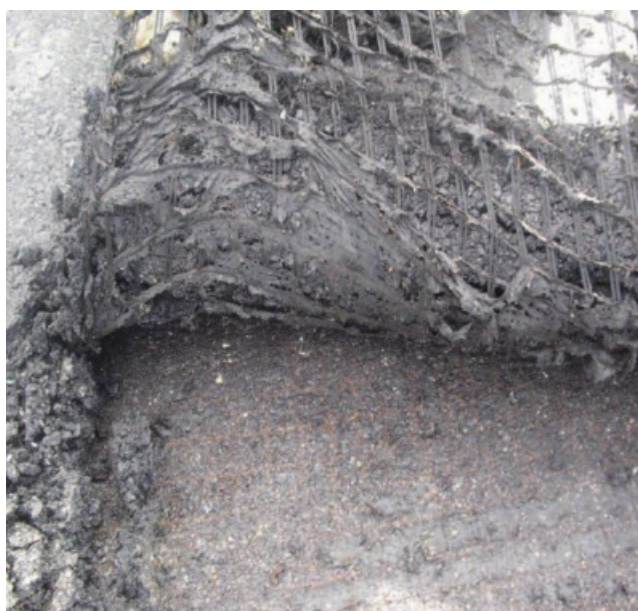
Figure 2. Test section: (a) removal of the bituminous layer, and (b) recovery of the geosynthetics

differed from the real installation procedure for geosynthetics in which a tack coat is employed with the objective of allowing a good bonding between the layers. After compaction and cooling of the bituminous mixture to a temperature of about 80°C (to avoid damaging the geosynthetics) the overlay layer was removed manually. The geosynthetics had to be recovered by pulling (Figure 2), which could cause additional damage.

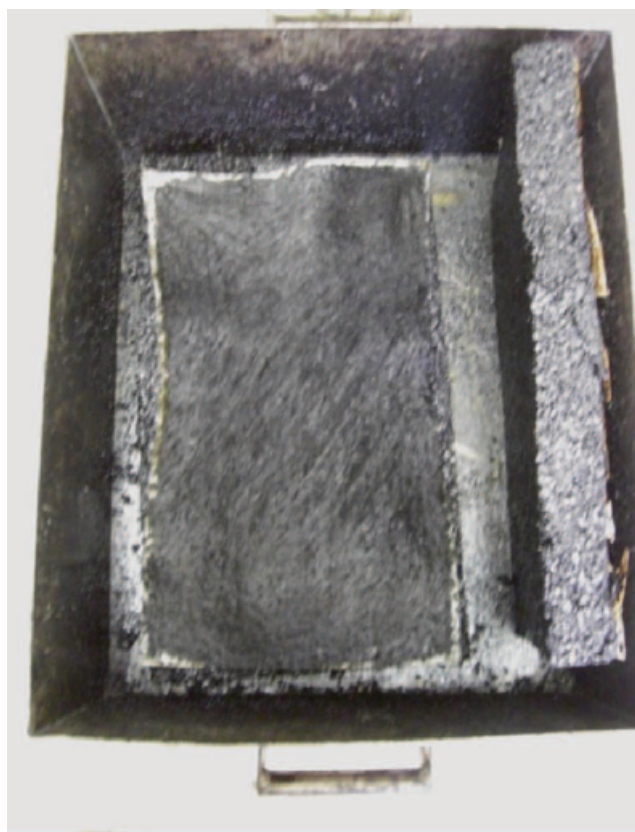
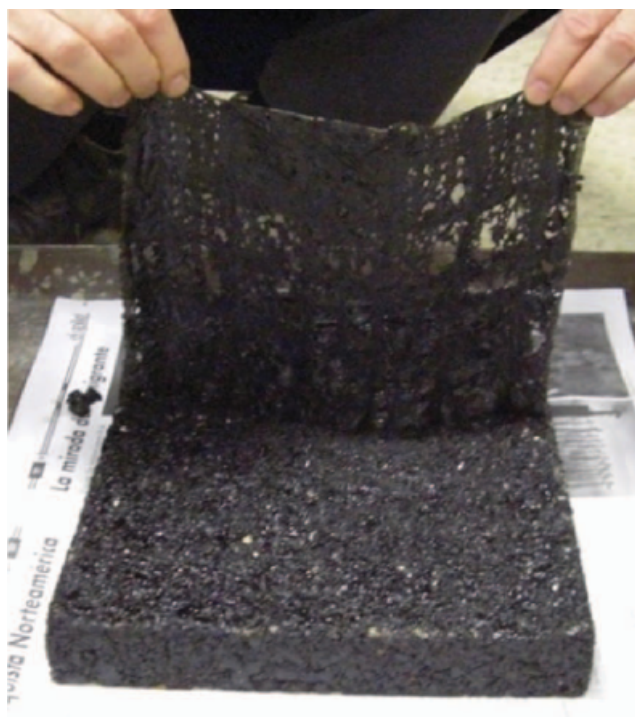
Figure 3. Laboratory test: (a) separated layers, and (b) extraction of the geosynthetic

Finally, the specimens were left to cool at ambient temperature and the last step was the removal of the geosynthetics. For this purpose, the specimens were heated to 110°C and the layers were separated so that the geosynthetics could be easily extracted without causing any apparent damage (see Figure 3).

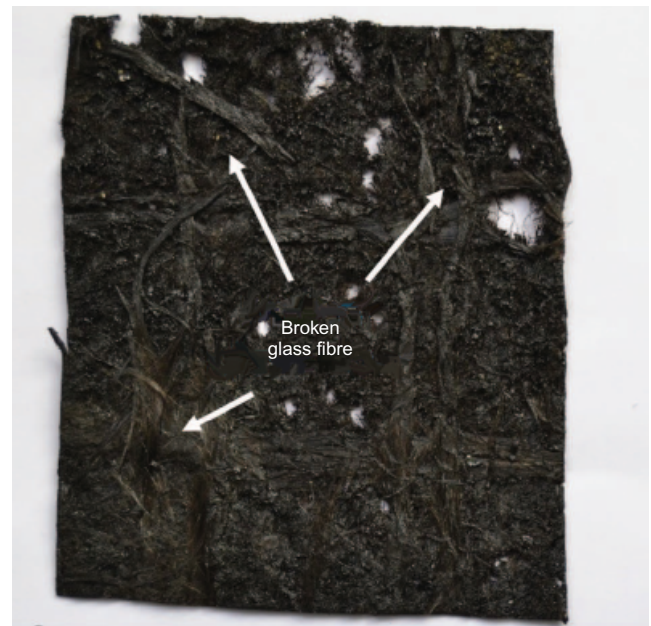
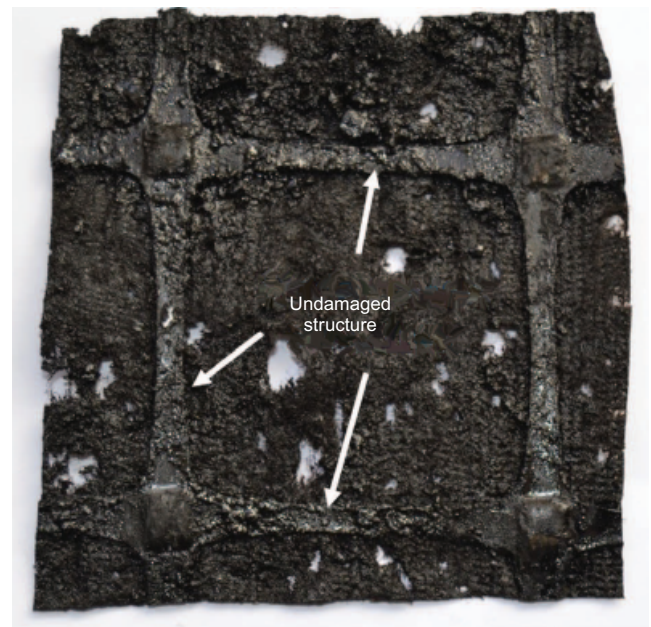
Figure 4. Deteriorated geosynthetics: (a) G2, and (b) G5 after the laboratory test

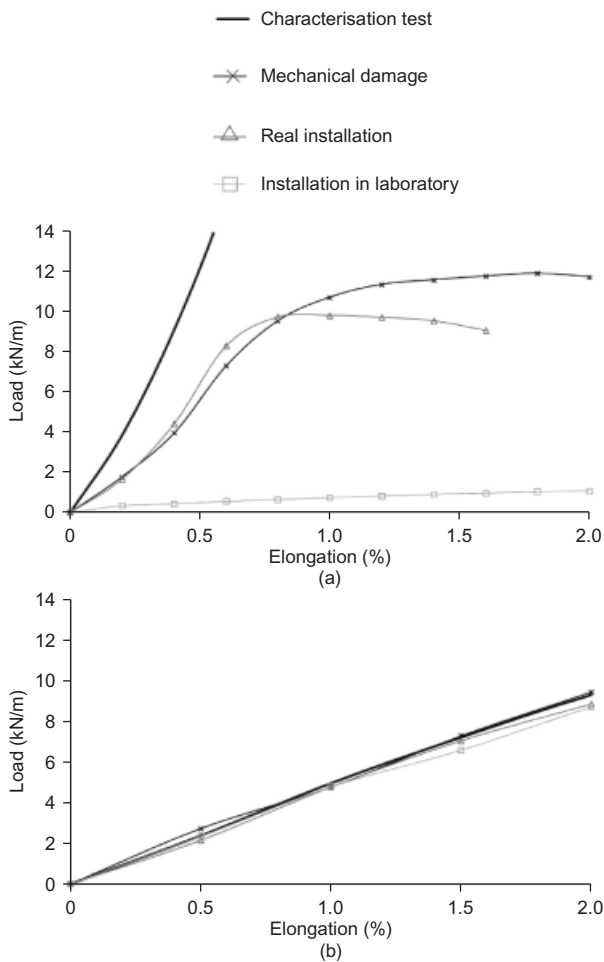
Figure 6. Initial part of the load–elongation curves obtained from wide-width tensile test: (a) G2, and (b) G5

are two geosynthetics that presented extreme behaviour, see G2 and G5 in Figure 6. Geosynthetic G2 showed an important loss of its mechanical properties after the deterioration procedures had been applied. Having initially behaved as a rigid material, it presented a load–elongation curve that was more typical of an elastic material after the deterioration tests. This can be explained because geosynthetic G2 is composed of glass fibre filaments that reinforced the geotextile without any coating and they were broken after the deterioration procedures (Figure 4a). It is clear that this material was very resistant to tensile stress, but also very fragile under mechanical actions. Both factors are very important in the potential use as an anti-reflective cracking system. In addition, it is important

In order to clarify the behaviours observed in Figures 5 and 6, a comparison between the residual secant modulus values and the values obtained from the characterisation test (geosynthetic under as-received conditions) is presented in Figure 7. It can be seen from Figure 7 that the mechanical damage test by aggregates is not a representative procedure of the installation of geosynthetics in asphalt pavements, because the obtained results were very different from those obtained after the real installation and installation in laboratory tests. Moreover, it appears that in most cases the mechanical effect of aggregates on geosynthetics does not produce an important amount of deterioration. The residual secant modulus was over 80% in the case of geosynthetic G1. Geosynthetics G3, G4 and G5 retained 100% of the initial modulus and a significant decrease was only seen in the case of G2 (glass fibre geocomposite) which had a residual secant modulus of

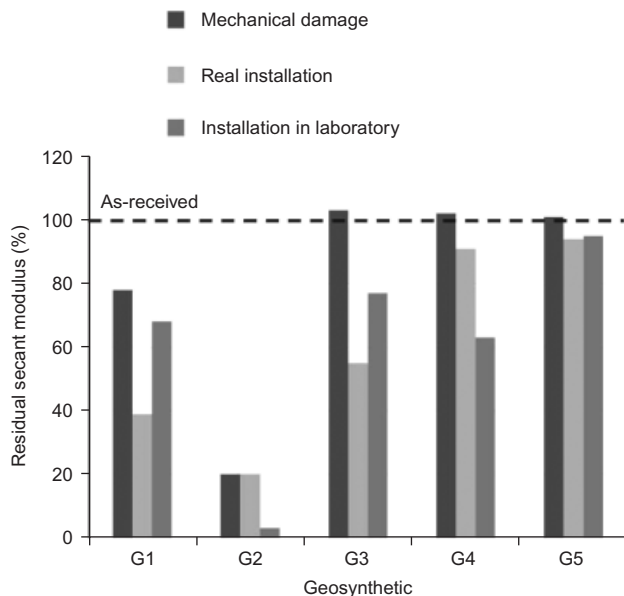
Figure 7. Residual secant modulus with regards to initial modulus in percent

20%. In contrast, after the real installation test the secant modulus was reduced although the obtained result was different in each case, varying between a residual secant modulus of 20% in the case of geosynthetic G2 and 90%

for geosynthetics G4 and G5. After the new installation in laboratory test, the secant modulus behaviour was also different depending on the type of geosynthetic tested. It varied from a maximal residual modulus of 95% for material G5 to a minimal value of 5% in the case of geosynthetic G2. The other three materials had a residual modulus of over 60%.

Finally, from Figure 7 a classification of the anti-reflective cracking systems can be defined based only on their resistance against deterioration using the procedures examined. From the least to the most resistant they can be graded as follows: G5 (stiff monolithic geogrid), G4 (polyvinyl alcohol geogrid), G3 (polyester geogrid), G1 (nonwoven polypropylene geotextile), and G2 (nonwoven polypropylene geotextile reinforced with glass fibre filaments).
