THE PRESERVATION SOCIETY OF NEWPORT COUNTY

WHITE PAPER

FEASIBILITY STUDY FOR THE USE OF GEOTHERMAL CLIMATE MODIFICATION AT THE BREAKERS

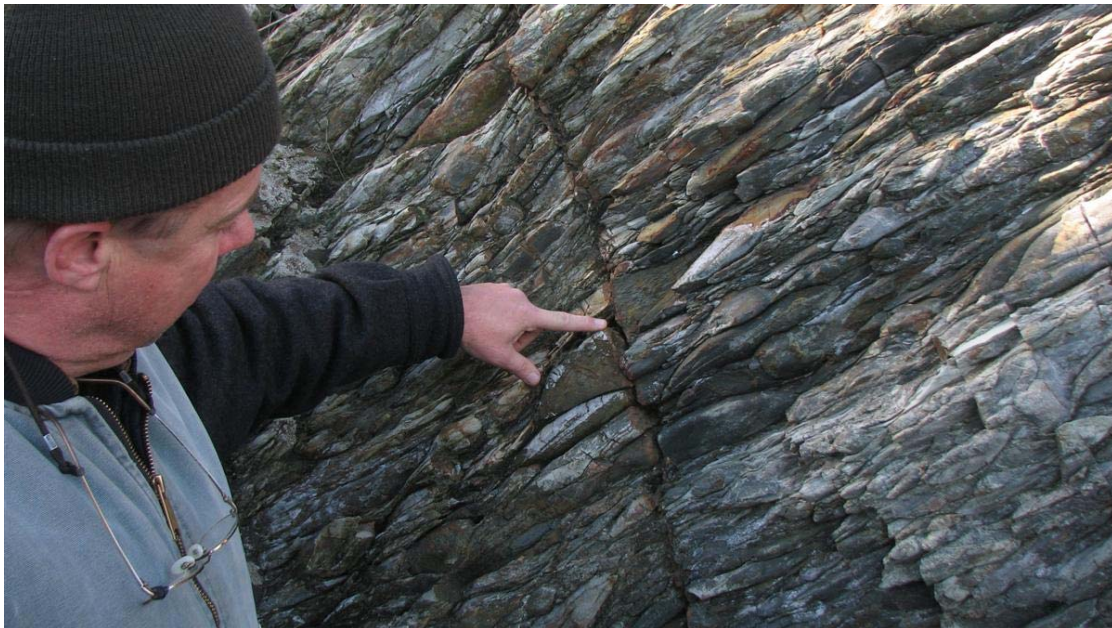
Figure 2: At the cliff on the east side of the site, geologist Christopher Covel indicates a typical fracture in a layer of conglomerate. This is the type of feature that holds and transmits underground water.

The project geologist was Christopher Covell, P.G./C.G. of Covell & Associates. He investigated the nature of the rock by examining the cliffs on the ocean side of the property (Figure 2). The cliff face shows the different layers of the rock—schist, conglomerate, competent bedrock, and slate—and how they are folded and fractured. An old hand-pump well head was found at the edge of the cliffs, with water running out of the fractures in the rock nearby (Figure 3). The axis of the main fault line through The Breakers property extends out into the water, exactly in line with a well known surf spot at Ruggles Avenue (Figure 4). By touring the site, one can visualize as well the network of fractures that emanate from the main fault. This network of fractures has the potential to hold water.

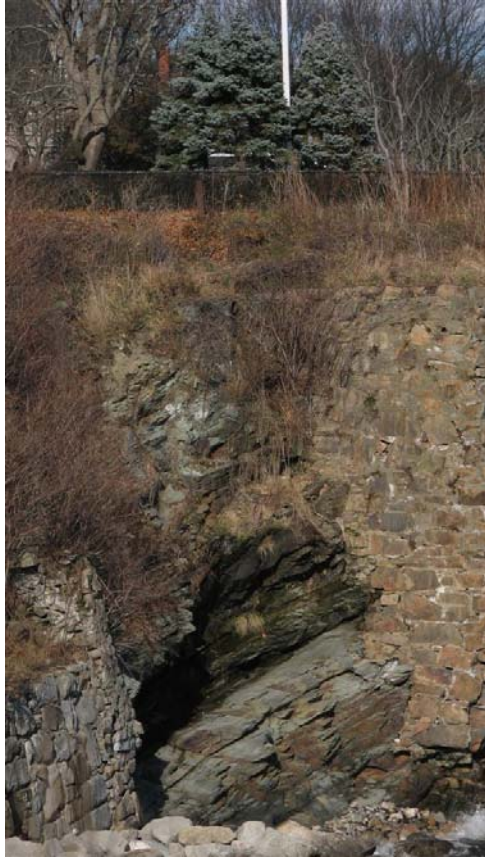
Figure 3: An old well head (at arrow), probably hand-pumped, is found abutting The Breakers on Cliff Walk. Different layers and rock can be seen on the cliffside: overburden, schist, conglomerate, and slate. The schist layer is very wet.

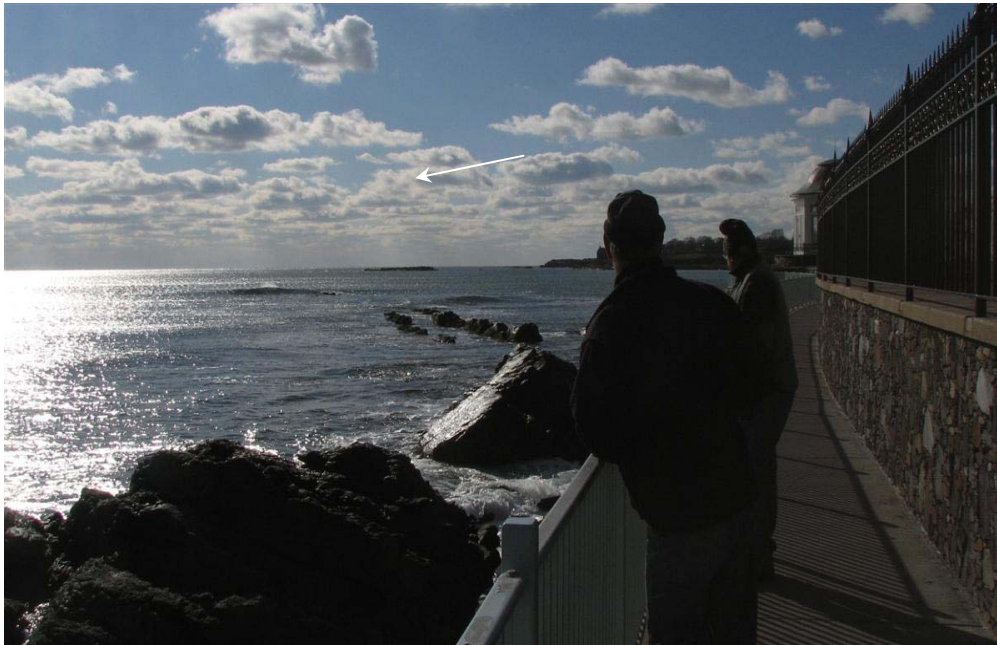
Figure 4: A north-south fault running through the site extends into the ocean, creating a well known surf spot at Ruggles Avenue.

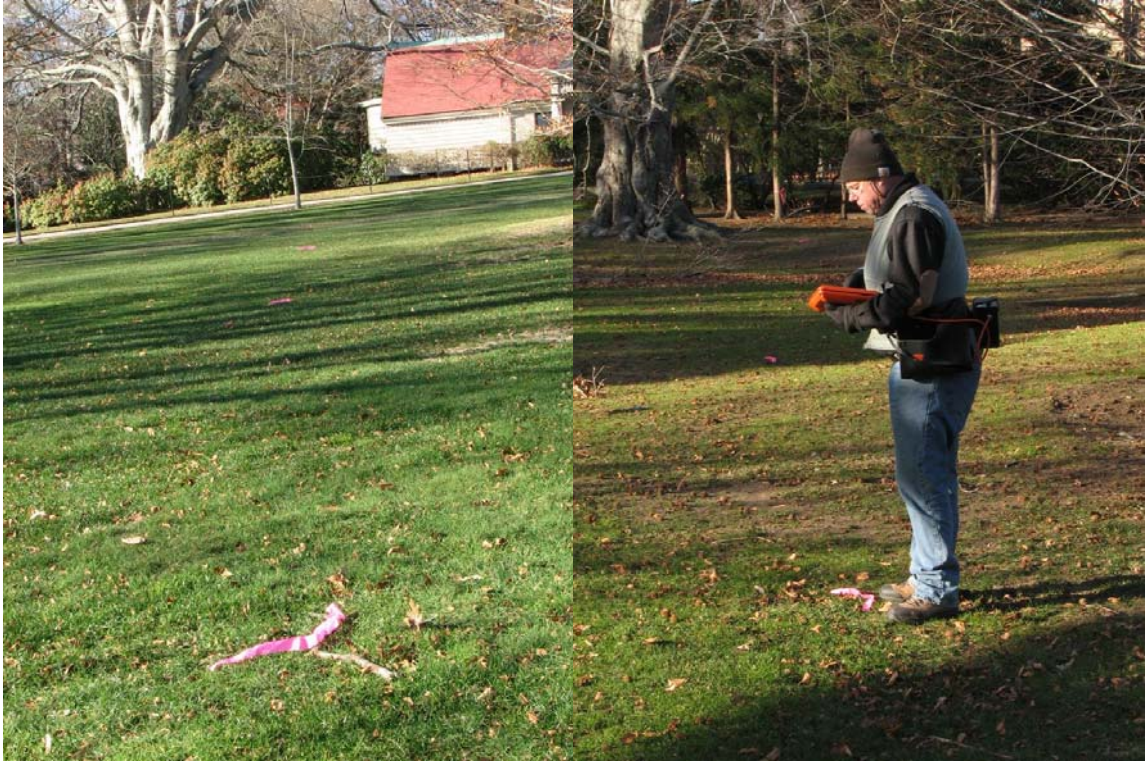
Figure 5: Markers indicate one of the lines laid out for gathering VHF data. The geologist walks the line with the ABEM WADI instrument which gathers data relative to the behavior of the radio waves at water- and non water-bearing underground structures.

The process involved laying out geophysical data lines perpendicular to the trend of the fault and walking with the instrument periodically to gather data as the fault is crossed (Figure 5). Several replicate lines were tested as this ensures repeatability. The project geologist laid out approximately 1,300 meters of VLF geophysical line and collected data along the designated paths. The relative strengths of the current were recorded and the data presented in graph form (Current Density Profiles) and in color-coded cross section maps. High current density indicates the presence of water and is shown by hotter red areas on the maps as opposed to non-water-bearing structures in cooler blues. The relative wetness of the site and the angle of the fault are clearly visible (Figures 6, 7).

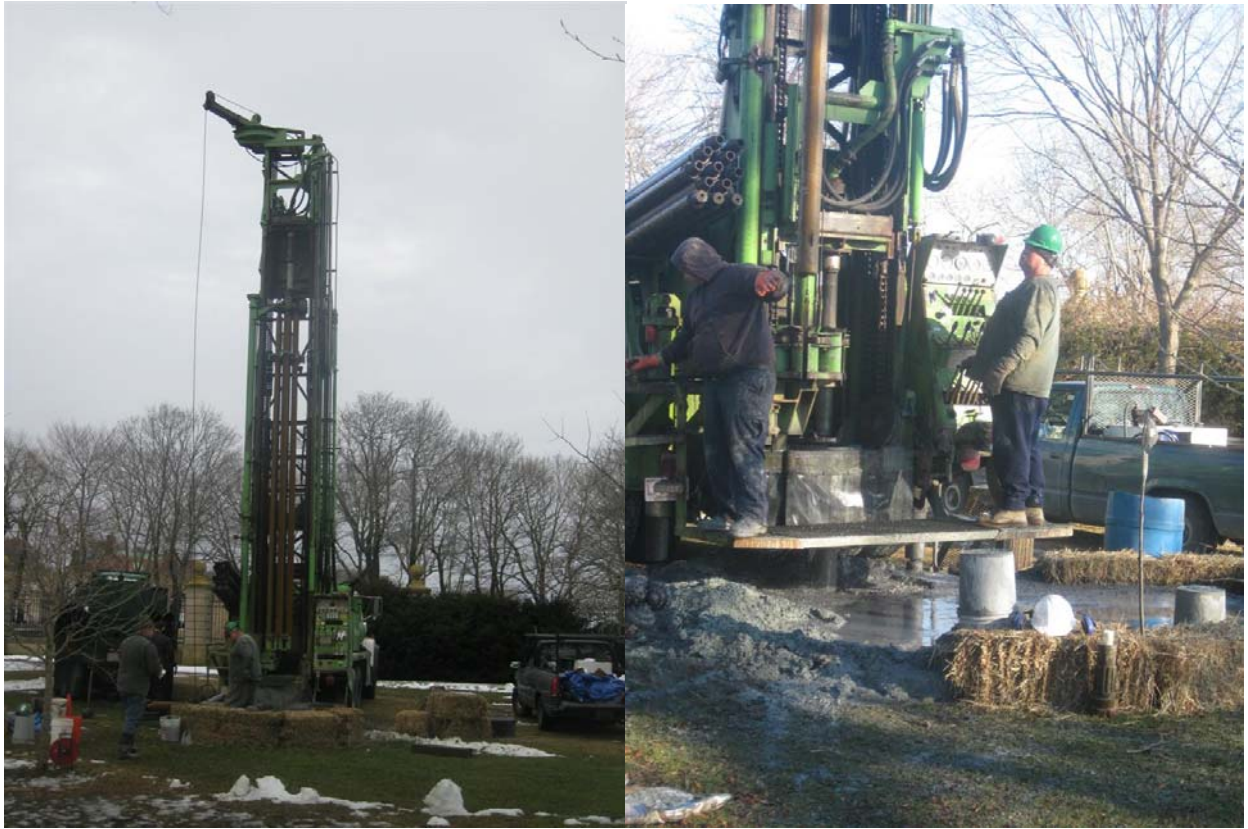
Figure 10: Drilling underway at Drill Target #1. Note hay bales to contain drill slurry. Eventually, a containment pit had to be dug.

Joel Russell and his team arrived with the drill rig on Monday, January 17, 2011 (Figure 9). Bad weather kept them from setting up and beginning drilling until Wednesday, January 19 (Figures 10, 11). The area was taped off and kept secure during the drilling process. They drilled seven

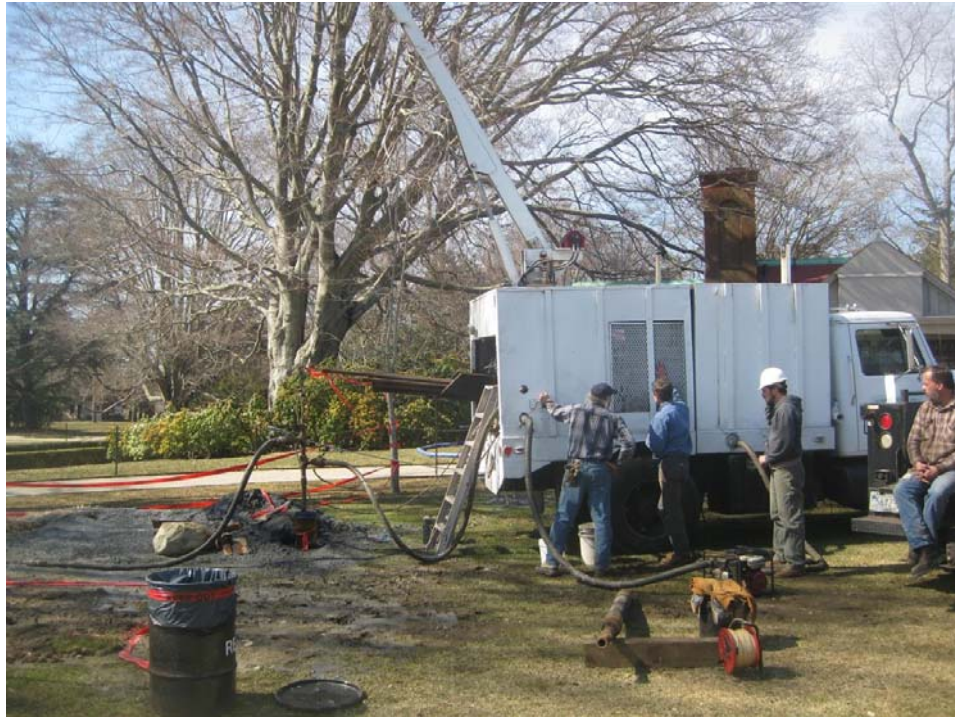
Figure 13: Setting up for hydro-fracturing. Truck is fitted out with a crane and pumps/compressor

Under the direction of the project geologist and well driller, each borehole was subsequently hydro-fractured, requiring a water truck and a truck outfitted with a compressor and pump (Figures 13, 14). An expandable plug, called a “packer” (Figure 15), was lowered into each borehole and inflated just above the water-bearing zone. Water was then pumped at high pressure through an integral pipe (Figure 16). This was repeated at each zone. The pressure, which fractures the web of water-bearing zones further, could go as high as 3,000 pounds per square inch (psi) and the process used over 15,000 gallons of water.

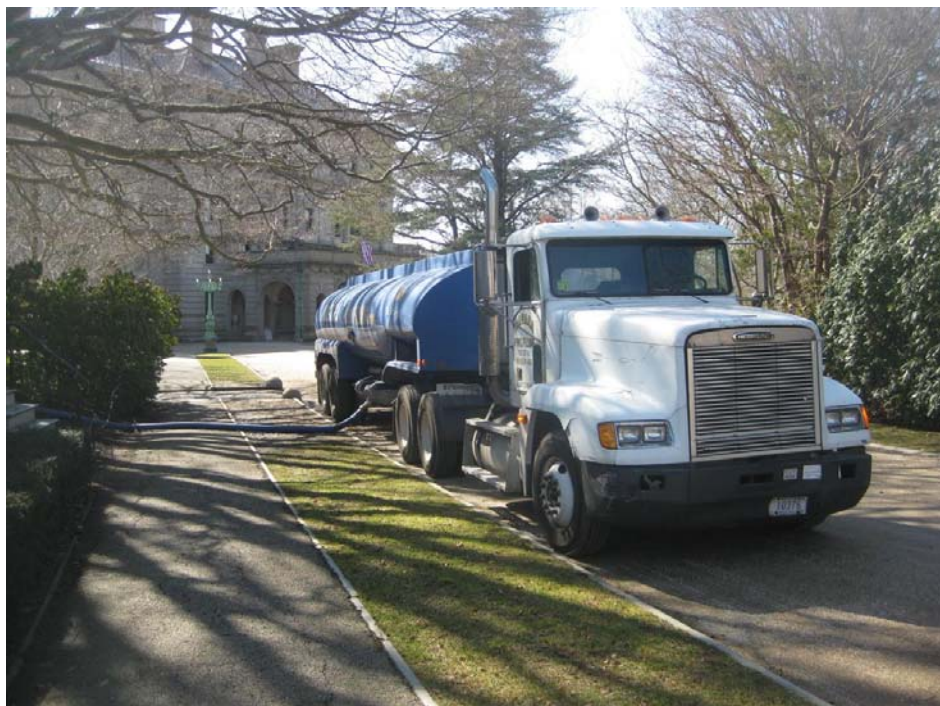
Figure 14: Water for the hydro-fracturing is supplied by a tanker truck.

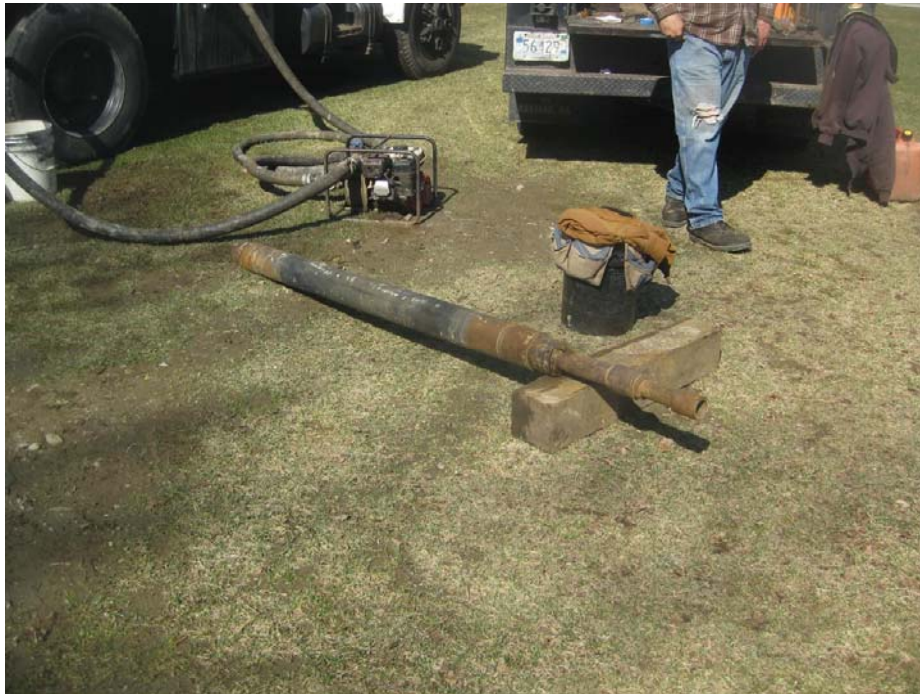
Figure 15: An expandable plug (“packer”) is inflated in the hole at each fracture zone to seal it while compressed air and water is injected through the pipe.

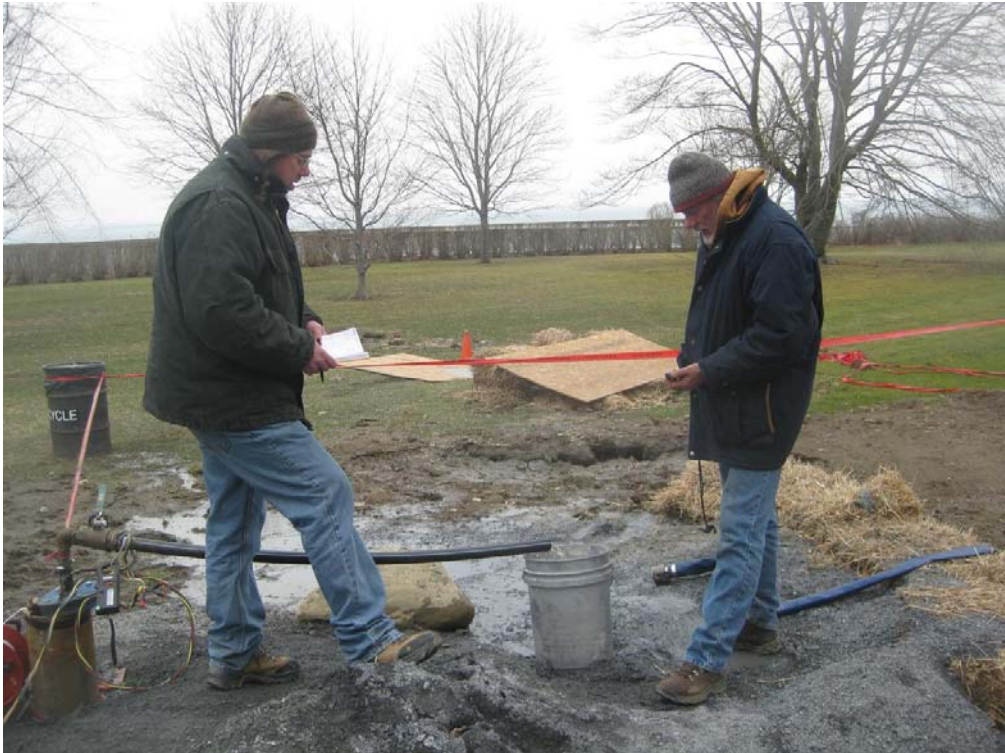
Figure 17: Chris Covell and Joel Russell perform initial rating of gallons per minute.

Hydro-fracturing Drill Target #1 caused the yield to go from 4.5 to 7.5 gpm, and for Drill Target #2 the yield rose from 5 to 10 gpm, for a total yield of 17.5 gpm, significantly closer to our goal of 30 gpm (Figures 17, 18). The water volumes identified are considered to be very conservative numbers that can be counted on continuously. The addition of two boreholes (one north of Drill Target #1 and one south of Drill Target #2), bringing the total to four, would very much increase the probability that we could achieve at least 30 gpm, the lower estimate of our need for the most sustainable system (Figures 17, 18).

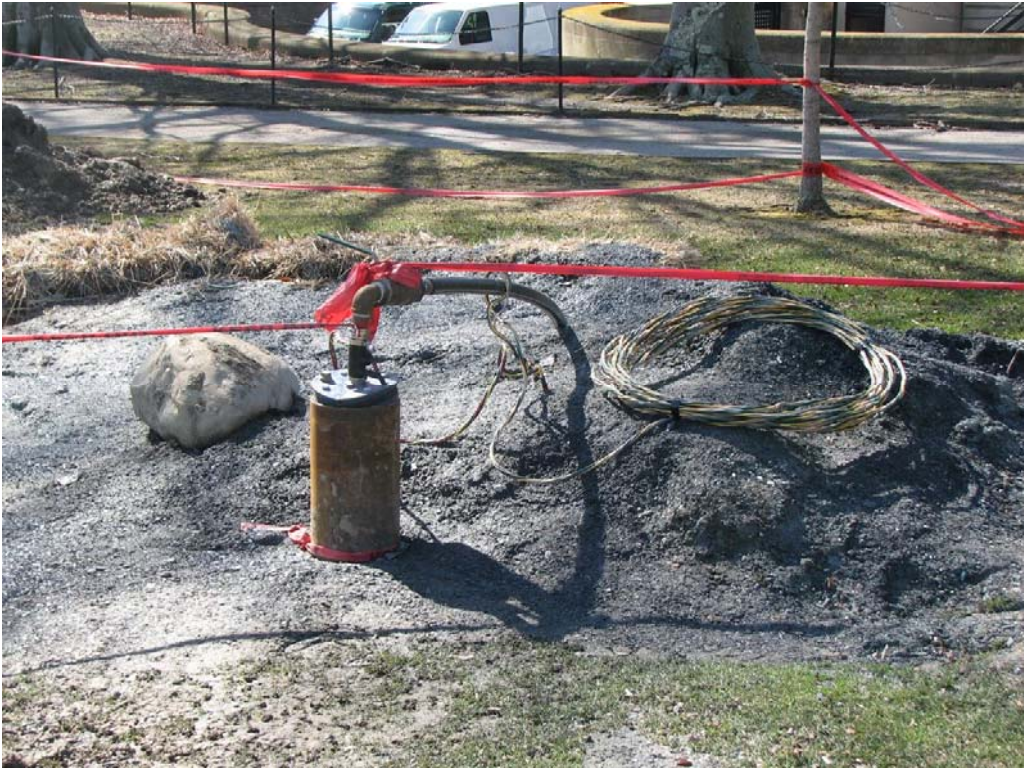
Figure 18: 48-hour drawdown pump test in operation. Pumped water was discharged into drains in the maintenance drive.

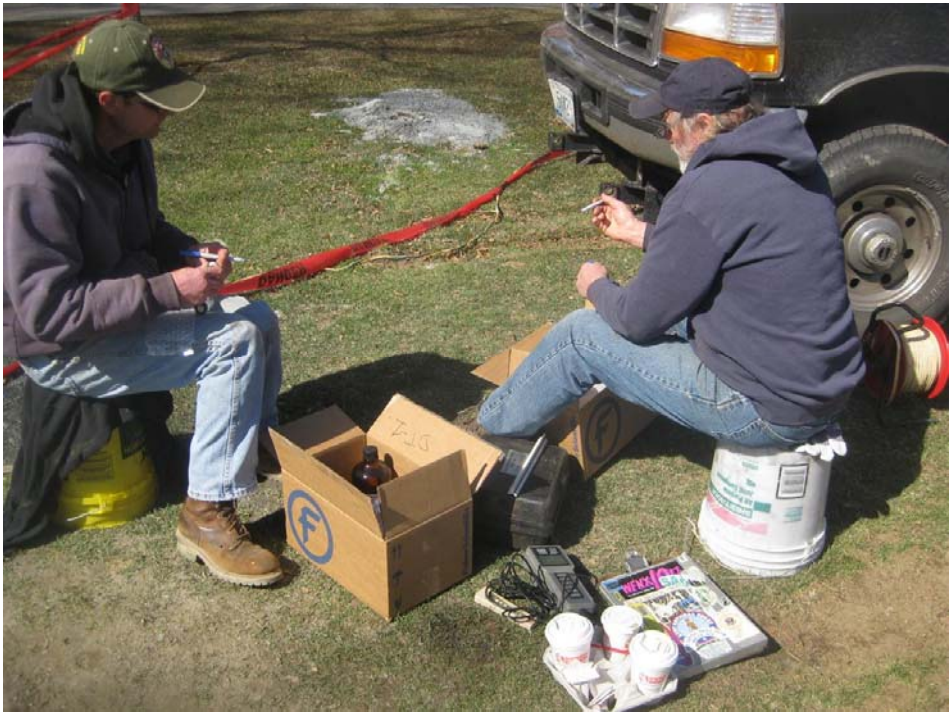
Figure 19: Water sampling for laboratory analysis.

The water was tested for temperature, pH, conductivity, volatile organic compounds and semi-volatile organic compounds, and for dissolved metals and hardness (Figure 19). We found the water has a temperature average of 55.2° F—close enough to our target of 52° F—and has a nearly neutral pH, is free of volatile organic compounds and semi-volatile organic compounds, and contains a minimal amount of sodium chloride, making it suitable for the system proposed.
