Quasi-static cyclic tests on different types of masonry spandrels

Katrin Beyer
Ahmad Abo-El-Ezz
Alessandro Dazio

Institute of Structural Engineering
Swiss Federal Institute of Technology

Zürich
September 2010

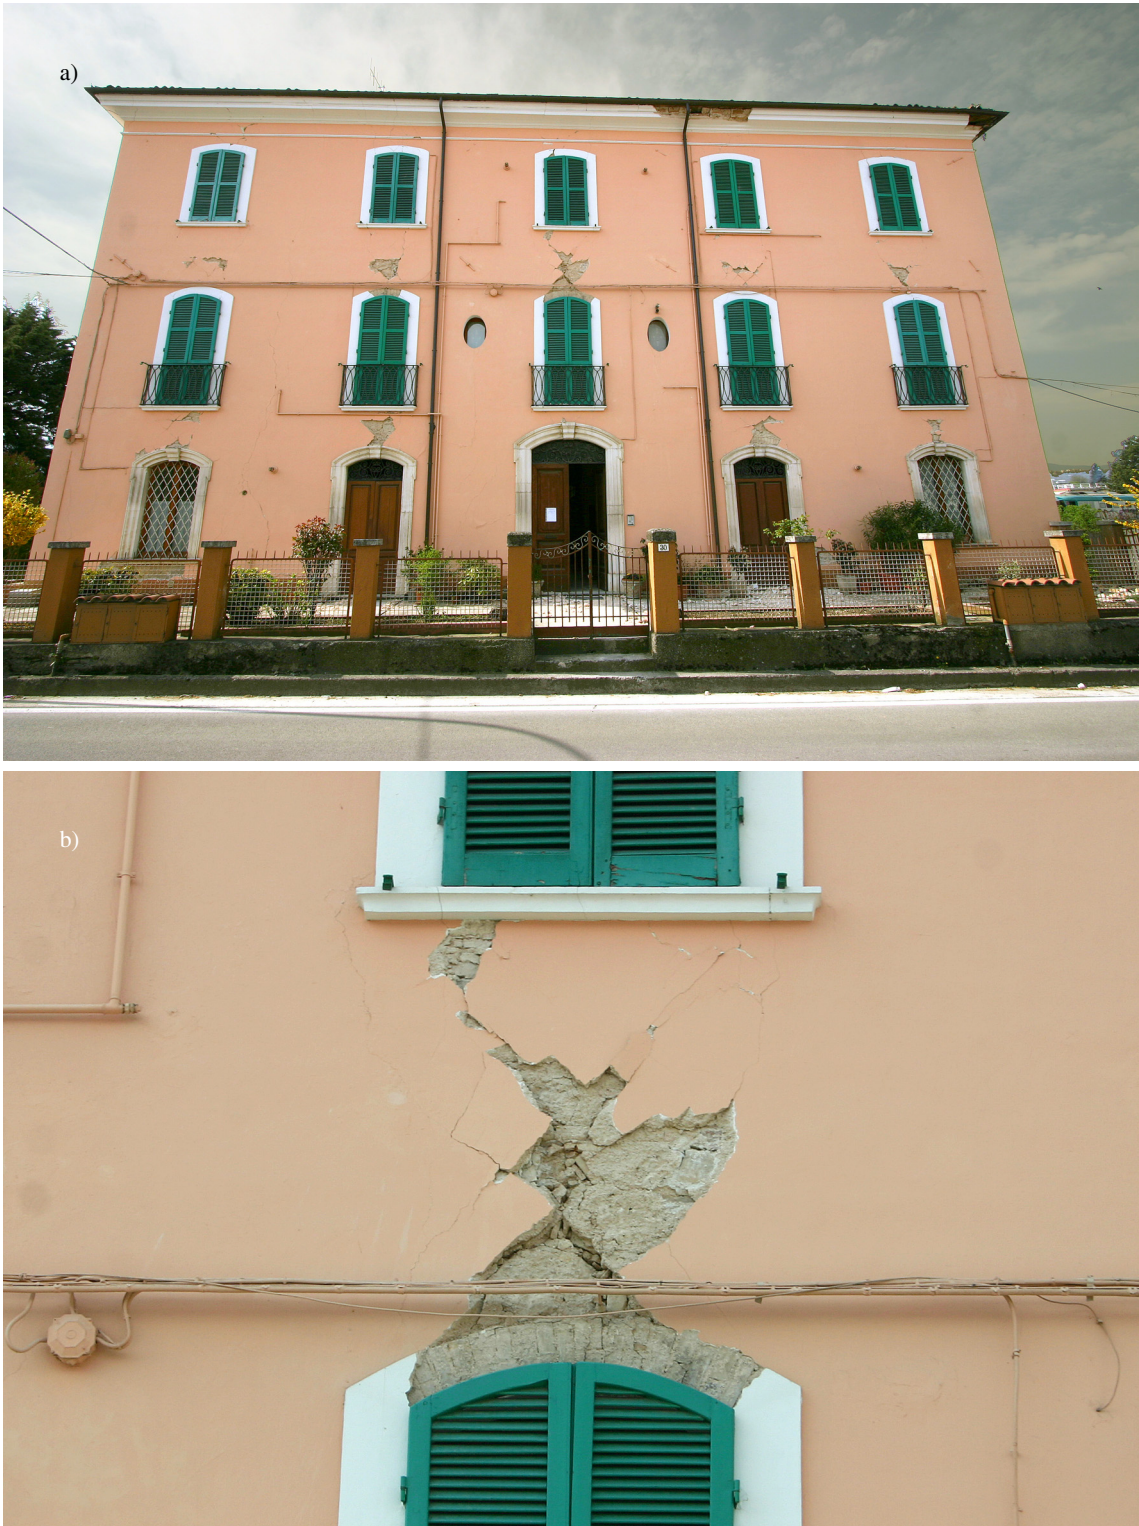
Figure 1.6: Shear failure of spandrels in an old URM building with masonry arches during the L'Aquila earthquake on April 6th, 2009: Entire building (a) and detail of a spandrel (b).

Spandrels have been subjected to extensive damage during earthquakes and are often the first elements within a URM building to crack or fail. In the following two types of failure modes of spandrels that were observed after the $M_w = 6.3$ earthquake in L'Aquila (Italy) on April 6th, 2009 are briefly discussed [DBB⁺09]. A typical failure mode of URM spandrels with masonry arches is shown in Fig. 1.6. It is a URM building in the city centre of L'Aquila. All the spandrels between window openings have failed in shear and show the characteristic X-crack pattern. The horizontal stiffness and strength of the building are therefore very much reduced. In this case the spandrels are heavily restrained by both the relatively wide piers as well as by tension ties running along the facade embedded in the masonry. When looking at the building from the side, it was possible to see the anchorage of those ties. The anchorage of the ties running perpendicular to the facade can be easily identified on Fig. 1.6a. A different example is shown in Fig. 1.7. This building stood also close to the city centre of L'Aquila. In this case tension ties were definitely not present. In addition the piers were very slender providing only a minor restraint to the axial elongation of

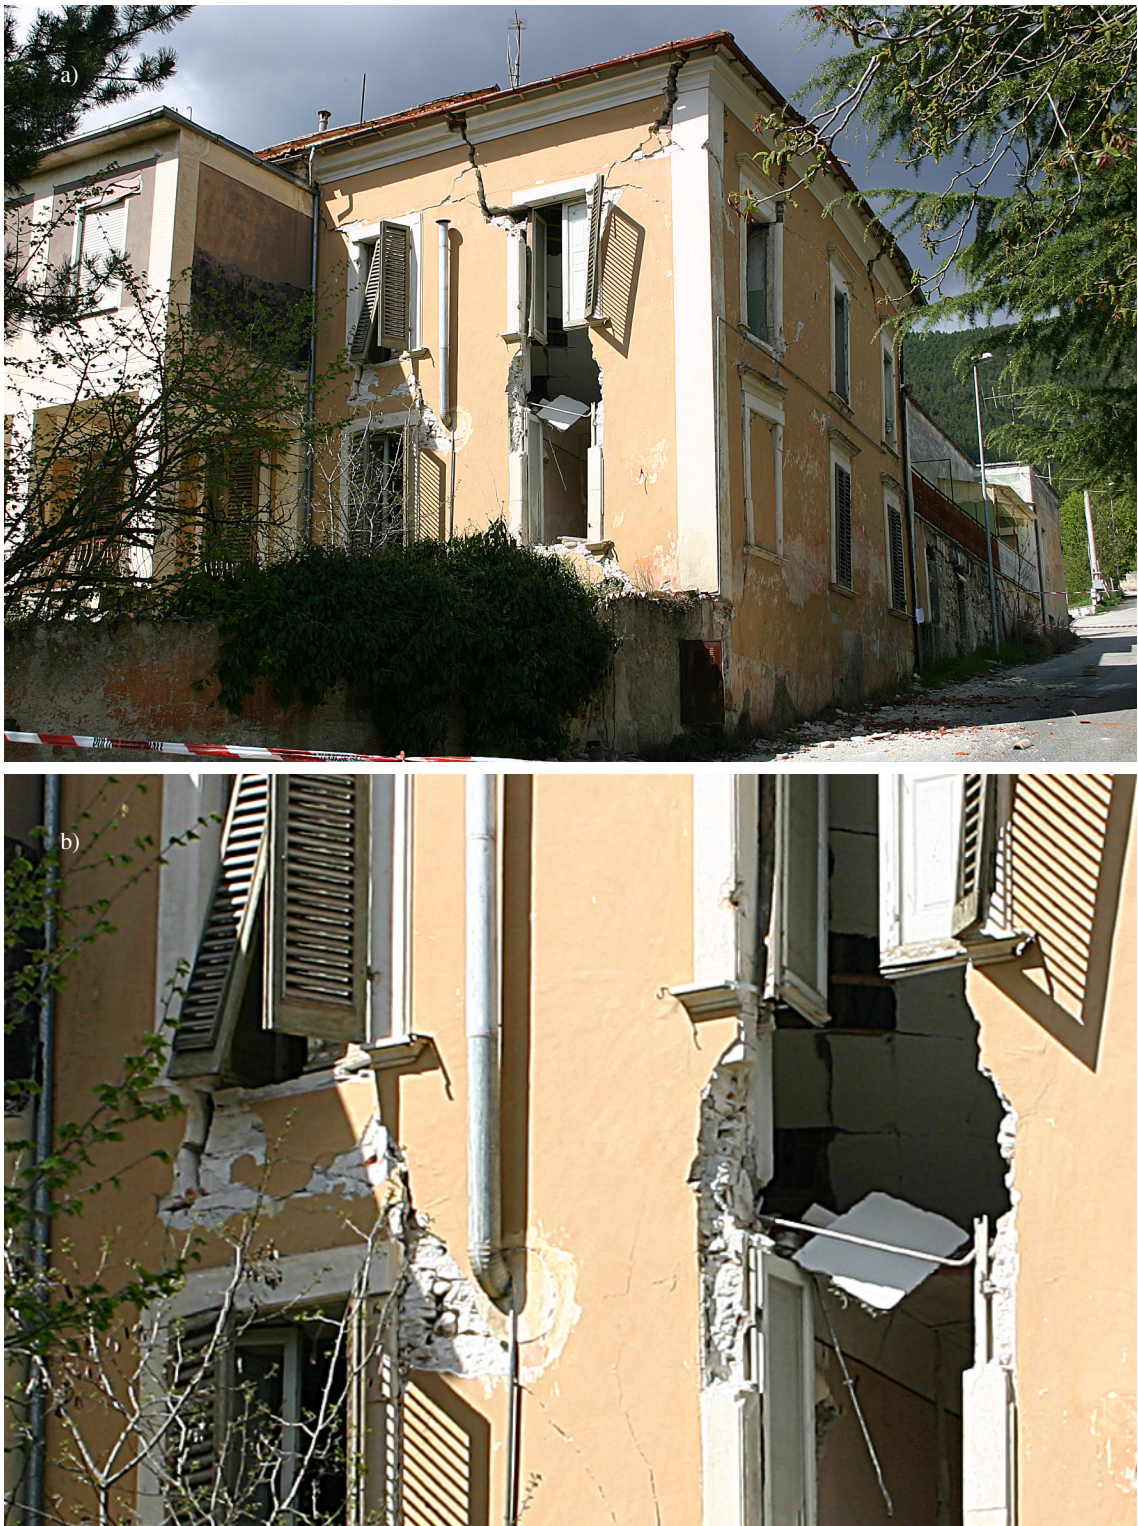
Figure 1.7: Flexural failure of spandrels in an old URM building with lintels during the L'Aquila earthquake on April 6th, 2009: Entire building (a) and detail of a spandrel (b).

the spandrels. As a consequence the spandrels failed in flexure by means of wide vertical cracks at both ends of the spandrel. Due to out-of-plane accelerations one of the spandrels collapsed completely. This building was a complete loss and was pulled down after the earthquake. Only one building with composite spandrels was identified during the Swiss reconnaissance mission to L'Aquila [DBB⁺09]. It was a very small building and remained undamaged. For this reason damage to composite spandrels has not yet been observed by the authors.

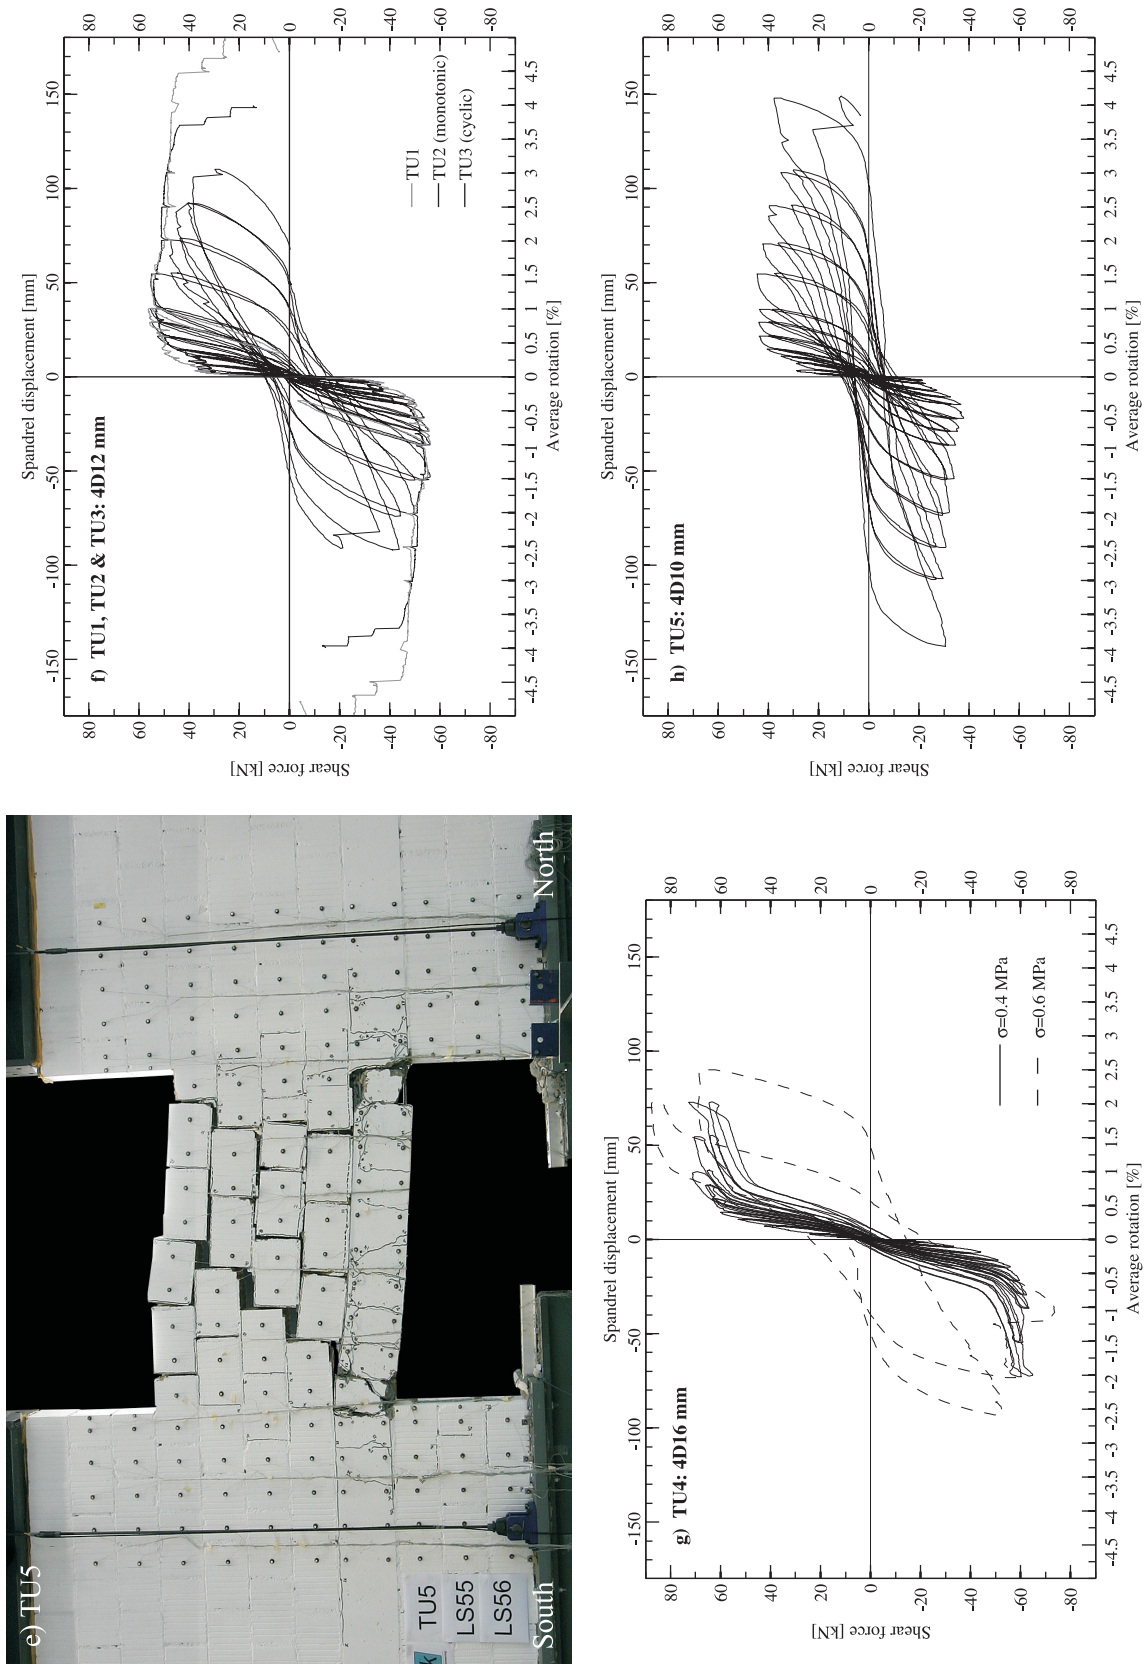
Figure 3.2: Composite spandrels: Failure modes of TU1-5 (a-e) and hysteresis curves of TU1-5 (f-h).

The crack pattern of the masonry spandrel of TU2 at failure was characterised by two major stair-stepped cracks (Fig. 3.2b). At the beginning of the test, the bricks of TU2 remained largely undamaged and the cracks followed the joints. As the deformation demand increased, crushing of the compression diagonal took place leading to a Southward shift of the positive plastic hinge. The final failure of the test unit was caused by the rupture of longitudinal bars in both the negative and the positive plastic hinge. Although TU1 and TU2 had different masonry properties and exhibited a different masonry behaviour, the force-rotation relationships of TU1 and TU2 were very similar (Fig. 3.2f). For both test units, the initial elastic phase was followed by a zacky branch, which was associated with the formation of cracks in the masonry spandrel and the RC beam. The onset of yielding in the longitudinal reinforcement of the RC beam caused the force-rotation curve to round off. It stayed level for a small range of rotations and began then to drop. This reduction in capacity starting at a rotation of 1 to 1.5% was associated with the crushing of the compression diagonal.

TU3 was the first test unit subjected to cyclic loading. It showed a very stable cyclic behaviour up to a drift of 1.5% (Fig. 3.2f). Afterwards, the capacity of the test unit decreased. This reduction in capacity was again associated with the crushing of the compression diagonals in the masonry spandrel. TU3 failed within the first cycle at a rotation demand of 3% due to shear failure of the RC beam (Fig. 3.2c). On the whole, the envelope of TU3 corresponded very well to the force-deformation relationship of TU2, which had identical properties but had been subjected to monotonic loading. Up to a drift of 1.5% the peak capacities of TU3 exceeded even the curve of TU2. This is most likely due to the slightly larger mortar strength of TU3. TU2 and TU3 were built at the same time. Since TU2 was tested first, the mortar strength at the day of testing was less than the mortar strength of TU3 at the day of testing. For drift demands larger than 1.5% the reduction in capacity was stronger for TU3 than for TU2. It is believed that the cyclic behaviour led to a faster degradation of the compression strut and therefore to a stronger reduction in capacity. The cyclic behaviour also led to a larger growth in length of the RC beam since the plastic strain in the longitudinal reinforcing bars accumulated. As a consequence, at the same drift demand, the crack widths in the RC beam were larger for TU3 than for TU2. The shear reinforcement in the RC beam was not sufficient to carry the entire shear force of the beam. As the contribution of the concrete to the shear capacity reduced below a certain limit, TU3 failed within the positive plastic hinge in shear. When the loading was reversed thereafter, also a longitudinal bar fractured within the positive plastic hinge.

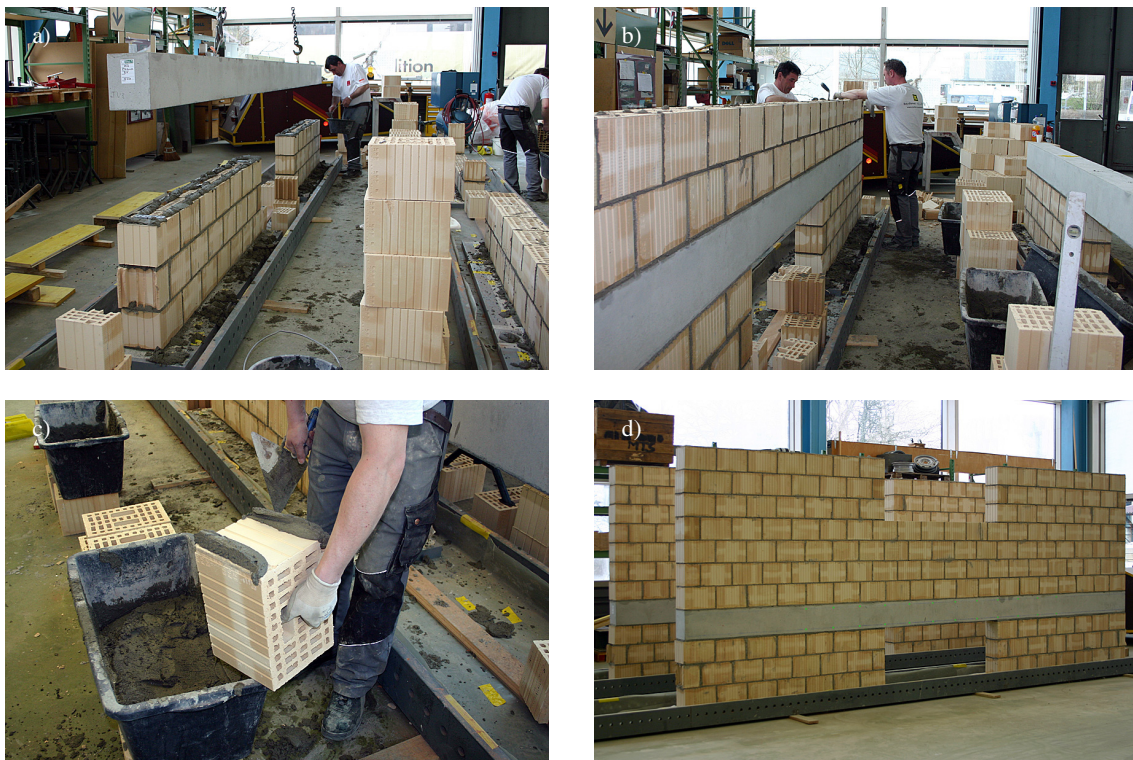
Figure 1.3: Construction of composite spandrels.

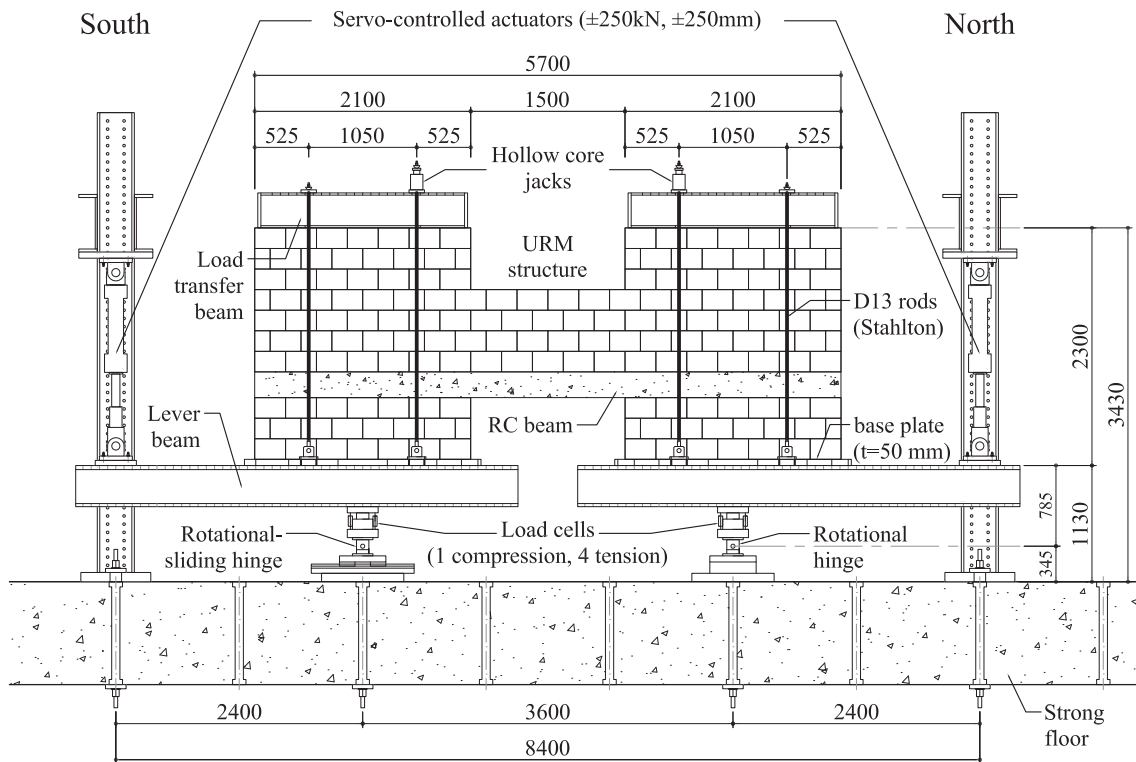
Figure 1.5: Drawing of the test setup for the composite spandrels. View from the East without side restraint. All dimensions in [mm].

A drawing and a photo of the test setup are shown in Fig. 1.5 and Fig. 1.6, respectively. The test unit stood on two stiff steel beams ("lever beam") that were supported on hinges at the centre line of the piers and connected to servo-hydraulic actuators at their ends. The actuators had a force capacity of $\pm 250 \text{ kN}$ and a displacement capacity of $\pm 250 \text{ mm}$. Both actuators were displacement-controlled. The support of the South lever beam allowed next to a rotation also a sliding movement in the direction of the beam. Hence, there was no axial restraint on the beam and for the composite spandrels the total axial force in the spandrel was zero during the entire time. During testing the two servo-hydraulic actuators were moved with the same velocity in opposite directions. As a

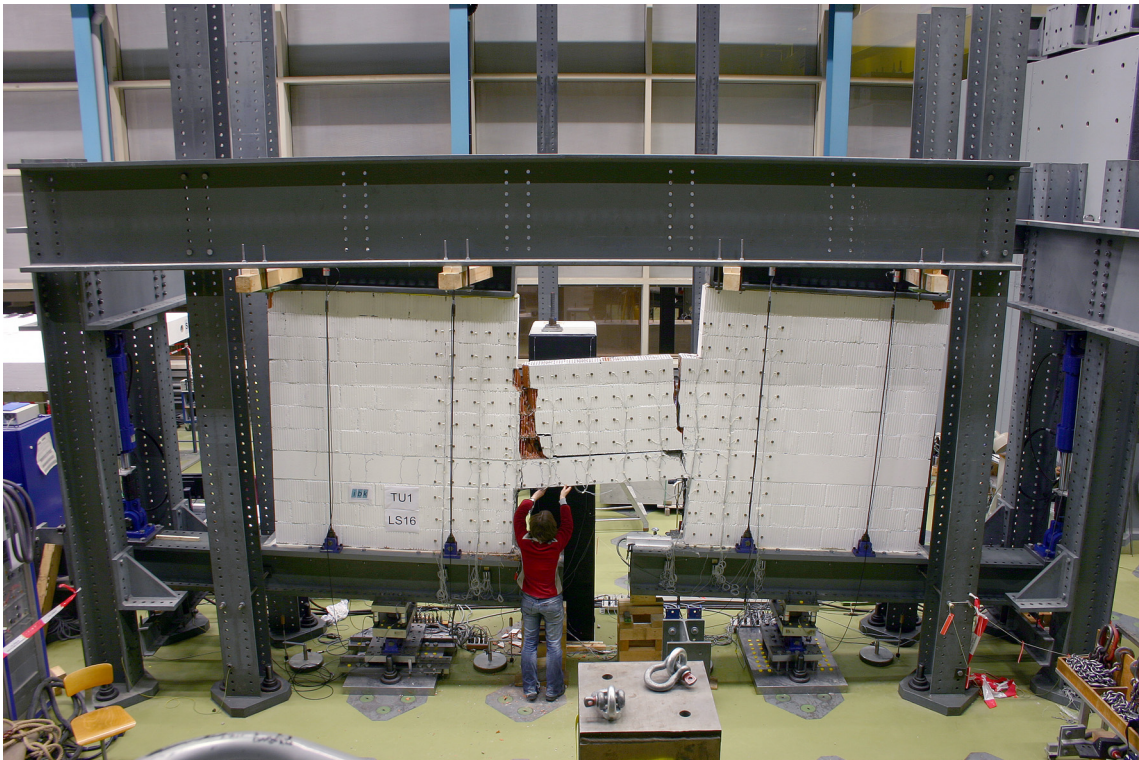
Figure 1.6: Photo of the test setup for the composite spandrels. View from the East.

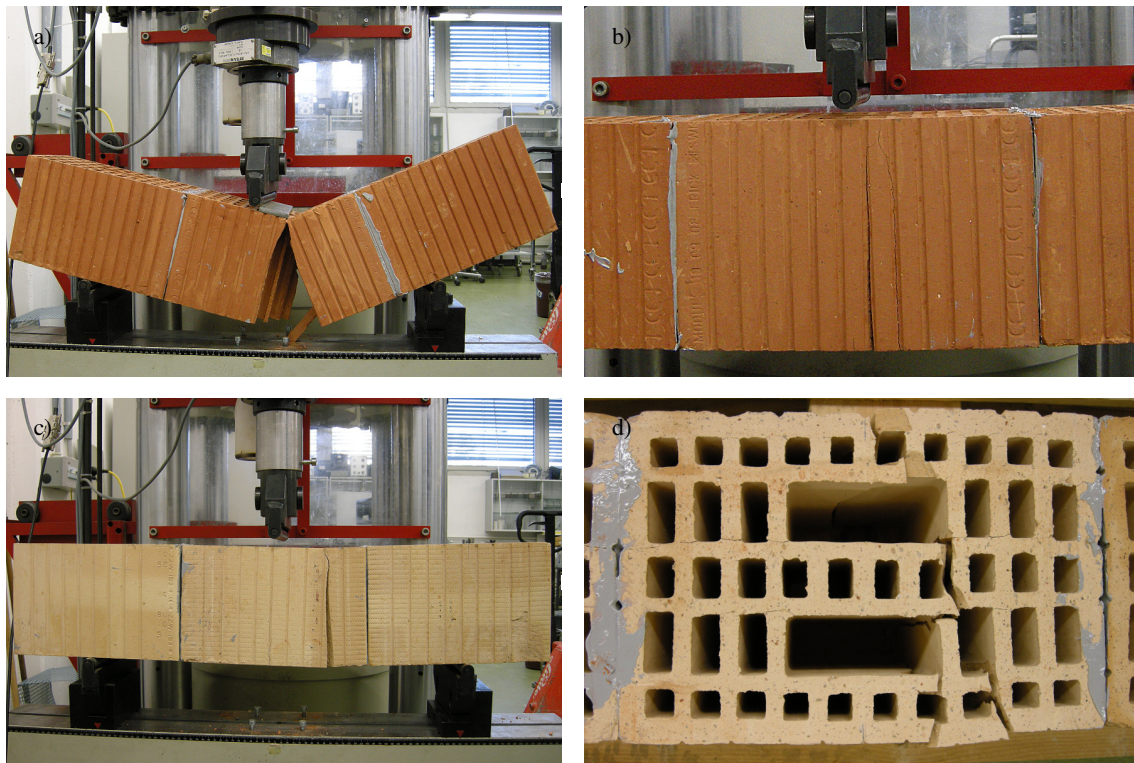
Figure 2.9: Composite spandrels: Failure modes of bricks tested under 3-point bending for Brick Type 1 (a and b) and Brick Type 2 (c and d).

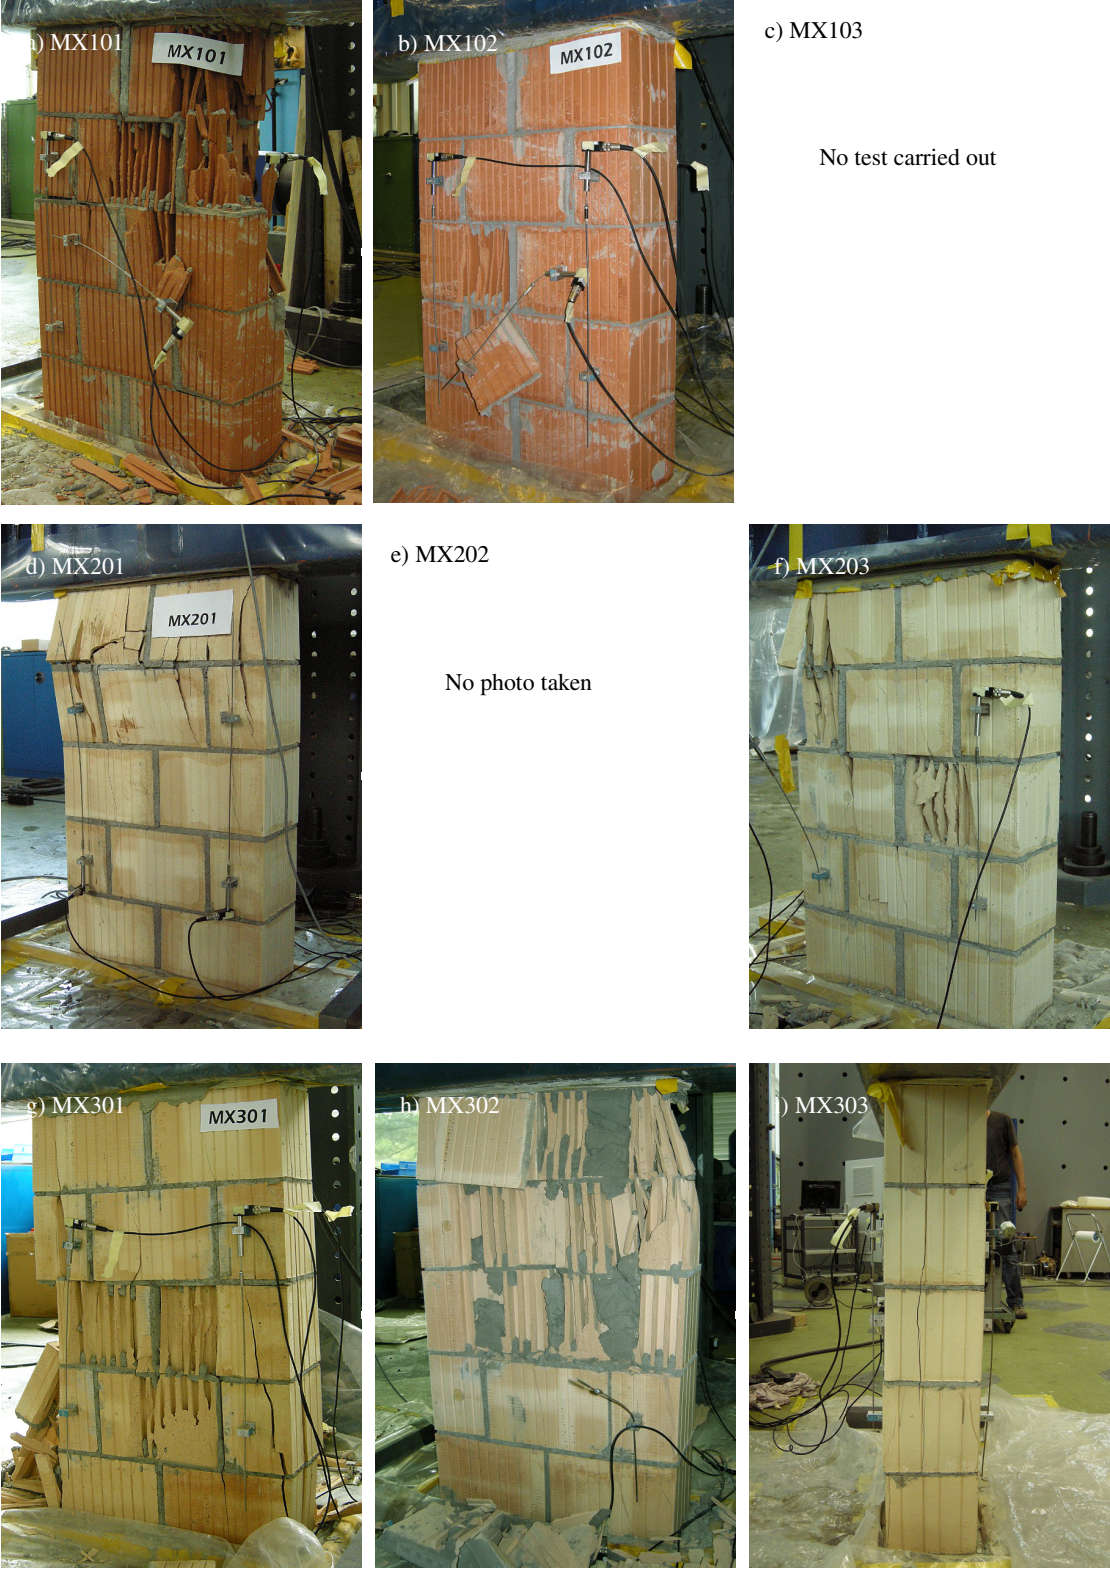
Figure 2.14: Failure modes of masonry wallets tested under compression orthogonal to the bed joints.

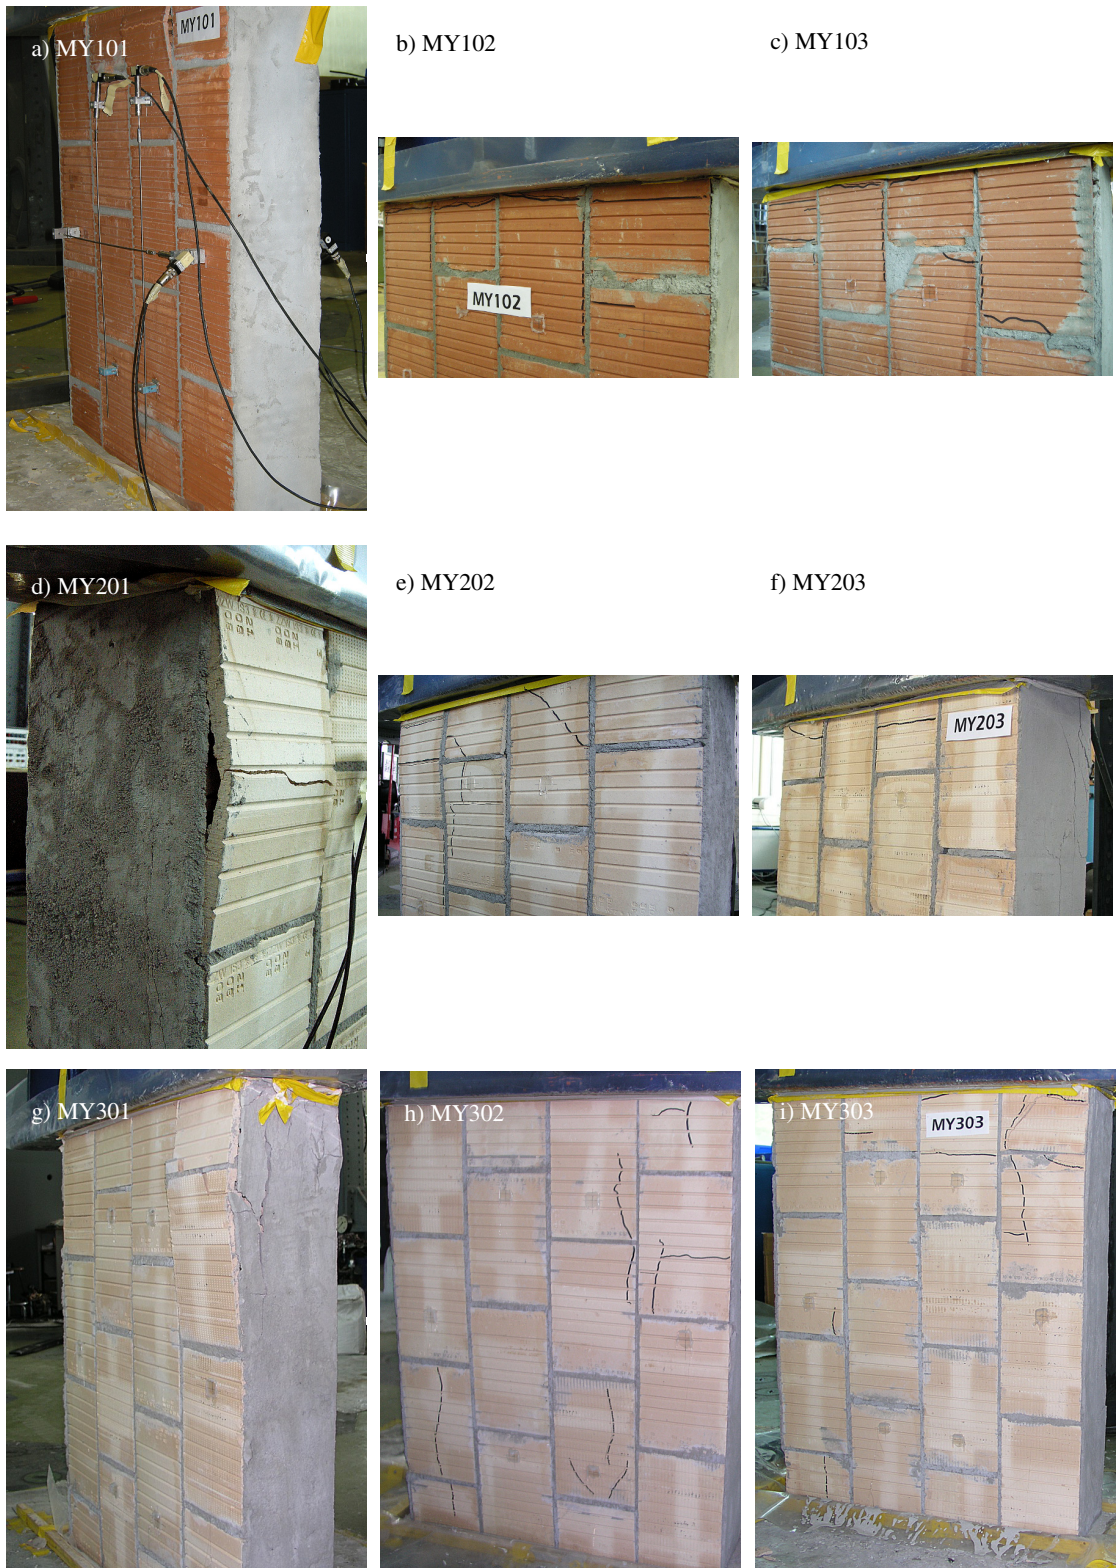
Figure 2.15: Failure modes of masonry wallettes tested under compression parallel to the bed joints.

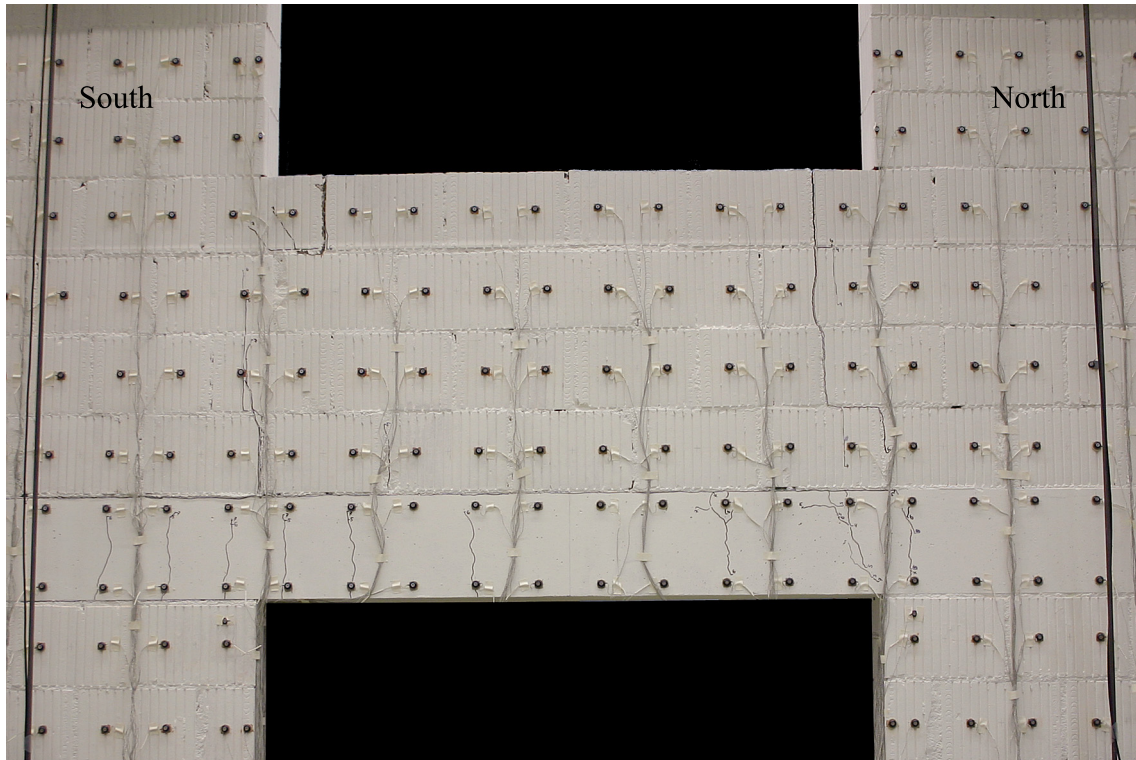
Figure 3.2: TUI: Crack pattern of spandrel at LS 7. Drift towards North with $\theta_{nom} = 0.4\%$.

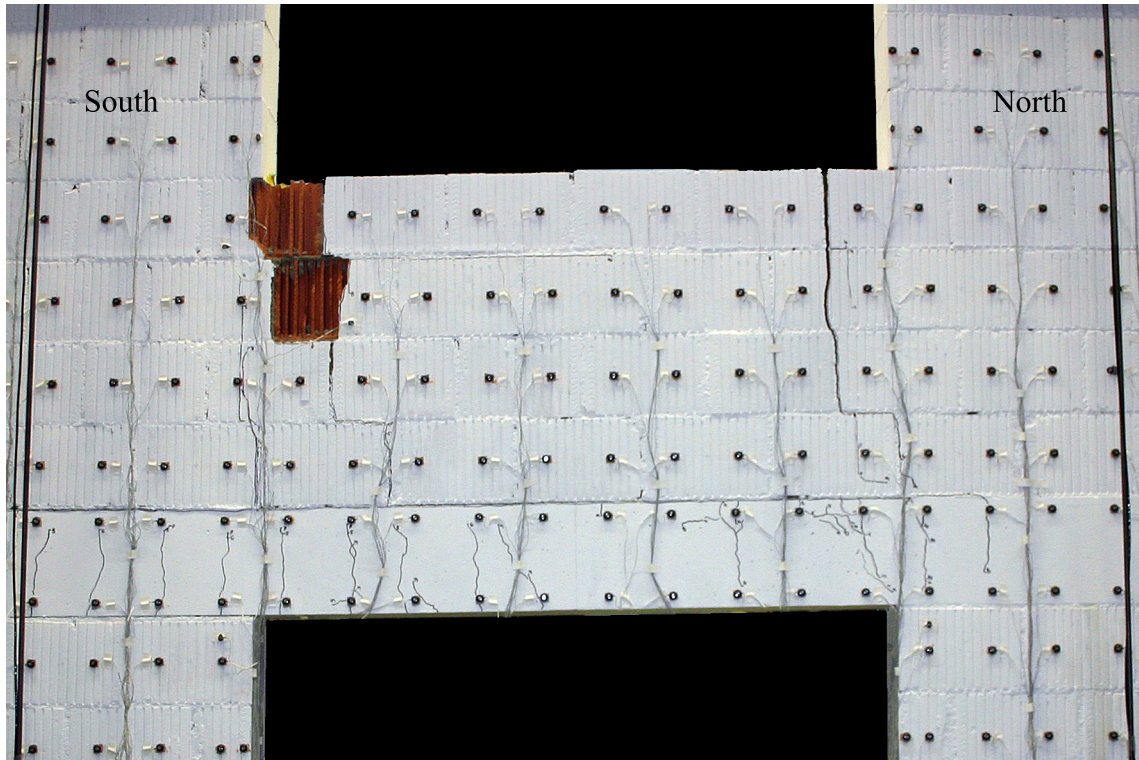
Figure 3.4: TUI: Crack pattern of spandrel at LS 9. Drift towards North with $\theta_{nom} = 0.8\%$.

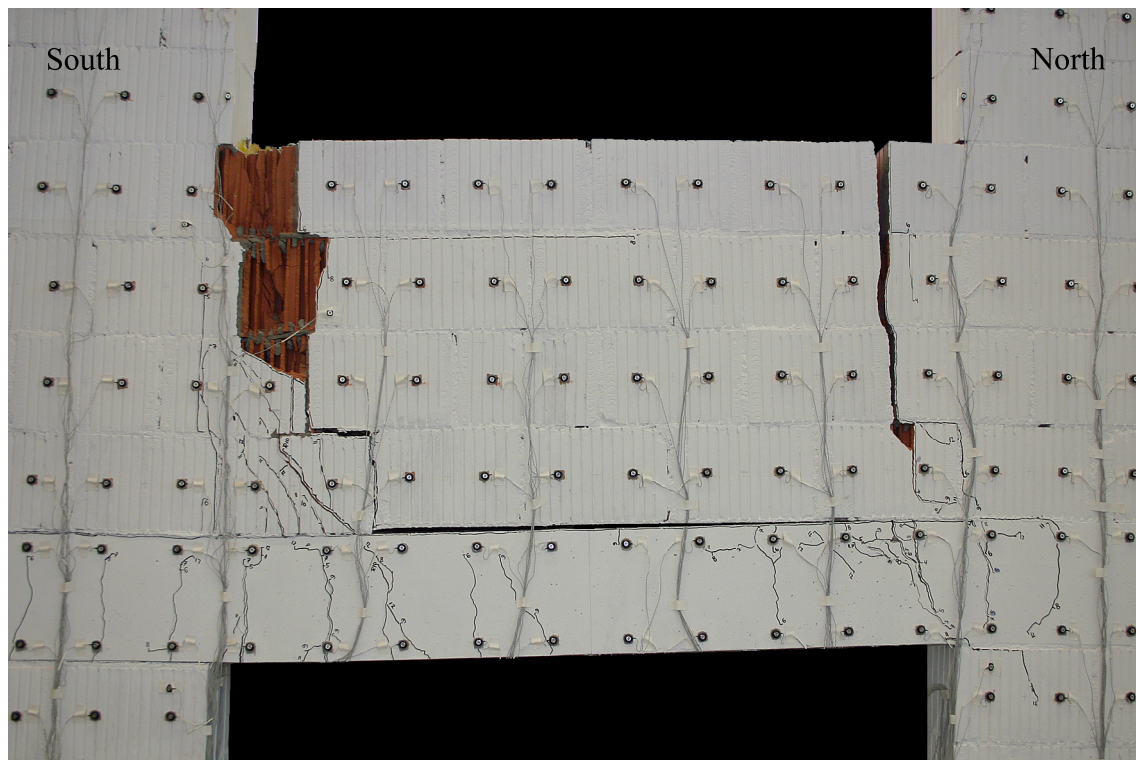
Figure 3.5: TU1: Crack pattern of spandrel at LS 12. Drift towards North with $\theta_{nom} = 2\%$.

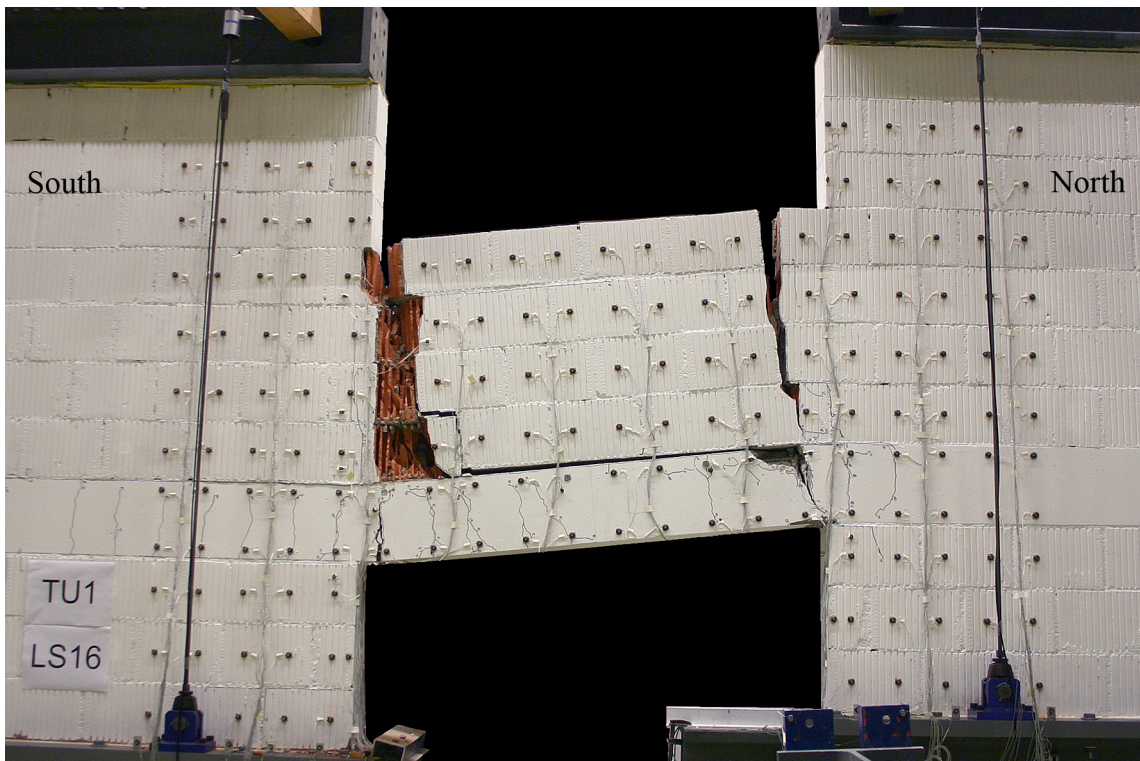
Figure 3.6: TU1: Crack pattern of spandrel at LS 16. Drift towards North with $\theta = 5.3\%$ (failure of TU1).

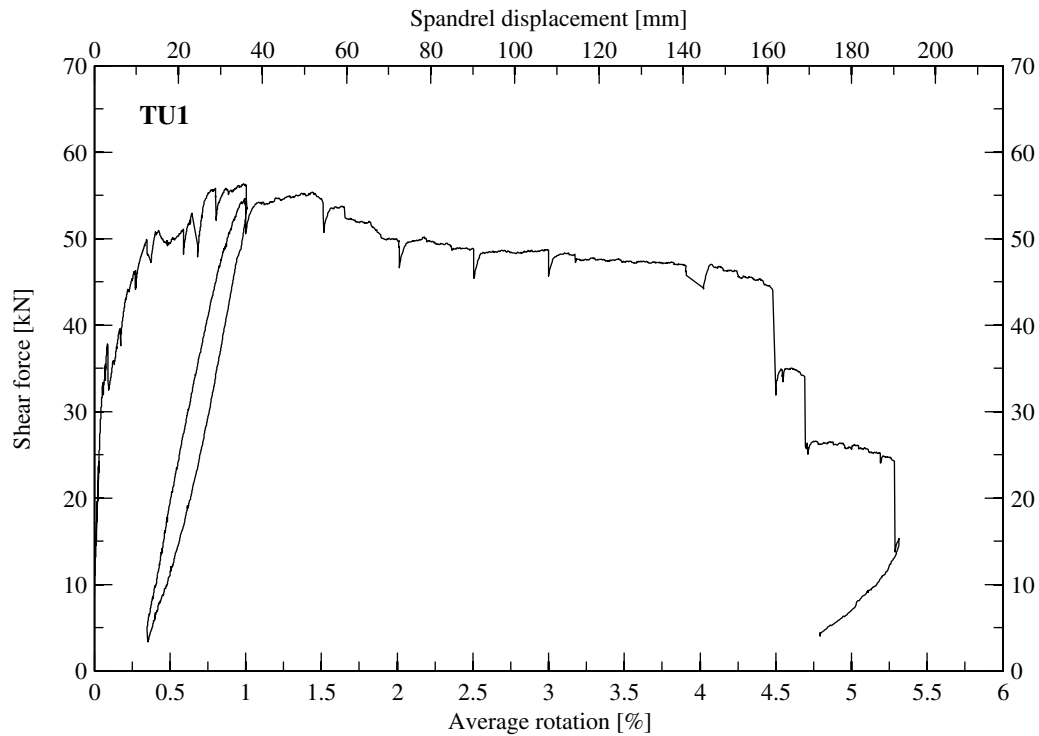
spandrel. The final drops in force for drifts larger than 4.5% are associated with the rupture of three longitudinal reinforcement bars.

Figure 3.7: TU1: Force-rotation relationship.

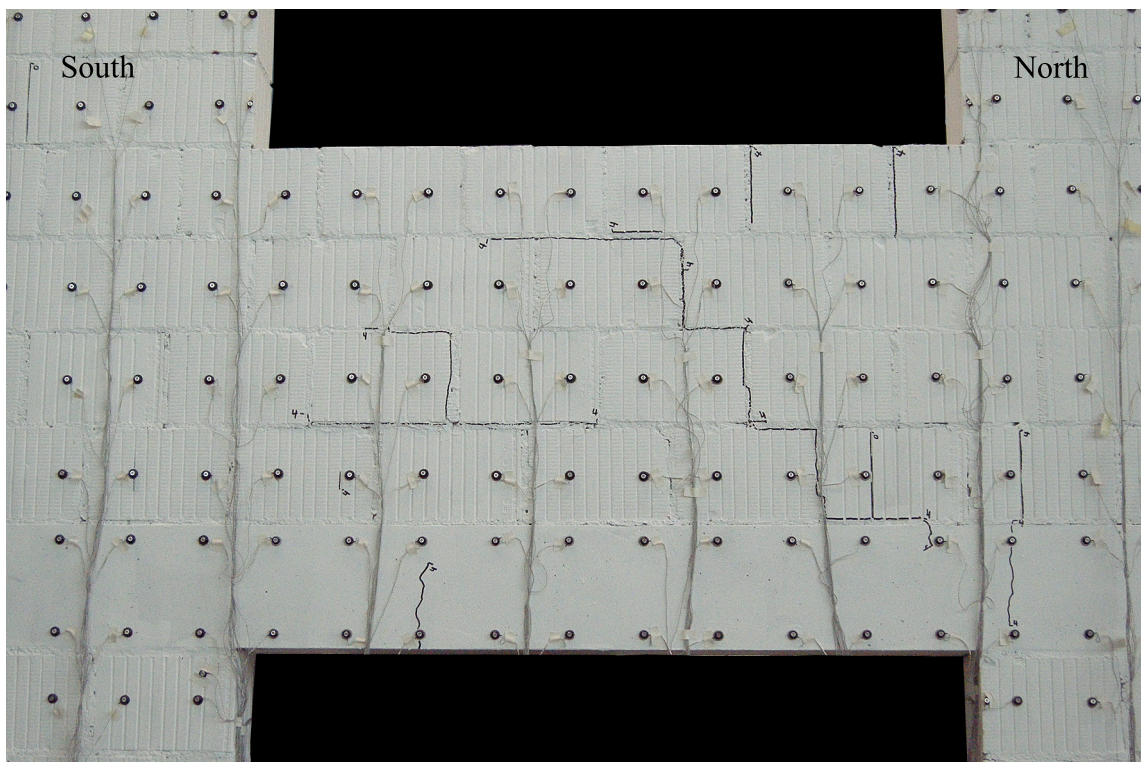
The first cracks appeared when loading to LS 4 ($\theta_{nom} = 0.1\%$, Fig. 3.14). In the masonry spandrel two stair-stepped cracks formed. Further cracks of one brick height formed at the North top end of the spandrel. A crack in the RC beam formed 37 cm away from the South edge of the spandrel, i.e. approximately where the centre line of the compression strut in the masonry was supported by the RC beam. Further cracks in the RC beam formed at the North end of the spandrel.

Figure 3.14: TU2: Crack pattern of spandrel at LS 4 when first cracks appeared. Drift towards North with $\theta_{nom} = 0.1\%$.

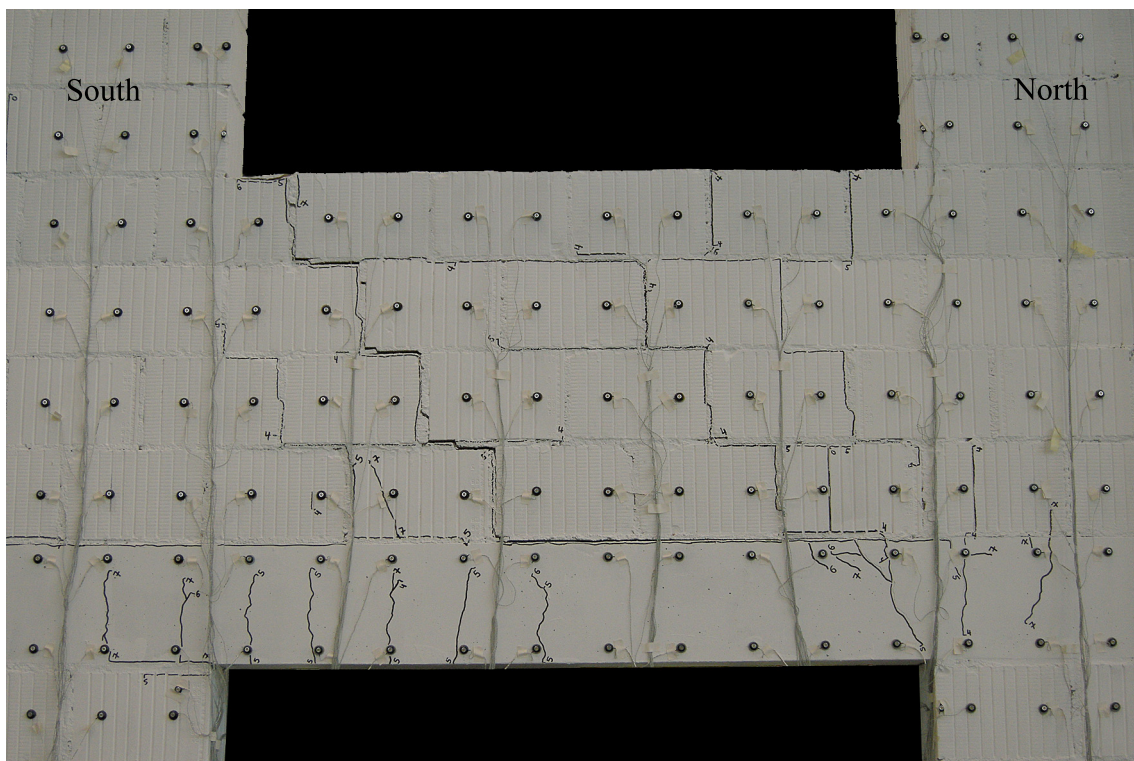
Figure 3.15: TU2: Crack pattern of spandrel at LS 7. Drift towards North with $\theta_{nom} = 0.4\%$.

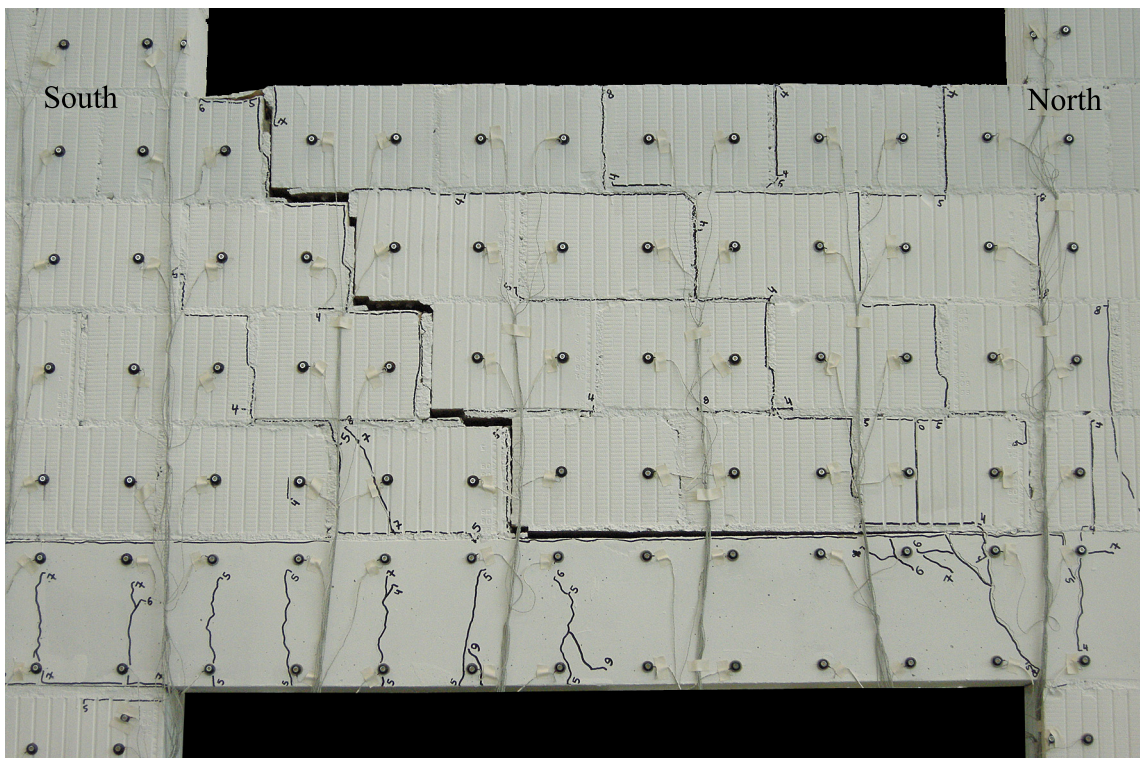
Figure 3.17: TU2: Crack pattern of spandrel at LS 9. Drift towards North with $\theta_{nom} = 0.8\%$.

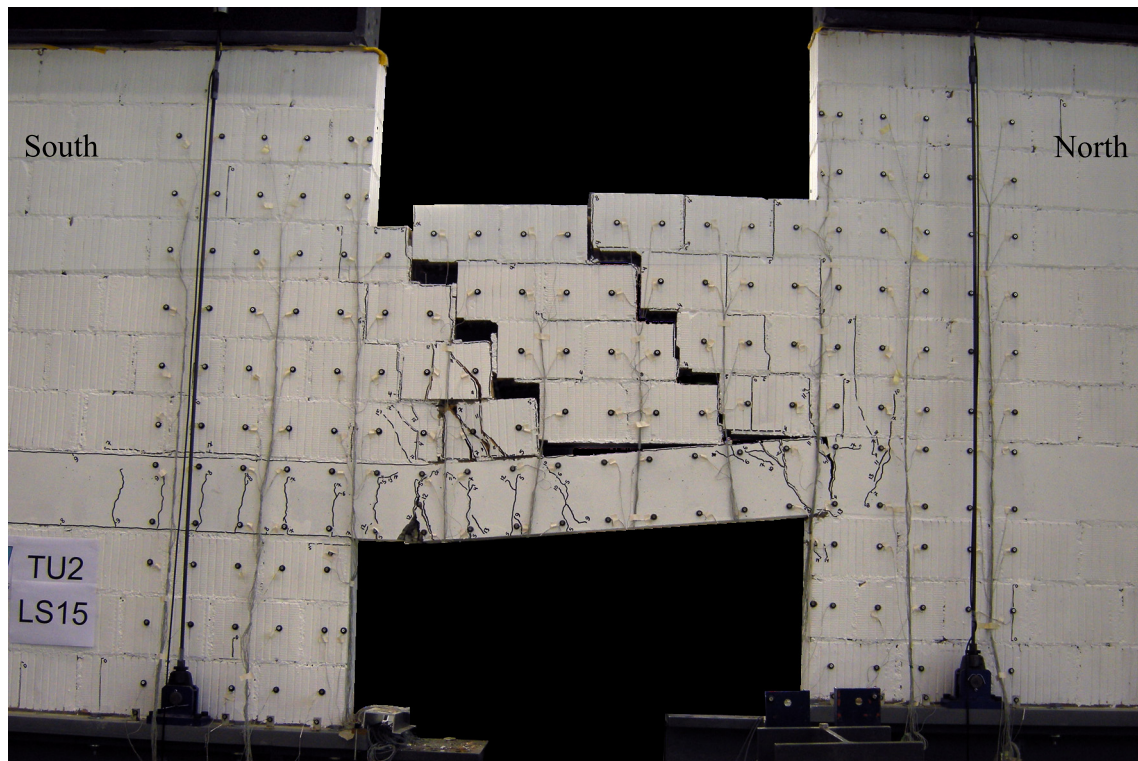
Figure 3.18: TU2: Crack pattern of spandrel at LS 15. Drift towards North with $\theta_{nom} = 4\%$ (failure of TU2).

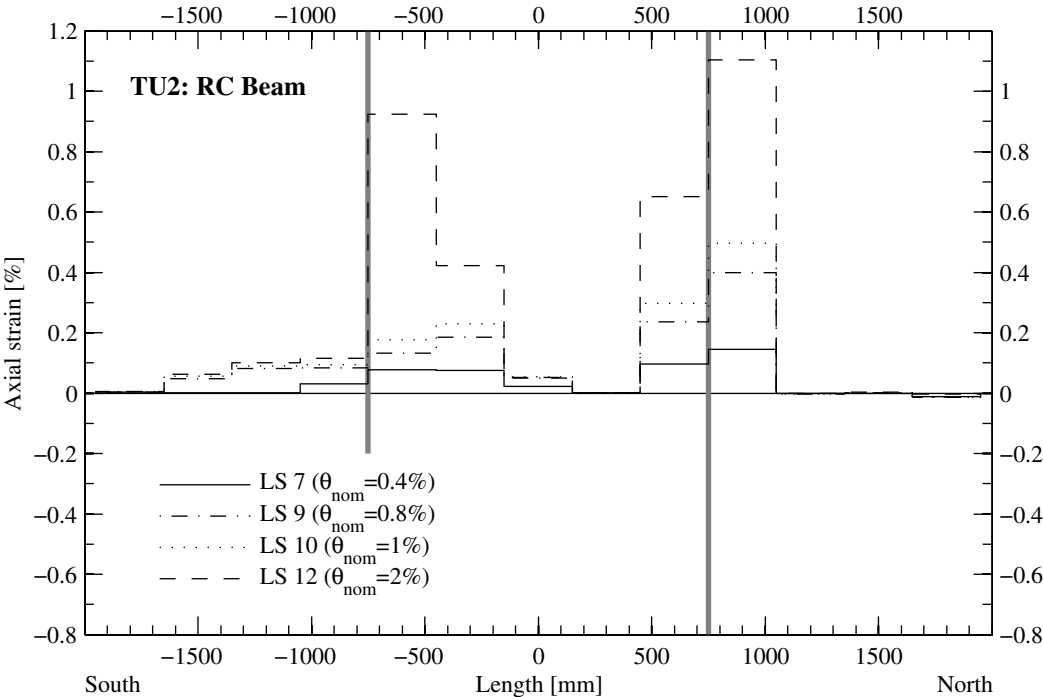
Figure 3.24: TU2: Axial strain distribution along the RC beam. The thick grey lines symbolise the edges of the piers.
