Quasi-static cyclic tests on different types of masonry spandrels

Katrin Beyer
Ahmad Abo-El-Ezz
Alessandro Dazio

Institute of Structural Engineering
Swiss Federal Institute of Technology

Zürich
September 2010

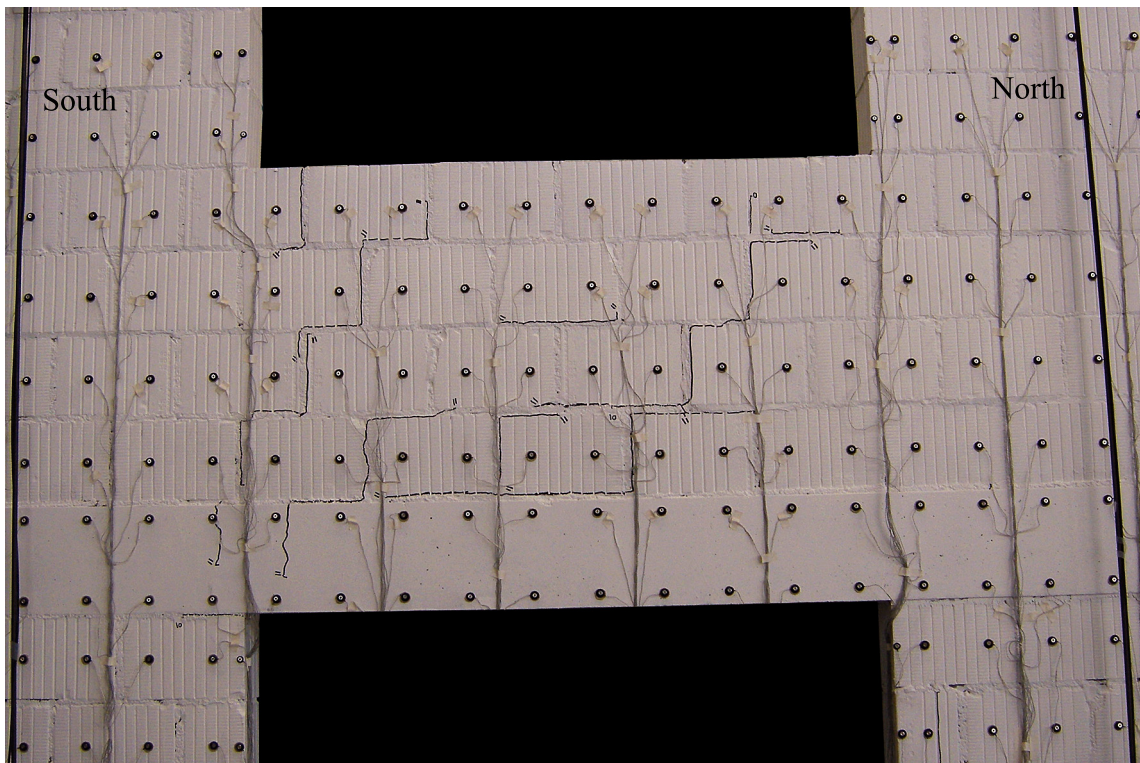
Figure 3.26: TU3: Crack pattern of spandrel at LS 11. Drift towards South with $\theta_{nom} = -0.1\%$.

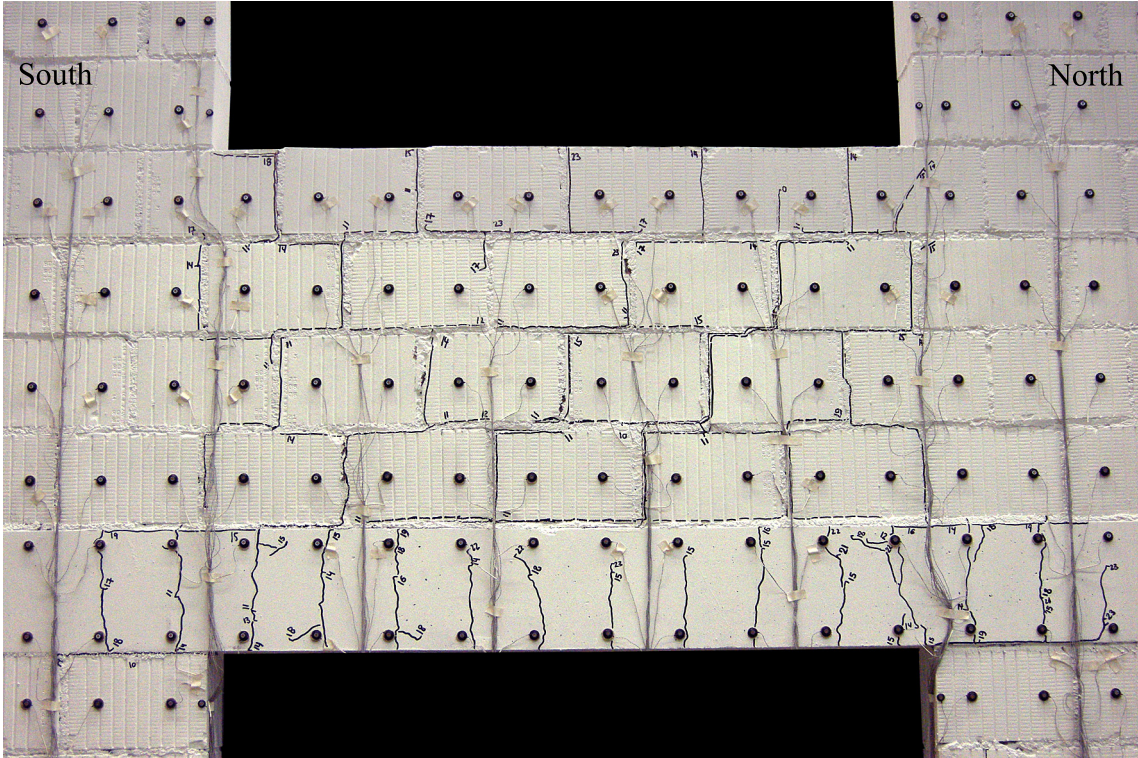
Figure 3.27: TU3: Crack pattern of spandrel at LS 23. Drift towards South with $\theta_{nom} = -0.4\%$.

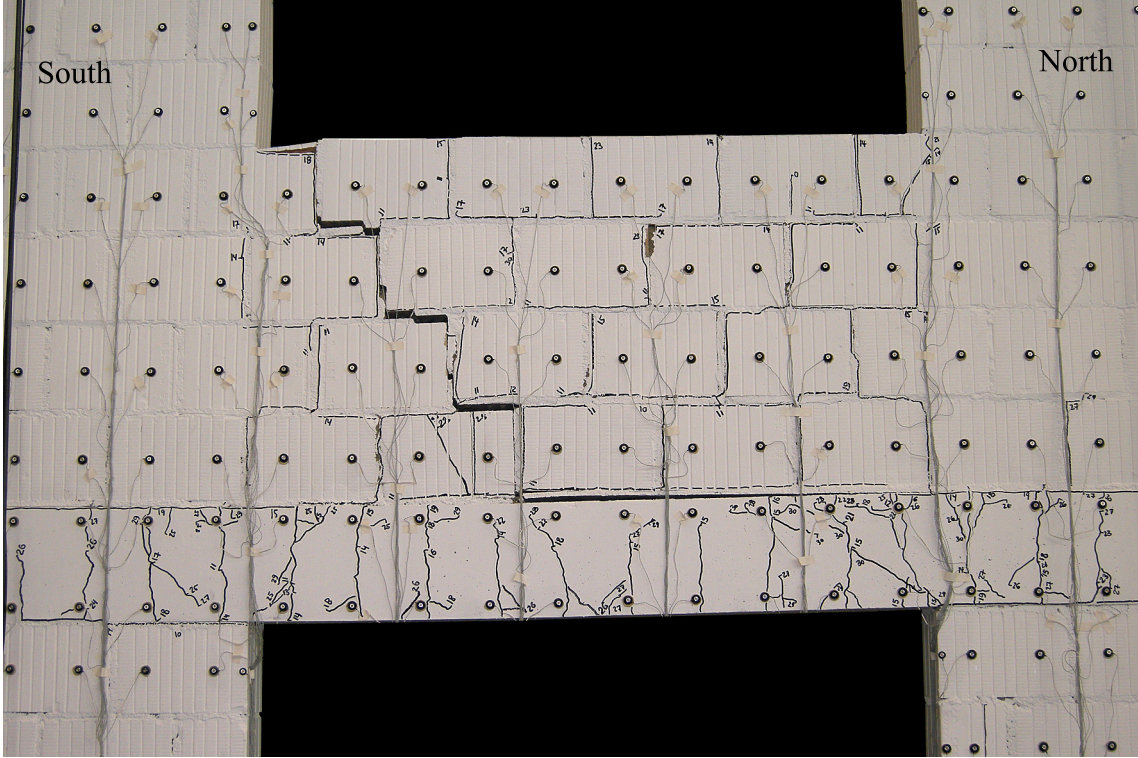
Figure 3.28: TU3: Crack pattern of spandrel at LS 30. Drift towards North with $\theta_{nom} = 0.8\%$.

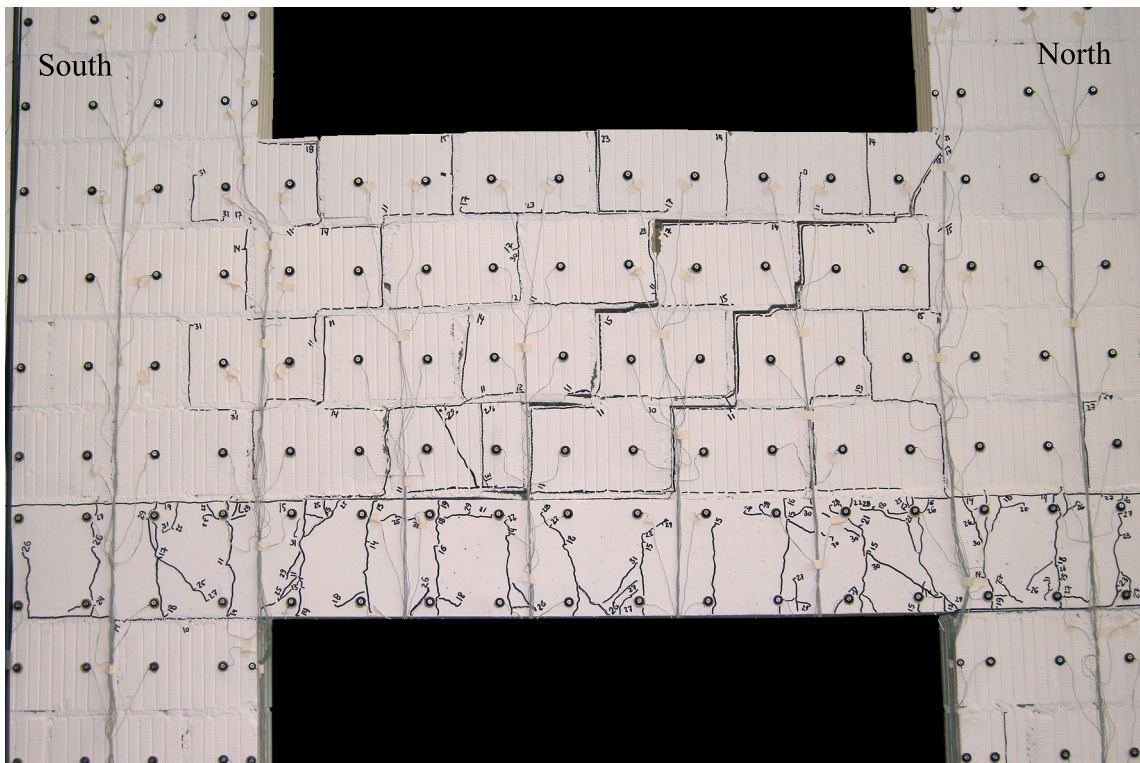
Figure 3.29: TU3: Crack pattern of spandrel at LS 31. Drift towards South with $\theta_{nom} = -0.8\%$.

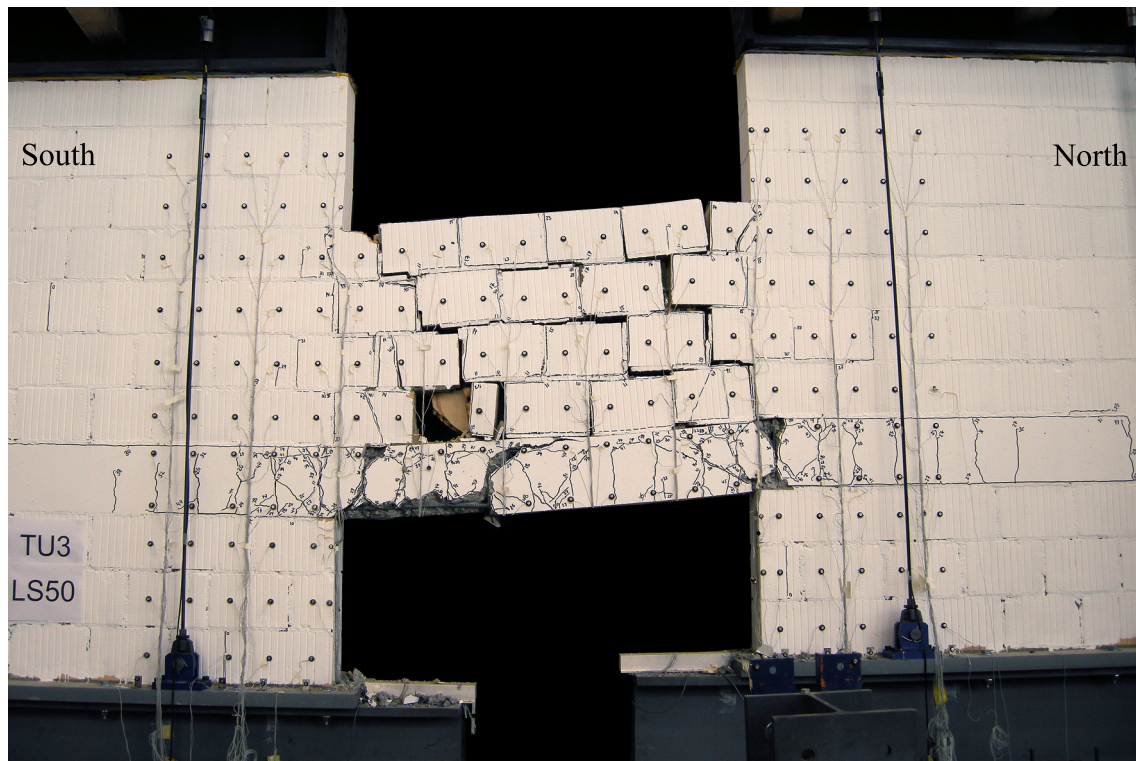
Figure 3.30: TU3: Crack pattern of spandrel at LS 50. Drift towards North with $\theta_{nom} = 3\%$ (failure of TU3).

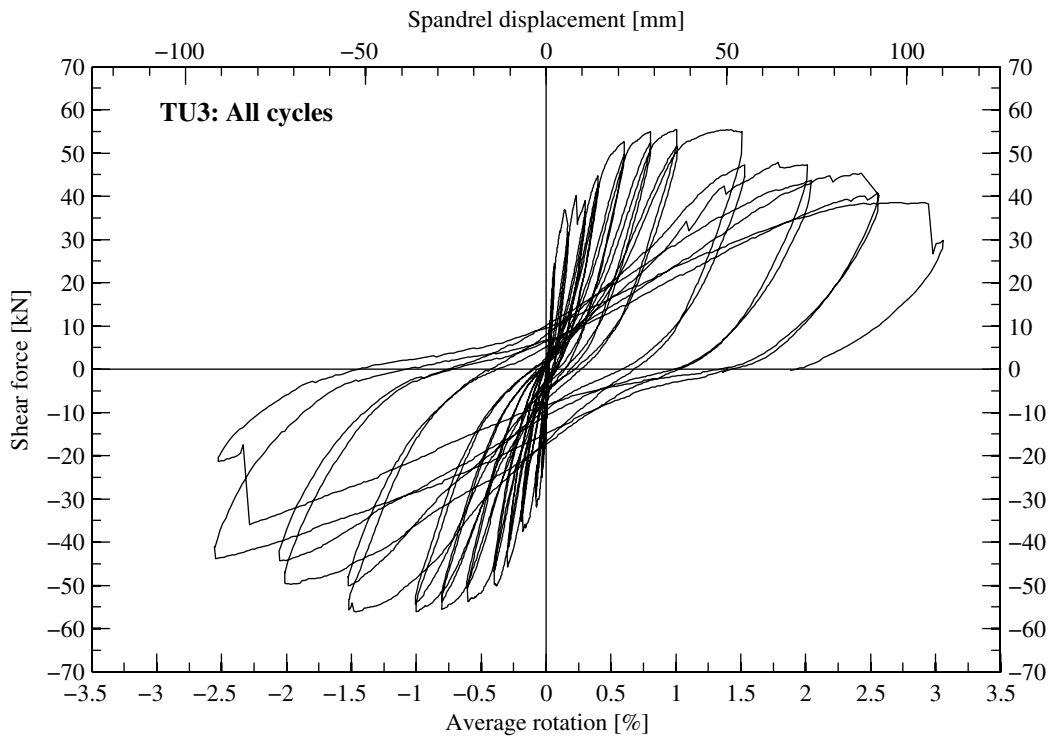
Figure 3.31: TU3: Force-rotation relationship for all cycles.

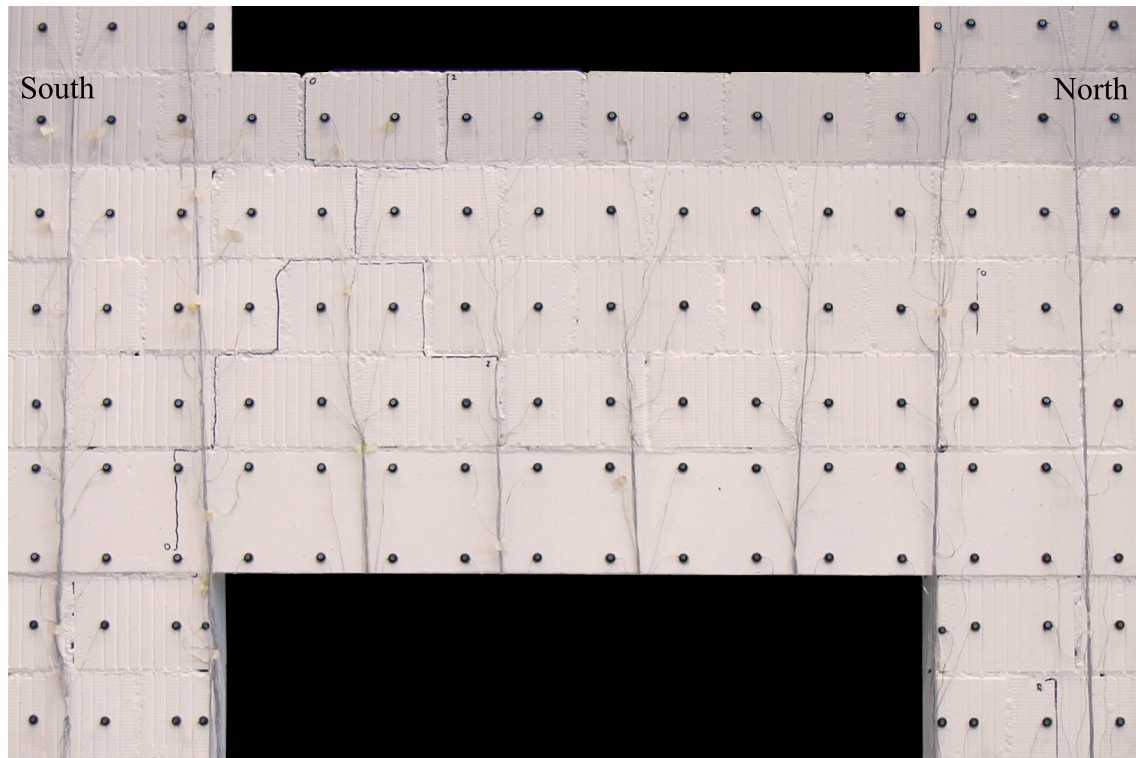
Figure 3.38: TU4: Crack pattern of spandrel at LS 2 resulting from bolting the test unit onto the lever beams.

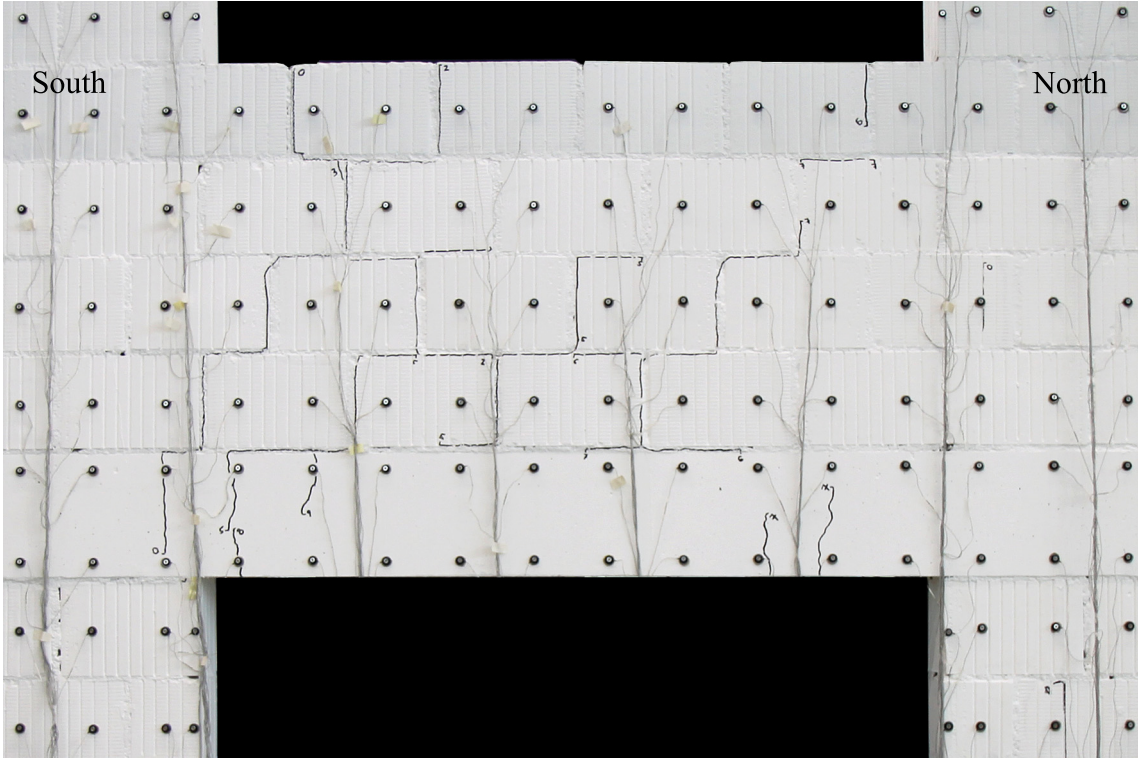
Figure 3.39: TU4: Crack pattern of spandrel at LS 9. Drift towards South with $\theta_{nom} = -0.05\%$.

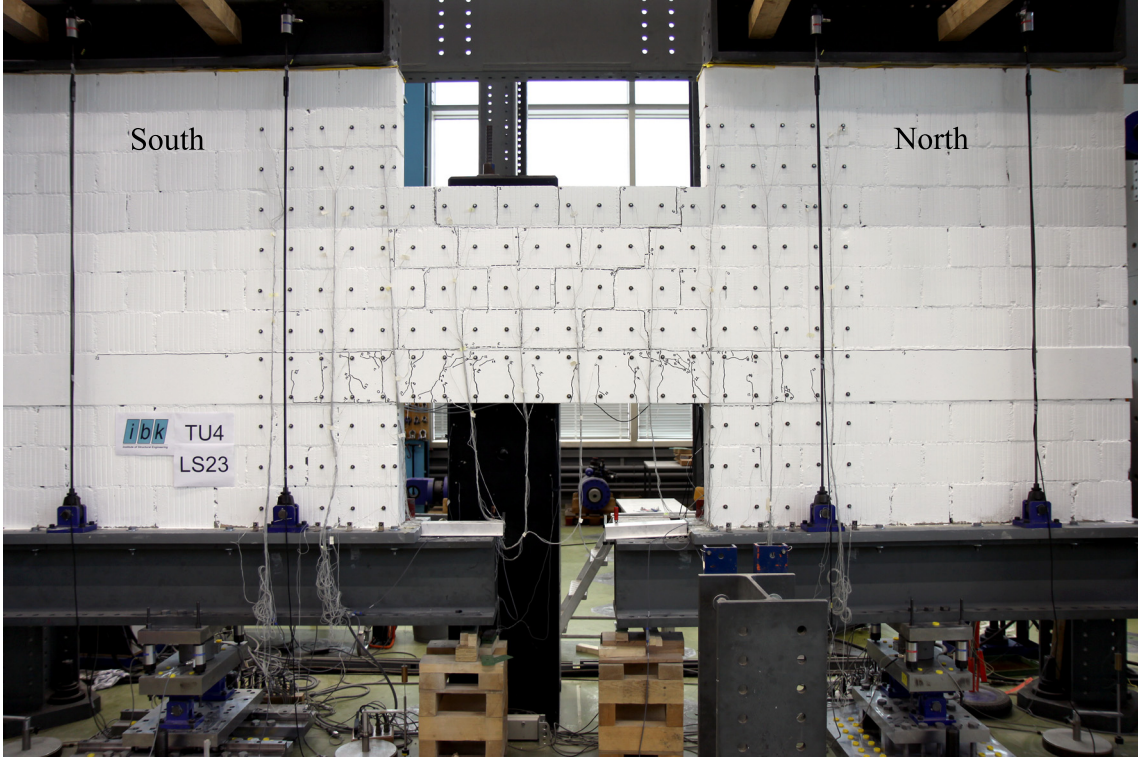
Figure 3.40: TU4: Crack pattern of entire test unit at LS 23. Drift towards South with $\theta_{nom} = -0.4\%$.

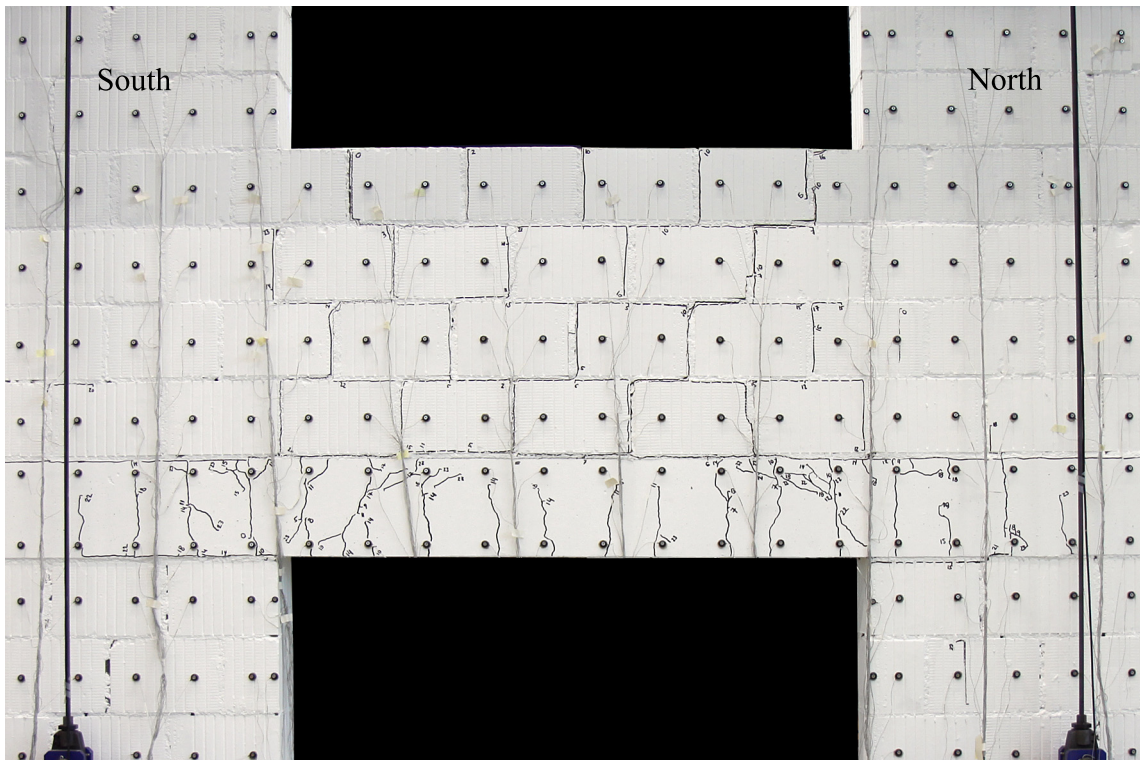
Figure 3.41: TU4: Crack pattern of spandrel at LS 23. Drift towards South with $\theta_{nom} = -0.4\%$.

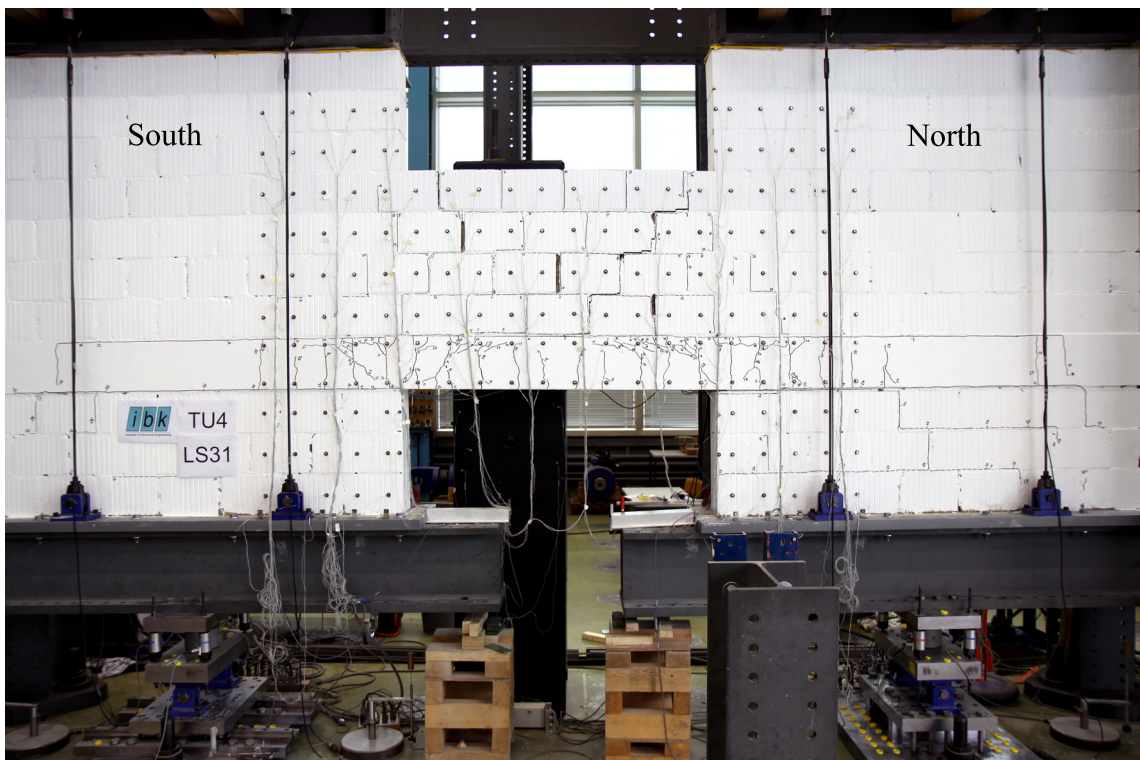
Figure 3.42: TU4: Crack pattern of spandrel at LS 31. Drift towards South with $\theta_{nom} = -0.8\%$.

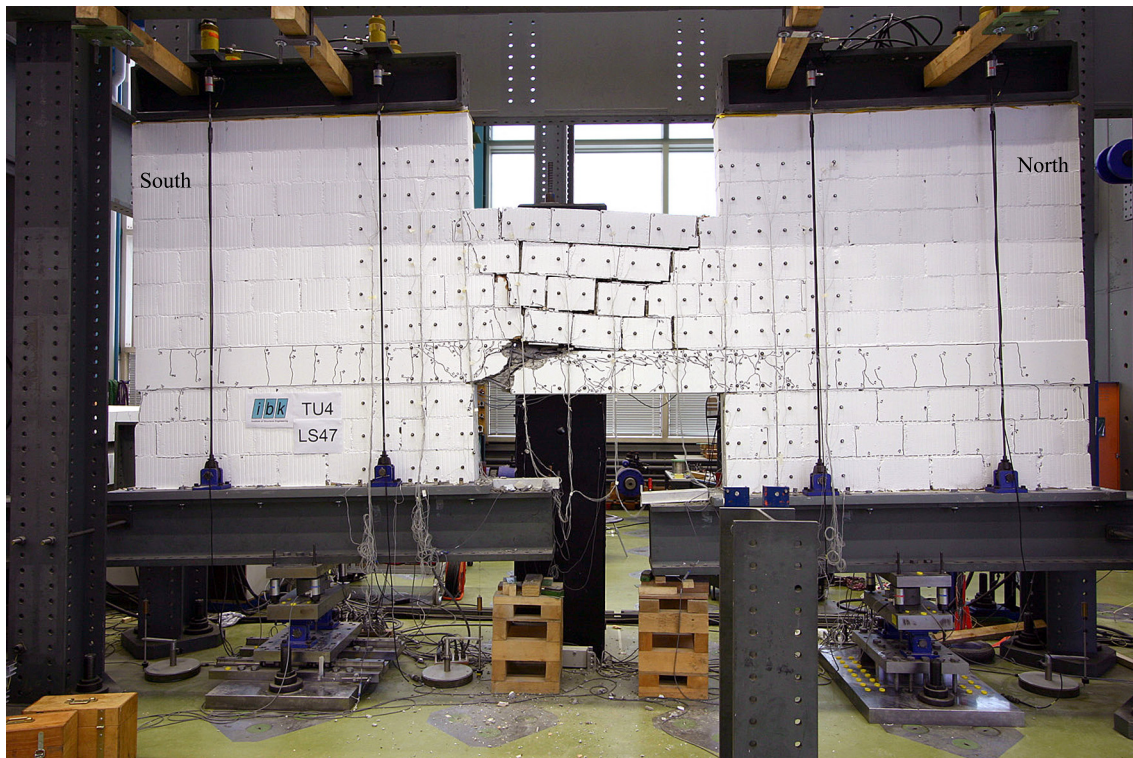
Figure 3.43: TU4: Test unit at LS 47. Drift towards South with $\theta_{nom} = -2.5\%$ (failure of TU4).

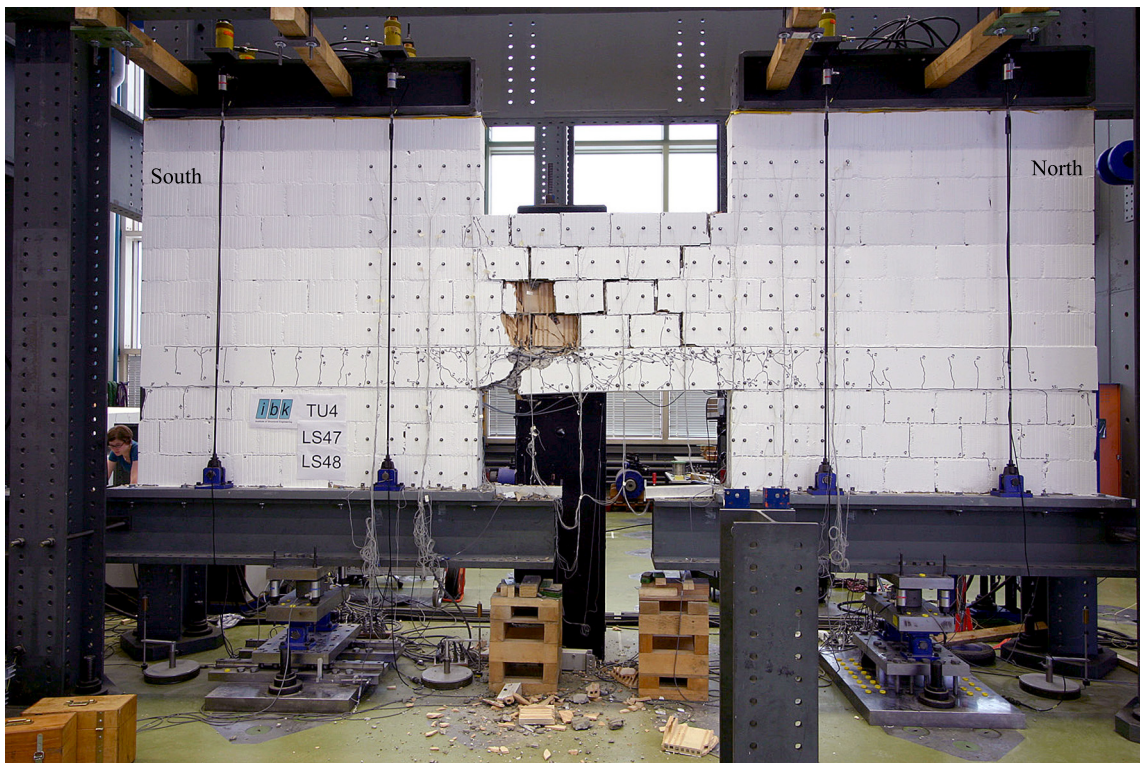
Figure 3.44: TU4: Test unit at the end of the test, i.e. after unloading from LS 47 ($\theta_{nom} = -2.5\%$).

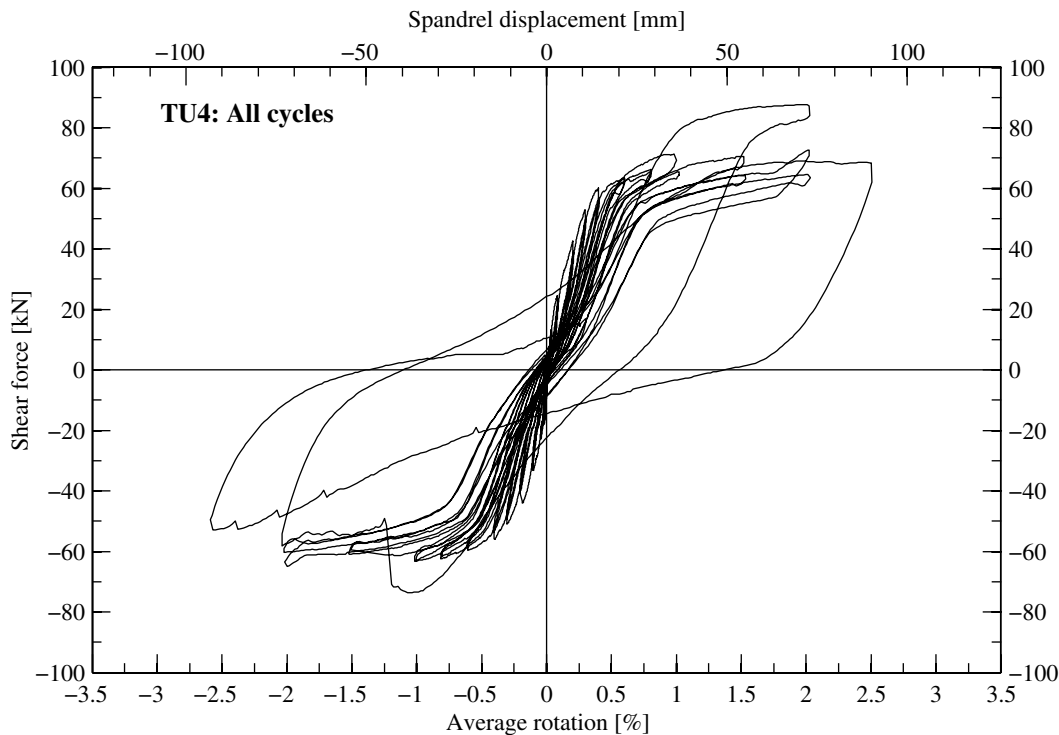
Figure 3.45: TU4: Force-rotation relationship for all cycles.

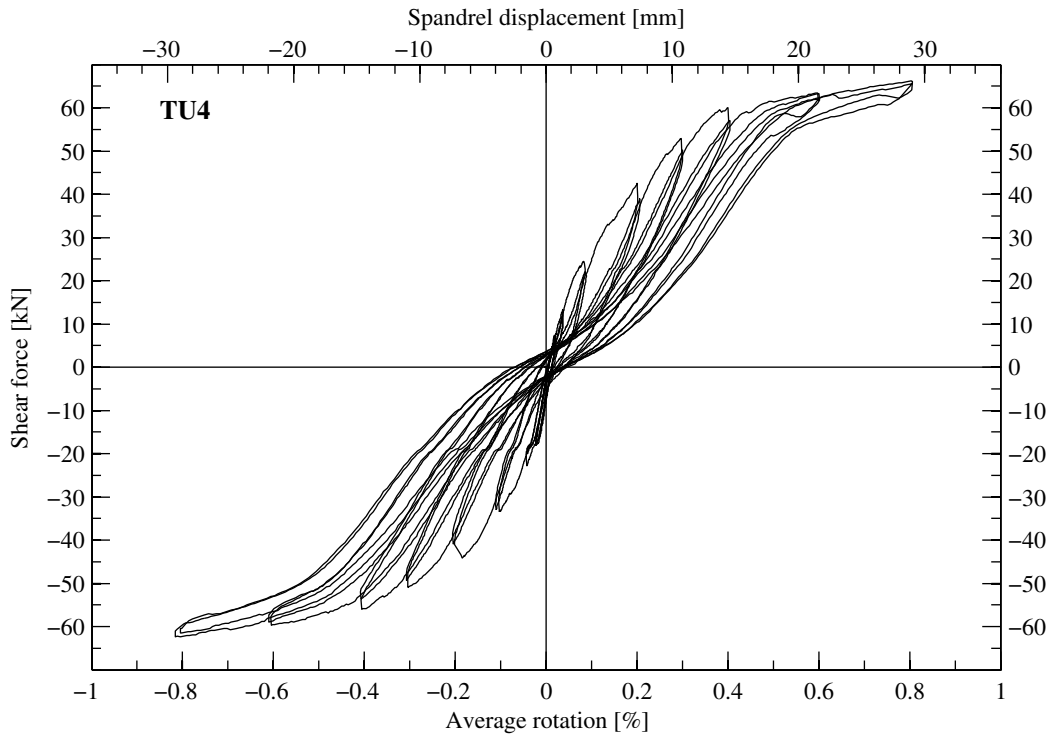
Figure 3.46: TU4: Force-rotation relationship for the cycles up to $\pm 0.8\%$ (LS 1-33).

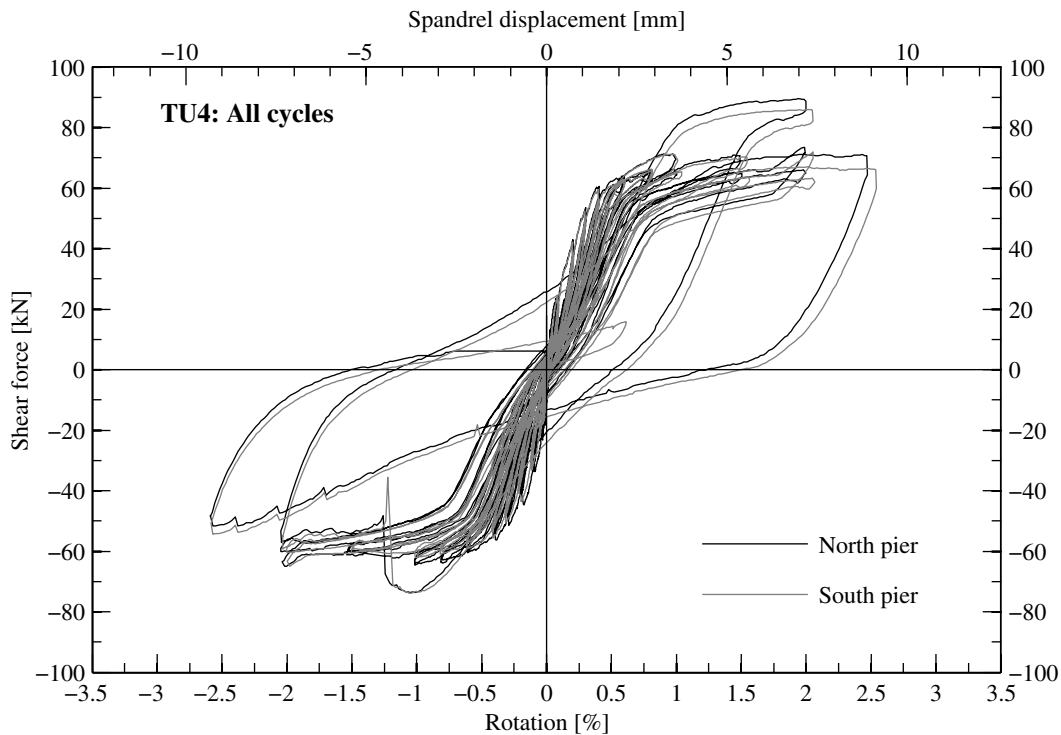
Figure 3.49: TU4: Force-rotation relationship for all cycles showing the non-averaged pier rotations and shear forces.

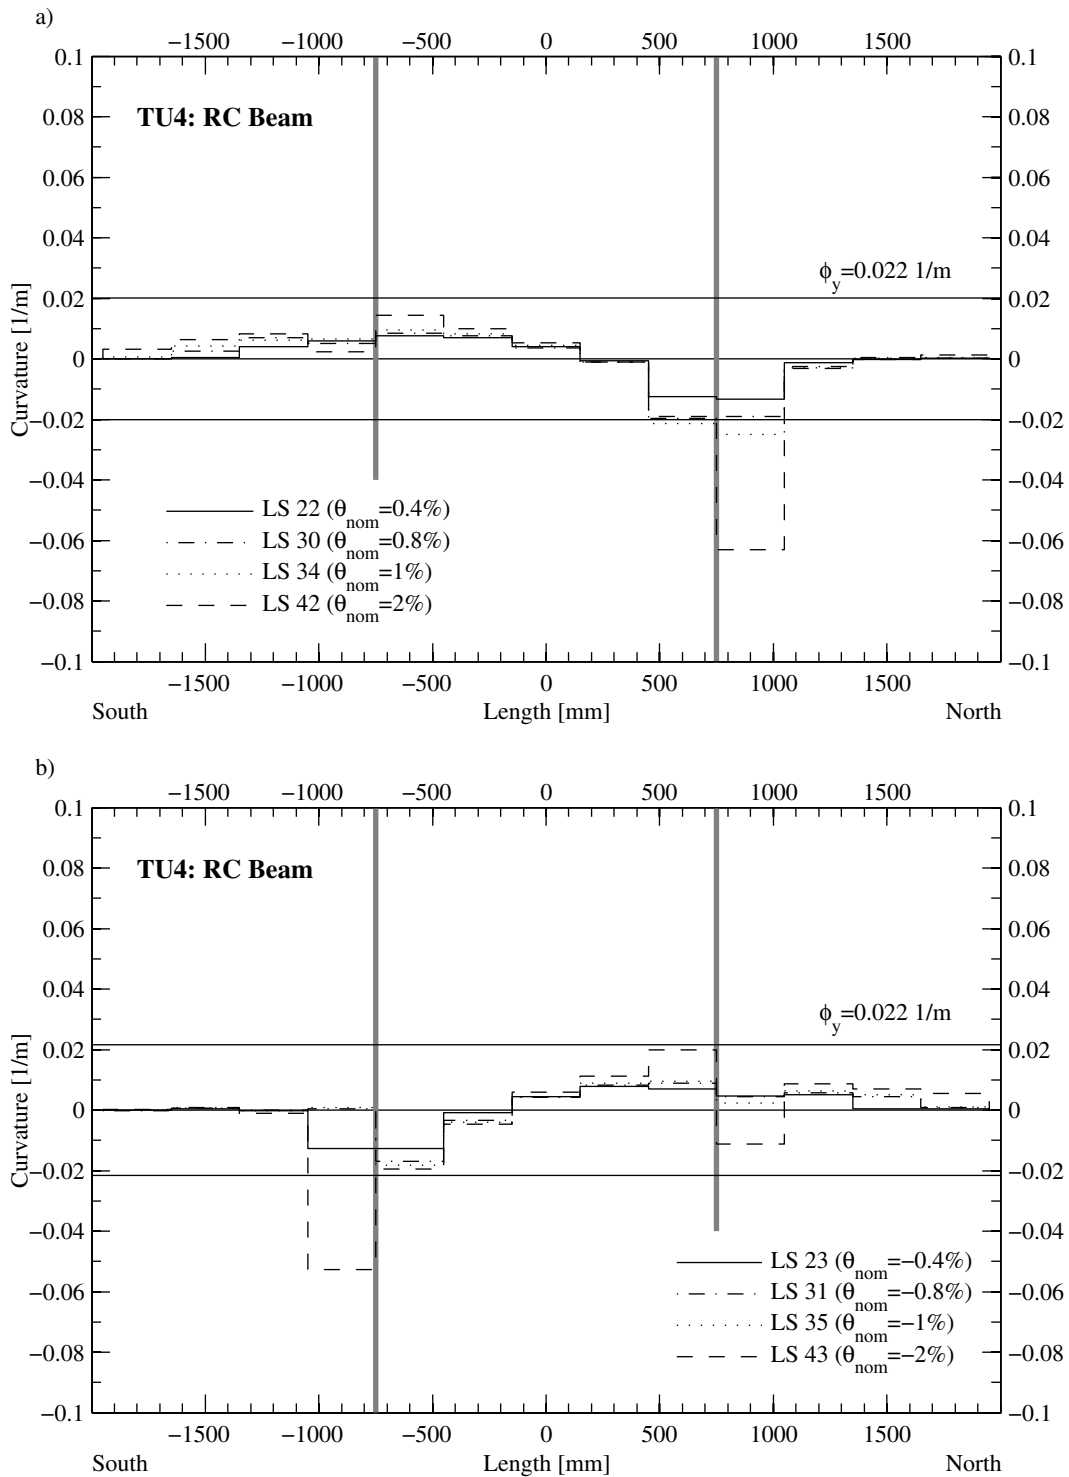
Figure 3.51: TU4: Curvature distribution along the RC beam. The thick grey lines symbolise the edges of the piers.

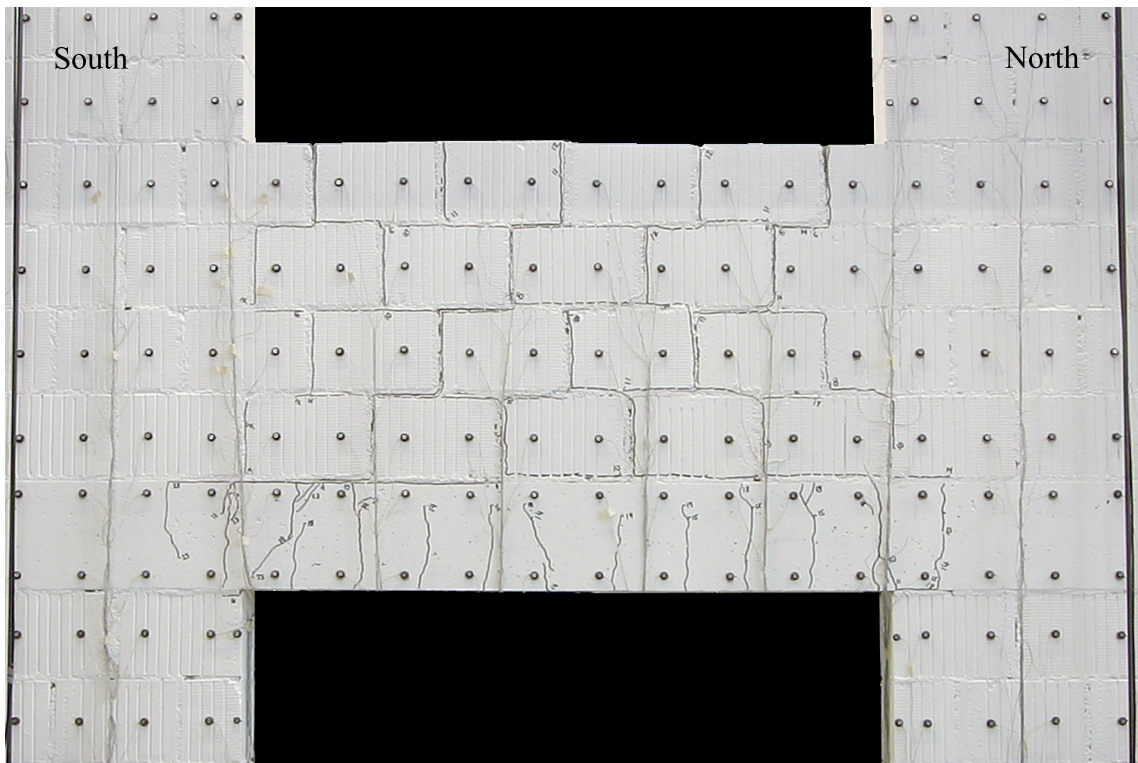
Figure 3.54: TU5: Crack pattern of spandrel at LS 23. Drift towards South with $\theta_{nom} = -0.4\%$.

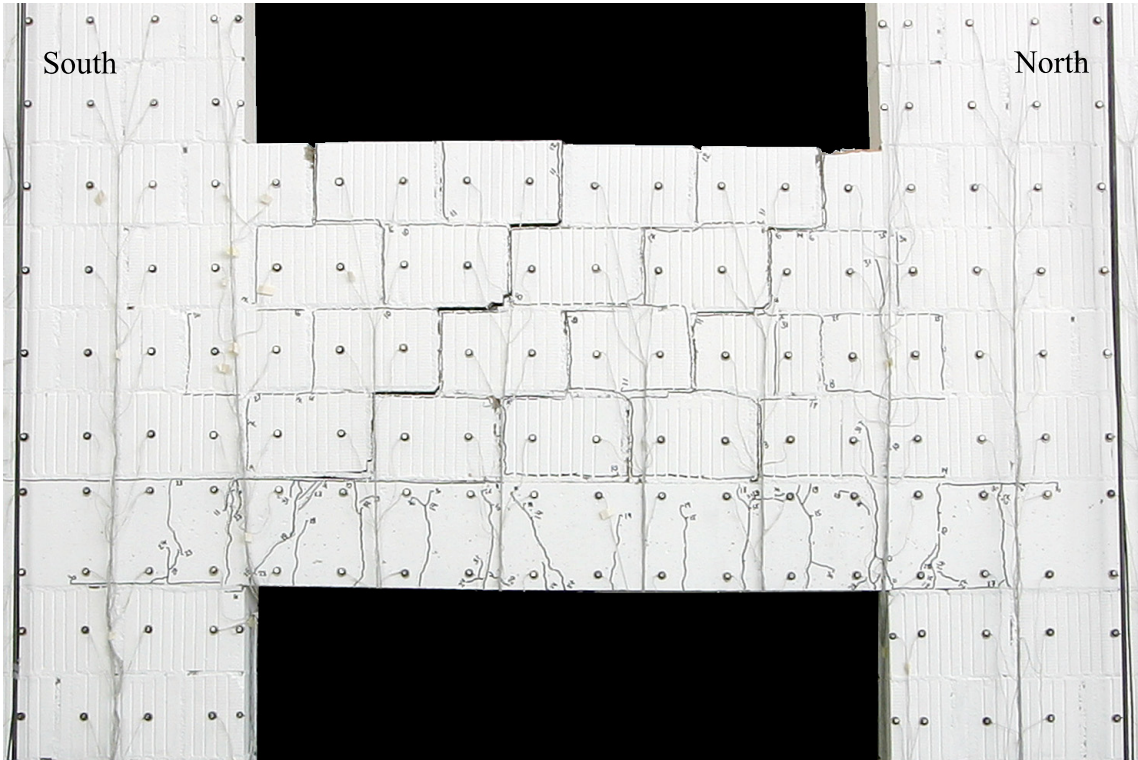
Figure 3.55: TU5: Crack pattern of spandrel at LS 31. Drift towards South with $\theta_{nom} = -0.8\%$.

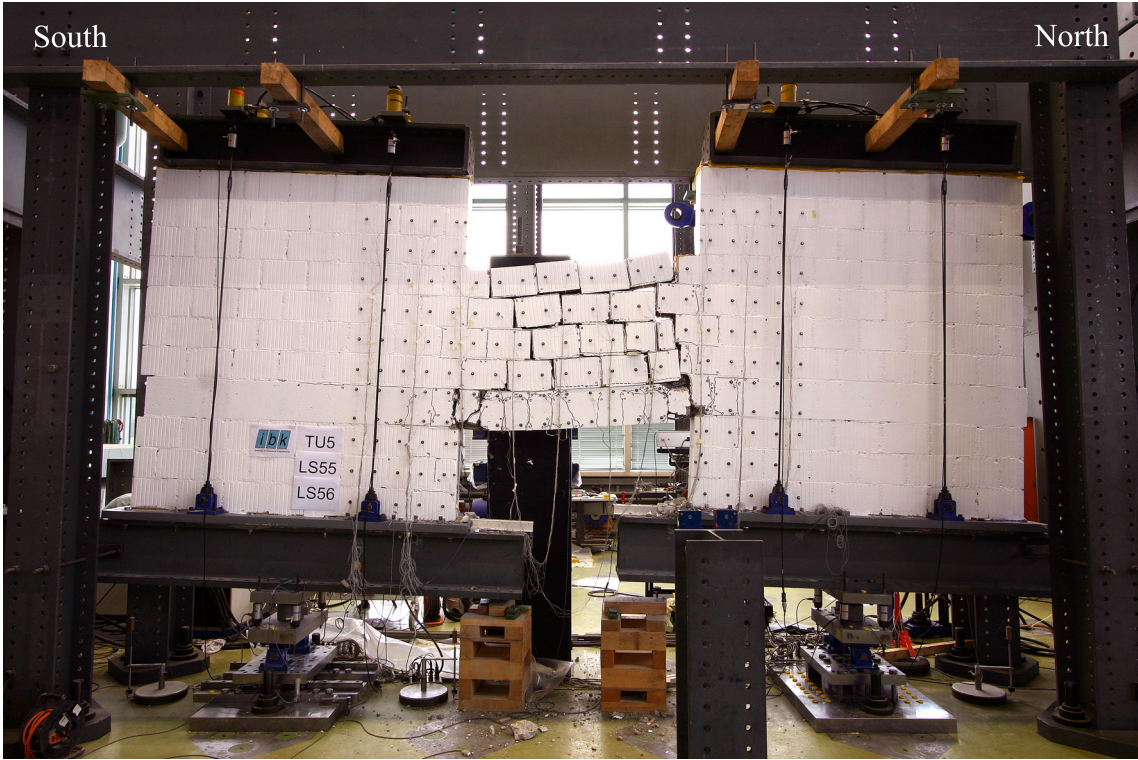
Figure 3.56: TU5: Test unit at LS 56. Drift towards North with $\theta_{nom} = 4\%$ (failure of TU5).

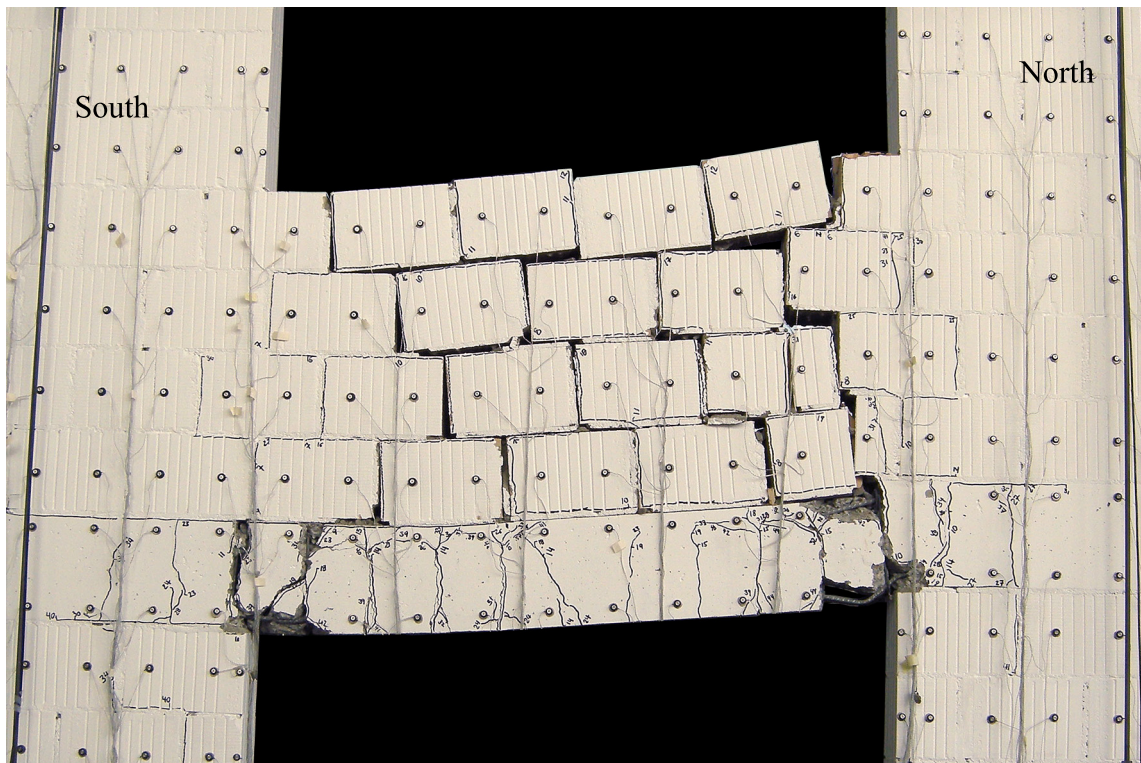
Figure 3.57: TU5: Crack pattern of spandrel at LS 56. Drift towards North with $\theta_{nom} = 4\%$ (failure of TU5).

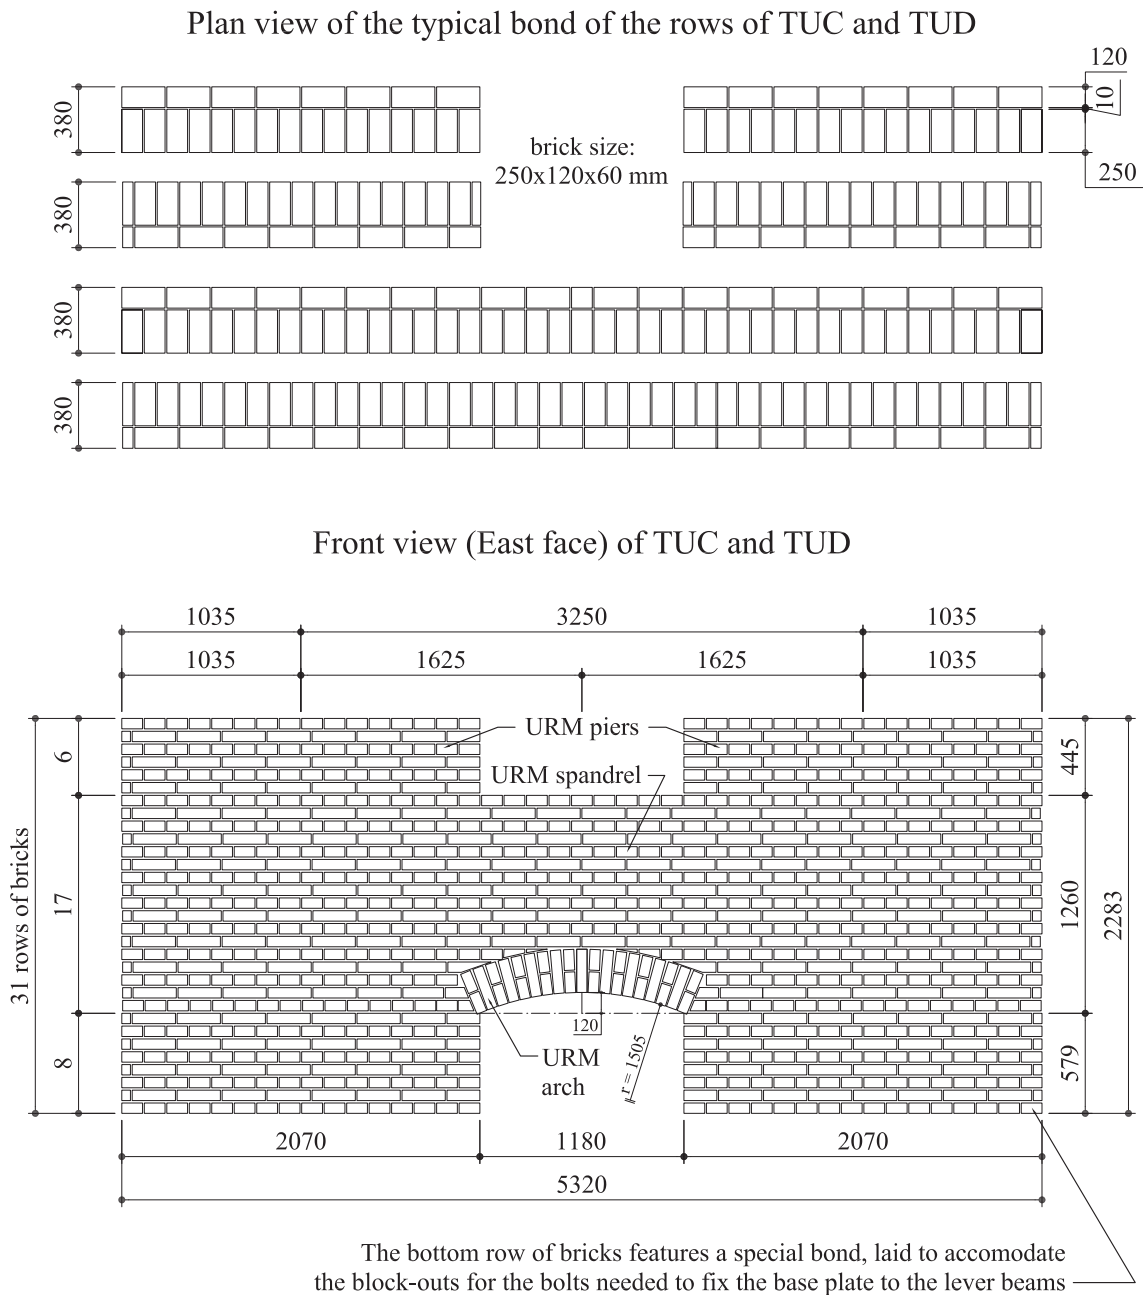
Figure 1.2: Dimensions and typical bond pattern of masonry spandrel type II featuring a URM arch.

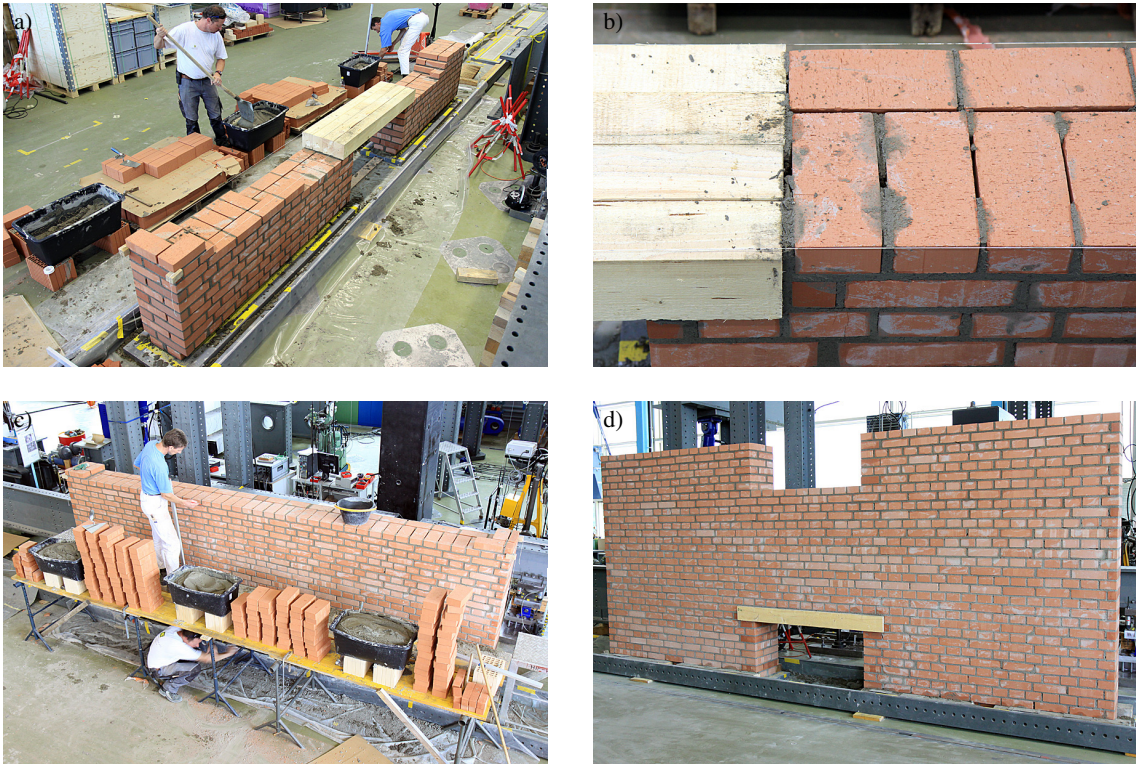
Figure 1.3: Construction of masonry spandrel with timber lintel (TUA).

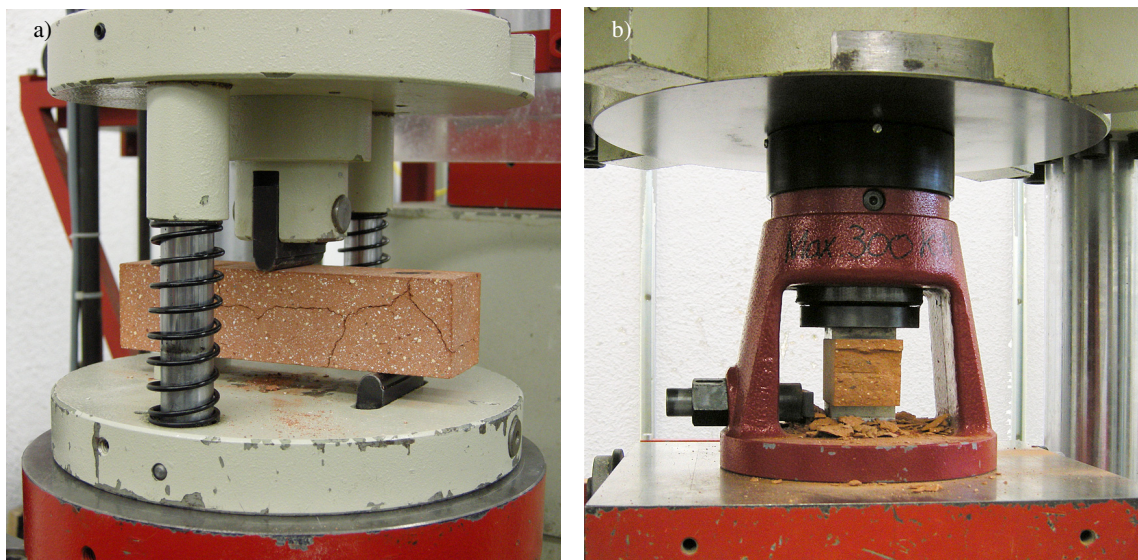
Figure 2.1: Material tests on brick prisms: 3-point-bending test (a) and cube compression test (b).

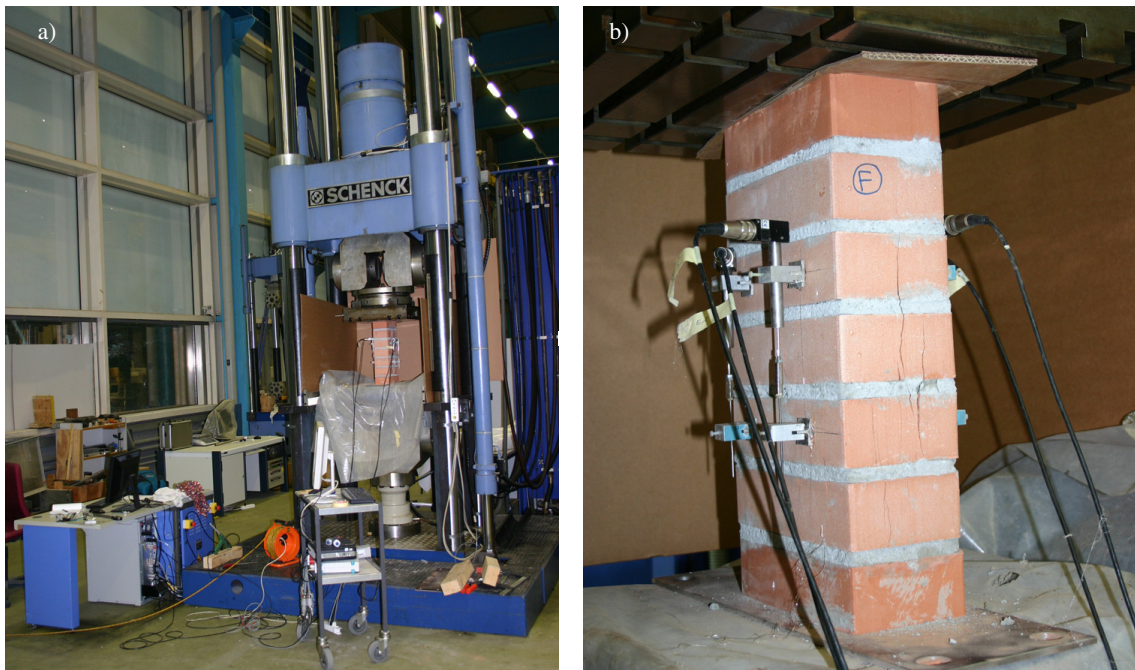
Figure 2.12: Compression tests on masonry wallettes: Global view of the test setup (a) and detail of a wallette with the instrumentation (b).
