Quasi-static cyclic tests on different types of masonry spandrels

Katrin Beyer
Ahmad Abo-El-Ezz
Alessandro Dazio

Institute of Structural Engineering
Swiss Federal Institute of Technology

Zürich
September 2010

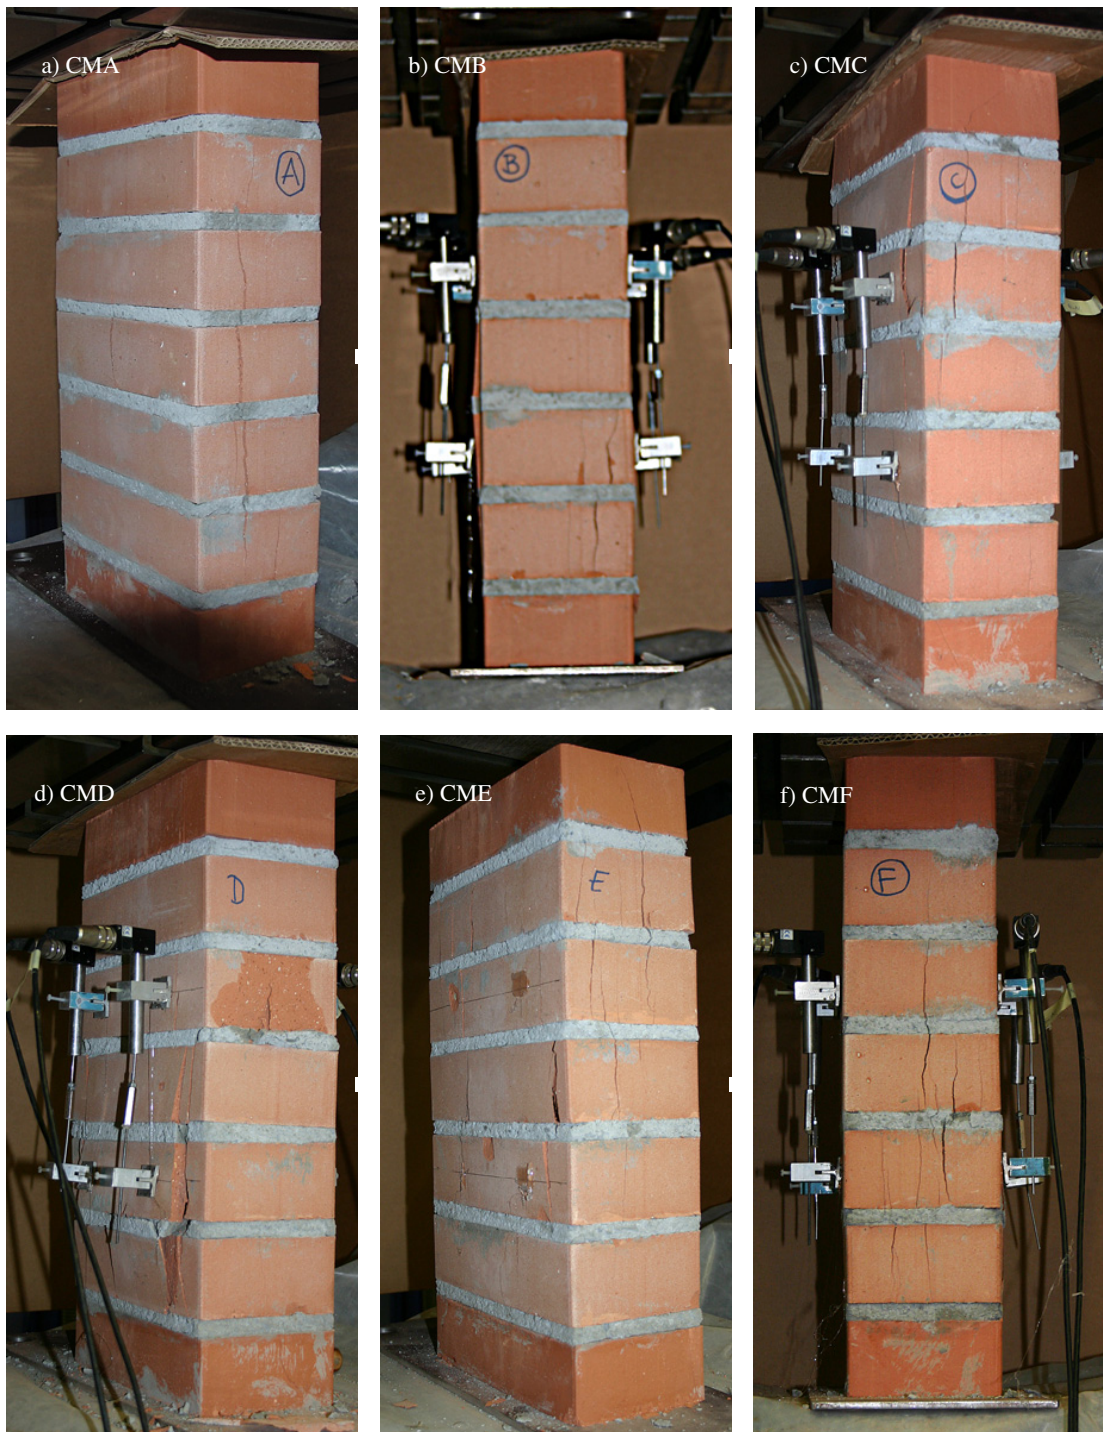
Figure 2.15: Compression tests on masonry wallettes: Crack pattern after failure for units CMA-CMF.

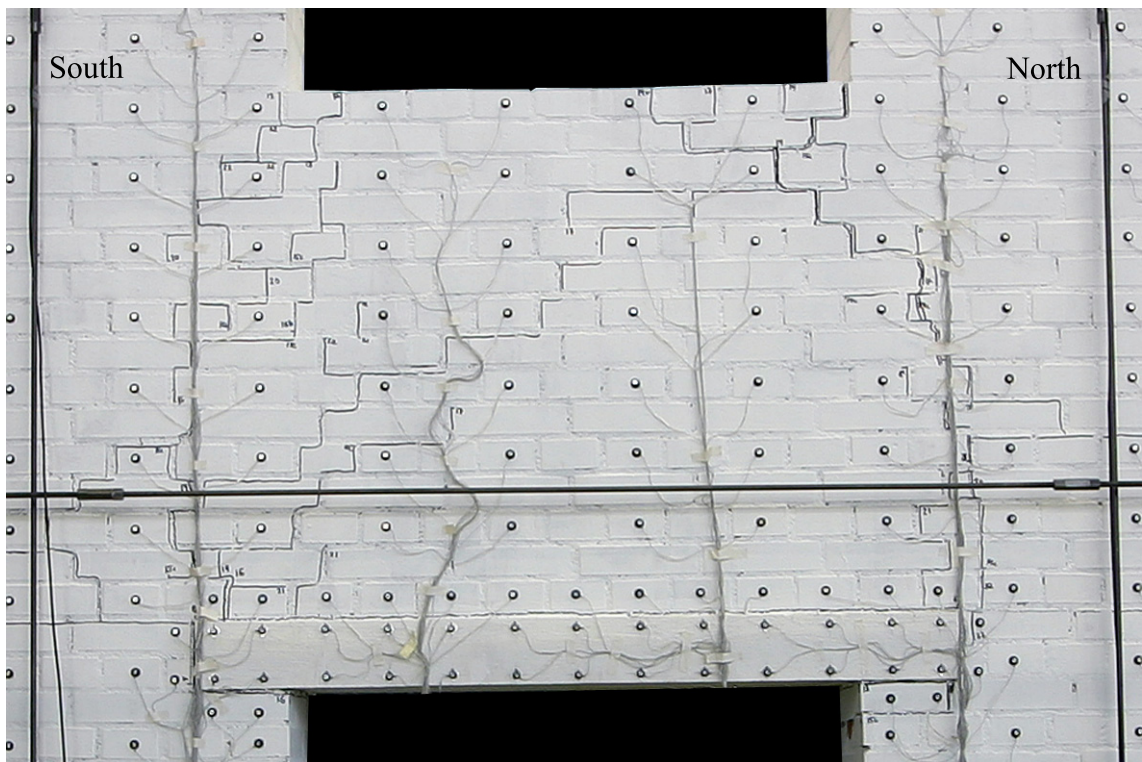
Figure 3.2: TUA: Crack pattern of spandrel at LS 22. Drift towards North with $\theta_{nom} = 0.4\%$.

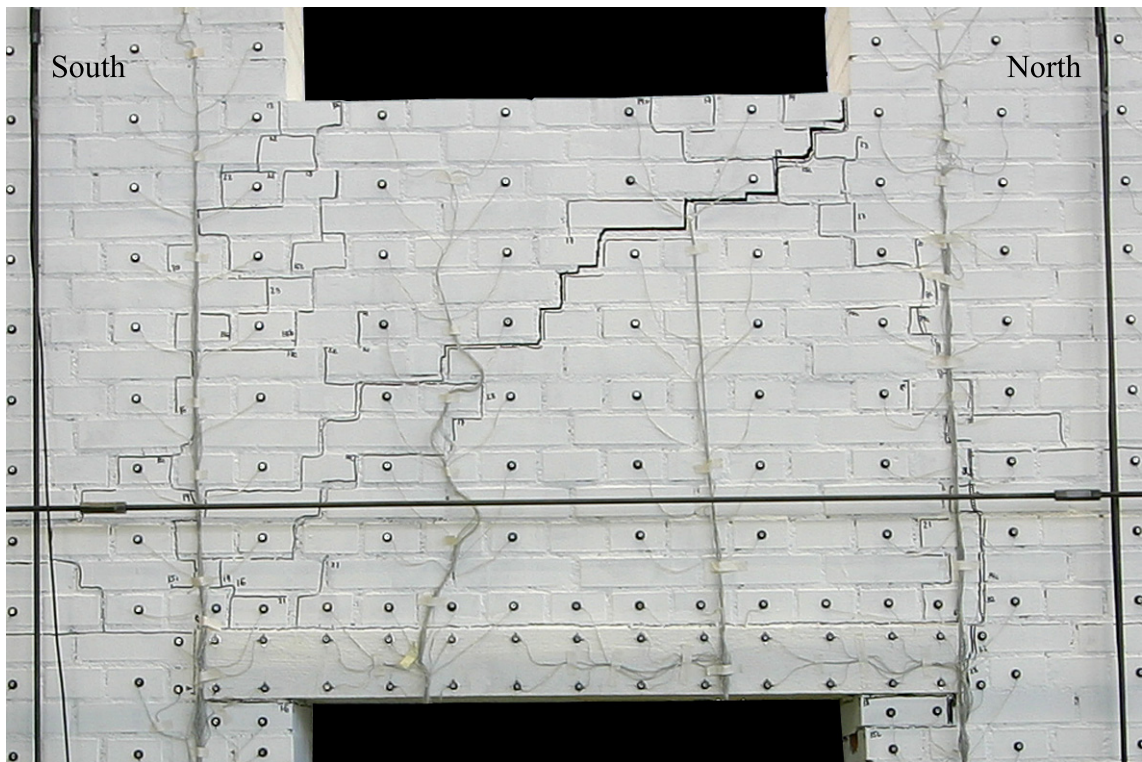
Figure 3.3: TUA: Crack pattern of spandrel at LS 23. Drift towards South with $\theta_{nom} = -0.4\%$.

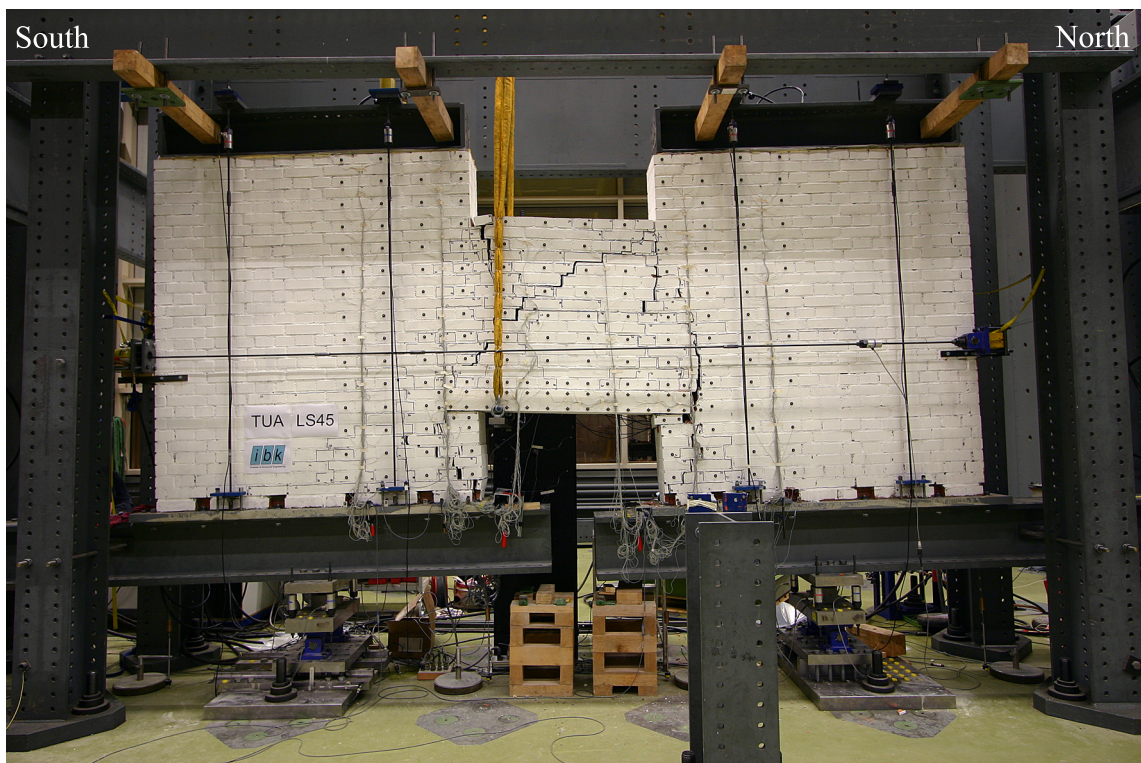
Figure 3.5: TUA: Crack pattern of spandrel at LS 45. Drift towards South with $\theta_{nom} = 2.0\%$.

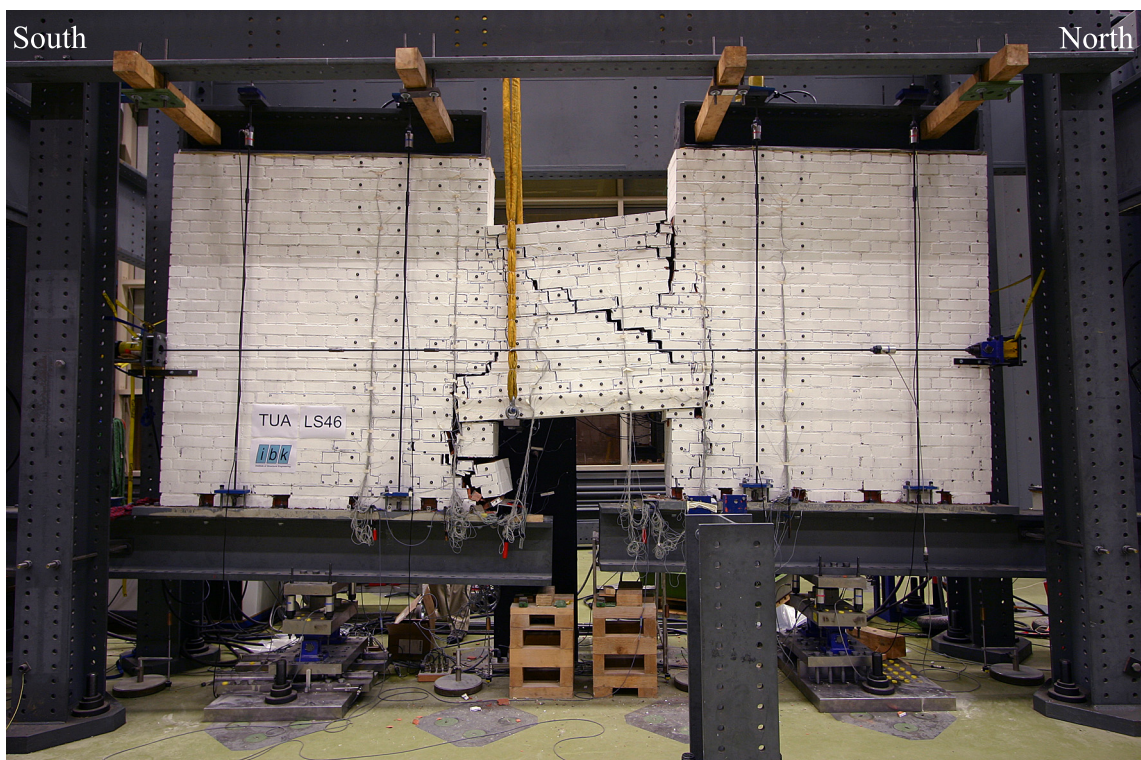
Figure 3.6: TUA: Crack pattern of spandrel at LS 46. Drift towards North with $\theta = 3.0\%$ (failure of TUA, $\theta_{nom} = 2.5\%$).

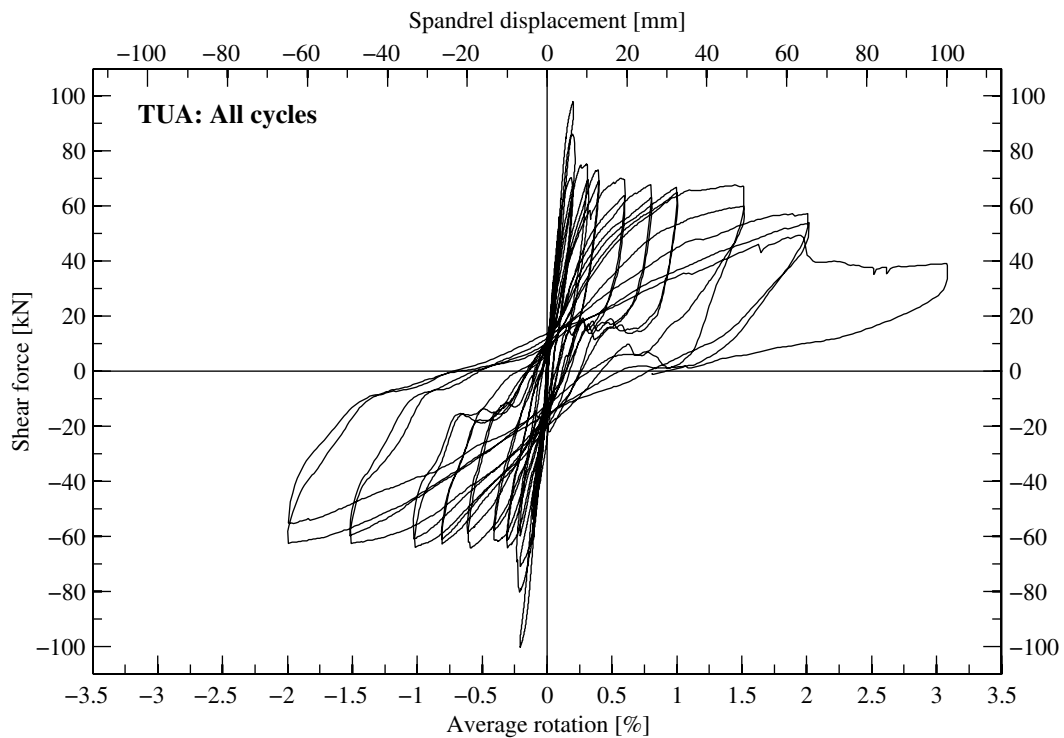
Figure 3.7: TUA: Force-rotation relationship for all cycles.

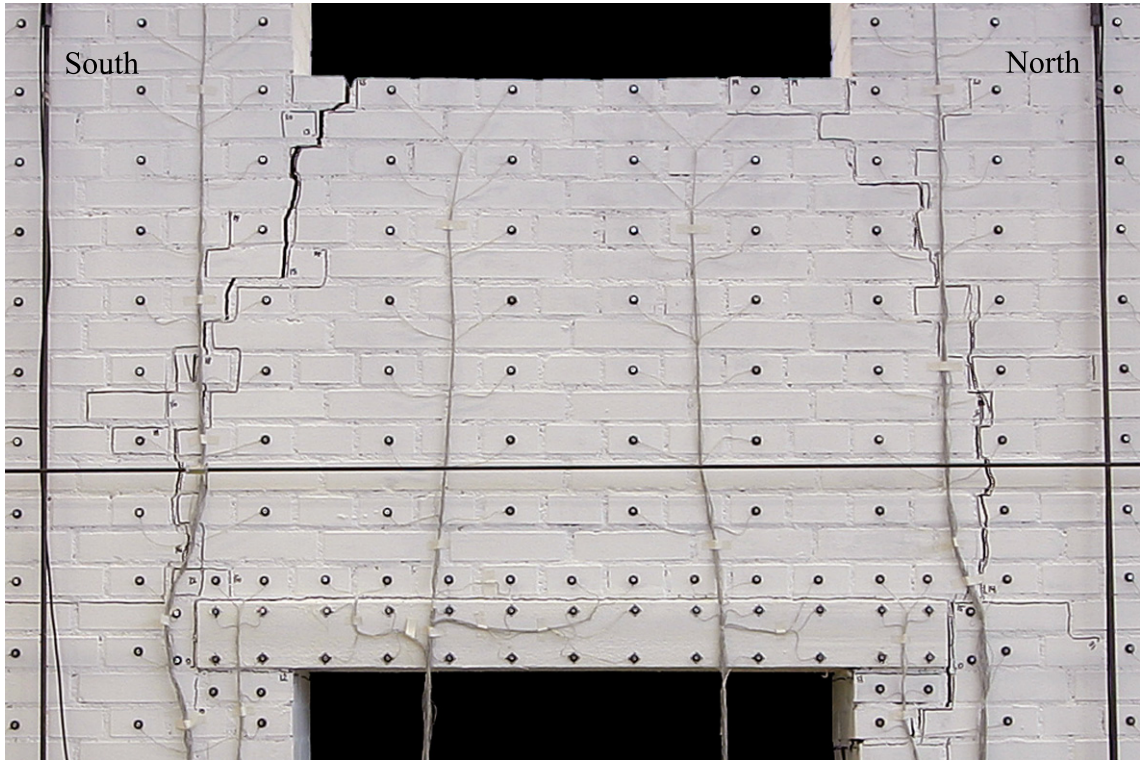
Figure 3.16: TUB: Crack pattern of spandrel at LS 23. Drift towards South with $\theta_{nom} = -0.4\%$.

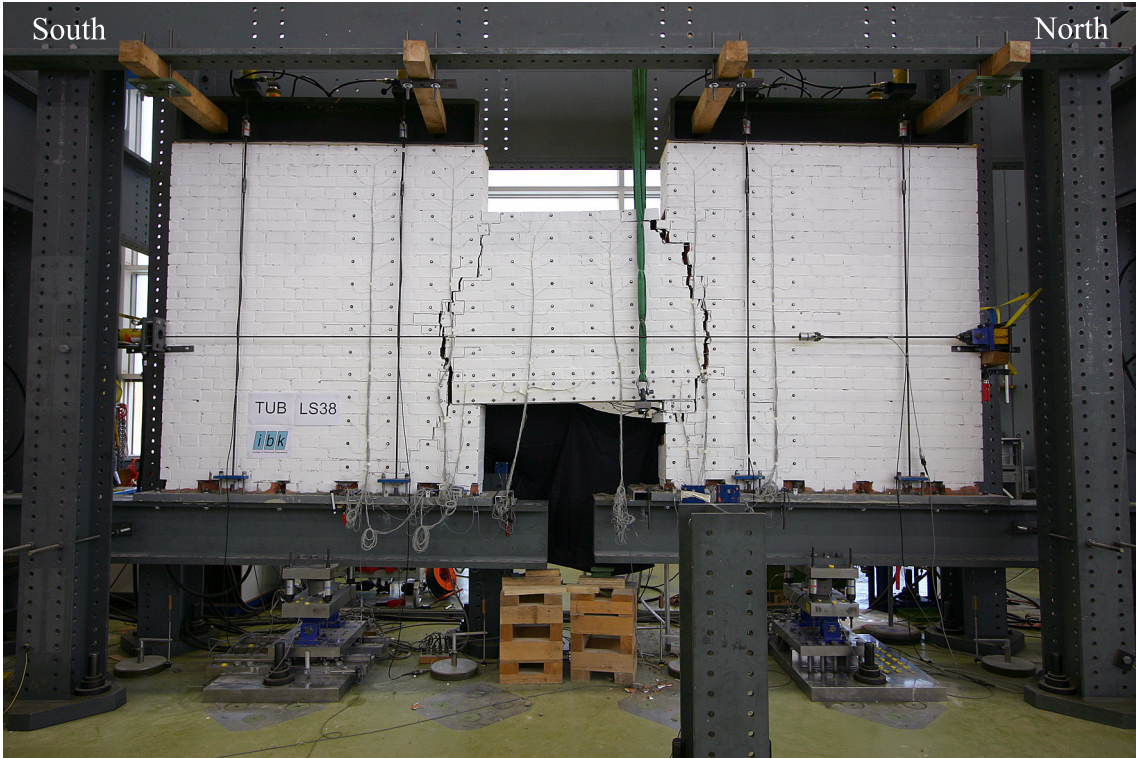
Figure 3.19: TUB: Crack pattern of spandrel at LS 38. Drift towards North with $\theta_{nom} = 1.5\%$.

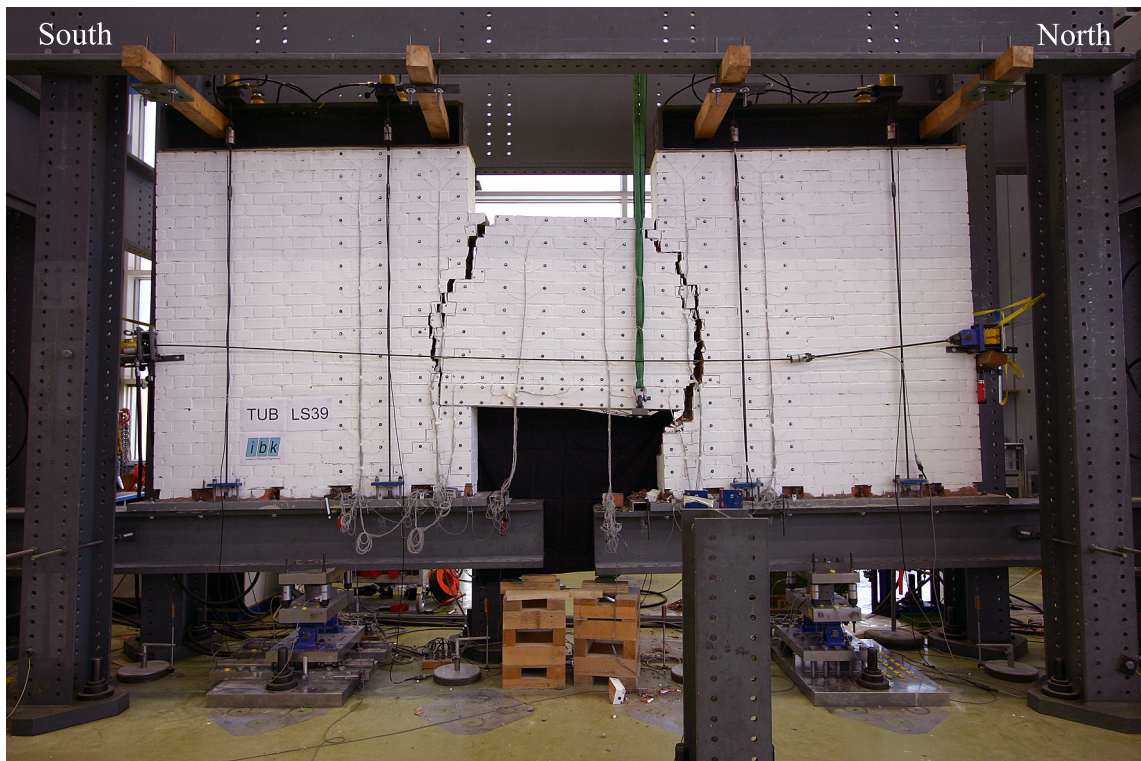
Figure 3.20: TUB: Crack pattern of spandrel at LS 39. Drift towards South with $\theta_{nom} = -1.5\%$ (failure of TUB).

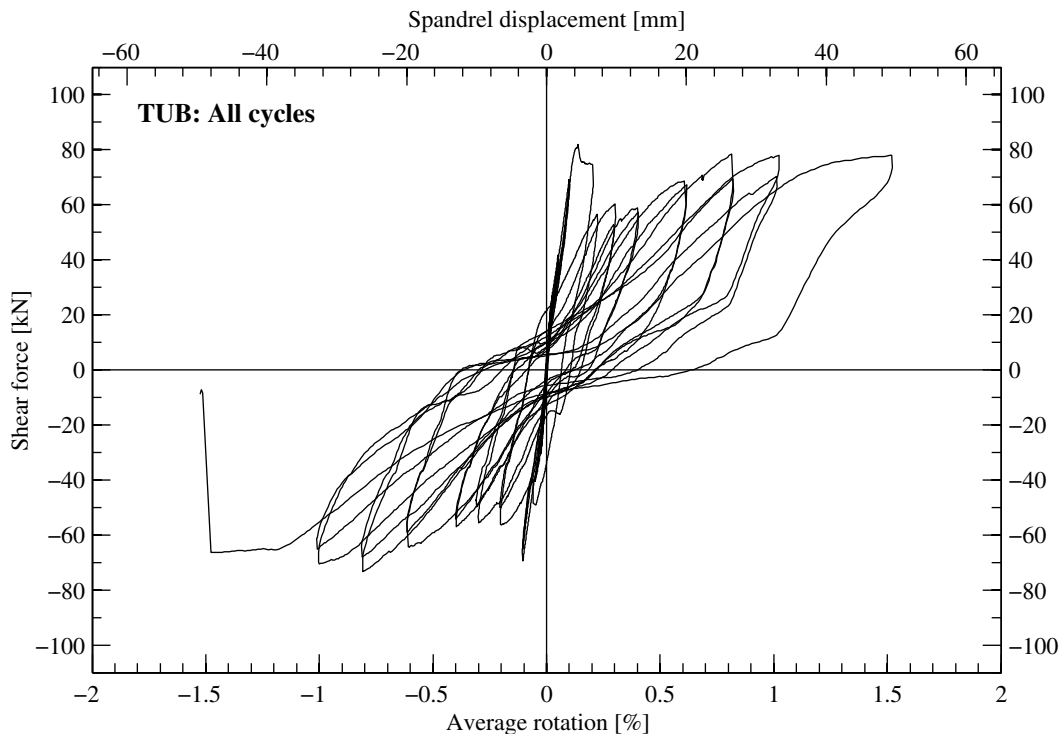
Figure 3.21: TUB: Force-rotation relationship for all cycles.

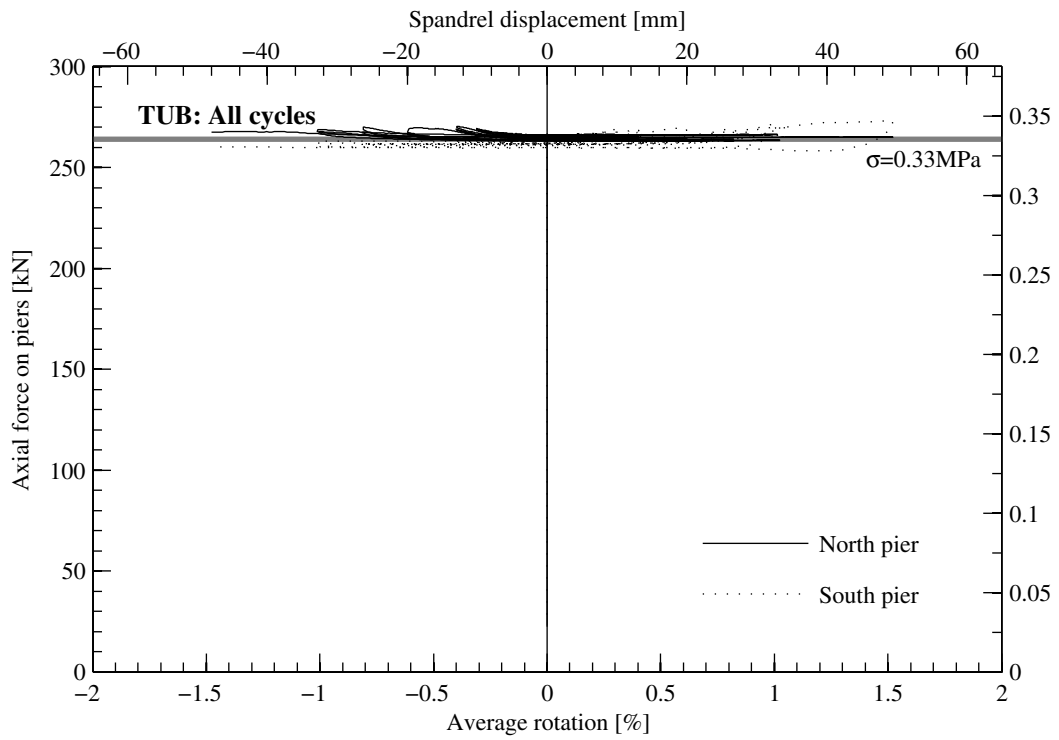
Figure 3.24: TUB: Axial force on piers - rotation relationship for all cycles.

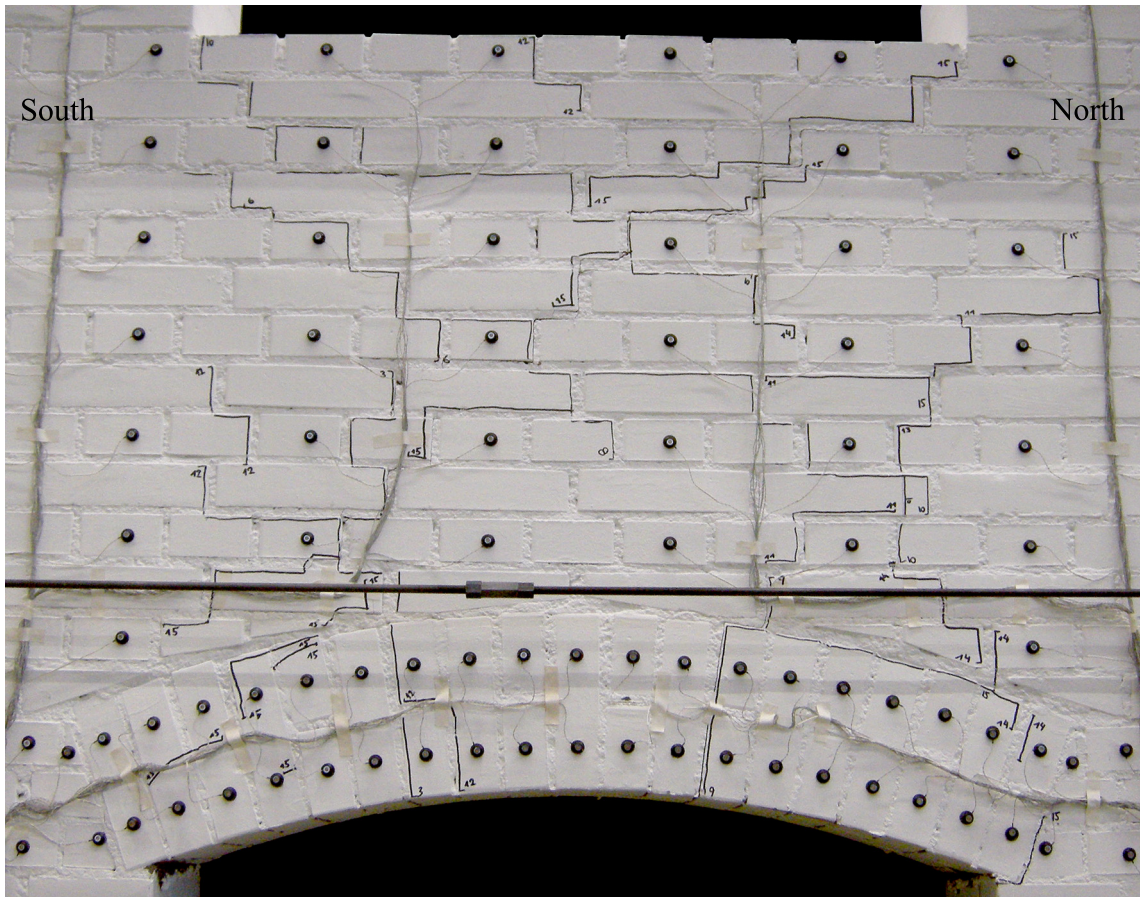
Figure 3.28: TUC: Crack pattern of spandrel at LS 15. Drift towards South with $\theta_{nom} = 0.2\%$.

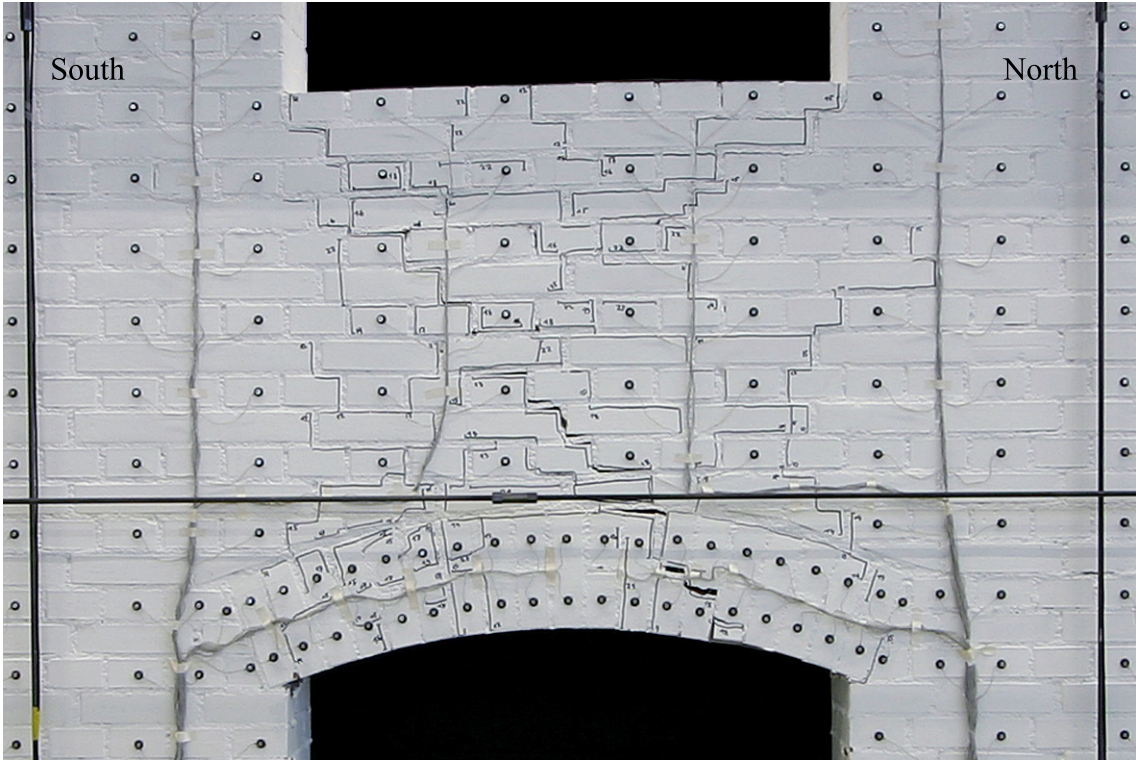
Figure 3.29: TUC: Crack pattern of spandrel at LS 22. Drift towards North with $\theta_{nom} = 0.4\%$.

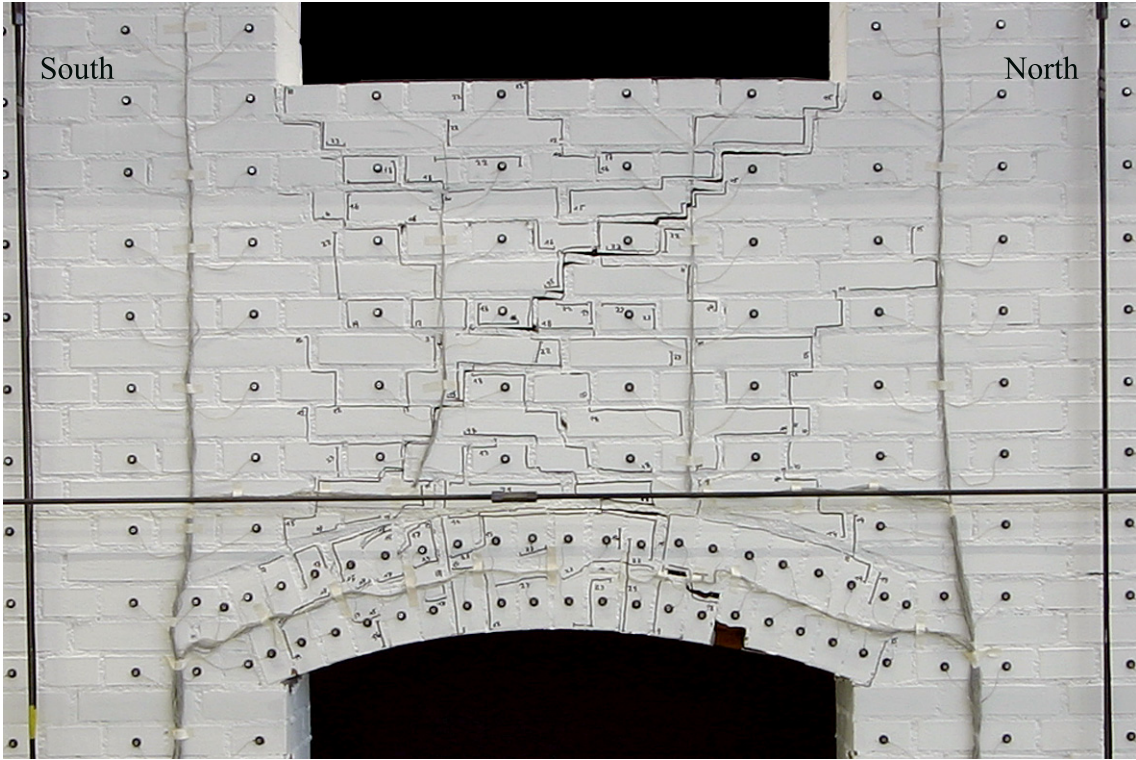
Figure 3.30: TUC: Crack pattern of spandrel at LS 23. Drift towards South with $\theta_{nom} = -0.4\%$.

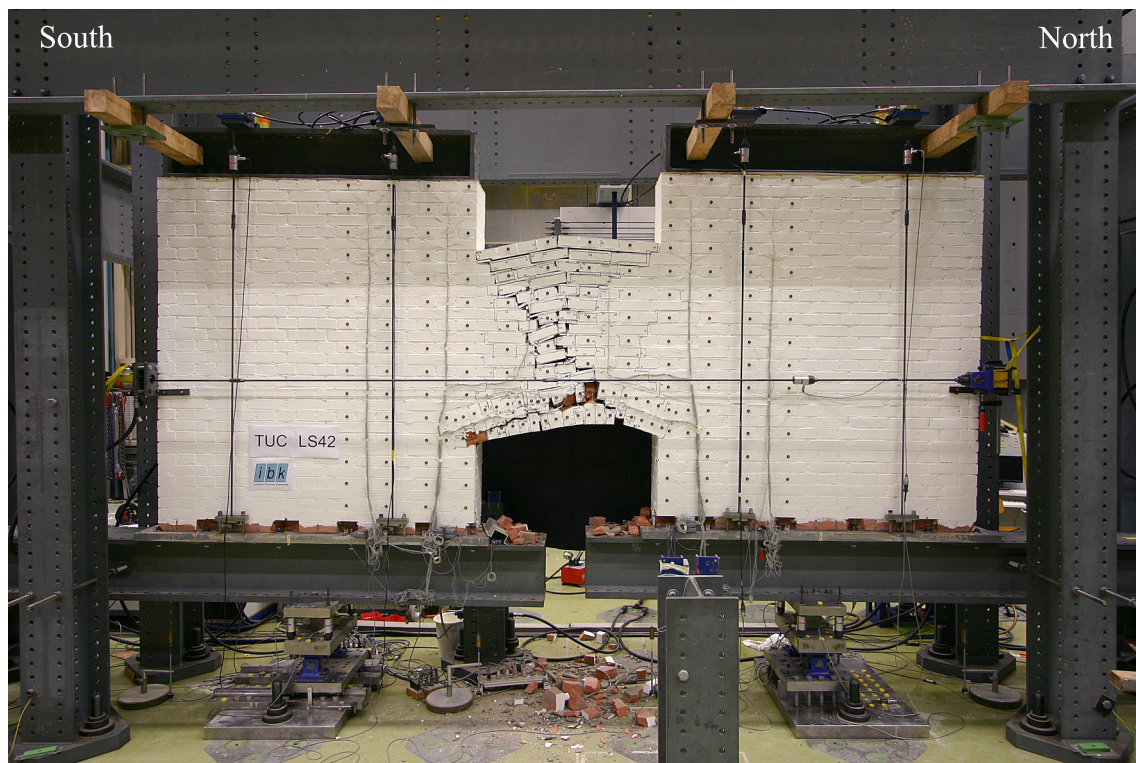
Figure 3.33: TUC: Crack pattern of spandrel at LS 42. Drift towards North with $\theta_{nom} = 2.0\%$.

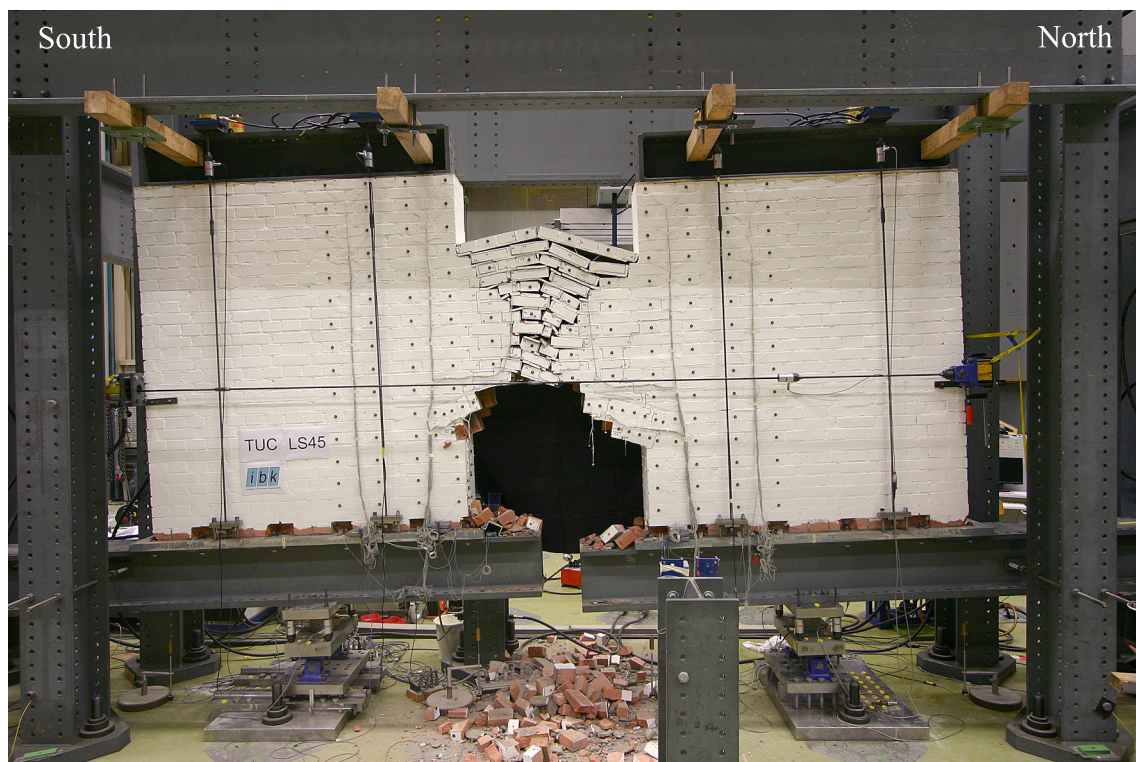
Figure 3.34: TUC: Crack pattern of spandrel at LS 45. Drift towards South with $\theta = -3.5\%$ (failure of TUC, $\theta_{nom} = -2.0\%$).

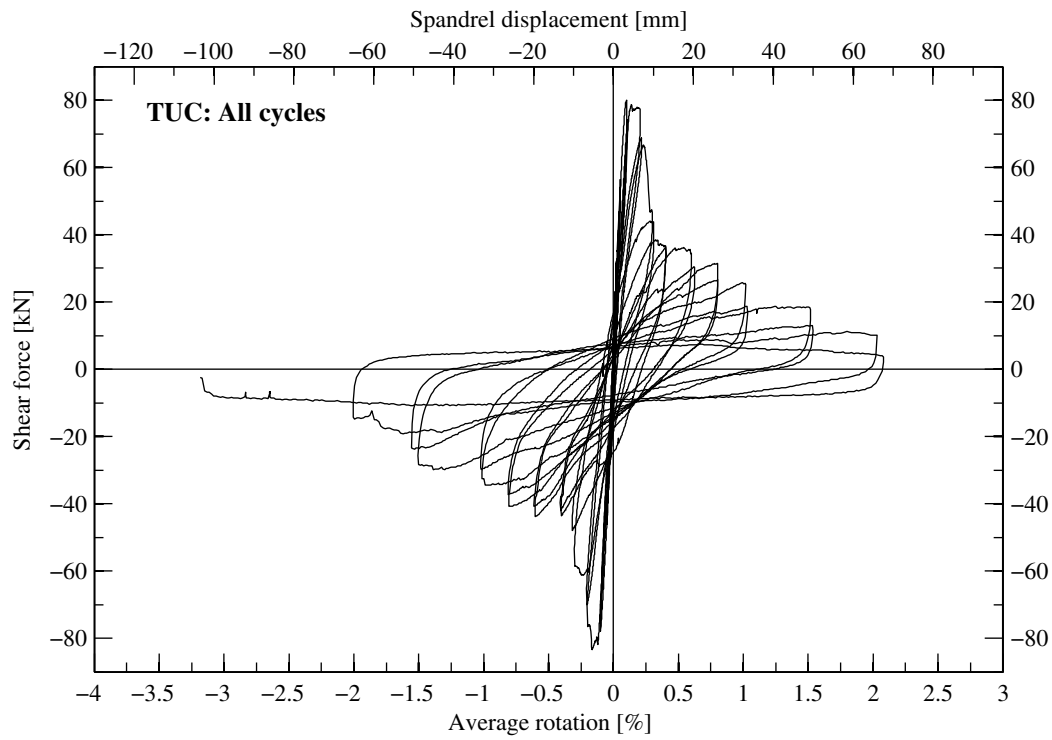
Figure 3.35: TUC: Force-rotation relationship for all cycles.

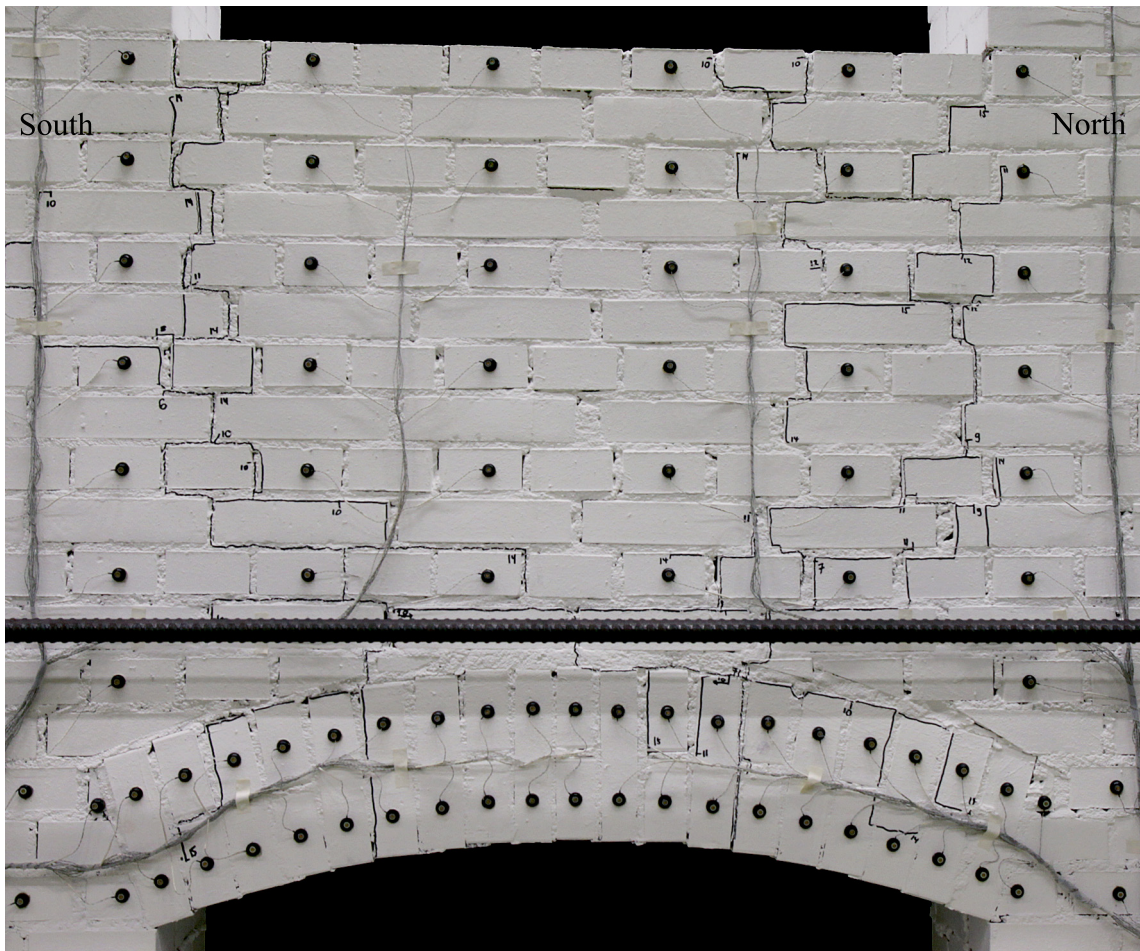
Figure 3.41: TUD: Crack pattern of spandrel at LS 15. Drift towards South with $\theta_{nom} = 0.2\%$.

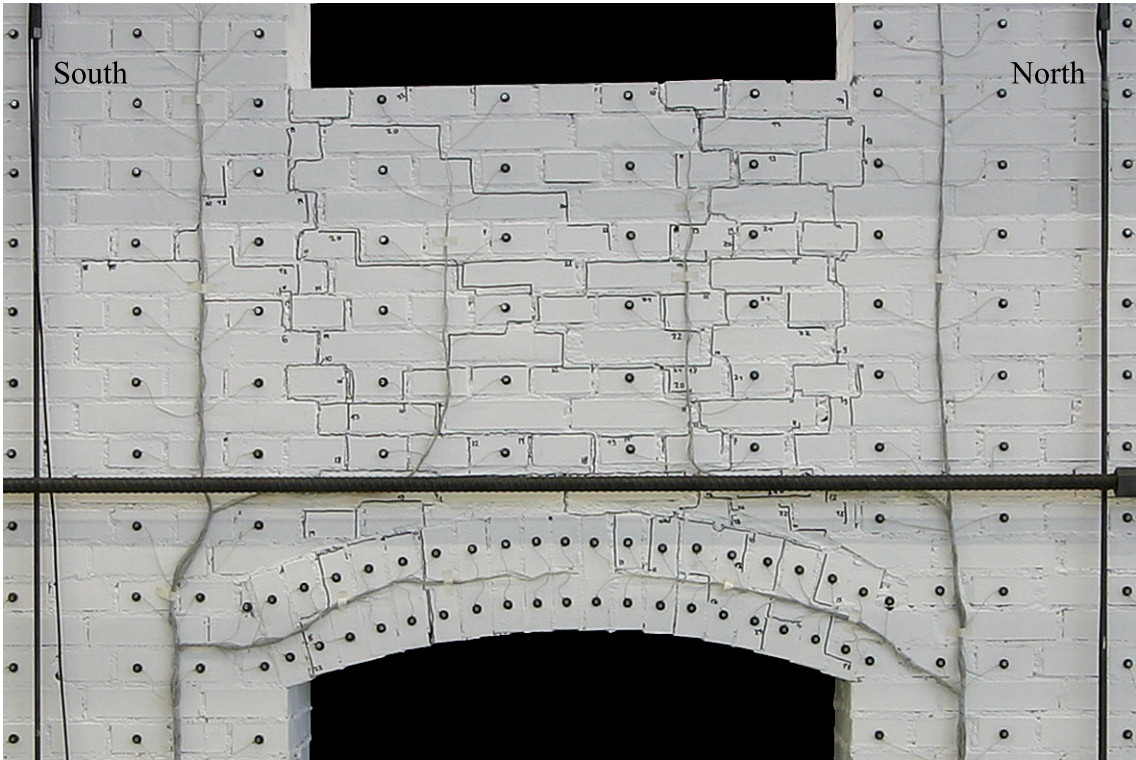
Figure 3.42: TUD: Crack pattern of spandrel at LS 22. Drift towards North with $\theta_{nom} = 0.4\%$.

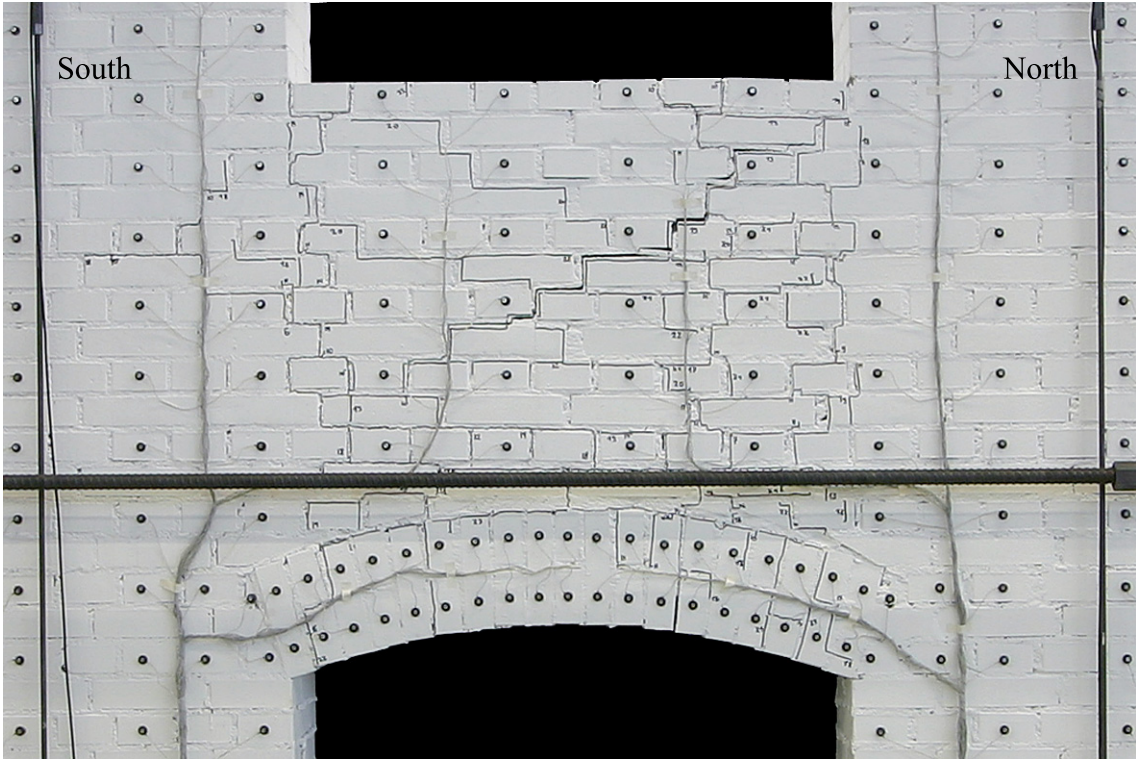
Figure 3.43: TUD: Crack pattern of spandrel at LS 23. Drift towards South with $\theta_{nom} = -0.4\%$.

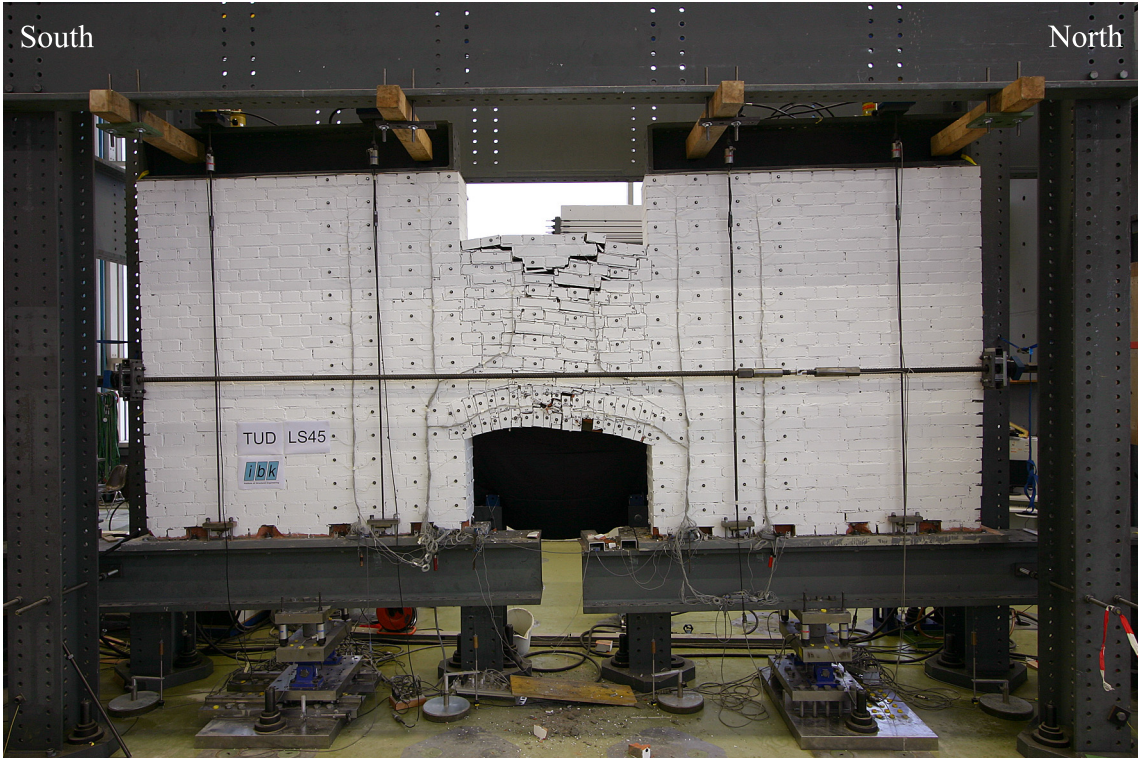
Figure 3.46: TUD: Crack pattern of spandrel at LS 45. Drift towards South with $\theta_{nom} = -2.0\%$.

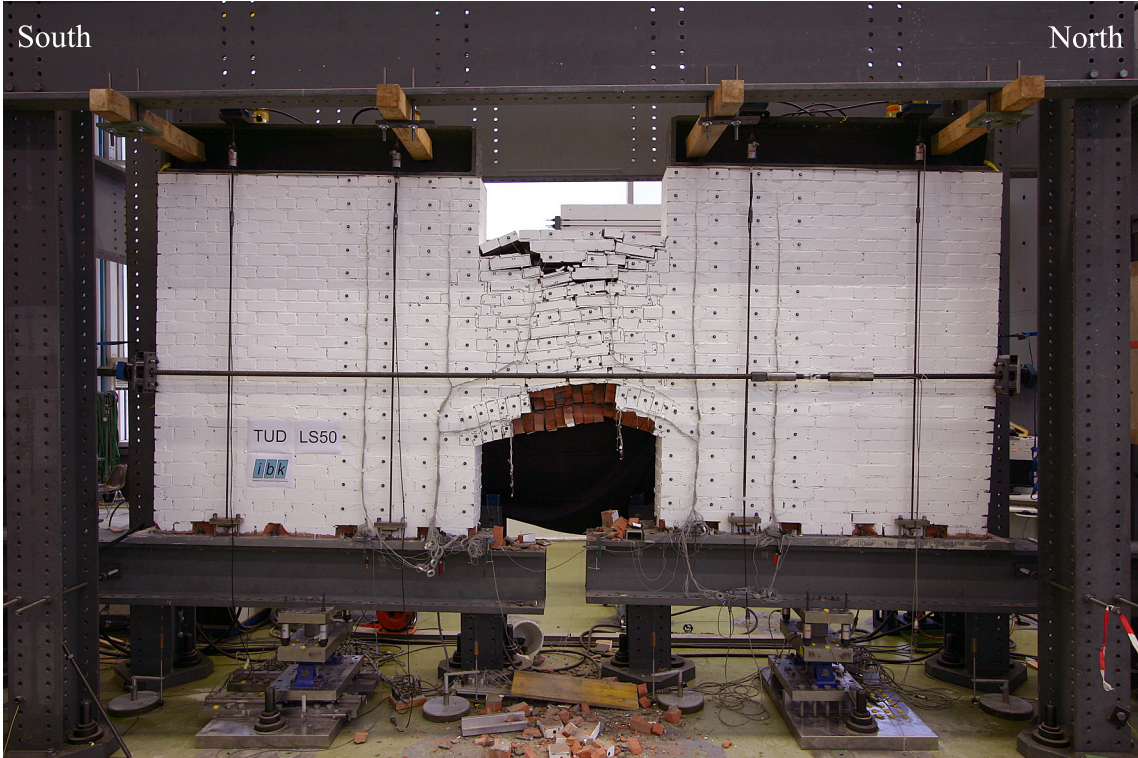
Figure 3.47: TUD: Crack pattern of spandrel at LS 50. Drift towards North with $\theta = 2.5\%$ (failure of TUD, $\theta_{nom} = 3.0\%$).
