# Measurements of internal cracking in punching test slabs without shear reinforcement

Advancing the knowledge about the punching behaviour of flat slabs has been held back by the fact that only indirect measurements of the internal failure mechanism have typically been available. In this paper, a novel experimental approach for tracking the formation and development of cracks inside punching test specimens is presented. In six full-scale specimens without shear reinforcement, 48–64 measurement points were installed inside small holes drilled on the soffits of the slabs. During the punching tests, the displacements of these points were followed at various levels of load with a high-precision coordinate measuring arm. Development of inclined flexural cracks (called the critical shear cracks) from the tension chord to the neutral axis was observed in every specimen. In some cases, the punching failures occurred along these cracks. However, in other cases, new lower-angled failure cracks developed, either at the moment of failure or already at earlier stages of loading. These cracks had very different patterns of development, even between two monitored sides of the same specimen, alt

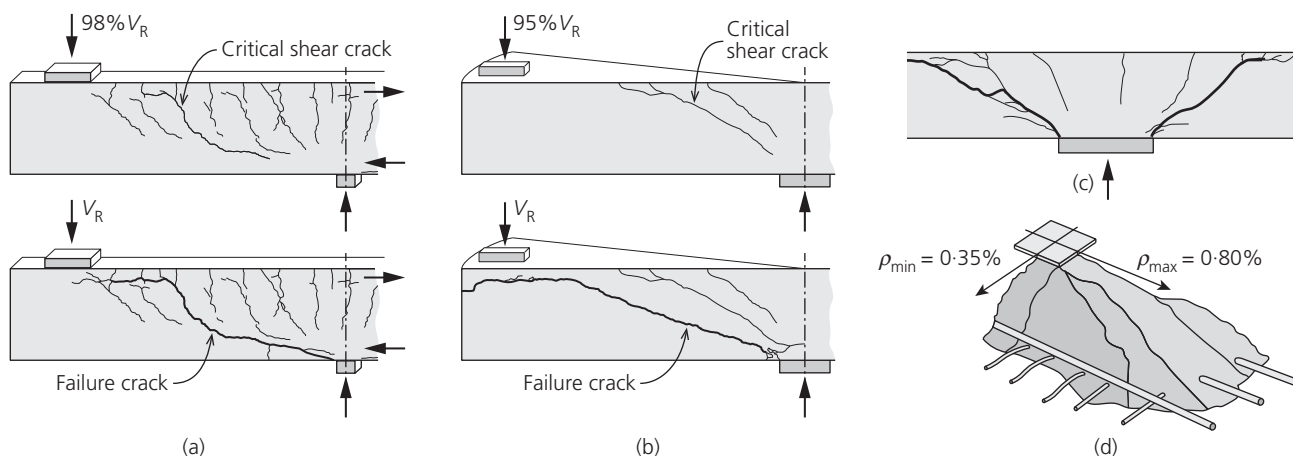
**Figure 1.** Comparison between the cracking patterns in (a) one-way (beam) specimen SC12b of Campana *et al.* (2013) ( $\rho = 1.5\%$ ); (b) saw-cut surface of two-way (slab) specimen PF22 of Clément *et al.* (2012) ( $\rho = 1.5\%$ ); (c) saw-cut surface of specimen PG3 of Guandalini *et al.* (2009) with low flexural reinforcement ratio ( $\rho = 0.33\%$ ); (d) punching cone of specimen PT23 of Sagaseta *et al.* (2011) with unequal reinforcement ratios in two directions (only a quarter of the slab is shown)

Previous experiments have shown that the post-failure cracking patterns on beam specimens without shear reinforcement can be notably different from those observed on the saw-cut surfaces of punching test slabs. In Figure 1, some previously tested specimens are compared. In sufficiently slender beams (such as SC12b (Campana *et al.*, 2013), shown in Figure 1(a)), the tension chord is normally cracked over almost the whole length of the element. These flexural cracks develop towards the neutral axis and may propagate into the compression chord. Among these cracks, the shear strength is normally controlled by one, called the critical shear crack (Cavagnis *et al.*, 2015), which may progress to become the failure crack (as in specimen SC12b shown in Figure 1(a)), or which triggers the development of a new crack leading to failure in a sudden manner (Cavagnis *et al.*, 2015).

With respect to punching failures, Figure 1(b) shows a two-way slab specimen (PF22 of Clément *et al.* (2012)) with similar geometry (slab depth 400 mm, distance between the load and the support 1380 mm) and reinforcement ratio ( $\rho = 1.5\%$ ) as the previous beam SC12b. Internal measurements similar to the ones described in this paper were performed during this test. Flexural cracking detected with the internal measurement system and visible on the saw-cut is concentrated in the zone directly above the column. The furthest flexural crack from the column edge (the critical shear crack) is inclined at

approximately  $45^\circ$ . This crack propagates to the vicinity of the compression chord, influencing its stress state. The failure crack, which does not touch the critical shear crack in this specimen, can be seen as having a much flatter angle than in beam elements. Even at the last measurement step (at 95% of the failure load) before a sudden punching failure, the internal measurement system did not detect the failure crack, which indicates its sudden appearance and propagation. However, the behaviour of other previously tested specimens might have been different. For instance, on the saw-cut of specimen PG3 of Guandalini *et al.* (2009) with  $\rho = 0.33\%$ , which is shown in Figure 1(c), failure cracks with steeper angles can be observed. In some cases, these cracks turn quasi-vertical close to the tension chord, which suggests a flexural origin of this part of the crack and can thus be assumed to be coincident with the critical shear crack. Even in slabs with non-symmetric flexural reinforcement (PT23 of Sagaseta *et al.* (2011) with  $\rho_{\min} = 0.35\%$  and  $\rho_{\max} = 0.80\%$  in Figure 1(d)), the two types of failure cracks have been observed to occur in the same specimen. In the direction with the lower amount of flexural reinforcement, a steeper failure crack can be seen, whereas the failure crack in the direction with the higher reinforcement ratio has a lower angle, similar to that of PF22 (Figure 1(b)).

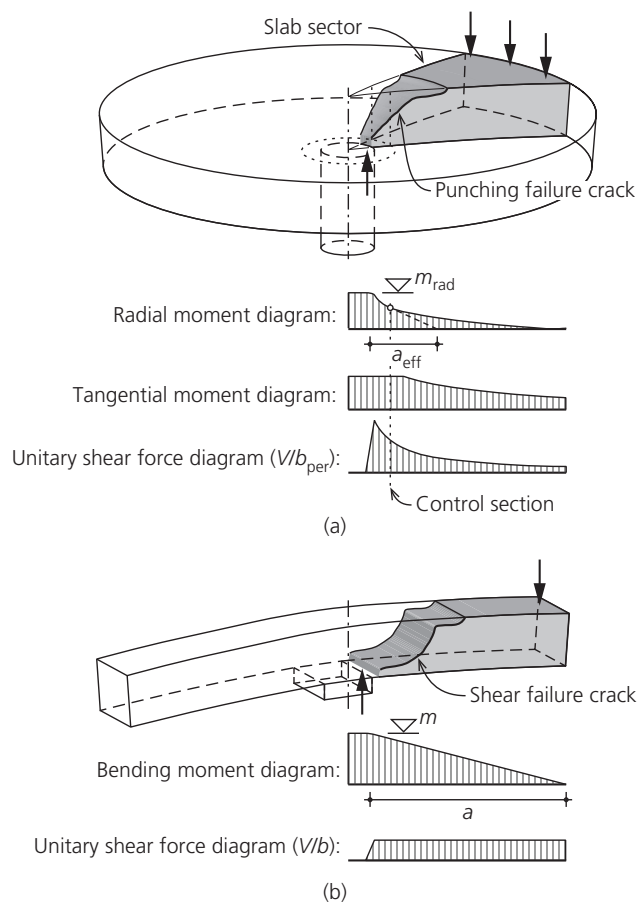
**Figure 2.** Distribution of moments and shear stresses: (a) two-way (slab) specimens; (b) one-way (beam) specimens

known to influence the shear strength of elements without shear reinforcement (Kani, 1964), is significantly smaller in a two-way slab than in a corresponding beam (the effective shear span  $a_{\text{eff}}$  in two-way slabs can be graphically shown as a gradient of the radial moment diagram (Figure 2(a)). Owing to the rapid decrease of the radial bending moment with increasing distance from the column, circular flexural cracking only occurs close to the column. In addition, because the width of the sector elements in axisymmetric slabs increases linearly with distance from the column, the unitary shear force, in the case when load in the column region is neglected, decreases hyperbolically (Figure 2(a)). In the uncracked region,

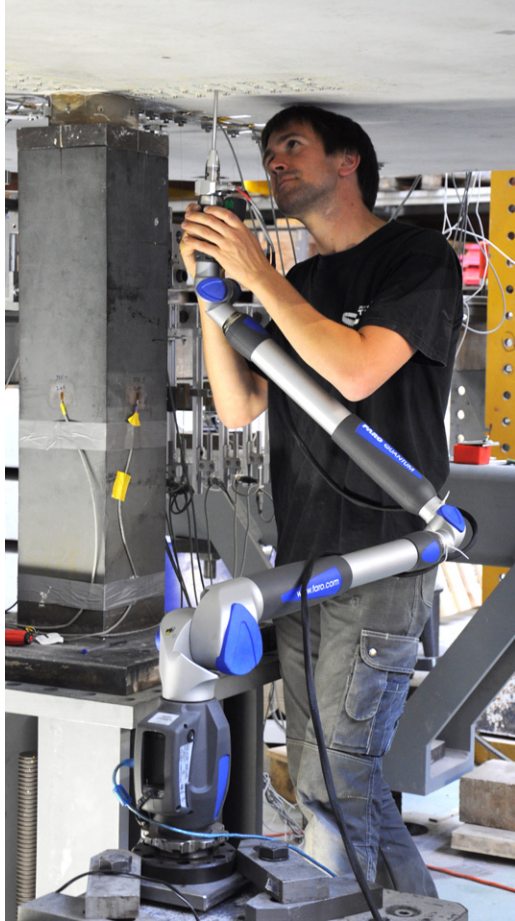
Figure 4. Performing internal measurements with FaroArm

The specimen was loaded by pumping oil into the hydraulic jacks. The load was applied in steps, with larger load increments at the beginning of the test and smaller increments closer to the failure. After applying each load increment, the pumping was stopped, which caused the load to decrease slightly. After approximately 10 min, when the rate of decrease of load had diminished, the coordinates of each point were measured sequentially (Figure 4). One measurement step lasted for 10 to 15 min.

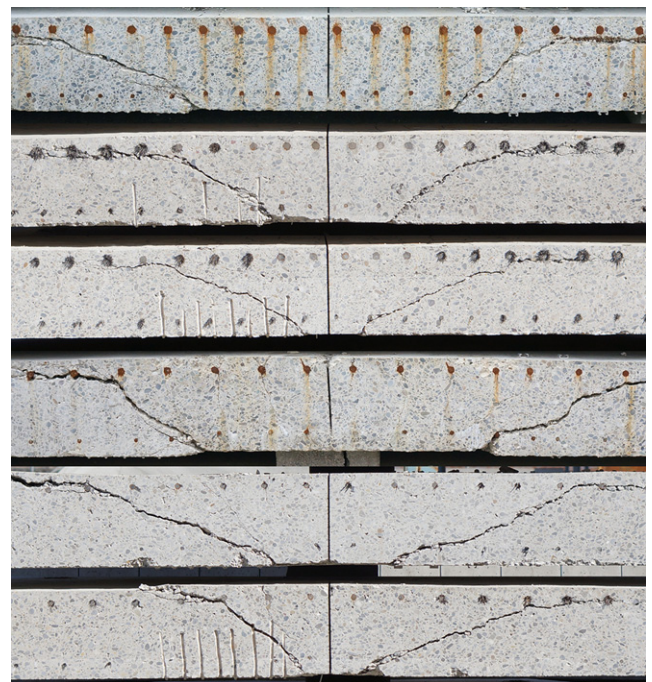
Figure 5. Photographs of saw-cuts of the specimens along the E–W axis (from top to bottom: PE5, PE8, PE7, PE12, PE9, PE11, i.e. decreasing column size and reinforcement ratio)

After the test, in order to observe the internal cracking patterns, all specimens were cut along the E–W axis, whereas the northern halves were additionally cut along the N–S axis. One wide crack, referred to as a ‘failure crack’, was clearly distinguishable on all the saw-cut surfaces (Figure 5). This crack extended from the edge of the column plate in the slab soffit to the tensile reinforcement layer (except on the east side of PE12, where the crack started at some distance from the column). The shapes and angles of this crack varied significantly between specimens and even between different sides of one specimen. On most saw-cut faces, some narrower flexural cracks were also visible that extended from the top surface of the slab either to the bottom half of the slab or to the failure crack. As intended, the presence of holes for the internal measurements did not have a significant influence on the cracking patterns and punching performance.

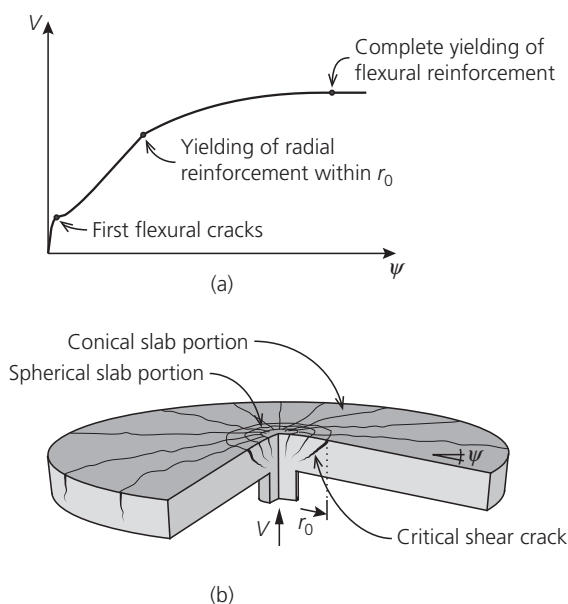
Figure 6. (a) Load–rotation curve. (b) Assumed deformed shape of a specimen

Regarding the flexural response of a specimen, three phases can be observed, characterised by different stiffnesses of the load–rotation curve (Figure 6(a)).

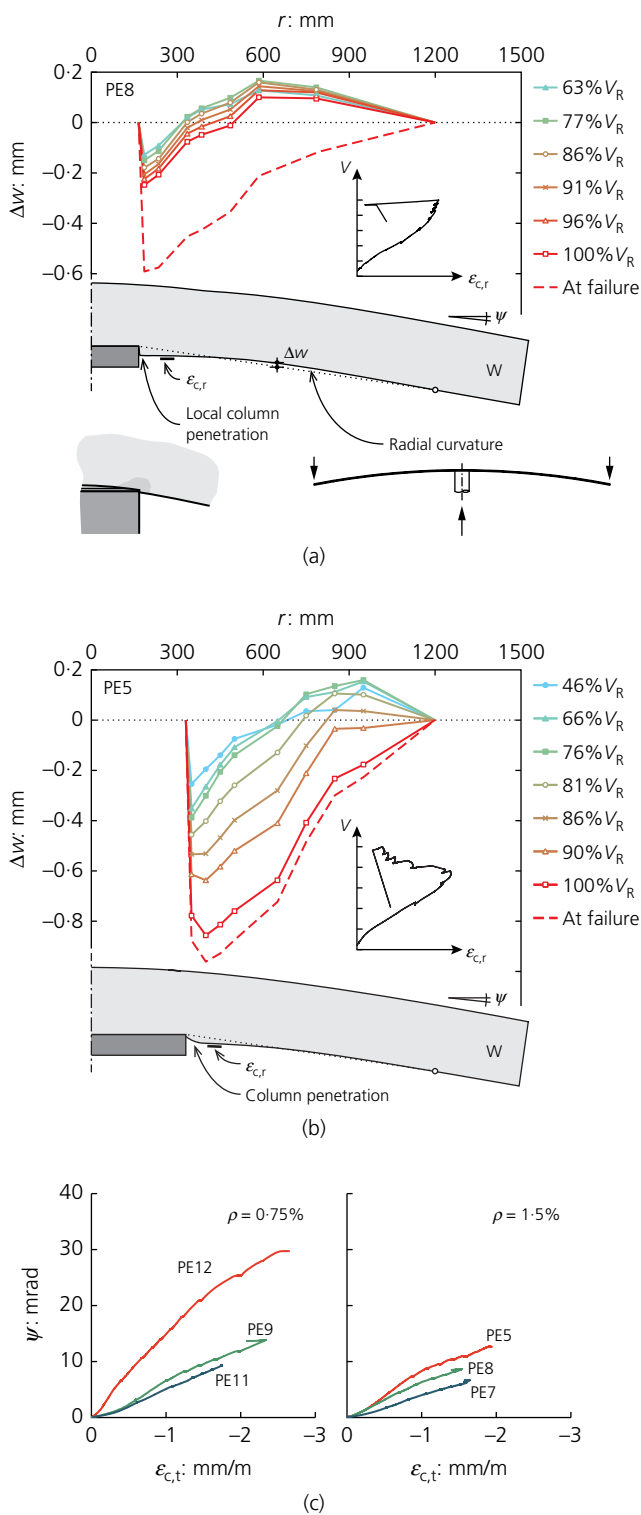
**Figure 7.** Deformations of the slab soffit in comparison to the conical shape: (a) deviations of the slab soffit compared to the conical shape, specimen PE8; (b) deviations of the slab soffit compared to the conical shape, specimen PE5; (c) tangential strains at 100 mm from the column on the strong axis (S from the column) as a function of average slab rotation

Figure 7(c) shows the tangential compressive strains on the slab soffit at 100 mm from the edge of the column as a function of the average slab rotation (measured on the south side of the column, refer to Figure 3(a)). The ultimate strains range from  $-1.5\text{‰}$  to  $-2.6\text{‰}$  in different specimens. This remains below the strains corresponding to the compressive strength of normal strength concrete in biaxial compression as reported by Kupfer (1973). According to the conical model, the tangential curvature and thus the tangential strains on the slab soffit are proportional to slab rotation (expressed from a geometrical compatibility condition as  $\chi_t = -\psi/r$ ). This was confirmed by measurements, although on the south side of the column, slightly larger strains than predicted were measured close to the failure.

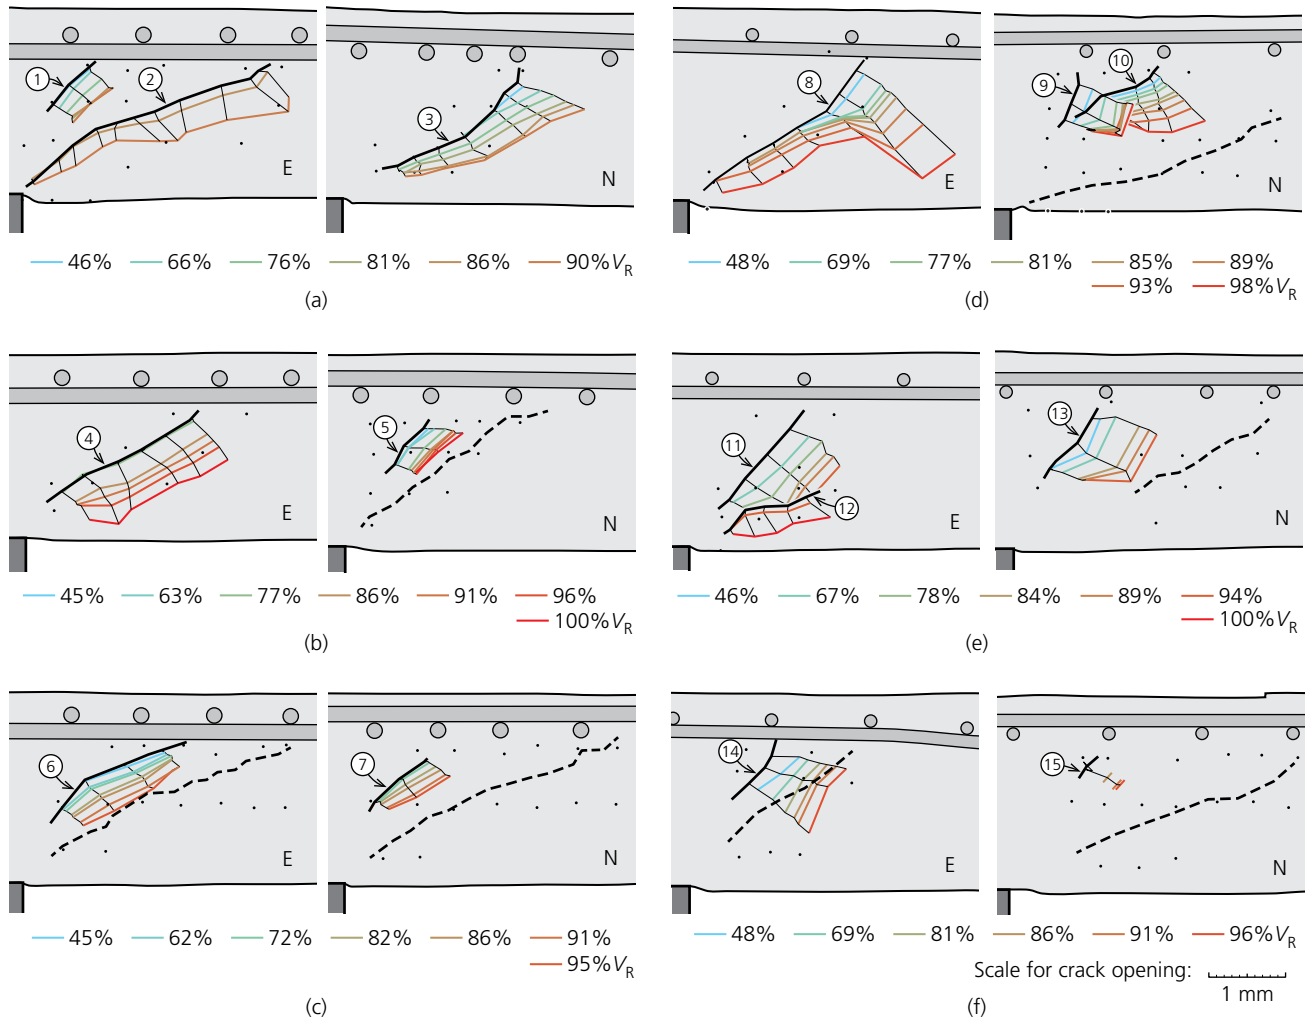
**Figure 8.** Crack widths and opening directions (dashed lines indicate the cracks that were first detected after the punching failure): (a) PE5 ( $d_c = 660$  mm;  $\rho = 1.5\%$ ); (b) PE8 ( $d_c = 330$  mm;  $\rho = 1.5\%$ ); (c) PE7 ( $d_c = 166$  mm;  $\rho = 1.5\%$ ); (d) PE12 ( $d_c = 660$  mm;  $\rho = 0.75\%$ ); (e) PE9 ( $d_c = 330$  mm;  $\rho = 0.75\%$ ); (f) PE11 ( $d_c = 166$  mm;  $\rho = 0.75\%$ )

The critical shear crack (the furthestmost inclined circular crack of flexural origin) was followed in all the cases, except in the east direction of specimen PE8 (Figure 8(b)). These cracks (1, 3, 5–11, 13–15 in Figure 8) were first observed as having occurred already at approximately 50% of the failure load. Widths of the critical shear cracks in different specimens,

Progression of the punching failure along the critical shear crack was observed in the specimens with the largest column sizes ( $d_c = 660$  mm): on the north side of the column in specimen PE5 (crack 3 in Figure 8(a)) and on the east side of the column in specimen PE12 (crack 8 in Figure 8(d)). In both cases, the eventual failure cracks were detected having started opening at load levels clearly below the punching capacity: at 76% of  $V_R$  in specimen PE5 and at 85% of  $V_R$  in specimen PE12. Yet, in both of these specimens, the failure cracks in the other monitored sides of the column were of the second type, developing below the critical shear crack. In specimen PE5, at 90% of the maximum load (the last measurement step), the failure crack on the east side of the column, inclined at  $18^\circ$  from the horizontal, had a width of approximately 0.3 mm (crack 2 in Figure 8(a)). However, in specimen PE12, where the failure crack on the east side of the column had a very low inclination, it was not detected

In the two specimens with intermediate size columns ( $d_c = 330$  mm: PE8 in Figure 8(b) and PE9 in Figure 8(e)), the failure cracks developed independently of the critical shear cracks in every surveyed region. Both specimens failed during or after performing the internal measurements, while the load had decreased below the maximum applied load  $V_R$ . On the north side of the column, no strains were measured at the location of the eventual failure crack in either of the slabs. In contrast, on the east side of the column of PE8, a failure crack (with an inclination of  $30^\circ$ ) was observed to start opening at 86% of  $V_R$  (Figure 8(b)). The width of the crack, uniform over the whole measured length, increased to 0.7 mm before the failure. The column penetration, however, which was measured on the west side of the column (Figure 7(a)), started to increase only after the maximum load had been applied. Punching failure of the specimen occurred approximately 20 min after the loading was stopped, during which period the applied load dropped from the maximum of 985 kN to 835 kN and the column penetration (on the west side of the column) increased from 0.2 mm to 0.6 mm. In specimen PE9, punching failure occurred while the measurements were being taken. During the last measurement step, a failure crack with an opening of 0.3 mm (crack 12 in Figure 8(e)) was detected on the east side of the column. Yet, on the west side of the column, increasing column penetration had already been measured at earlier loading stages.

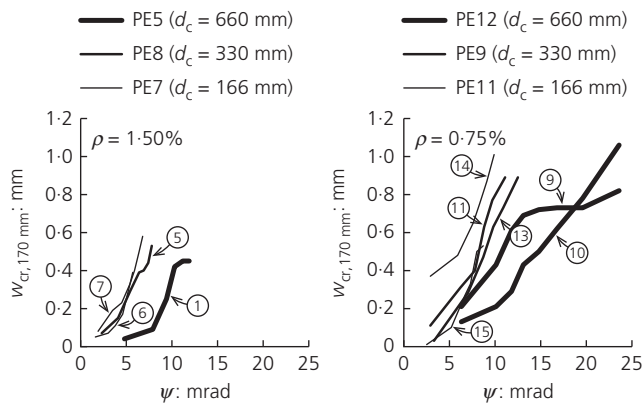
Figure 9. Widths of the flexural cracks as a function of slab rotation (for crack numbers – refer to Figure 8)

measured at the level of the highest internal measurement points (approximately 170 mm from the bottom face of the slab), are shown as a function of slab rotation in Figure 9. It can be seen that the crack widths at punching failure were larger in slabs with lower reinforcement ratios. This shows that these cracks are mainly related to bending. However, the critical shear crack widths before failure did not depend significantly on the column size. It can also be noted that in the case of larger columns, the cracks outside the perimeter of the column plate started opening at larger rotations. This can be explained by other flexural cracks closer to the centre of the column developing first (outside the monitored range). This is confirmed by the measurements performed in slab PE12, where two flexural cracks were located within the region of the internal measurement points (Figure 8(d)). It can be seen that the crack which was closer to the centre (crack 9) started opening at a lower rotation. However, another crack

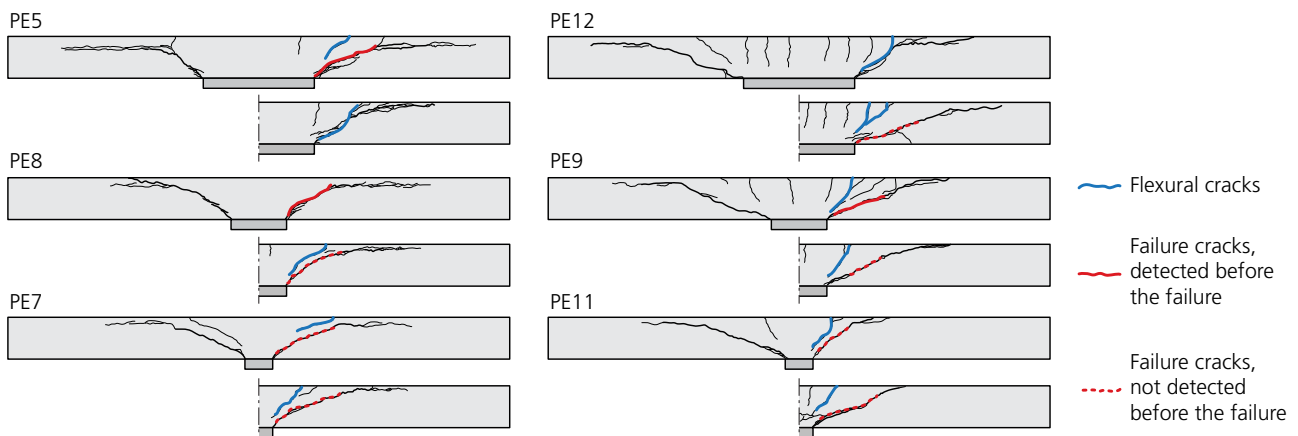
Figure 10. Types of cracks in punching test specimens

The different types of cracks for all the specimens are shown in Figure 10. It is interesting to note that the development of failure cracks could be remarkably different not only between specimens but even on different sides of the column in the same slab, although the specimens were nominally axis-symmetric (actually, the N–S axis had approximately 10% higher flexural strength and stiffness than the E–W axis due to the orthogonal layout of reinforcing bars that had the same diameter and spacing in both directions (refer to Table 1)). The experiments show that the failure cracks appeared in some slab sectors at lower load levels than in the others, in some cases already at 75–80% of  $V_R$ . This can be compared to the observations regarding shear behaviour of beams of Campana *et al.* (2013), as well as Cavagnis *et al.* (2015), who have demonstrated that different cracking patterns and consequent differences in mechanical shear transfer actions through the cracks can emerge in different beam specimens of similar geometries and mechanical properties. In slab specimens, however, the initiation of a failure crack did not yet prompt a sudden punching failure but, in several cases, its development could continue in a semi-stable manner.

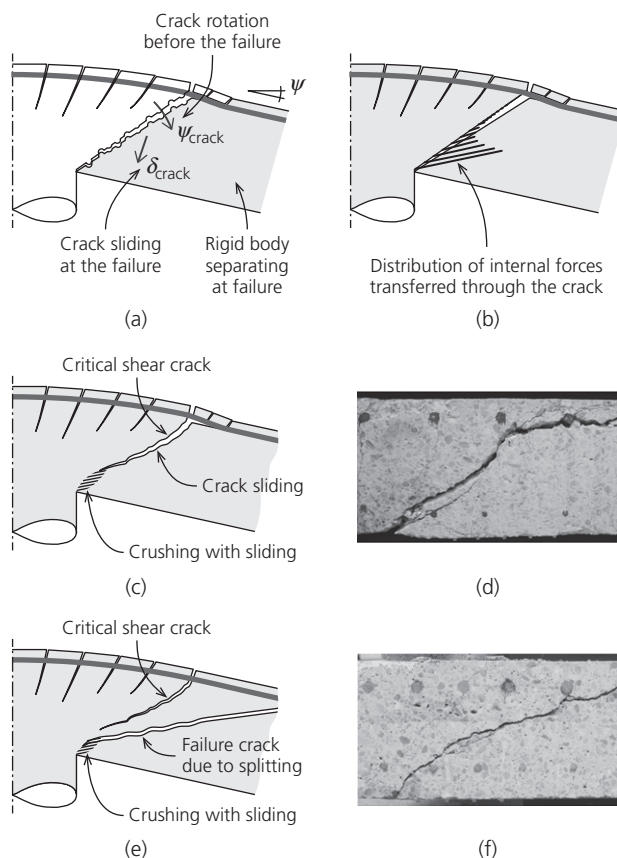
**Figure 11.** Interpretation of the test results: (a) kinematics of punching failure assumed in the CSCT; (b) distribution of internal forces transferred through the critical shear crack (adapted from Muttoni and Fernández Ruiz (2010a)); (c) development of a punching failure crack along the critical shear crack; (d) failure crack in specimen PE12 (east); (e) development of a punching failure crack independently of the critical shear crack; (f) failure crack in specimen PE7 (north)

described in the present paper. In some cases, failure occurred along the critical shear crack (Figure 11(c)), which is consistent with the theoretically assumed mechanism shown in Figure 11(a). On the saw-cuts (refer to an example in Figure 11(d)), the lower part of the crack is significantly more damaged, which is consistent with the fact that most of the shear force is carried in this region (Figure 11(b)). In other cases, the failure occurred with a sudden appearance of a flat-angled crack that was probably related to splitting (refer to Figures 11(e) and 11(f)), again referring to a failure in the critical region near the column. For both failures, a single crack eventually localised the strains. In addition, the states of strains and stresses in the compression strut close to the edge of the column, which are determined by the geometry and position of the critical shear crack, were governing for the failures. Therefore, the main assumptions of the critical shear crack theory may suitably describe both punching failure types observed in the presented experiments.

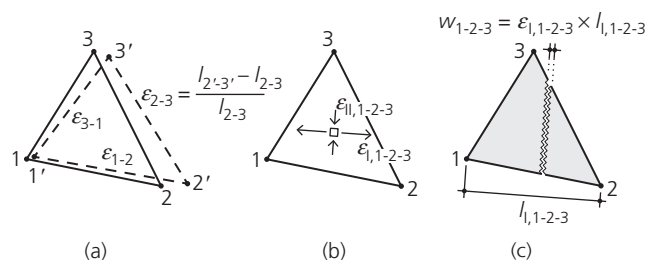
**Figure 13.** Conversion of the measured displacements to crack opening  $w$ : (a) strains at the edges of the triangles; (b) principal strains; (c) crack opening in the direction of principal tensile strain

The crack widths and opening directions at different levels of loading were calculated from the coordinates of the measurement points by dividing the mesh of points into triangles. Strains on all sides of each triangle ( $\varepsilon_{i-j} = \Delta l_{i-j} / l_{i-j}$ ) (Figure 13(a)) were then converted into principal strains ( $\varepsilon_{I,1-2-3}$  and  $\varepsilon_{II,1-2-3}$  in Figure 13(b)). The directions and magnitudes of the principal compressive strains in the triangles show the compressive stress field in the slab. However, the mesh

of internal points was too coarse and the precision of the system too low to obtain reliable information about the compressive strains in concrete. In contrast, the precision was sufficient to follow the formation and kinematics of cracks. Crack widths  $w_{cr}$  and their opening directions at different load steps were calculated by multiplying the maximum principal tensile strains in each triangle by the length of the triangle in the direction of the strain (Figure 13(c)). This represents an assumption that the tensile strain in a triangle was concentrated into a single crack, the direction of which was perpendicular to the direction of principal tension.
