A Working Paper Series in Physical Geography  
2010/2

## Quantification of channel planform change on the lower Rangitikei River, New Zealand, 1949-2007: response to management?

Jane M. Richardson  
Ian C. Fuller

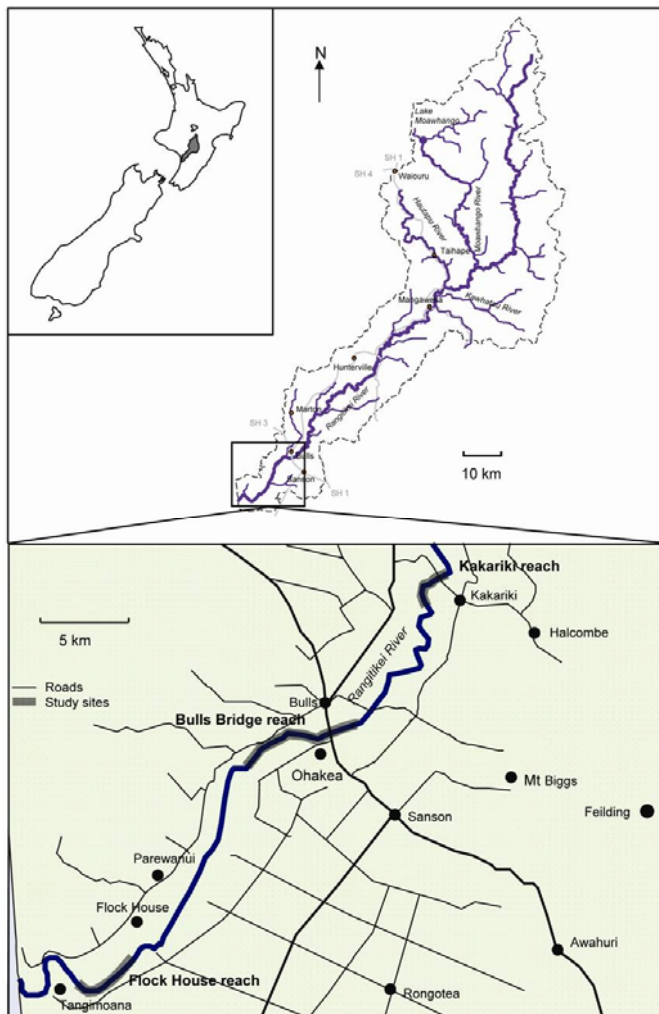
**Figure 1.** Location of study reaches within the Rangitikei River catchment, New Zealand

This study examines three reaches of the lower Rangitikei River, the locations of which are shown in Figure 1. The Kakariki reach is approximately 3 km long and is located 30 km upstream from the river

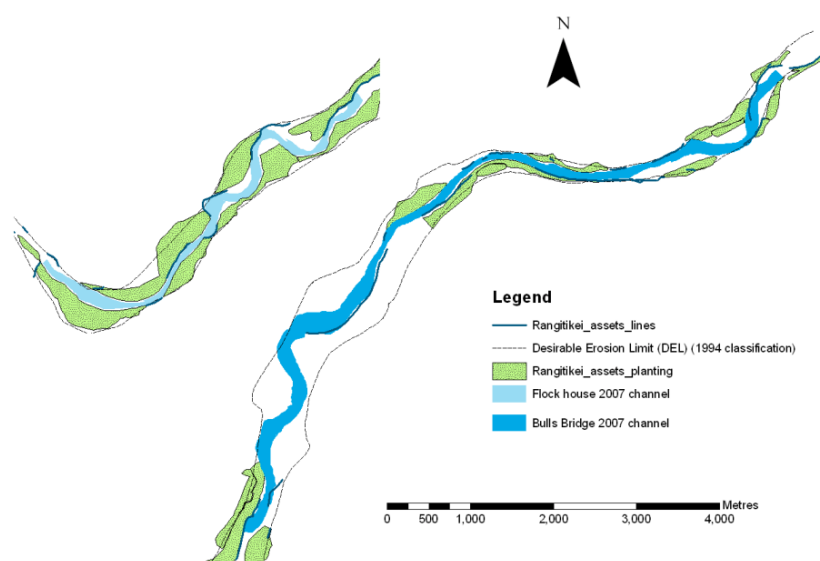
**Figure 2.** Rangitikei River Scheme assets and Desirable Erosion Limit map, Flock House and Bulls Bridge reaches.

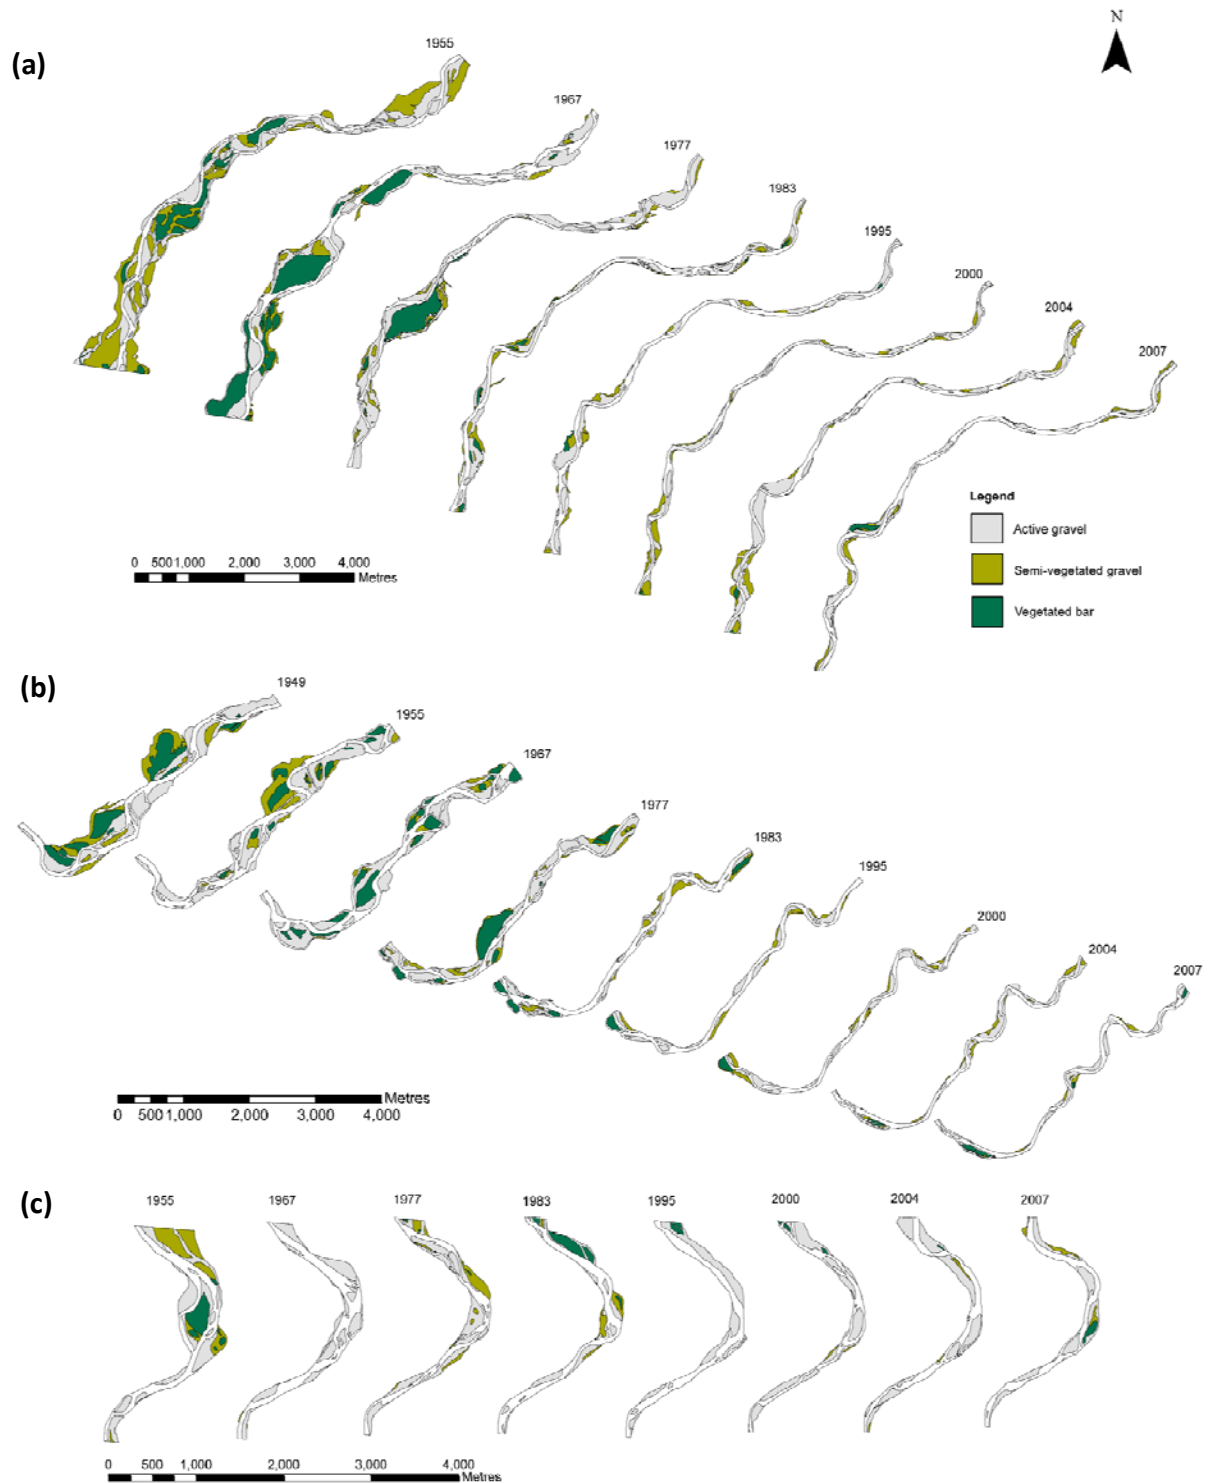
**Figure 3.** (a) Channel planform changes at the Bulls Bridge reach, lower Rangitikei River, derived from aerial photographs (1955-2007); (b) Channel planform changes at the Flock House reach, lower Rangitikei River, derived from aerial photographs (1949-2007); (c) Channel planform changes at the Kakariki reach, lower Rangitikei River, derived from aerial photographs (1955-2007). Flow is from north to south in each.

Historic planform reconstructions of each reach (Figure 3) show that in 1949 and/or 1955 the wide active channel was multi-threaded, comprising numerous bare gravel, vegetated and semi-vegetated mid-channel bars, high flow chute channels, abandoned anabranches and extensive lateral bar surfaces displaying various degrees of vegetation development. By 2007 all three reaches narrowed considerably, display less morphological complexity and are predominantly laterally stable single thread reaches. The 2007 active channel almost entirely comprises active gravel surfaces, with relatively small isolated patches of semi-vegetated and vegetated lateral bars evident (Figure 3).

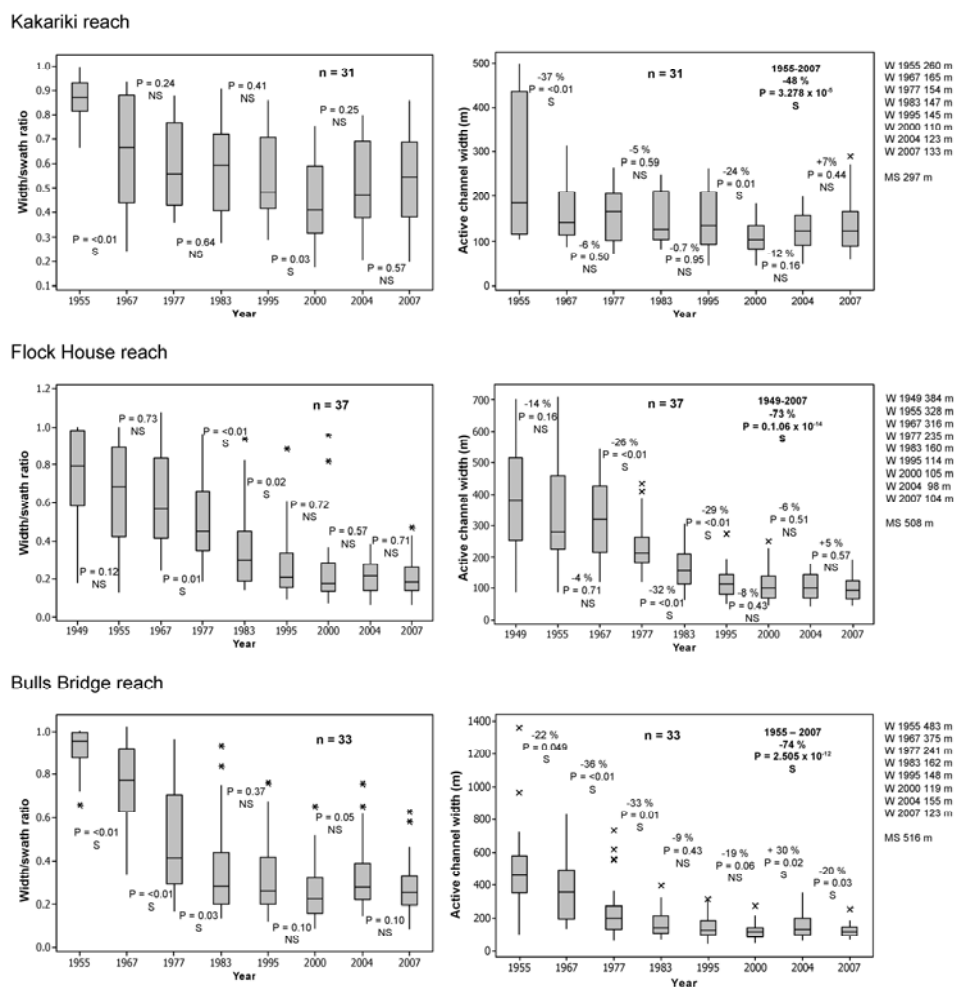
**Figure 4.** Rangitikei River active channel width and width/swath ratio changes in the study reaches between 1955 (1949 Flock House) and 2007; boxes represent inner and outer quartiles; vertical lines represent the upper limit = Q3 + 1.5(Q3-Q1) and lower limit = Q1-1.5(Q3-Q1); crosses are extreme values; n, number of width measurements; MS, mean value of floodplain swath; W, mean values of active channel width for each date; values in percent represents the rate of channel narrowing between dates; results of a parametric t-test are presented; S indicates significant differences of channel width and width/swath ratio between dates; NS, not significant.

The reduction in active channel widths derived from 30 cross sections in each reach is statistically significant (Figure 4). These results support the qualitative assessment of change derived from planform maps (Figure 3). Since 1983 the data suggest channel width has remained relatively stable with slight reductions in 2000 before an increase in 2004 (Figure 5). Overall between 1955 and 2007 the mean channel width of the Rangitikei River at Bulls Bridge reach has altered substantially, reducing by 74% (Figure 4). At Flock House mean active channel width reduced by 73% and at Kakairiki a 48% reduction occurred. Reach stability was also assessed by calculating the ratio of active channel width to total active channel width (or floodplain swath) for the three study the reaches (Figure 4). Channel width to floodplain swath ratios between 1955 and 1983 indicate a period of channel adjustment and narrowing before remaining relatively stable to 2007.

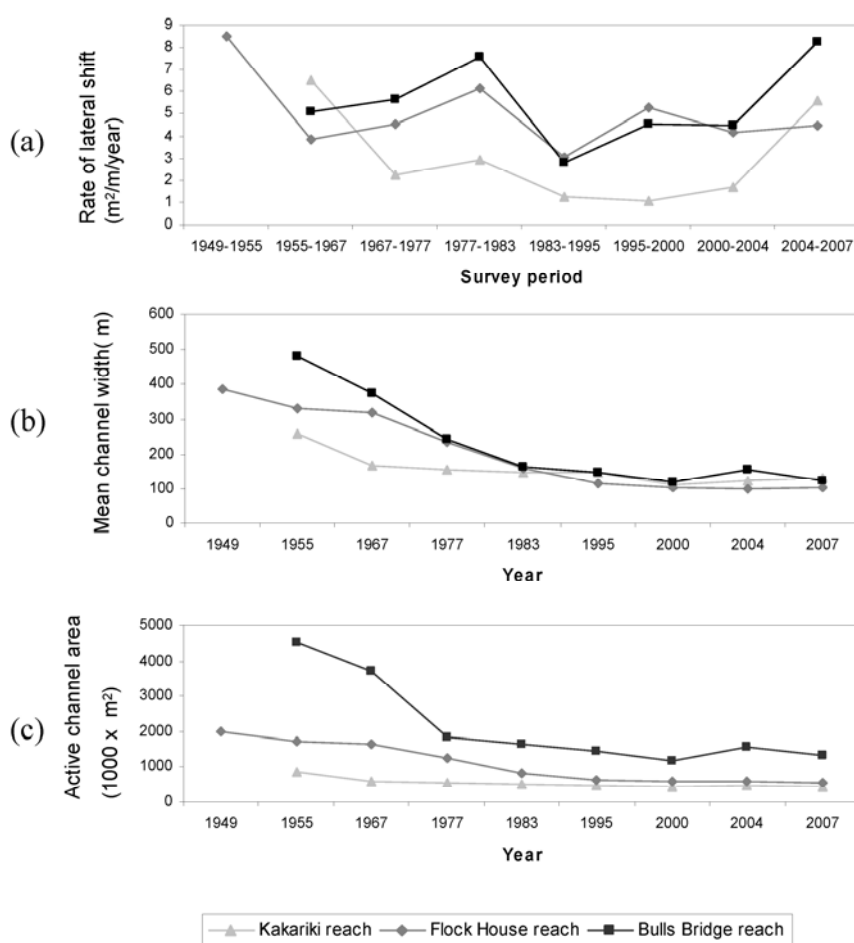
**Figure 5.** Changes in active channel parameters (a) rate of lateral shift (b) mean channel width and (c) active channel area, for the Kakariki, Flock House and bulls Bridges study reaches.

The rates of lateral channel shift calculated for each reach indicate that there has been movement of the channel midpoint and that the rate of this movement over time has been variable (Figure 5a). Although direct comparison of the rates of lateral shift is made difficult by the unequal number of years between records it does give some indication of channel stability over the study duration. The Flock House reach was subject to the greatest rates of channel midpoint migration during the period 1949-1955 with a rate of over  $8 \text{ m}^2\text{m}^{-1}\text{year}^{-1}$  calculated (Figure 5a). The Bulls Bridge reach experienced the greatest rate of lateral shift during two periods, 1977-1983 and 2000-2004. For the Kakariki reach the rate of lateral shift was highest between 1955-1967 and 2004-2007. The results illustrate similarities in the way the Flock House and Bulls Bridge reaches have behaved over time, with the variation in the rates of lateral rate shift mirroring each other between 1955 and 2004 (Figure 5a).

Quantitative analysis of active channel composition change was carried out for each of the study reaches of the lower Rangitikei River (Figure 5c). What is immediately evident is a marked reduction in

the active channel area for all three reaches between 1949 and 1983. Analysis of channel modification revealed that in less than 30 years the active channel area contracted by 64% at Bulls and 68% at Flock House (Figure 5c). Since 1983 there have been relatively small changes in the active channel area. A small (25%) expansion of the Bulls Bridge active channel between 2000 and 2004, but by 2007 the extent of the active channel had reduced again. At Flock House after 1995 very little variation in the total area occupied by the active channel is evident (Figure 5c).

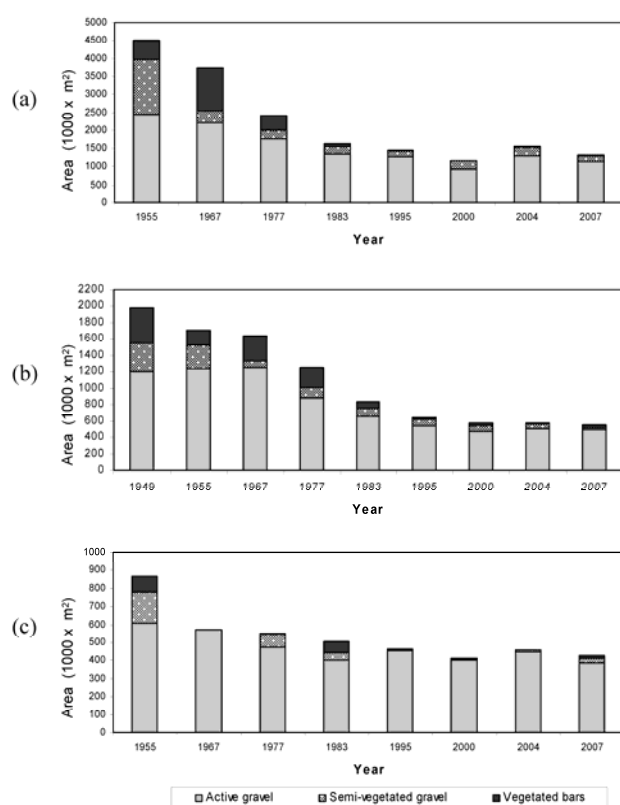
**Figure 6.** Changes in active channel composition showing active gravel area, semi-vegetated gravel and vegetated bars at: (a) Bulls Bridge, (b) Flock House, (c) Kakariki reaches.

slightly, comprising between 80 and 87% of the total active channel area. In 1949 just over 60% of the total active channel area of the Flock House reach comprised active gravel (Figure 6b). By 1995 the area of active gravel accounted for 84% of the total active channel area. A similar increase in the relative proportion of active gravel area was also identified in the Kakariki reach (Figure 6c). In 1955 69% of the active channel comprised active gravel, 12 years later over 99% of the total active channel area was active gravel. Since then the extent of active gravel in the Kakariki reach has remained high at between 86% and 98% of the total active channel area. Changes in the relative proportion and area of semi-vegetated and vegetated gravel can also be identified in the three study reaches (Figure 6), with marked declines in all reaches.

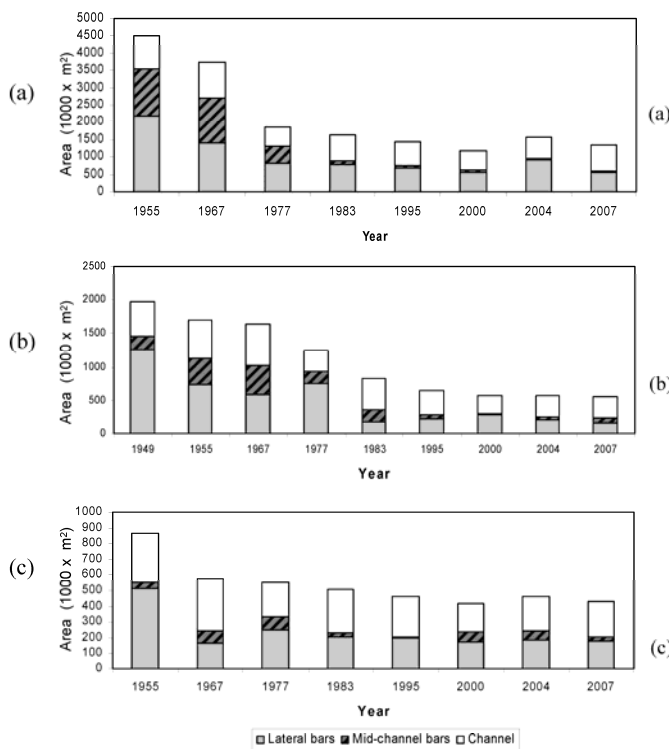
**Figure 7.** Changes in active channel geomorphology showing mid-channel and lateral bar area at: (a) Bulls Bridge, (b) Flock House, (c) Kakariki.

GIS analysis of the active channel not only included the composition of the active channel but also differentiated between areas of wetted channel, lateral and mid-channel bars (Figure 7). Although the aerial photographs were taken during periods of low flow there will be some fluctuation in the relative proportion of bar type and wetted channel area. Despite these limitations some clear trends can be identified, with a reduction in the extent of lateral and mid-channel bars between 1955 and 1983 clearly visible. For example, in 1955 30% of the active channel area at Bulls Bridge comprised mid-channel bars, by 1983 this reduced to 5%.

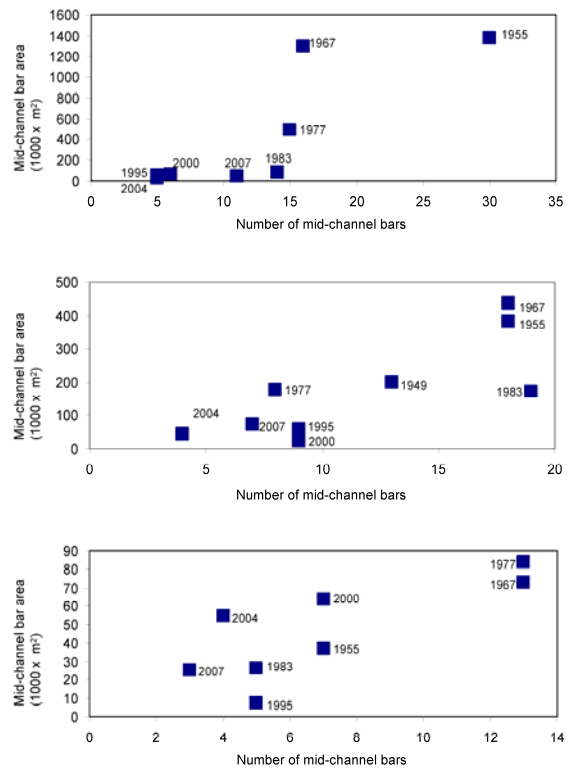
**Figure 8.** Changes in the number and area of mid-channel bars 1955 (1949 Flock House)-2007 at: (a) Bulls Bridge, (b) Flock House, (c) Kakariki.

Figure 8 shows that not only has there been a reduction in the area associated with mid-channel bars between 1955 and 1983 but that the actual number of bars has also decreased. Lees and Werritty (1999) used an analysis of total medial bar area and number of bars to identify a trend from braided to single thread planform. This study uses a similar approach which identifies a reduction in braiding with fewer mid-channel bars detected within the study reaches and an associated reduction in the area of mid-channel bars between 1955 and 1983 (Figure 8). Whilst Bulls Bridge and Flock House show similar

trends (Figure 8a-b), results from Kakariki do not show a clear trend (Figure 8c), although there is some indication that the reach was more braided in 1967 and 1977. A braiding index summarises these changes (Figure 9a), showing a clear reduction in braiding over the period of study. Commensurate with this reduction in braiding is an overall increase in reach sinuosity, although the trend is not dramatic (Figure 9b).

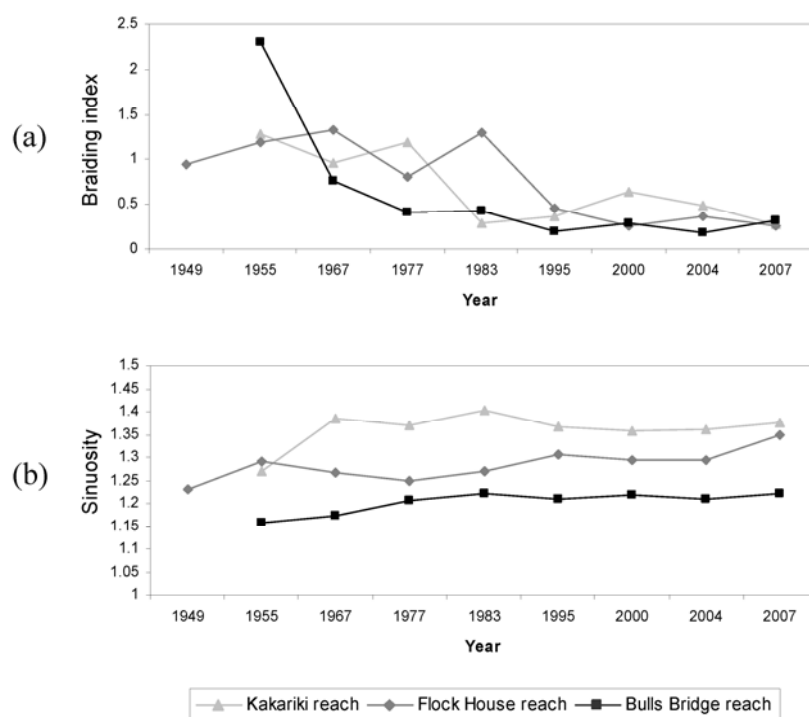
**Figure 9.** Changes in (a) braiding index and (b) sinuosity for the Bulls Bridge, Flock House and Kakariki reaches of the lower Rangitikei River 1955 (1949 Flock House)-2007.

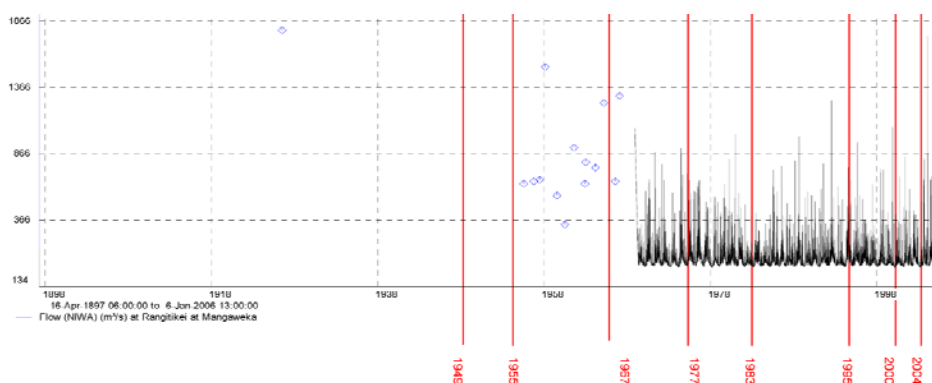
**Figure 10.** Flood hydrograph for the Rangitikei River gauged at Mangaweka, 16 April 1897 to 2006. Aerial photograph dates labelled (Courtesy of Brent Watson, Horizons Regional Council, Sept 2008).

Relatively small-scale alterations in the climate and flood regime can produce significant morphological adjustment in river channels (Rumsby and Macklin, 1994; Wishart *et al.*, 2008). The Mangaweka flow gauging site provides the longest continuous record of river flow for the Rangitikei River (Figure 10). Flow at Mangaweka comprises 79 to 88% of the flow at Kakariki during low flow periods (Horizons Regional Council, 2004) and so can be considered relatively representative of the general flow conditions occurring at the study reaches in the lower river. Figure 10 shows the flood peaks recorded at Mangaweka prior to 1970 in addition to the more recent continuous flow record. The data series shows no clear alteration in flood frequency or magnitude over the period of observation which would likely be responsible for river channel morphological change. It is also unlikely that the Moawhango dam in the upper catchment and associated flow diversion has contributed to channel change, since its influence is not detectable in the flow record at high flows and the effect on flood flow in the lower Rangitikei is estimated to be only a 0.4 percent reduction in flow (Horizons Regional Council, 2004). There is no evidence to suggest that there has been any change in the flood regime in the Rangitikei River from these records, although such changes have been identified in gravel-bed rivers in Scotland and northern England over a similar time period (Rumsby and Macklin, 1994; Werrity and Lees, 2001; Wishart *et al.* 2008). However there is no reason why New Zealand rivers should be in phase with British systems, in fact evidence suggests an anti-phase relationship (Macklin *et al.* 2009).

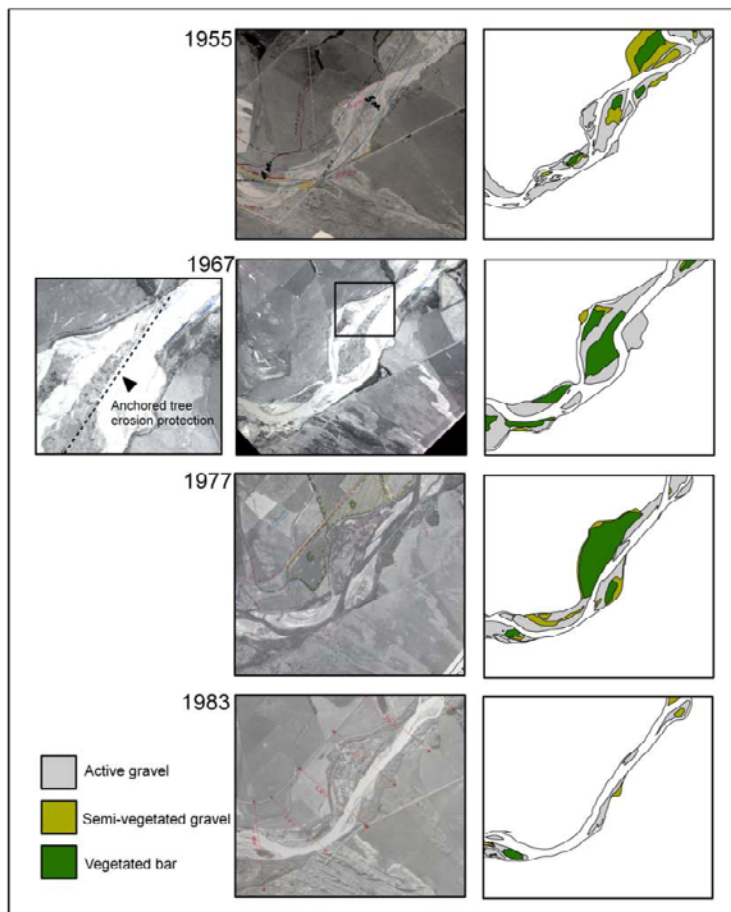
**Figure 11.** The effect of anchored tree erosion protection on channel planform in the Flock House reach of the lower Rangitikei River, 1955 to 1983.

The Rangitikei River scheme commenced in the early 1950s with a programme of river control involving bank protection work using anchored trees and protective planting to stabilise banks. The stabilising effect of bank vegetation is well reported (e.g. McKenny *et al.*, 1995; Marston *et al.*, 1995; Gurnell, 1997; Abernethy and Rutherford, 1998). Observation of channel planform changes that have occurred in selected reaches of the lower Rangitikei suggest that bank protection measures implemented through the Rangitikei River Scheme have been particularly effective in controlling bank erosion. Figure 11 shows how a line of anchored trees placed in the active channel before 1967 has influenced channel form in this section of the Flock House reach. In 1955 this part of the channel was wide, multi-channelled and with a large mid-channel bar present. A line of anchored trees installed down the length of the mid-channel bar prior to 1967 effectively cut off the side channels from the main thalweg. Further vegetation stabilisation of the bar surface prevented reactivation of the abandoned channels, maintained a narrower single-thread planform and culminated in complete disconnection from the active channel by 1983. Closer inspection of aerial photographs and reconstructed planform maps

reveals the extensive role that the bank protection works played in modifying the active channel throughout the Flock House, Bulls Bridge and Kakariki reaches. Quantitative and qualitative evidence of channel change suggests that the early bank protection measures were particularly successful at reducing the active channel width and area, with the majority of the changes occurring prior to 1983 with relative stability since then. These findings are in agreement with research that has found that the development and encroachment of riparian vegetation, either through land use change or river engineering, has played a major role in promoting geomorphic change within river systems (Gurnell, 1997; Marston *et al.*, 1995; Liébault and Piégay, 2002).
