Embedded Sensors for the Monitoring Of Durability in Spain

I. Martínez, C. Andrade, A. Castillo, N. Rebolledo, and R. D'Andrea

Instituto de Ciencias de la Construcción Eduardo Torroja (CSIC). C/Serrano Galvache n^o. 28033, Madrid, Spain. Email <isabelms@ietcc.csic.es>

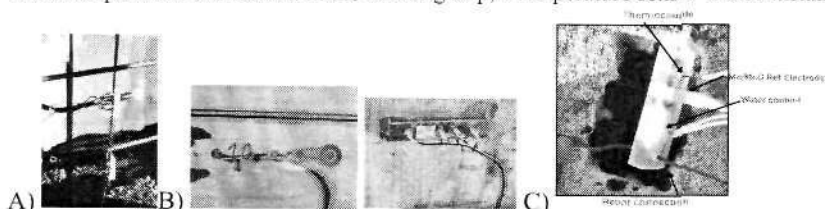
Fig. 1. A) Embedded sensors for electrochemical measurements installed in a dock in the south of Spain. B) Surface sensors installed inside a bridge. C) Passive sensors installed in Zarzuela Racecourse.

The type of embedded sensors used can be observed in Fig. 1. Depending on the structure in which they are going to be installed (new structures or existing structures), different group of sensors able to be attached to the concrete surface or embedded inside the concrete cover have been designed [Martínez and Andrade 2009].

Each group of sensors installed is composed by different electrochemical sensors or electrodes depending on the parameter to be measured. In one hand some sensors, as are the ones needed to evaluate corrosion rate or concrete resistivity, need an electrical impulse to be activated (active sensors). These sensors need to be connected to an electrochemical device (galvanostat-potentiostat) able to apply the signal and to record the sensor response. A stainless steel disk electrode is commonly used as counter electrode for the injection of the electrical signal in the corrosion rate and resistivity measurements. For the measurement of the corrosion rate, potential attenuation method [Feliú et al 1996] is the most useful to be used with permanent sensors. For these measurements, the sensor shown in Fig. 1B is used.

The structures whose results are presented are: 1) a bridge in the south part of Spain (the sensors installed are shown in Fig. 1.B). 2) A loading platform in a harbor in the south of Spain (sensors of Fig. 1A). 3) A Spanish pilot container for radioactive waste storage (structure shown in Fig. 5). 4) The Zarzuela Racecourse in Madrid, structure designed by E. Torroja in 1934 (sensors of Fig. 1C).

Electrochemical sensors able to indicate the risk of corrosion of reinforcement were installed in the decks and in the ties (Fig. 1C). These sensors enable the monitoring of the water content and the corrosion potential, in order to predict the need of maintenance interventions. As an example, some of the first results obtained are presented in Fig. 10.

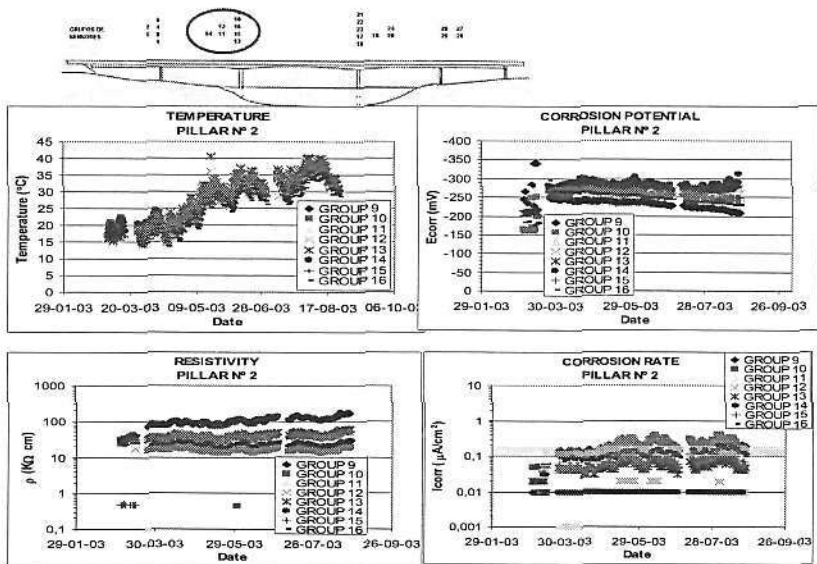
Fig. 3. Results obtained through corrosion surface sensors installed inside a bridge.

The bridge (Fig. 2.1) has a post-tensioned deck with a metallic girder. The concrete was contaminated with chlorides during mixing due to salt in the mixing water. Due to this contamination, corrosion started in the bridge from its casting. Sensors were installed in order to monitor 32 points near the four piles of the bridge. The results of some of the sensors are shown in Fig. 3, in which temperature, corrosion potential, corrosion rate and resistivity parameters are monitored. It can be noticed that due to the presence of chloride in some parts of the bridge, corrosion rate values higher than $0.2 \mu\text{A}/\text{cm}^2$ are detected.

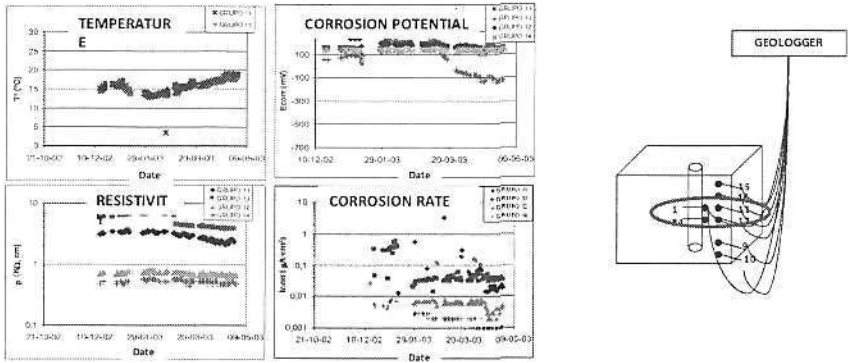
Groups 11, 12, 13 Y 14

Fig. 4. Results obtained in the harbour situated in the south part of Spain

The harbor structure (Fig. 2.2) was a hollow cube in a dock of around 30 m side. 14 groups of sensors were embedded during the construction at different dept, as Fig. 4 shows. As could be expected in an underwater structure, in which the concrete pores are almost saturated with salt water, resistivity values are lower than $10\text{K}\Omega\text{cm}$. Even when the resistivity is so low, the results show no corrosion, however, the values of E_{corr} in this structure are not easy to interpret due to the saturated condition.

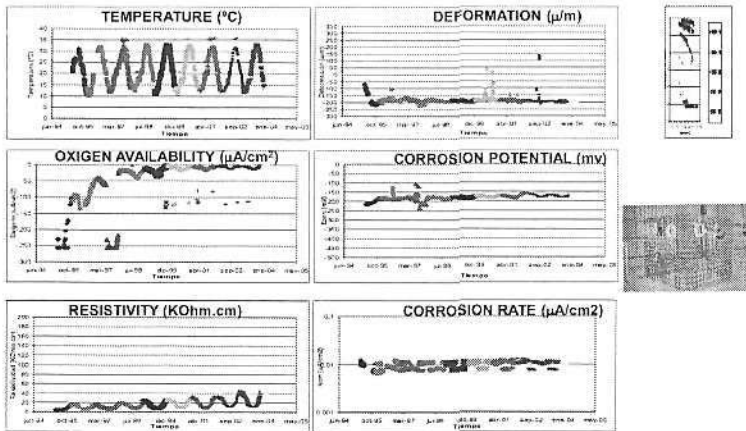
Group- 13 – Reinforcement container

Fig. 5. Parameters registered on the concrete pilot container since 1995 to 2004.

Regarding the resistivity, it is measured by means of the current interruption method from a galvanostatic pulse. The oxygen flow at the rebar level is measured by applying a cathodic constant potential of about -750 mV (SCE) and measuring the current of reduction of oxygen. From the 27 groups of sensors installed, only less than 10% of them have failed. The rest show a good response even ten years after their installation. As an example, Fig. 5 depicts the results obtained from one group of sensors placed in one wall of the concrete container (group 13). The reinforcement remains passive as expected ($I_{corr} < 0.1 \mu\text{A}/\text{cm}^2$).

The recording during 10 years has enabled several deductions among which can be stressed that the temperature influences very much the responses of the sensors and that a progressive decrease of the amount of oxygen is detected without being this noticed by the values of the corrosion potential. The progression of hydration is well reflected by the electrical resistivity and the strains are very good detectors of the presence of water in liquid state.

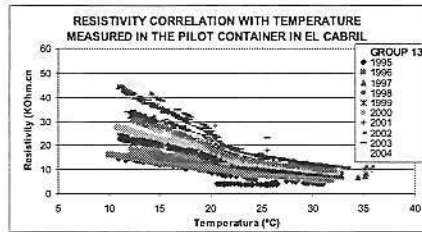
Fig. 6. Correlation between resistivity and temperature measured in buried conditions Zarzuela Racecourse

As an example among the 27 groups of sensors, Fig. 6 shows the correlation between resistivity and temperature of Group 13, and how it changes with time. It is clear that this relation is different at temperatures below around 22°C and at higher temperatures.

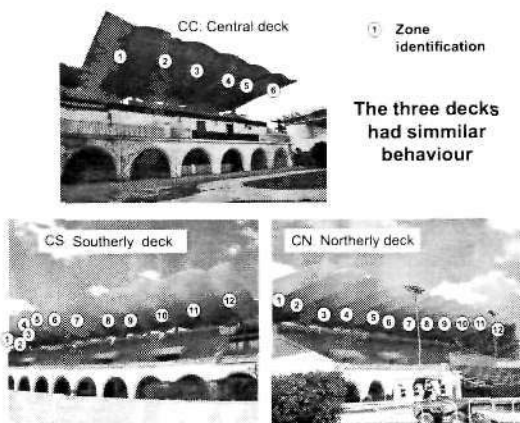
Fig. 7. Different zones evaluated in the three decks.

The corrosion rate (evaluated by the modulated confinement method by means of the corrosion rate meter Gecor 08 [Feliú et al 1990] [Andrade and Martínez 2005]) was quantified in different areas of the three decks (Fig. 7). The results indicate that almost all the structure is corroding due to the concrete carbonation. The majority of the values registered are in the range of moderate corrosion rates (between 0.5 and 1 $\mu\text{A}/\text{cm}^2$), as is shown in the example of Fig. 8b.

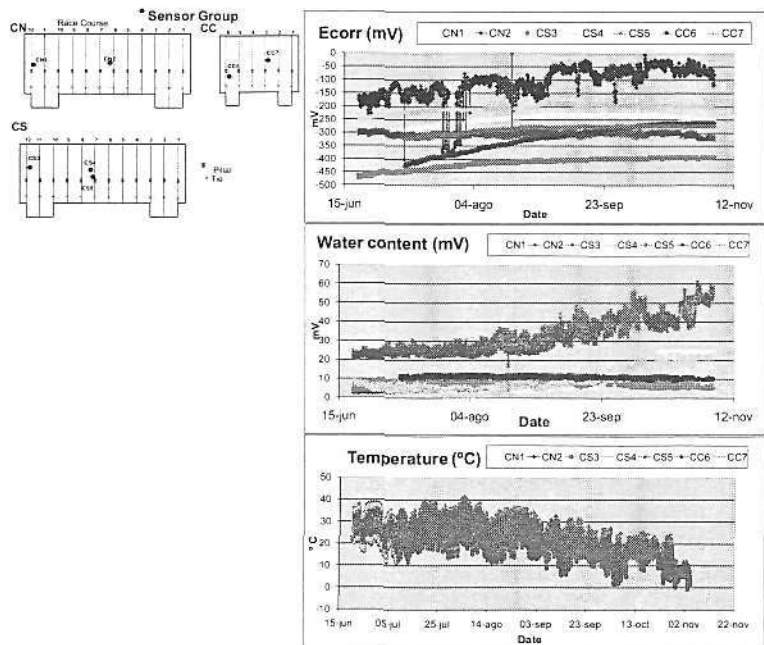
Fig. 10. Some of the results obtained from the embedded sensors

The E_{corr} tend to less negative values with time what means that the steel is being passivated. In the case of water content sensors, the response is measured in mV (difference of potential between two metals embedded in the sensor). Values around 0mV means no liquid water, so, the new waterproofing system is working properly
