TRADITIONAL BUILDING ADAPTATION TO NEW REQUIREMENTS: HISTORIC

CENTER OF AREQUIPA, PERÚ

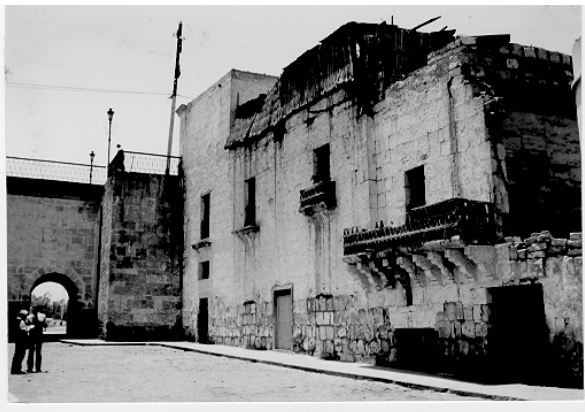
The façade disfiguration is another aspect of the abandonment. Figure 2 shows the present façade of the “tambo” (a public lodging of the colonial period) of La Cabezona, and the hypothetical original state. Some existing recycled balustrades can be noticed, which are inserted in the door opening, although the original ones, which supported the bracket of the balconies, have disappeared.

Fig. 2. Tambo de La Cabezona. See in photograph present state and in the drawing the possible original state.

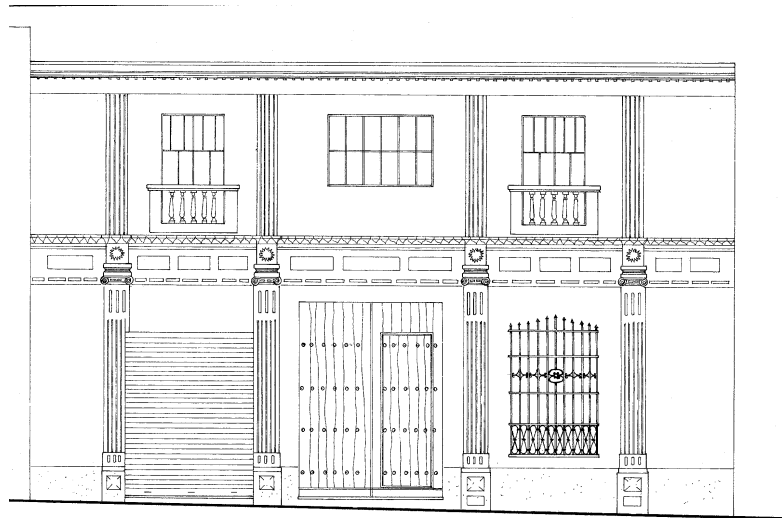
dwelling is shown in figure 3, with the addition of the first floor and the conversion of one of the original ground floor window into a door (Fig. 3 House in Jerusalén Street #204).

Fig. 3. Façade with two different age floors and left window converted into door.

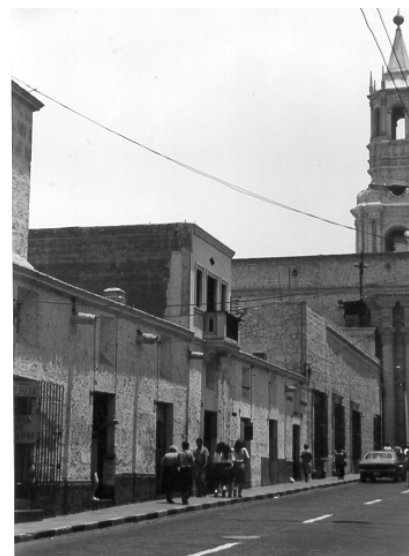
Other didactic examples show the slow growth of the city. Through the years, since the local premises built in 1796 changed ownership, one of the owners built this first floor destroying the original cornice of the bay. (Fig. 4 Buildings on San Agustín Street 101-113).

Fig. 4 Commercial premises of St. Agustín Street. In drawing previous stage, and in photograph first floor over one of them.

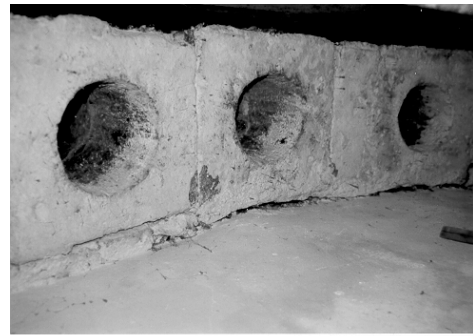
One of the changes was produced with the introduction of the bathrooms, once drinkable water reached the homes in late 19th century. For installing them, the empty areas were used, the wall niches were enlarged or the built-in arches, where old cooker or larders were located, were recycled. Nevertheless, new openings were done eliminating one of the sides of stretcher stonework and the concrete core, leaving only the other side also as stretcher bond. By doing this, space for the sanitary fittings was gained (Fig. 6, house en Cruz Verde Street # 423, bathtub in an old built-in arch used as a cooker conserving still the fireplace holes).

Fig. 6. See in photograph the wedgestones of the old built-in arch where the bathtub has been introduced.
