Digital image processing techniques as a tool for evaluating and mapping patinas on granite monuments

ABSTRACT: Monument conservation is related to the interaction between the original petrological parameters of the rock and external factors in the area where the building is sited, such as weather conditions, pollution, and so on. Depending on the environmental conditions and the characteristics of the materials used, different types of weathering predominate. In all, the appearance of surface crusts constitutes a first stage, whose origin can often be traced to the properties of the material itself. In the present study, different colours of “patinas” were distinguished by defining the threshold levels of greys associated with “pathology” in the histogram. These data were compared to background information and other parameters, such as mineralogical composition, porosity, and so on, as well as other visual signs of deterioration. The result is a map of the pathologies associated with “cover films” on monuments, which generate images by relating colour characteristics to desired properties or zones of interest.

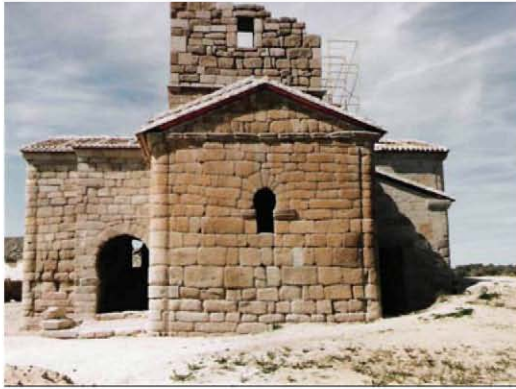
Figure 1. Ashlar morphology in granite and their colour (Southwest façade Santa María de Melque).

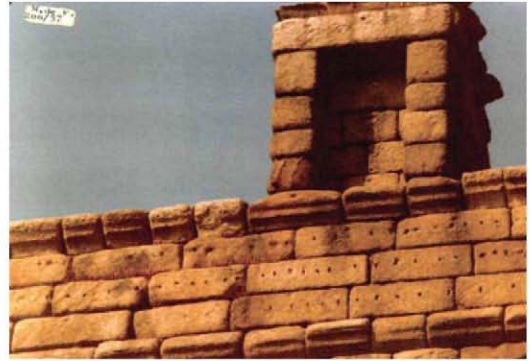
Figure 2. Natural orange colour of the granite (East façade of aqueduct at Segovia).

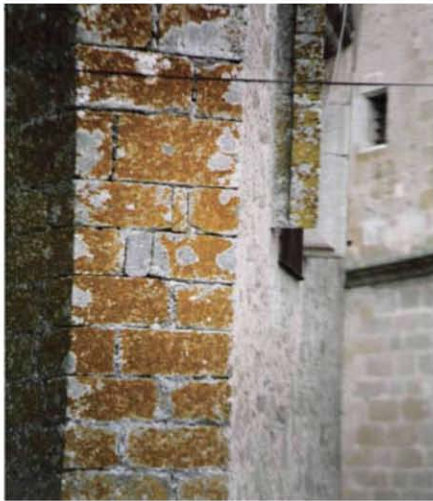
Figure 3. Patinas aspect in granite and their colour of cut-water (Northwest façade of bridge at Cáceres).

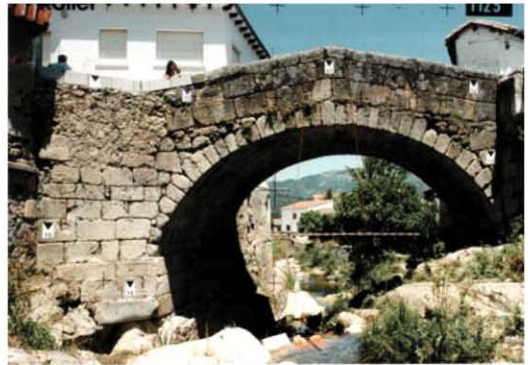
Figure 4. Granite bridge at Cáceres (East facade).

The Boolean operator AND is applied to the two images of the ashlar; the original (fig. 4) and photogrammetric (fig. 5) and as derived from digital images techniques (fig. 7). It extracts information common to both and the differences are deduced. These occur principally on the edges and sometimes are especially significant in the arch.

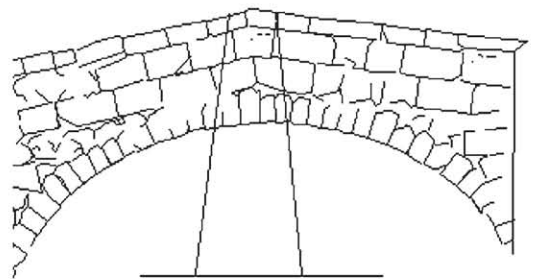
Figure 5. Contour ashlars by photogrammetry techniques.

In this case, they both have been digitized using a scanner, correcting by slight distortions produced during the process, and adapting and referencing them in order to coordinate the scales and facilitate the overlap process, as shown in figures 4 and 5. Also, the image is processed with a L(ook)U (Up) T(able) or false colour technique to obtain the texture of the ashlar stones.

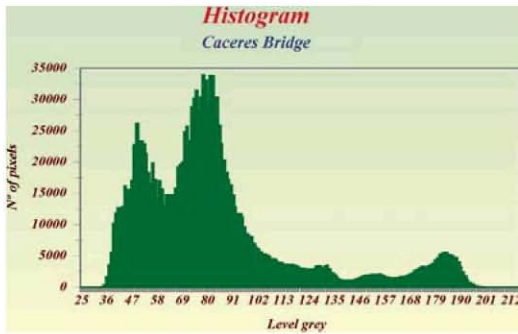
Figure 6. Histogram of the bridge image.

The restoration of the image, when the photograph of the bridge is digitized, is performed by studying the frequency histogram (fig. 6) of grey level. The structural characteristics of the ashlar forming the bridge are revealed by applying a standardization algorithm that enhances contrast linearly to the maximum and minimum possible levels of grey in the image (i.e., 0 to 255) and subsequently performing matrix high-pass filtering (fig. 7). This highlights ashlar contours.

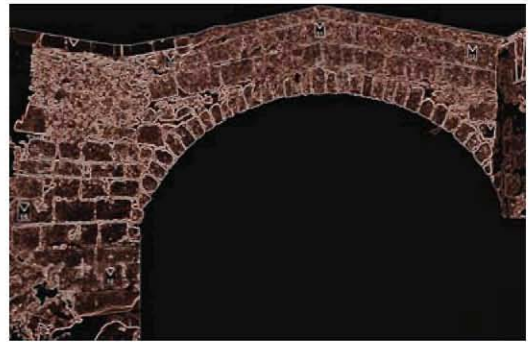
Figure 7. Granite bridge highpass filter.

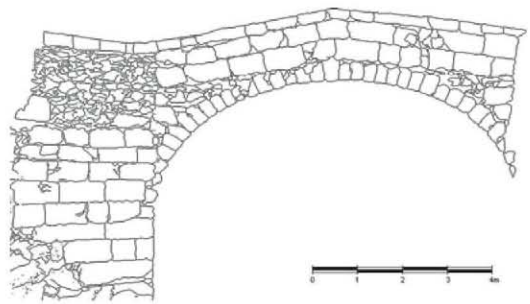
Figure 8. Contour ashlars by thresholding process. Calibrated image.

Another image derived with of photogrammetry is shown in fig. 8. Scaled and calibrated, this image is, therefore, the reference for the first process of digital analysis?

Beginning with the image resulting from the first image restoration procedure, we subdivided and classified the information obtained to ultimately arrive at the desired conclusions. In short, this process, denominated “thresholding”, generates an image by recognizing some areas, textures, forms, etc., with the desired properties or zones of interest (the procedure consists of delimiting a range of previously defined grey values, and reassigning to this range an output value of 1, and setting the rest to 0, as shown in the fig. 8).
