## ON THE CUP ANEMOMETER WORKING CONDITION MONITORING

Santiago Pindado, Alejandro Martínez, Enrique Vega, Encarnación Meseguer, Luis García, Ángel Sanz-Andrés  
 Instituto Universitario de Microgravedad "Ignacio Da Riva" (IDR/UPM)  
 Universidad Politécnica de Madrid.

### Summary

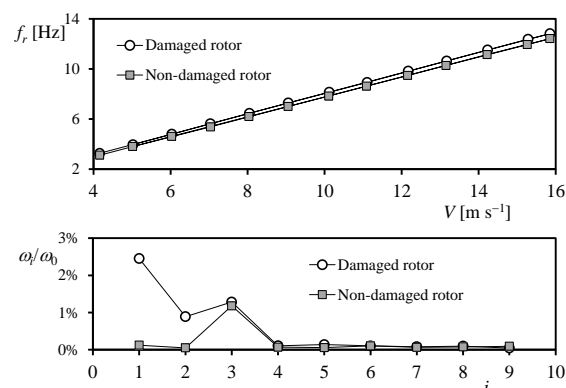
Fig. 2 (Top) Calibration curves of a Vector Instruments A100 LK cup anemometer with damaged (Fig. 1) and non-damaged rotors. (Bottom) Rotational speed Fourier decomposition terms of the anemometer with both damaged and non-damaged rotors.

Estimating a cup anemometer working condition is not an easy task, even when results from several consecutive calibrations are available [5]. One of the biggest troubles that people responsible for wind speed sensors condition face is that even in a damaged condition, the cup anemometer can produce a quite regular output signal. As an example, see in Fig. 2 the calibration curve of the cup anemometer from Fig. 1, equipped with the damaged rotor of the figure and with an undamaged rotor. It can be appreciated that the calibration curve of the anemometer with the damaged rotor is as linear as the one related to the anemometer

equipped with the undamaged rotor. And even more, the damaged case seems to be better in terms of aerodynamic efficiency, as the rotation rate is higher. Of course, this not entirely right as the damaged rotor has a lower moment of inertia when compared to the undamaged one (the damaged cup is closer to the rotation axis), consequently increasing the rotation rate.

The described Fourier decomposition of the rotational speed allows anomaly detection on the sensor, as any asymmetric effect on the rotor-shaft system (dirt, damage, wear and tear...) is reflected mainly on the first term of the rotational speed Fourier series decomposition, see Figs. 2 and 4.

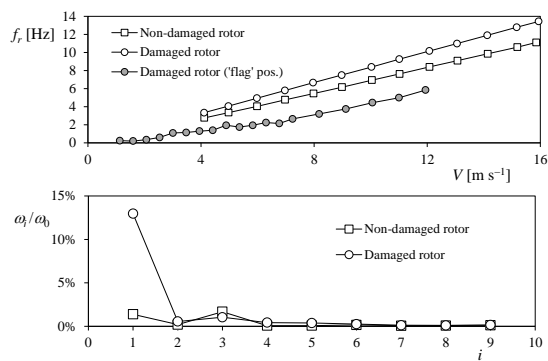
Fig. 4. (Top) Calibration curves of a Climatronics 100075 cup anemometer with non-damaged and damaged (one cup missing, see Fig. 3) rotors. The rotational frequency regarding the damaged rotor has been included, as a function of the wind speed, in both the normal rotating situation, and the “flag” position situation. (Bottom) Rotational speed Fourier decomposition terms of the anemometer in the described cases.

As said before and stated in Fig. 4, this one-cup-missing rotor can rotate quite linearly. Besides, in case of being in “flag” position, a signal output can be produced due to the rotor oscillations, that is, a pulse train that can be misinterpreted as a correct wind speed by the sensor data logger (see in Fig. 4 the false rotation frequency given by a one-cup-missing rotor at “flag” position as a function of the wind speed). This false pulse train can be produced in most of Class-1 cup anemometers, as they are equipped with opto-electronic systems that give a quite number of square pulses per turn [8]. In the present work, a new methodology to monitor cup anemometer status when working on the field is described. This methodology is under development by the IDR/UPM Institute in collaboration with Kintech Engineering. This method could help to optimize the maintenance of these sensors, if it is implemented on the corresponding data loggers.

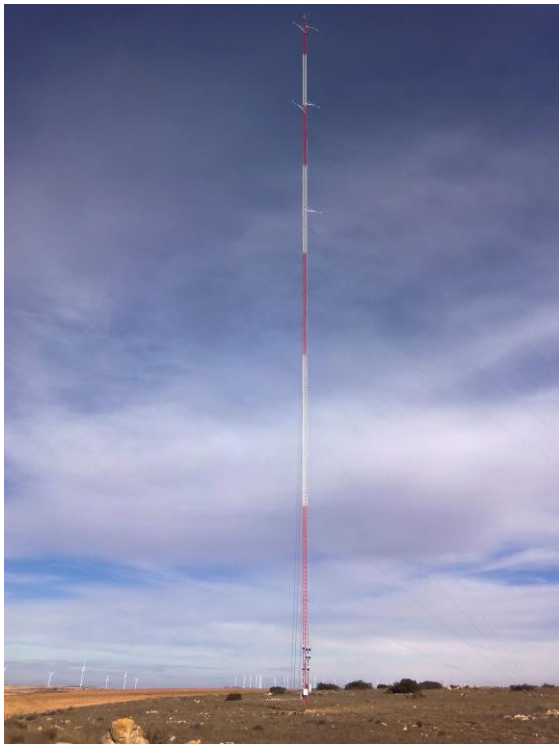
Fig. 6. Kintech Engineering meteorological tower located at Zaragoza (Spain).

Two Thies First Class Advanced cup anemometers are installed in the meteorological tower of Kintech Engineering in Zaragoza (Spain), see Fig. 6. The first one was installed in December 2014 at 58 m height, and the second one was installed in April 2015 at 73 m height.

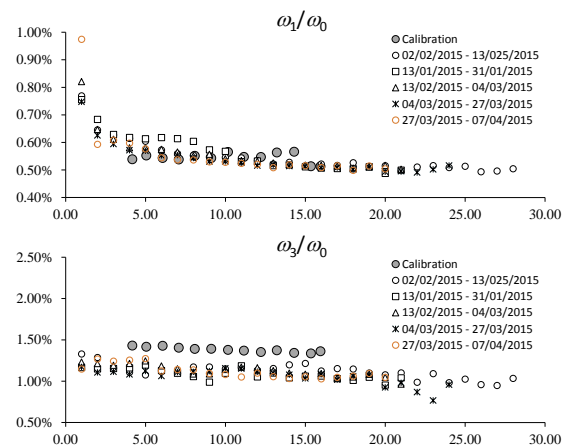
Fig. 8. First and third harmonic terms corresponding to the 58 m height anemometer installed at the Kintech Engineering meteorological tower. In the graphs the values corresponding to 5 different periods are included.

In Fig. 8 the first and the third harmonic terms corresponding to measurements of the 58 m height anemometer taken at several periods are plotted as a function of the wind speed, together with the values from the initial calibration.

first and third harmonic terms with changes on the anemometers' performance. For this reason several recalibrations at the IDR/UPM Institute are foreseen in the next year. Besides, the effect of the atmospheric turbulence and the temperature on the harmonic terms will be taken into account. Initial results indicate a reduced effect of the temperature but quite great effect of the turbulence, especially on the third harmonic term.
