INTEGRATED STUDIES FOR THE EVALUATION OF CONSERVATION TREATMENTS ON BUILDING MATERIALS FROM ARCHAEOLOGICAL SITES. APPLICATION TO THE CASE OF MERIDA (SPAIN)

Keywords: NDT; Conservation; Treatments; Archaeological sites; Evaluation

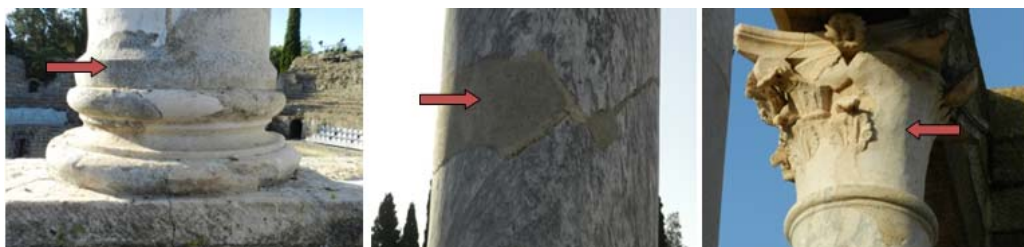
Fig. 3. Restoration mortars used in different periods for the structural consolidation of the Front stage in the Roman Theater of Merida (Photos by Natalia Perez)

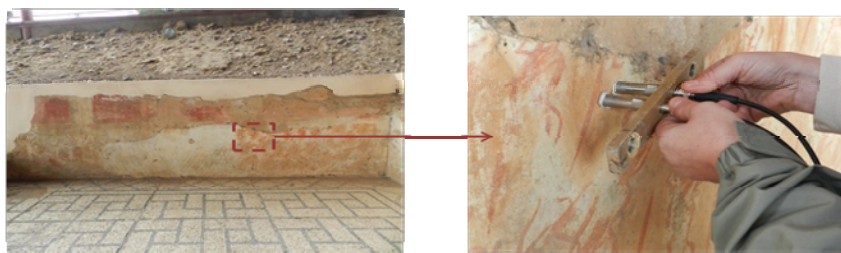
Treated area: 2182 m/s

Untreated area: 1611m/s

Fig. 4. UPV measurements on SDH13MA wall from Mitreo’s House (Photo by Natalia Perez)

- UPV is especially useful when evaluating the efficacy of consolidative treatments [5, 6]. Measurements, in indirect mode, have been carried out on some wall paintings from Mitreo’s House using transducers with a flat contact surface diameter of 12 mm and 1 MHz of energy. In the example showed in figure 4, comparative analysis results in a remarkable difference between treated (with Paraloid B72©) and untreated areas of the same panel. Values will allow us to assess the effectiveness of consolidative treatments applied in terms of higher strength of this area; nevertheless it should be correlated with other parameters, such as, for instance, chromatic measurements, in order to confirm a positive judgment.

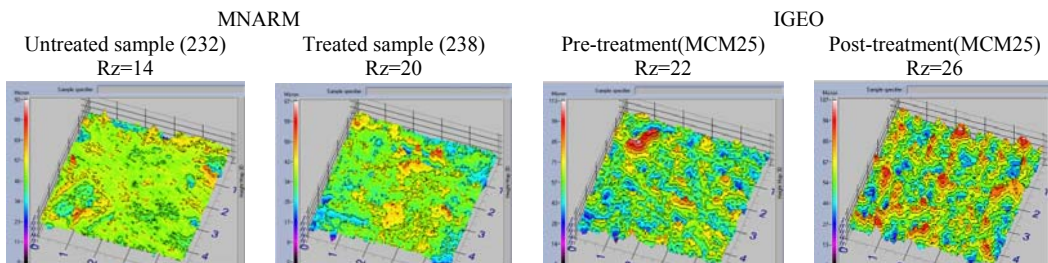
Fig. 5. Rz values and topographic maps from different fragments of wall-paintings from Mitreo’s House comparing treated and untreated areas in the MNARM’s case, and pre- and post-treatment measurements in the IGEO’s case, in both cases with PB72[®].

The roughness-meter is a very useful tool to assess changes on these roughness parameters due to the application of conservation treatments [9, 10]. Nevertheless measurements carried out comparing treated and untreated areas of marbles from the Roman Theater cannot be confronted because of the differential state of conservation in treated areas, mainly affected by sugaring (and consolidated for this reason), and untreated ones, with a well-preserved smooth surface. Results are not representative of the effects derived from application of treatments in this case. By contrast we can compare the results of measurements taken on several mural painting fragments from Mitreo's House. In the first case different fragments of mural painting preserved in the National Museum of Roman Art of Merida (MNARM) were measured attending punctual consolidation with PB72[®] (recently applied) and comparing color by color treated and untreated areas. In the second case three samples of mural painting from this same site were moved to IGEO's laboratory and measured pre- and post-treatment. The results show a slight increase in roughness for the case of fragments treated with PB72[®] (Fig. 5), and a significant increase in the case of those treated with ethyl silicate (Fig. 6).

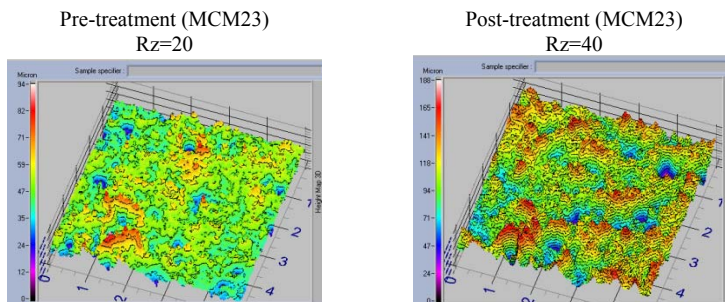
Fig. 6. Rz values and topographic maps from different fragments of wall-paintings from Mitreo’s House comparing pre- and post-treatment with Estel 1000[®] on IGEO case
