NDT to identify biological damage in wood

Key words: Nondestructive testing, probing, biological damage, identification.

19th International Nondestructive Testing and Evaluation of Wood Symposium

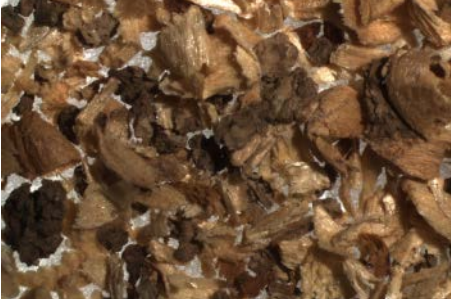
Termites (Reticulitermes spp)	Normal with gaps	30% High	Mud	Muddy powdery

Table 4—Results obtained using the Wood Extractor on conifer wood pieces damaged by the most common timber pathogens.

As with the resistograph, one of the advantages of this equipment is that it allows the identification of disease causing damage. To do this, quantification study of powder content (minute chips) and visual analysis of the presence of detritus (pellets), hyphae or characteristic remains of each pathogen in the extracted sample must be done (Bobadilla et al. 2008, 2013). Identification is therefore based on the detritus left by the degrading agent.

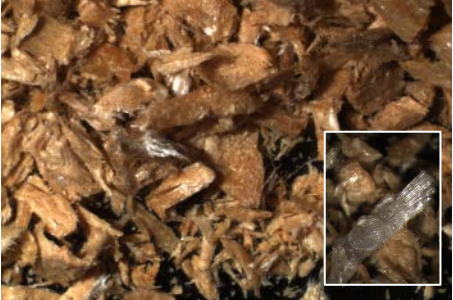
White rot	Low	30% High	Fiber shaped bits	Powdery fibrous
