ZYLSTRA, KATHERINE L., M.S. Visualizing Architectural Character: The Effects of Rehabilitation on the Voices of 20th Century American Theaters. (2009)
Directed by Professor Jo Ramsay Leimenstoll. 160 pp.

VISUALIZING ARCHITECTURAL CHARACTER:
THE EFFECTS OF REHABILITATION ON
THE VOICES OF 20TH CENTURY
AMERICAN THEATERS

A Thesis Submitted to
the Faculty of the Graduate School at
The University of North Carolina at Greensboro
in Partial Fulfillment
of the Requirements for the Degree
Master of Science

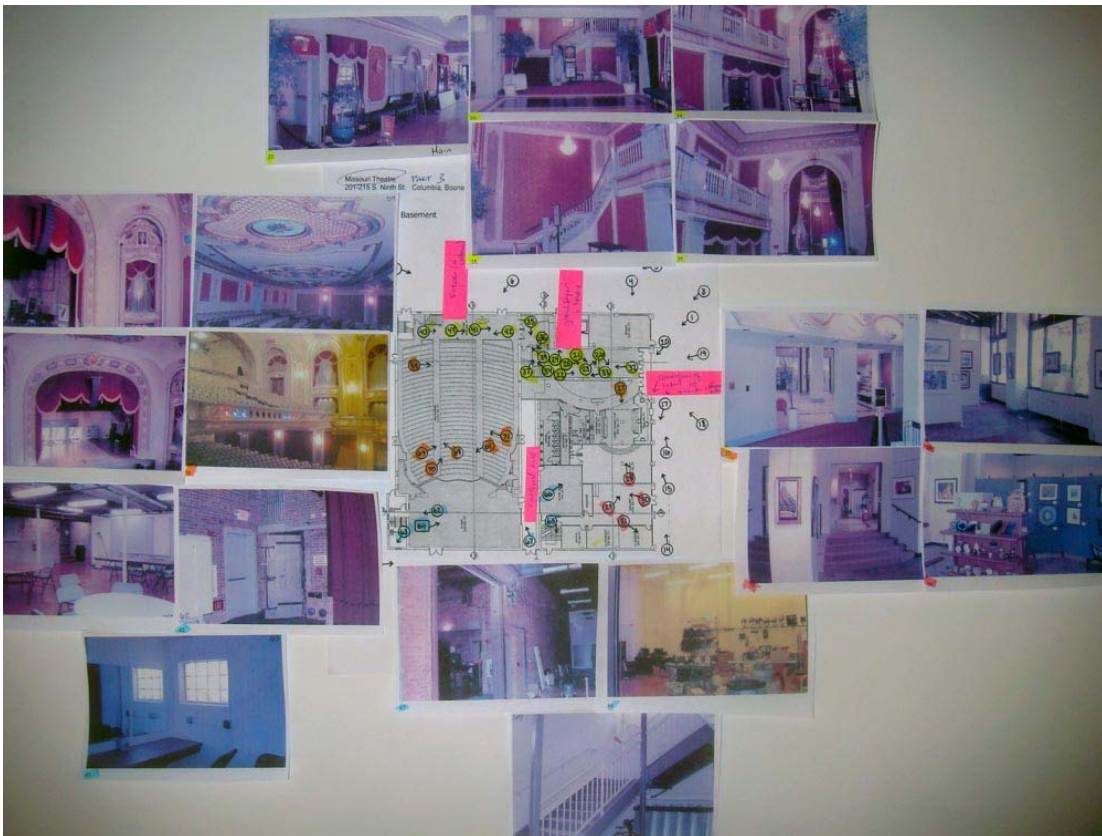
Figure 6. Example of Photographs Keyed to Plan

plans for each project were also printed, and each photograph was keyed to its matching plan, for both pre- and post-rehabilitation (see Figure 6). The pre-rehabilitation images were then matched to the post-rehabilitation images with a similar view. Many of the pre-rehabilitation photographs did not coordinate precisely with the post-rehabilitation images, which presented a limitation to the study.

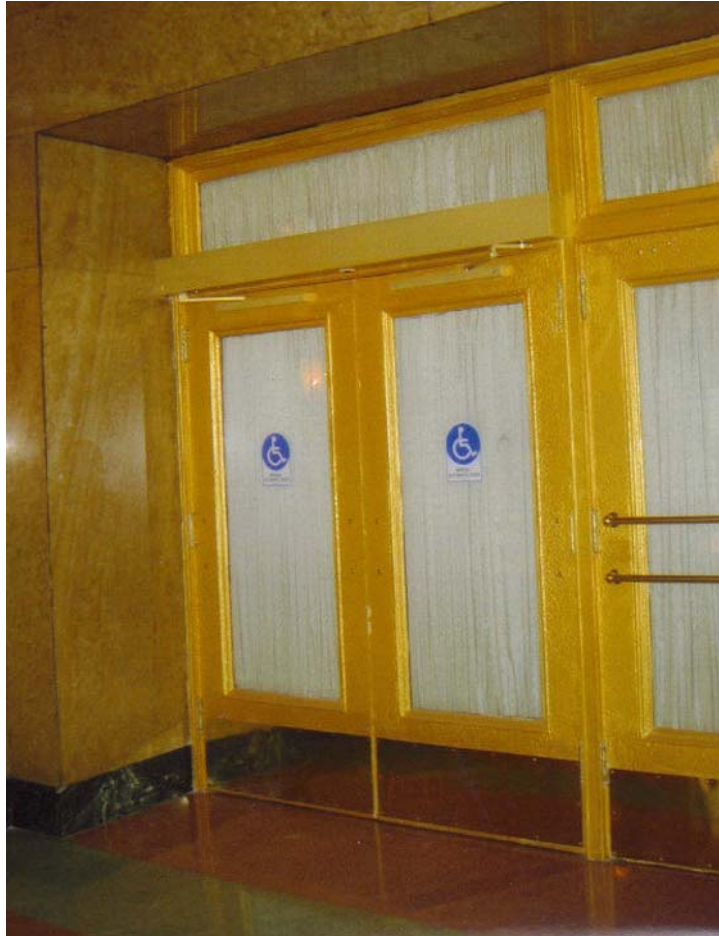
Figure 8. The Tennessee Theatre installed automatic doors to comply with ADA standards

While ADA requirements often pose many challenges for historic interiors, the theaters within the sample were generally able to abide by these guidelines through sensitive alterations and only minimally affect the interior historic voices. The Tennessee Theatre and Proctor's Theatre were the only two within the data sample that inserted elevators into the historic interior. This was the most visible change due to ADA within the data sample. The Stanley Theatre incorporated an elevator in the new addition and the Fox Tucson Theatre and Missouri Theatre did not install elevators.

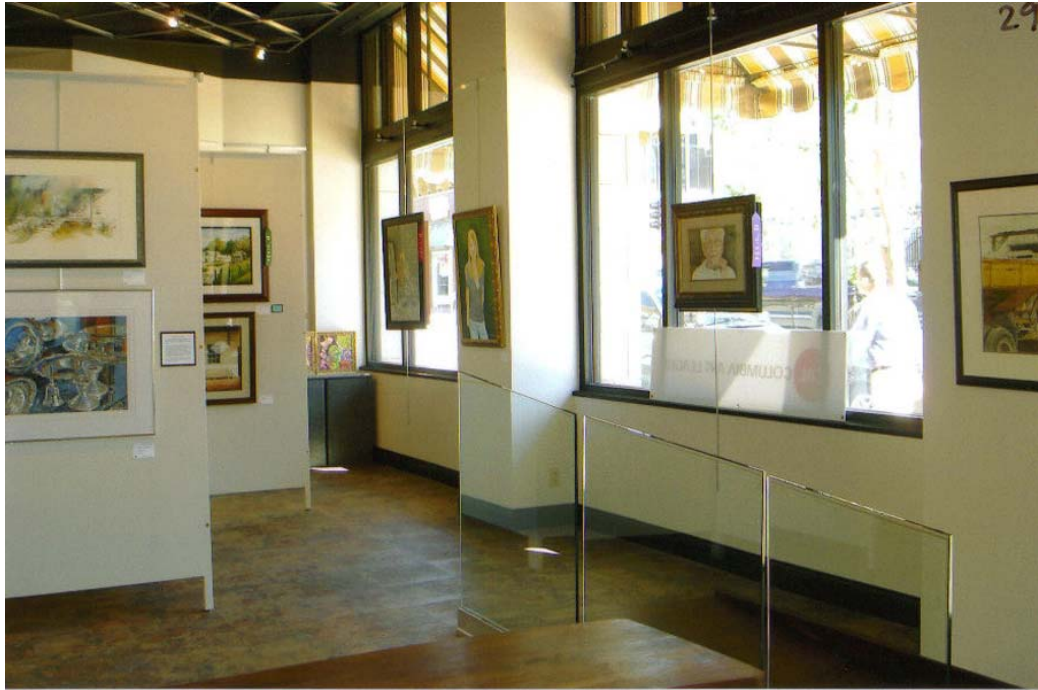
Figure 9. The Missouri Theatre acquired this neighboring space and redesigned its interior as an art gallery

Although the square footage of every theater in the sample increased, not every project included a new addition. Three of the projects, namely the Missouri, Proctor's, and Fox Tucson, appropriated neighboring spaces that formerly served a different function. In either case; however, a transitional area was needed to coalesce the two spaces and their individual voices, blending both historic and new. In some areas, such as the Proctor's Theatre's arcade, an entire wall partition was removed in order to enlarge a space. In other situations, like the lobby area of the Stanley Theatre, small openings or hallways were introduced to connect the two areas.

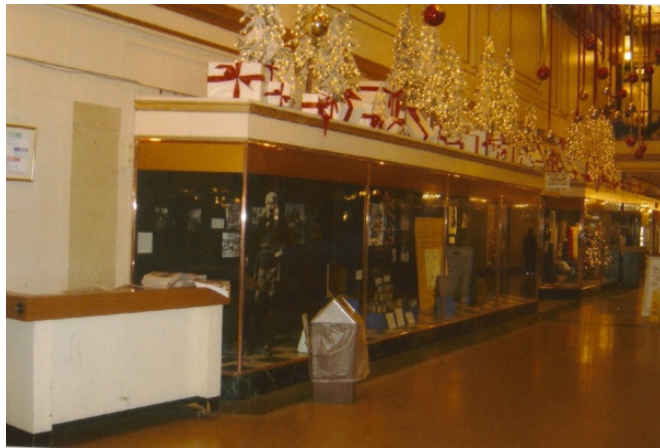
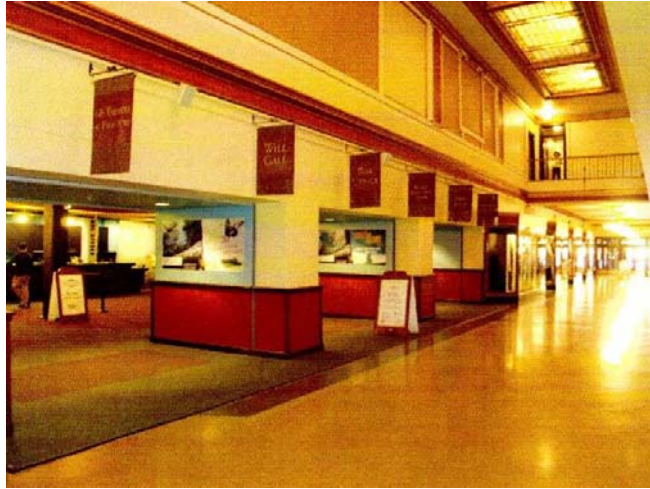
Figure 10. Proctor's Theatre, arcade west wall prior to rehabilitation

Figure 11. Proctor's Theatre, arcade west wall was removed to gain access to the adjoining space (now part of theater interior); affected form, proportion, rhythm, and scale

interior quality of space within the historic Proctor's arcade space. The west wall of the arcade was removed allowing access to the new spaces in the adjacent building. The removal of this wall eliminated the forms created by the display cases along the west wall. In addition, it introduced rhythm in the vertical wall sections as well as in the arrangement of hanging signs. In this manner, the design team fused a new modern interpretation of the space's voices with the lingering original voices (see Figures 10 and 11).

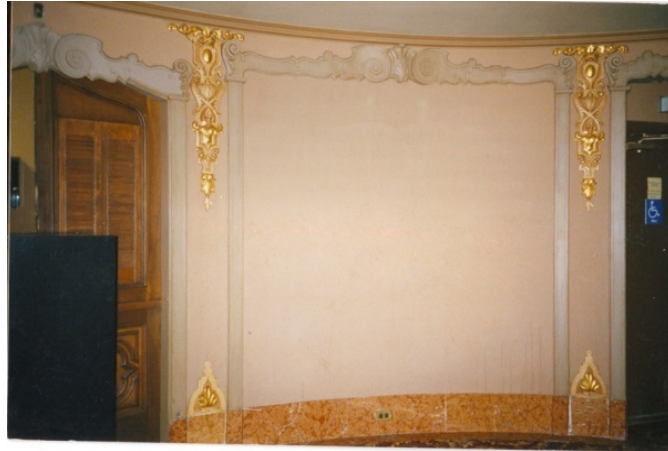
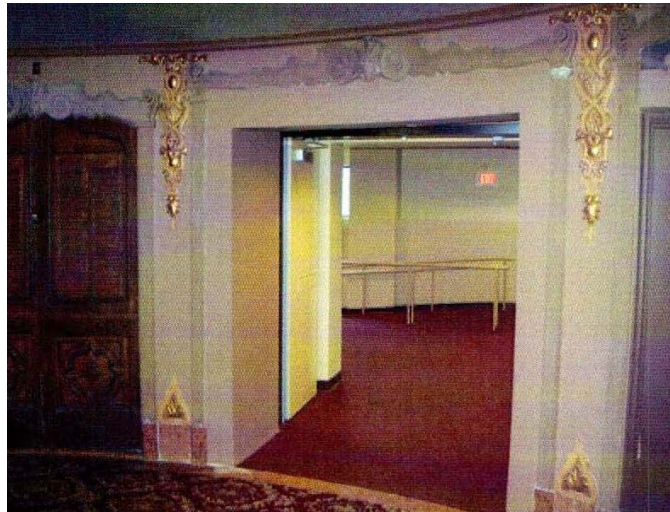
Figure 12. Stanley Theatre, orchestra level, lobby area prior to rehabilitation

Figure 13. Stanley Theatre, orchestra level, lobby area wall removed to gain access to new addition off south exterior elevation; affected form, proportion, rhythm, and scale

Similarly, the Stanley Theatre rehabilitation created an addition which necessitated an access point. One of these points was chosen at the south end of the orchestra level's grand lobby along the curved plaster wall. An opening was cut into this wall, and while the opening did not destroy the historic ornamental pilasters or cornice molding, it did affect the form and rhythm of the space, again blending old voices with new (see Figures 12 and 13).

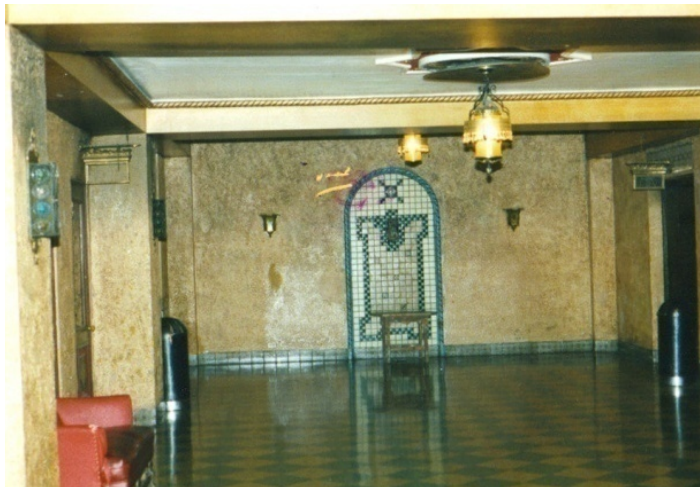
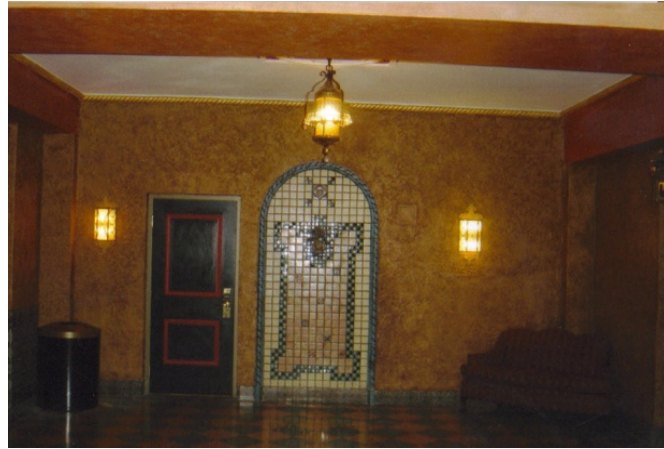
Figure 14. Tennessee Theatre, basement lobby area prior to rehabilitation

Figure 15. Tennessee Theatre, a door was added on the east wall of the basement lobby to access the corridor; affected rhythm

The Tennessee Theater also experienced this type of alteration through the addition of a door located in the basement lobby on the east wall. This passageway was created to access the corridor that services the meeting rooms and dressing rooms created

from the Clinch Avenue storefronts. This change was not proposed in Part II of the tax credit application. The addition of this door greatly affected the rhythm of the wall, causing the previously balanced elevation to be weighted heavily to one side. In addition, the dark colors of the door draw attention to the form, competing for attention with the mosaic tile design centered on the wall. While the previous voices spoke of balance, the new voices tell a story of asymmetry (see Figures 14 and 15).

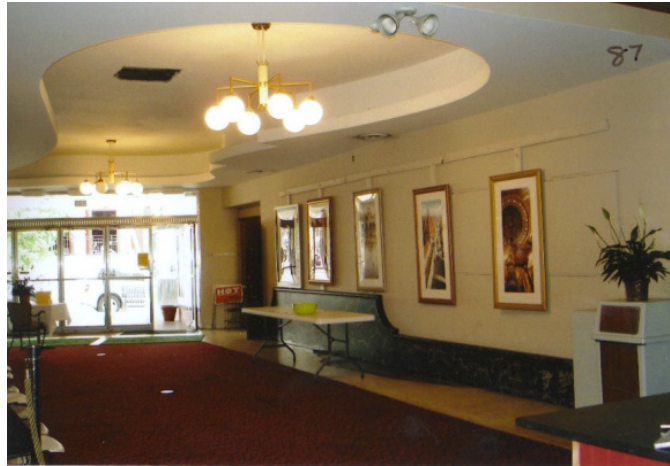
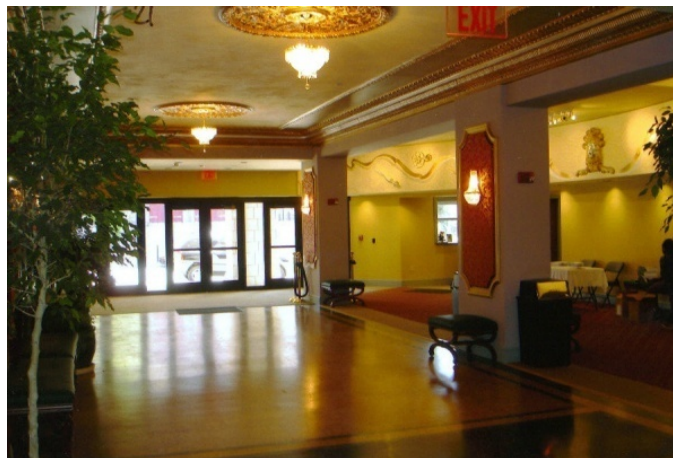
Figure 16. Missouri Theatre, foyer area prior to rehabilitation

Figure 17. Missouri Theatre, foyer area south wall was removed to gain access to adjoining space (now part of theater interior); affected form, rhythm, proportion, and scale

In a similar method as the Proctor's Theatre's arcade area, the Missouri Theatre's rehabilitation team also removed a wall in order to create an access point to the adjoining building that became part of the theater. Most of this south wall was eliminated to create a larger gathering space, thereby erasing the voice of an intimate assembly area. This alteration removed the form of the wall and also introduced new repetition through the soffit and the retention of wide piers that were left in place along the line of the wall, echoing some sense of the vertical plane the wall had provided (see Figures 16 and 17).

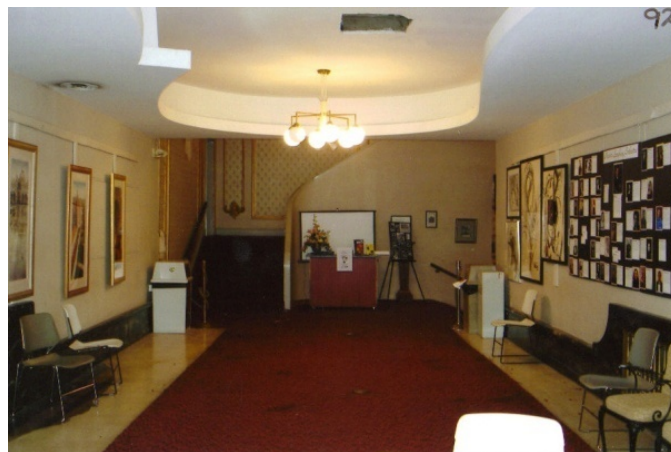
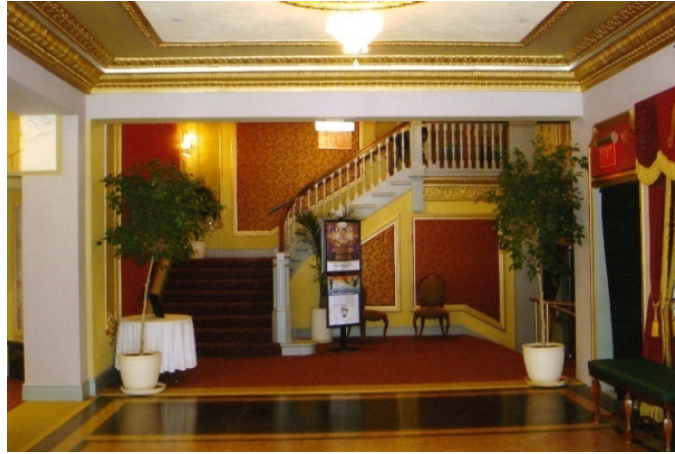
Figure 18. Missouri Theatre, lobby area prior to rehabilitation

Figure 19. Missouri Theatre, ceiling form in lobby was significantly altered; affected form and rhythm

changed the form of the ceiling in the lobby, taking it back to its original historic cornice and ceiling design, and in doing so recreated the authentic voice of the space while blending it with the new modern voices (see Figures 18 and 19). This leads to a question regarding Secretary's Standard number 4: "Changes to a property that have acquired historic significance in their own right shall be retained and preserved." The ceiling prior to rehabilitation dated back to the 1960s. Some might argue this ceiling had gained significance and a reputable voice in and of itself. However, the National Park Service allowed this change that sought to reflect the quality of the original historic space, which was consistent with other decisions to alter the interior.

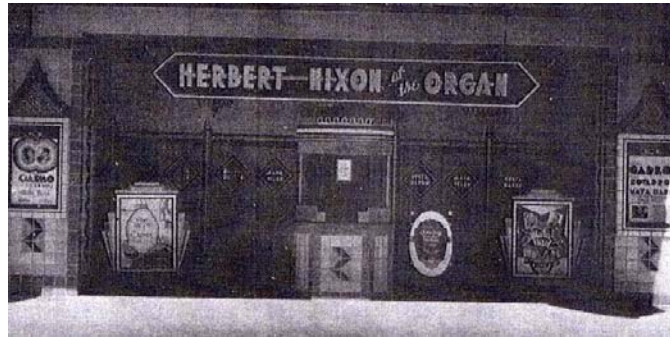
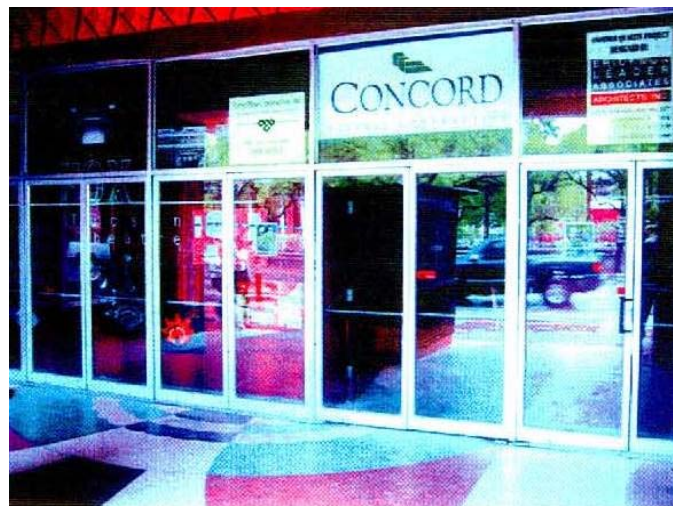
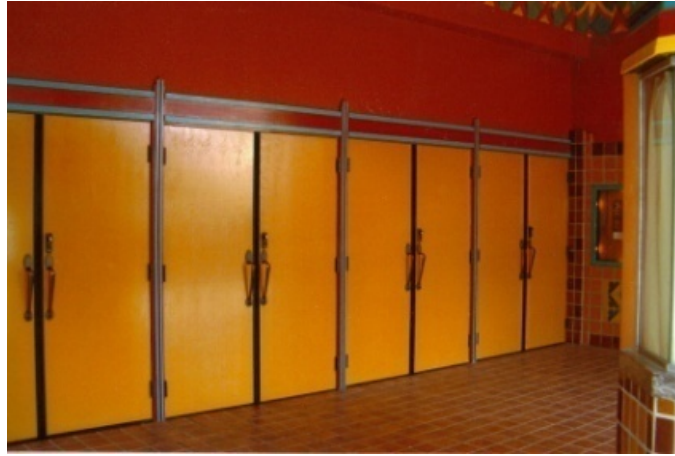
Figure 20. Fox Tucson Theatre, main entrance, historic photograph

Figure 21. Fox Tucson Theatre, main entrance prior to rehabilitation

Figure 22. Fox Tucson Theatre, main entrance glass doors were replaced with solid doors prohibiting natural light from entering the lobby space

The Fox Tucson Theatre's rehabilitation team vastly altered the quality of light in the entry lobby space by removing the glass doors and replacing them with solid core doors (see Figures 20, 21, and 22). This decision resulted in the lack of any daylight in the lobby space, thereby removing the natural voice and replacing it with something artificial. Prior to rehabilitation much natural light came in through the glass doors,

creating patterns of light and shadow in the interior entry space. This decision was based on original drawings and photographs of the space.

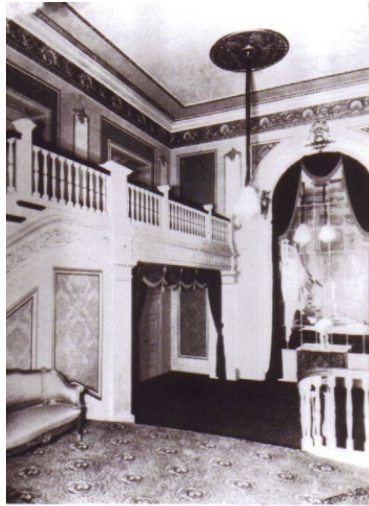
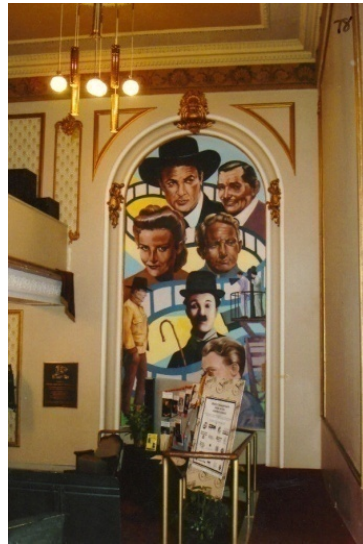
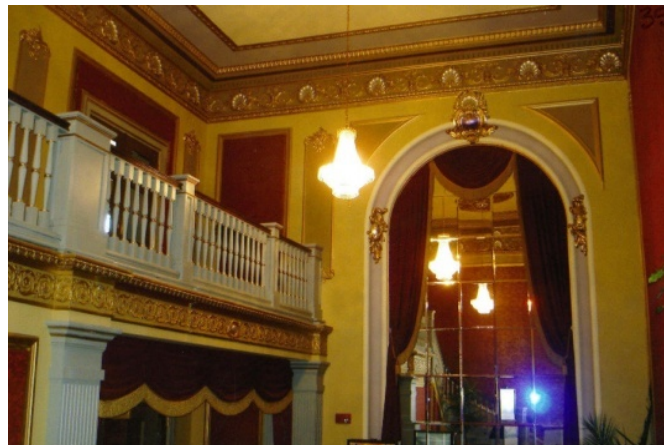
Figure 23. Missouri Theatre, grand foyer, historic photograph

Figure 24. Missouri Theatre, grand foyer prior to rehabilitation

Figure 25. Missouri Theatre, mural was replaced with a large mirror in the grand foyer

The Missouri Theatre experienced numerous changes in materiality during rehabilitation. The purpose of the rehabilitation in this space was to bring the interior back to its historic appearance, since alterations had been made during the 1960s. The rehabilitation team used the historic photographs as a guide to understand the original appearance (see Figure 23). One such material alteration took place in the grand foyer where a large mural was replaced with a mirror. In addition, the modern plaster covering was removed from the original balustrade, which was repaired and remounted on new bases to meet building codes. Pilasters were installed on either side of the passageway leading to the lobby outside the auditorium. These changes both reawakened and recreated the original voices found within the space. In the case of the balustrade, the voices were simply hiding behind more recent story layers. The addition of pilasters resulted in the recreation of original architectural voices (see Figures 24 and 25).

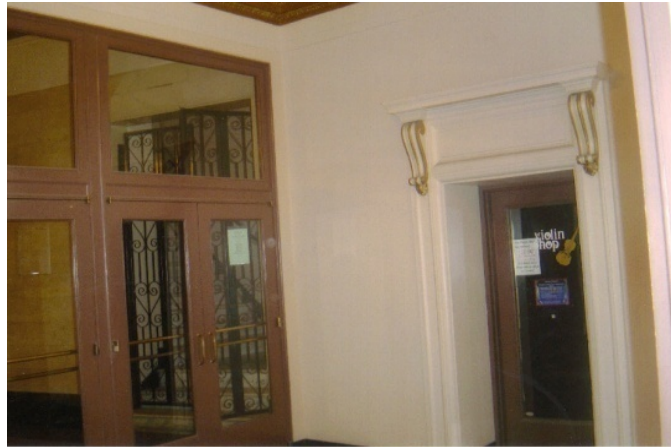
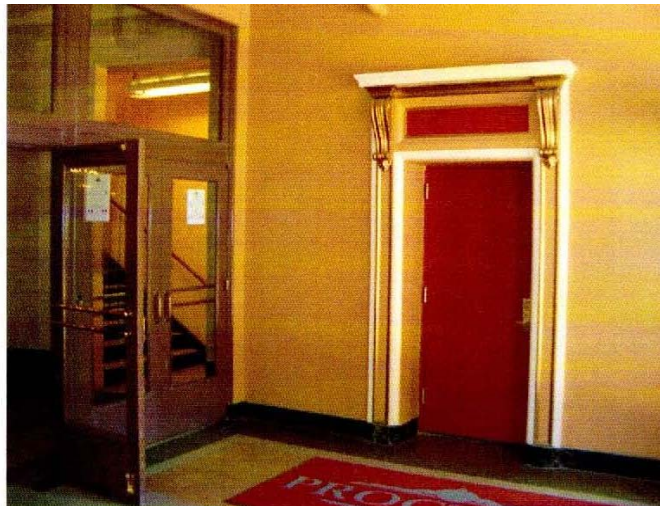
Figure 26. Proctor's Theatre, arcade entrance prior to rehabilitation

Figure 27. Proctor's Theatre, the glass inset door was replaced with a solid core door; also the wall and door color vastly changed

The Proctor's Theatre and Arcade also experienced changes in materiality. One alteration was the replacement of a glass inset door with a solid core door in the arcade entrance. The glass door matched well both materially and stylistically with the entrance doors on the adjacent wall. The new solid core door; however, became a focal point in

the entryway with its brightly painted red color, thus altering a drab voice and personality to a bubbly language (see Figures 26 and 27).

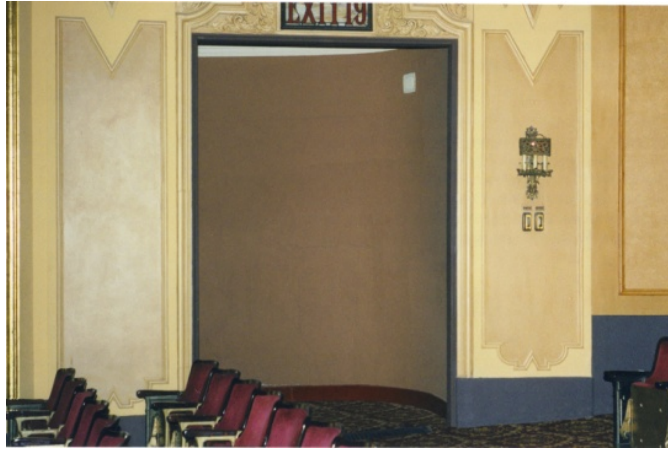
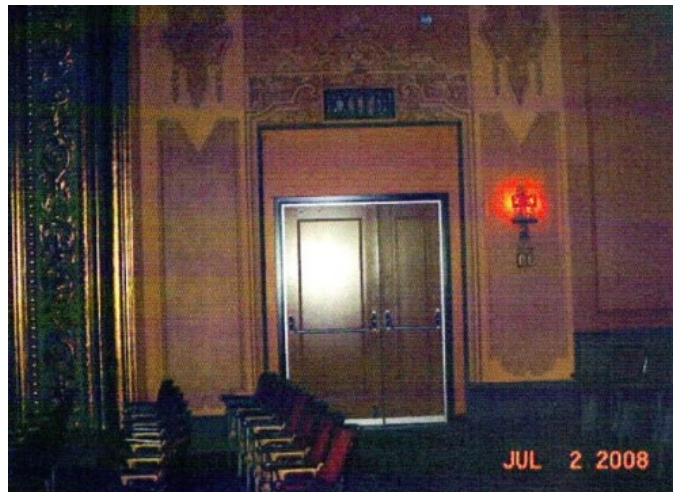
Figure 28. Stanley Theatre, auditorium side exit prior to rehabilitation

Figure 29. Stanley Theatre, auditorium side exit experienced significant color changes

The researcher noticed substantial interior changes to color, which often affects the reflectivity of an object. In three projects, including the Fox Tucson, Missouri, and Tennessee Theatres, the color palettes of rooms were completely changed, enlivening and brightening the voices of the interior spaces. Both the Missouri and Fox Tucson projects addressed color treatment by mentioning that paint analysis was performed, and in the case of the Missouri, the results were submitted to the SHPO for review and approval. The Fox Tucson had little paint remaining in many areas; however, paint preservation specialists tested surfaces in order to recreate the original color palette. Cleaning and polishing also changed the finish, enhancing the surfaces' reflectivity. These changes both enlivened and strengthened the voices found within the interior.

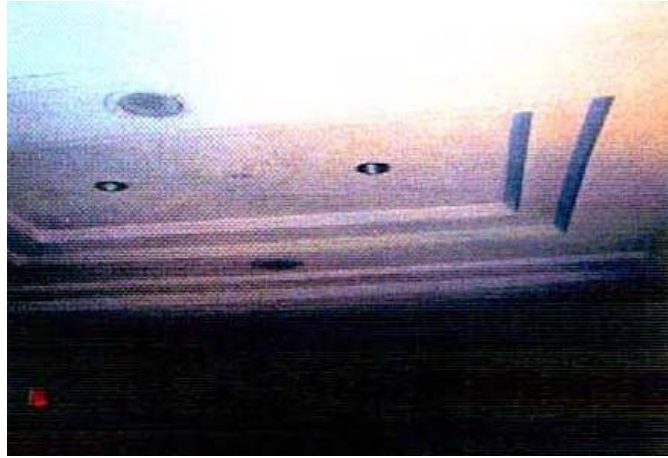
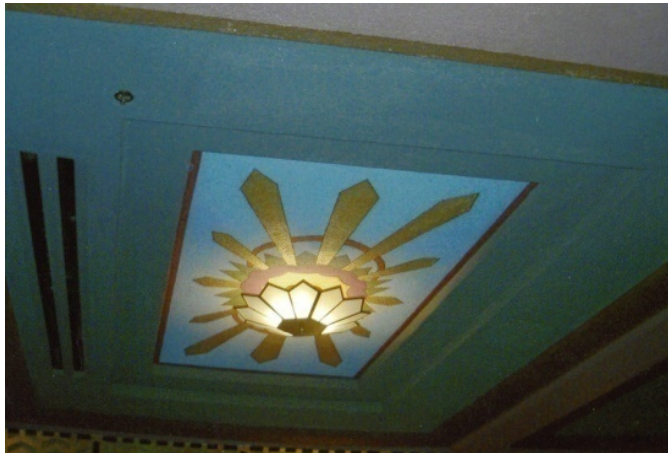
Figure 30. Fox Tucson Theatre, audience chamber ceiling prior to rehabilitation

Figure 31. Fox Tucson Theatre, ceiling was repainted in the audience chamber

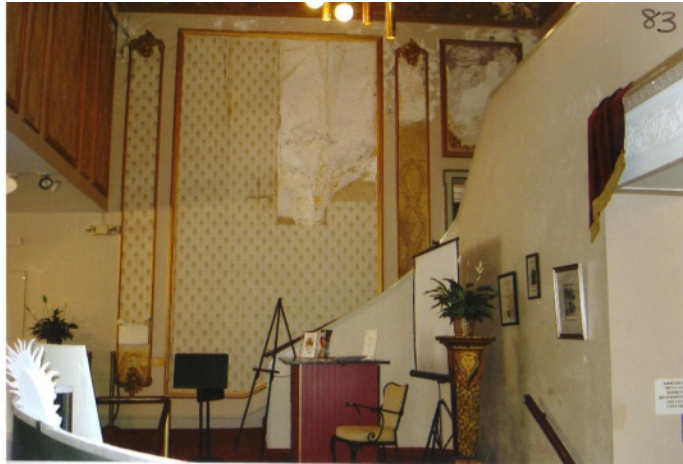
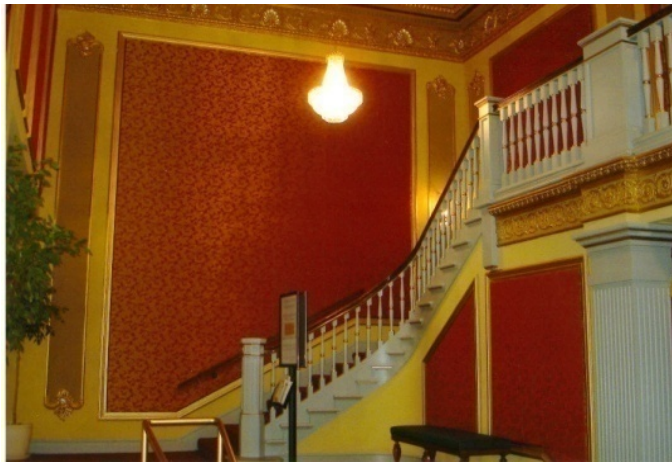
Figure 32. Missouri Theatre, grand foyer prior to rehabilitation

Figure 33. Missouri Theatre, grand foyer wall covering colors were altered

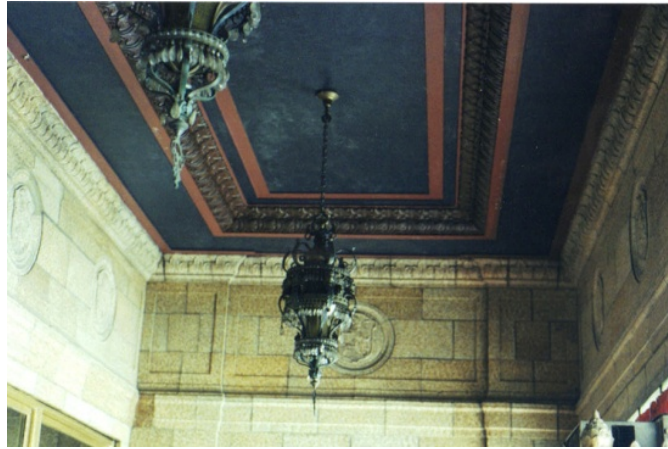
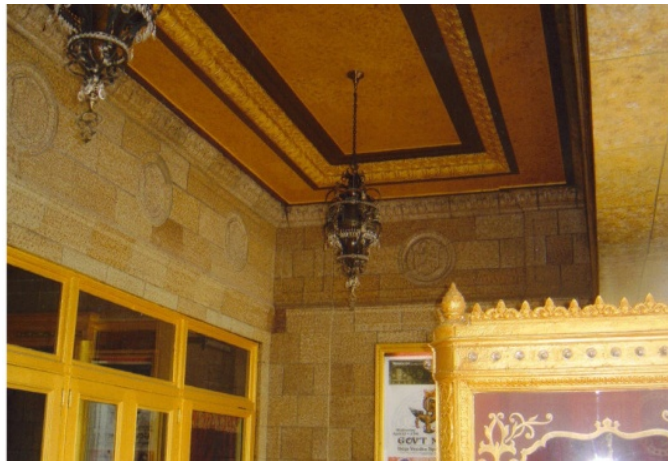
Figure 34. Tennessee Theatre, main foyer ceiling prior to rehabilitation

Figure 35. Tennessee Theatre, main foyer ceiling color was drastically changed

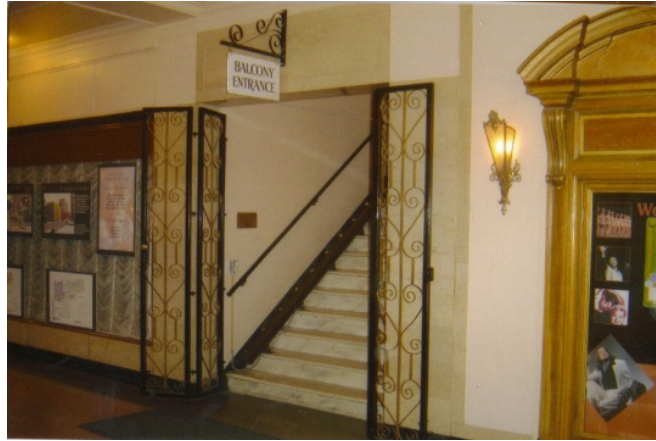
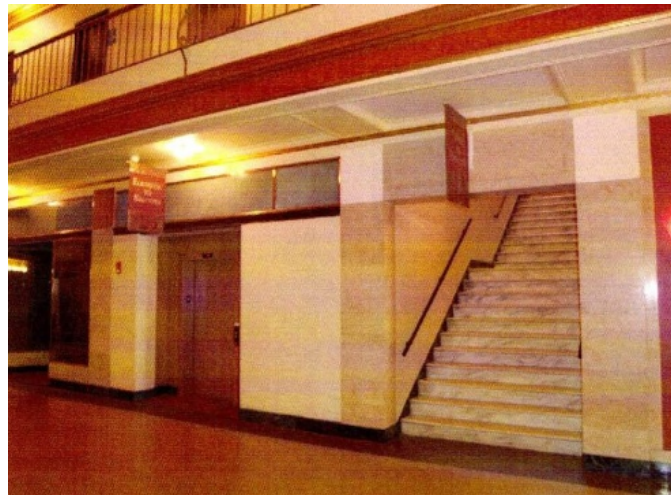
Figure 36. Proctor's Theatre, east wall of arcade prior to rehabilitation

Figure 37. Proctor's Theatre, details on the east wall of arcade were altered, including signage, stairwell gate, and sconce fixture

While two of the projects chose to alter detail by removing it, four theaters changed the lack of detail by adding it. On the east wall of the arcade, the Proctor's Theatre and Arcade team not only altered the color palette but also removed the stairwell gate and signage detail (see Figures 36 and 37). In the grand foyer of the Missouri Theatre pilasters were added on either side of the hallway (see Figures 38 and 39).

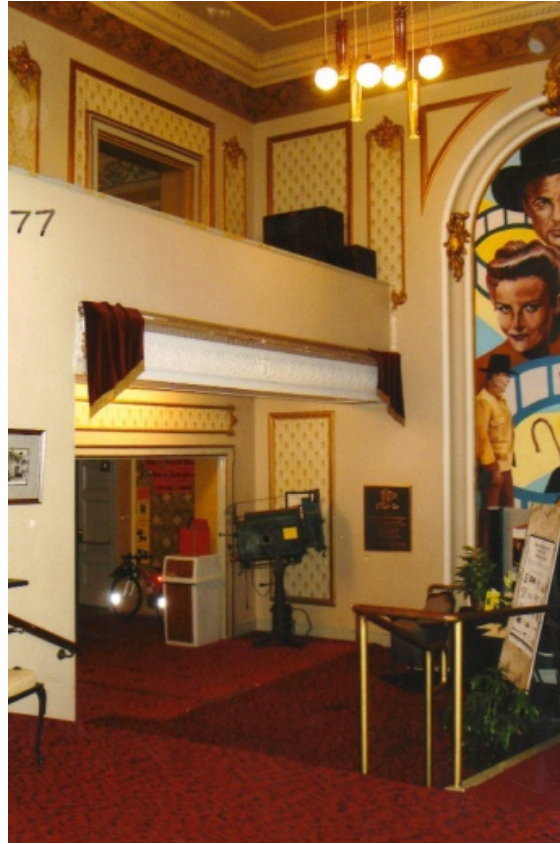
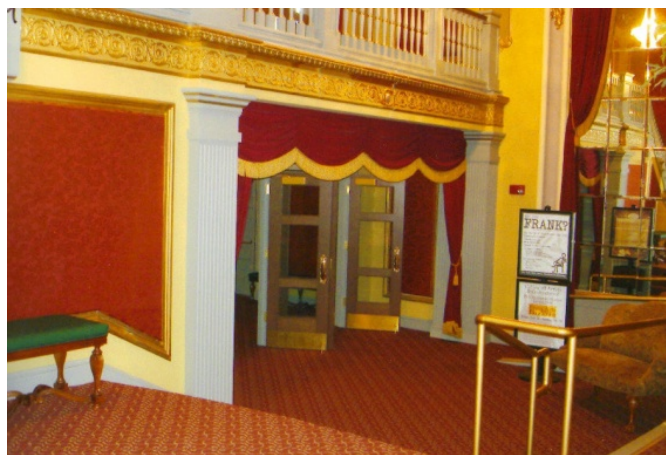
Figure 38. Missouri Theatre, grand foyer prior to rehabilitation

Figure 39 Missouri Theatre, pilasters were added on either side of the opening in the grand foyer
