# Damage Development During Pin Loading Of A Hole In A Quasi-Isotropic Carbon Fibre Reinforced Epoxy Composite \*

**ABSTRACT:** Damage development and progression was monitored by acoustic emission during pin loading of a hole in a quasi-isotropic Hexcel F593/T300 W2G 190 carbon fibre reinforced epoxy composite. Analysis of the acoustic emissions showed that failure was initiated by fibre matrix debonding, followed by fibre fracture, and subsequent matrix cracking. Sections taken through the specimens at varying intervals between the initial acoustic emission and final catastrophic failure confirmed this sequence of events. Good agreement was obtained between the load at the onset of failure and that predicted by finite element modelling.

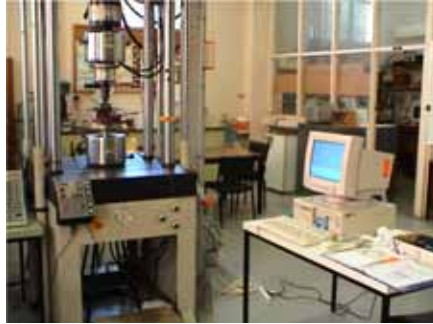
Figure 2. Pin loading setup on testing machine

A set of 6 specimens was first tested to failure to determine the ultimate failure strength and to obtain the approximate load levels at which acoustic emissions occurred. For subsequent tests, the testing was stopped immediately after the 1<sup>st</sup>, 2<sup>nd</sup> or 3<sup>rd</sup> AE signal event. These, together with the panels tested to final failure, provided a set of samples with various levels of damage. Figure 2 shows the pin loading setup on the Instron 1185 testing machine.

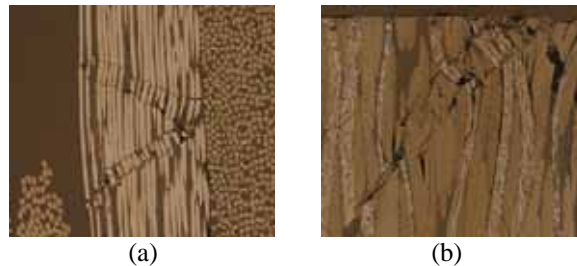
The fracture mechanisms arising from the pin loading contact were correlated with the AE events according to the load level. The corresponding failure modes can be seen in Figure 6. Figure 6(a) shows fibre breakage at a load level between 70-80% of ultimate load. Figure 6(b) shows shear bands, matrix cracking and microbuckling as the load was increased from 80-100% of the ultimate load.

Figure 6. Micrograph of sectioned specimens; (a) Carbon fibre breakage, (b) Matrix cracking.
