UNIVERSITY OF QUEENSLAND
DEPARTMENT OF CIVIL ENGINEERING
OCTOBER 1971

DESIGN OF MINIMUM ENERGY CULVERTS

THE DESIGN TECHNIQUES ASSOCIATED WITH THE
CONCEPT OF CONSTANT TOTAL ENERGY AND
COMPATIBLE SPECIFIC ENERGY WITH PARTICULAR
REFERENCE TO DRAINAGE STRUCTURES ON HIGHWAYS,
WITH A REPORT OF THE PERFORMANCE OF MANY OF
THESE STRUCTURES DURING THE QUEENSLAND WET
SEASON 1970-1971

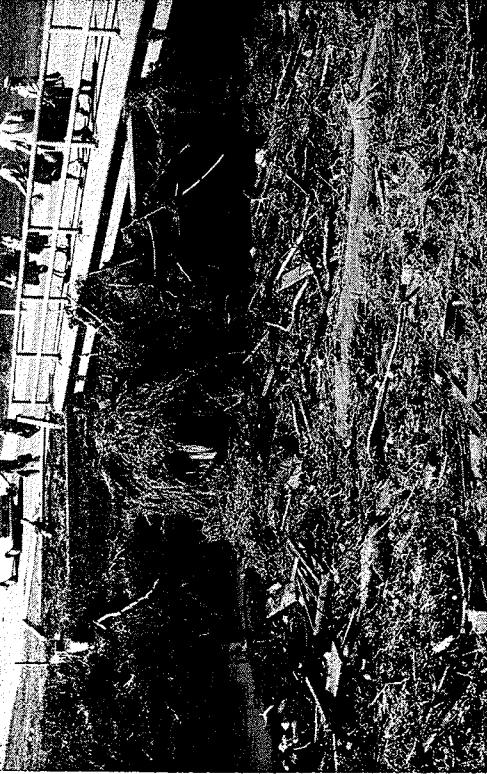
Slide 1. Debris at Melton Road Bridge during a small flood October 25th, 1970. (Taken 28th October, 1970, by C.M.)

On Sunday, 25th October, 1970, a small flood occurred in Kedron Brook in the early hours of the morning. Slides 1, 2 and 3 contrast the resulting situation at three successive bridges on the Kedron Brook, viz., Melton Road, Hedley Avenue and Nudgee Road (refer to Fig. 3). The debris collection was common to all bridges on this creek, large and small. At some crossings structural damage resulted and a car was swept from an approach.

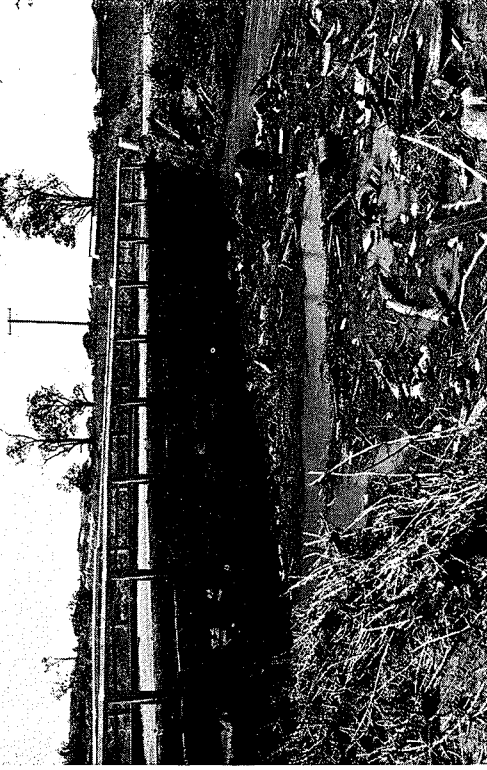
Slide 2. Debris at Hedley Avenue Crossing taken 29th October, 1970, after B.C.C. had cleared debris from roadway.

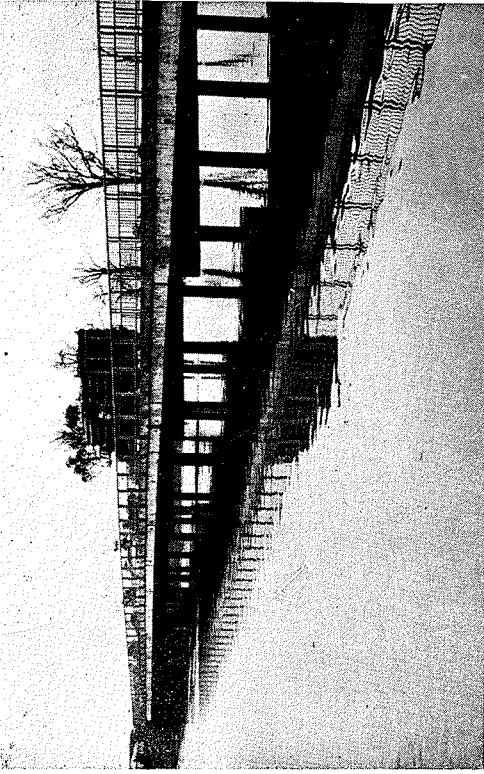
Slide 6. Nudgee Road Bridge 8th November, 1970. General view of bridge. No fixed debris.

On Sunday, 8th November, 1970, another similar flood occurred. Slides 4, 5 and 6 show the situation at the same three crossings just after the peak of the flood. Again the collection of debris at Melton Road and Hedley Avenue.

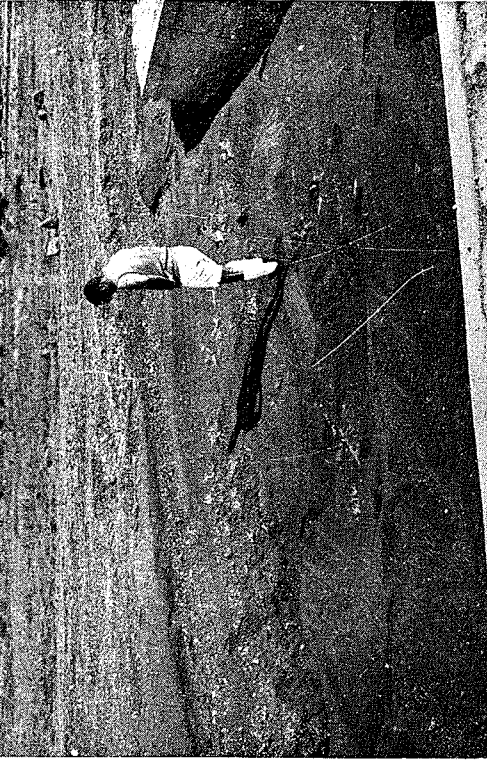
Slide 10. The upstream end of a single cell culvert showing the radiused concrete lip on which the C.D.W. engineer is standing.

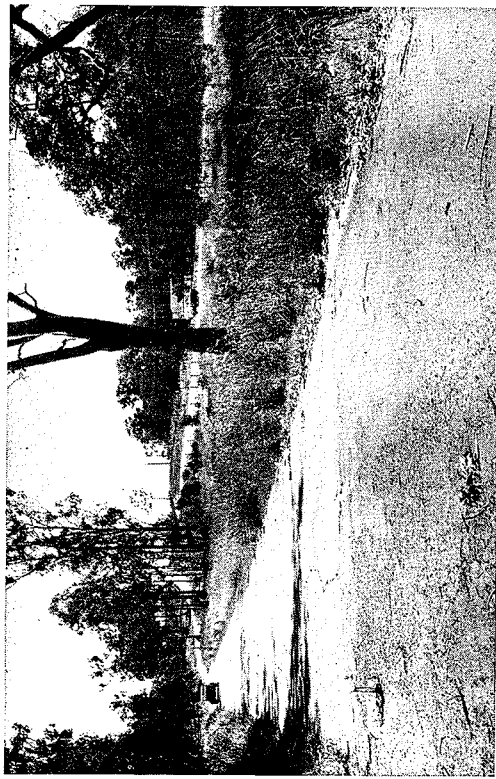
Slide 15. The same culvert immediately after a major flow (in excess of design) 24th February, 1971.

Subsequent levelling showed the flood height, measured by the considerable debris marks on a fence 75 feet downstream of the road formation, to be R.L.151.00. This was an average of a number of levels, the maximum variations being 0.03 feet. This flood level is thus higher than design R.L.150. In addition, it was found that a barbed wire fence heavily laden with debris had been swept down by the flood. One end went through culvert one, the other through culvert five, so that a partial block of culverts 2,3 and 4 had occurred.

In view of this, discharge performance could be rated as high. The upstream fan was unscathed. At the downstream fan, a portion of the kikuyu had been torn off, but the maximum depth of scour was about 1 foot. The structure was in no way endangered. There is no doubt that the partial blockage had given rise to considerable turbulence which would cause both the downstream scour and the unduly high levels. It also became apparent that the wing walls could be raised with advantage as at these high levels some spillage must have occurred over the wings interfering with the major flow. The scour of the downstream fan was less severe than the scour round a telephone pole 75 feet downstream and some distance to the side of the line of culverts.

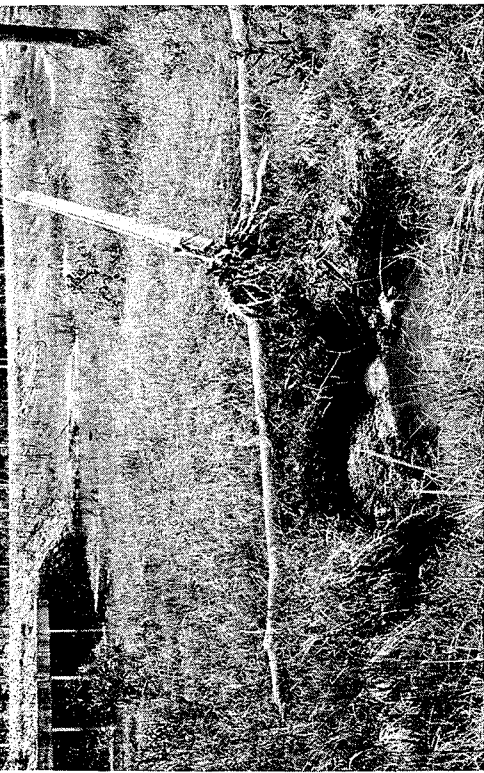
Slide 17. Scour round a telegraph pole near "Jerry's Downfall" culvert.

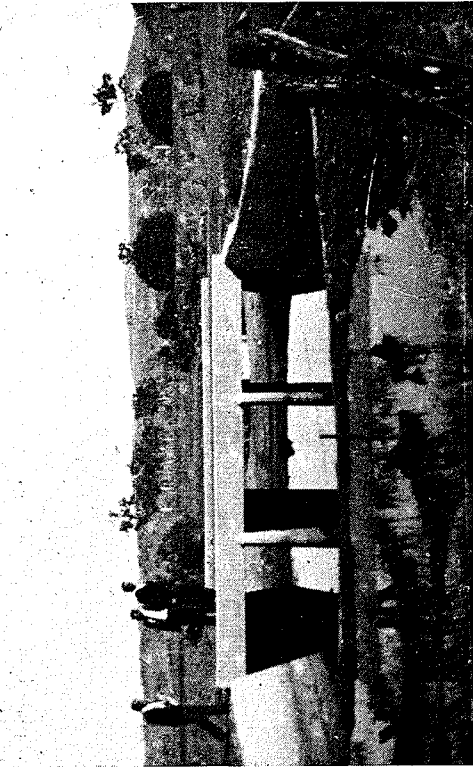
Slide 18. Culvert on Burnett Highway, Shire of Kilkivan looking downstream.

The creek catchment is farming area 4000 acres in extent, hilly at the source and lightly undulating at the culvert site. The design discharge was 1140 cusecs at R.L.62.00. Bed level in the drainage depression was R.L.59. The road is level R.L.62.5. Any increase in flood level would inundate adjoining fields which are sown to lucerne and some other high priced crops, which deteriorate rapidly when flooded.

The slope of the inlet and outlet fans was chosen as 1:4 in order to accommodate the structure within the limits of the road boundaries and avoid resumptions.

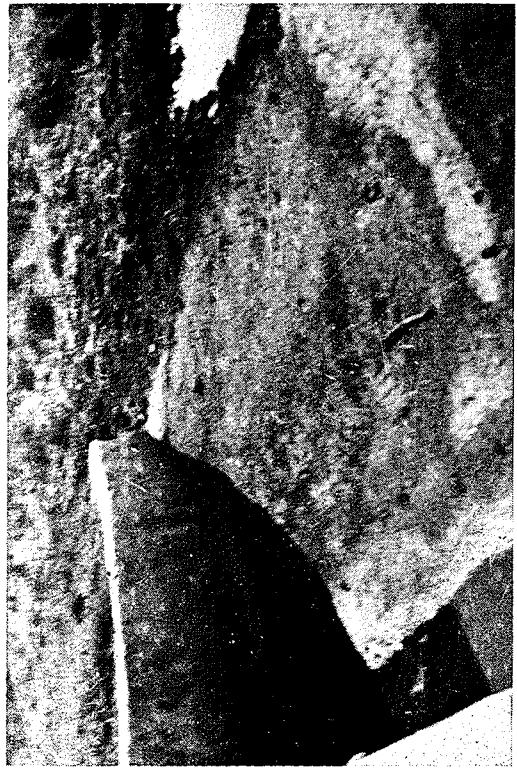
Slide 19. Culvert on Burnett Highway entrance fan.

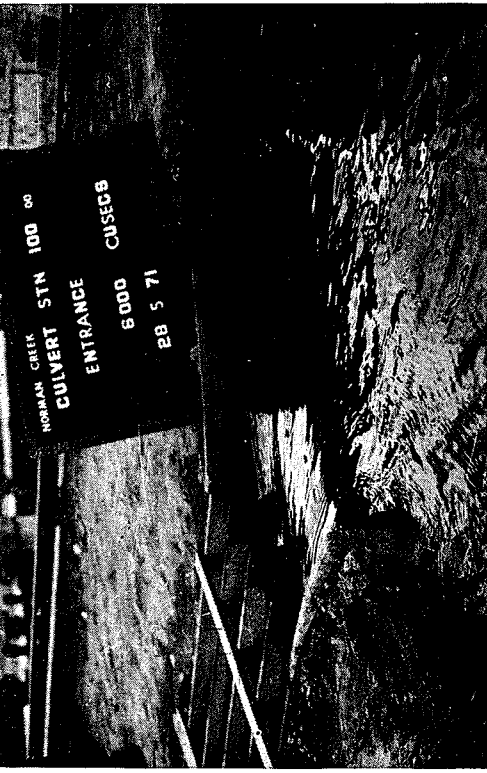
Slide 21. Model of culvert for South East Freeway (Brisbane) Station 100 (No noses).

The layout and ground features demanded considerable obliquity of the approach flow. It was desired to observe if guide vanes, in the sense of commencing the culvert walls at the lip, or some other device would be necessary. However, the obliquity of approach apparently presented no serious problem. There was some separation from the entrance boundary wall on the left bank between the lip and culvert entrance, but not to the extent of causing undue overload or deficiency in any cell. At exit, despite high velocities (15.0 ft/sec) in the culvert, the flow spread reasonably over the exit fan and no further protection except grass downstream is proposed. In fact, the exit fan edge was made square to the culvert to save concrete as no detrimental effect of this curtailment could be observed.

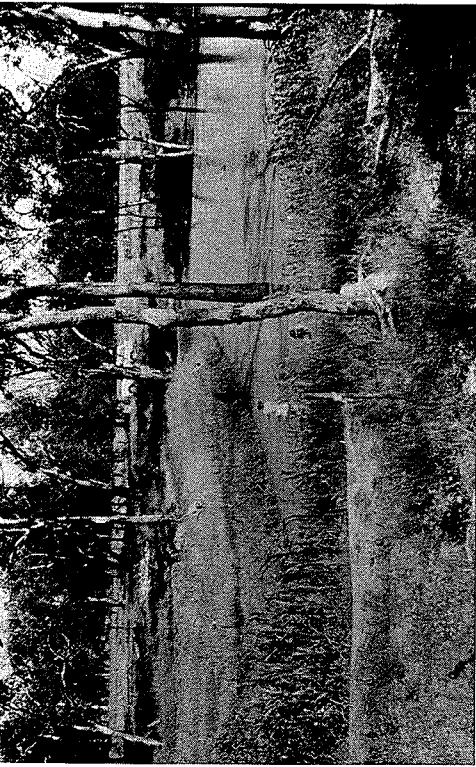
Slide 25. Grass weir at Yuleba.

The first was built at Yuleba near Roma. The cross section and finished plan is shown in Figure 7. The construction cost was \$292.00. It stores 5½ million gallons. Five weeks after construction overflow occurred. The owner had, however, managed to obtain a fair cover of sown grass and the weir survived. Since then it has been inundated many times in many ways. In 1969, a sudden storm of over 3" caused an overflow after the dam had been completely exposed for over six summer months. In 1970, overflow took place continuously for twenty eight days, although at times this flow would only be about one inch (Slide 25).
