Assessing Historical Change in Coastal Environments

Port Curtis, Fitzroy River Estuary and
Moreton Bay Regions

**Report to the
CRC for Coastal Zone Estuary and Waterway Management**

July 2003

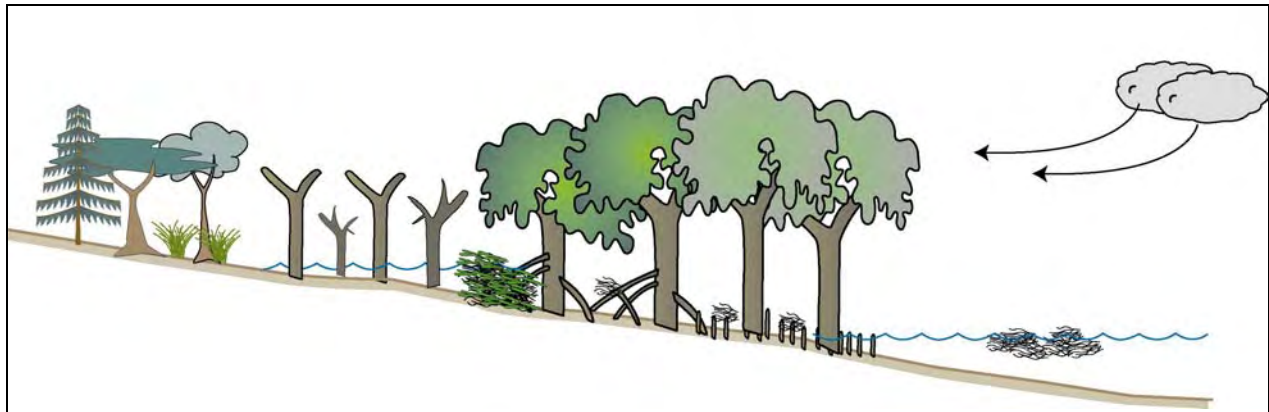
Figure 10. *Wrack accumulation* conceptual model. Compare with the pristine tidal wetland zone profile shown in Figure 1, with legend items in Figure 2.

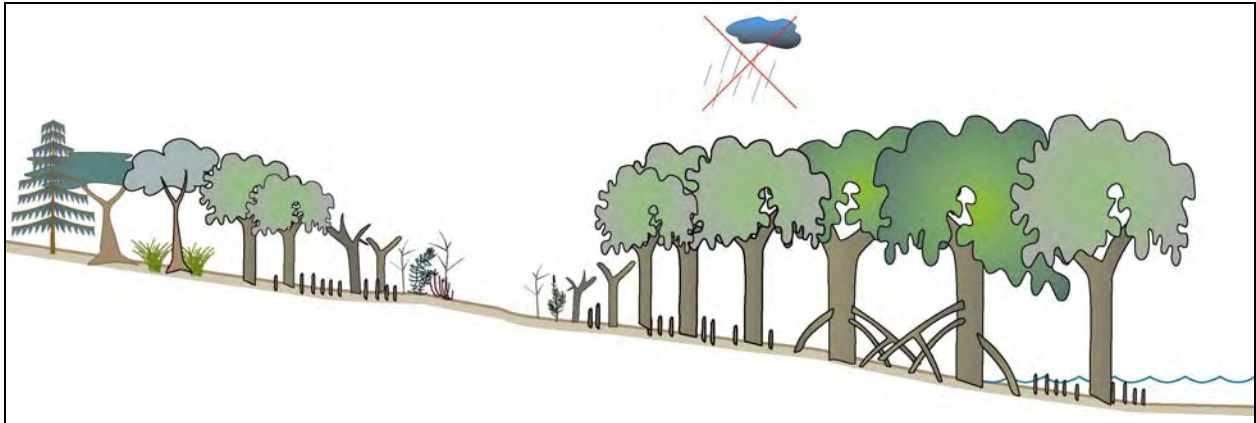
Figure 13. *Ecotone shift* conceptual model. Compare with the pristine tidal wetland zone profile shown in Figure 1, with legend items in Figure 2.

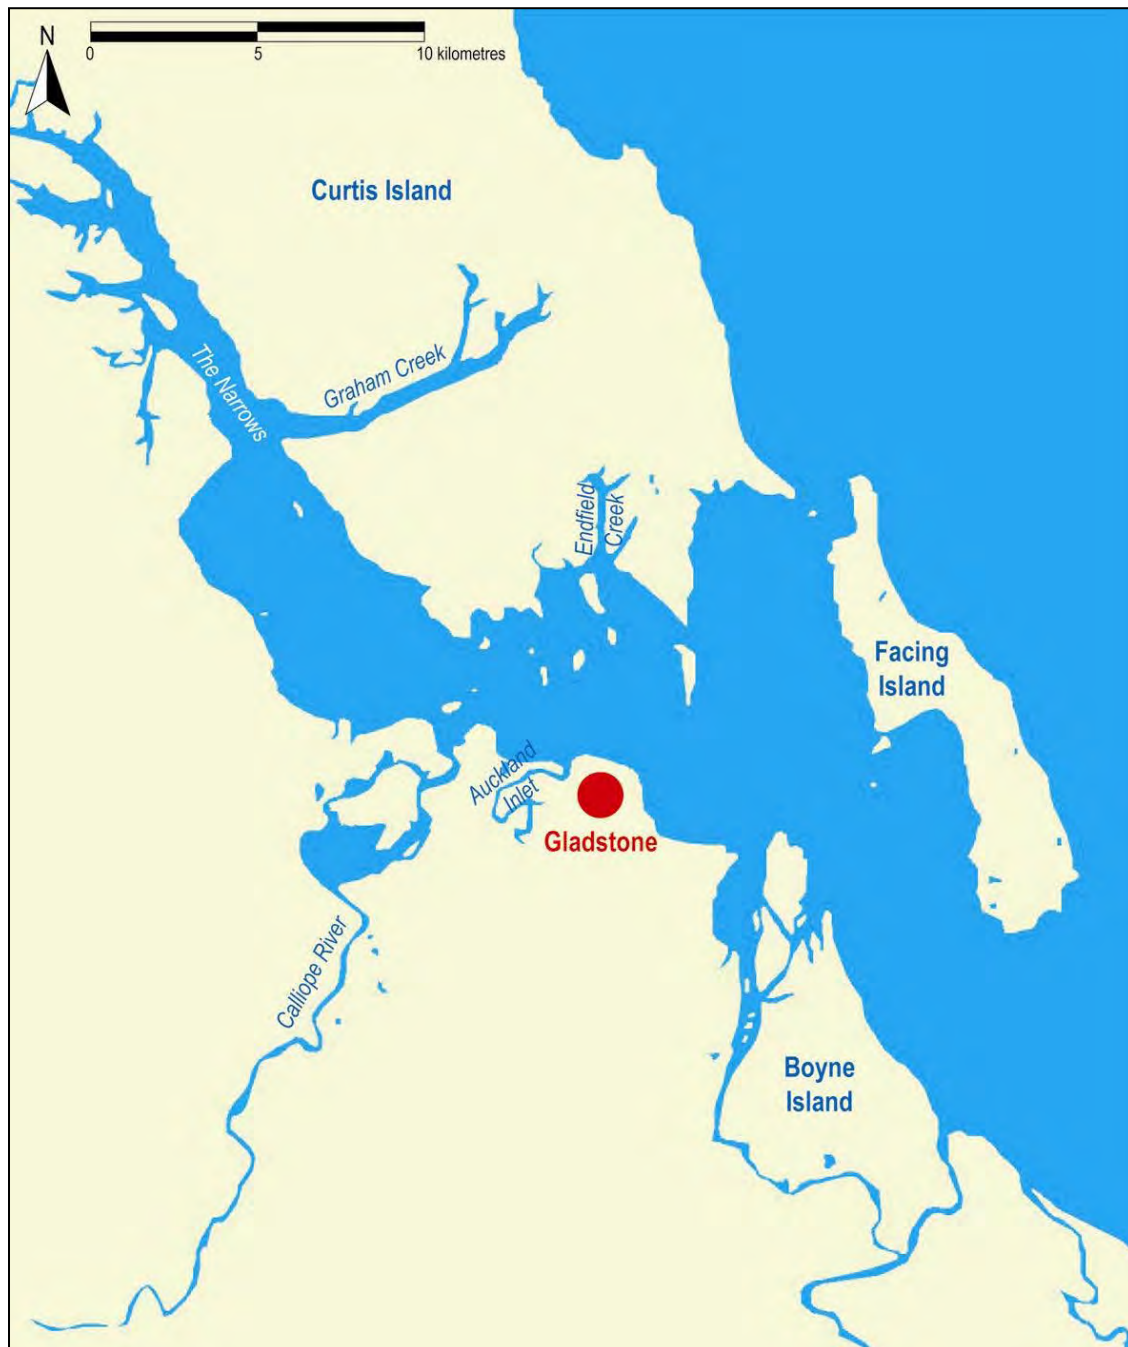
Figure 20. Map of the Port Curtis Region, showing Gladstone and the major creeks and islands.

Port Curtis (approximately 23.8°S, 151.5°E) is located on the Central Queensland coast, near the Tropic of Capricorn (see Figure 20). The area borders on the tropical/ subtropical transition zone, and the climate is warm (average daily maximum: 27.6°C, minimum: 18.5°C) with moderate rainfall (mean annual rainfall: 928.4 mm) (Bureau of Meteorology Australia). Most of this rainfall occurs during summer months. The region comprises the coastal area east of the Calliope and Dawes ranges, and includes Gladstone City, Calliope Shire and part of Miriam Vale Shire. Calliope River and Auckland Inlet are dominant water courses within the region. The Port Curtis embayment, a natural, deepwater harbour, is protected from the open ocean by the large Curtis and Facing Islands.

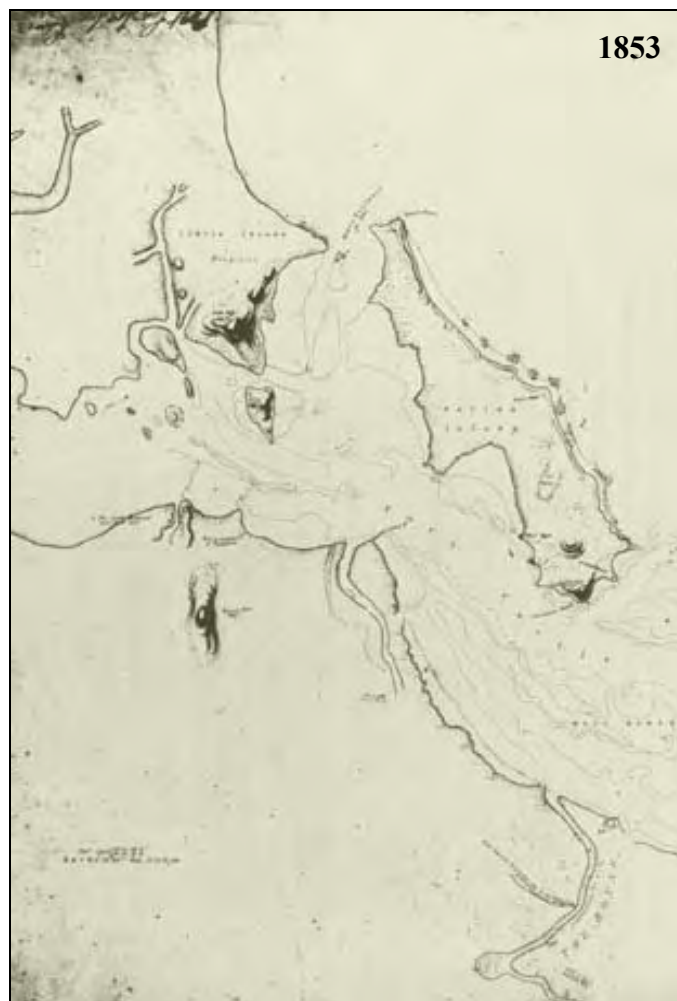
Figure 21. Early chart of the Port Curtis region, revealing a substantially different coastline from that which exists today. (Source: Department of Harbours and Marine, 1986)

Gladstone was originally settled by Europeans in 1846. Early in the colonisation of Australia, it had been destined to become the grand Northern Australian Colony. These plans were soon laid aside, however, and, after a brief period as a penal colony, it functioned largely as a cattle port up until the mid 20th century, with small-scale harbour developments at Auckland Point, Auckland Inlet and Parsons Point. In the 1960's, however, industrial, urban and port development accelerated. This trend has continued ever since, making Gladstone the major industrial centre and port it is today. Accompanying these developments, Port Curtis has undergone radical changes in coastline and coastal habitat from its original condition. Large areas of wetland have been 'reclaimed' and intertidal habitats cleared or modified. Some of these changes can be seen by comparing Figure 21, an early chart of the region (1853), with Figure 20, a line map created from 1999 data.

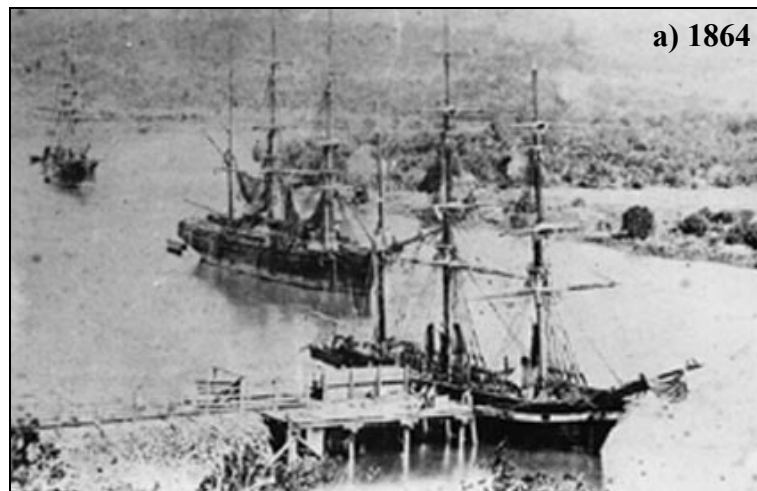
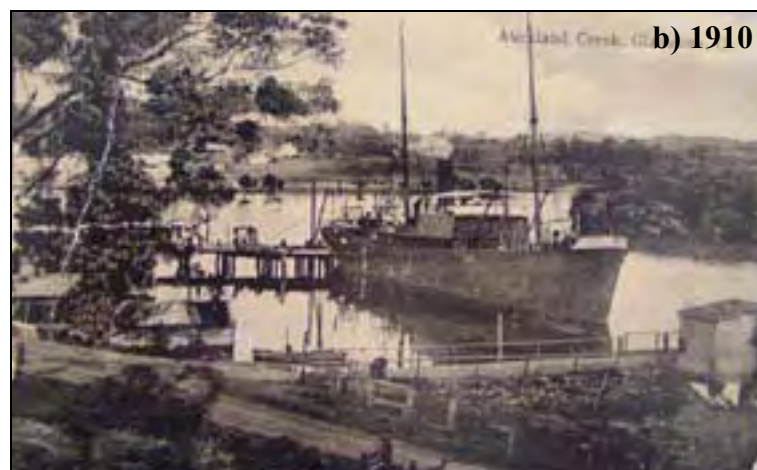
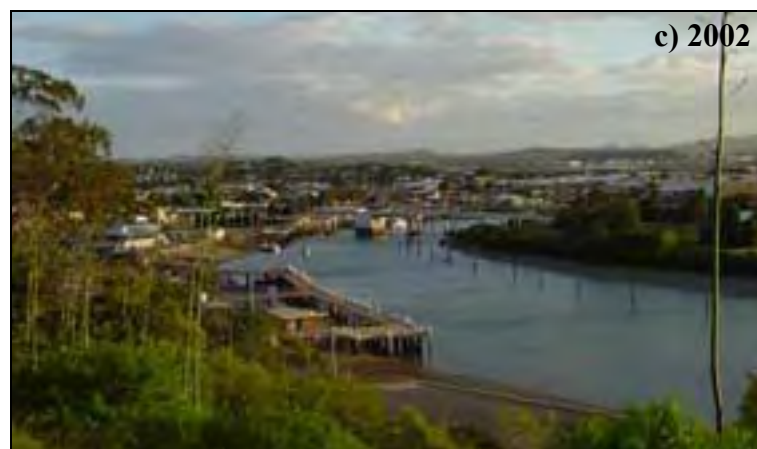
Figures 22(a), (b) & (c). Views through time of Auckland Inlet, Gladstone: in 1864, loading cattle for international ports; in 1910, a motorised vessel of a new age; and in 2002, a relatively tranquil tourist and fishing port exists now that larger vessels load at the outer harbour wharves. Note that the same rock wall jetty features in all photos. (Sources: (a) & (b) Gladstone Port Authority; (c) Norm Duke)

Figures 22a), b) and c) show a view through time of Auckland Inlet, Gladstone, in 1884, 1910 and 2002, respectively. The 1884 image shows the loading of cattle for international ports onto tall ships. The 1910 photo shows the same, but upgraded wharves, with a motorised vessel of the new age. Today, a relatively tranquil tourist and fishing port exists, now that the larger vessels load at the outer harbour wharves.

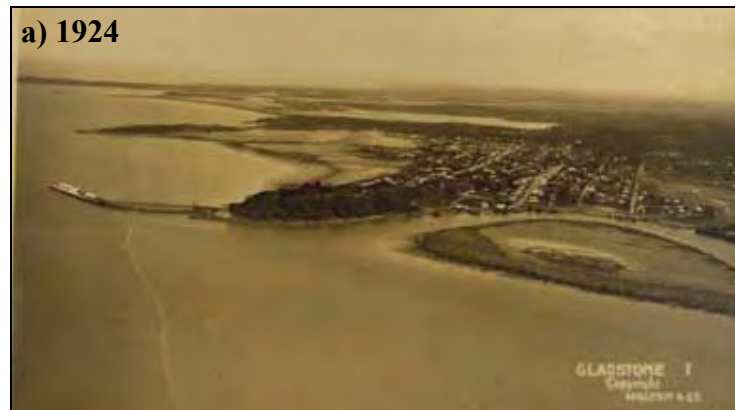
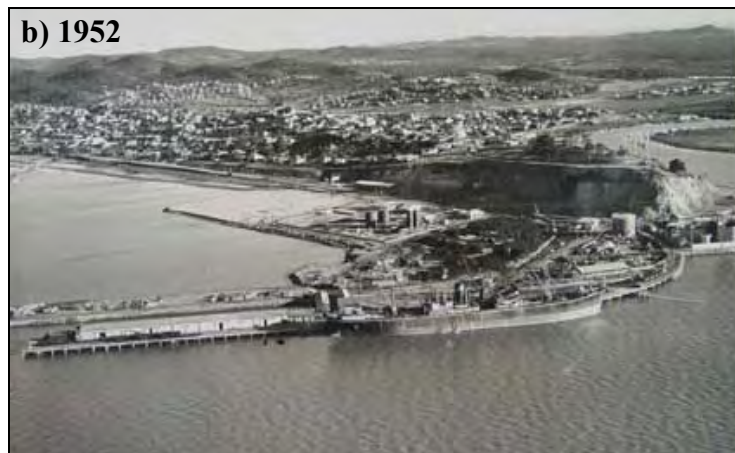
Figure 23(a) & (b). Aerial views of Auckland Point in 1924 and 1952. Within this period, extensive reclamation of land surrounding the point may be observed (Source: Gladstone Port Authority)

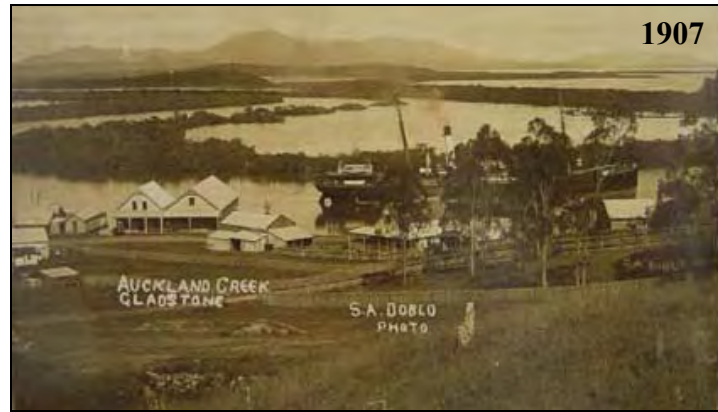
Figure 24. Historical view of Auckland Inlet in 1907, showing the commercial centre (Source: Gladstone Port Authority)

Aerial views of Auckland Point in 1924 and 1952 and be seen in Figures 23a) and b), respectively. It can be seen from these photos that within this short time period, extensive reclamation of land surrounding the point, has taken place. Figure 24 shows a historical view of Auckland Inlet in 1907, with the commercial centre visible in the photo.

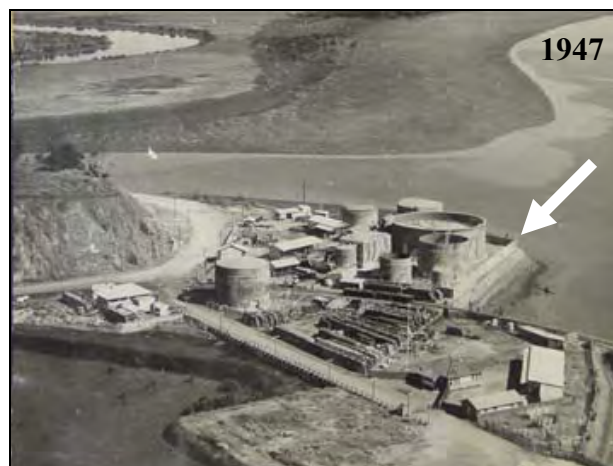
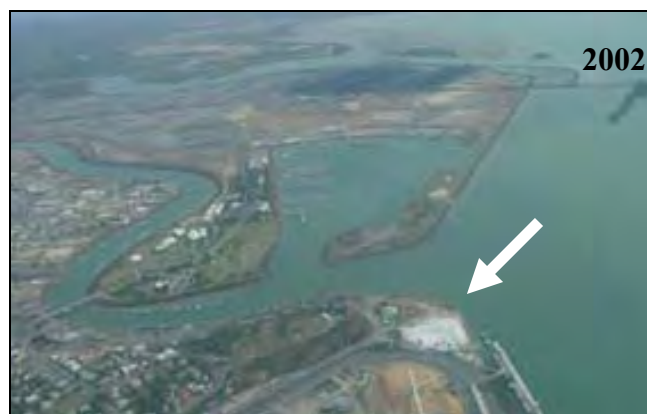
Figure 25(a) & (b). Oblique aerial photos showing the advancing developments in Auckland Inlet. The white arrow denotes the same point in both years. In 1947, the Shell Terminal is visible on reclaimed land, Auckland Point. In 2002, there has been further reclamation, construction and modification, particularly opposite Auckland Hill, where the ‘new’ harbour and port developments may be seen. (Source: (a) Gladstone Port Authority; (b) Norm Duke).

Figures 25a) and b) highlight the advancing developments that were taking place in Auckland Inlet between 1947 and 2002. In 1947, the Shell Terminal is visible on reclaimed land at Auckland Point. In the 2002 photo, it can be seen that there has been further reclamation, construction and modification, particularly opposite Auckland Hill, where the ‘new’ harbour and port developments can be seen.

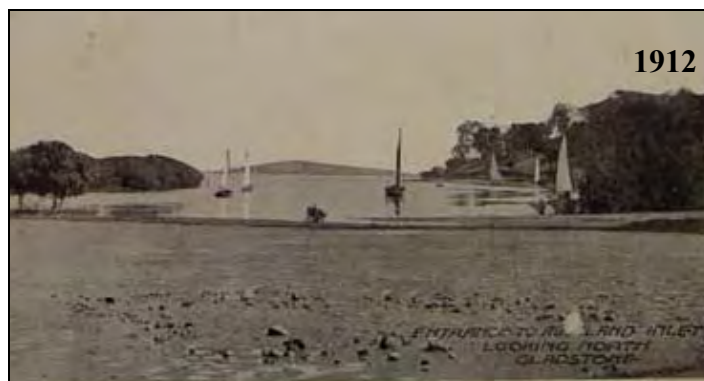
Figure 26. Sailing boats at the entrance of Auckland Inlet in 1912, showing a relatively undisturbed shoreline. (Source: Gladstone Port Authority)

Figure 26 displays a calm view of sailing boats at the entrance of Auckland Inlet in 1912, showing a relatively undisturbed shoreline.

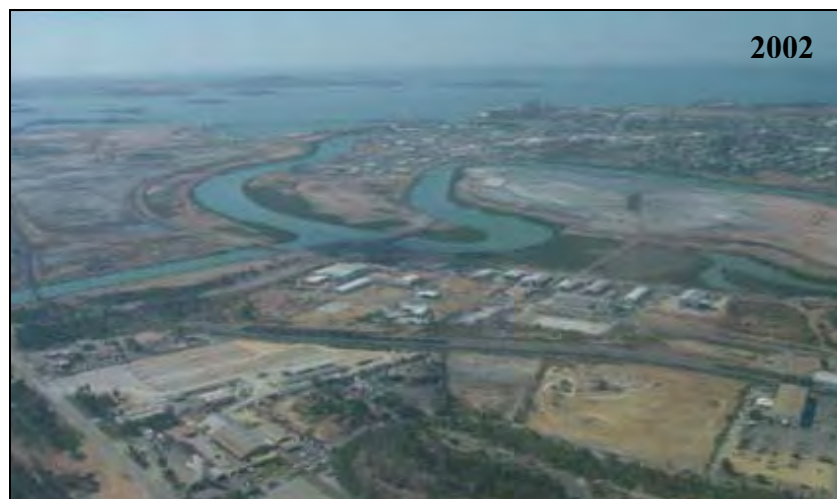
Figure 29. Aerial view of Auckland Inlet, showing substantial industrial developments and influences. (Source: Norm Duke)

Auckland Inlet is the most disturbed catchment in the Port Curtis region (Figure 29). In the past, the inlet served as a busy harbour and cattle port but, today, it is mainly used for local boat traffic, as a water supply for the power station, and to direct storm water away from the city. It has undergone substantial urban and industrial development, including modifications by the Gladstone Port Authority (coal terminals, reclaimed industrial estates and Gladstone Marina), Gladstone Power Station (Clinton Ash Pond reclamation) and Gladstone City Council (city tip and sporting fields). As a result of these activities, large areas of habitat have been removed. Between 1941 and 1988, for example, an estimated 90% of intertidal wetlands were lost (Arnold 1995). By 1988, nearly no saltpan and less than 50 hectares of mangroves remained (Arnold 1995).

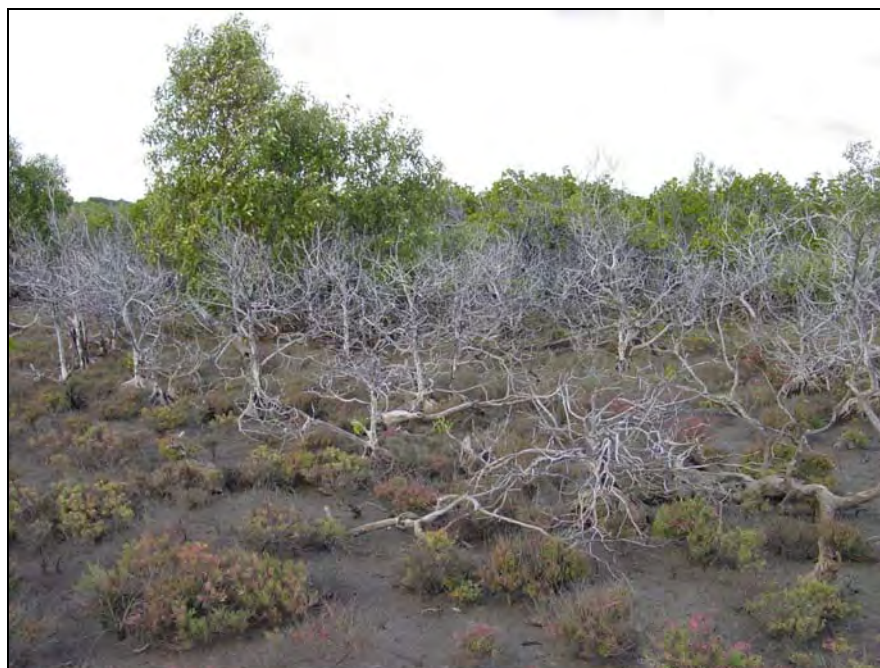
Figure 34. Photograph of the hail-damaged area, showing dead *Ceriops* in the foreground, with surviving *Avicennia marina* trees in behind the dead *Ceriops*. This photo was taken in 2002, approximately 8 years after the hail storm occurred in 1994. (Source: Norm Duke)

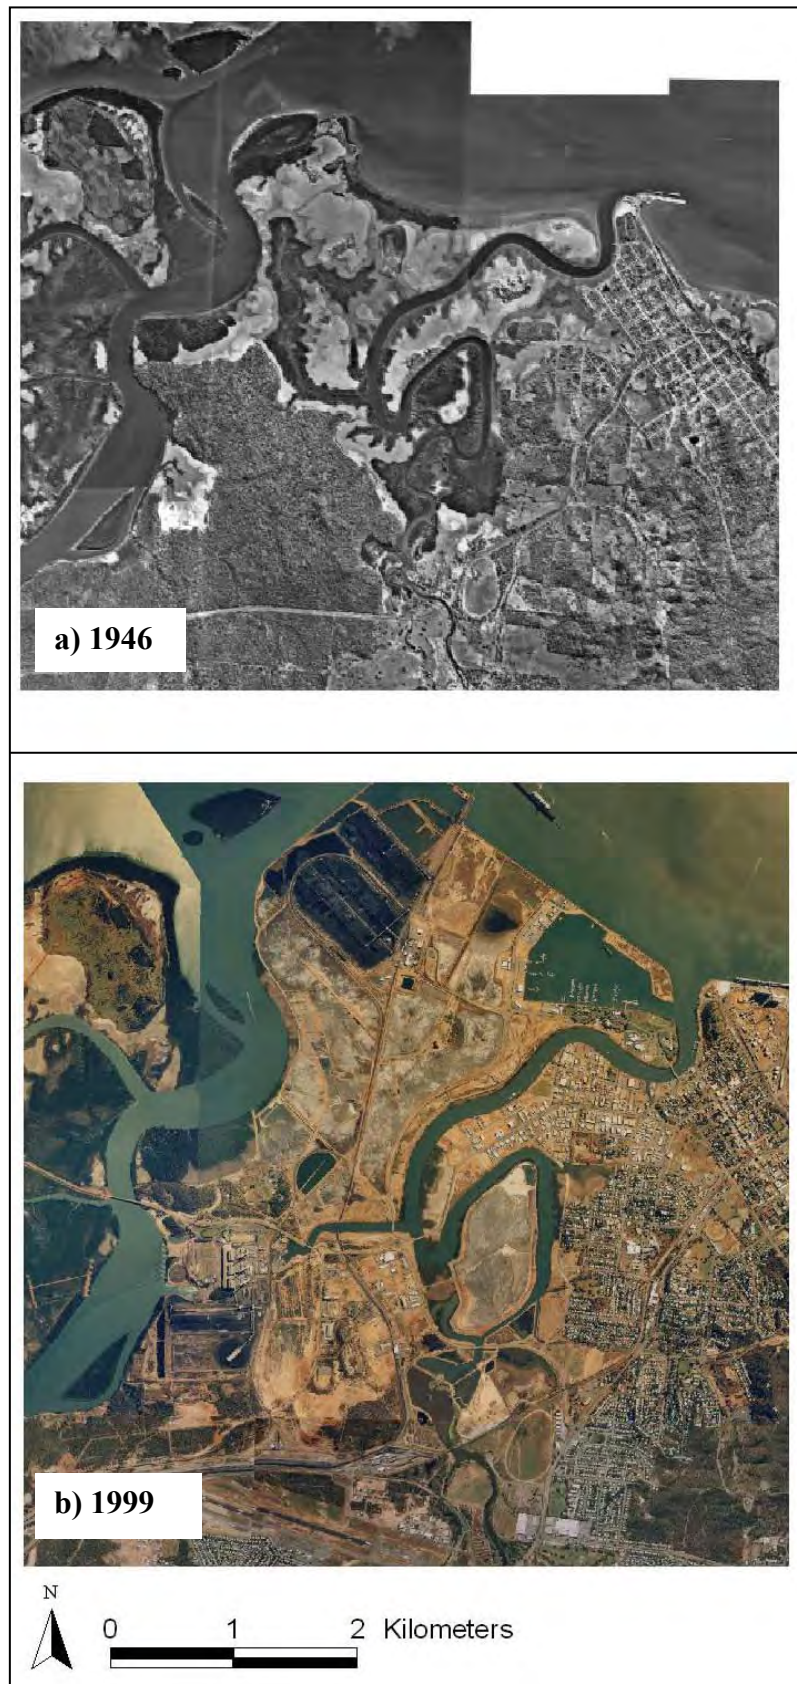
Figure 36(a) and 36(b). Auckland Inlet mosaics in a) 1941 and b) 1999, which can be used as a comparison with the tidal wetland maps in Figure 37.

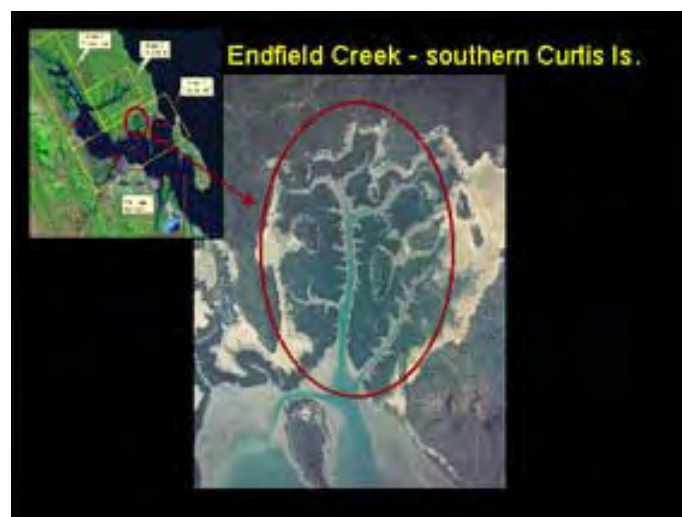
Figure 38. Location of Endfield Creek study site.

The study site was selected to encompass locations with a low, gradual rise in elevation, consisting of terrestrial ‘islands’ surrounded by salt marsh/ saltpan and completely fringed on the seaward edge by mangroves (Figure 38).

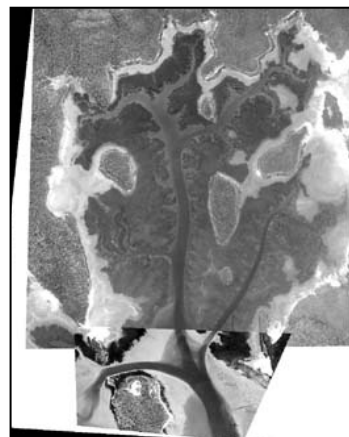
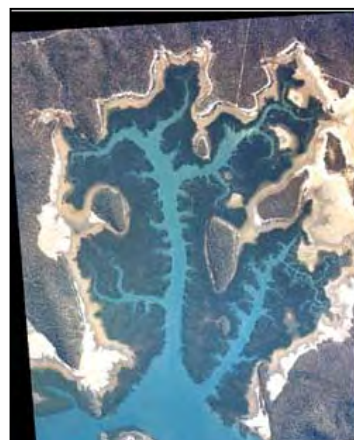
Figures 39a), b), c) and d). Aerial photography of Endfield Creek for the years specified, to be used for comparison with the vegetation map in Figure 40 (Scale: 1:70 000)

For the study site at Endfield Creek, four maps at approximately 20 year time intervals were created, depicting the vegetation types (Figure 39). These sequential maps, whilst few major changes are immediately obvious, allow for the detection of small scale changes to the total areas of vegetation types. Information regarding the amount of mangrove and salt marsh in proportion to total area, and any changes to this, is also able to be taken from the images. The years that maps have been created for were 1941, 1959, 1979 and 1999, which also allows for the rate of any changes to be determined.

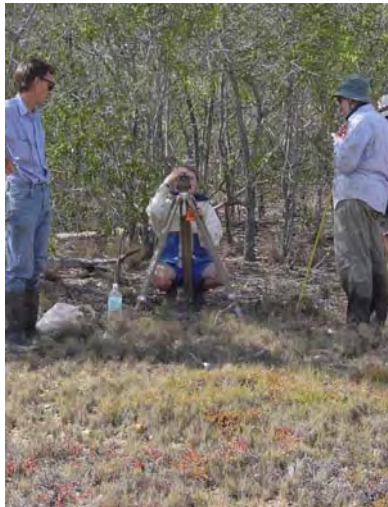
Figure 44. Field survey: elevation readings using dumpy level.

Field verification (ground truthing) was used to help interpret the imagery and define boundaries. This was achieved by setting transects through the vegetation from the seaward to the terrestrial fringe, and taking GPS coordinates at ecotones. Relative elevations at ecotones across the transects were also measured, using a combination of a dumpy level and staff, and a fluid-filled U-tube and ruler (Figures 44-46). This information was used to determine a possible correlation between elevation and ecotone.

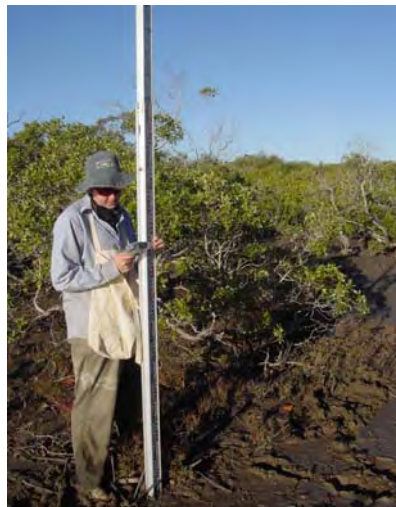
Figure 45. Field survey: staff viewed with dumpy level.

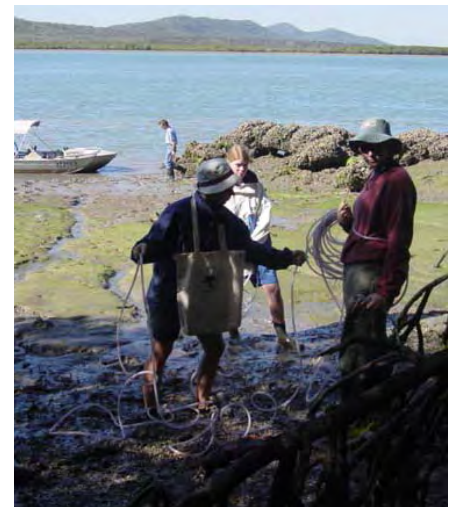
Figure 46. U-tube and ruler used for elevation readings where dense vegetation restricted usage of dumpy level and staff.

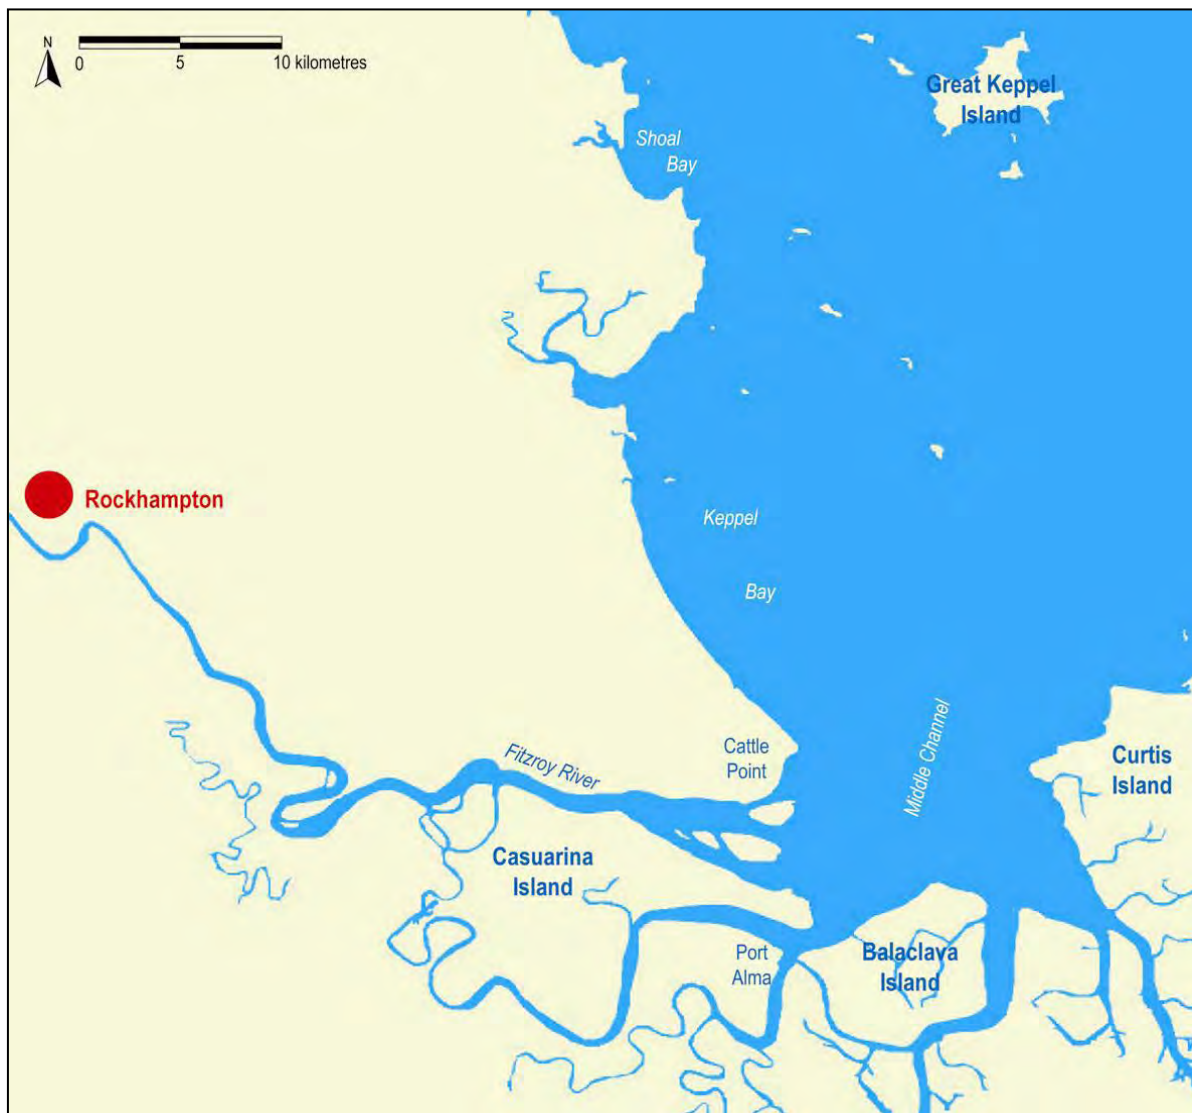
Figure 49. Map of the Fitzroy River Region, showing the city of Rockhampton and the major islands.

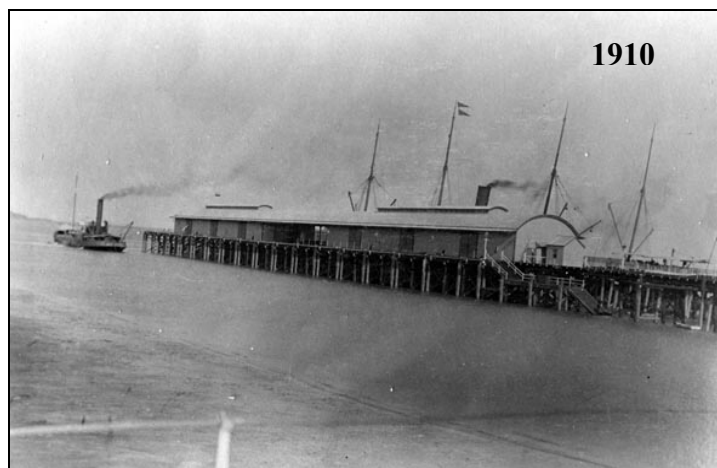
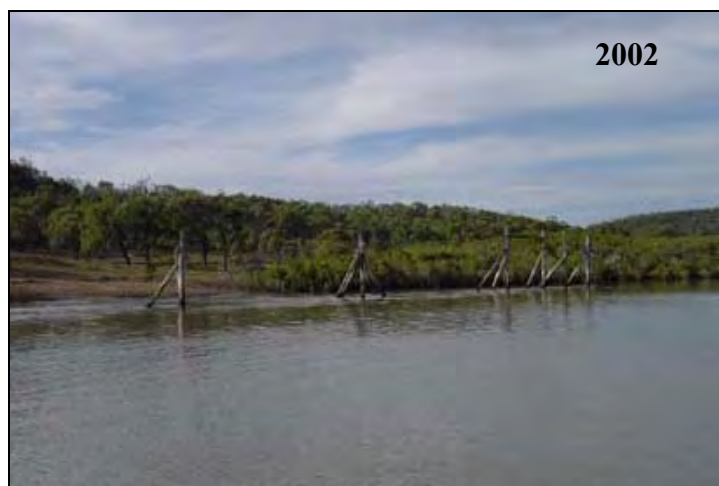
Figures 53(a), (b) & (c). Views of Broadmount harbour, Fitzroy River estuary, in 1880, 1910 and 2002. Today, the wharves have been demolished and the Broadmount ‘port’ abandoned. (Source: (a) & (b) Rockhampton District Historical Society; (c) Norm Duke)

Figures 53a), b) and c) display a view of Broadmount harbour, in the Fitzroy River estuary, in 1880, 1910, and 2002, respectively. What was a busy harbour in the late 1800s and early 1900s, is now deserted. Today, the wharves have been demolished and the Broadmount 'port' abandoned.

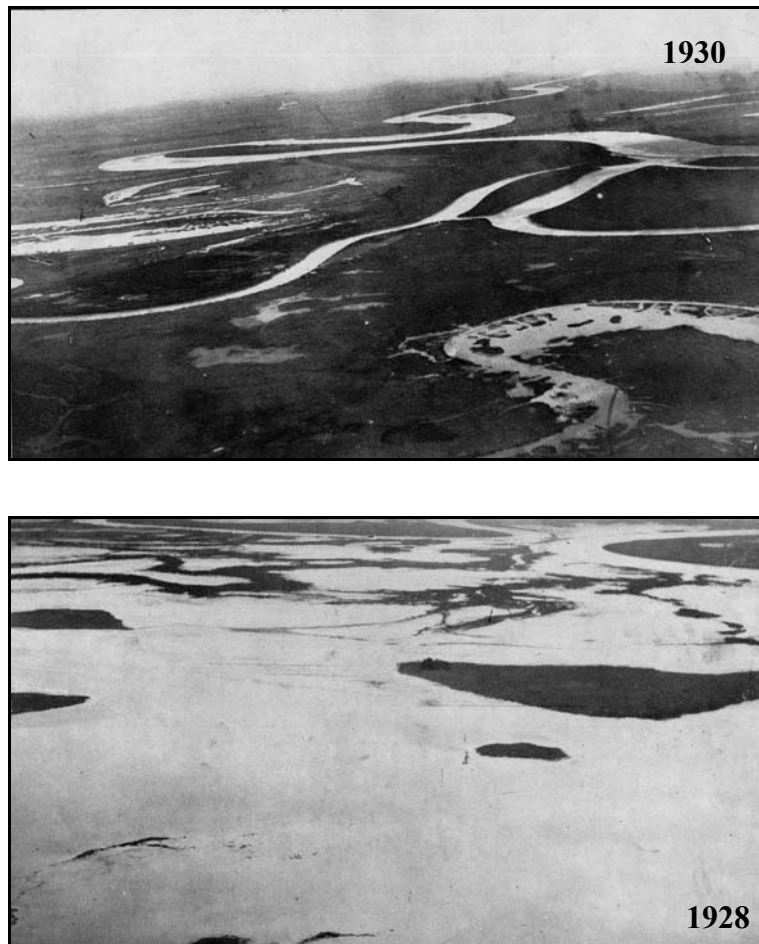
Figure 54(a) & (b). Early aerial views of the Fitzroy River, near Dunlop Island, in normal conditions (a), and during the 1928 flood (b). (Source: the *Queenslander* 1930)

Figures 54a) and b) show early views of the Fitzroy River, near Dunlop Island, both normal conditions (54a) and during the 1928 Flood (54b).

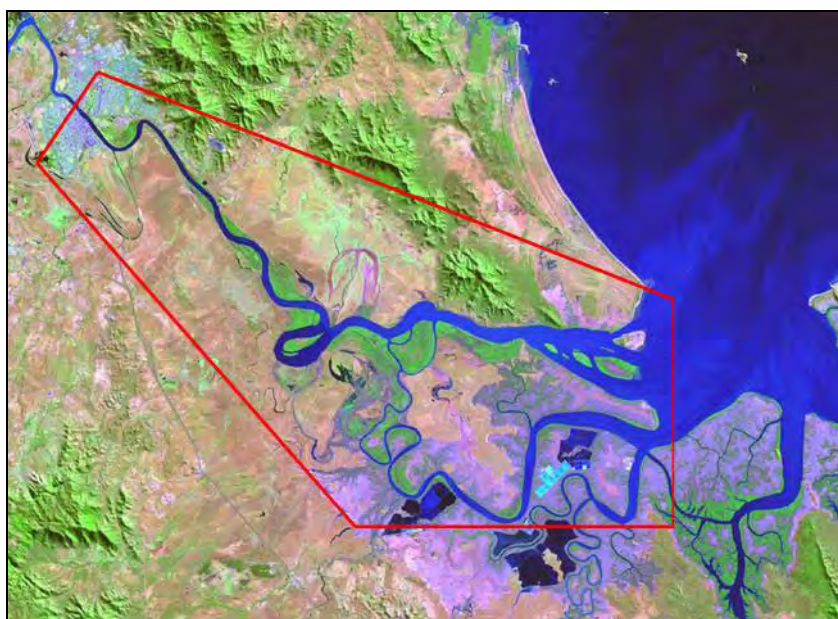
Figure 57. Location of Fitzroy River Estuary study site (Scale: 1:500,000).

The case study focuses on the Fitzroy River estuary, consisting of the tidal reaches of the river (i.e. the area between the river mouth and the tidal barrage in Rockhampton) and the surrounding intertidal wetlands. The approximate study area is shown in Figure 57.

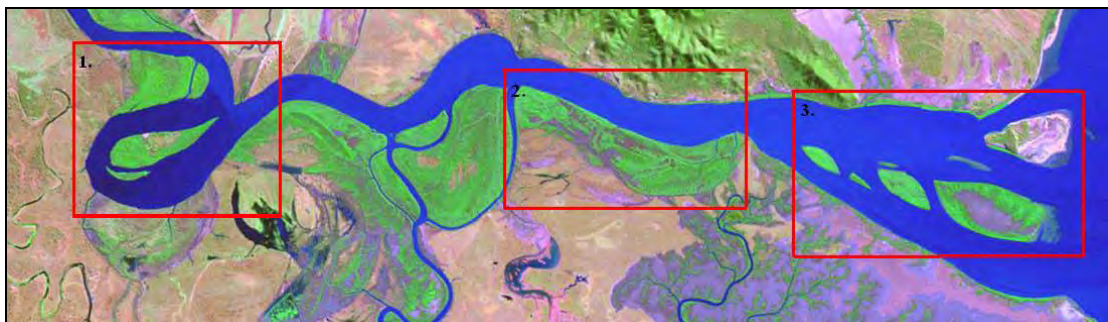
Figure 61. Location of the three case studies illustrating the three proposed drivers of change within the Fitzroy River. 1. Pirate Point; 2. Sandfly and Mosquito Islands; and 3. River mouth islands.

There appears to be two main drivers of change evident within the Fitzroy River. These have been identified as natural change in river hydrology, and unintentional human change as a result of 1) river-altering structures being constructed, and 2) deposition of sediment in the mouth of the River. There are three separate case studies that have been identified that represent the two main proposed drivers of change, one showing natural change and two showing unintentional human changes, and these are outlined below. They are Pirate Point, Sandfly and Mosquito Islands and the River mouth islands (see Figure 61).

The second case study of change is proposed to be related to unintentional human changes that result in alteration of the hydrology of the river and erosion and deposition processes that occur. The case study is of Pugh Sand, Tait Islet, and Sandfly and Mosquito Islands, which is identified in Figure 61 above, and is an example of mangrove gain within the Fitzroy River.

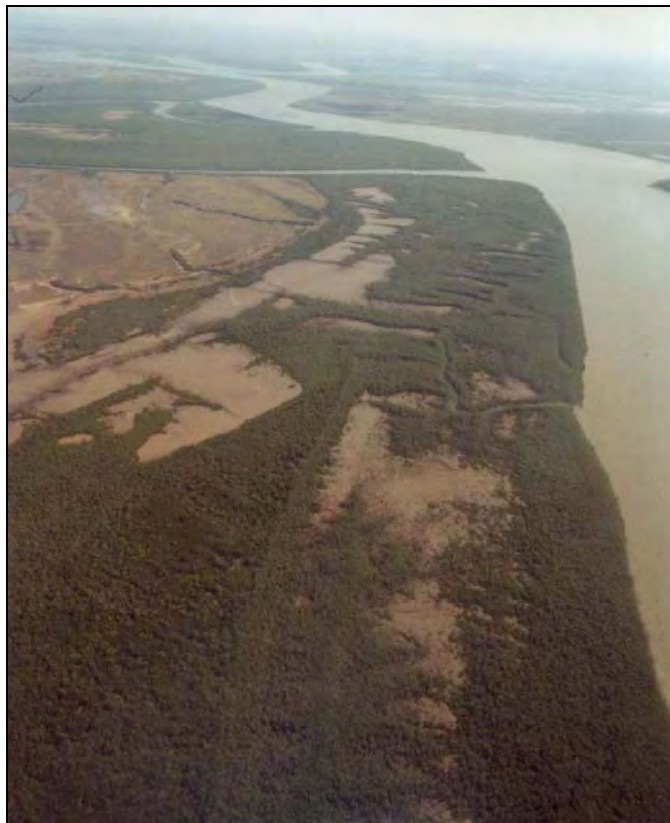
Figure 65. Aerial view of saltpan encroachment into the mangrove forest between Shoal Island (in the top right corner of the photo) and Rocky Point, 2002. (Source: Katherine Zahmel)

By 1999, the new mangrove island, A, had also been subsumed by mangroves. The creek present in 1941 had almost been closed in with the formation of another smaller creek along the eastern edge of the new mangrove island. There is also the encroachment of salt marsh/saltpan into the mangrove from the mainland direction, in Figure 64c, and in Figure 65.

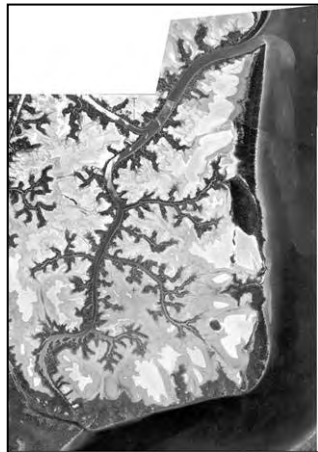
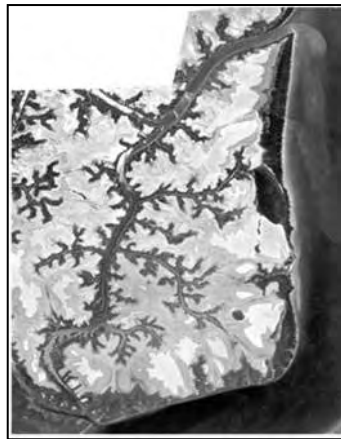
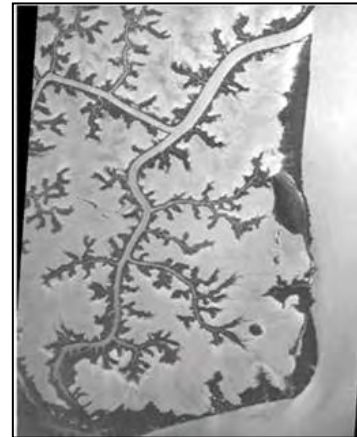
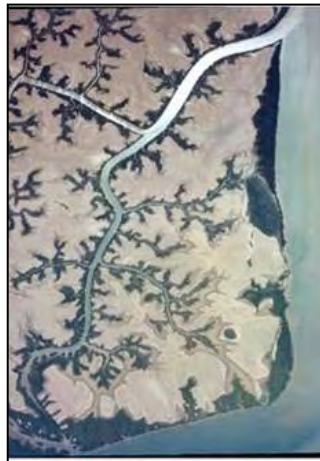
a) 1941 (Scale: 1:70,000).

b) 1956 (Scale: 1:70,000).

c) 1979 (Scale: 1:70,000).

e) 1999 (Scale: 1:70,000).

Figure 72. Aerial photo mosaics of Balaclava Island, south of the Fitzroy River mouth, in a) 1941, b) 1956, c) 1979, d) 1990 and e) 1999. These provide a visual comparison with the vegetation strips in Figure 71.

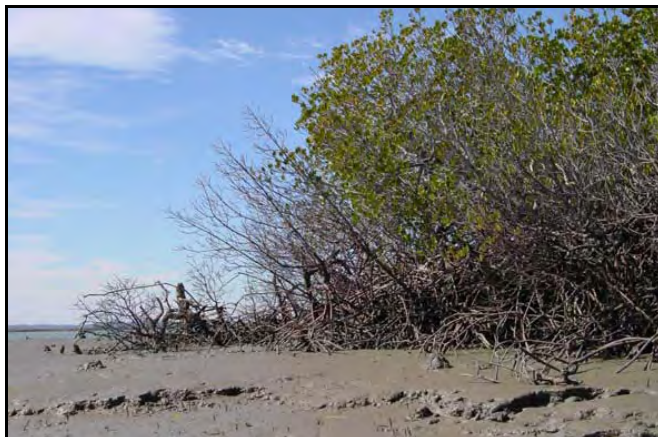
Figure 76. Dieback at seaward fringe.

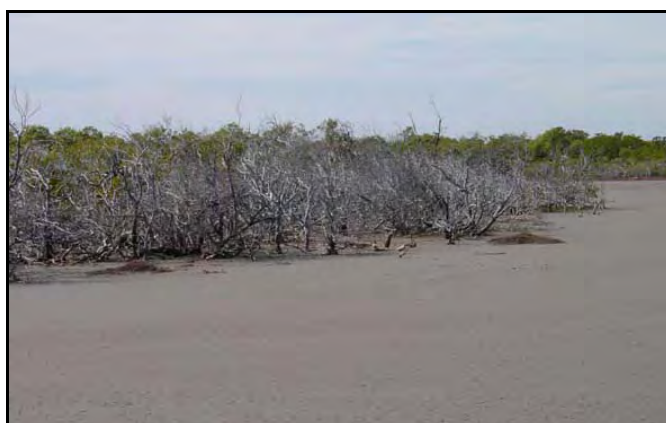
Figure 77. Dieback at inner, saltpan fringe: recent effect.

During the field transects, evidence of longer term change in Balaclava Island was detected, revealed through effects such as dieback of mangroves at ecotone fringes. Figures 76, 77 and 78 provide visual examples of the effects observed.

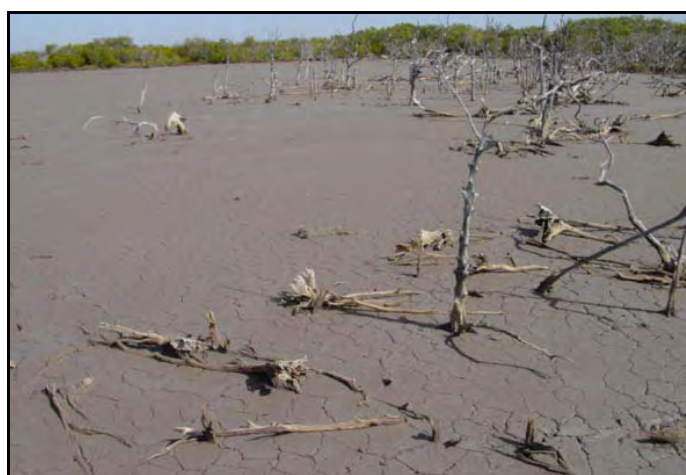
Figure 78. Dieback at inner, saltpan fringe: older effect.

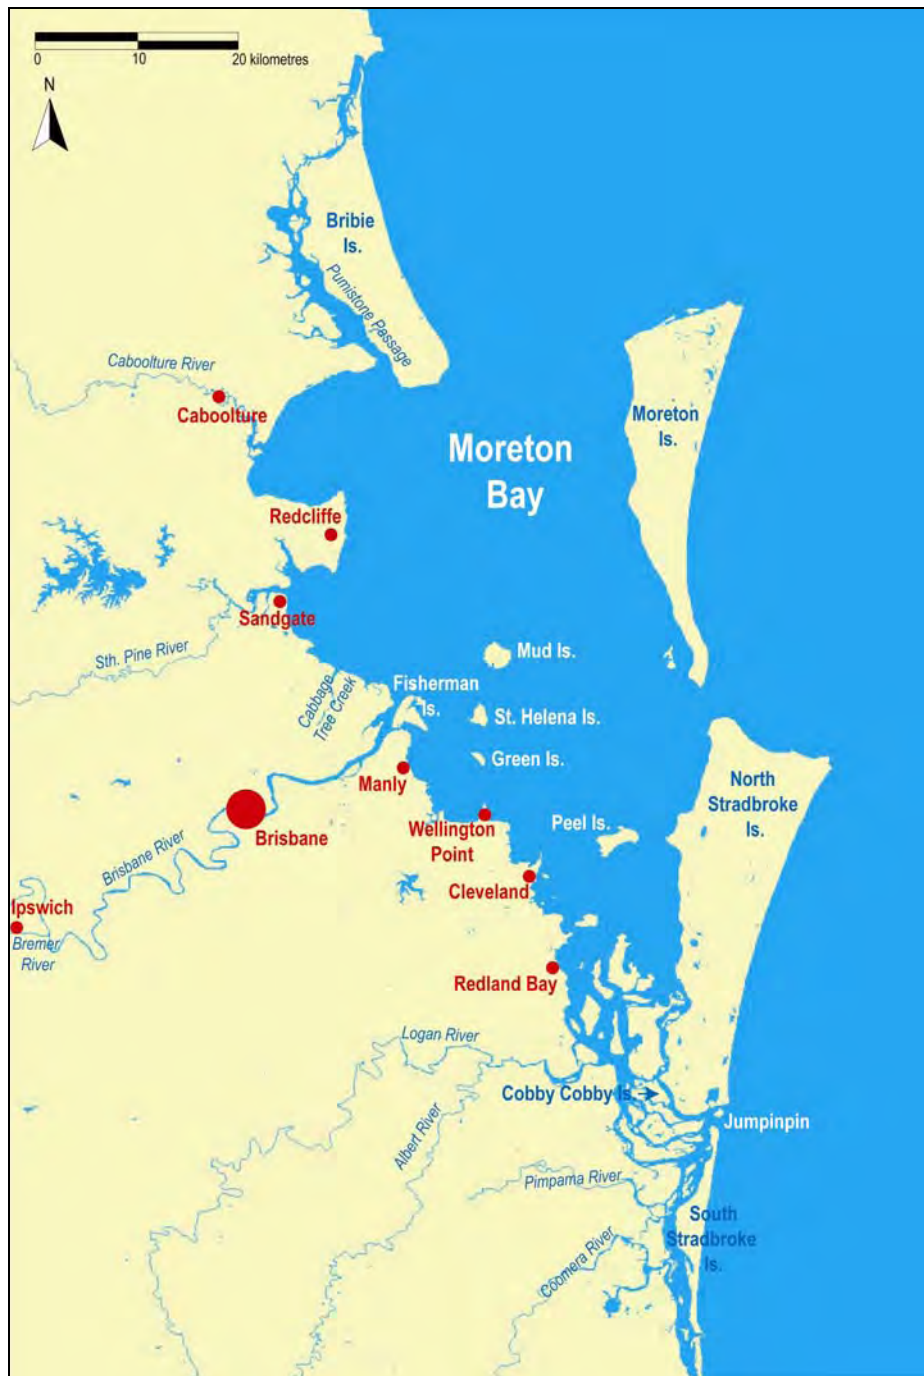
Figure 79. Current map of Moreton Bay, showing major rivers, cities and islands.

Moreton Bay (approximately 27.5°S, 153.3°E) is located in southeast Queensland, about 450 kilometres south of the Tropic of Capricorn (see Figure 79). The climate is warm and subtropical (average daily maximum: 25.4°C, minimum: 15.7°C) with moderate to high rainfall (mean annual rainfall: 1185.4mm) and acute storm activity, mostly occurring during summer months (Bureau of Meteorology Australia). The region comprises five major catchments, the Brisbane River, Logan/Albert Rivers, Pine Rivers, Pumicestone Passage and Caboolture River catchments, with a total area of 21,220 km², and includes the heavily developed cities of Brisbane, Ipswich and Logan (Dennison and Abal, 1999). The Brisbane River is the largest of these catchments, measuring 13,100 km², and extends from Moreton Bay to the Great Dividing Range (Dennison and Abal, 1999). It includes the Upper Brisbane, Stanley, Lockyer and Bremer River subcatchments and 50 major creeks. The Brisbane River estuary is defined by the tidal portion of the river, extending from the mouth 90 km upstream to Mt Crosby. It has a long history of flooding, with 11 major floods recorded since 1840 (Bureau of Meteorology Australia). The next largest catchment is that of the Logan/Albert Rivers, which measures 3157 km², extending west to the Great Dividing Range and south to the Lamington Plateau (Dennison and Abal, 1999). This is followed by the Pine Rivers catchment (including North and South Pine Rivers), the Pumicestone Passage Catchment and the Caboolture River catchment, measuring 808 km², 761 km² and 354 km², respectively (Dennison and Abal, 1999). In comparison, the Bay measures 1,523 km², giving a total catchment to bay ratio of 14:1 (Dennison and Abal, 1999). Moreton Bay, a shallow, protected embayment, is largely enclosed to the east by Moreton and North Stradbroke Islands.

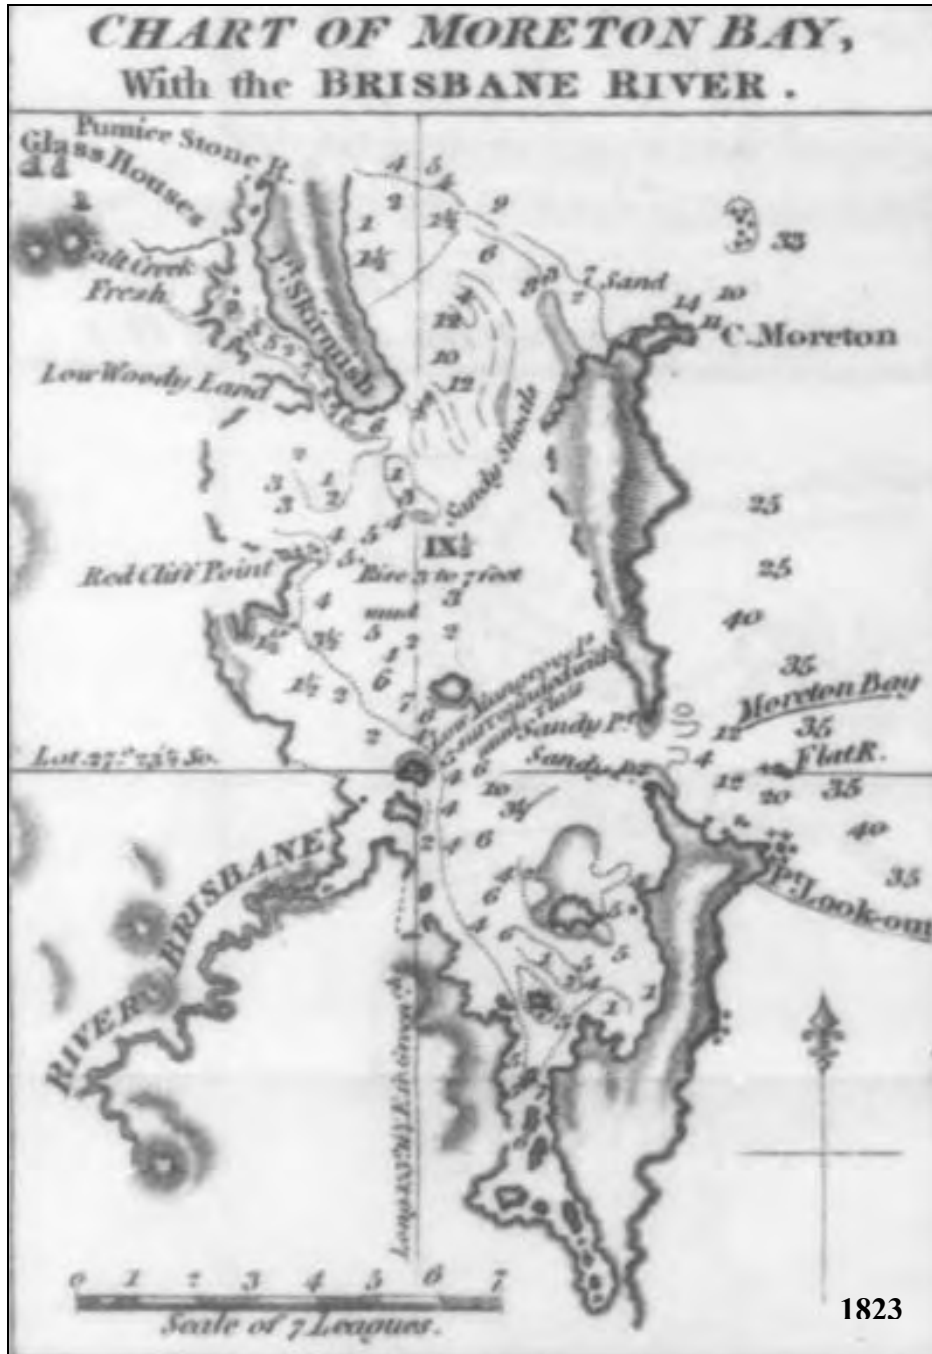
Figure 80: Chart of Moreton Bay from 1823. (Source: John Oxley Library)

In 1823, while exploring Moreton Bay, John Oxley first charted the Brisbane River (Figure 80). The following year, a penal colony was established at Redcliffe Point. This was soon relocated upstream to North Quay, a site that would later become Brisbane's Central Business District. By 1842, the Moreton Bay penal colony was closed and the area opened for free settlement. In the decades following the separation of Queensland (1859), Brisbane experienced rapid population growth, expansion and urban, industrial and commercial development, a trend which accelerated after World War II, despite periodic setbacks afforded by droughts, floods and economic depressions. Today, Brisbane is Australia's third largest capital city, and a major urban centre with a busy, international port. Accompanying these developments, the region, particularly the Brisbane River, has undergone major changes in form, shoreline and coastal habitat. Construction of bridges, wharves and training walls, dredging, channel improvements, deepening of the Bar at the river mouth, removal of obstacles and points hazardous to navigation, reclamation, and port development have all acted to modify the river and its surrounding environment. Some of these changes, such as the straightening of the river and the developments near the mouth, can be seen by comparing Figure 81 (an early chart of the river from 1823), with Figure 92 (a map from 1998). In the recent map (Figure 92), the port can be observed at Fisherman Islands, near the mouth of the river. This was not always the case, and represents the end point of a series of shifts that saw the port move upstream from its initial position near the mouth, to the Town Reach, and then progressively back downstream to its current location. In the early and mid 1800's, obstacles, bars and shallow stretches in the river forced most large vessels to anchor outside the mouth, where cargo was transferred to smaller boats for transport upstream. Subsequent deepening of the river and channel improvements allowed these large vessels to travel upstream, facilitating a shift to a Town Port in the late
