Assessing Historical Change in Coastal Environments

Port Curtis, Fitzroy River Estuary and
Moreton Bay Regions

**Report to the
CRC for Coastal Zone Estuary and Waterway Management**

July 2003

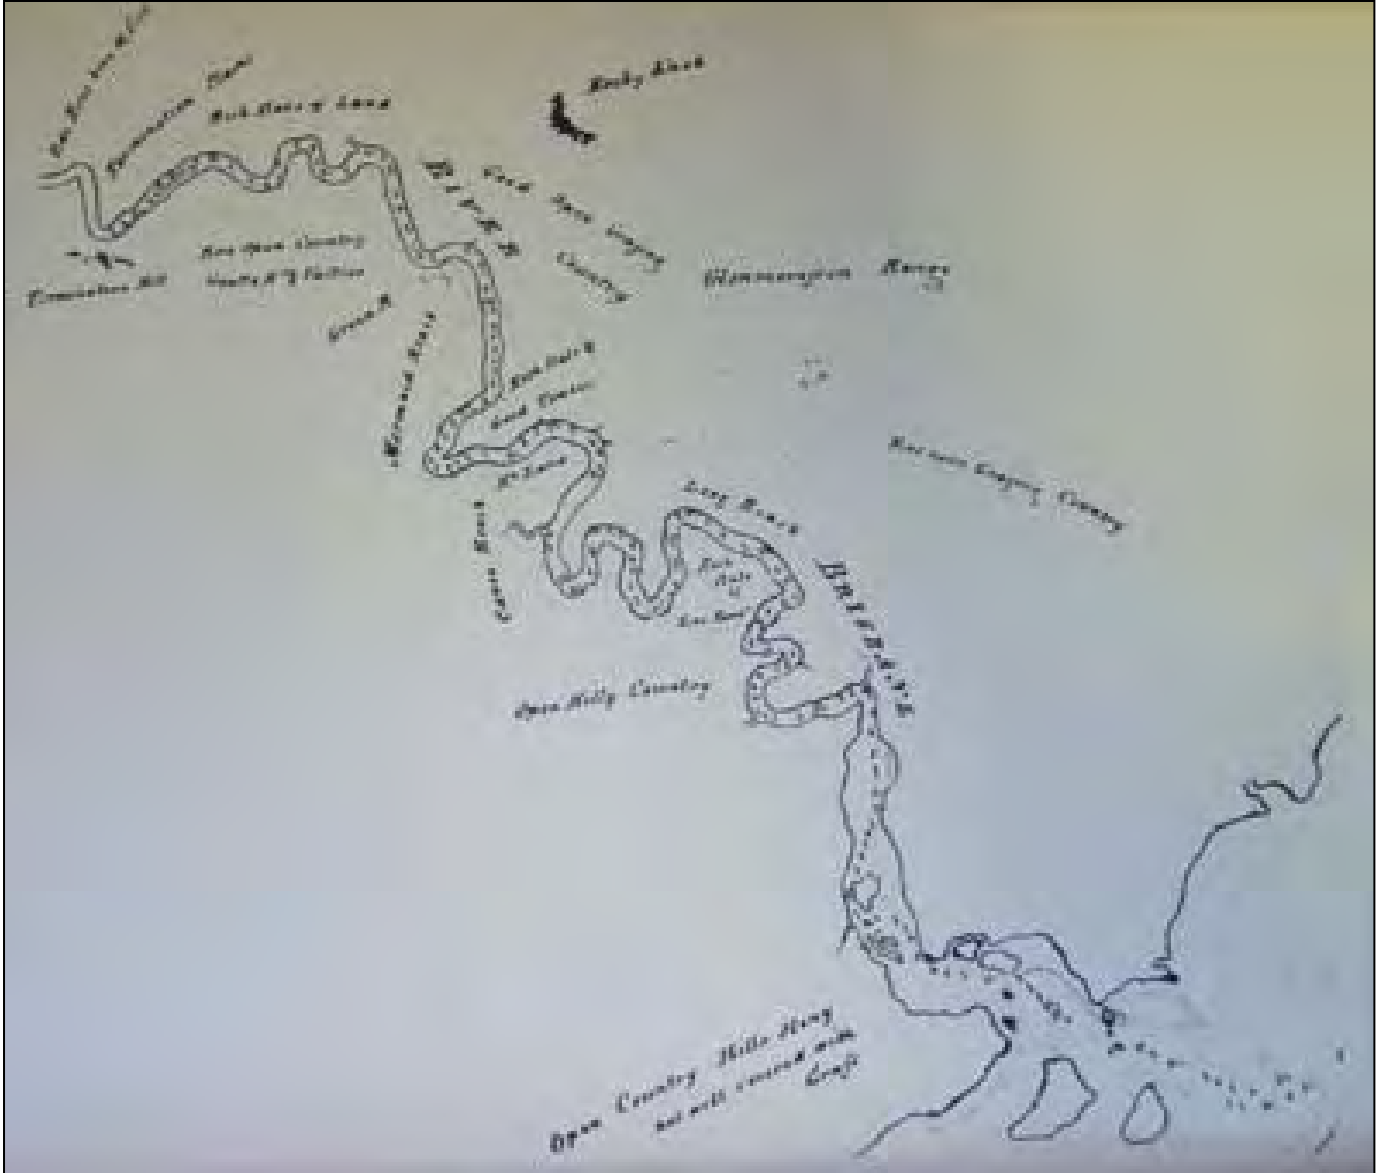
Figure 81: Chart of the Brisbane River, as surveyed by John Oxley in 1823. (Source: Survey Office Brisbane)

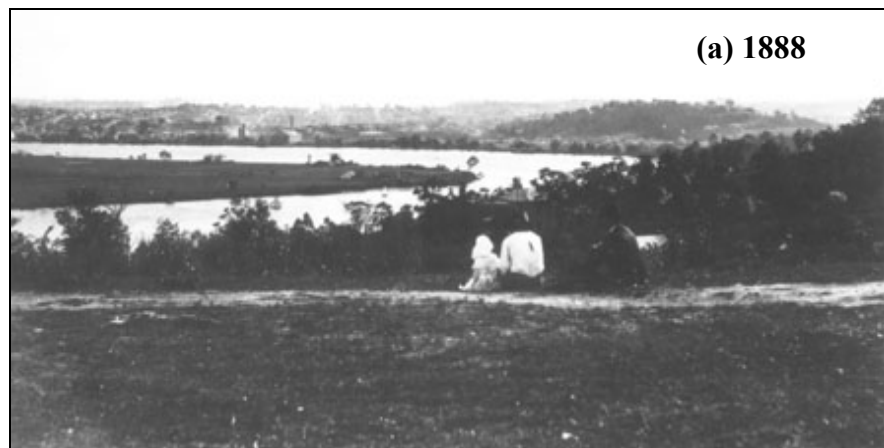
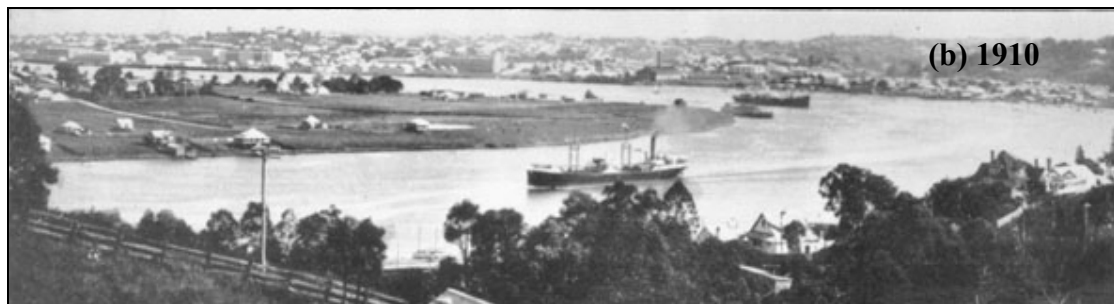
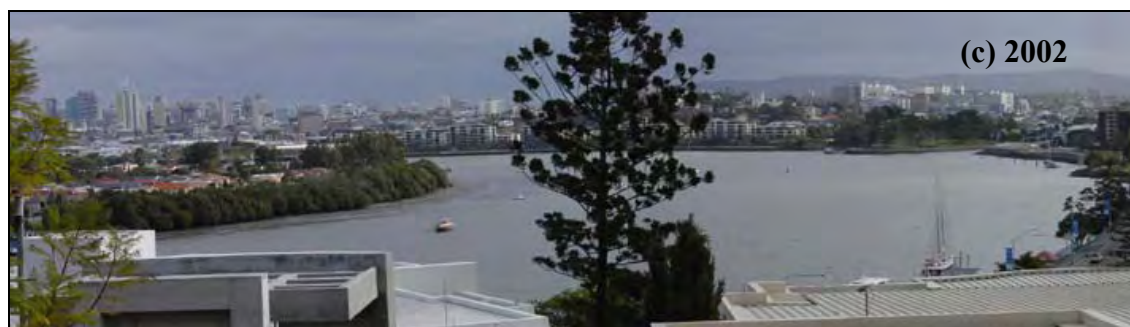
Figures 82(a), (b) & (c): The changing view of Bulimba Reach, showing increases in urban development and construction. (Sources: (a) & (b) John Oxley Library; (c) Norm Duke)

Figures 82a), b) and c) show the changing view of Bulimba reach, in 1888, 1910 and 2002, respectively. The photo time series shows increasing urban development and construction occurring, changing from a rural town, by today's standards, to a built-up city that we see today.

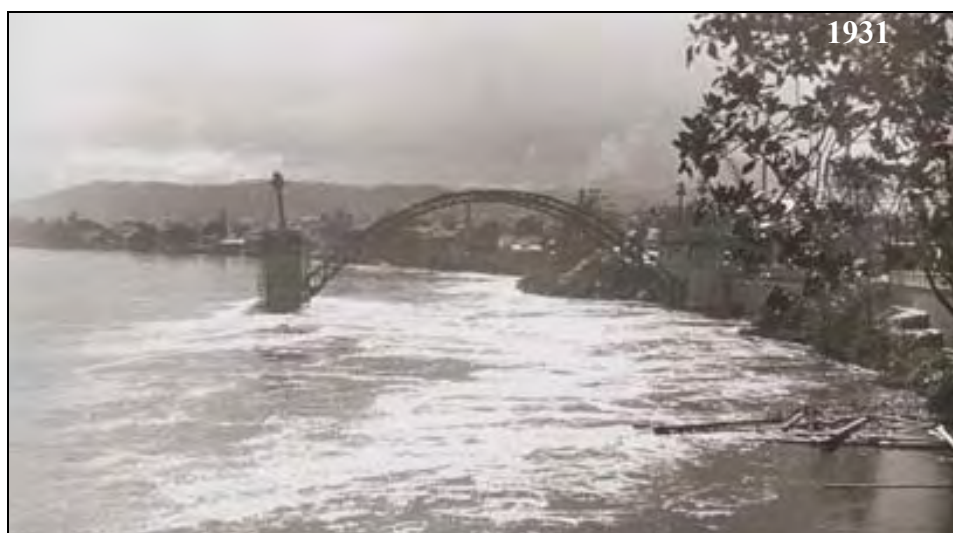
Figure 85: View of the river from North Quay during the major flood of 1931. (Source: Fryer Library, UQ)

A view of the Brisbane River during the major flood of 1931, from North Quay, can be seen in Figure 85. Figure 86 shows a view of the Old Victoria Bridge, when it was under construction, in 1872.

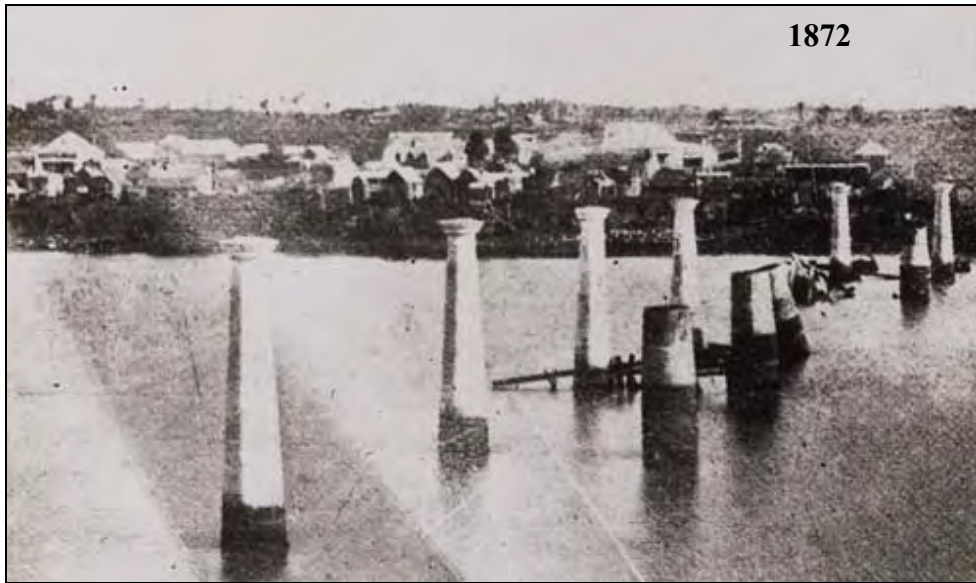
Figure 86: Old Victoria Bridge, under construction in 1872. (Source: Fryer Library, UQ)

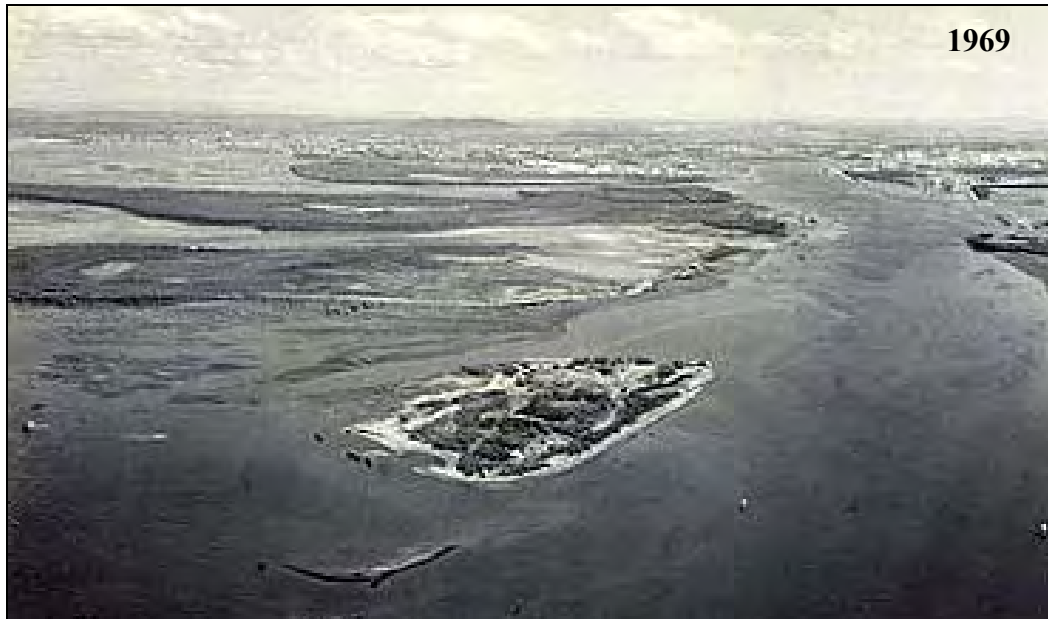
Figure 90: The mouth of the Brisbane River in 1969, prior to major development of Fisherman Islands by the Port of Brisbane Authority. (Source: Brisbane City Council)

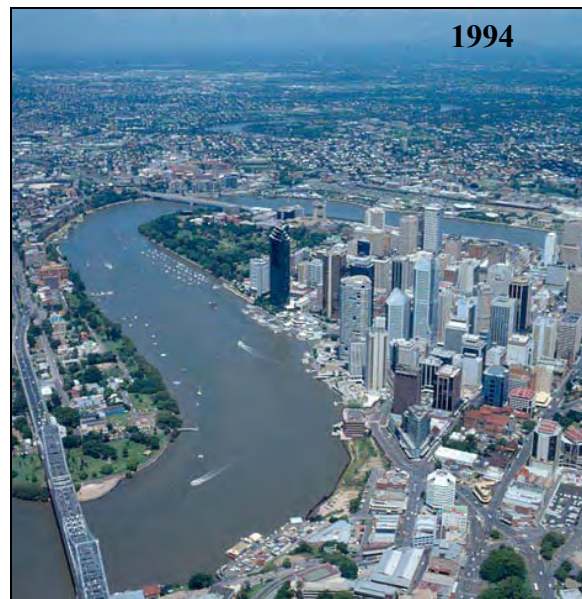
Figure 93: Aerial view of Brisbane River at the Brisbane City Centre, showing substantial urban developments and influences. (Source: Brisbane City Council)

The Brisbane River estuary runs through the heart of Brisbane City, Australia's third largest capital city, and is an area of intense urban, industrial and port activity (Figure 93 & 94). Anthropogenic impacts include population pressure, sewage inputs, sediment and nutrient loads, 'paving' of the landscape, reclamation activities, dredging and modification of the river, urban and industrial expansion and port developments at the river mouth.

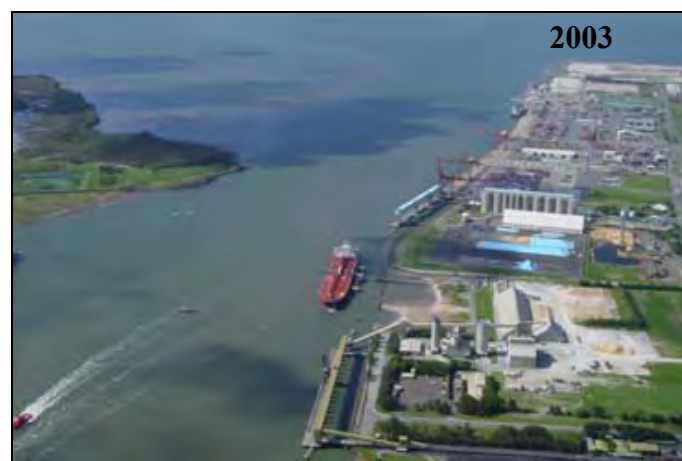
Figure 94: Aerial view of the Port of Brisbane at Fisherman Islands, at the river mouth. (Source: Norm Duke)

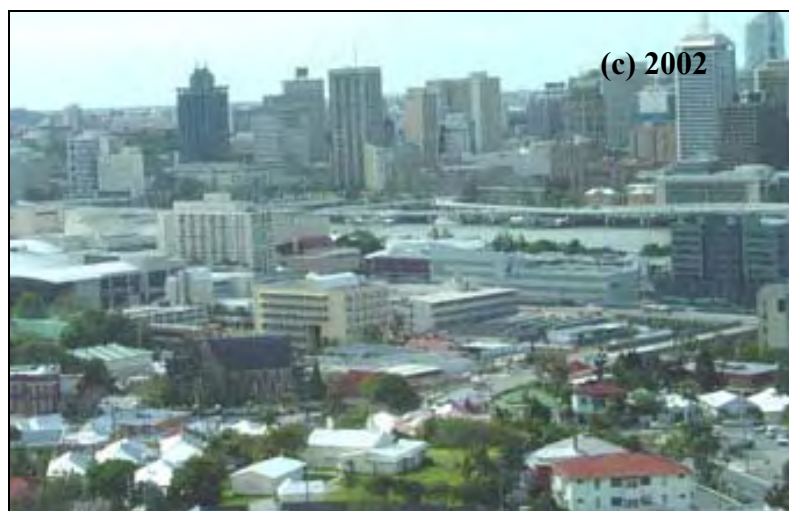
Figures 97(a), (b) & (c): The changing view from Highgate Hill, South Brisbane: in 1867, with scattered housing; in 1960, where the town hall dominates the city centre; and in 2002, where the town hall is no longer visible behind towering high rises. (Sources: (a) & (b) John Oxley Library; (c) Norm Duke)

From early times, recorded in early charts of the day, it was acknowledged that sediment deposition had increased significantly at the mouth. This was apparently exacerbated by the clearing of terrestrial and riparian vegetation upstream, hardening of city surfaces (Figure 97b), and increased run-off flows. The impact of this kind of disturbance on coastal processes has no equal in past times. For instance, Neil and Yu (1996) showed a relationship between catchment run-off and unit sediment yield in Queensland coastal catchments. When this model was applied to geological data of deteriorating late Holocene climate over 6-7 thousand years ago in the Brisbane River area, it showed mean flow-weighted sediment concentrations increased from about 90 mg/L to 150 mg/L (Capelin et al., 1998). By contrast, mean flow-weighted sediment concentrations increased to 525 mg/L as a consequence of land use intensification

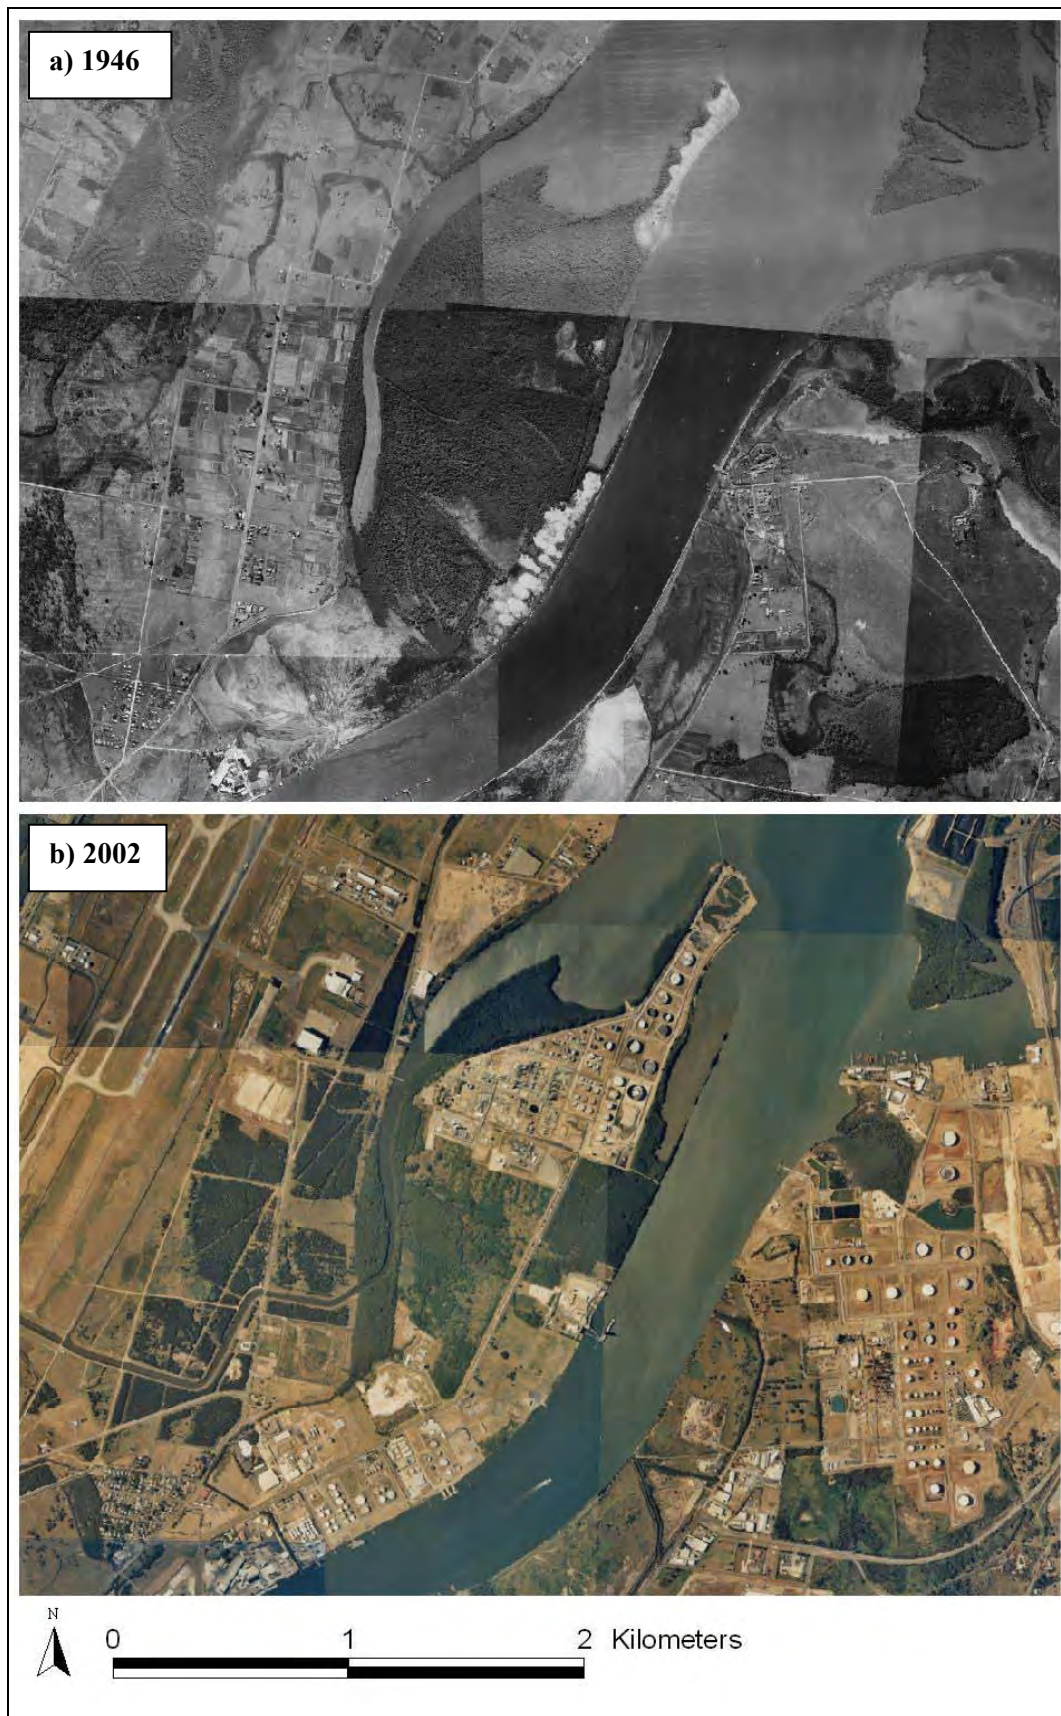
Figures 101a) and b). Mosaics of aerial photographs depicting Bulwer Island, Brisbane River, in a) 1946 and b) 2002.

Many changes have occurred to the wetland communities once present on Bulwer Island. A detailed timeline of this change, incorporating historical events, maps and photographs, is provided as Appendix 4. Figures 101a) and b) show close-up aerial photographs of the island in 1946 and 2002, respectively. Figures 102a) and b) are vegetation maps of the location, while Table 21 gives the comparative areas of wetland coverage. Over the period, net losses of 114

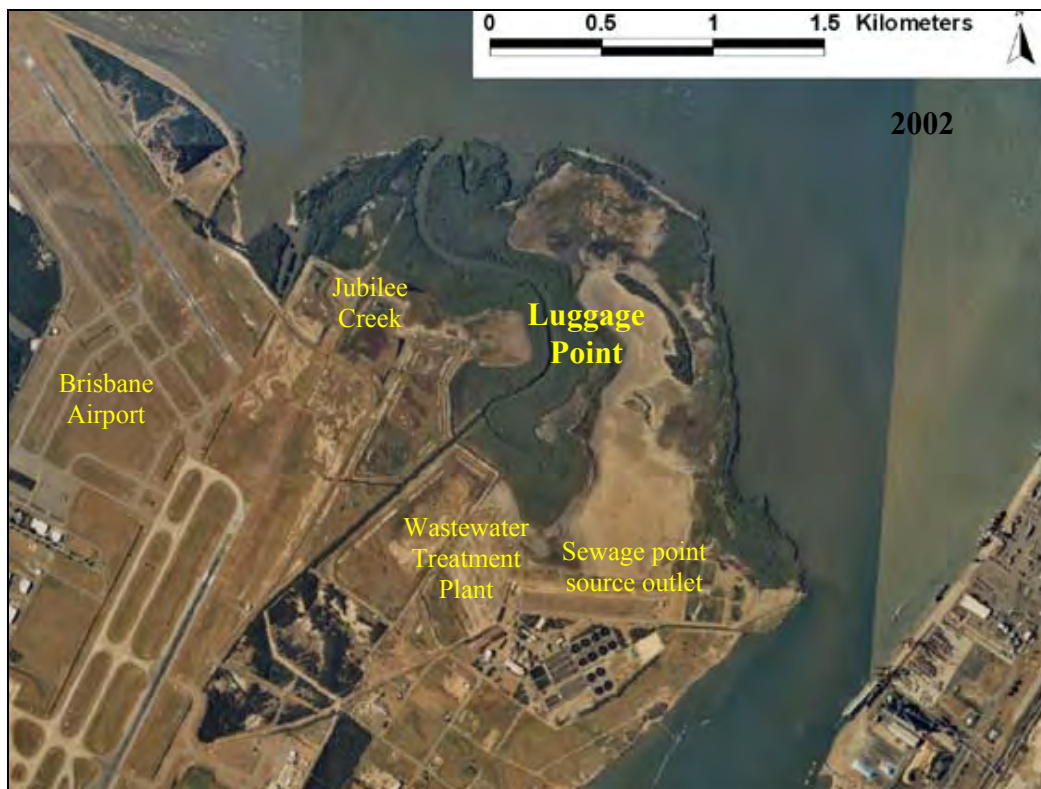
Figure 104: Luggage Point, at the mouth of the Brisbane River, is adjacent to a sewage treatment plant and Brisbane Airport.

Luggage Point is located on the northern tip of the mouth of the Brisbane River (Figure 92). The area is occupied by Luggage Point Wastewater Treatment Plant and point source outlet and Brisbane Airport (Figure 104). The Luggage Point Wastewater Treatment Plant, which discharges its treated effluent into the Brisbane River to the south of the study area, is the largest wastewater treatment plant in Brisbane. Luggage Point also contains areas of wetland habitat. The largest area of mangrove vegetation is located around Jubilee Creek, a small tributary of the Brisbane River, which enters the region from the north. The dominant species of mangrove is *A. marina*, although the occasional *A. corniculatum* is also present. Inland from Jubilee Creek, to the east, there is an extensive saltpan. The saltpan is fringed on its outer edges by salt marsh and then mangrove vegetation. Several patches of these mangroves fringing the saltpan are currently dead or dying. Pools of impounded water have been observed on the outer edges of the saltpan, and large algal mats have been present since 1981 (e.g. Laegdsgaard and Morton, 1998).

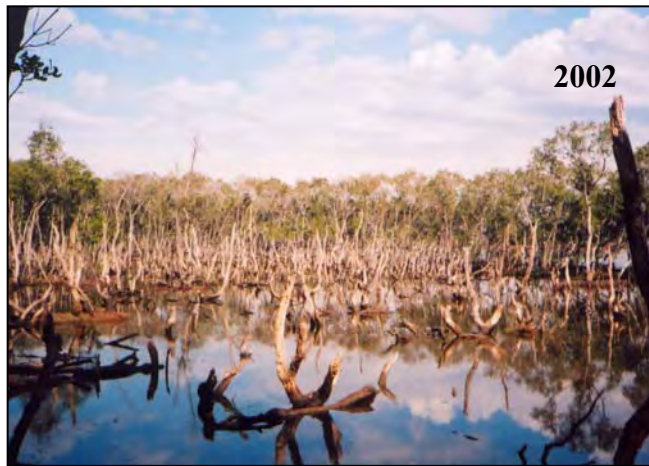
Figure 107: Pooled, impounded water surrounding dead mangroves at Luggage Point. (Source: Dan Pedersen)

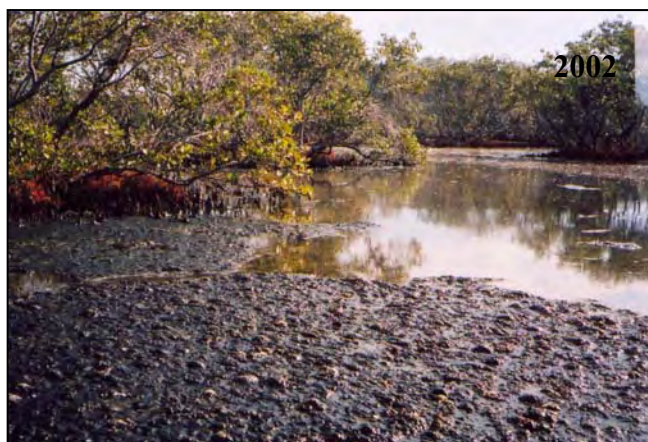
Figure 108: Extensive algal mats on the surface of the water and covering mangrove pneumatophores at Luggage Point. (Source: Dan Pedersen)

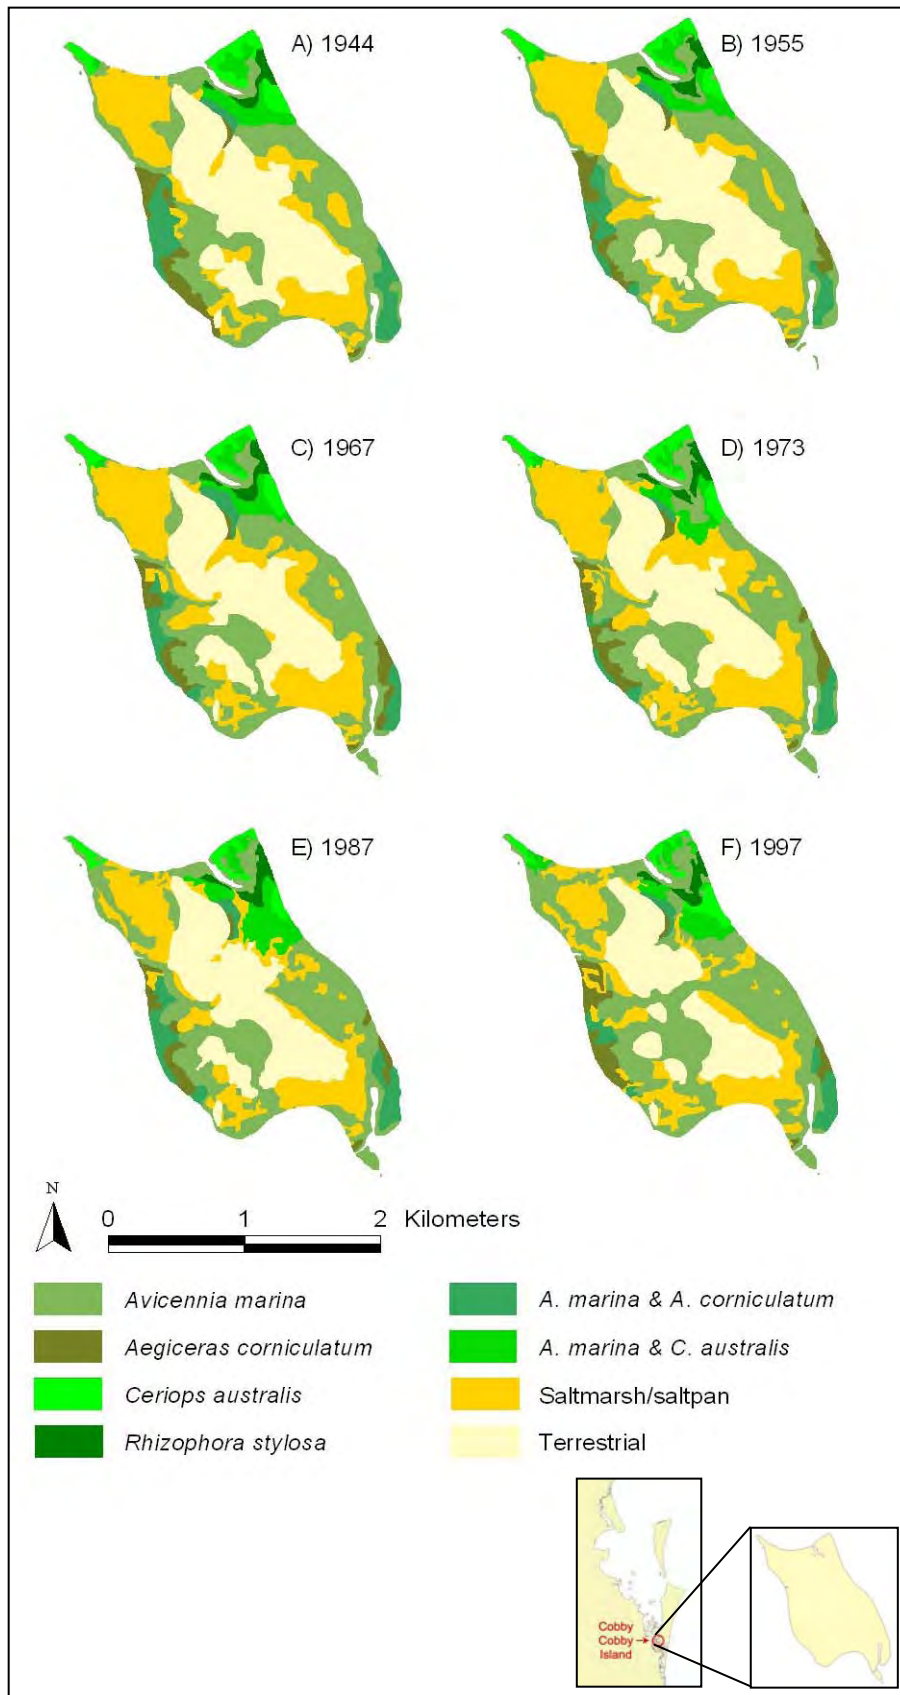
Figure 110: Time series of vegetation maps, showing different vegetation types on Cobby Cobby Island in 1944, 1955, 1967, 1973, 1987 and 1997.

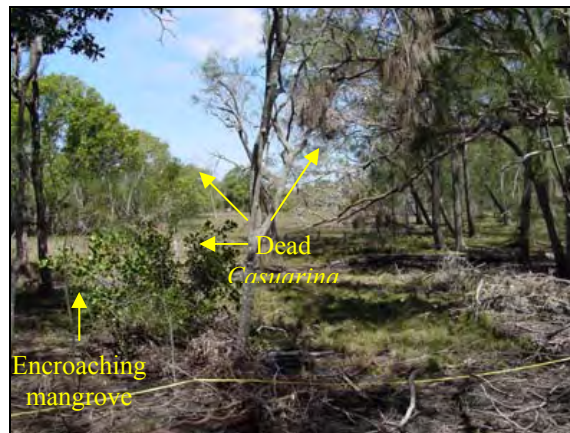
Figure 121: Dying and dead *Casuarina* trees were observed at the wetland-terrestrial interface on Cobby Cobby Island.

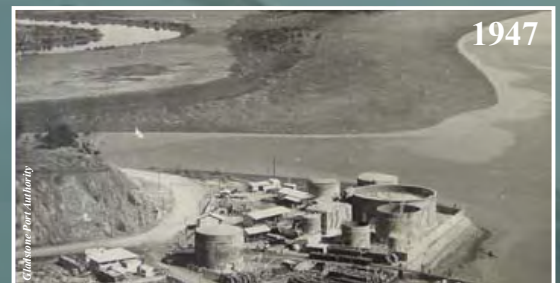
1947

Early aerial view of Shell Terminal on reclaimed land, Auckland Point Wharf.

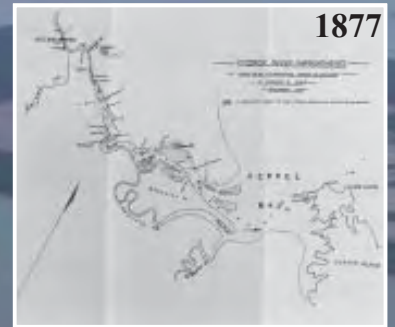
Chart of the Fitzroy River and its estuary as it appeared in 1877.

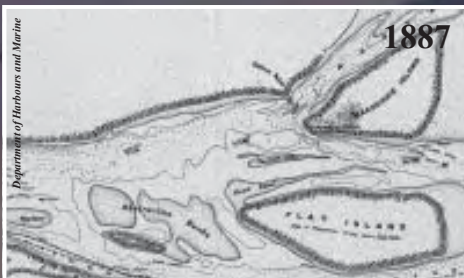
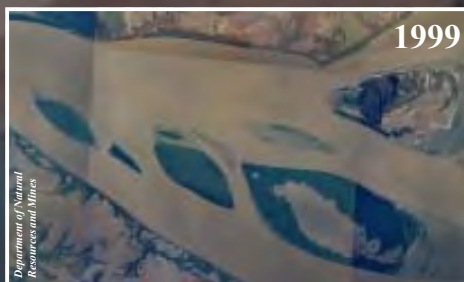
Changing view of river mouth from 1864 to 2002, showing the formation of new mangrove islands.

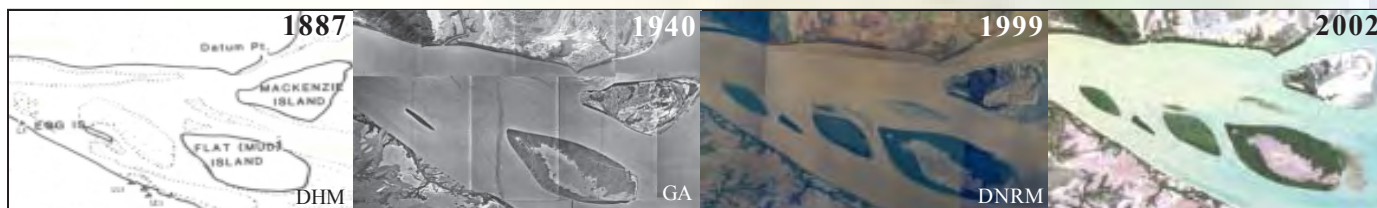
Appearance of new islands in the mouth of the Fitzroy River, revealed through comparison of an early chart (1887), early aerial photography (1940), modern aerial photography (1999) and satellite imagery (2002).

Maps will be drawn from images and charts of the day based on GIS (Geographic Information System) format as far as possible for detection and quantification of change. In some instances, there have been dramatic changes within the last century like the appearance of new mangrove islands in the mouth of the Fitzroy River (images below). The rate of deposition appears to have increased with the clearing of catchment vegetation but this question can only be answered with historical studies like this one.
