## Determining bridge deck deterioration through the use of 3D photogrammetry

DETERMINING BRIDGE DECK DETERIORATION THROUGH THE USE OF 3D  
PHOTOGRAMMETRY

A THESIS

CIVIL ENGINEERING

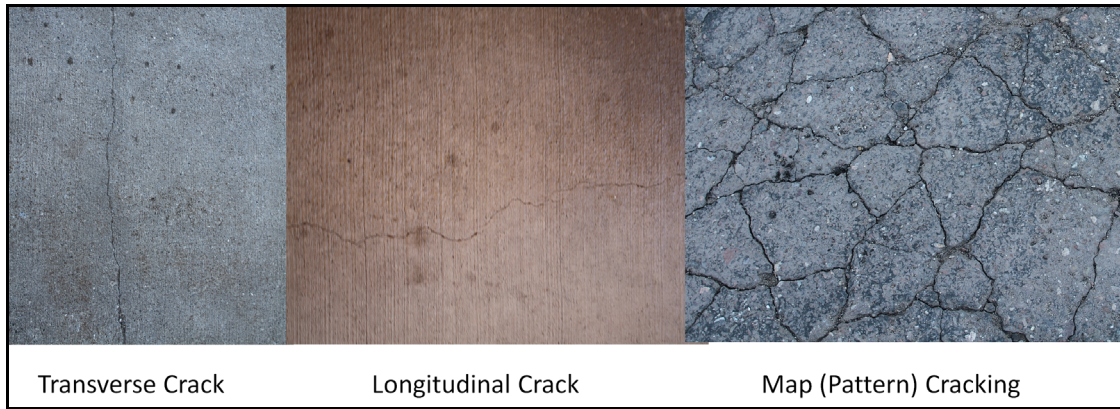
Surface cracks come in a variety of different types and widths with different causes behind them. The most common type of crack in bridge decks are transverse cracks which are often caused by restrained shrinkage and typically occur shortly after construction (Nowak et al. 2000). Pattern cracking or map cracking is cracking that occurs in random directions which can be caused by several factors such as freeze and thaw cycles and the steel corrosion process. There are several other varieties of cracks that can be present including longitudinal and diagonal cracks (Nowak et al. 2000). Examples of the main types of cracks can be seen in Figure 2.1(Federal Highway Administration (FHWA) 2006). A trained bridge inspector can determine the presence of other problems with knowing the type of cracks present on the bridge. While the size of the cracks can vary from hairline to several inches, the magnitude of the cracks considered ranged from 1/16 in. (1.59 mm) to 3/16 in. (4.76 mm) in width (FHWA 2006).

**Figure 2.1: Different Crack Types**

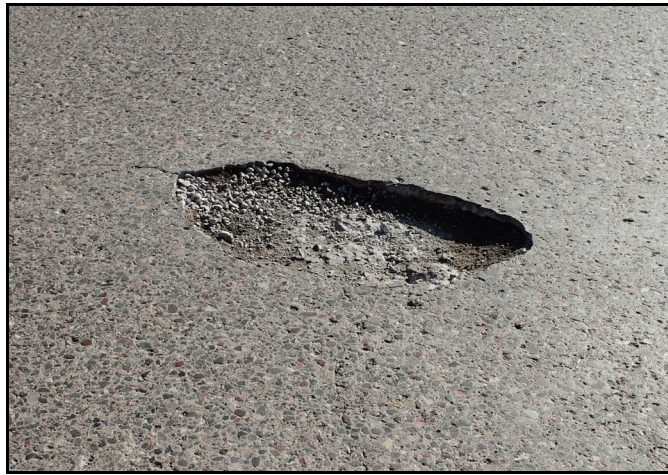
The next deterioration mechanism appears when corrosion occurs on the reinforcing steel causing expansion of the reinforcing steel. This triggers the concrete to crack around the corroded rebar leading to delaminations above the rebar. Once the concrete above the delamination breaks away from the surface, it leaves a hole in the surface creating a spall.

An example of spalling on a concrete bridge deck can be seen in Figure 2.2. Scaling is a deterioration mechanism similar to that of spalling with different sources for the material loss. Scaling is an issue with the deck surface that is caused by a loss of material due to material degradation as seen in Figure 2.3. The magnitude of  $\frac{1}{4}$  in. (6.35 mm) in depth is the minimum considered with spalling and scaling measurements when a bridge inspector is recording the deck condition (FHWA 2006).

**Figure 2.2: An Example of a Spall**

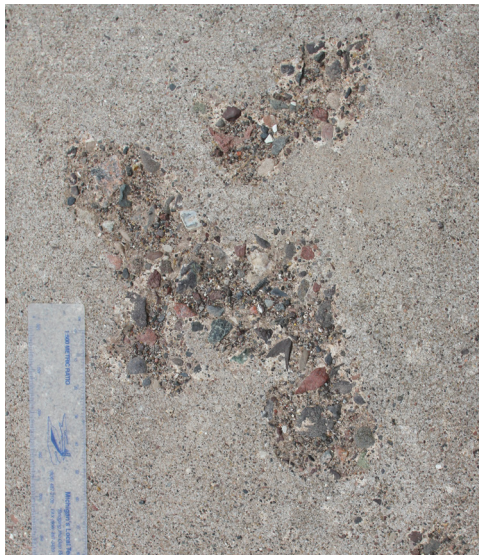
**Figure 2.3: An Example of Scaling**

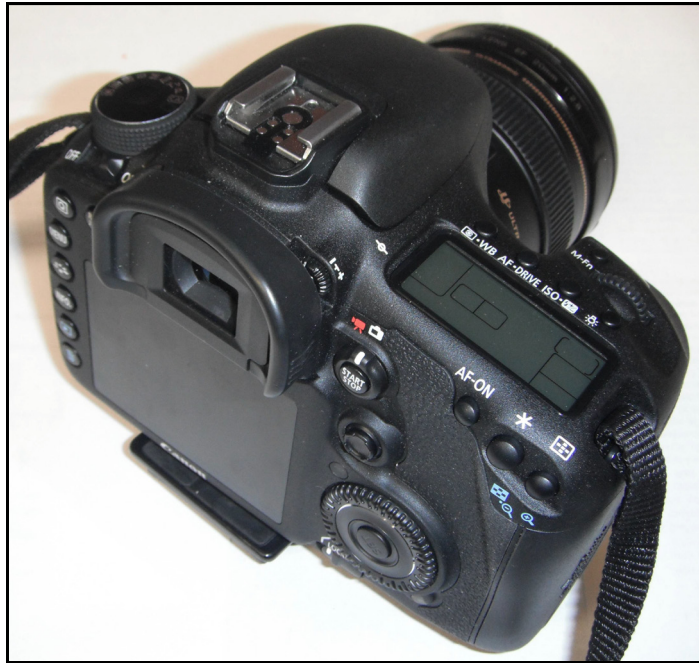
The camera that was chosen for this project was the Canon EOS 7D. A high-performance digital SLR camera with a CMOS sensor has about 18 effective megapixels along with capabilities to take approximately 8 frames per second during continuous shooting. Determined to have the best overall properties for the applications in this study, yet affordable enough while providing the necessary speed and resolution. For determining the capability photogrammetry can provide in determining deterioration mechanisms in bridges. Figure 3.1 shows the camera that was used for taking all the images that were used in the modeling applications in this study.

**Figure 3.1: Canon EOS 7D Camera**

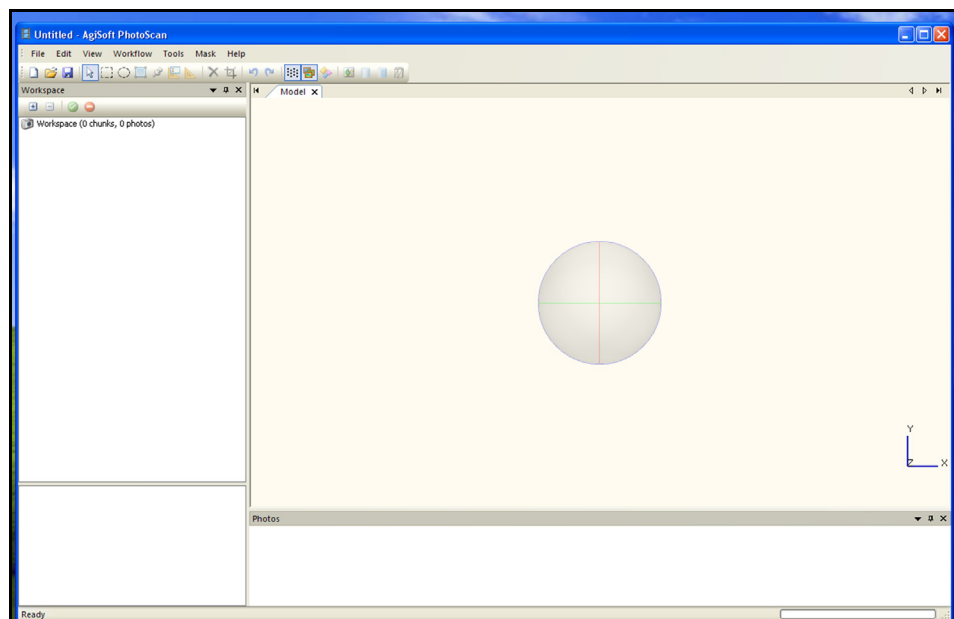
AgiSoft PhotoScan was the program chosen to complete the work for this study (AgiSoft LLC. 2010). The user interface of the program is shown in Figure 3.2. One of the factors that led to the decision to use AgiSoft PhotoScan was that it uses automatic image recognition to align the photos being processed. Processing the images in the program takes varying amounts of time depending on variables such as the number of images used and the computing power of the computer. One option within the program to speed up the process is to mask the parts of the photo that do not need to be modeled thereby decreasing the complexity of the model. Masking also allows the program to concentrate on modeling the desired area. Once the points for the model have been calculated, a model can be generated from the point cloud using several different options.

**Figure 3.2: Screen Shot of AgiSoft Program**

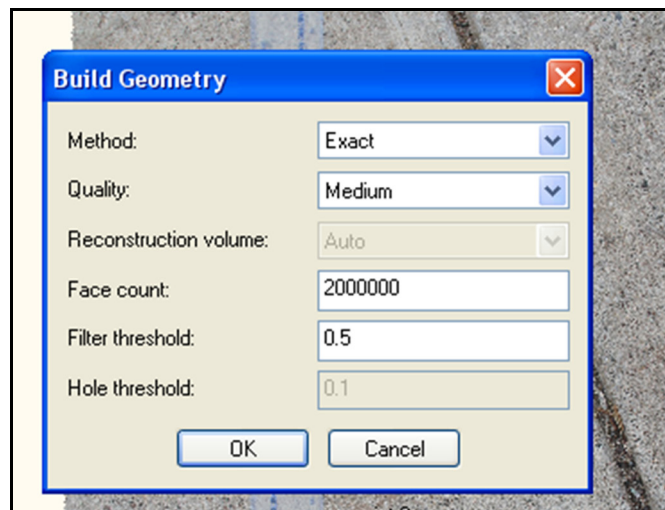
The different options were reviewed and the best options were chosen to create a 3D model based upon the desired model accuracy of the output for the model and the amount of computing power being used. This is a balancing act that needs to be decided upon by the user to achieve the best and most efficient results for the modeling for the particular application. Keeping this in mind, the chosen parameters for the modeling done in this study included choosing the exact method for reconstructing the surface model and medium quality was chosen to help increase the speed the processing that could be completed. The program default values were used for face count and filter threshold which were 200000 and 0.5, respectively. The final selections can be viewed in Figure 3.4.

**Figure 3.4: Building Geometry Final Selections**

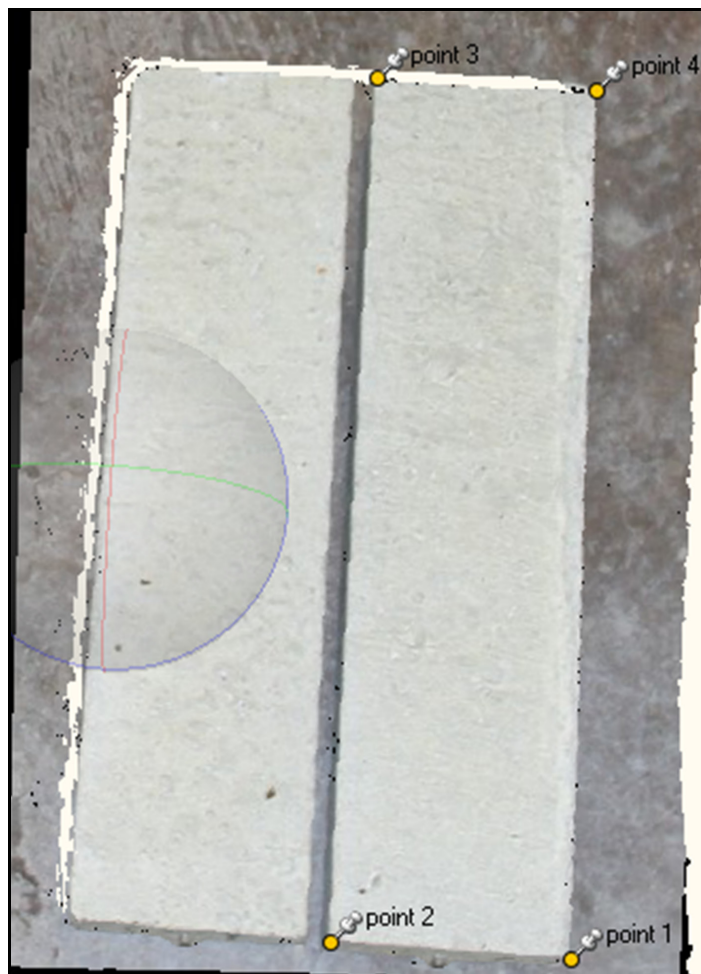
The DEM is setup through the user making points on the model that are recognizable and have known measurements. Figure 3.6 shows an example of four points that were marked in the model. Once marked, a keypoint file is created in which the coordinates of the points are given, allowing the program to accurately align all the points. An example of a keypoint file is shown in Figure 3.7 with the coordinates for four points set up. Creating accurate coordinates of the points inside the model where before the values could be measured, but are only correlated to each other not to actual measurements. This allows the model to be opened in a variety of 3D modeling programs for further analysis (See Section 3.5).

**Figure 3.6: Points Marked in AgiSoft to Create DEM**

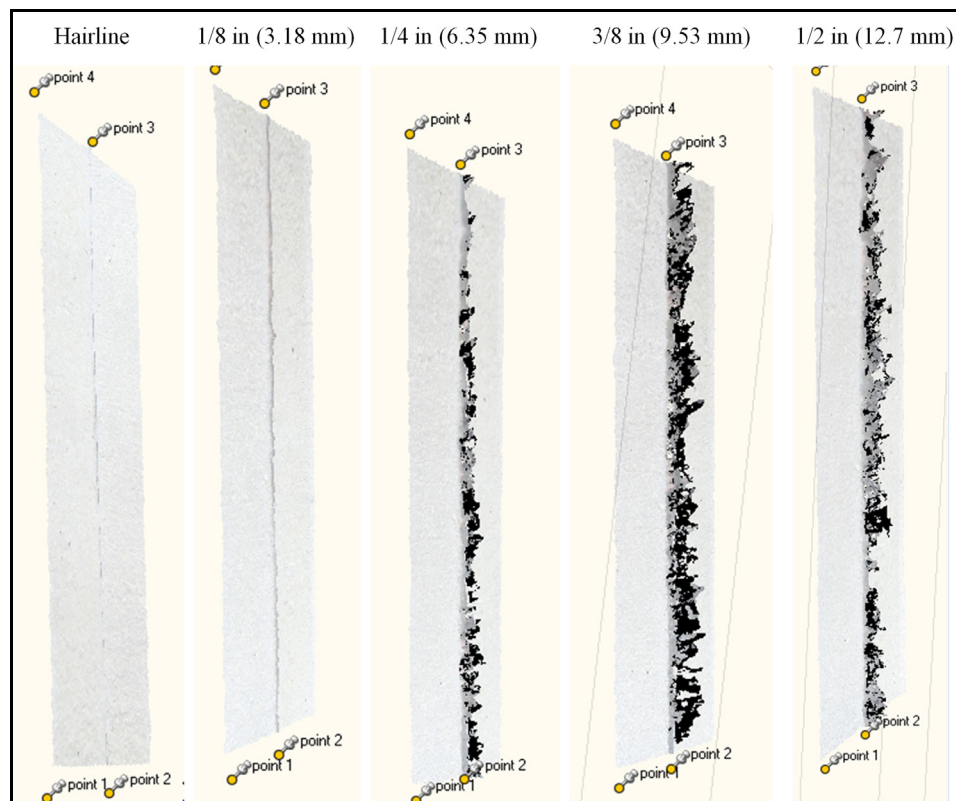
The first experiment was conducted with the five photos of each specimen and is shown in Figure 4.1. Screen shots from PhotoScan of each of the different models were created for the crack width as a comparison. The view of the models is of the underside of the surface showing the points below the surface. In Figure 4.1, it can be observed that once the crack width reached  $\frac{1}{4}$  in. (6.35 mm) the points below the surface become prevalent. This shows that that  $\frac{1}{4}$  in (6.35 mm) cracks are apparent and that if an algorithm were created to measure the points differentiating from the deck surface it would pick up the points in any crack greater than  $\frac{1}{4}$  in (6.35 mm) as long as it is not filled with other materials.

**Figure 4.1: Agisoft PhotoScan models for the Different Crack Widths with Five Photos Modeled from Two Feet Away**

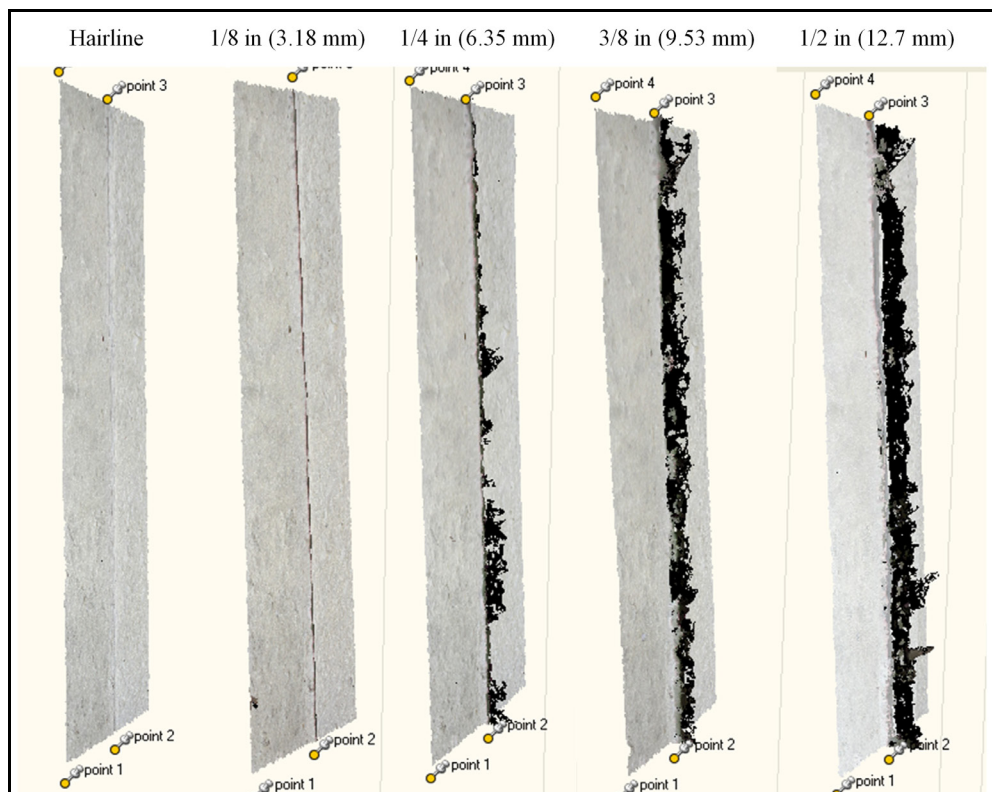
Figure 4.2 shows the results from the second experiment conducted which was similar to the first experiment with the difference being fifteen photos used instead of the five. The results from this experiment, as can be seen, are similar to the first experiment which shows that the increase in photos did not lead to increased accuracy based upon the PhotoScan models. More points were created with these models, but appear to offer little or no increased accuracy with these models although there was a decrease in noise. This led to the use of fewer photos in the next experiments to help reduce the amount of processing time for the models.

**Figure 4.2: AgiSoft PhotoScan models for the Different Crack Widths with Fifteen Photos Modeled from Two Feet Away**

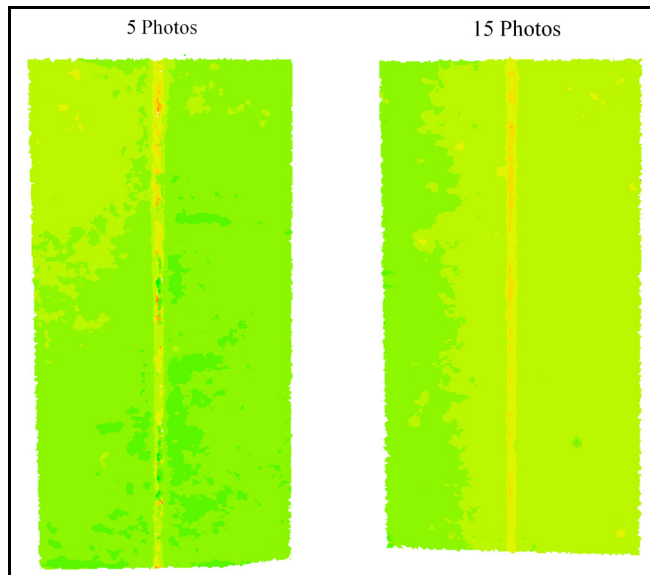
The measurements were then analyzed in ArcMap which allowed for the visualization of elevation differences. Using elevations showed some difference from the results taken from AgiSoft PhotoScan. One difference concluded was that the images from the fifteen photos compared to the five photos seemed to be much clearer as far as definition of the crack area as seen in Figure 4.3. This shows that the model has less noise with more photos, but does not necessarily correlate to greater accuracy due to the increase in points in the model.

**Figure 4.3: Comparison of 5 Photos to 15 Photos using 1/4 in. (6.35mm) Crack Specimen in ArcMap**

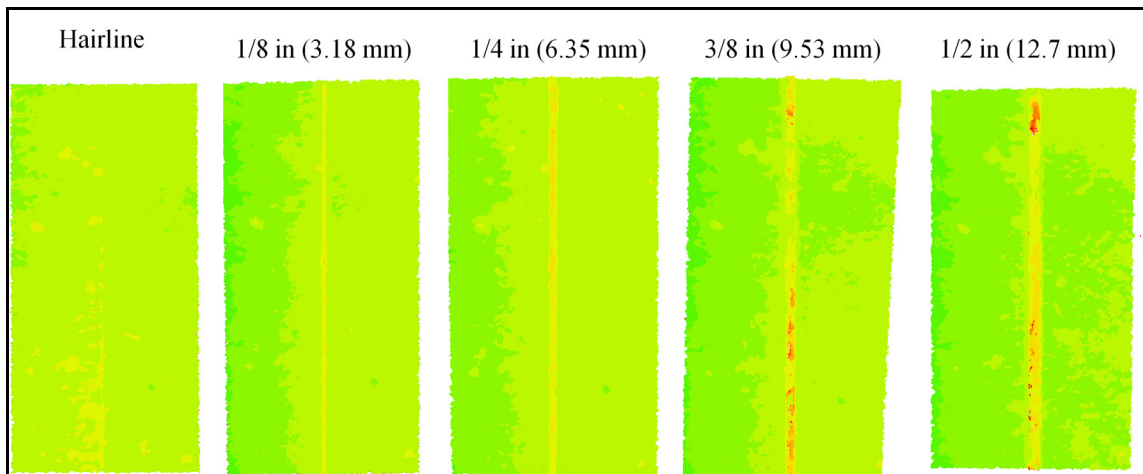
The ability to measure cracks based on the DEM created from the model is based on measuring the change in elevation. DEMs of the five different crack widths at 2 ft (61 cm) away can be seen in Figure 4.4. This shows that a 1/8 in. (3.18 mm) crack could be resolved by the technique using a 0.079 in. (2 mm) elevation change. The slight change in elevation will make transferring this accuracy to the field difficult but does show the capabilities of 3D photogrammetry. DEMs of all the models are available in Appendix A.

**Figure 4.4: Comparison of Cracks at 2 Feet Away**

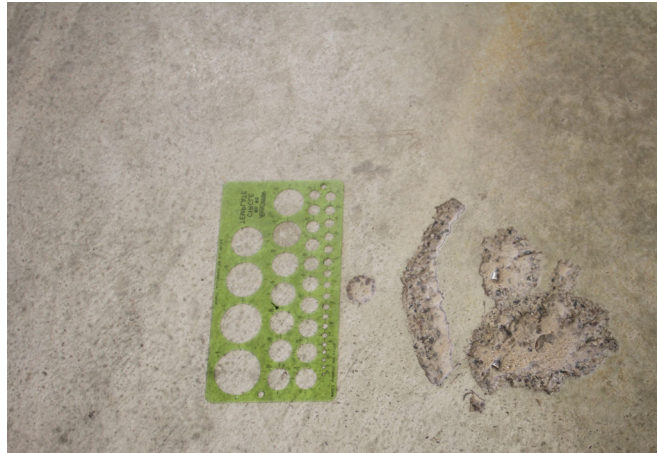
The first scaling test was completed using one of the concrete lab floors and is shown in Figure 4.5. The DEM of the scaling is shown in Figure 4.6, and shows the elevation at 0.079 in. (2 mm) of elevation bands. The elevation model shows four different scales that were in this section of the concrete with the smallest one being about 1 in. (2.54 cm) in diameter on the far left. Based on the elevation changes, the deepest scale was 0.157 in. to 0.236 in. (4 to 6 mm) in depth. The results show that scales in this floor were able to be detected using this technique.

**Figure 4.5: Picture of Scales in Test 1**

The final scaling test was done for the same scales as those in the first scale test shown in Figure 4.5. The scale on the bottom right was 1.5 in. (3.81 cm) in diameter and ¼ in. (6.35 mm) in depth as seen in Figure 4.21. With the difference being the standoff distance was 5.5 ft (1.68 m) from the scales. The scales in this case were any elevation below 3.26 ft (0.994 m) for the whole model where local scaling could be considered on the top center of the model below 3.27 ft (0.996 m) as seen in Figure 4.21. The percentage of scaling was 0.18 percent based on the raster cells from Figure 4.22.

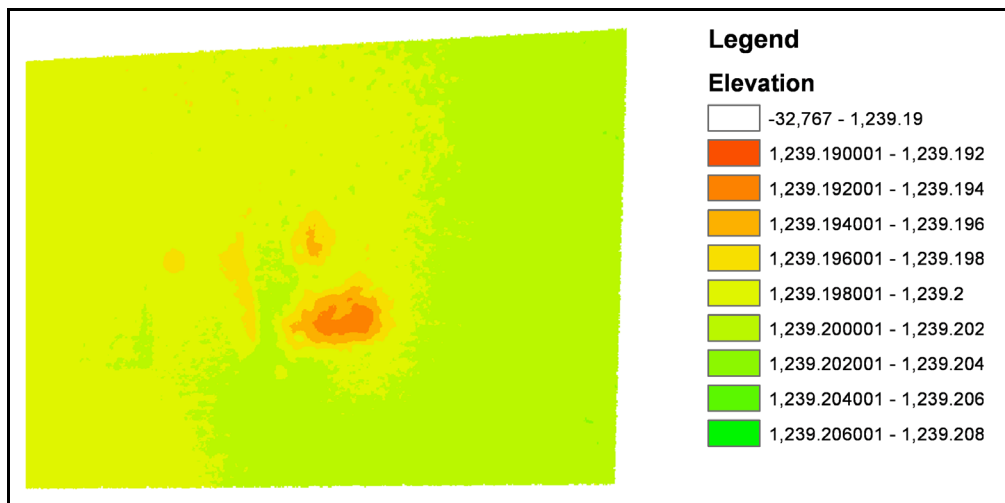
**Figure 4.6: Elevation Model of First Scale Test**

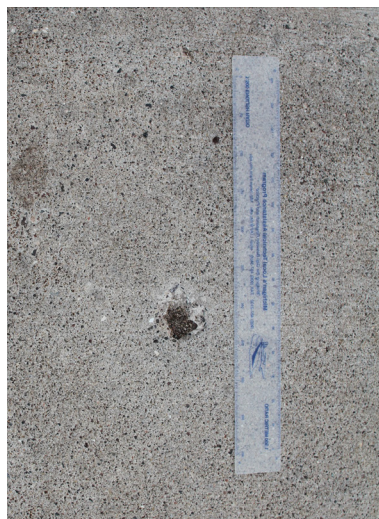
The results in second experiment considered a smaller single scale which is shown in Figure 4.8. The DEM is shown in Figure 4.9 in which the spall can be seen to have about a 0.157 in. to 0.236 in. (4 to 6 mm) elevation change. This scale was located by itself which made isolating its measurement possible, and as can be seen it was able to be measured using 3D photogrammetry. The percent area of scaling was calculated in this model taking any elevation below 4065.604 ft (1239.196 m) while extracting the raster cells between -107,503 to 4065.558 ft (-32,767 – 1239.182 m). The percent area scaled was 0.64 percent of the area based on the raster cells from the histogram shown in Figure 4.10.

**Figure 4.8: Picture of Scale in Test 2**

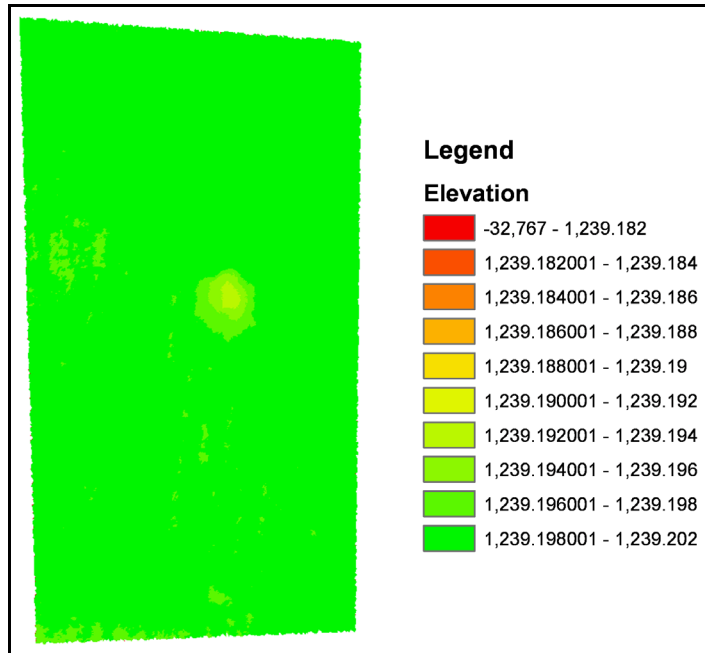
**Figure 4.9: Elevation Model for Scale in Test 2**

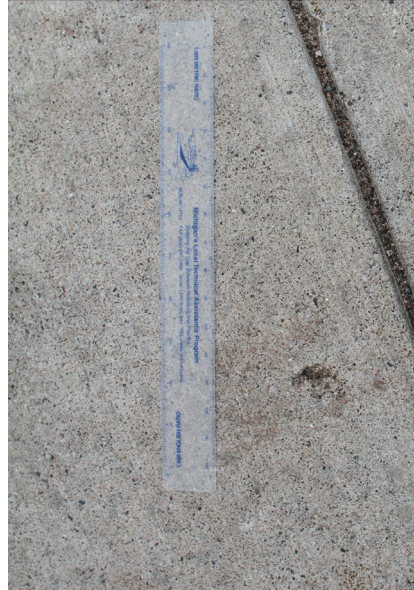
**Figure 4.11: Picture of Scale in Test 3**

The third test was similar to that of the second test, but with the scaling being smaller than the one in the second test. Figure 4.11 shows a picture of the scale which is in between the ruler and the joint in the sidewalk. The scale was able to be measured as seen in Figure 4.12, but only had an elevation change of about 0.157 in. (4 mm) and had a

0.75 in. (19.1 mm) diameter. This would be on the edge of what will be discernable from that of regular surface roughness.

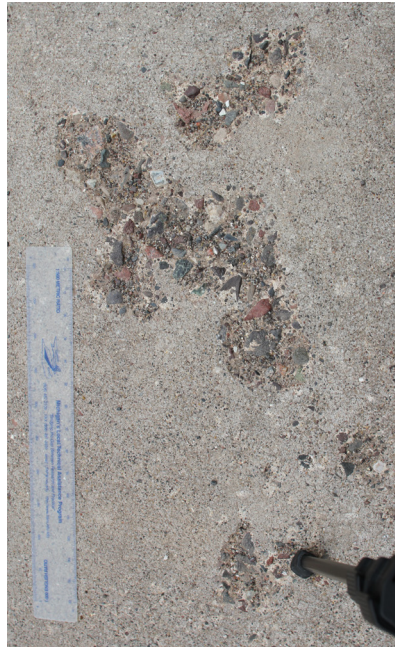
The fourth test completed was taken of an area with significant scaling to show an area with several scales as can be seen in Figure 4.14. The DEM is shown in Figure 4.15 and several different areas can be seen to be scaled as expected. These scales are not very deep with an elevation change of 0.236 in. to 0.315 in. (6 to 8 mm) of change. To calculate the area of scale in this model, any value below 4062.329 ft (1239.198 m) was taken as a scale using the point information from the histogram in Figure 4.16. This percentage was calculated to be 15.38 percent in this model. This showed an area with a much larger percentage of scaling relative to previous experiments, validating that the technique works for larger areas also.

**Figure 4.14: Picture of Scaling in Test 4**

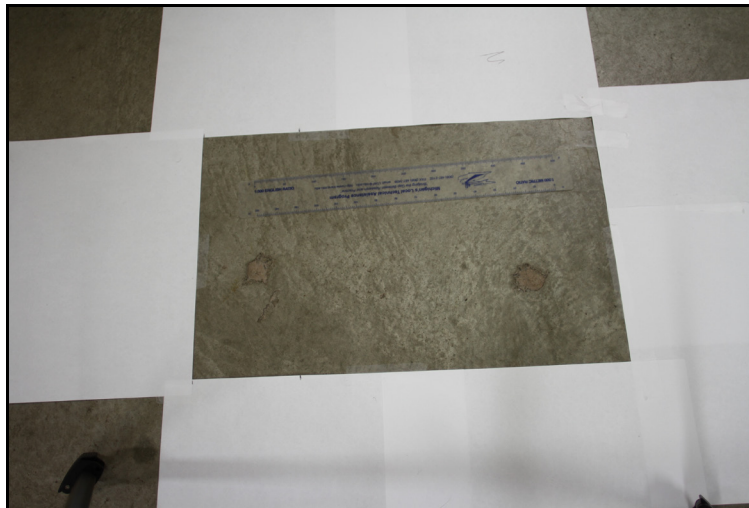
The fifth scaling test was setup up differently from the first four tests as an area was formed around the scales using paper as seen in Figure 4.17. Allowing the scaling area of the model to be calculated and compared to the actual measured value. For the DEM shown in Figure 4.18 the scales were taken as the raster cells under 3.26 ft (0.994 m). Both scales were visible in the image with the one on the left being 7/8 in. (22.23 mm) in diameter and 1/8 in (3.18 mm) in depth. The scale on the right was 1 in. (25.4 mm) in diameter and 1/4 in. (6.35 mm) in depth.

**Figure 4.17: Picture of Scale Test 5**

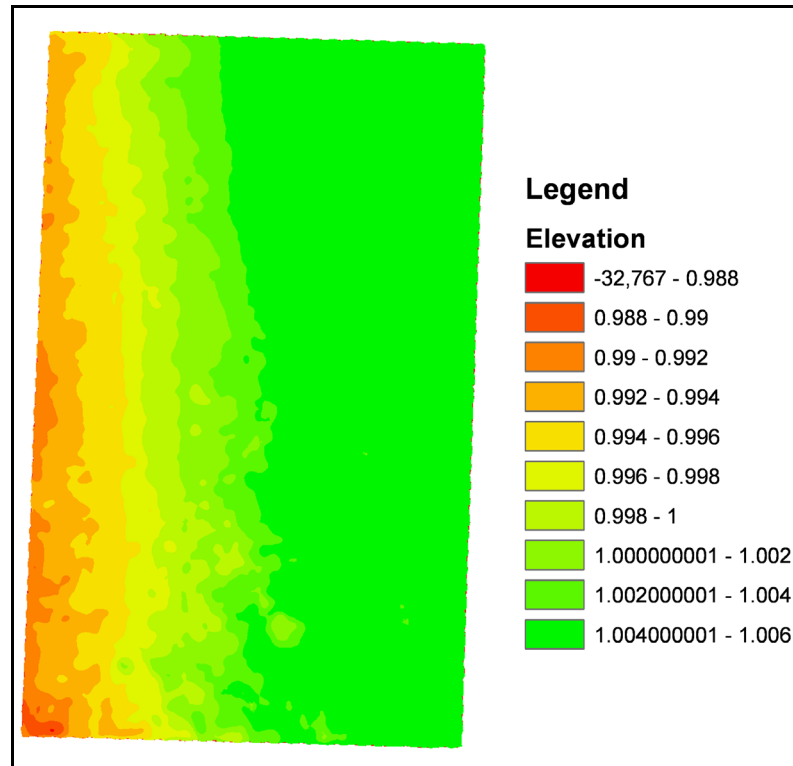
Scaling test six consisted of looking at the same scaled section as in test five, but at a standoff distance of 5.5 ft (1.68 m) instead of the 2 ft (61 cm). The DEM is shown in Figure 4.20 and shows that the spalls were unable to be resolved at this distance from the scales.

**Figure 4.20: Elevation Model of Scaling in Test 6**

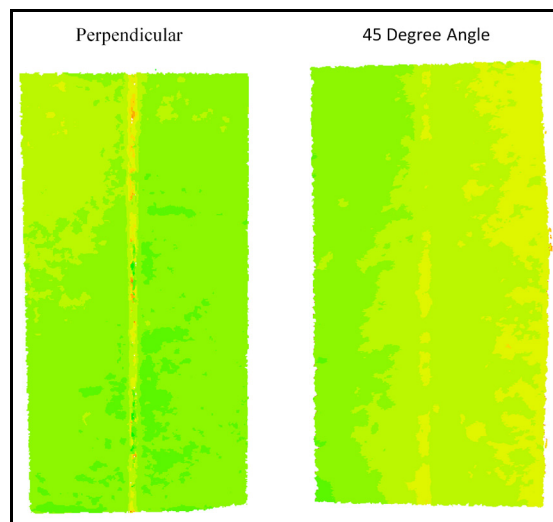
The angle of the camera has the potential to influence 3D photogrammetry and was tested to see how it would affect the ability for measuring surface deterioration mechanisms. Previously noted tests were conducted at a camera angle of 90 degrees to the specimen surface Figure 4.23 shows the comparison of DEMs generated using photos taken perpendicular (90 degrees) to the surface along with photos taken at 45 degrees to the surface. It can be seen that in the perpendicular DEM the  $\frac{1}{4}$  in. (6.35 mm) crack is able to be resolved while with the 45 degree camera angle the crack was not able to be resolved, confirming what the AgiSoft PhotoScan user manual stated in that it was best to take the pictures perpendicular to the surface than at an angle. This was completed with the camera moving perpendicular to the crack along the x-y plane, which would be the surface of the specimen, which could have made seeing the crack more difficult than if the camera was moved parallel along the x-y plane, but cracks can be in any direction. The smallest crack detectable using an angle of 45 degrees was  $\frac{1}{2}$  in. (12.7 mm) crack at 2 ft (61 cm) away which is considerable worse than  $\frac{1}{8}$  in. (6.35 mm) using parallel images. This makes using an angled camera not a good alternative to one perpendicular to the surface. The DEMs of all the crack widths are included in Appendix A.

**Figure 4.23: Comparison between Different Camera Angles for  $\frac{1}{4}$  in. (6.35 mm) Crack**
