Full-scale testing of a damaged reinforced concrete frame in fire

This paper will describe the progress on a collaborative project involving a number of institutions in India and the UK (2008–2011). The key aim of this project has been to carry out possibly the first ever large-scale tests to understand the behaviour of damaged reinforced concrete (RC) frames in fire. Considerable new understanding was gained on the behaviour of steel-framed composite structures in fire from the Cardington test in the mid-1990s (British Steel, 1999) and a large collaborative project on

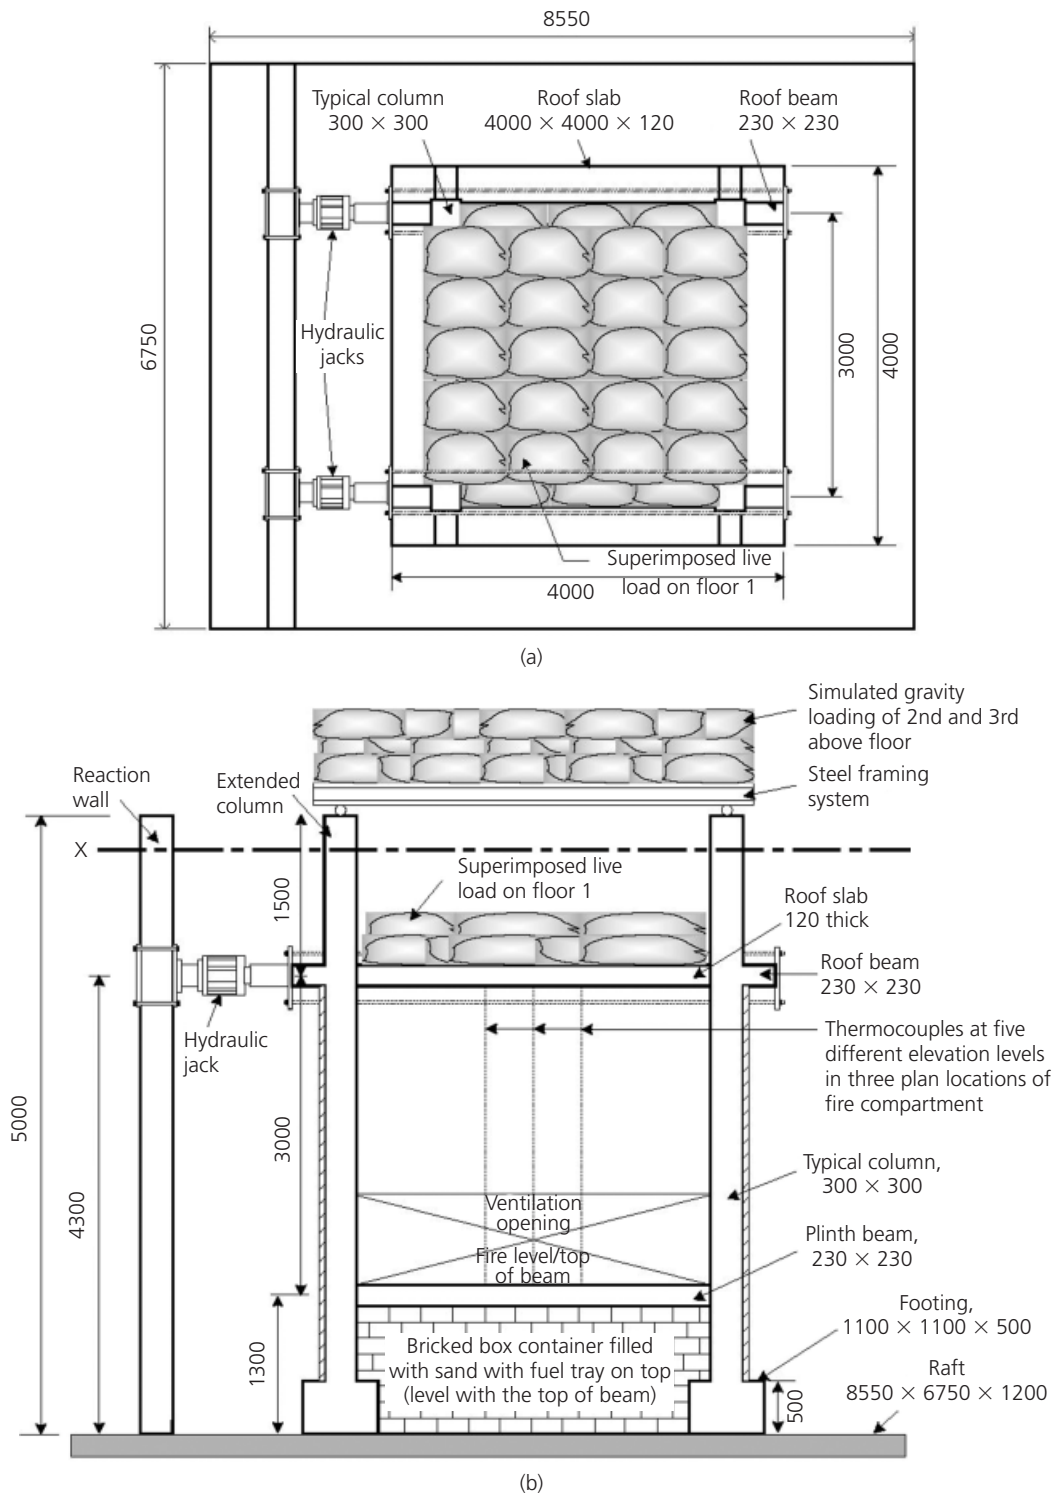
Figure 1. Schematic view of the test set-up: (a) plan of the test set-up; (b) elevation of the test set-up (all dimensions in mm)

level of FEMA 356:2000 (FEMA, 2000). Figure 1 shows a schematic diagram of the front elevation of the test frame set-up with key dimensions. The frame was tested on a 1.2 m thick raft of dimensions 6.75 m × 8.55 m (Figure 1a). The lateral load was

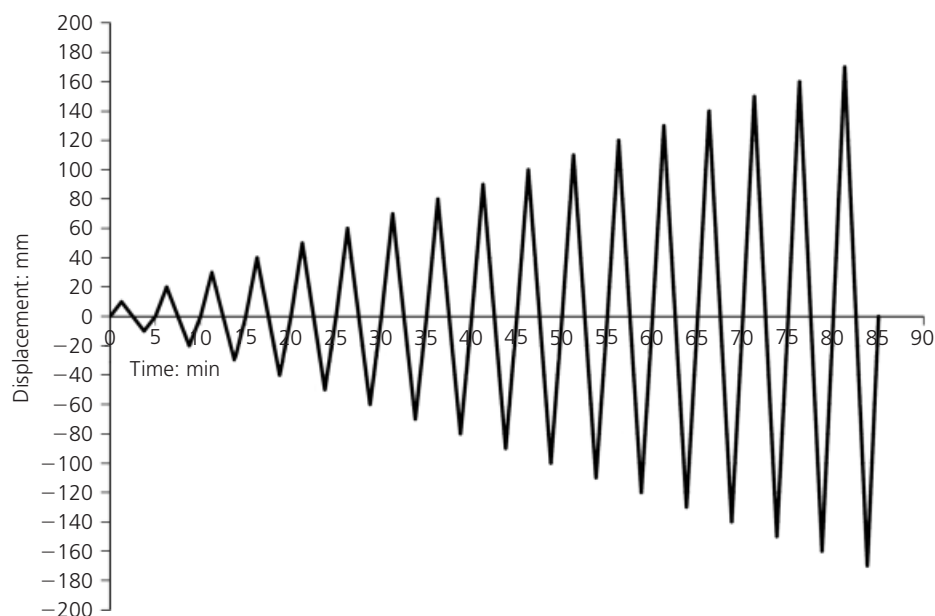
Figure 2. Incremental cyclic loading of the frame; roof displacement plotted against time

To ensure that the design did indeed provide adequate ductility, a number of different numerical models of the test frame were developed to investigate the expected behaviour of the frame under the imposed quasi-static displacements (Figure 2).

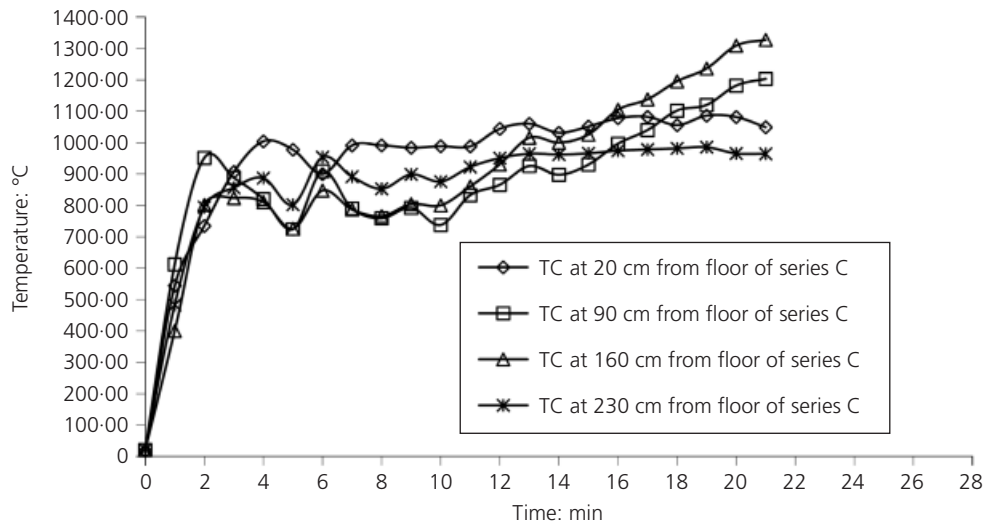
Figure 3. Temperatures inside the fire compartment (near the centre of the back wall opposite to opening)

obtained in the mock tests (Figure 3). This work will be reported in much more detail in a number of separate reports and papers; however, brief results from one of the predictive models (using OpenSees) are presented here.

The fire loading was based on a considerable simplification of the temperature field shown in Figure 3. The fire was assumed to be represented by a constant temperature of 1000°C at the boundaries of the structural members applied for 1 h. A one-dimensional heat transfer analysis was carried out to determine the temperature evolution in the structural members, which was then used to determine the mechanical response (after the damage-inducing cycle).

Four days after the cyclic loading, the pre-damaged test frame was exposed to fire. The fire test was performed for the planned duration of 1 h. The desired temperature–time behaviour, as achieved in mock fire tests earlier (Figure 3), could be obtained precisely, and full-blown fire with flashover was attained within 8–10 min. The sound of concrete spalling off from the roof slab

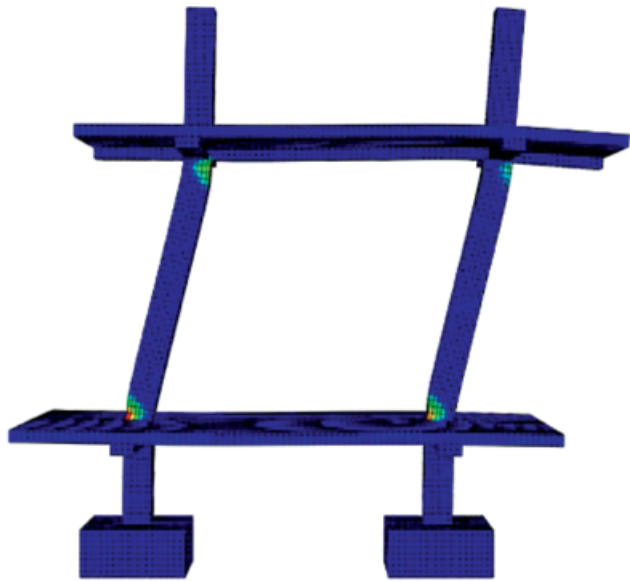
Figure 5. Finite-element model of the frame showing hinges in columns

Although not explicitly stated in the standard, it was expected that if the code-based design recommendations were followed, strong-column weak-beam type behaviour would be obtained, that is the first hinge would form in the beams. A simple plastic analysis showed that this was not the case for the one-storey test structure and this was later confirmed by more detailed finite-element frame analyses, as shown in Figure 5.

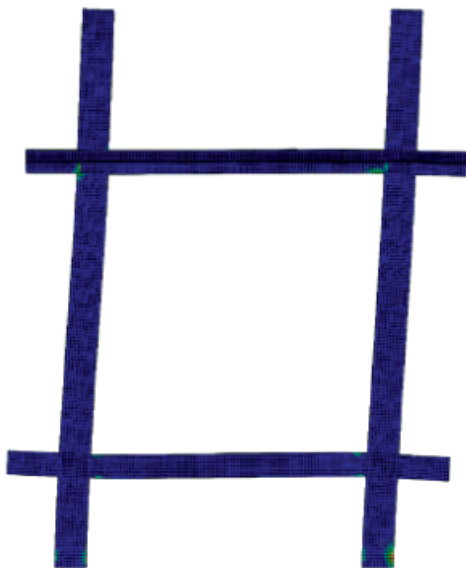
Figure 6. Finite-element model of the modified RC frame (with stronger columns and weaker beams)

teams and it was decided to revise the design to produce a more desirable ‘seismic’ behaviour and ensure that first hinge formation occurs in the beam. The reinforcement in the column was increased (to eight 20 mm dia. bars) and that in the beam was decreased (to three 16 mm dia. bars top and bottom). Now the results from a single-storey frame model analysis in the SAP2000 software package (SAP) showed that first hinges formed in the beams; however, a more detailed Abaqus finite-element model (using brick elements for columns, beams and slabs) was still inconclusive, with plastification starting at joints (as shown in Figure 6) where the beam is composite with the slab (lower beams without slabs clearly formed hinges first). The revised design was, however, adopted.

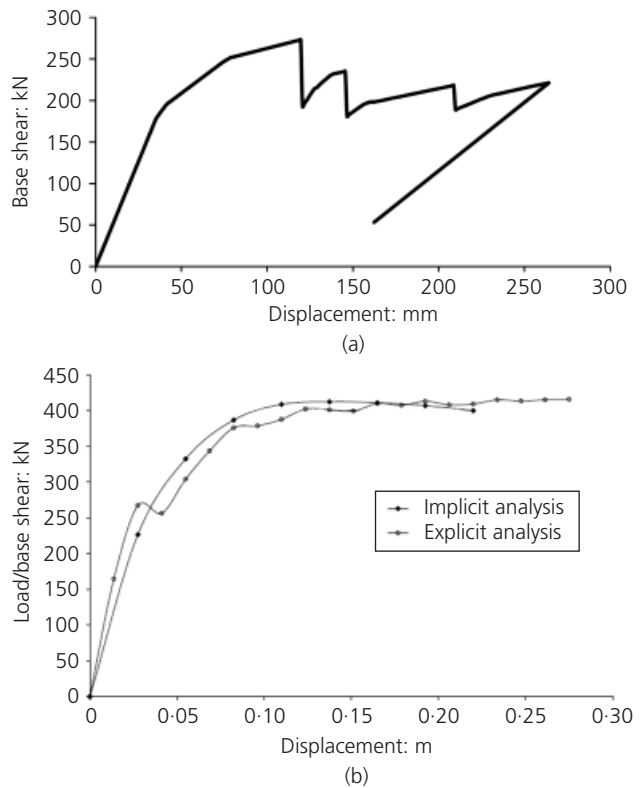
Figure 7. Load–displacement curves from (a) frame model and (b) detailed finite-element model

carried out using two different software packages and using different types of models based on the modified design. Figure 7(a) shows the results from a quasi-static non-linear SAP frame model and Figure 7(b) shows the results from two non-linear dynamic finite-element models (using Abaqus). The two Abaqus analyses (with the same data) were carried out using the 'implicit' dynamic procedure and the conditionally stable 'explicit' dynamic procedure, both of which produced similar results (with the explicit procedure taking significantly large computing

time). The Abaqus models seem to overestimate the peak load considerably; however, at a displacement of roughly 50 mm the two models are somewhat in agreement (200 kN and 260 kN); the displacements at peak load are also similar (~100 mm). It is likely that the Abaqus model, constructed of brick elements, is over-stiff (despite using non-conforming elements and a relatively fine mesh). An Abaqus beam and shell model provided results comparable to the SAP model. These two preliminary analyses were primarily carried out to obtain upper and lower bound estimates of the frame load displacement response for planning the experiment properly and to obtain useful data on the capacity and stroke lengths of the loading jacks required to carry out the damage-inducing cyclic loading for the frame. A more detailed predictive analysis is reported in the next section.

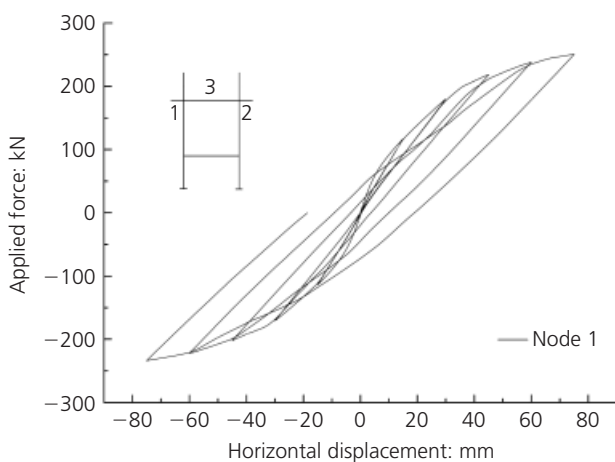
Figure 8. Horizontal displacement of node 1 under quasi-static cyclic loading

Figure 8 shows the lateral (or horizontal) displacement of the frame through five cycles of loading, which produces a peak load of roughly 250 kN, corresponding to a displacement of approximately 76 mm, which agrees reasonably well with the SAP ‘pushover’ analysis of Figure 7. Figure 8 also shows that a permanent ‘drift’ of approximately 19 mm (leftward) occurred at the end of the cyclic loading.

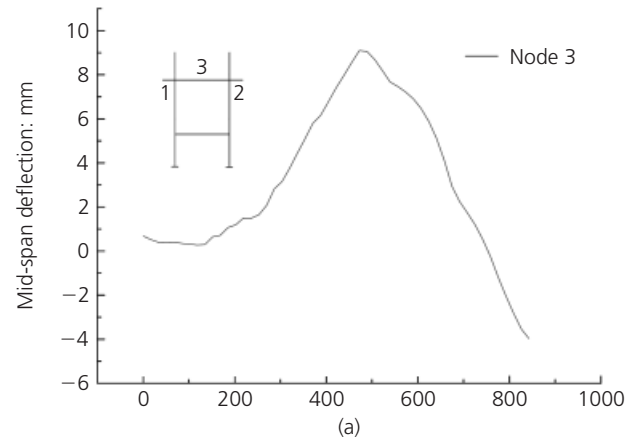
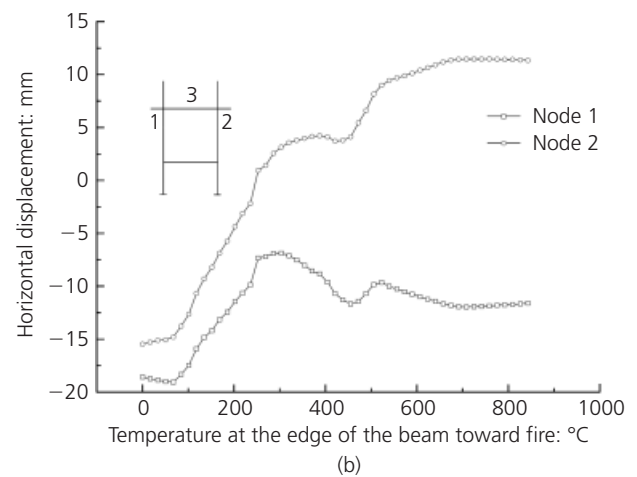
Figure 9. Displacements during the fire loading phase: (a) node 3 at mid-span of top beam; (b) at nodes 1 and 2

Figure 9(a) shows the vertical displacement of the mid-span of the top beam (node 3) during the fire loading phase, and Figure 9(b) shows the horizontal displacement of the end nodes (nodes 1 and 2) of the top beam during the fire phase (both continuing from the permanent residual displacements at the end of the cyclic displacement). Both figures are plotted to start from the point where the nodes were located at the end of the gravity and cyclic loading stages. Therefore, node 3, in Figure 9(a), was displaced in the positive direction (upward) and nodes 1 and 2, in Figure 9(b), were displaced in the negative direction (leftward) at the end of the cyclic loading. The initial displacement of node 1 in Figure 9(b) is the same as the drift mentioned for Figure 8, above. An interesting and counterintuitive feature of behaviour from this analysis is that during the early phase of the fire, the

frame as a whole moves towards becoming more ‘upright’. The permanent lateral ‘drift’ at the end of the cyclic loading of about 19 mm is initially reduced to about 7 mm when the exposed surface of the beam reaches approximately 300°C, which suggests a ‘stiffening’ of the frame. After this, however, the drift begins to increase again, but plateaus out by the end of the heating.

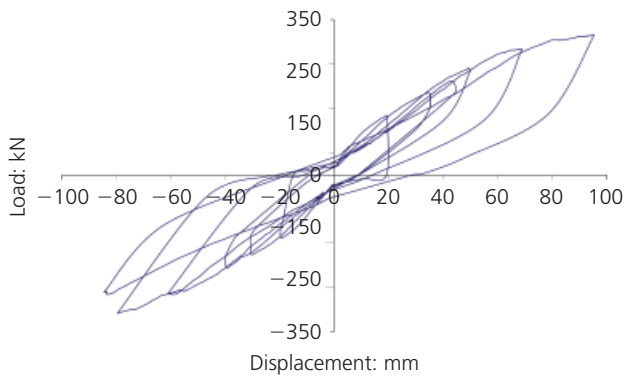
Figure 10. Test load–displacement response of frame

This section presents some key results of the first test conducted in March 2011. A pre-planned mechanical damage in the form of 2% of the storey height (FEMA 356, FEMA, 2000) was introduced in the frame by applying lateral quasi-static cyclic loading. Seven incremental lateral displacement cycles of equal push and pull were applied using the loading jacks, as explained earlier. Figure 10 shows the recorded lateral load–displacement response of the test frame. A maximum displacement of 95 mm in push and 85 mm in pull was registered, corresponding to load levels 316 kN and 267 kN, respectively. After each cycle of push and pull, a careful visual inspection was carried out to locate cracks and spalls, if any. All the cracks were graded with permanent markers. No cracks were noticed up to a lateral displacement of

20 mm. However, first visible cracks were observed at the ends of the roof beams aligned parallel to the direction of loading after the third cycle of push and pull and at a displacement of 30 mm. In subsequent cycles, these cracks propagated and further cracks were observed in beams and columns as well. The cracks were observed to be more pronounced at the beam–column joints. However, the frame remained structurally stable after the initial mechanical test.

Although the permanent residual displacement after the cyclic loading phase matched well with the OpenSees prediction of approximately 20 mm, the ‘pinching’ effect clearly visible in the test results was not predicted by the computer model. The model was rerun with an OpenSees ‘pinching material’ (Lowes *et al.*, 2004) used for all elements adjacent to the joints. This produced a more realistic comparison with the test, as shown in Figure 11. Figure 12 shows exaggerated displaced shapes of the frame after (a) cyclic loading and (b) fire loading. Figure 12 shows the frame displaced shapes at the end of the cyclic displacements and at the end of fire. The displaced shape (b) is more reliable than (a), as the fire-induced displacements cannot be modelled properly by a two-dimensional model (more comprehensive three-dimensional models are currently being developed and will be reported in due course). Nevertheless, Figure 12 clearly shows that the frame as a whole does move towards becoming more ‘upright’ (as predicted by the previous model shown in Figure 9) and some of the drift is

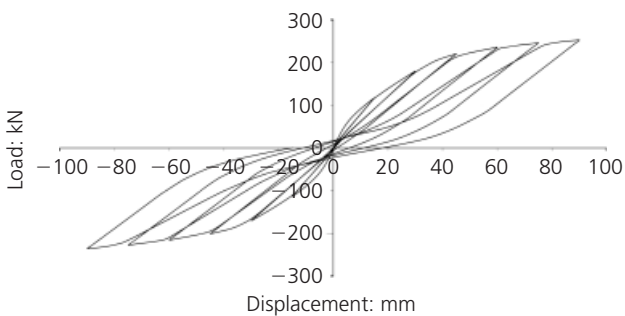
Figure 11. Modelled load displacement using ‘pinching material’ (OpenSees analysis)

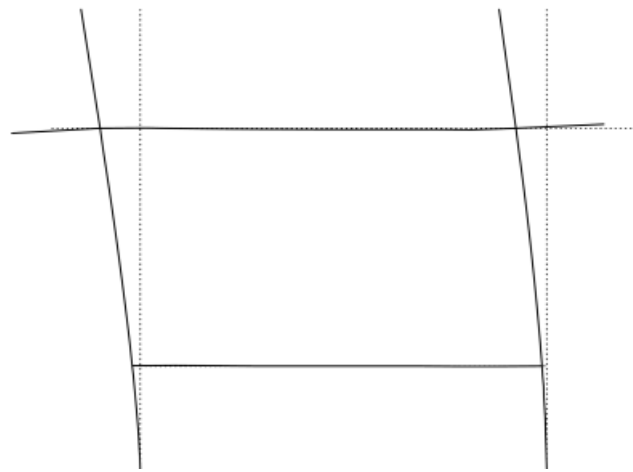
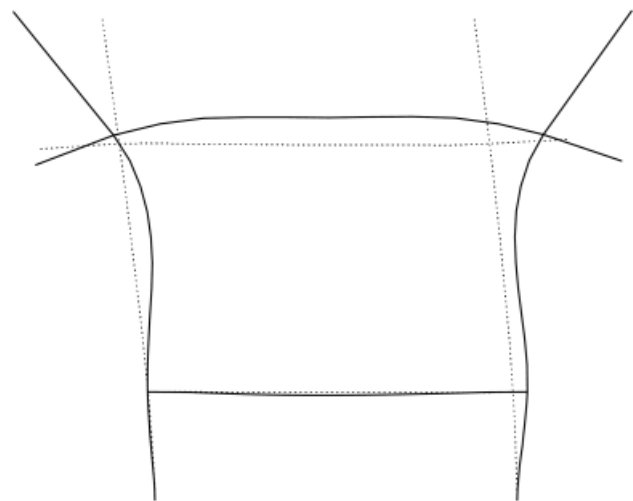
Figure 12. Frame displaced shapes (magnified 20 times): (a) at the end of the cyclic displacements; (b) at the end of fire

recovered. However, it is notable that the drift recovery is much less in this model (more consistent with the test results), suggesting that hysteretic damage has been relatively more accurately modelled by using the pinching material. Figure 12(b) also clearly shows the effect of thermal expansion. Figure 13(b) shows the lateral displacement of nodes 1 and 2 of the frame for the updated model (corresponding to Figure 9(b)). The increasing relative displacement between nodes 1 and 2 is because of thermal expansion.

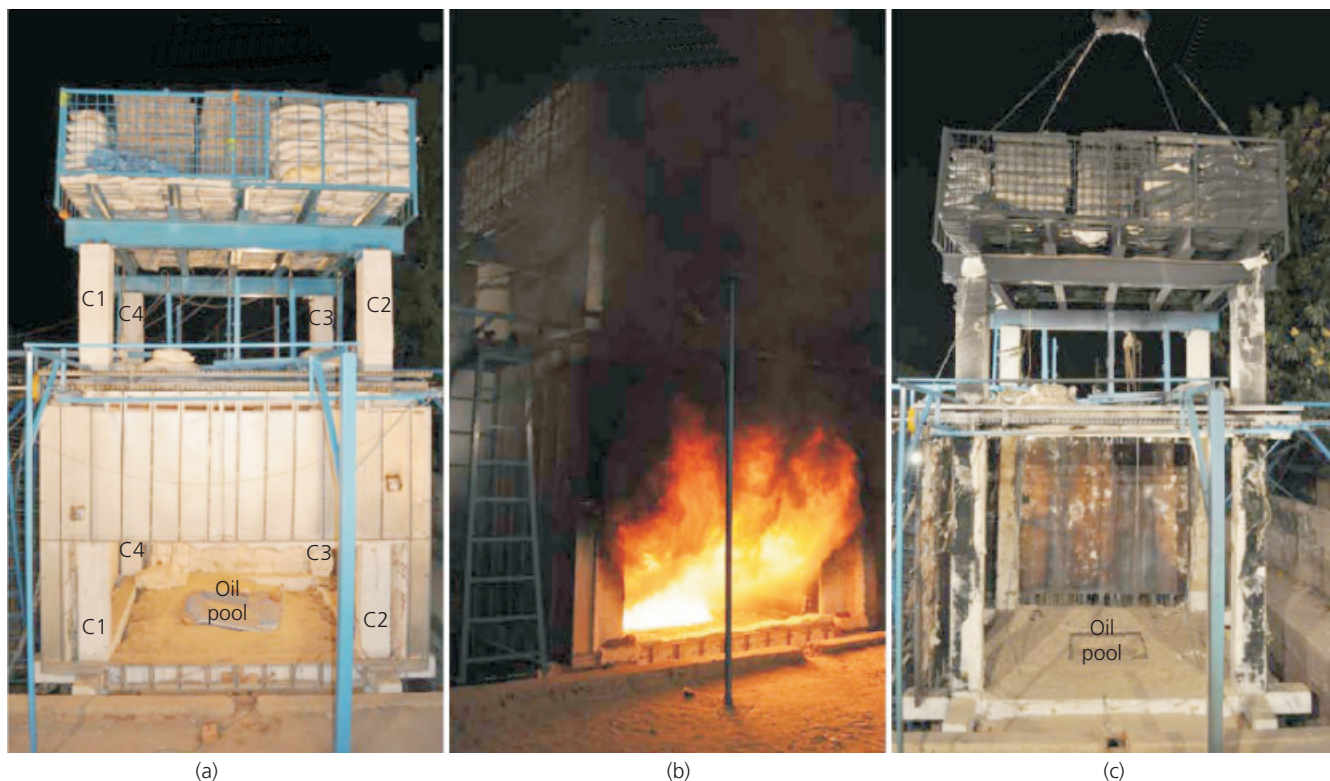
Figure 15. (a) Pre-loaded frame before fire; (b) fire test in progress; (c) fire-damaged frame after test

could be heard clearly after 5 min from initial ignition, continuing for another 15 min. The spalling sounds corresponded to temperatures between 300 and 400°C. Later, the spalling of concrete was observed in beams and columns as well. The geo-PIV system did not perform well during the fire test owing to high temperatures and much reduced visibility because of the smoke. A detailed visual inspection of the frame was undertaken the next day after the frame had cooled down. Considerable damage was noticed in the slab in terms of spalling of concrete and resultant exposure of reinforcement. A maximum fire-induced vertical displacement of 46 mm was recorded in the roof slab. The beams and columns suffered considerable spalling on exposed surfaces, but only at a few locations; however, widespread cracks could be clearly marked in these elements. An attempt was made to drill a core for the purpose of conducting a core compression non-destructive test; this was, however, rendered impossible by disintegration of concrete all along the exposed surface. The frame was still able to withstand the 1 h fire exposure without losing structural integrity in terms of complete collapse. Temperature–time curves

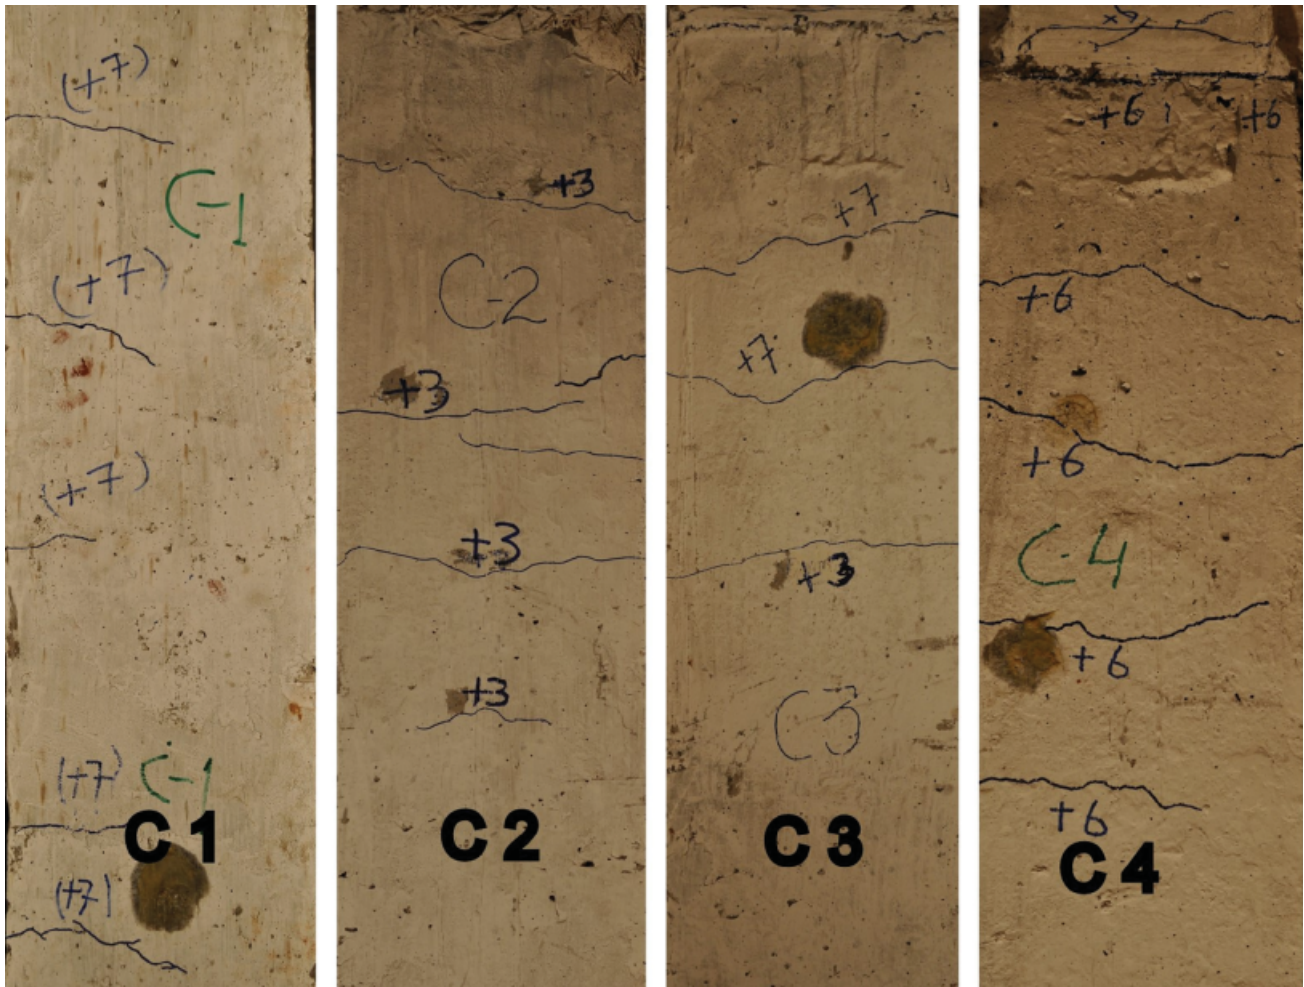
Figure 16. Crack patterns in columns attributable to pre-loading

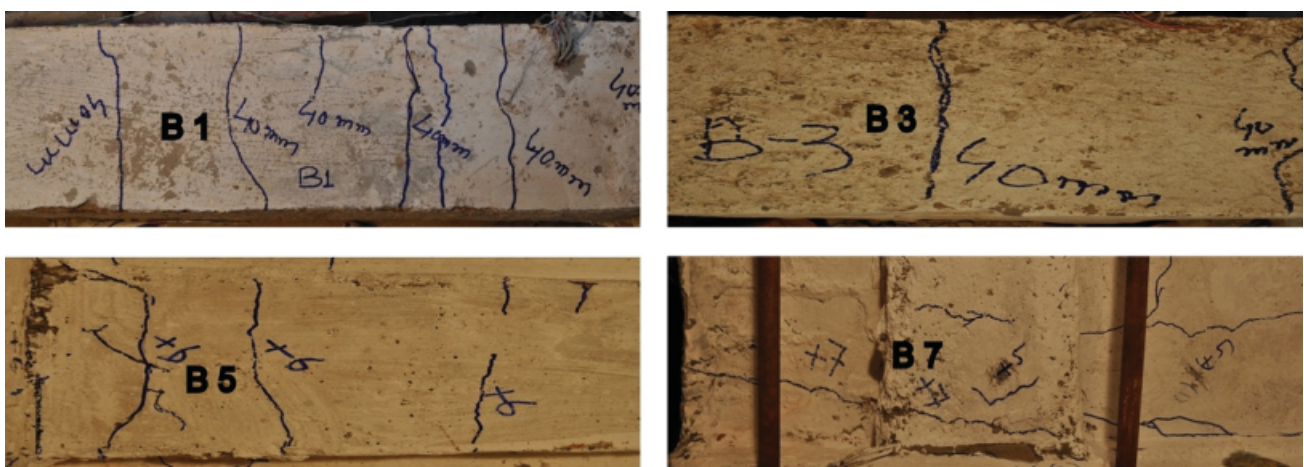
Figure 17. Crack patterns in beams attributable to pre-loading (+3, +4, +6 and +7 markings on the beams indicate cracks initiated at displacements of 30 mm, 40 mm, 60 mm and 70 mm, respectively)
