TREE ROOT ENCROACHMENT ON LEVEE DRAINAGE SYSTEM

THESIS

Master of Science in Civil Engineering

The University of New Mexico
Albuquerque, New Mexico

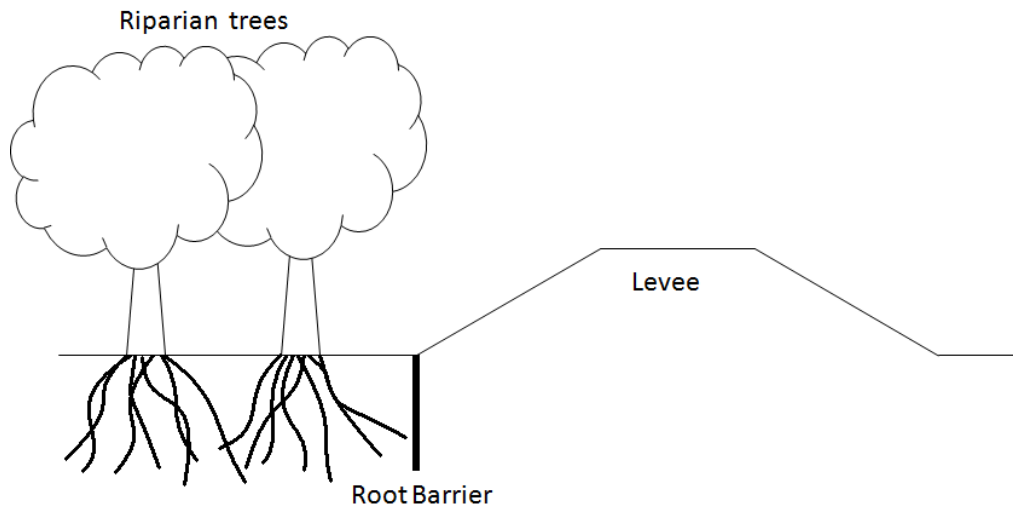
Figure 1.2 Example of root barrier installation near the levee

As described in 1.1, riparian trees have the potential to degrade the levees as their roots extend under the levees. Vertical root barriers are one treatment that has been found to redirect root growth to lower levels of the soil, thus reducing damage to the sidewalk (Costello et al. 1997). The root barriers may allow trees to grow near the levee without compromising levee stability. Geosynthetics are frequently used as root barriers in various drainage designs (AVSR et al, 1994).

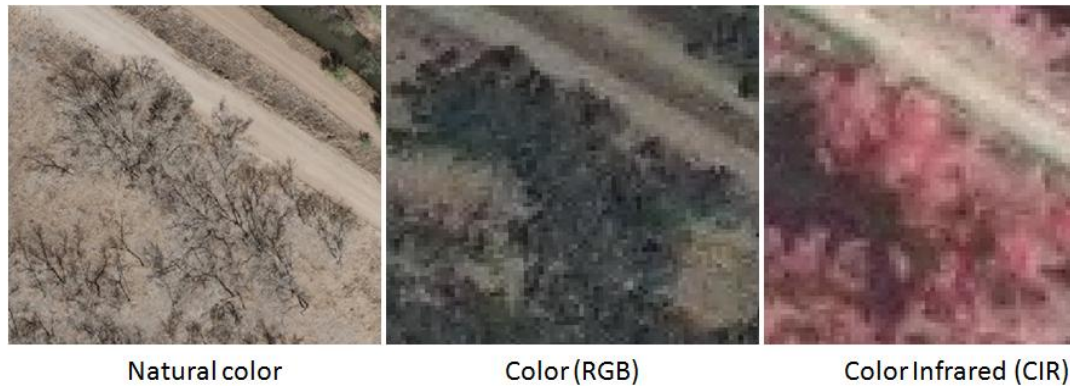
Figure 2.3 Aerial photographs

Three different types of aerial photographs were used to measure the tree crown sizes: Natural color, RGB (Red, Green, Blue), and CIR (Color Infrared) as shown in Figure 2.3.

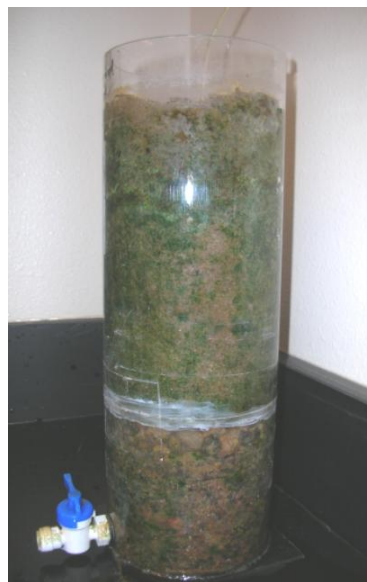
Figure3.2 Photograph of experimental column

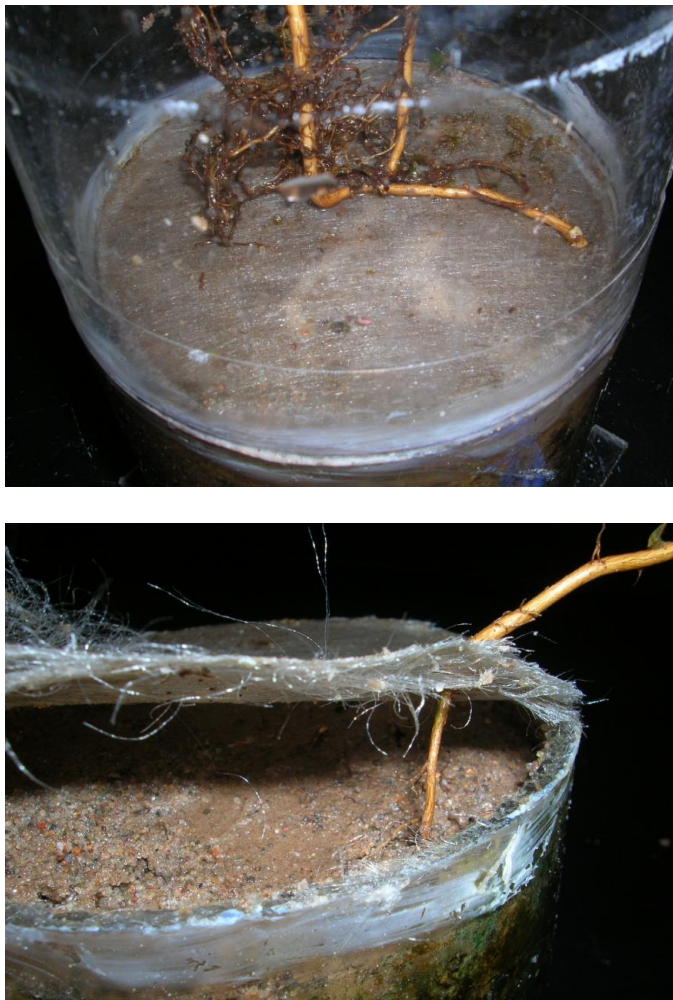
Figure 3.4 Photograph of root growth through geotextile

*The drainage material was sand, and the root barrier was the 4 oz geotextile.

Even though the water table was lowered to create air gap, roots can continue growing through gap in response to gravitropism and thereby breaking through the root barriers. The estimated total root lengths seemed to be unrelated to the drainage material or root barriers. After bridging the gap to the water table, root proliferation generated a full root system and equalized root growth in upper and lower chambers.

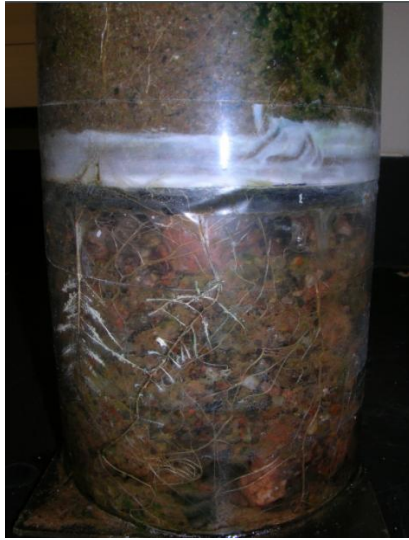
Figure 3.9 Picture of root system grow found outside of the column

The second reason for low survivability is that some roots did not grow into lower columns. In many columns, some roots grew between the root barrier and the column wall (Figure 3.9). As willow roots are much finer than cottonwood, some root found a small gap along the column wall and the root barrier. When the columns were built, 30 cm of acrylic columns were first cut into two pieces to insert the root barriers, and they

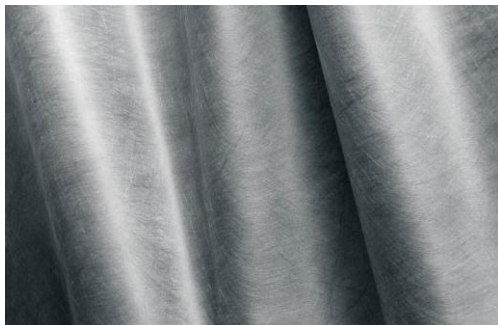
Material: nonwoven polypropylene geotextile fabric, water permeable

Figure A-1 Geotextile

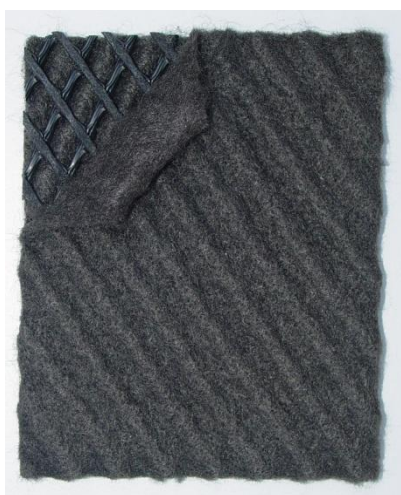
Material: The geotextile is bonded to the geonet with a hot knife application allowing for high bond strength without the reduction of transmissivity values of other processes

Figure A-2 Geocomposite

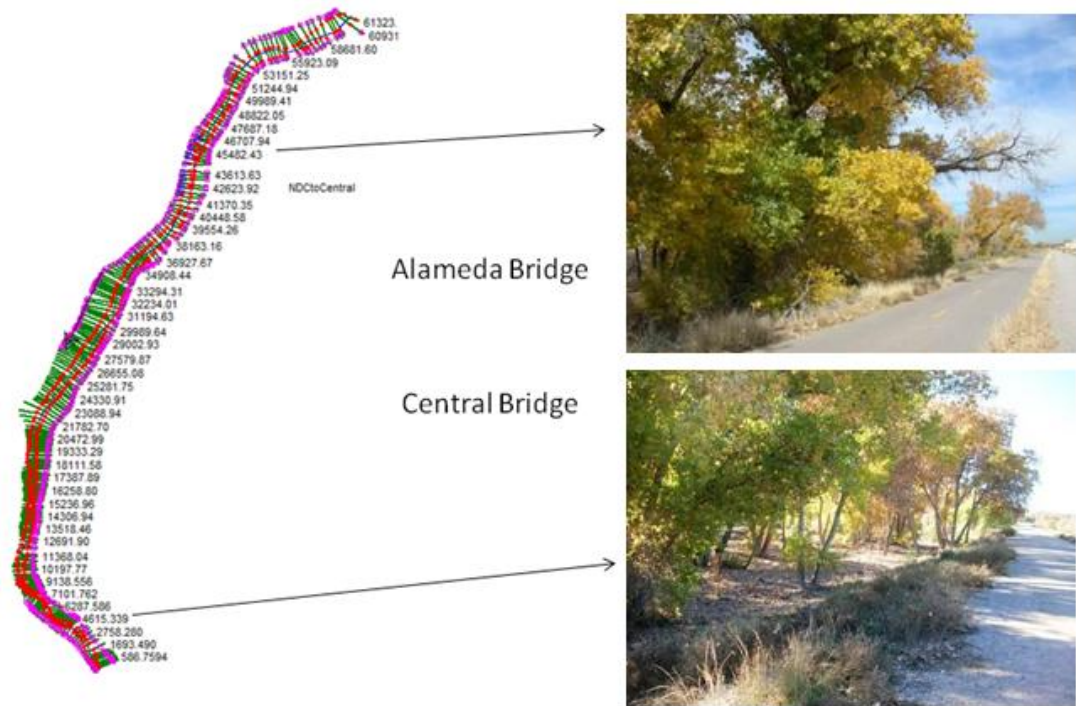
Figure D- 2 Cross sections
