Water resources assessment in the greater Rio Casas Grandes Watershed

Water Resources Assessment in the Greater Rio Casas Grandes Watershed

**WR 573
Summer 2007
University of New Mexico**

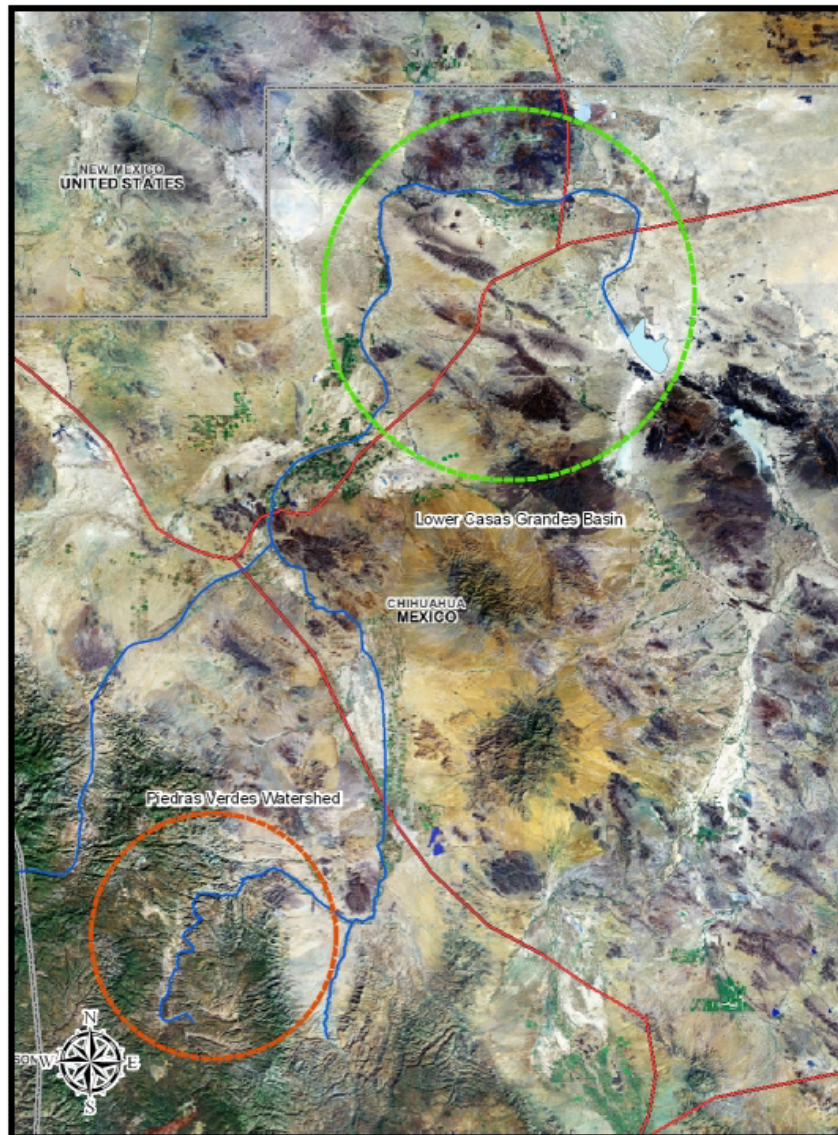
Figure 2. Map of the study locations within the Rio Casas Grandes watershed.

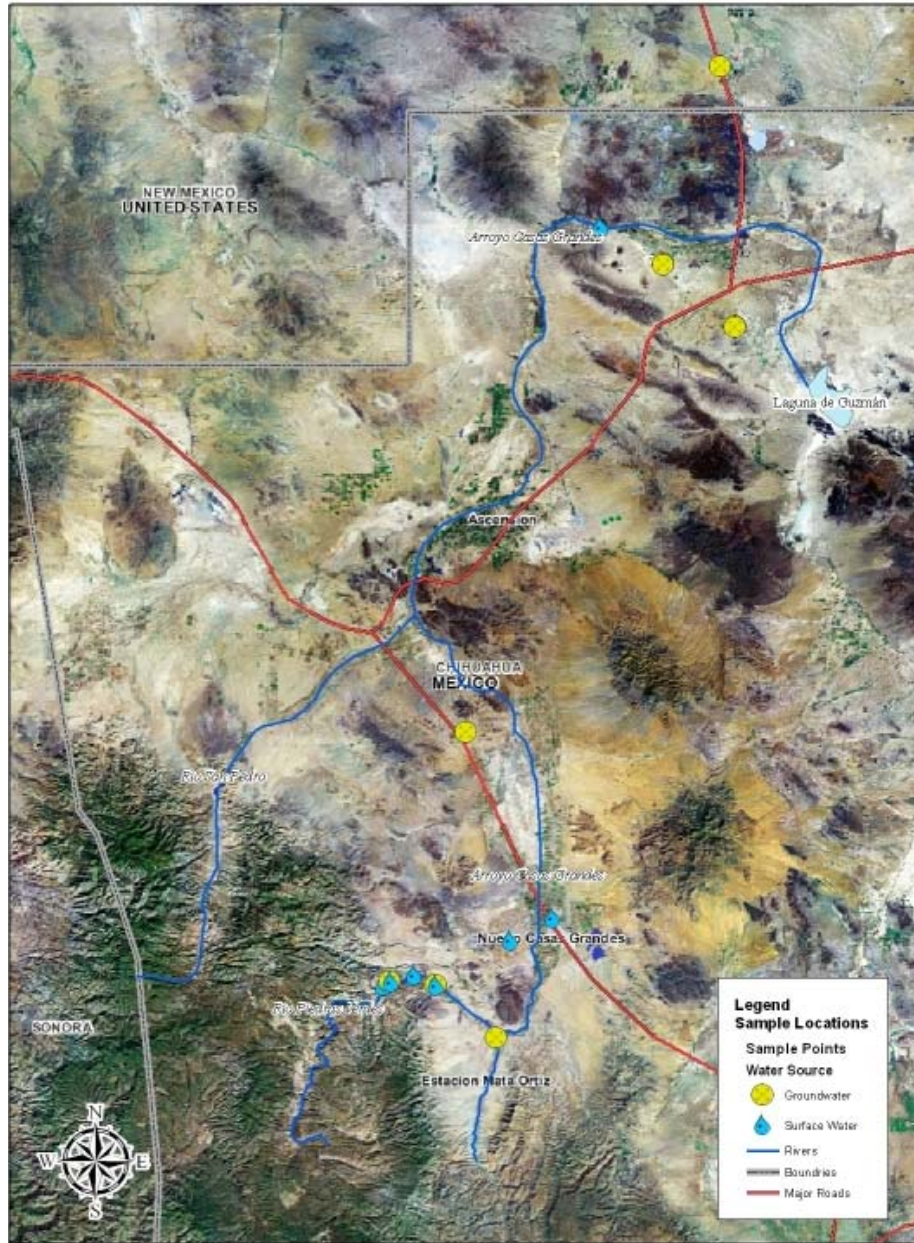
Figure 4. Map of sample locations distinguishing groundwater and surface water sources.

Sample locations were determined primarily by the presence of water. Points of interest included surface water both above and below the irrigation diversion structure, in addition to domestic well water. Samples from various sources were taken to analyze the constituents of the water, evaluate its suitability for human consumption, and compare surface and groundwater properties to look at potential source connectivity and watershed topology.

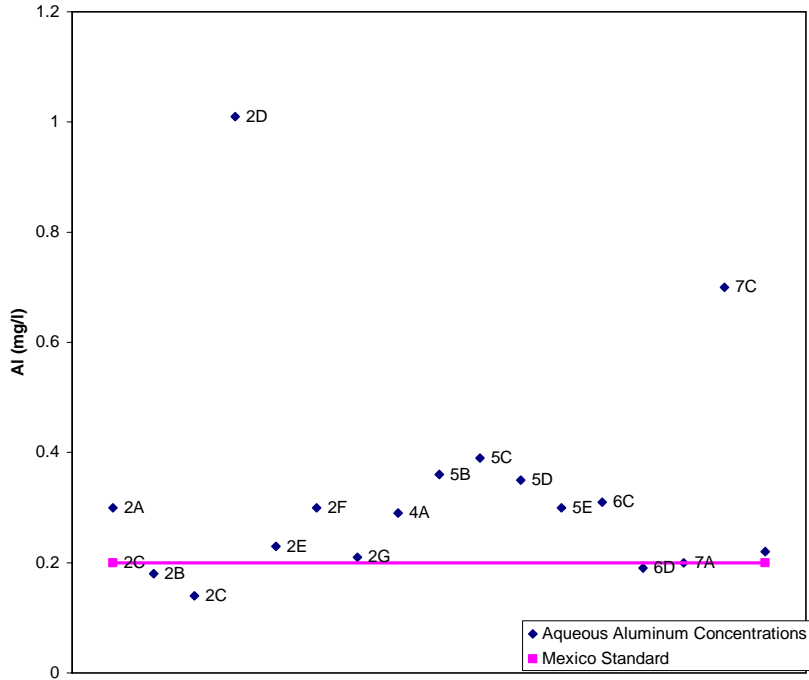
Figure 7. Dissolved aluminum concentrations from sample locations plotted against 1994 standards developed by Mexico's Ministry of Health for certifying the quality of drinking water.

Many of the samples did not exceed Mexico's drinking water standards for anions and cations (see Table 5). Notable exceptions were aluminum and fluoride, where many samples exceeded the more stringent Mexican but not U.S. drinking water standards. Figure 6 and Figure 7 demonstrate the high variability of aqueous concentrations of fluoride and aluminum as they relate to Mexico's drinking water standard. It should be noted that surface water along the Rio Casas Grandes is not used for public water supply;
