Salinity of the Lower Middle Rio Grande, Socorro County, New Mexico

A Professional Project Report Submitted in Partial Fulfillment
of the Requirements for the Degree of

Master of Water Resources

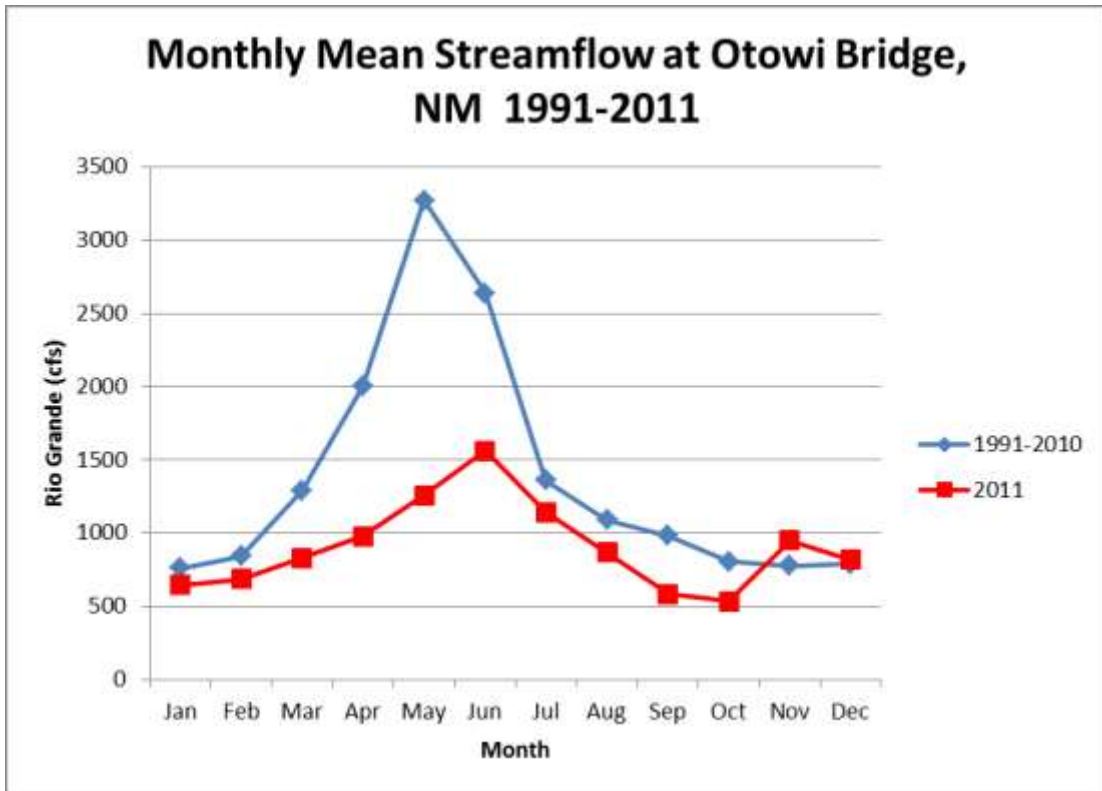
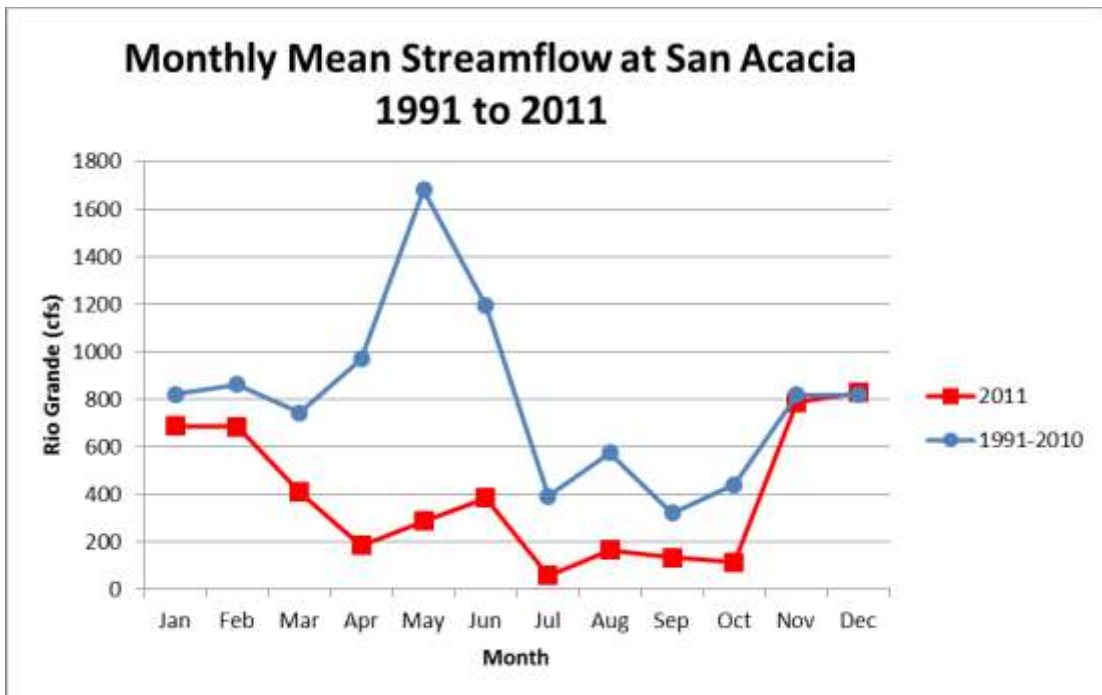
Figure 2a-b. Top: Average monthly streamflow mean at USGS Otowi gauge station comparing the 1991-2010 Rio Grande streamflow to the 2011 season. Bottom: Comparison of the 1991-2010 Rio Grande streamflow to the 2011 season at San Acacia gauge.

2011 had a lower streamflow than the last average twenty years (Figure 2 a-b: USGS gauges: Otowi Bridge and San Acacia, NM). The 2011 water balance season was a departure from the long term mean of water supply, showing minimal flow from March through October. Elevated salinity in the middle reaches of the Rio Grande is also believed to be naturally caused by flow through geologic processes and weathering through dissolution of minerals (Anning, 2011; Hendrickx et al., 1999; Newton, 2004; Phillips et al., 2003).

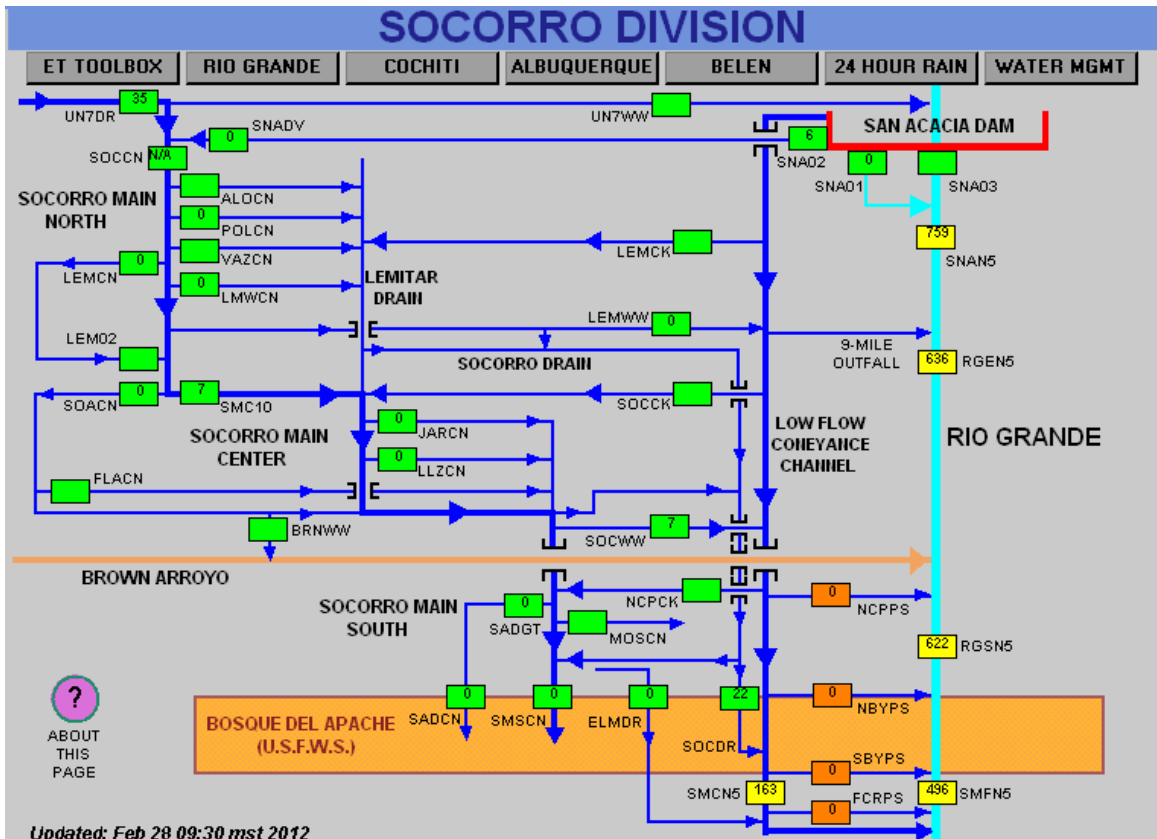
Figure 7. Schematic of the MRGCD waterways of the Socorro Division canal and drain system of the Middle Rio Grande in Socorro County (MRGCD, 2012)

The Low Flow Conveyance Channel (LFCC) is located directly west of the river south of Socorro and conveys water to Elephant Butte reservoir. The Riverside Drain is found west of the LFCC, between the irrigation canals and farms, and LFCC, drawing off excess water from agricultural fields. At the peak of the growing season it is not unusual for the Rio Grande to become dry within some areas of this reach. Compact obligations for delivery to Elephant Butte have become difficult at times, particularly in drought conditions.

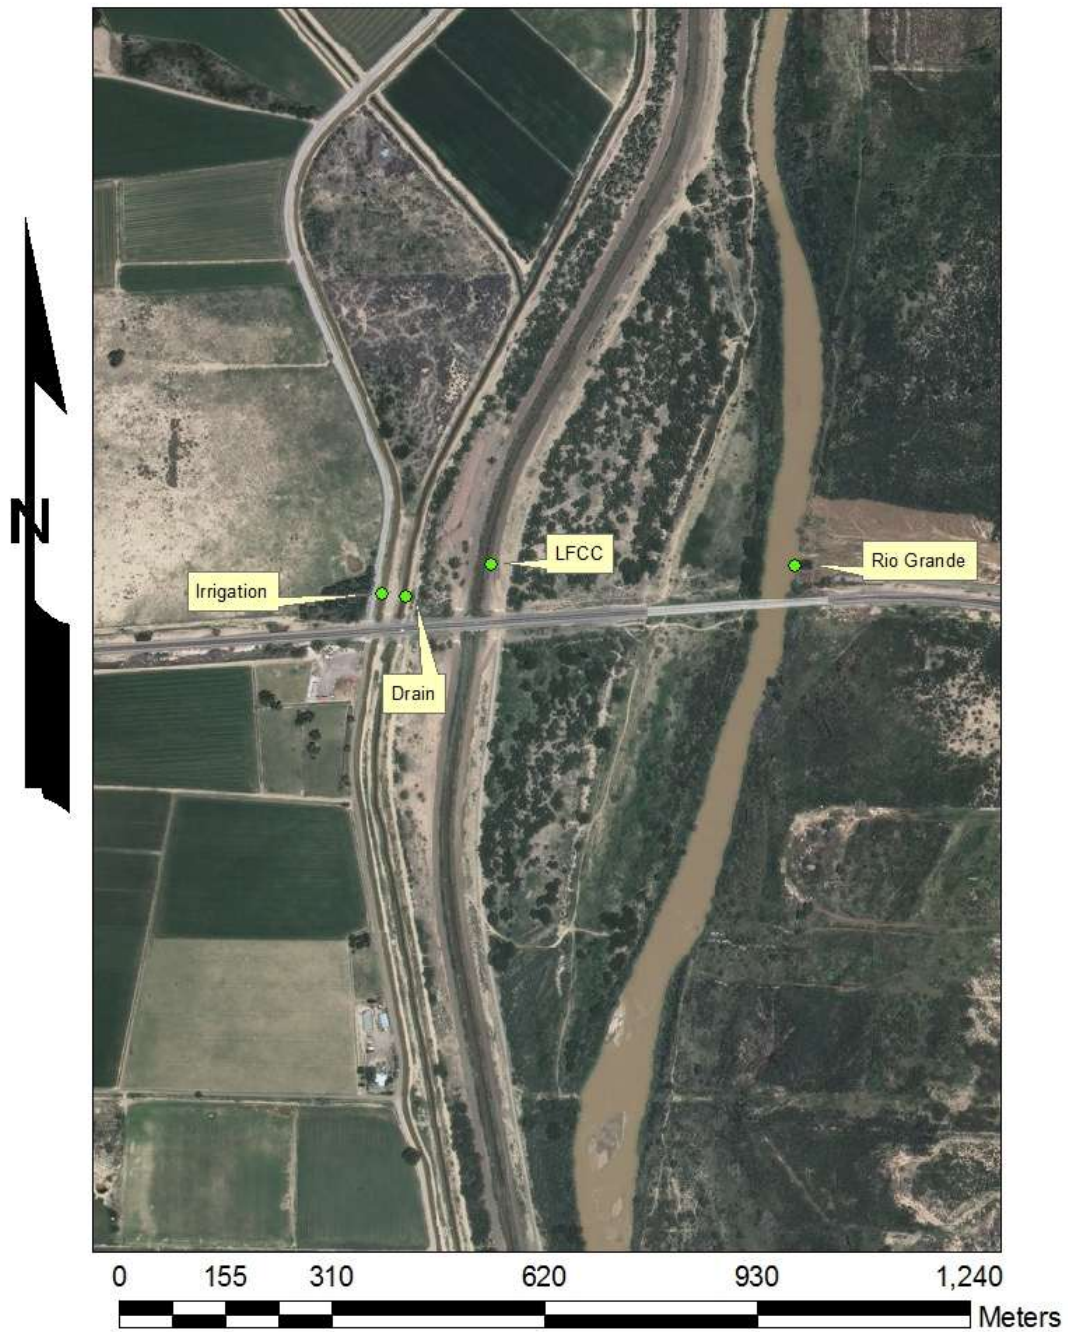
Figure 13. Aerial view of sampling sites in San Antonio at Highway 380. Area is predominately agricultural and approximately 13 km south is Bosque Del Apache National Wildlife Refuge (W. Kolbenschlag, Socorro SWCD).

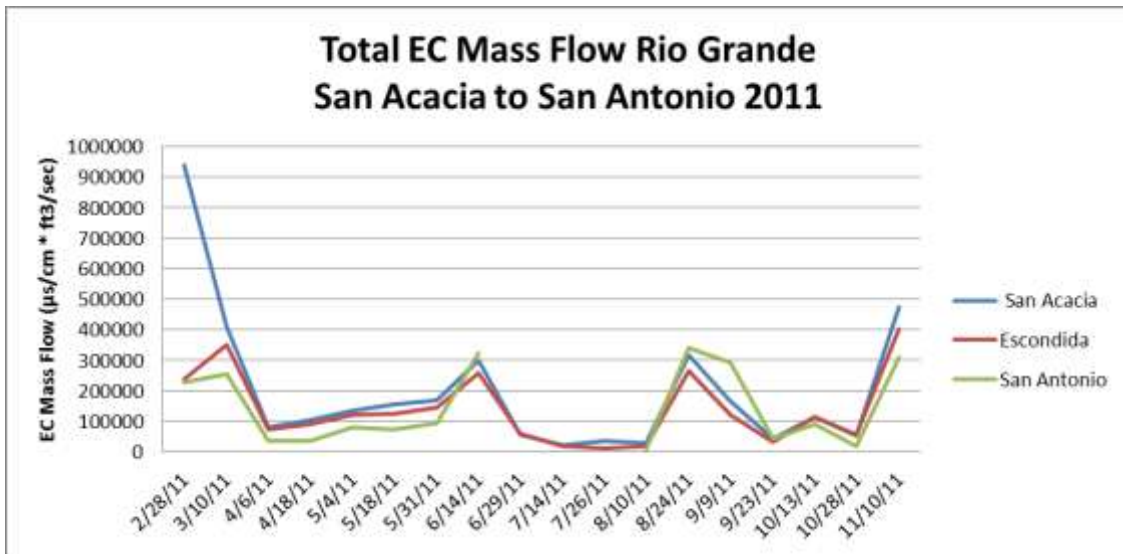
Figure 15. Total EC mass flow for the Rio Grande from February to November, 2011. Total mass flow showed similar trends with exception of San Acacia in late February, this may be due to a variety of causes including human error or faulty calibration.

The EC total mass flow (Table 3; Figure 15) was calculated for the Rio Grande from San Acacia to San Antonio. In general, San Acacia had a greater total EC mass flow, than at the gaged sites of Escondida and San Antonio. San Antonio had the least EC mass flow rates in general except in mid- June, late August and early September.

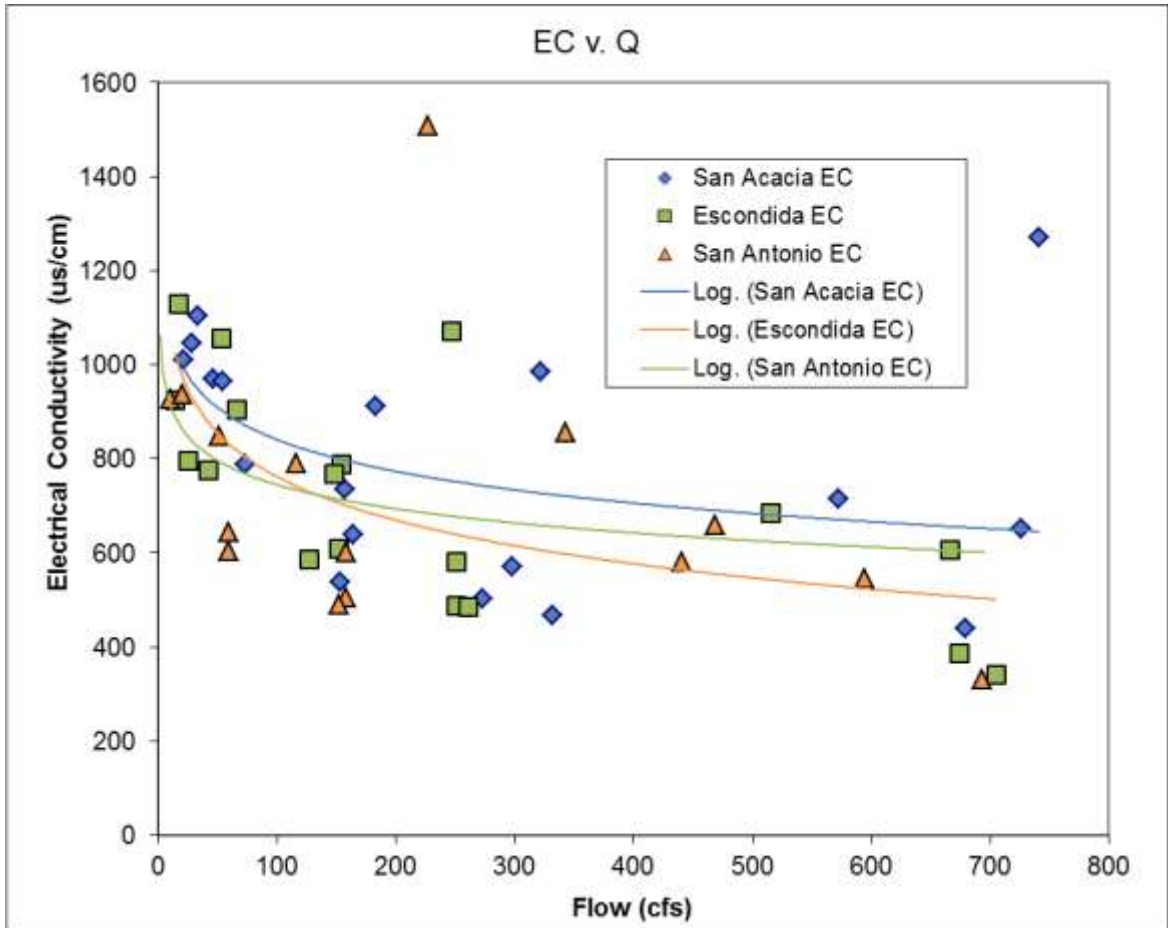
Figure 16. Streamflow versus EC from San Acacia to San Antonio study sites, averaged over the 2011 season.

EC and streamflow were plotted to show relationship at the three gaged streamflow sites (Figure 16). In general, less streamflow increased EC and vice versa, the greater the streamflow the lower the conductivity. A sharp increase in EC occurs when streamflow falls below 200 cfs, at greater streamflow the EC levels out between 400 and 750 $\mu\text{s}/\text{cm}$. At lower rates of streamflow greater evaporation may occur, especially where the river tends to be wider and less deep. Some sampling dates did not adhere to this, such as samples on August 24, here the samples had higher EC relative to higher streamflow. Also San Antonio on September 9 had higher EC and higher streamflow, due to previous night monsoon precipitation. Brown Arroyo, near the sample site was running and contributing increased inflow to the Rio Grande during the time of the collection of data. Lastly the first sample taken on February 28, pre-irrigation season, shows a higher EC and high streamflow. Water sample was taken above (behind) the dam, where water is held for LFCC diversion; here evaporation and concentration of salts may be indicative of the site.

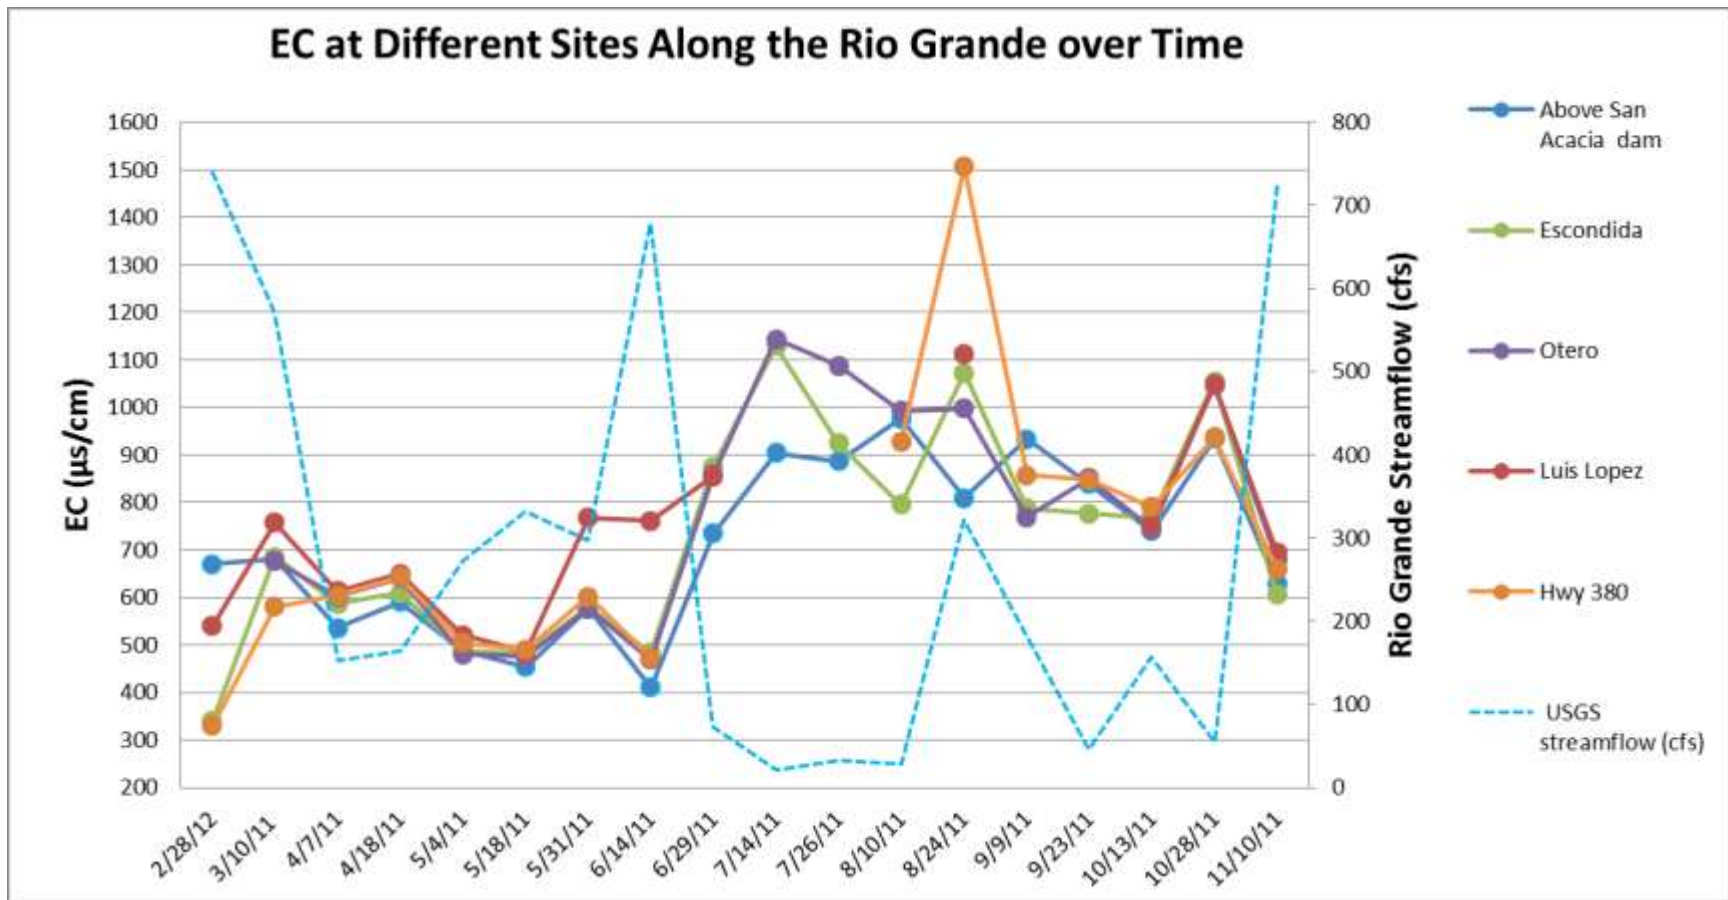
Figure 17. Measurements of the EC in the Rio Grande from San Acacia Dam to Highway 380 in San Antonio, NM. Note that the gap data gaps refer to the period of time when no data was collected because there was no stream flow within the channel.

site, and the sites in the south had lower EC levels (670 $\mu\text{S}/\text{cm}$ compared to an average EC of 403 $\mu\text{S}/\text{cm}$ at all the other river samplings on the same sampling date). During the mid-season the southern sites have higher EC than at San Acacia, especially during the time when the Rio Grande was at its lowest stream flow (0-50 cfs). During the months of July and August, the high EC in the river had several possible causes: monsoon weather generating flow from the Rio Salado and Puerco which contribute salts from outside the river stream, increased high EC irrigation return flow and from reduced streamflow and high evaporation conditions. The highest EC in the river, 1507 $\mu\text{S}/\text{cm}$ measured at San Antonio on August 24, is likely attributed to the extremely low or absent stream flow during the previous 58 days where the average of the Rio Grande at San Antonio measured less than 50 cfs per day.

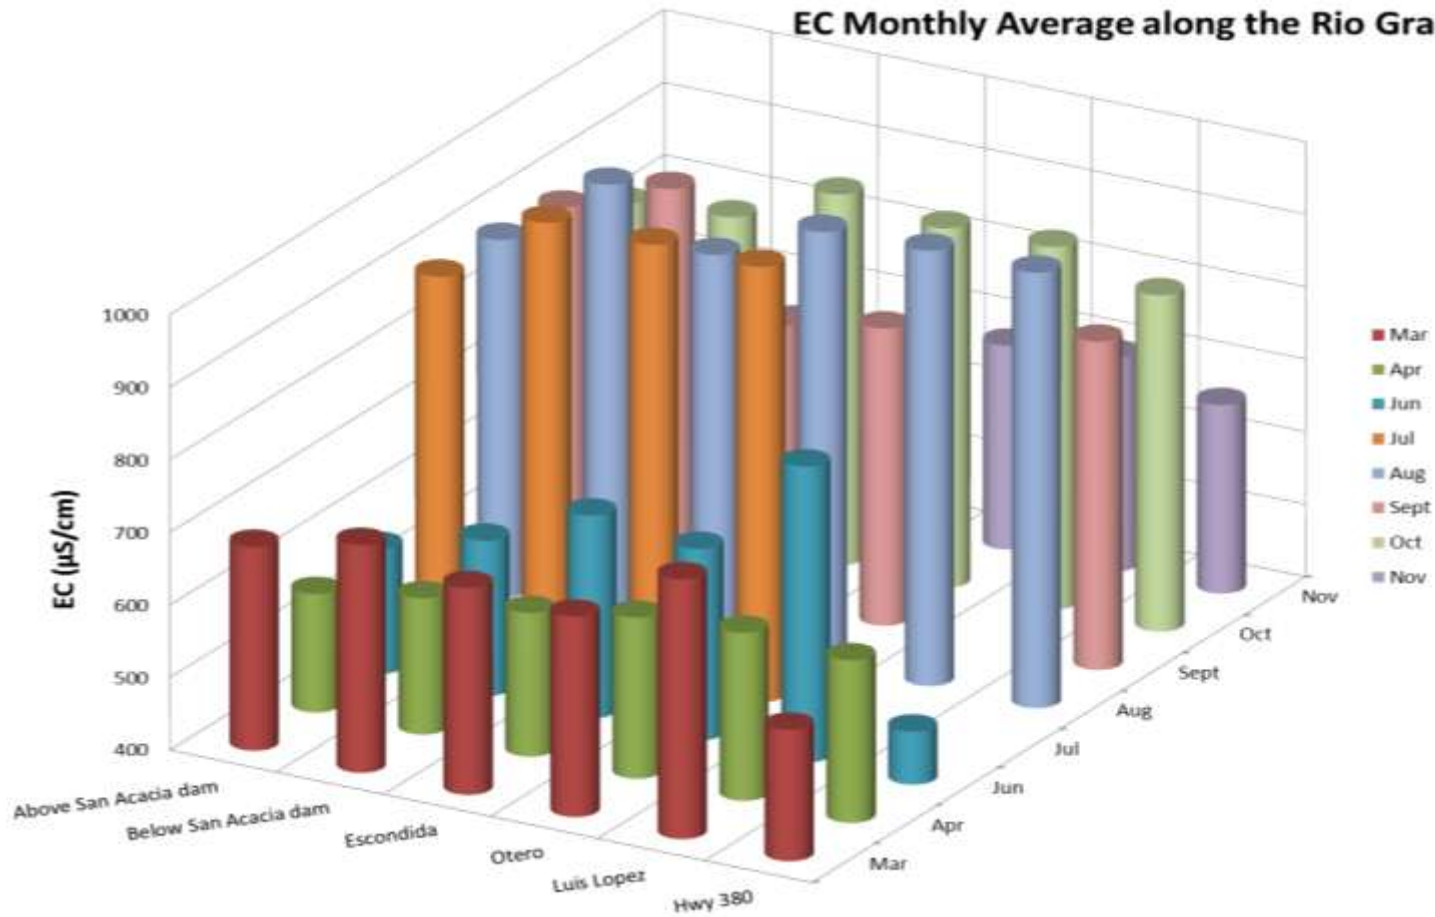
Figure 18. EC measurements, averaged monthly, along the study reach of the river from March to November 2011. Note that Luis Lopez and Hwy 380 lacks data in July (dry flow) and Luis Lopez in September (channel not accessible). Also the consistent pattern of slight increase above and below San Acacia dam, and another similar increase at Otero and Luis Lopez.

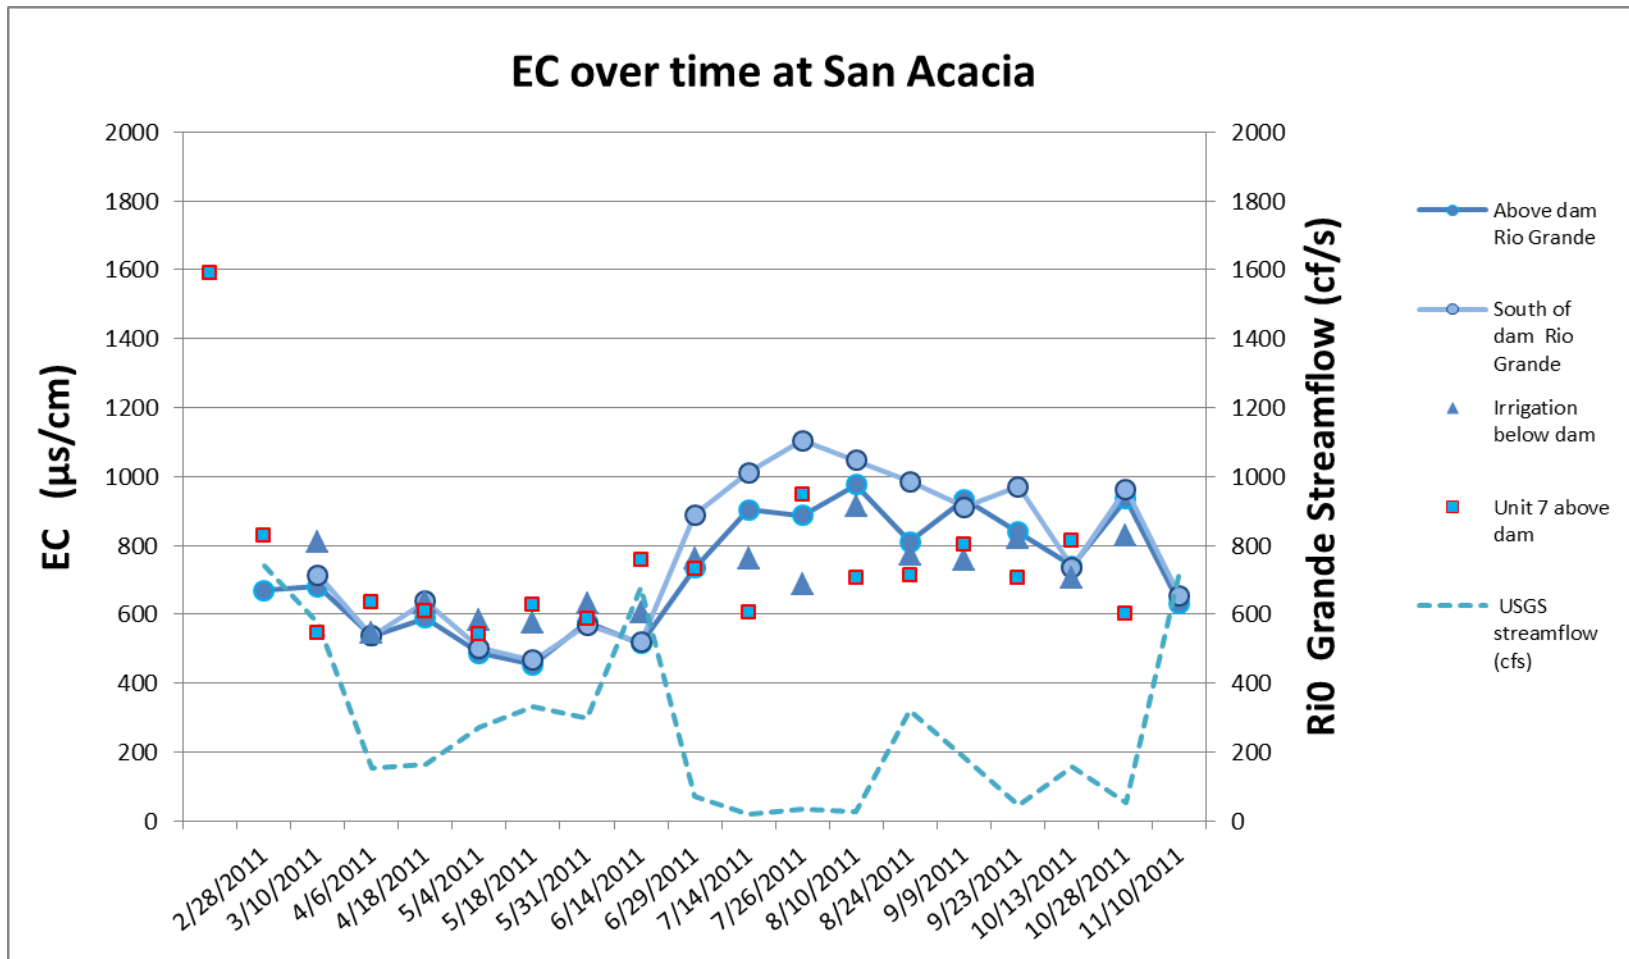
Figure 19. EC at the San Acacia Dam site. Irrigation water comes from Unit 7 drain and parallels the river (non-native flow and reuse water from north of Socorro from Los Lunas and Belen area)

the first 3 months of the irrigation season. In June the EC of these canals remained relatively steady, falling below the river EC, which increased somewhat proportionately to decreased streamflow, for the remaining irrigation season. In November the EC of the Unit 7 drain fell to $602\mu\text{S}/\text{cm}$. There are no drains at the San Acacia site to compare the river and irrigation system to.

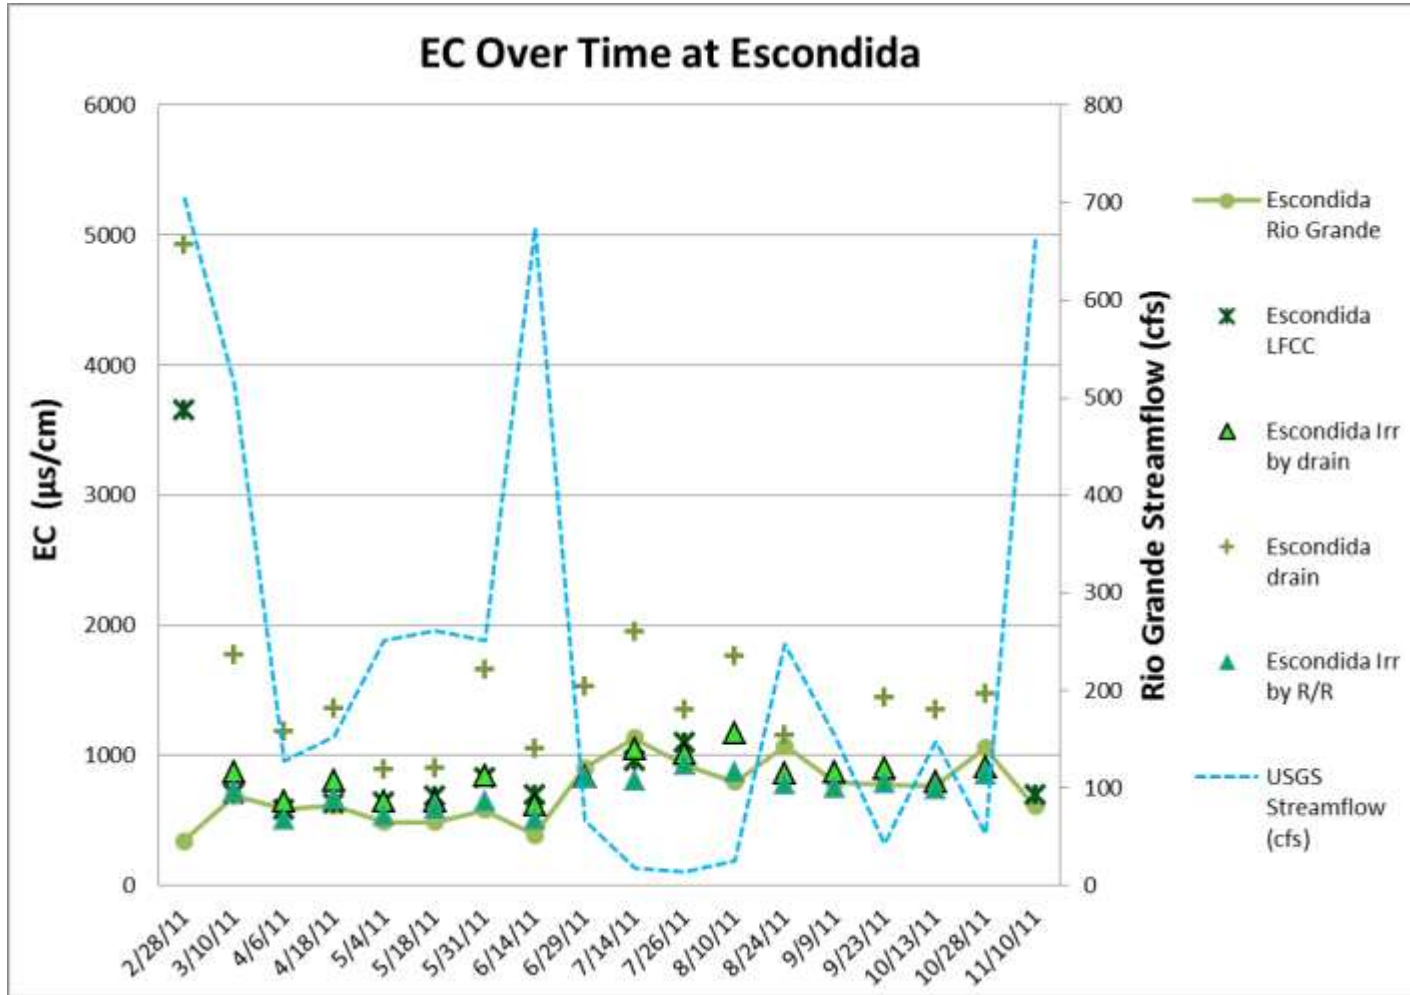
Figure 20. EC at Escondida. Note that two irrigation canals exist. The western canal near the railroad tracks does not parallel the river like the canal on the east (see irrigation location map).

At the Escondida sampling site the Rio Grande showed little change in EC when comparing it to river EC at San Acacia (Figure 20). There were differences at the LFCC and riverside drain at pre-irrigation (3650 $\mu\text{S}/\text{cm}$ and 4930 $\mu\text{S}/\text{cm}$, respectively) where EC was extremely high, possibly due to water ponding over the winter (non-irrigation) season. By the end of June, the water became so low in the LFCC that it became hazardous to climb down the steep banks for sampling. It was noted that, from August till October at this sampling site, the drain had very little water in it, and little-to-no-water movement. The drain, west of the irrigation canal, consistently had a much higher EC reading throughout the season ranging from 894 to 1768 $\mu\text{S}/\text{cm}$ during the irrigation season, it too slowed during the season but never ponded; there was always streamflow. The irrigation channel directly east of, and paralleling, the drain was consistently higher in EC over time and in comparison to the irrigation to the San Acacia site. In comparing the irrigation canal near the railroad crossing that flows further west and through fewer agricultural fields, it was found that this irrigation channel consistently had lower EC values over the course of the irrigation season (Figure 20). When comparing the river flow to this gaged site (likewise at San Acacia), when the streamflow increased, EC went down and vice versa when streamflow diminished, EC went up.

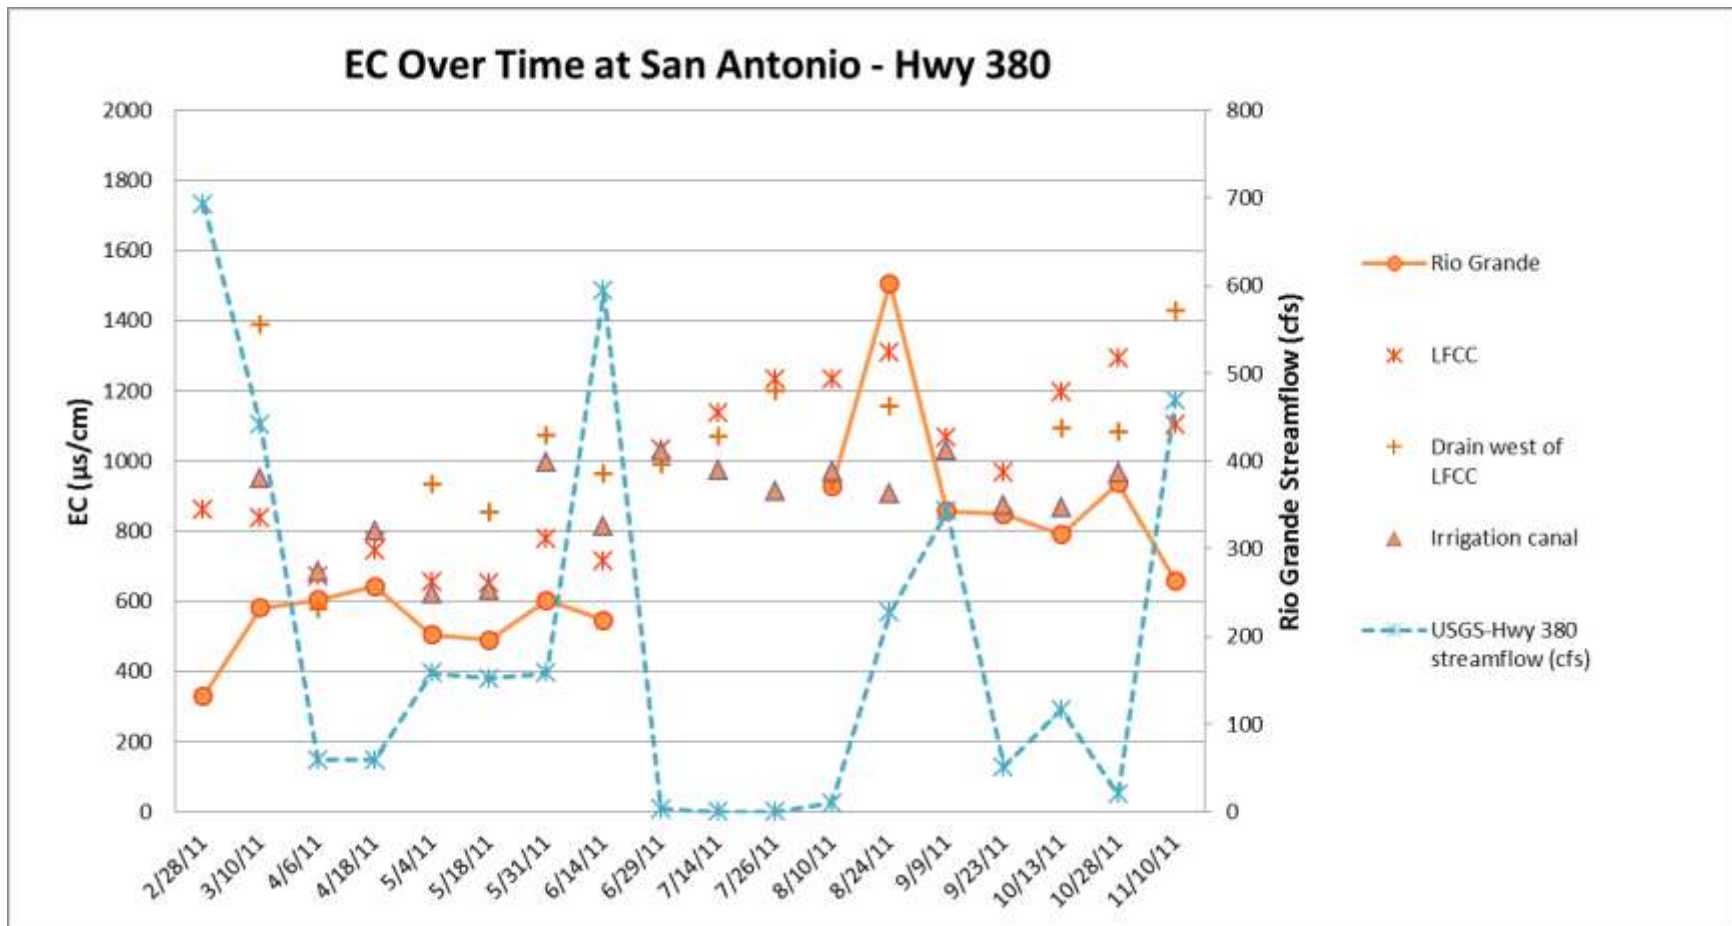
Figure 23. EC at San Antonio. Note that the gap in EC data for the river is due to no flow in channel. The EC spike on August 24 may be due to the Rio Puerco and Salado inflow during monsoon season.

The drain at San Antonio measured 1760 $\mu\text{S}/\text{cm}$ at the end of February just prior to the start of the irrigation season. As the irrigation season began and Unit 7 was released into the irrigation channels a markedly sharp decrease in EC occurred within a 6 week period to a low of 578 $\mu\text{S}/\text{cm}$ in the beginning of April. The EC of the drain rose fairly consistently thereafter to a rise of 1094 $\mu\text{S}/\text{cm}$ at the end of the irrigation season in late October. Post irrigation reading in November saw an increase to 1430 $\mu\text{S}/\text{cm}$.

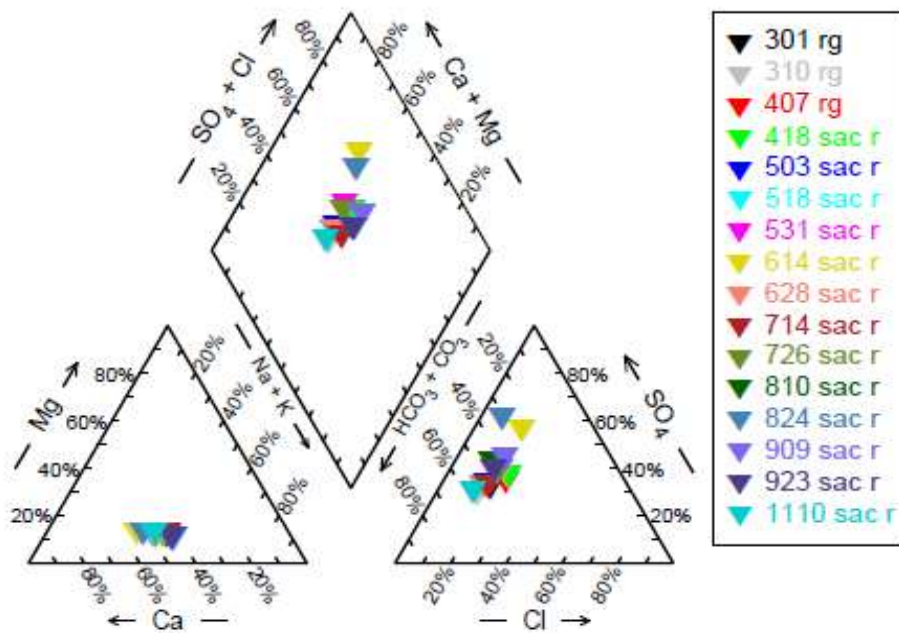
Figure 38. Water composition of the Rio Grande at San Acacia (top) and San Antonio (bottom).

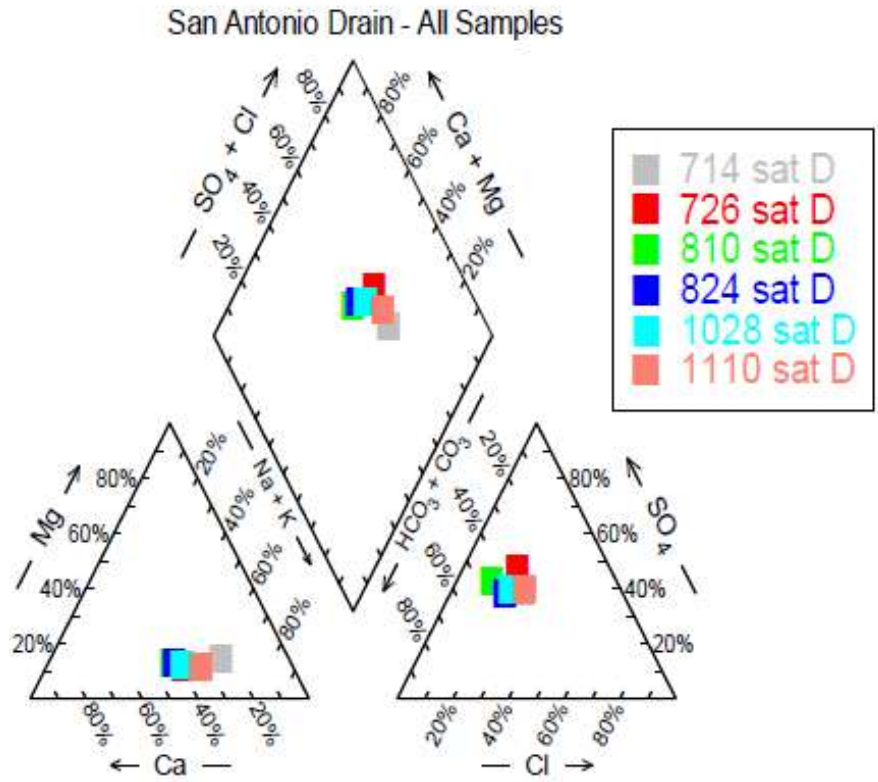
Figure 40. Water composition of drain (top) and LFCC (bottom) samples at San Antonio.

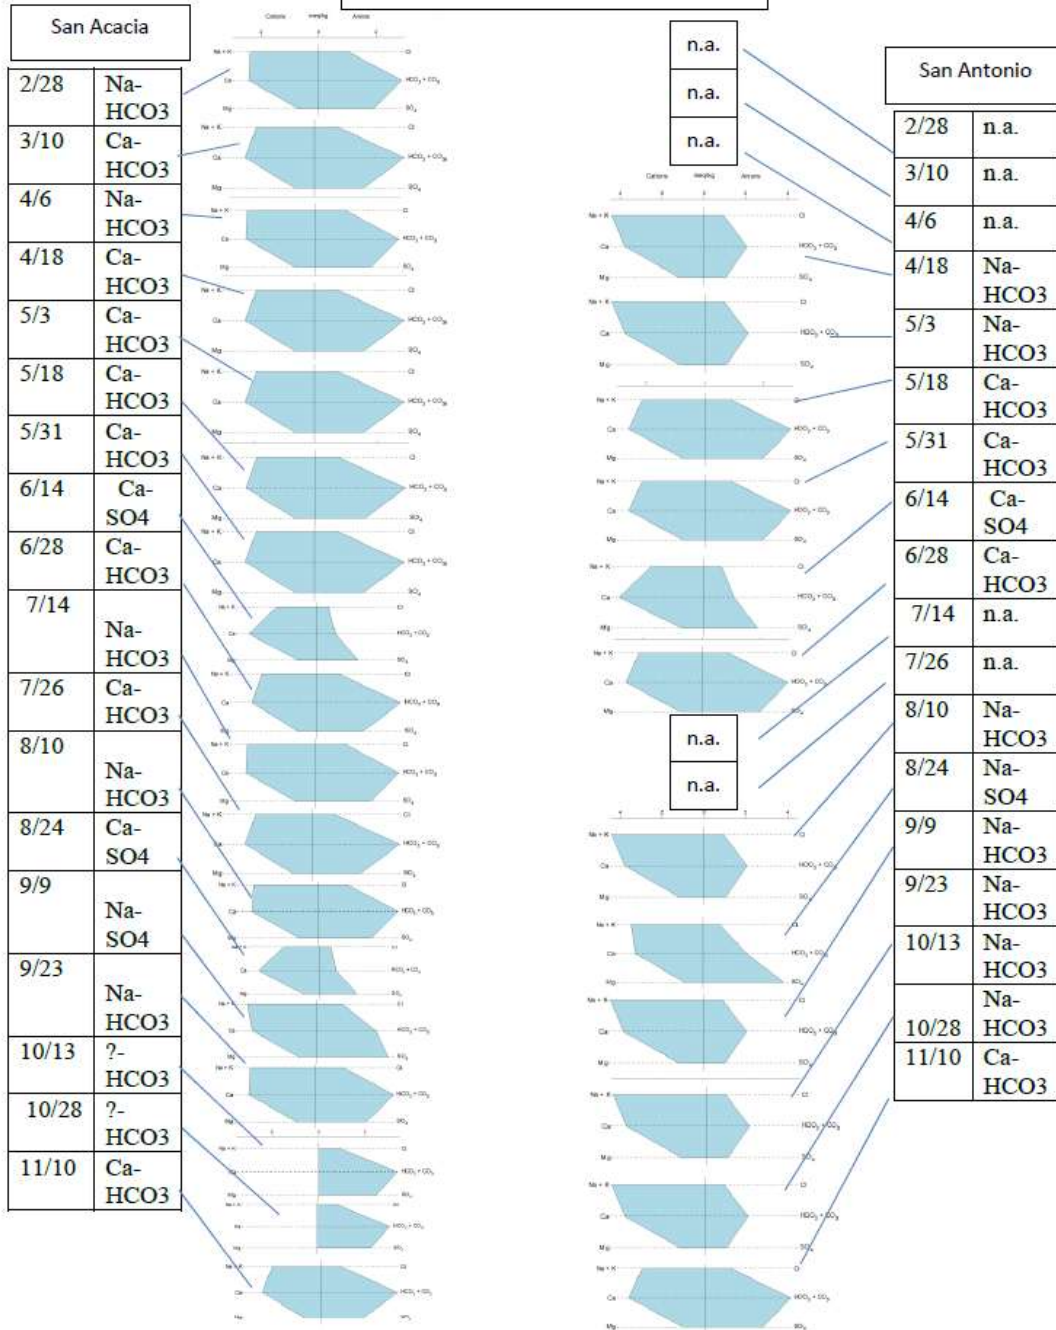
Rio Grande at San Acacia and San Antonio
Major Ion Composition 2011

Figure 42. Stiff diagrams represent composition of Rio Grande samples at San Acacia and San Antonio during 2011.
