**Erosion Impacts from Recreation
in the Enchanted Tower Climbing Area, New Mexico**

A Professional Project Report Submitted in
Partial Fulfillment of the Requirements for the Degree of

Master of Water Resources

Water Resources Program
The University of New Mexico
Albuquerque, New Mexico
August 2001

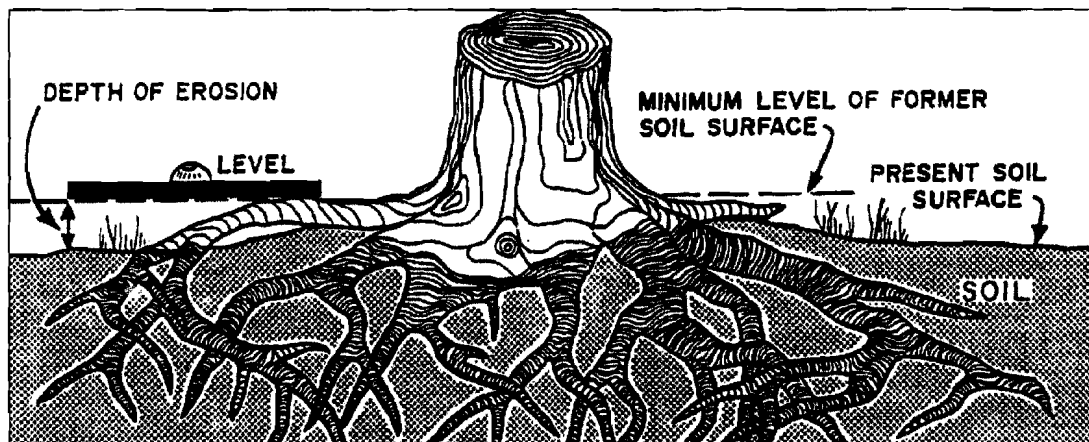
Figure 2-1 Measurement of erosion from tree root exposure.

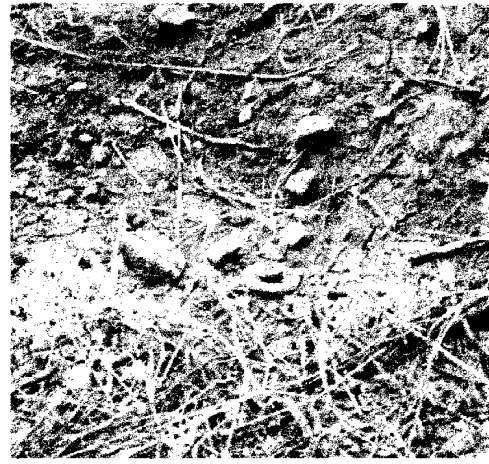
Figure 2-2 Erosion pin installed in the Thompson Canyon Watershed.

After a review of erosion measuring techniques, a decision was made to install erosion pins across stream channels in the Thompson Canyon watershed. A description of the Thompson Canyon watershed pin study areas is presented later in this report.

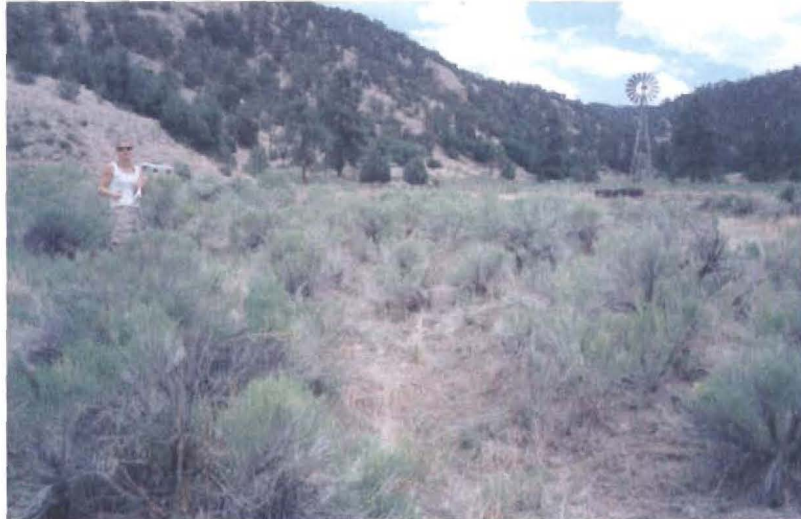
Figure 3-8 Picture taken upstream of the climbing area where the meadow has considerable more vegetation cover than near the climbing area.

Vegetation within the Thompson Canyon Watershed reflects elevation differences, available moisture content and land use intensity. Piñon/juniper (*Pinus cembroides* / *Juniperus scopulorum*) forest rises from an average elevation of 2308 m to ponderosa pine (*Pinus ponderosa*) and mixed conifer at elevations over 2769 m (Figure 3-7). Prairie/grasslands commonly occur in piñon/juniper forests (CNF, 2000). A number of species combine to make up the understory and meadows within the steep canyon sides including: Gambel oak (*Quercus gambelii* Nutt.), Oregon grape, pine dropseed (*Blepharoneuron tricholepis*), squirreltail (*Elymus Elymoides*), blue gramma, western wheatgrass (*Pascopyrum smithii*), wolf tail, Kentucky bluegrass (*Poa pratensis*), sagebrush (*Artemisia*) and a number of wildflowers (Figure 3-8).

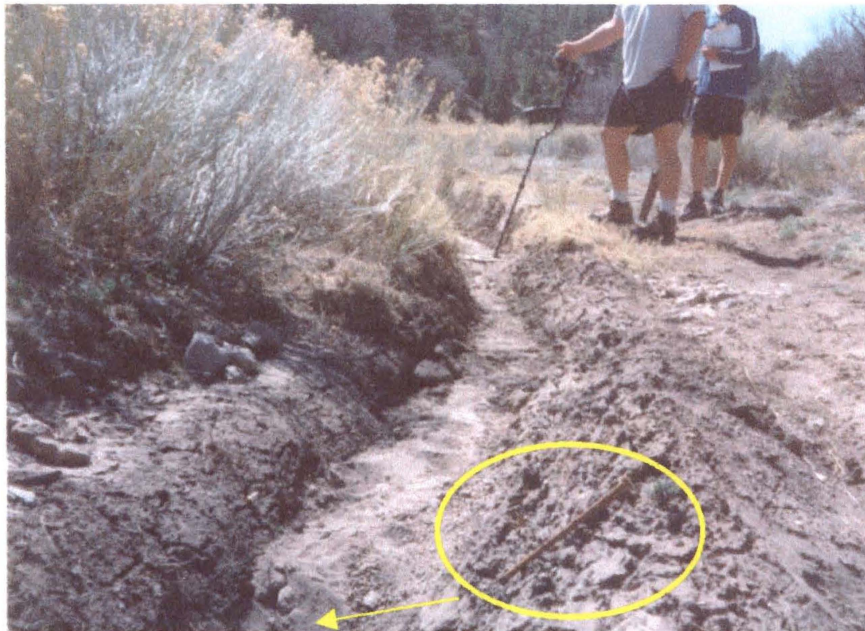
Figure 4-6 The metal detector in this picture shows the original location of Site 2A–pin 1. In April 2001, the pin was found 6m downstream of its original location and 0.4m in the ground.

Site 2B – pin 2, was in a similar position downstream of site 2A - pin 1. Two attempts, with a metal detector, were made to find pin 2, but to no avail. Similarly to other missing pins, site 2B – pin 2 was assigned values based on its last measurement. The value assigned to site 2B - pin 2, was likely the minimum amount of erosion.

Because of this pin's similar position to that of site 2A - pin 1, it too may have eroded away. No evidence of this was found, and for this reason, the pin was assigned the last recorded value, which was during September 2000.

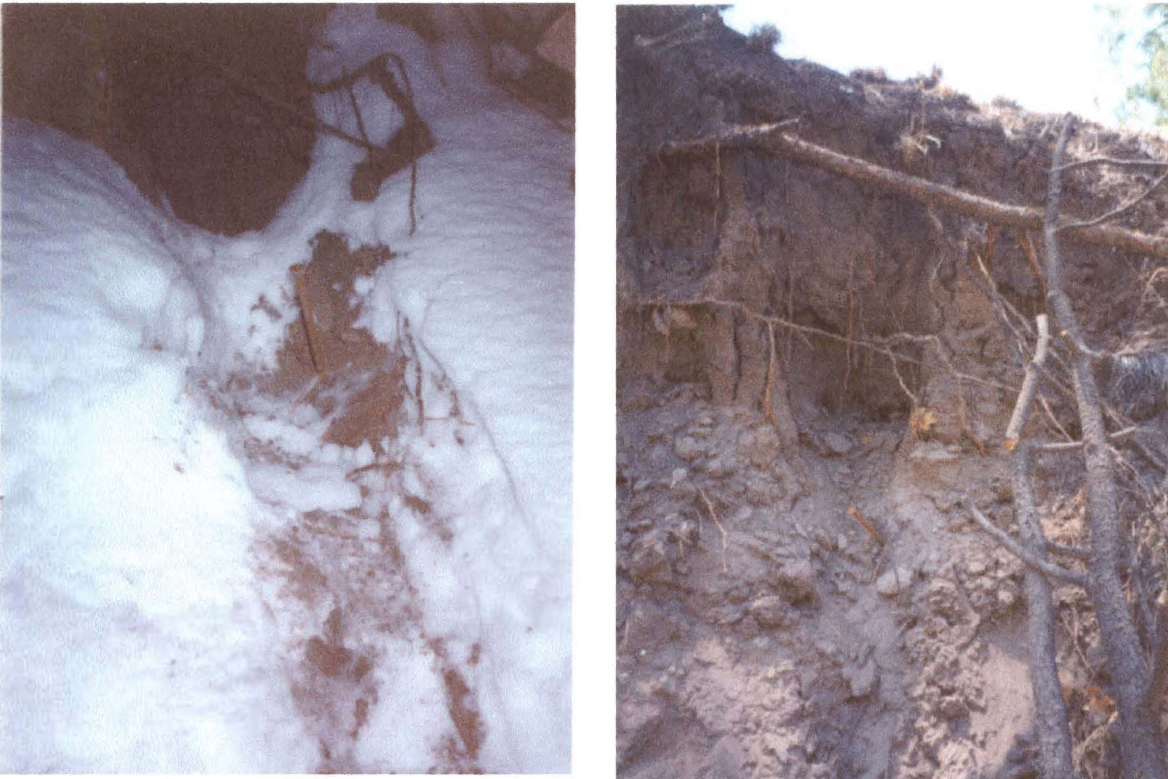
Figure 4- 7 Site 3A - erosion pin 2 The picture on the left was taken in January. The picture on the right was in March; notice the sediment on top of the washer.

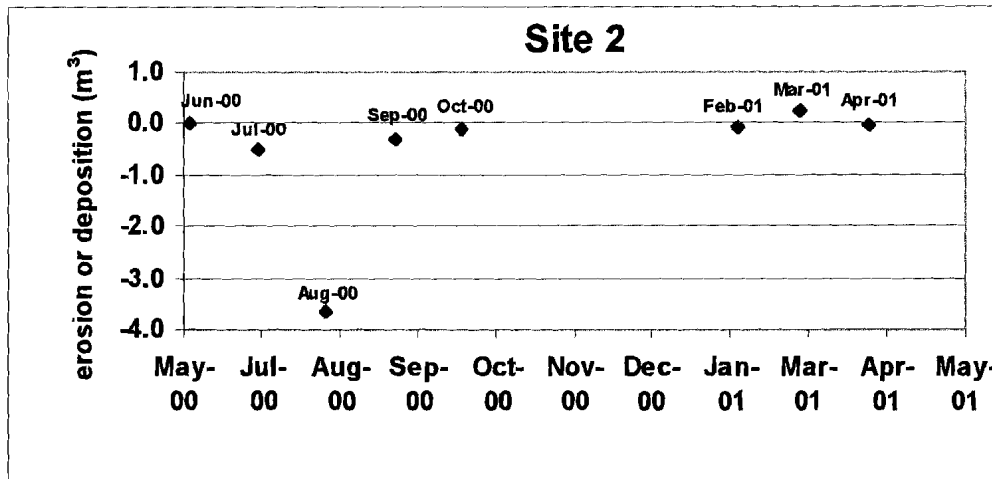
Figure 4-9 Graph showing cumulative erosion and sediment yield for erosion pin site 2 net deposition is distinguished by positive values and net erosion by negative values.

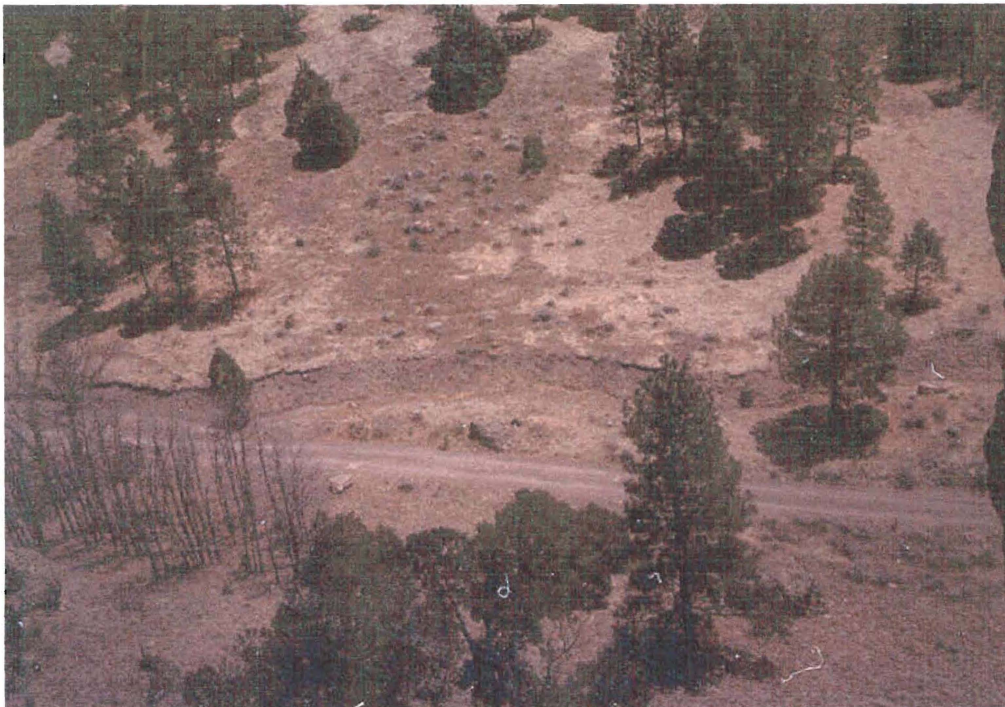
Figure 5-1 This picture shows the close proximity between the stream channel and Forest Road 59A. It was taken from the top of the Enchanted Tower

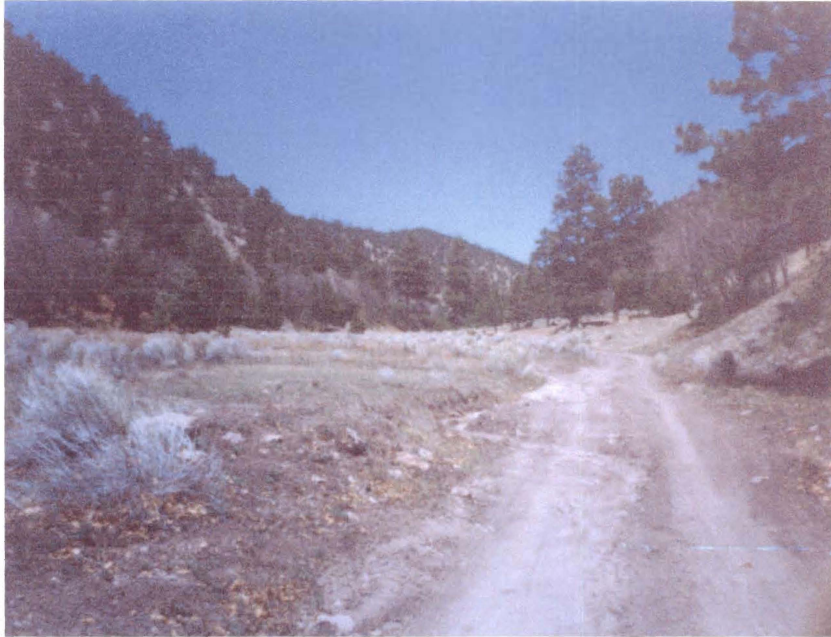
Figure 5-2 When the stream channel flows, water often floods Forest Road 59A in several different locations throughout the canyon.

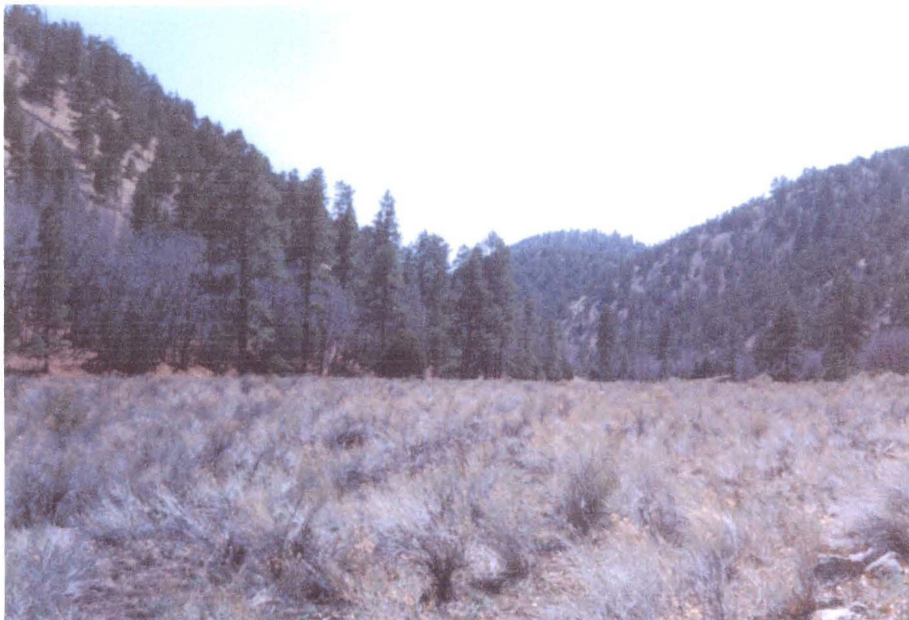
Figure 5-3 Picture taken upstream of the climbing area, showing the vegetated meadow and the narrow canyon.

where the road is moved it will still be in close proximity to the stream channel (Figure 5-3). It is also inevitable that the road would still cross the channel in several locations. Graveling the road would be a preferable option for reducing erosion.

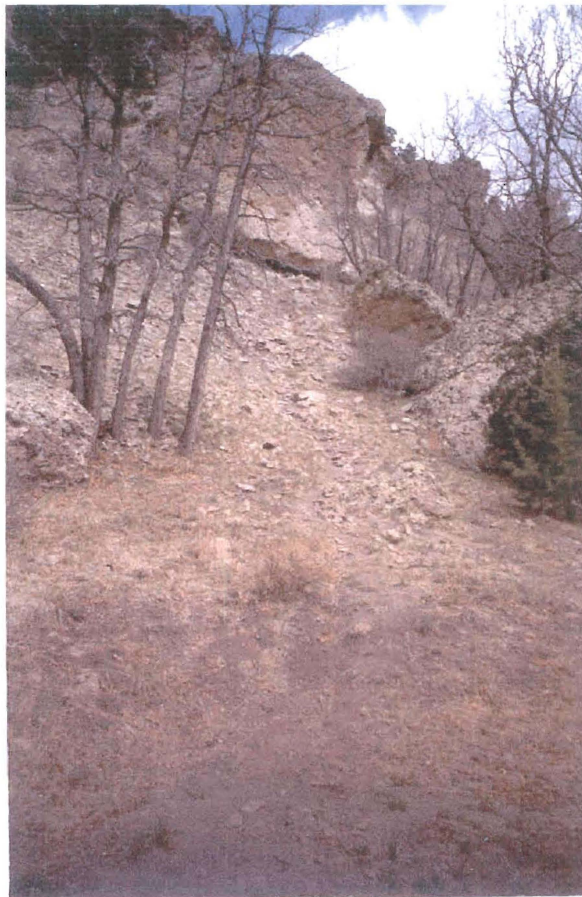
Figure5- 4 Trail leading up to the Ugly Duckling climbing area, this is the first of the trails that is diagrammed in Chapter 3.

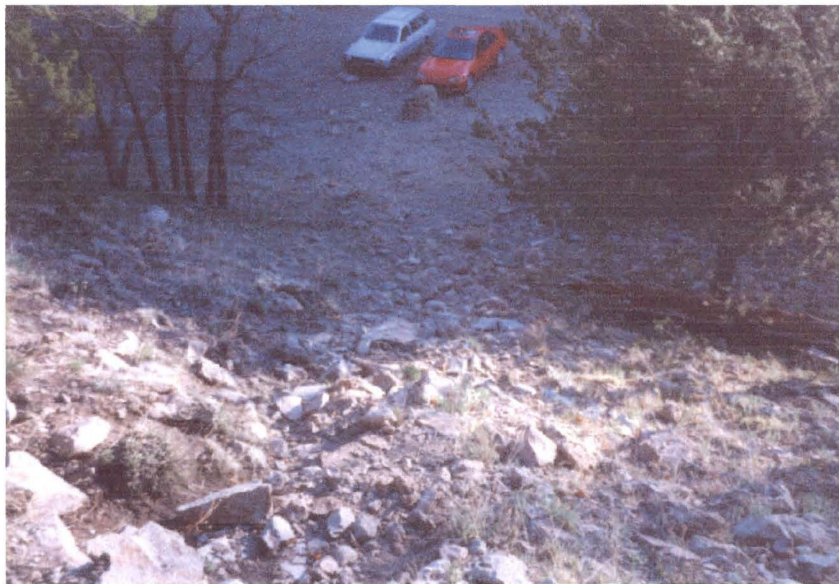
Figure 5- 5 Picture looking down the trail below the Enchanted Tower.

The trails within Thompson Canyon were never properly planned or constructed. The trails generally begin at the edge of Forest Road 59A, opposite from the campsites and head straight up the steep slopes to the nearest climbing wall. As a result, the pathways that people have created over the years have become channels of flowing water when it rains (Figures 5-4, 5-5). Rebuilding the existing trail system with stairs and

During June 2001, efforts were made to reconstruct new trails surrounding the Enchanted Tower climbing area. Computations from applying the RUSLE have shown that the newly constructed trails are eroding less than the old trails. The major differences between the old and new trails, resulting in lower erosion rates are the differences in slope steepness and slope length. I was unable to attend the organized trail building day. However, the following weekend I visited the canyon and was pleasantly surprised by the new trails. Figure 5-5 is a picture looking down the Enchanted Tower Trail. However,

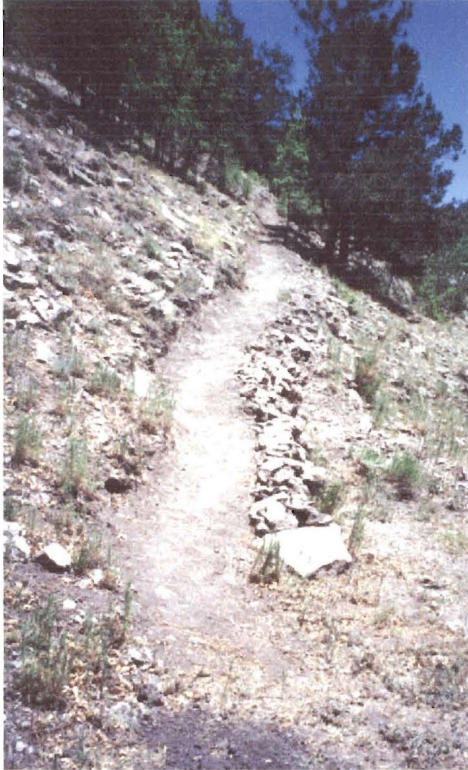
Figure 5-6 shows the changes that took place to the trail in one weekend. The new trails are wider and were constructed with a reduced grade when compared with the older trails. The new trails were also built up with rocks to minimize further erosion.

Figure 5-6 Picture taken of the newly constructed trail leading up to the Enchanted Tower.

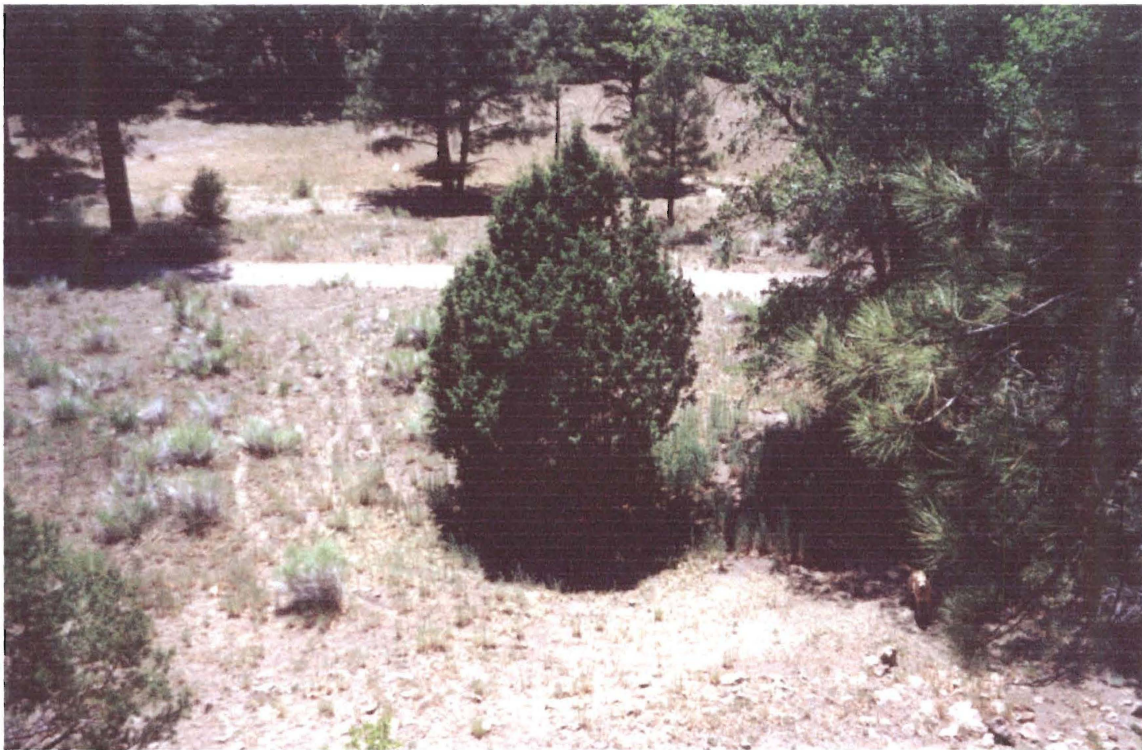
Figure 5- 7 Campsites are spread throughout this meadow. Here someone has driven into the meadow area, destroying vegetation, to turn around.

One of the primary issues within the Thompson Canyon Watershed is the creation of new campsites when existing sites are occupied. There are several ways to curb this degradation of the land that should be employed as soon as possible. One commonly utilized option is placing large boulders, trees and other natural obstacles around campsites and parking areas as barriers so that cars are unable to drive over them. For example, Figure 5-7 shows where people have extended the road by driving into the meadow adjacent to their campsite. Planting native vegetation and placing large obstacles around campsites and parking areas define their spaces by preventing further sprawling, and allowing native vegetation to recover. In addition, creating these borders around campsites creates privacy between the campsites and would prevent further damage to the
