# Justification for Class III Permit Modification January 2008 SWMU 28-2 Operable Unit 1332 Mine Shaft

## SWMU 28-2 Mine Shaft

Sandia National Laboratories/New Mexico (SNL/NM) is proposing an administrative no further action (NFA) decision for Environmental Restoration (ER) Site 28, Mineshafts, Operable Unit (OU) 1332. ER Site 28, formerly included in OU 1297, was identified in the Hazardous and Solid Waste Amendment (HSWA) Module IV (Ref. 1) of the SNL/NM Resource Conservation and Recovery Act (RCRA) Hazardous Waste Management Facility Permit (NM5890110518) (Ref. 2).

## **SUMMARY REPORT FOR ENVIRONMENTAL RESTORATION PROJECT VOLUNTARY CORRECTIVE ACTION AT SOLID WASTE MANAGEMENT UNIT 28-2 MINE FOOTHILLS TEST AREA**

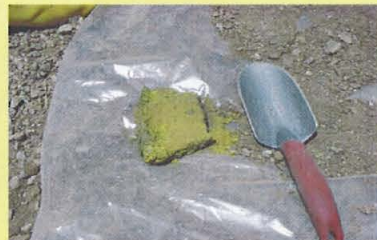
Photograph of depleted uranium removed from near the entrance to SWMU 28-2.

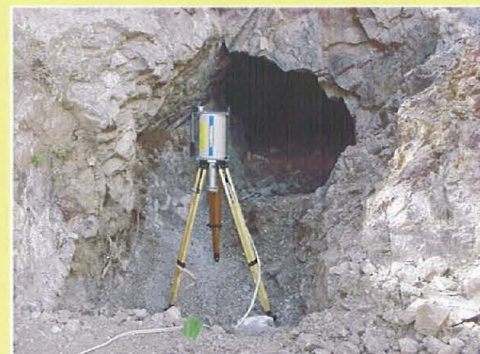
Photograph of in situ gamma spectroscopy measurement at SWMU 28-2

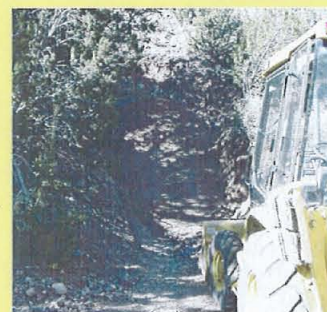
Photograph of the sealed mine entrance at SWMU 28-2

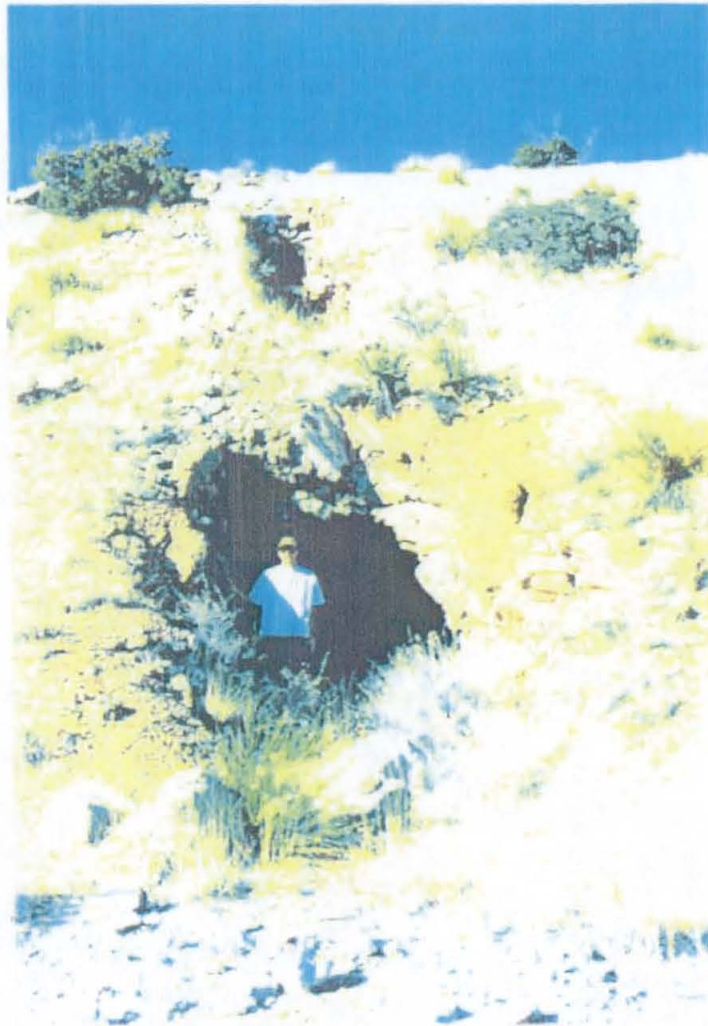
Figure 2a.  
Site 28-1, Adit Behind Technician Connected/Continuous  
With Excavated Trench in Background

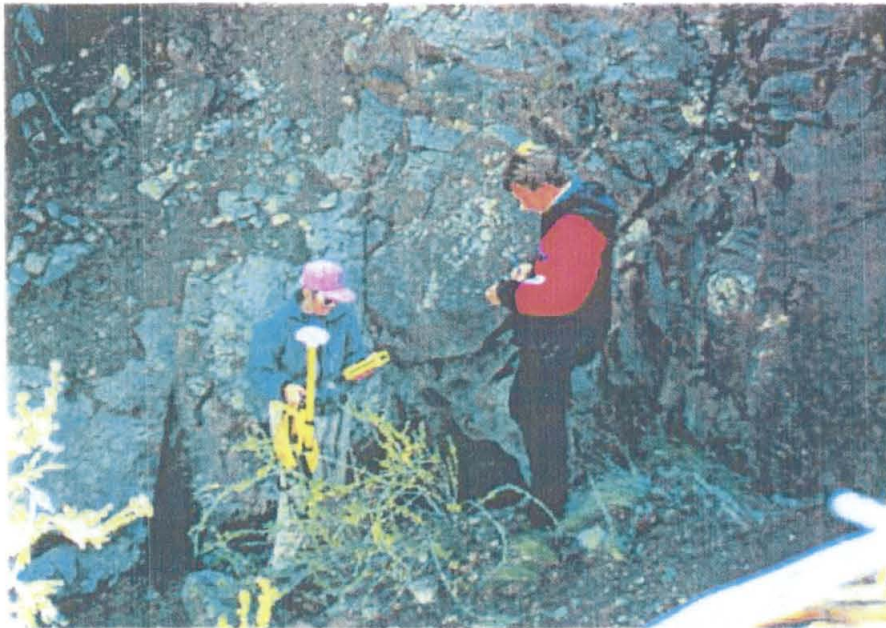
Figure 3a.  
Site 28-2, lower caved-in adit located between the two ER personnel.  
Yellow instrument is the Global Positioning System (GPS) instrument.

*Objective:* Photograph and survey with a Global Positioning System (GPS) instrument all locations (the GPS instrument is shown in Figures 3a, 4a, 9, and 10a). Document the current condition of the mines and look for any evidence of any type of postmining activity.

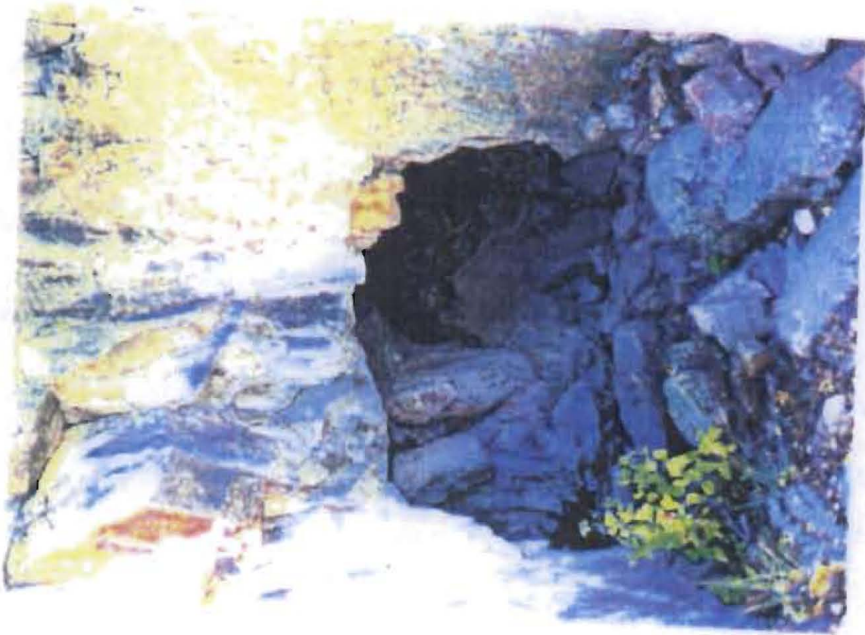
Figure 3b Site 28-2. Upper adit location.  
View of the opening.

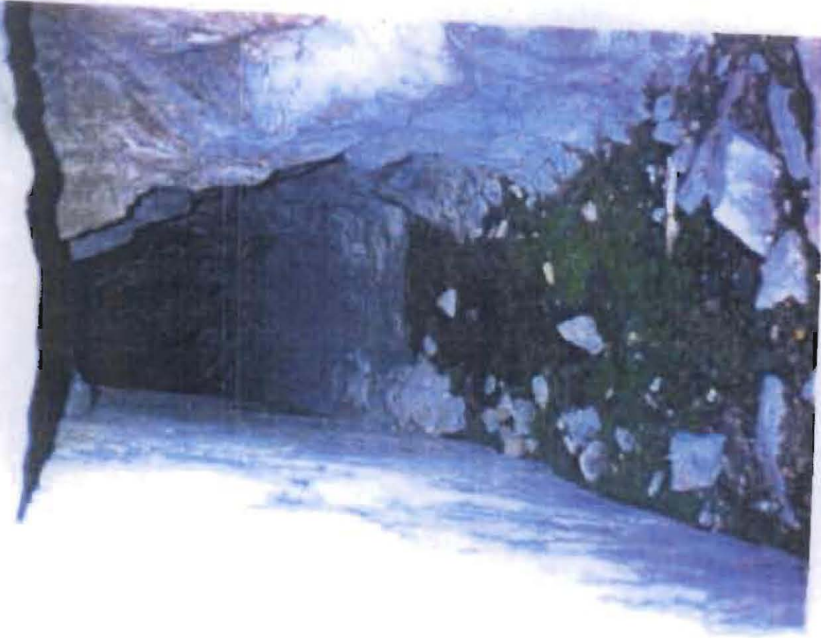
Figure 3c Site 28-2. View into the adit showing  
green vegetation, indicating  
the common presence of  
water.

protruding from the portal that was apparently used for draining water. Mud and green vegetation in the adit indicate that it is often saturated (Figure 3c). What remains of an abandoned road continues up the south side of the canyon to the east for a distance of approximately 1,800 feet, where it crosses to the north side, continuing up-slope for 400 feet. The road dead-ends at a leveled pad of unknown origin or use. Although a section of two-conductor black detonation wire was observed on the slope below this adit, there is no indication of any postmining activity.

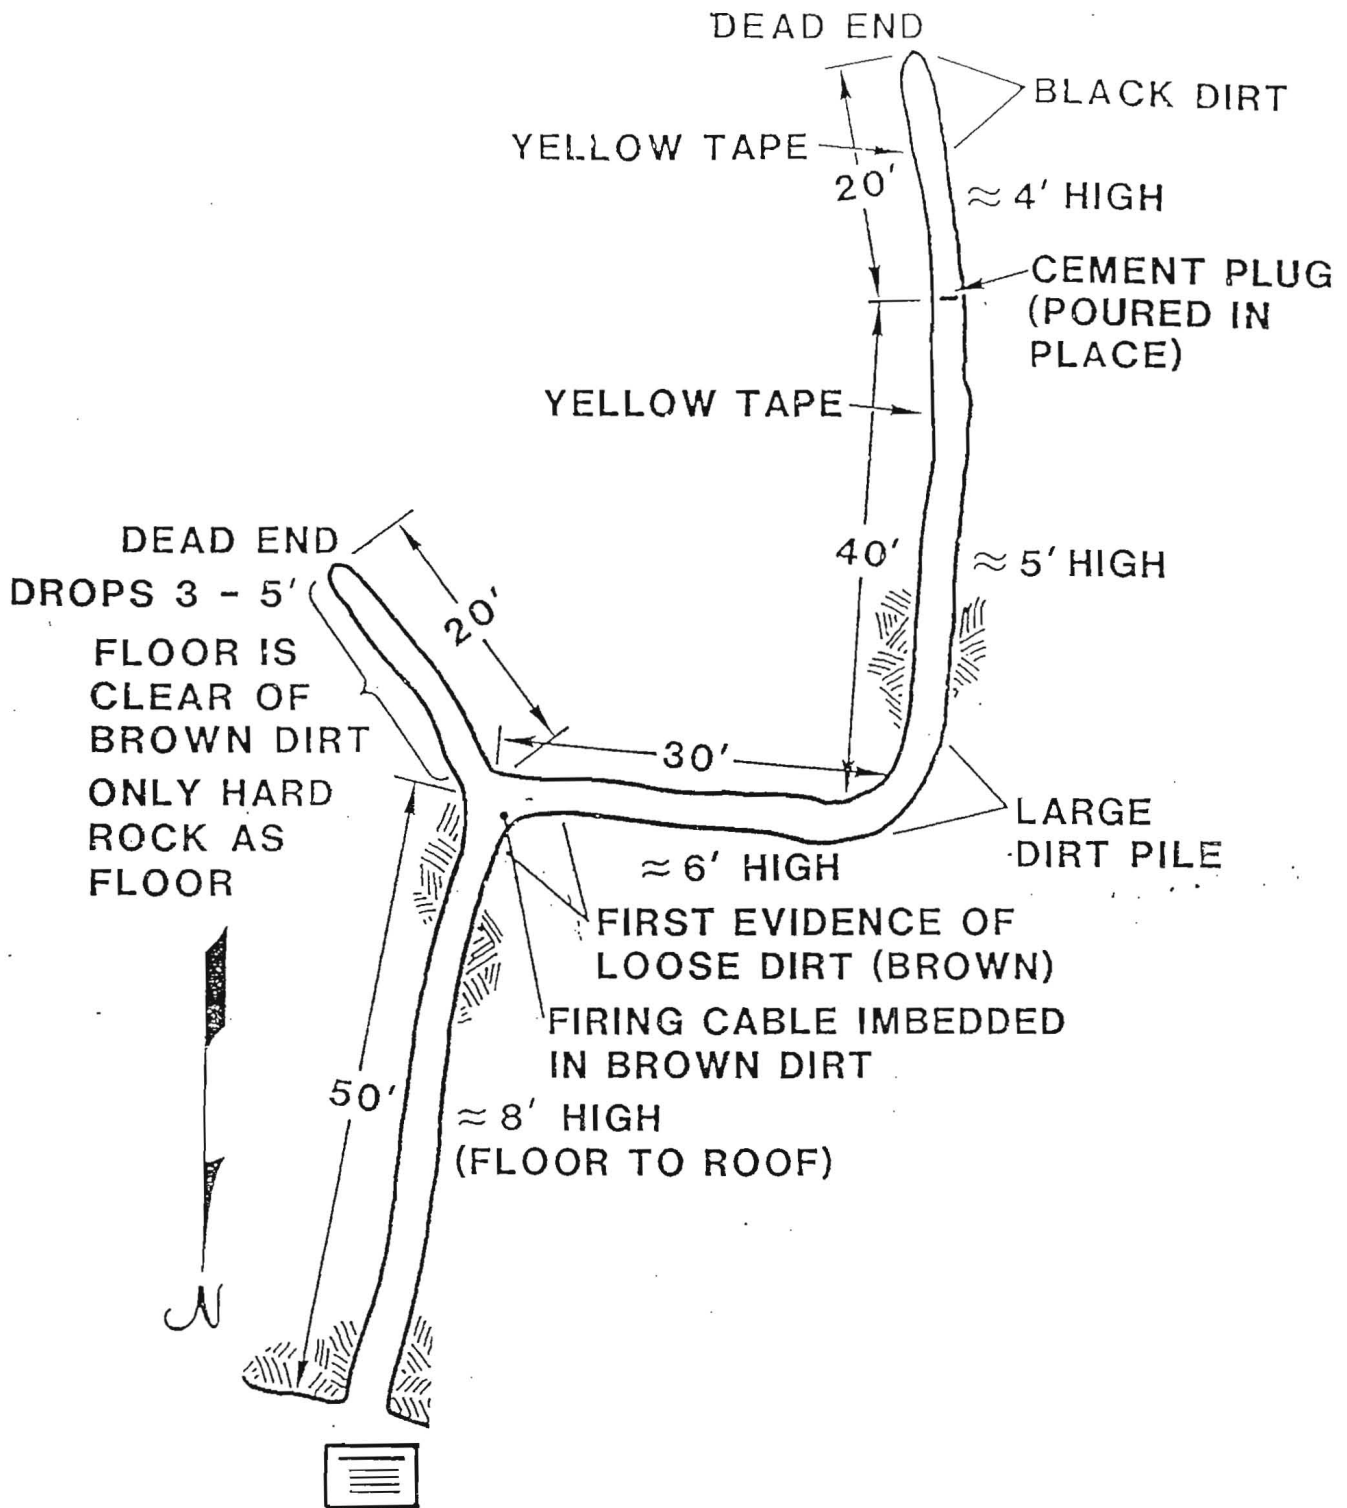
Figure 3d.  
Site 28-2, Sketch Map of the Lower Adit

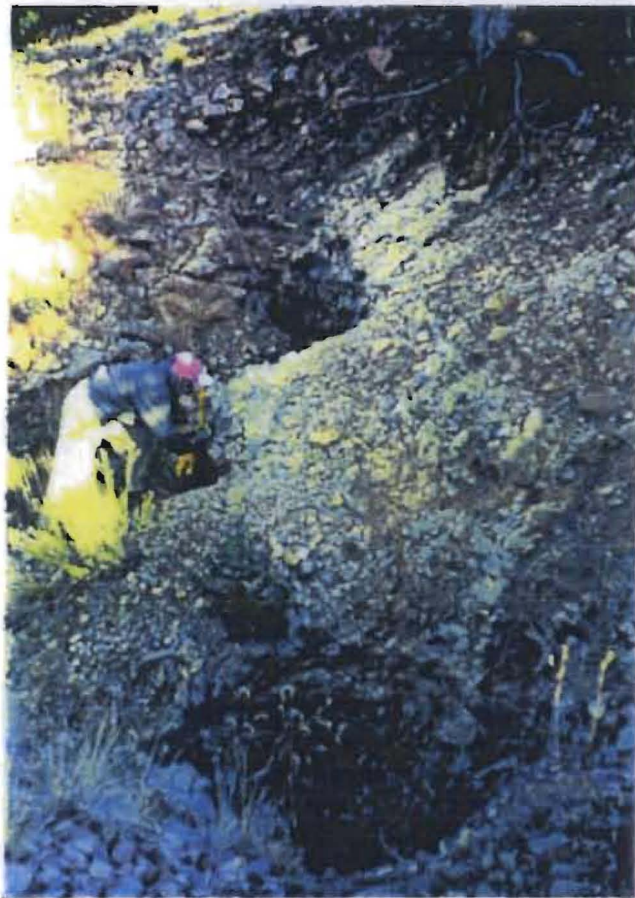
Figure 4a Site 28-3. Horizontal adit located above and vertical shaft located below ER GPS surveyor.

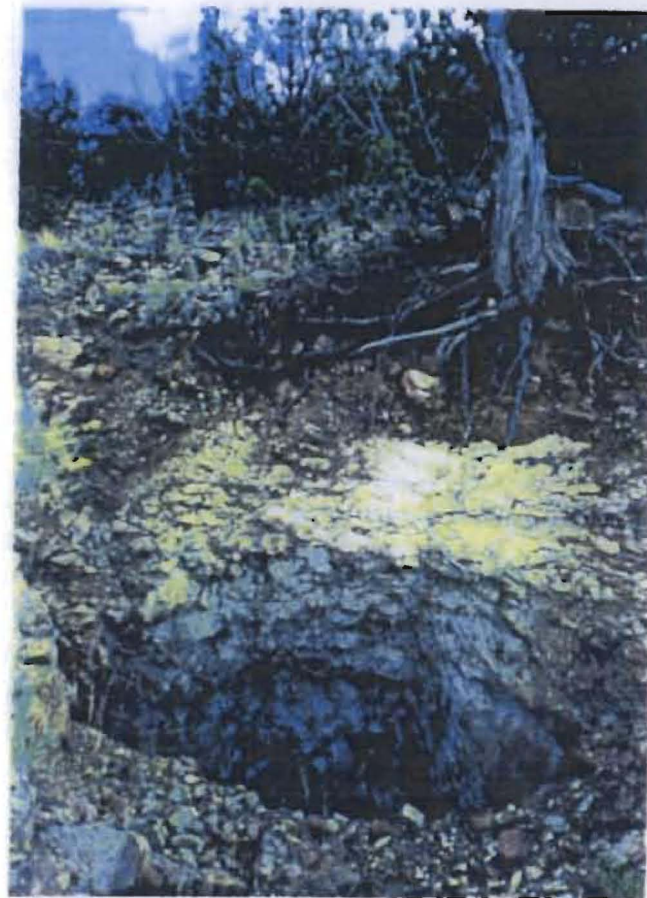
Figure 4b Site 28-3. Horizontal adit.

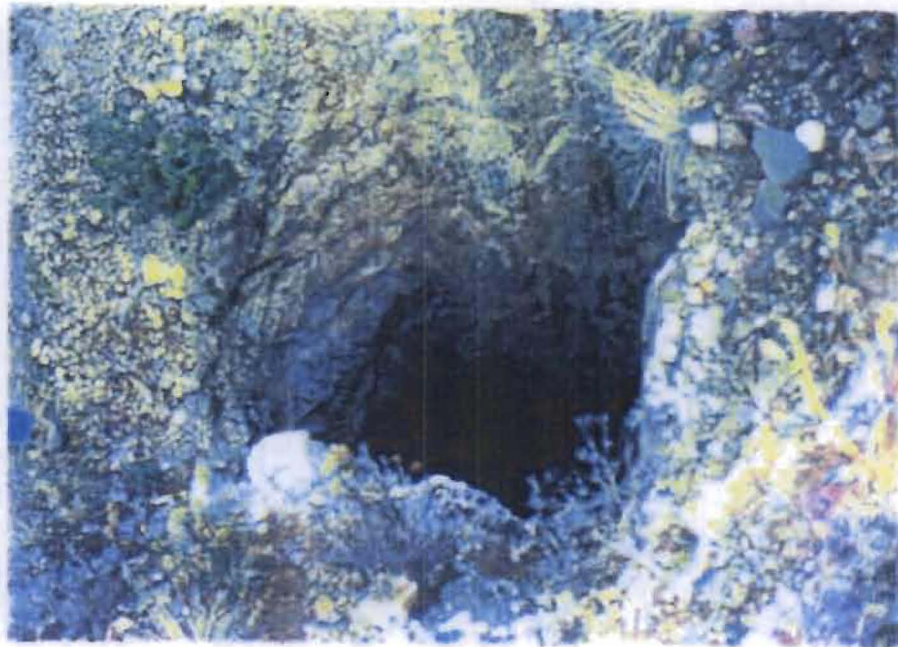
Figure 4c.  
Site 28-3, Vertical Adit With View Looking Down

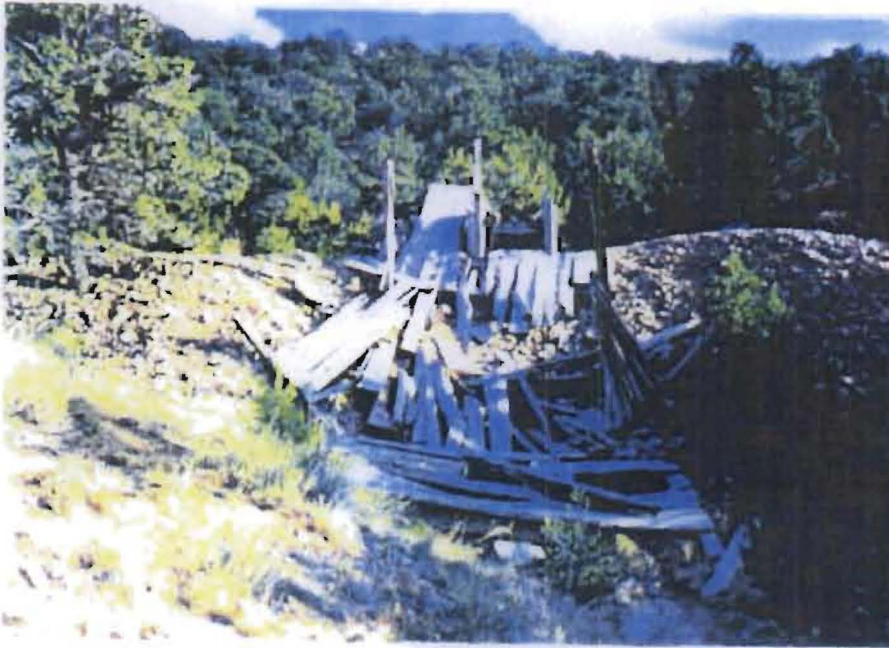
Figure 5a Site 28-4. Blackbird Mine. View to the north of the main shaft and associated timbers.

Site 28-4 is located in the north-central portion of the Withdrawn Lands (Figure 1 and 1a), approximately 200 feet north of 28-3. The mine is in Lurance Canyon just south of Coyote Springs Road (Figure 1a), and just west of ER Site 94 (Lurance Canyon Burn Site). The main part of this mine site is a shaft covered with broken wooden framing, which is the historic Blackbird Mine (Figures 5a and 5b). In addition to the shaft, there are two trenches at this site.

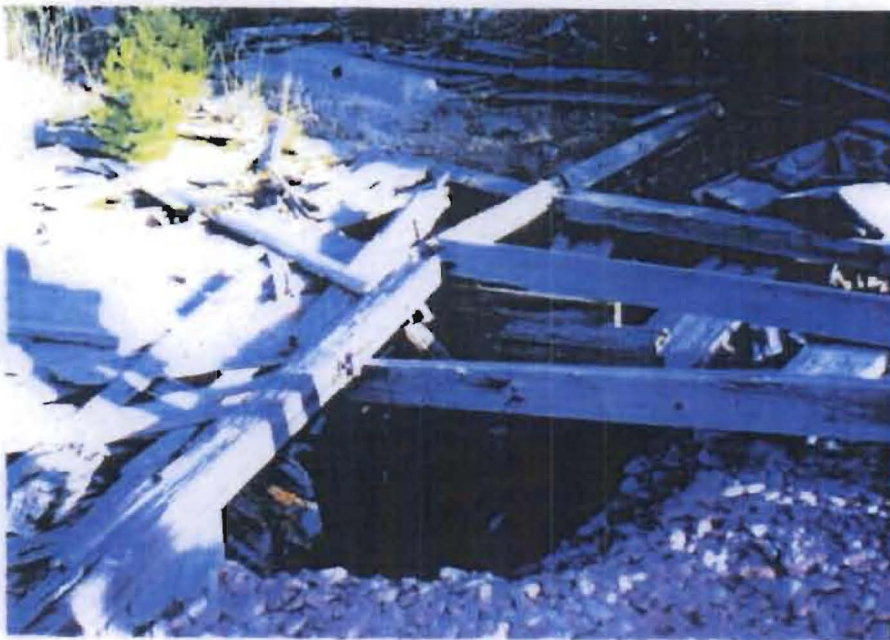
Figure 5b Site 28-4. Closeup of the top of the main shaft.

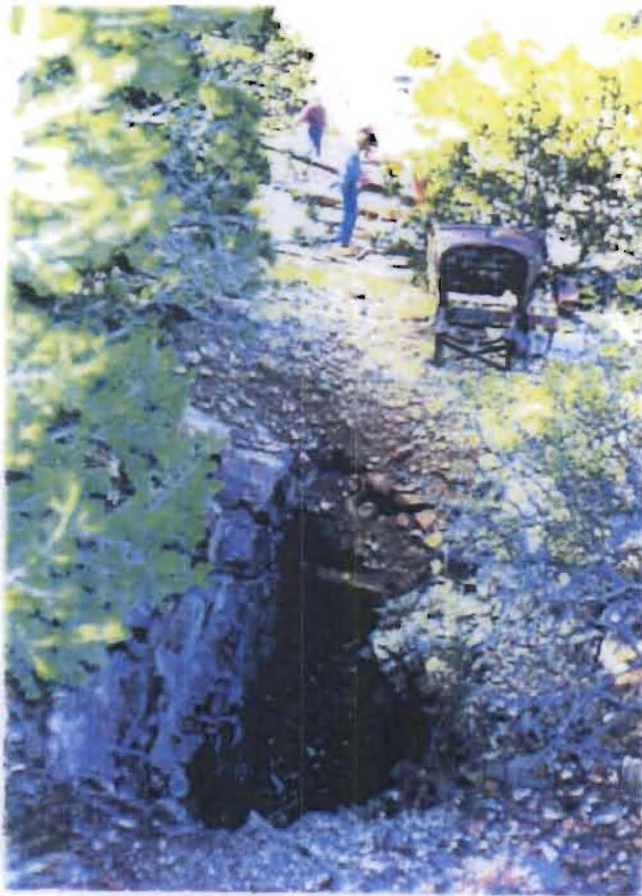
Figure 5c.  
Site 28-4, One of Two Shallow Trenches Located  
Just Southeast of the Main Shaft

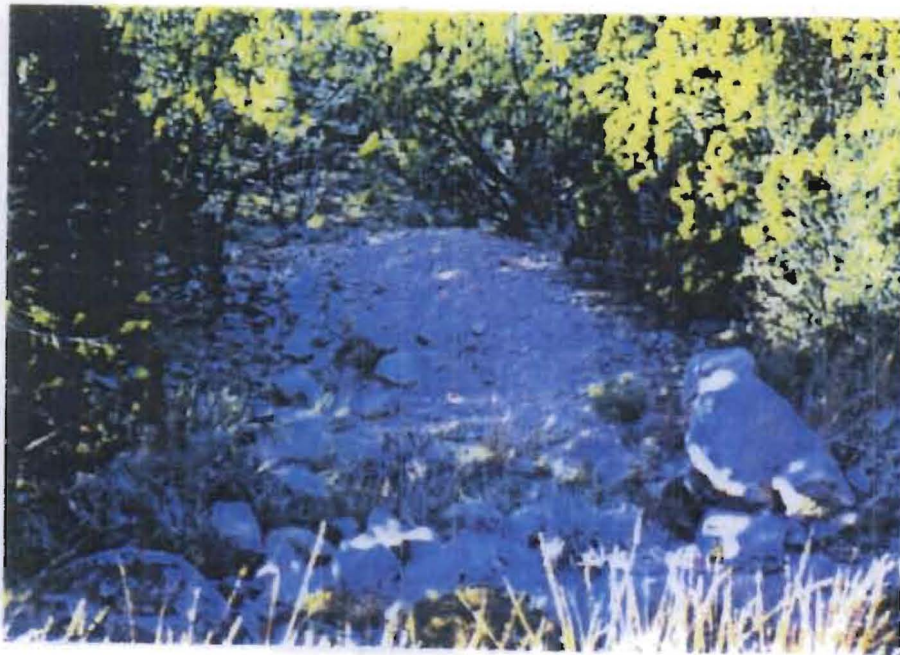
Figure 6.  
Site 28-5, Small, Nondescript Tailings Pile

This location is in the same vicinity as 28-4 and 28-3 (north-central part of the Withdrawn Lands), approximately 400 feet southeast of 28-4 (Figures 1 and 1a). Site 28-5 is comprised of a very small pile of what appears to be tailings from a prospecting pit (Figure 6). The area was searched thoroughly for a shaft or adit feature, but nothing was found (Ref. 20). The SNL/NM Health Physicist who surveyed the locations for radioactivity verified that this was the same location he surveyed back in the early 1980s (Ref. 19). Besides the pile of tailings, there is no other evidence in the area of either mining or postmining activities.

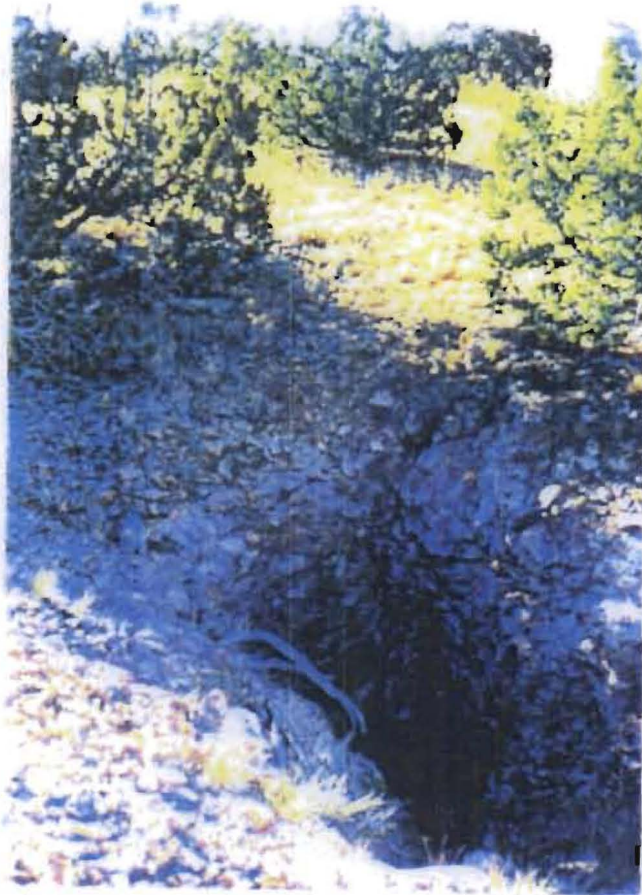
Figure 7.  
Site 28-6, Vertical Shaft

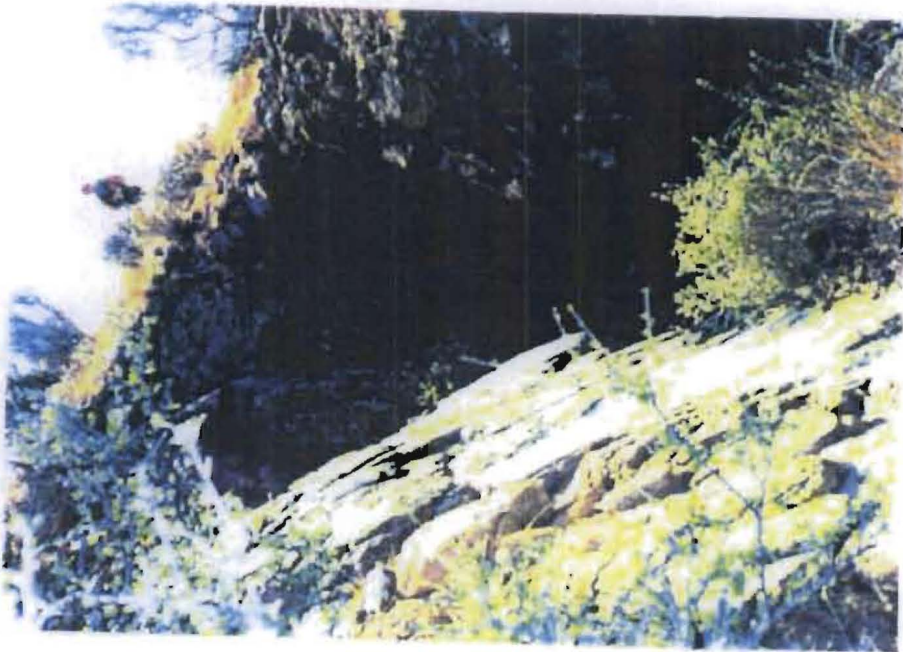
Figure 8a Site 28-7. View looking south of horizontal adit.

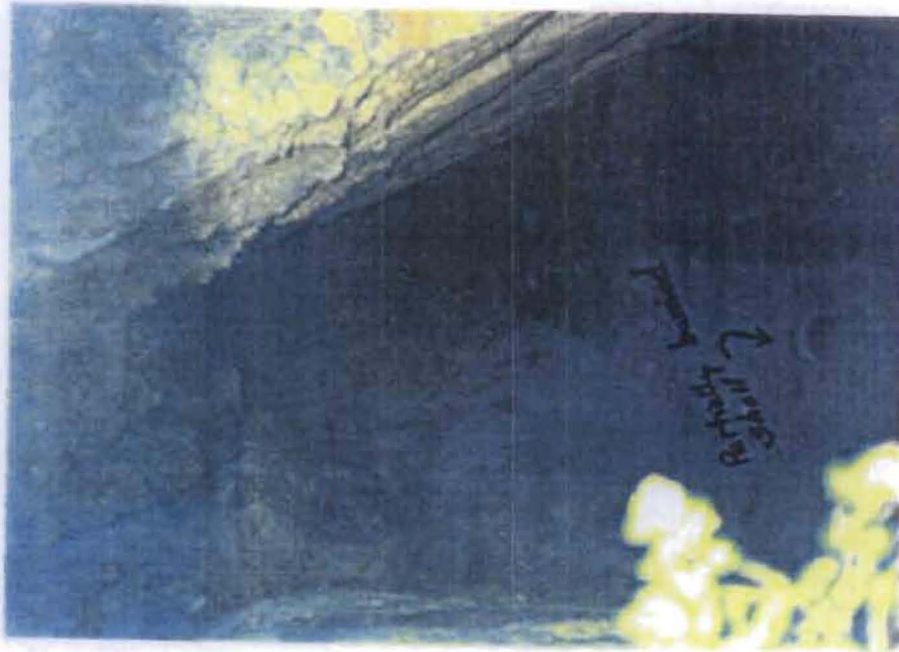
Figure 8b Site 28-7. Closeup of the inside of the adit.

A fragment of a shell is visible at the entrance of the adit (Figure 8b). It is similar to the shells that are found throughout the area, and appears to have simply landed in the entrance area. The interior of the mine has been carefully inspected and no shells can be seen within the mine. It is possible that the caving at the entrance to the mine resulted in part from the impact of the shell. Another explanation is erosion, because the hill slopes in this area. The entire adit can be viewed from the entrance and there is no evidence of postmining activities or disposal in the adit.

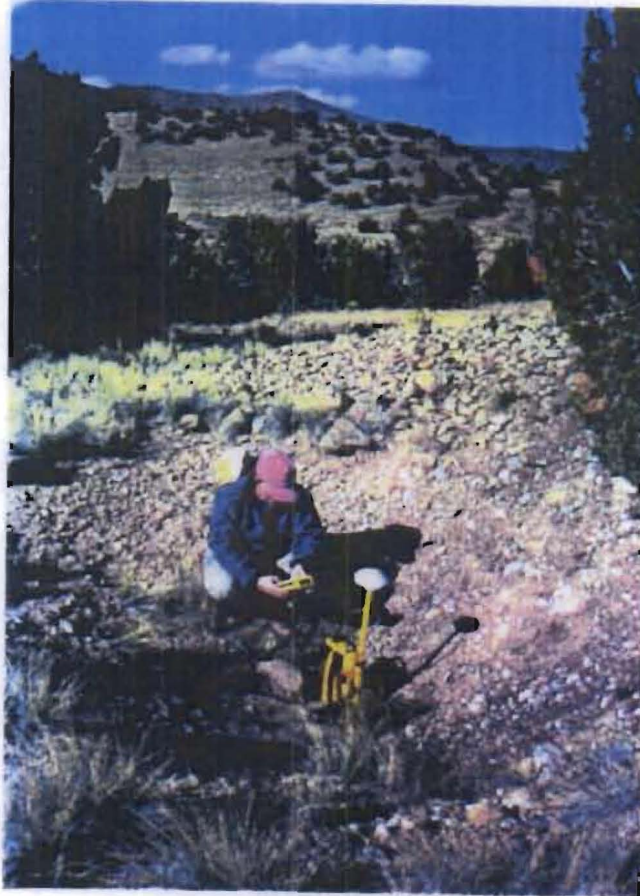
Figure 9 Site 28-8. View looking to the north. GPS technician surveying in location.

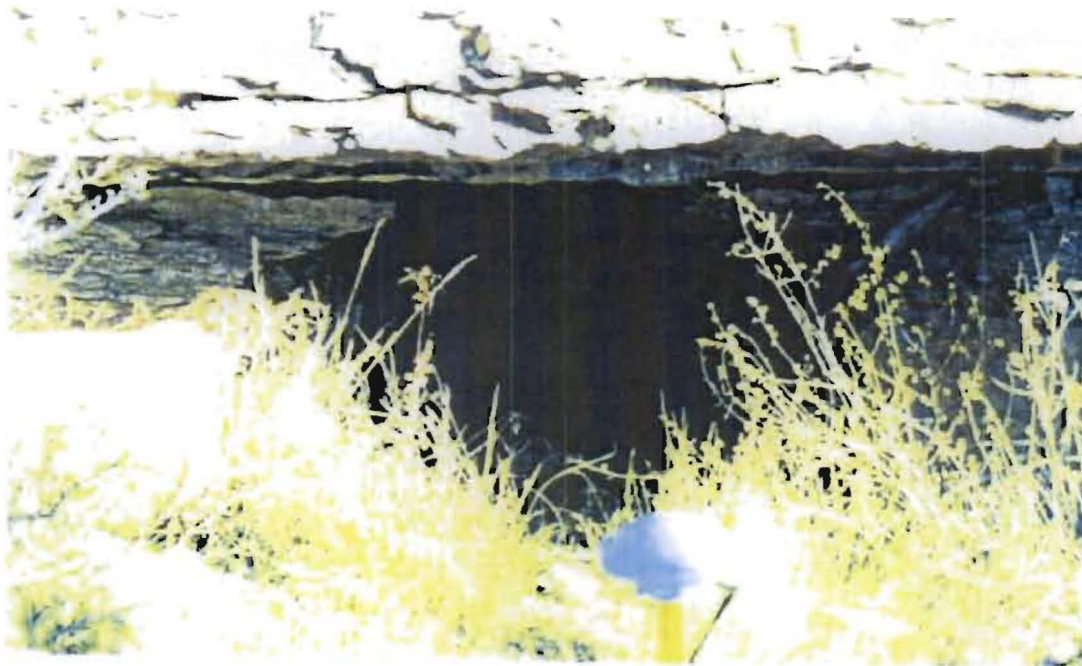
Figure 10a Site 28-9. Horizontal adit. View to the east.  
GPS instrument antennae in foreground.

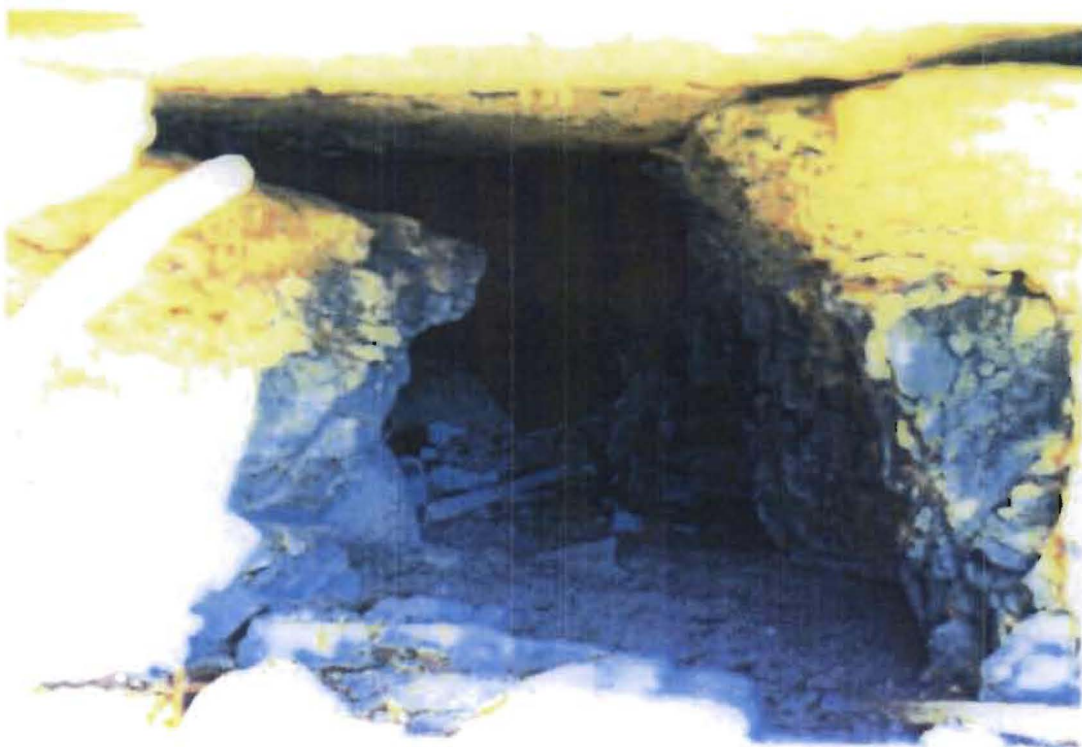
Figure 10b Site 28-9. Closeup of inside of adit.  
Approximately 5 ft. from ceiling to floor.

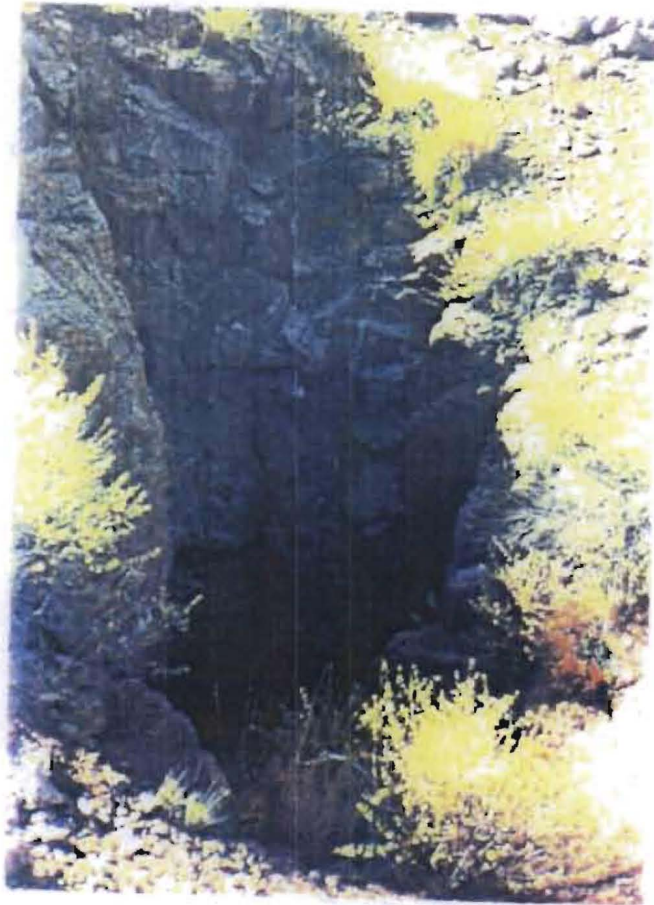
Figure 11.  
Site 28-10, Vertical Shaft

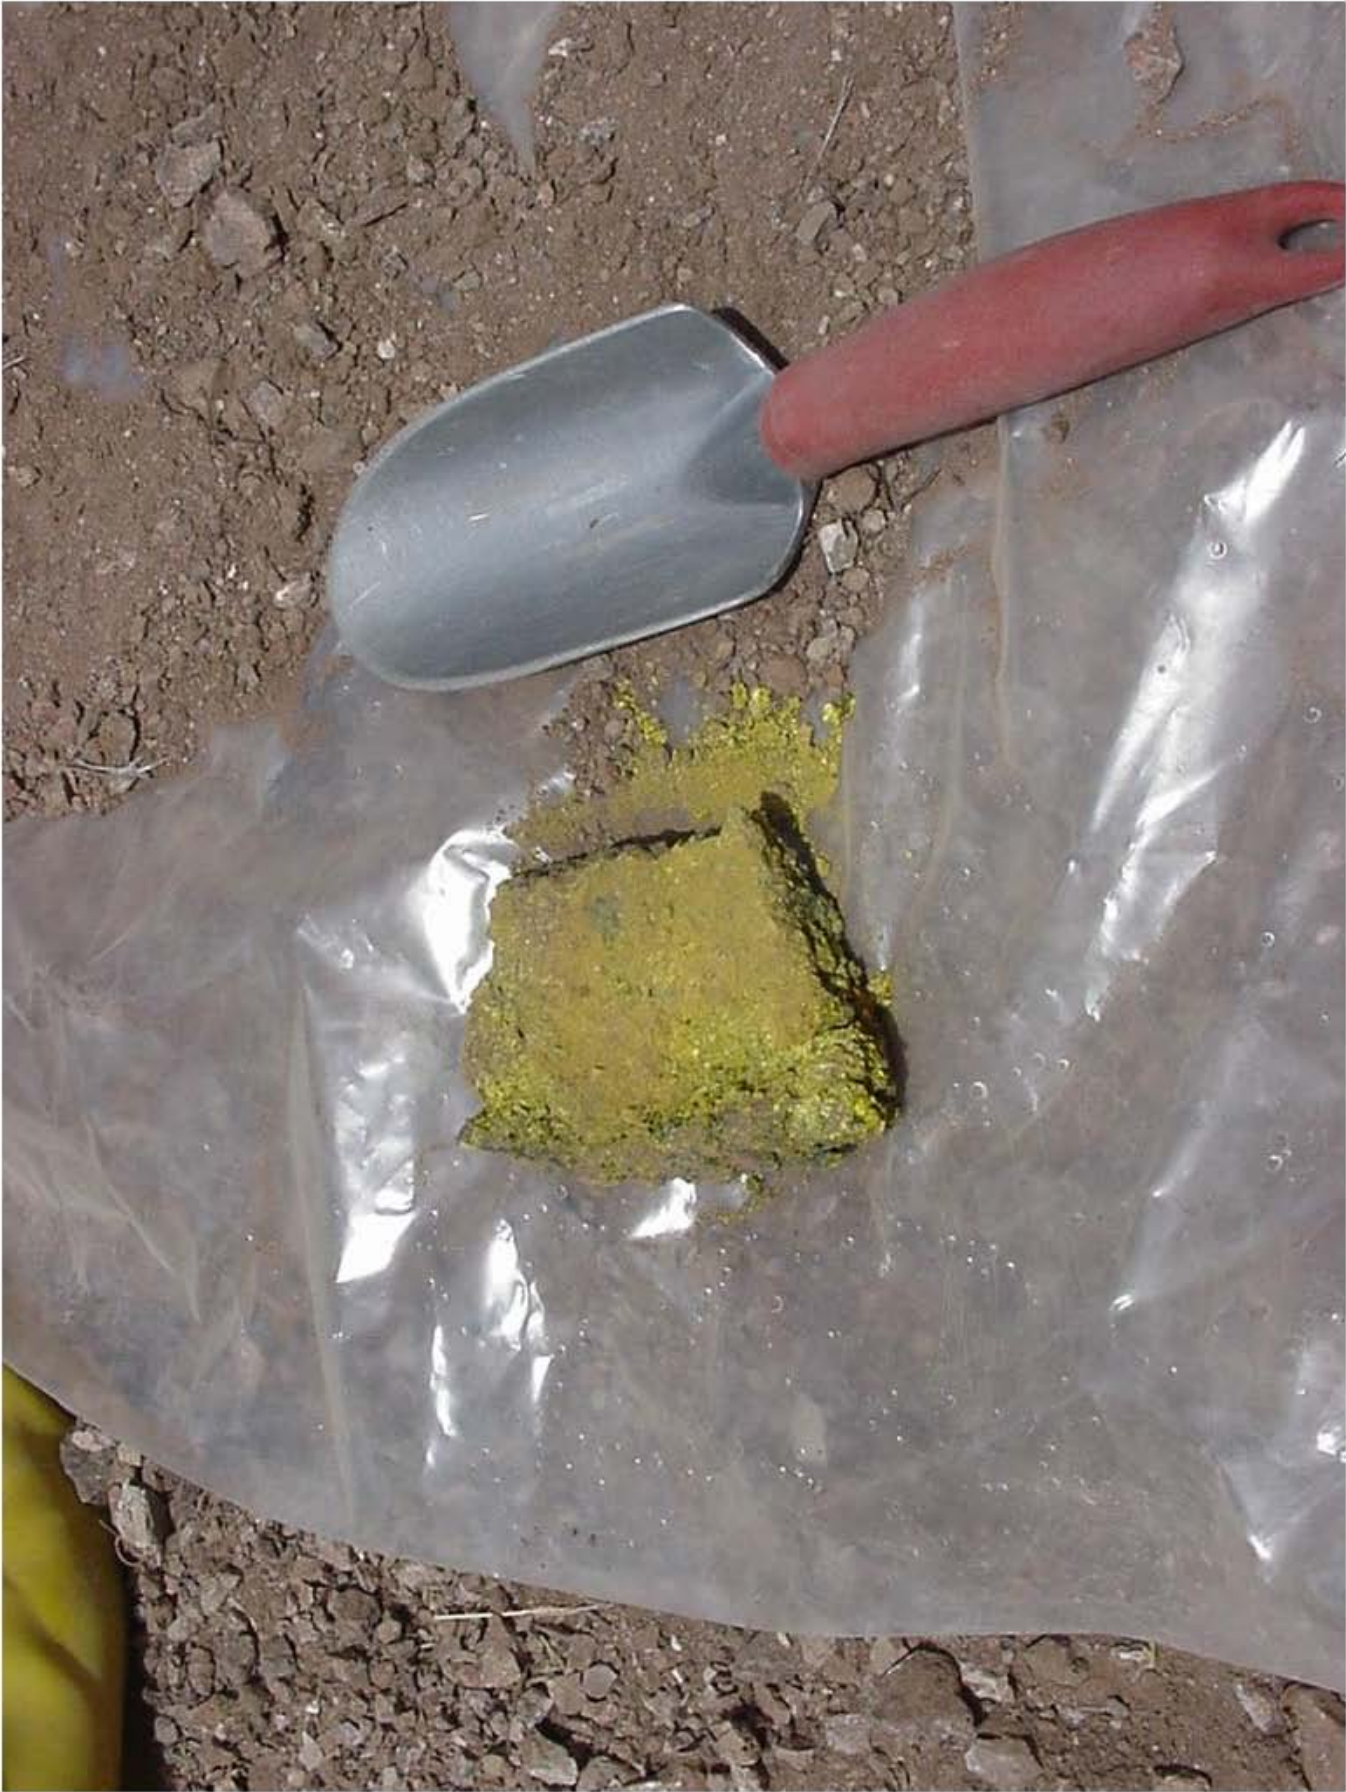
840857.04080000A5

Figure 3.2-2.  
Depleted Uranium removed from the  
exterior at Solid Waste Management Unit 28-2

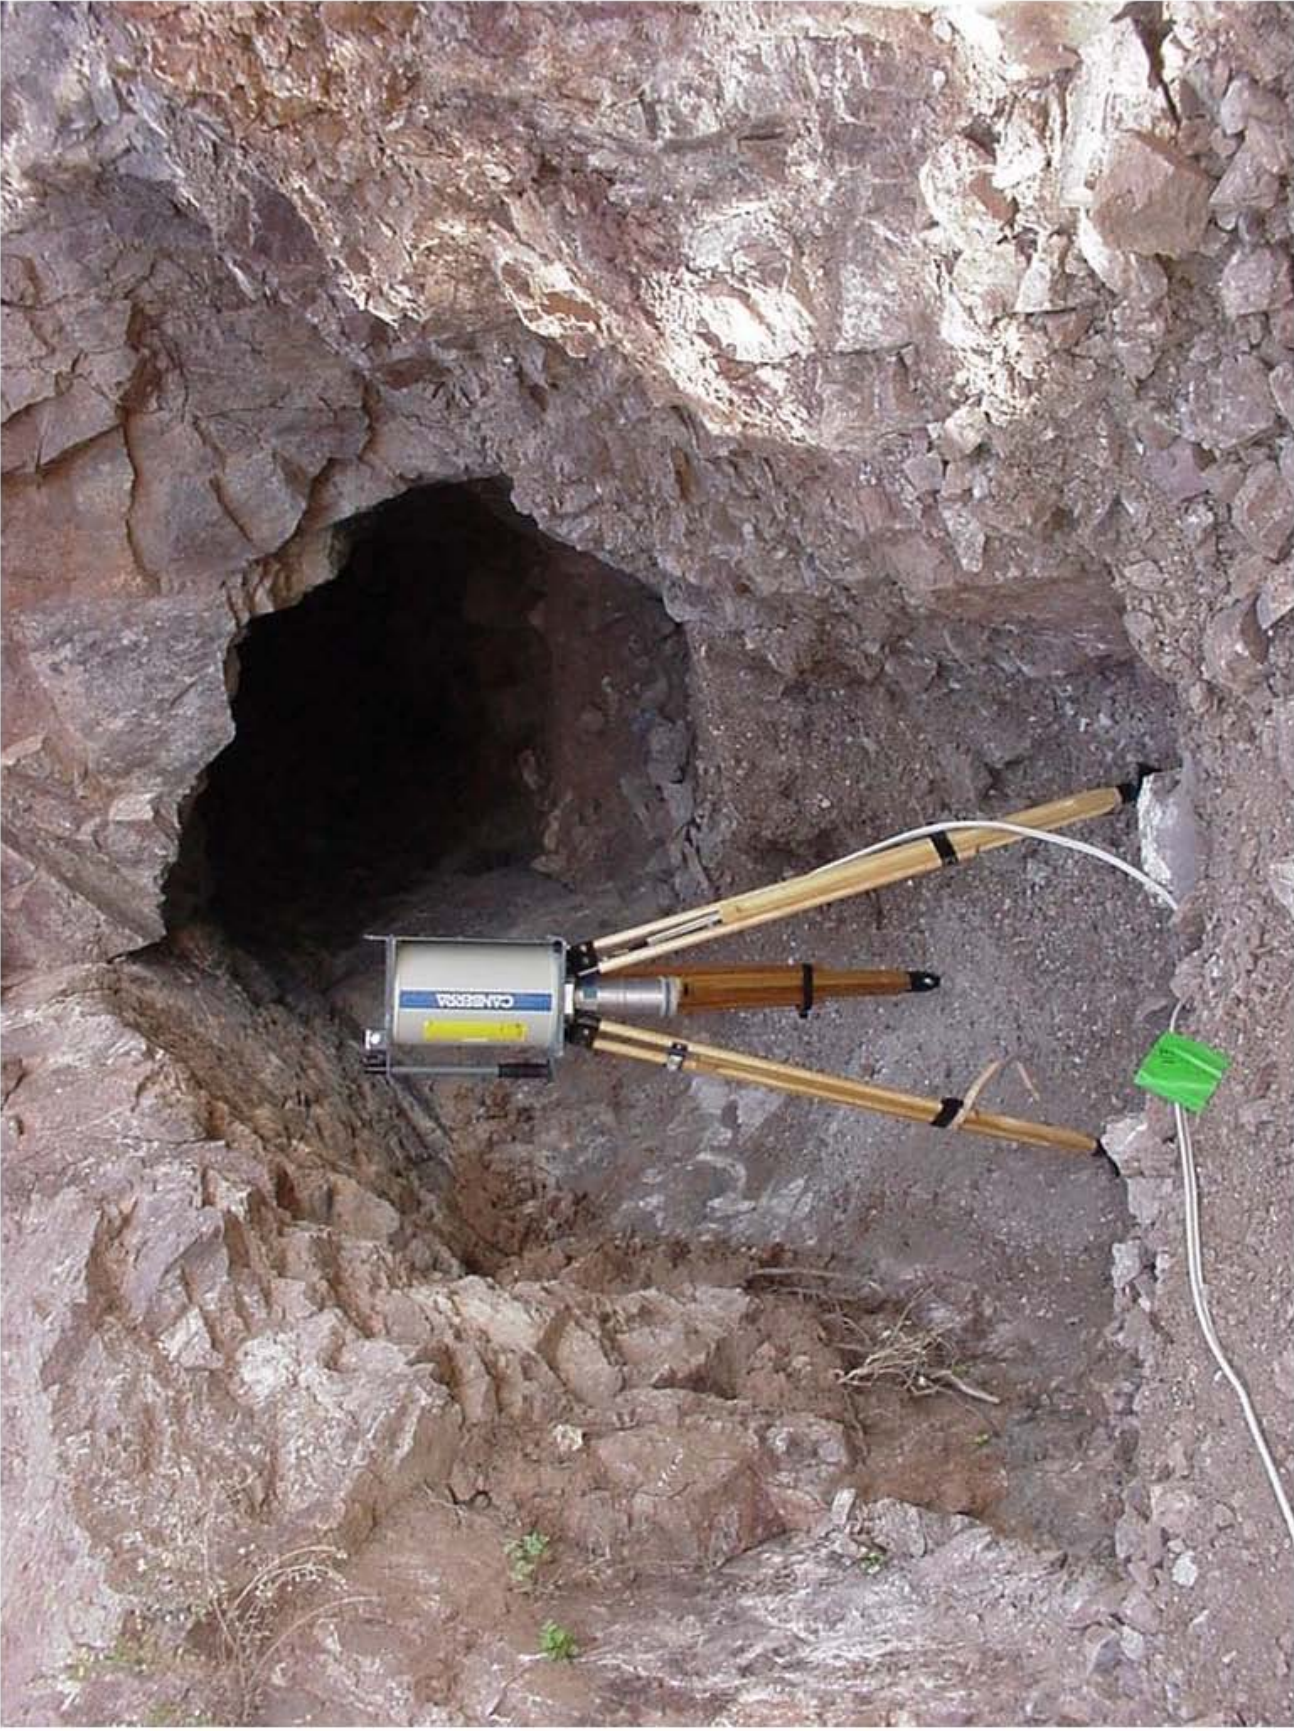
840857.0408000046

Figure 3.3-1.  
In situ soil gamma spectroscopy measurement at  
Solid Waste Management Unit 28-2

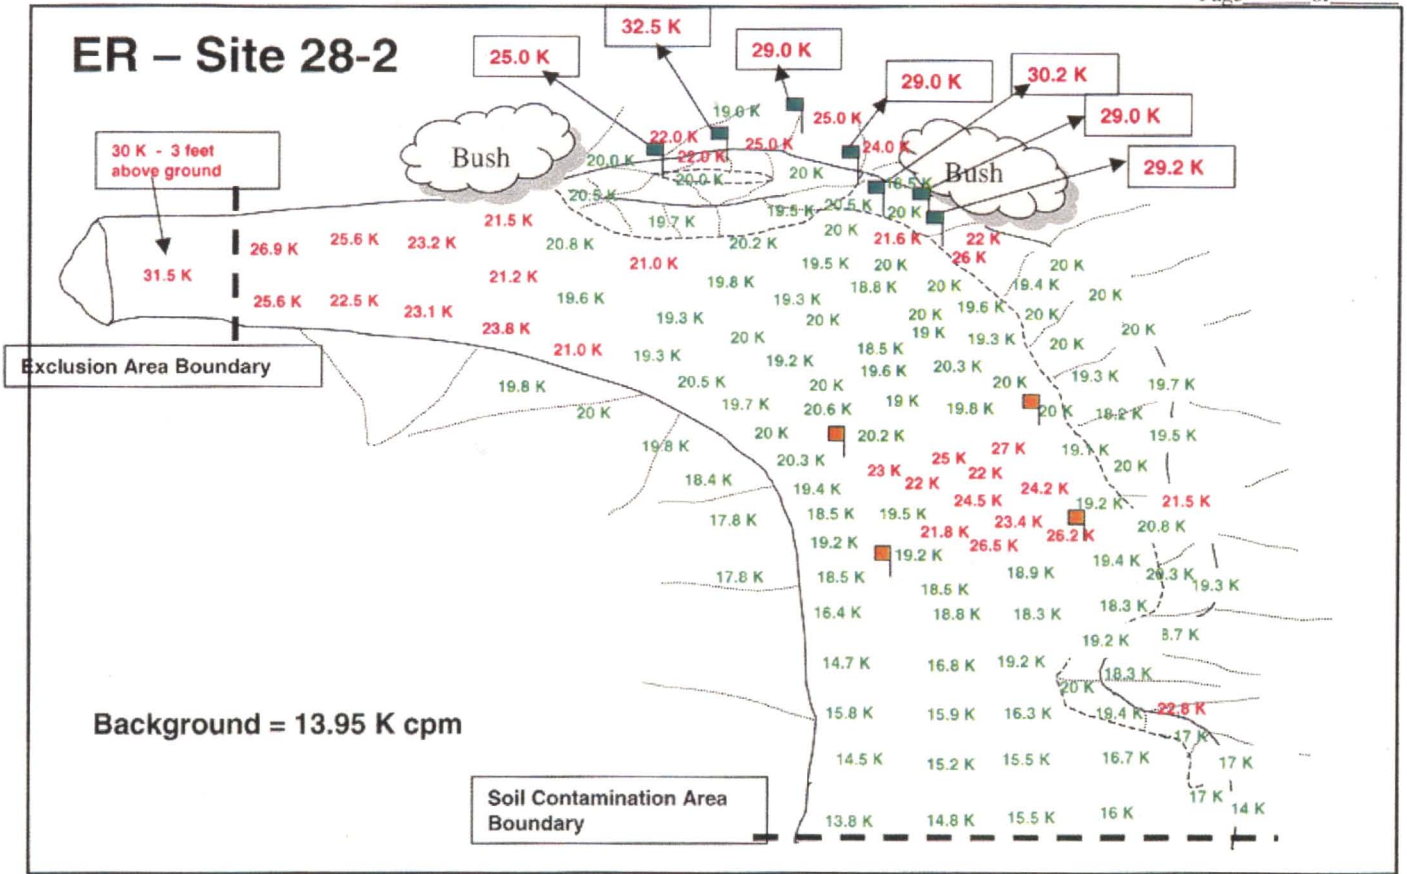
**RADIOLOGICAL SURVEY MAP**

**ER - Site 28-2**
