Patterns of failure in the distal radius following treatment for extra-articular fractures (AO 23-A3.2) using two-column volar plates

Christina Salas, Justin Brantley, James Clark, Evan Baldwin, Mahmoud Reda Taha, Deana Mercer. Patterns of failure in the distal radius following treatment for extra-articular fractures (AO 23-A3.2) using two-column volar plates. Poster presented at: ORS 2014 Annual Meeting; Mar 15-18 2014; New Orleans, LA

Patterns of Failure in the Distal Radius Following Treatment for Extra-Articular Fractures (AO 23-A3.2) Using Two-Column Volar Plates

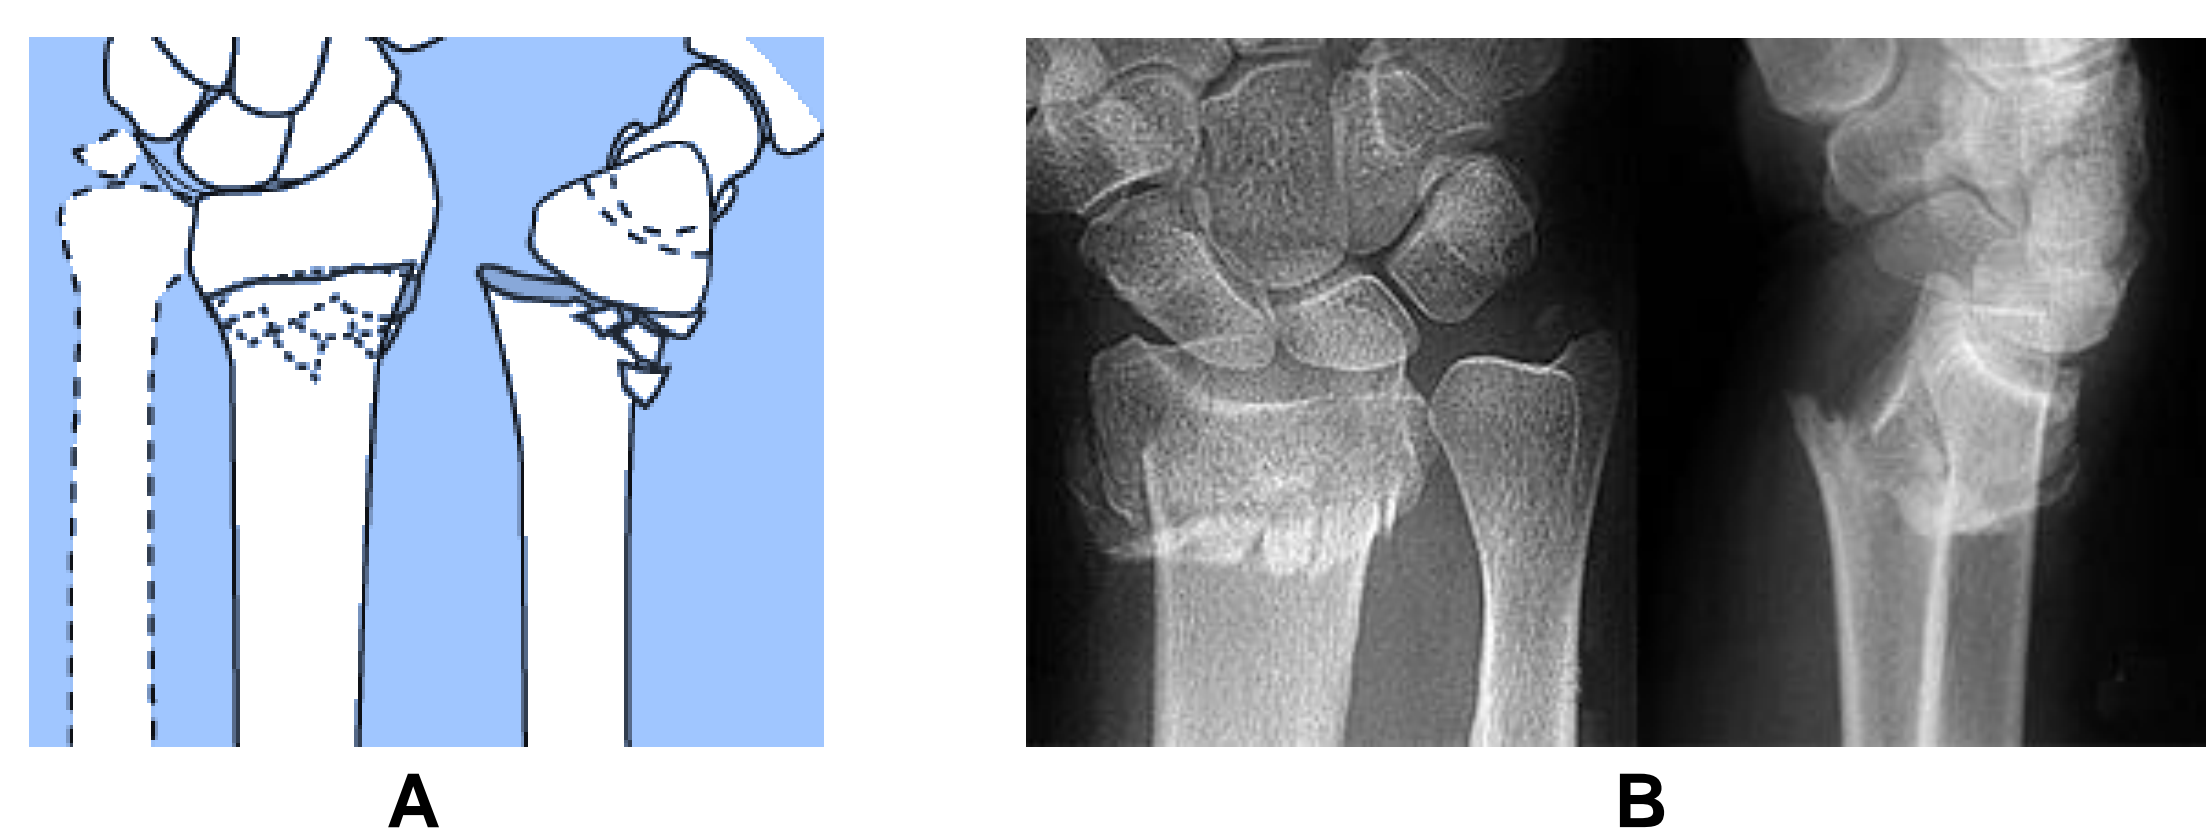
Figure 1: A. Extra-articular multi-fragmentary fracture of the distal radius with angulated dorsal wedge fragment (AO 23-A3.2). B. Radiographic depictions of AO 23-A3.2 fracture.

- The distal radius is the most common fracture site in the upper extremity.
- Dorsally displaced, unstable fractures are commonly treated with locked plate fixation using a volar approach.
- Damage analysis of matched paired specimens with simulated AO 23-A3.2 fracture treated with volar plating may provide information on whether implant geometry may affect fracture stability. (Fig. 1)

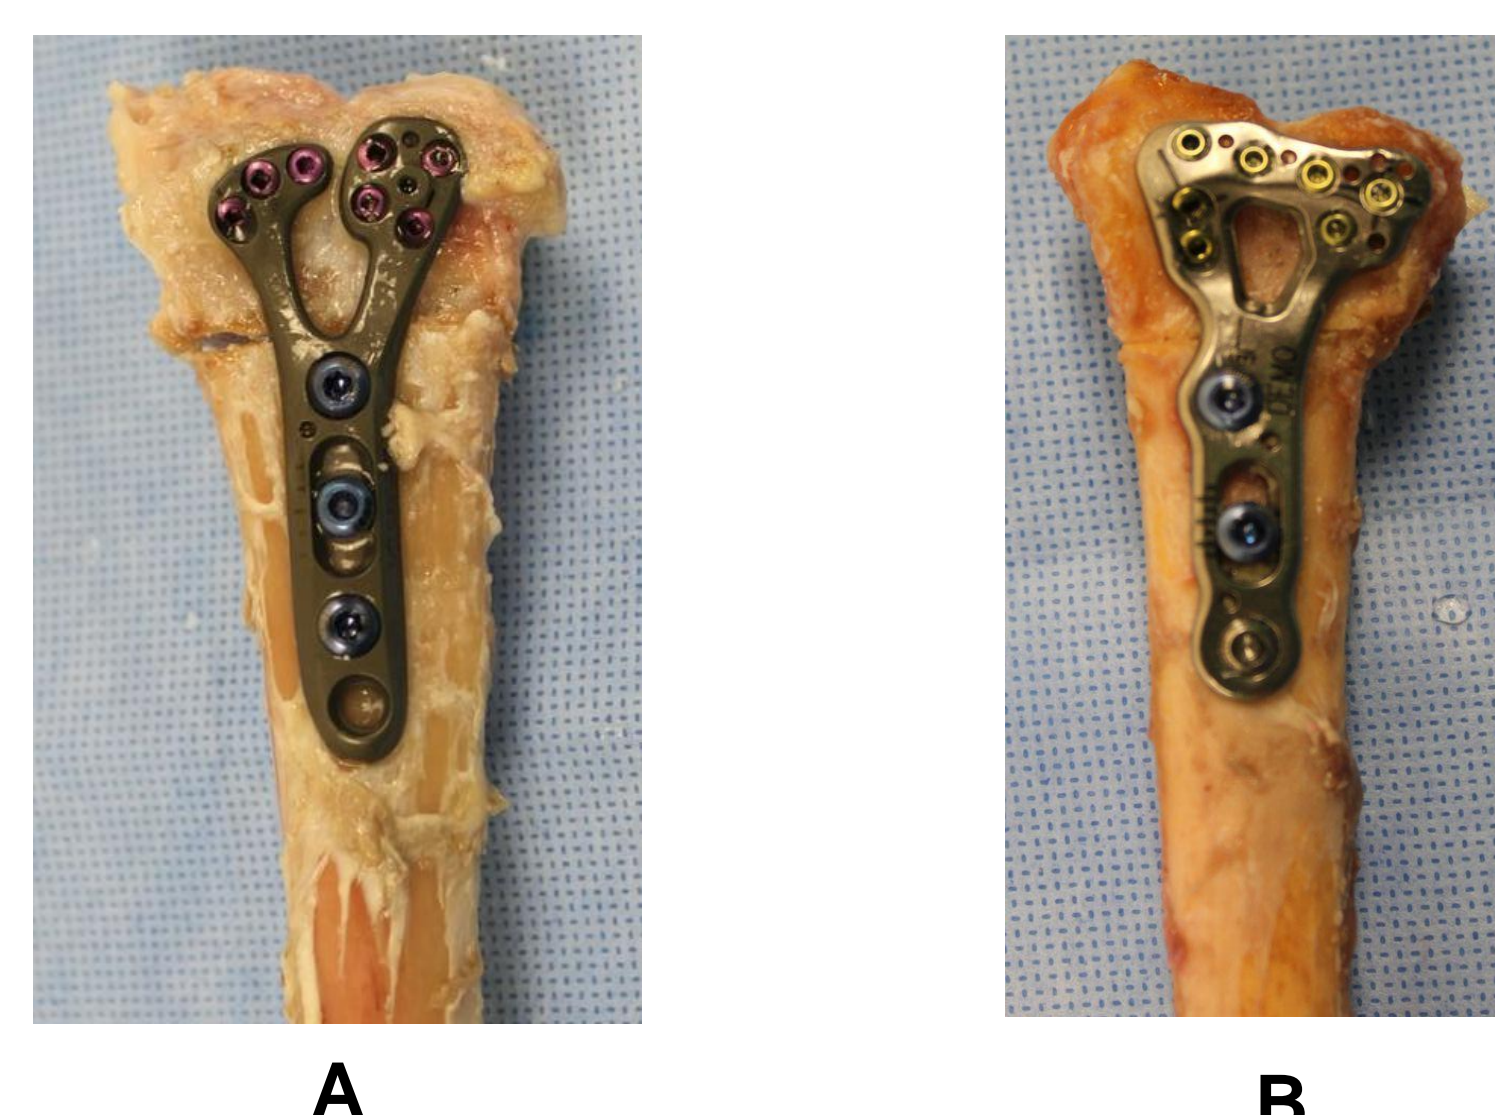
Figure 2: A. Group I radius plated with Geminus® volar distal radius plate from Skeletal Dynamics. B. Group II radius plated with Acu-Loc® 2 proximal volar distal radius plate from Acumed.

- Ten matched pairs of fresh-frozen, cadaveric distal radii were used in this study:
 - One radius from each donor was randomized to Group I; the contralateral limb from the same donor assigned to Group II
 - Group I: Prepared with Geminus® volar distal radius plating system by Skeletal Dynamics. (n=10) This implant uses a dual head design for independent two-tier scaffolding. (Fig. 2A)
 - Group II: Prepared with Acu-Loc® 2 Proximal Volar Distal Radius Plate by Acumed. (n=10) This implant uses a single head design for enhanced ulnar buttressing. (Fig. 2B)
- A custom fixture was designed to apply a 60/40 ratio through scaphoid and lunate facets. (Fig. 3A)
- Specimens were subject to cyclic axial loading; sinusoidally compressed from 75-250N at a rate of 1 Hz for 5,000 cycles

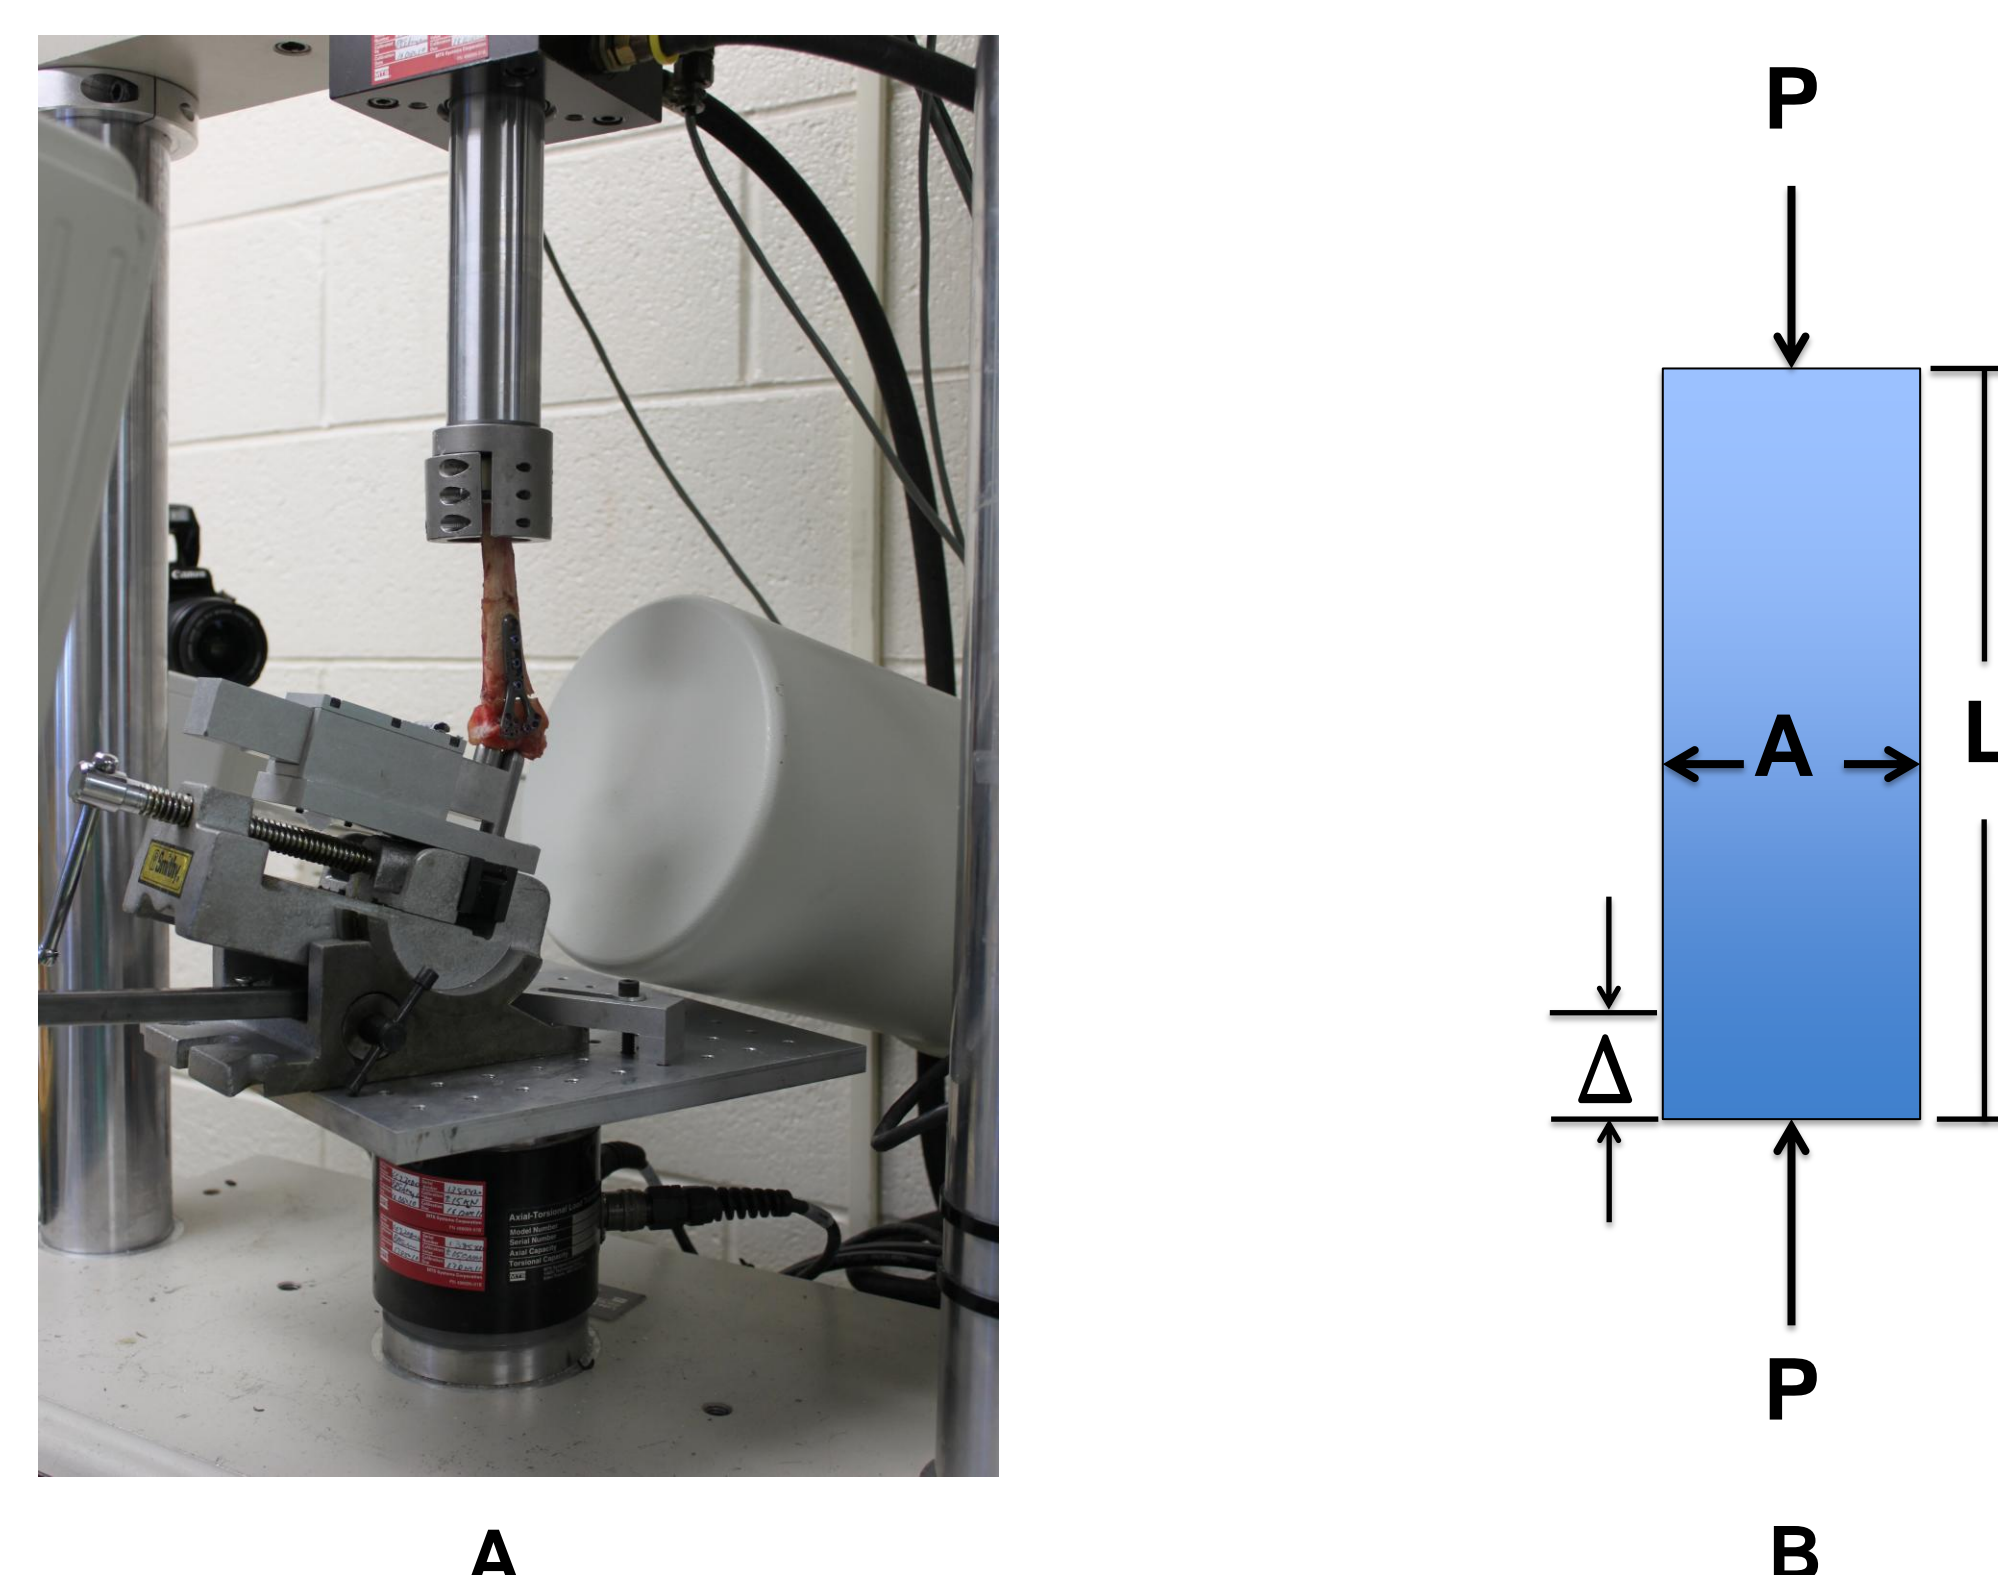
Figure 3: A. Experimental testing fixture. B. Figure depicting axial loading for calculation of effective Modulus of Elasticity.

- Damage (D), which defines the period between a state of material perfection and the onset of crack initiation, was calculated using the effective Modulus of Elasticity ($E = \frac{PL}{A\Delta}$) from hysteresis data (Fig. 3B)
- $D = 1 - \left[\frac{E_{final}}{E_{initial}} \right]$, where $E_{initial}$ is calculated at cycle 5; E_{final} is calculated at every 500th cycle
- Constructs not failed during cyclic loading were subject to a ramped load to failure at 1mm/s
- A matched-paired t-test was used to determine statistical significance (p=0.05)
