Innovative Methodologies for Structural Control of Masonry Building under Preservation or Reconstruction Using Geomatic and Topographic Techniques.

3 THE CASE OF STUDY - PALAZZO CAMPONESCHI

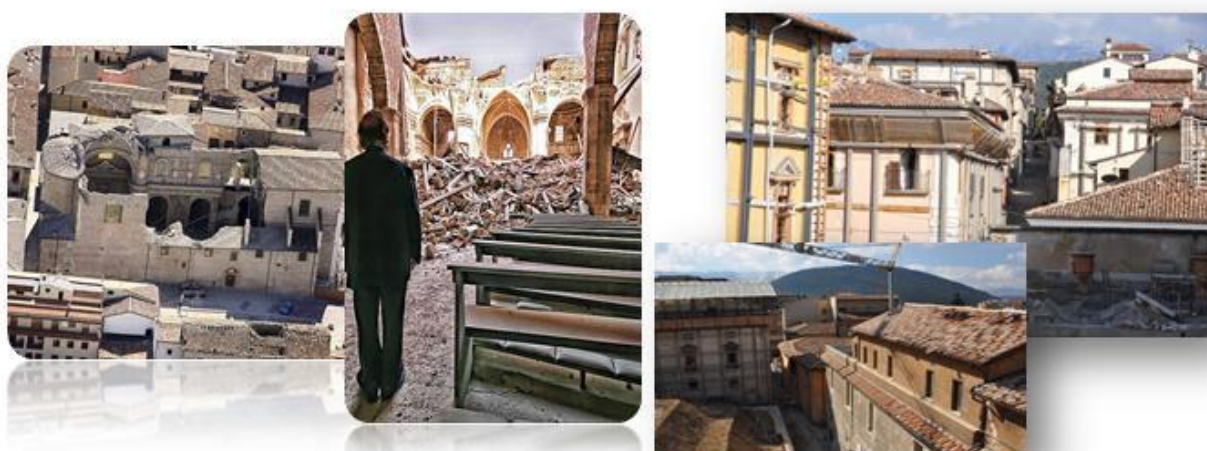
Figure 1: L'Aquila destroyed by the earthquake. On the left, two of the 99 monumental churches of the city. On the right, the whole city under provisory shoring.

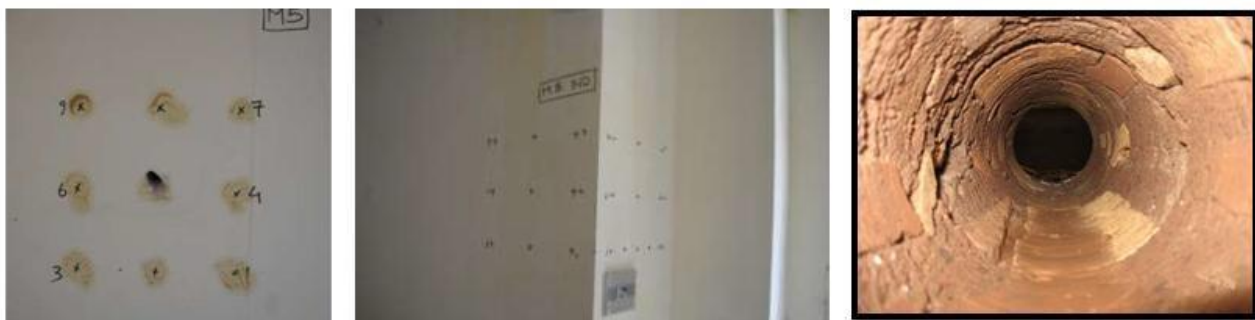
Figure 4: NDPT at Palazzo Camponeschi carried in Direct mode (left) and indirect angled mode (middle).

Endoscopic inspection of a masonry wall to study the wall's homogeneity. (right)

In Palazzo Camponeschi sonic tests were operated to many masonry walls to provide information regarding their consistence. Figure 4 shows some of the tests made both in direct mode and in semi direct - angulated modality. An integration of these techniques with endoscopic tests also permitted a visual inspection of the materials found in parts not easily accessible can be interesting as present both numeric and qualitative information regarding the studied elements. Thus, the overall and detailed investigation of the structure permitted both a good knowledge of the structure itself and for its particular characteristics. All tests were finally integrated among them to create models of the damage analysis and final plots of the building with all gathered information. Figure 5 shows the final damage analysis and the types of masonry found in all over the structure.

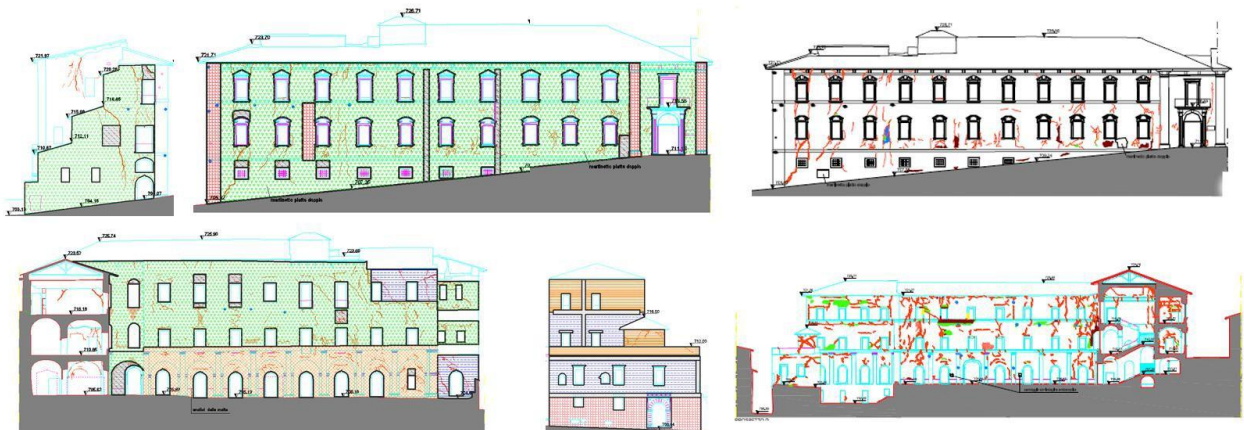
Figure 5: Different masonry types and their distribution on the structure (left).
The final damage analysis of the structure (right).
