Restoration Effects on the Experimental Dynamic Behavior of Historical Molla Siyah Mosque

Ismet Çalik¹, Alemdar Bayraktar², Temel Türker², Ali Osman Ayan¹

¹Directorate General of Foundations, Trabzon, Turkey

²Department of Civil Engineering, Karadeniz Technical University, Trabzon, Turkey

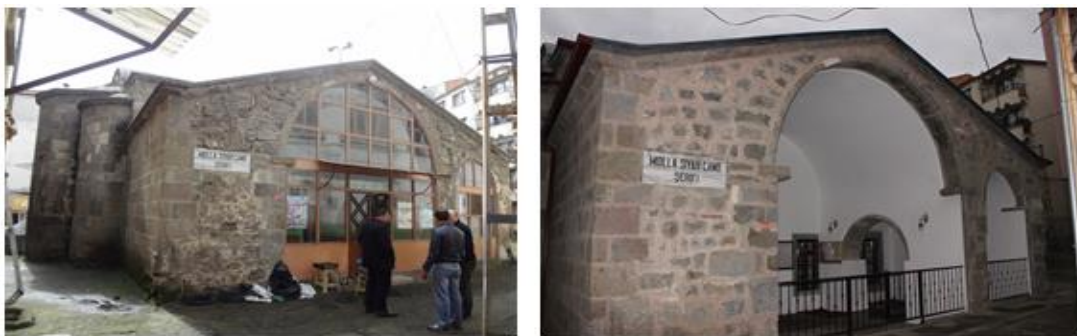
Fig. 2. Images of Trabzon Molla Siyah Mosque before and after the restoration

The structure of the mosque was built as a church in the XI Century initially. It was converted into a mosque before the 1557 [18]. The owner of the structure is Foundation of Fatih Sultan Mehmet, the administration and the representation is carried out by the General Directorate of Foundations. The mosque was restored and strengthened by the Trabzon Regional Directorate of Foundations in 2015. The photographs of the mosque before and after restoration are presented in Fig. 2.

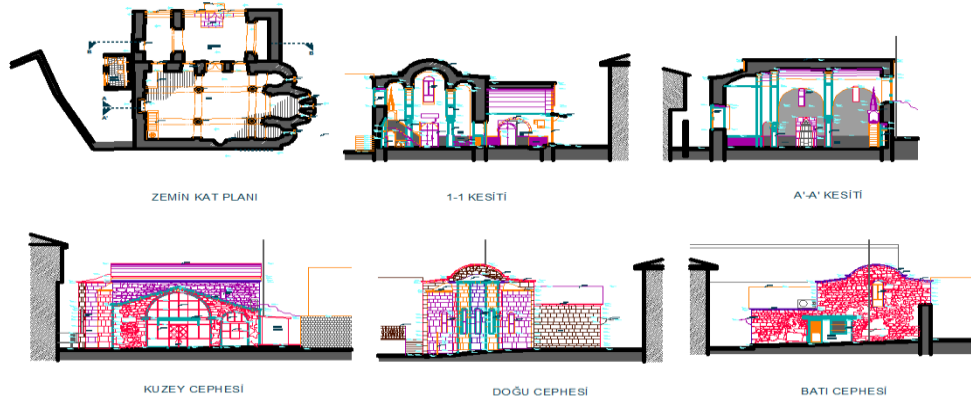
Fig. 3. Layout, inside and outside of the survey project of Molla Siyah Mosque [19]

The original structure was made of rubble stone with about 70cm wall depth as usual architectural church plan. There are 4 main columns in the middle of the structure. The structure has been seen interventions at different times to the present day. There is a concrete cover on the domes and vaults were constructed in early restorations. Fig. 3 provides images of the

layout, inside and outside of the survey project, and Fig. 4 shows images of the layout, inside and outside of the restoration project of Molla Siyah Mosque. The artifact, which was restored by the Trabzon Directorate of Foundations in 2015, is presently open for worship and is actively being used.

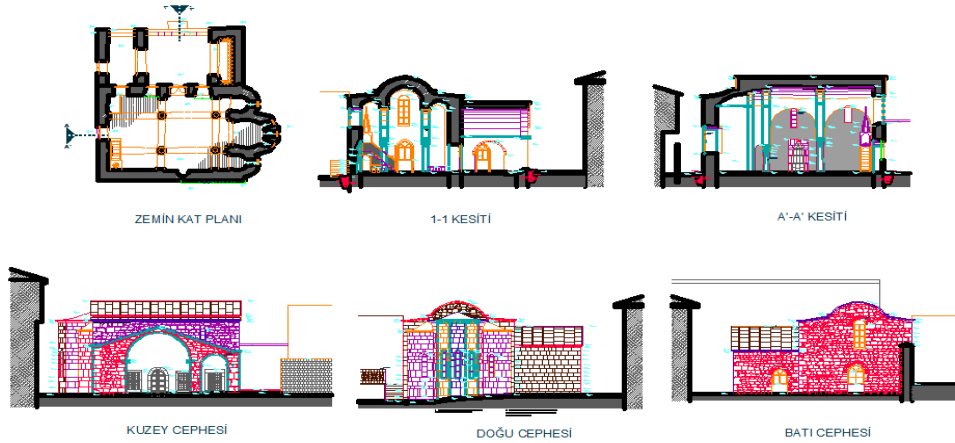
Fig. 4. Layout, inside and outside of the restoration project of Molla Siyah Mosque [20]

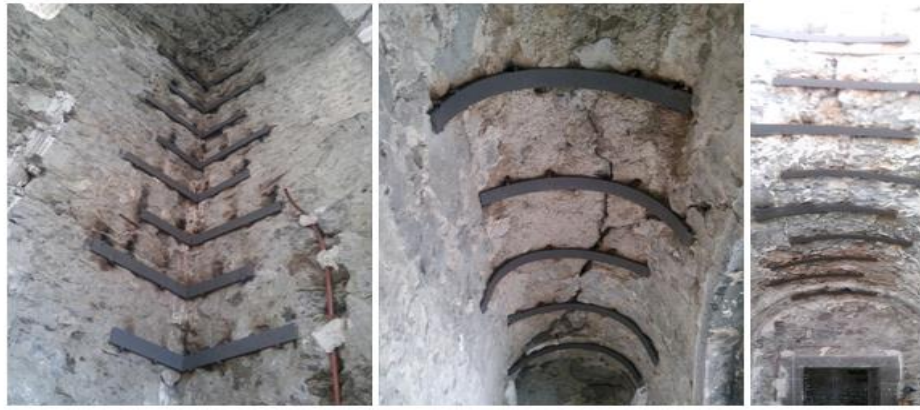
Fig. 5. Strengthening applications

- The attachment narthex was demolished and the original narthex was brought forth.
- Waterproofing was done at the roof and it was covered with the lead by traditional techniques.
- The stone altar was cleaned of oil paint and the original stone elements were revealed.
- The mosques interior plaster has been renovated with Horosan mortar.
- After dismantling of interior plaster, it was seen that there are some deep cracks on the east and west vaults of the narthex which are in line of north to south. The injection of hydraulic lime mortar and steel sewing techniques were used to strengthening of these structural elements (Fig. 5). Also at the southwest corner of the mosque, a crack was detected from the top to the bottom. This crack is also strengthened with same techniques (Fig. 5).

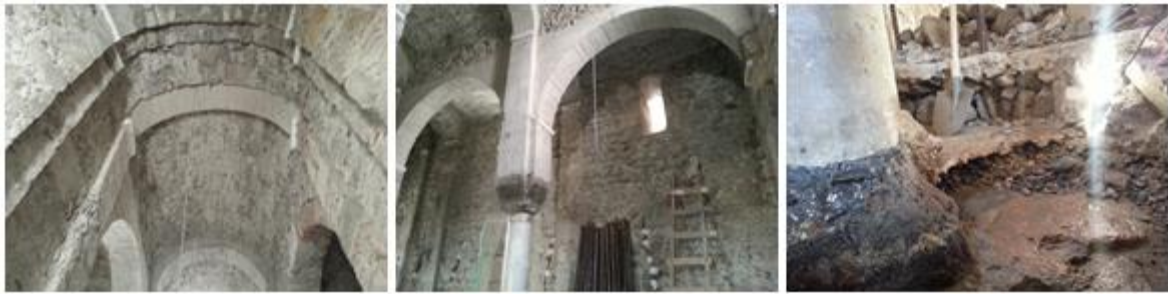
Fig. 6. Wall, arch and excavation applications

- After dismantling of interior plaster, it was observed that the beams connecting the walls and columns were made of reinforced concrete. Therefore, the beams were not converted to the masonry. They were renovated with Horosan mortar (Fig. 6). The filler on the ground were removed and it was covered with wooden slab (Fig. 6).

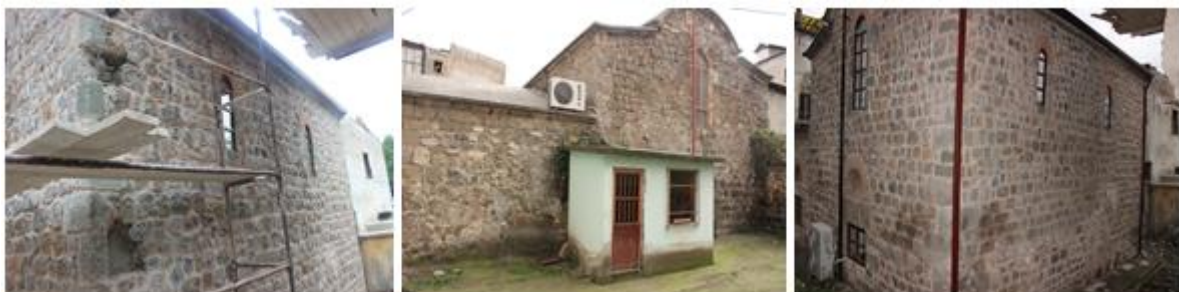
Fig. 7. Joint applications

- The rotten wood flooring and windows were refurbished.
- The outer facades of the mosque were stripped of mortar and joints are filled with Horosan mortar (Fig. 7).

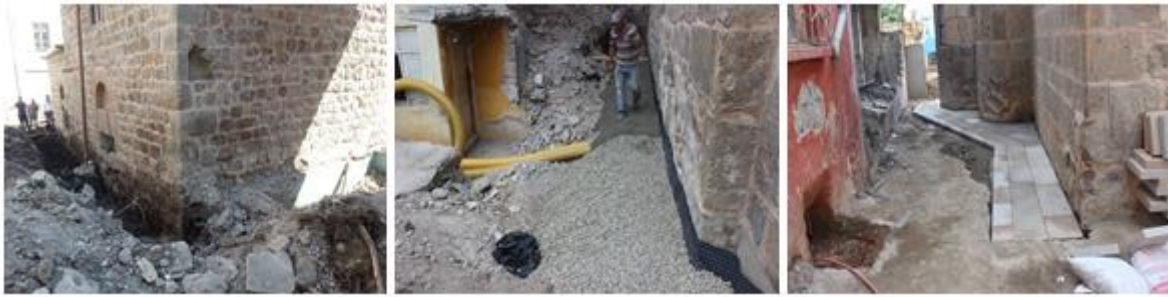
Fig. 8. Drainage and landscaping applications

- Drainage and landscaping applications were done (Fig. 8).

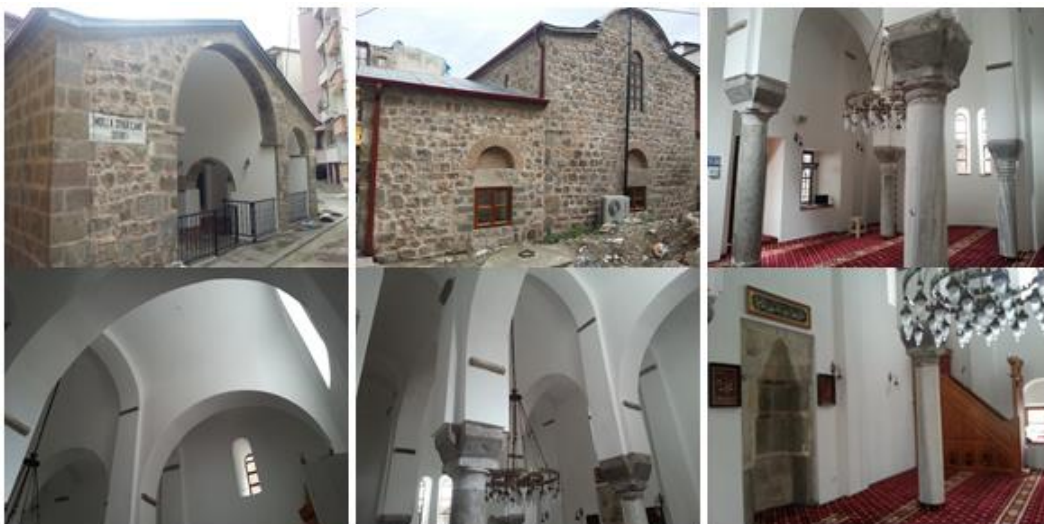
Fig. 9. The images of Molla Siyah Mosque after the restoration

The images of Molla Siyah Mosque after the restoration are given in Fig. 9

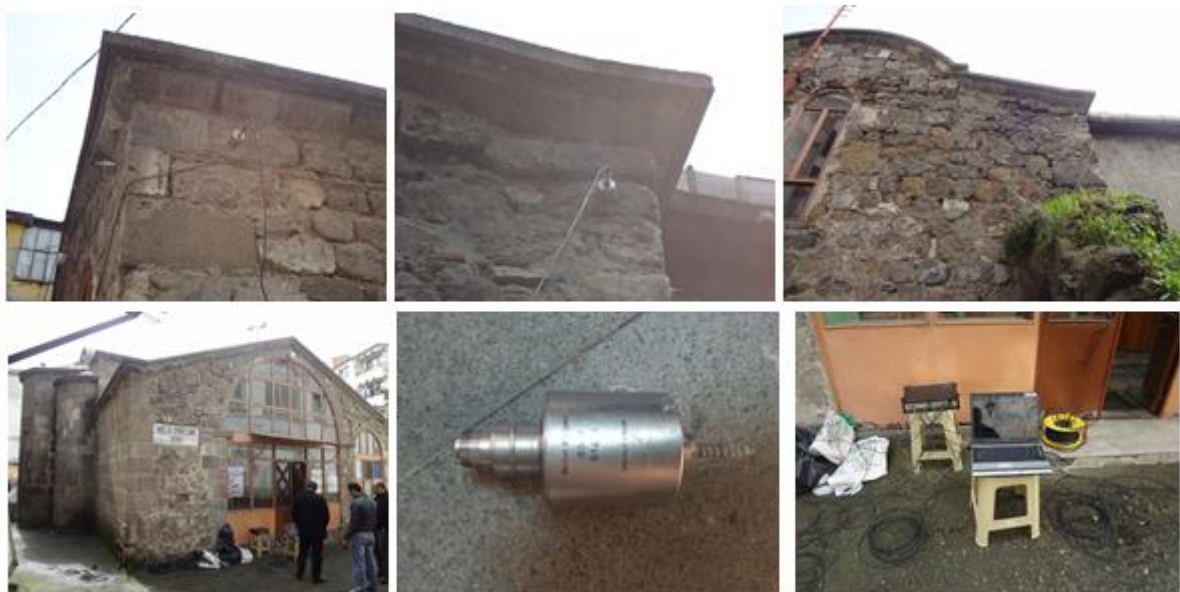
Fig. 10. The images of measurements of Molla Siyah Mosque before the restoration

A total of 12 accelerometers were used in the measurements performed on the Molla Siyah Mosque before and after the restoration. The accelerometers were attached to the corner points of the mosque in the transverse and longitudinal directions. Some images of the accelerometer placements and the data acquisition system are given in Fig. 10.

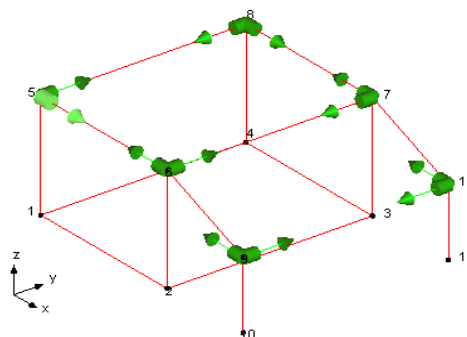
Fig. 11. A representative model of the accelerometer locations before the restoration

The representative model of the mosque and the accelerometer connection points and directions during the test is shown in Fig. 11.

The same representative model of the accelerometer locations given in Fig.11 are used after the restoration. There are some images of the accelerometer placements and the data collection systems in Fig. 14.

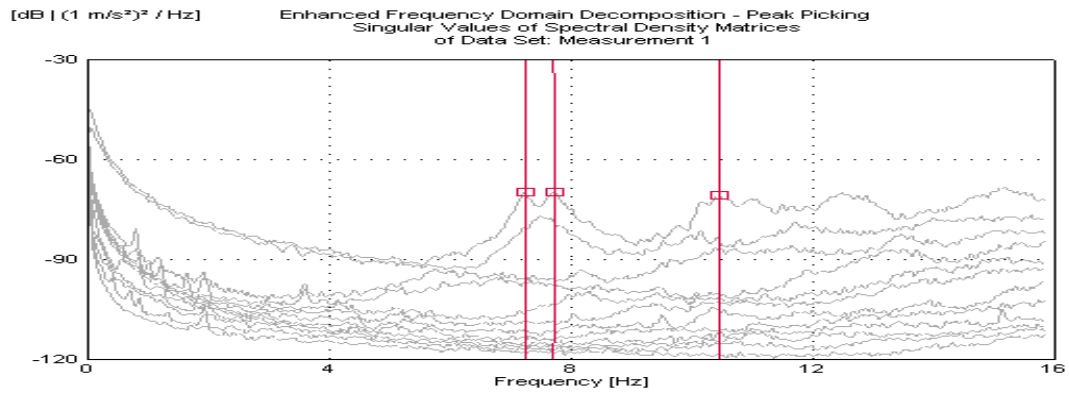
Fig. 12. The frequency response function obtained from the mosque before the restoration measurement

Measurements were taken from the outer body of the walls before the restoration for a period of 30 minutes and the resulting signals were analyzed using Enhanced Frequency Domain Decomposition (EFDD) technique. The frequency response function obtained from the mosque before the restoration measurement as shown in Fig. 12.

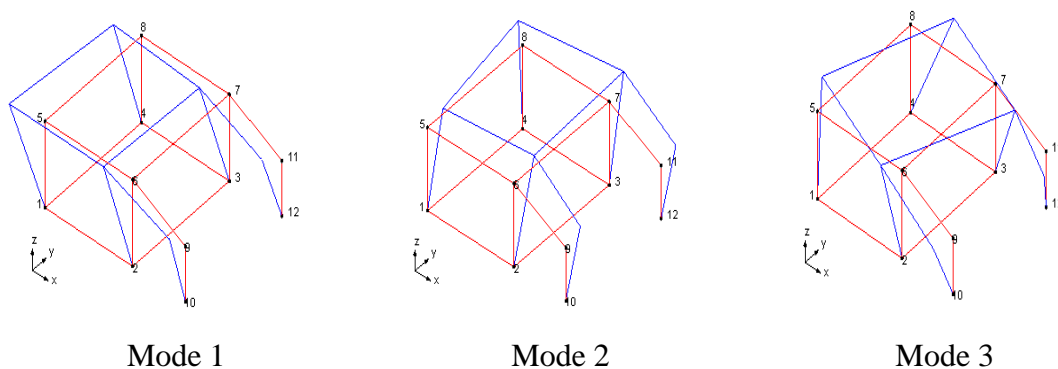
Fig. 13. The first three mode shapes of Molla Siyah Mosque before the restoration

The first three natural frequencies and modal damping ratios before the restoration are given in Table 1. The first three mode shapes obtained from the measurements are shown in Fig. 13.

The first three natural vibration frequencies of Molla Siyah Mosque before and after restoration are compared in Table 3. It can be seen from Table 3 that all frequencies slightly increase after the restoration. However, damping ratios decrease with the restoration. The first, second and third mode shapes of the mosque as shown in Fig. 13 and 16 occur in longitudinal, transverse and torsional directions, respectively, for both before and after restoration.

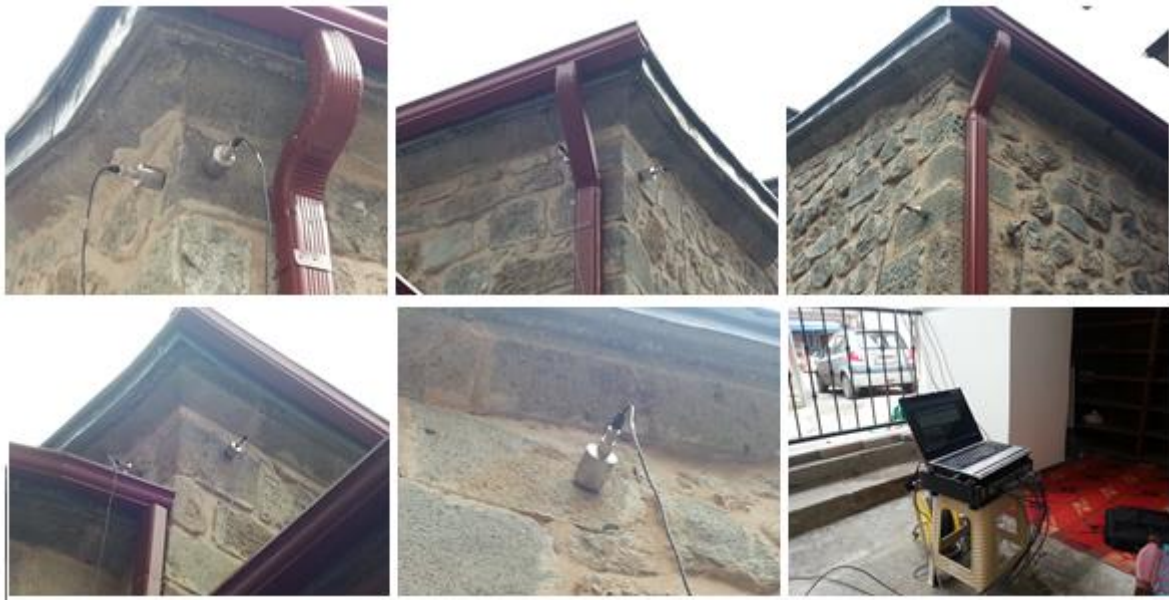
Fig. 14. Some images of the measurements of Molla Siyah Mosque after the restoration

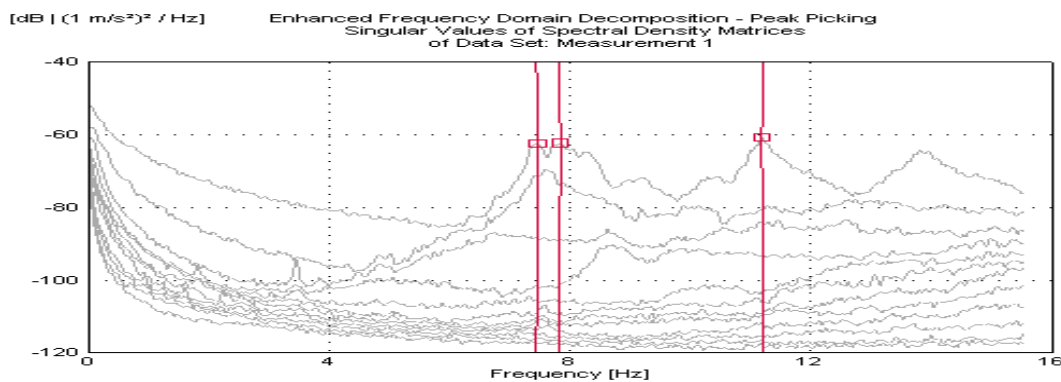
Fig. 15. The frequency response function obtained from the mosque after the restoration measurement

Measurements were taken from the outer body walls of the mosque after the restoration for a period of 30 minutes and the resulting signals were analyzed using the Enhanced Frequency Domain Decomposition (EFDD) technique. The frequency response function obtained from the mosque after the restoration measurement is given in Fig. 15.

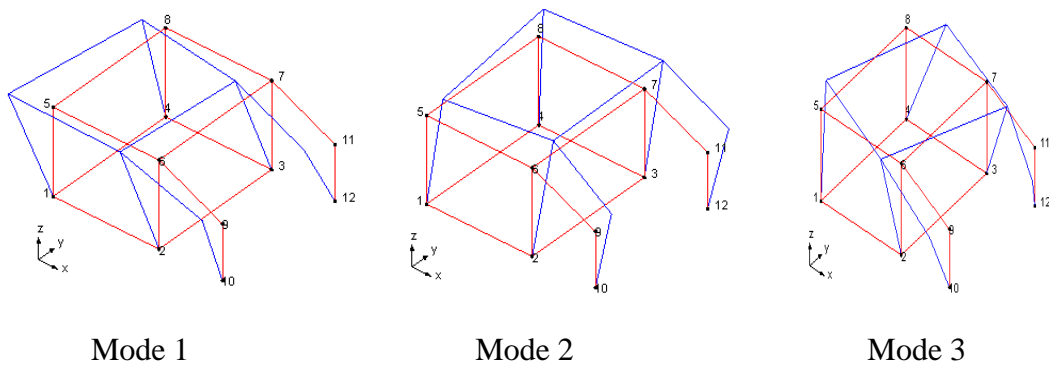
Fig. 16. The first three mode shapes of Molla Siyah Mosque after the restoration

In Table 2, the first three natural frequencies and modal damping ratios after the restoration are given. The first three mode shapes obtained from the measurements of the mosque are shown in Fig. 16.
