Non-Destructive Damage Detection and Retrofitting Techniques on a Historical Masonry Tower

The aim of the paper is to detect the damage of the bell tower of the Church “Santa Maria della Natività”, Noci (Bari, Italy) that in 2012 was hit by a lightning and to propose a retrofitting solution. The solution must be designed to improve the constructive regularity, the strength and ductility of the structure, especially on the more resistant structural elements or on the mechanisms of collapse so as to transform them from brittle to ductile ones. The tower is 35 m tall and it is structurally connected to the Church for about one third of its height; the remaining part of the tower is totally disconnected from the structure of the Church. The results of the experimental tests have been analyzed in order to estimate the modal parameters of the tower and to calibrate a 3D finite element model of the tower in order to design *ad hoc* improvement interventions.

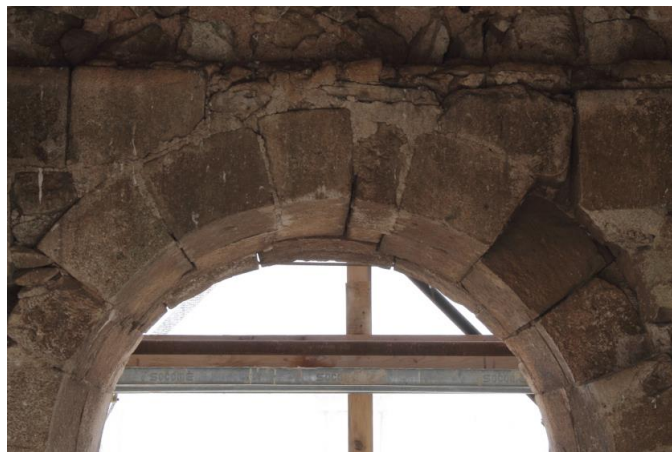
Figure 2 Internal disconnection of the keystone of an opening in the belfry.

From the analysis of related endoscopic inspections, integrated with 2D and 3D radar tomographies, it has been possible to reconstruct the masonry stratigraphy; it is everywhere composed by a layered masonry, interspersed with cavities of a reduced thickness formed by little altered material.

The pictures in Figs. 2-4 show the problems evidenced above.

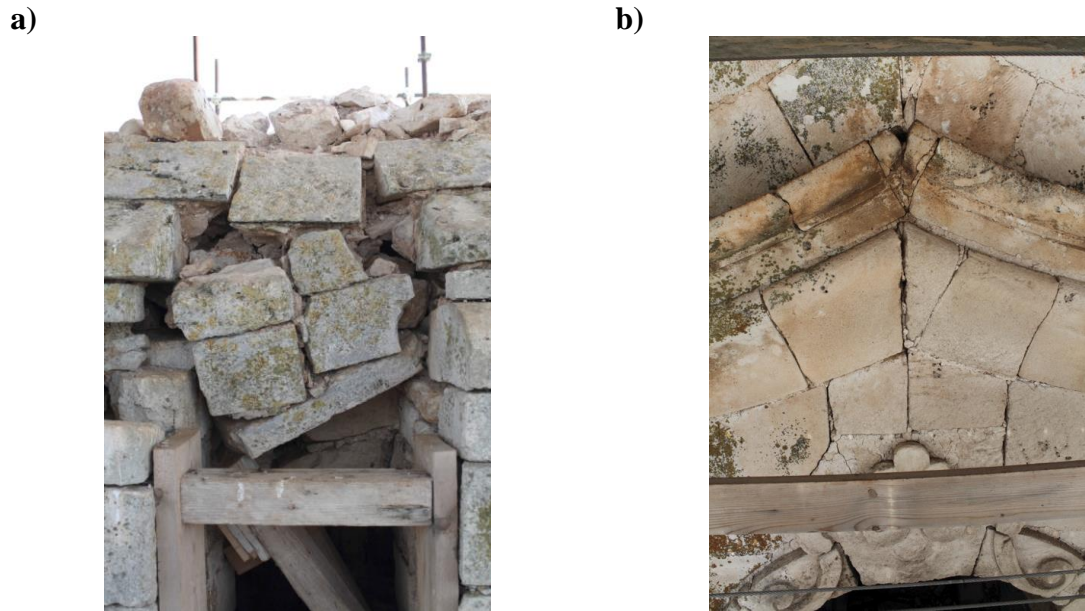
Figure 3 Disconnection a) at the basement level of the spire collapsed because of lightning; b) at the level of the keystone of an opening of the belfry.

The application of the verification method assumed the analysis of the local mechanisms significant for the construction, identified considering the wide crack pattern that affects the masonry of the bell tower of the Church.
