## Koch Mine Safe and the Cordon Sanitaire Clearance Program

Through the work of Koch GmbH and Mine-Tech, the 359 km-long Cordon Sanitaire in Zimbabwe is being demined in one of the first humanitarian demining efforts of its kind.

By Henry Thompson, *RHS Associates*

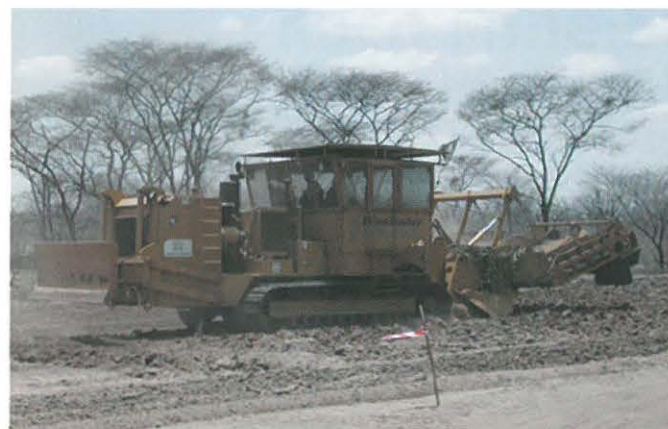
■ Minebuster takes to a mine field. c/o Andy Smith

The Mine Collector is like a heavy potato harvester built around a crawler tractor with a heavy mill added before the lifting and sifting apparatus. This machine can process a 3 m-wide swath down to a depth of 50 cm. Soil is mixed up by a carbide-toothed grinder and deposited onto a set of three large nylon-finger rollers that break up clods of earth and separate out solids from loose soil that escapes through the rollers. Any solid items such as stones, roots and mines are deposited on a slatted conveyor that deposits them back on the surface some 7 m behind the front mill. Mines and UXO are left on the surface, ready for the manual teams. It was found that roots of some trees would be picked up and

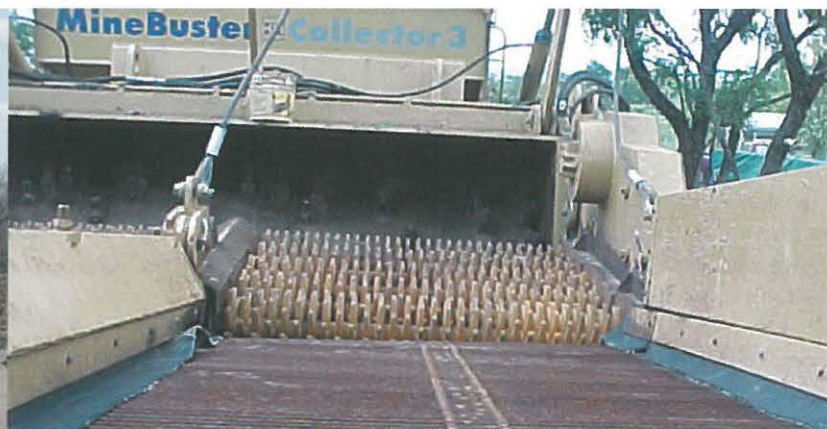
■ Minebuster griddle-rack from the rear. c/o Andy Smith

bound in the nylon rollers, so working depth (and forward speed) is partially varied according to vegetation. In practice, the Mine Collector works behind two other machines: a bulldozer that removes trees and shrubs and a heavy mine-protected tractor with steel wheels and a ripper that loosens soil and breaks up roots.

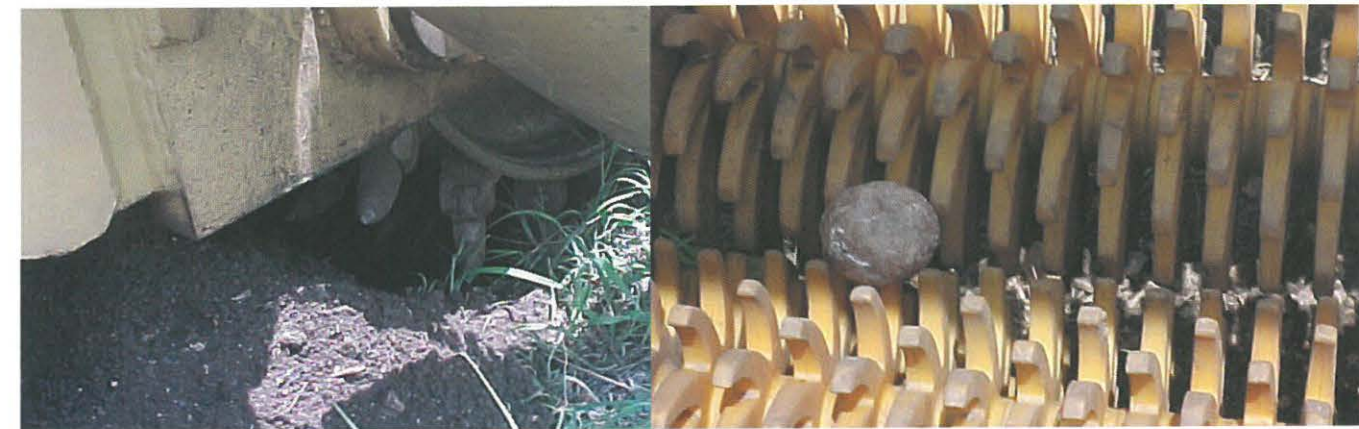
■ Grinding teeth and nylon finger rollers of the Minebuster. c/o Andy Smith
