# Assessment of Significant Causes to School Building Defects

**Abstract.** This paper focuses on the contribution factors of building defects in Malaysian school buildings. There are several building defects commonly found in Malaysia school buildings. In fact, building defects are becoming ordinary phenomena in the construction industry which results in negative impacts on schools, in the means of building performance, health and safety aspects and overall environment conditions as well as teaching and learning processes. Thus, a study is planned to identify the common building defects faced by school buildings in Kedah, Malaysia. Then, a thorough inspection is conducted and the respective defects are recorded with the aid of photographic. As the outcomes from the interview between researcher and person-in-charge from some schools, the main factors contributing to those building defects had been determined. Besides, appropriate mitigation solutions on the building defects have been offered, which are extremely essential in retaining a healthy and serviceable school building.

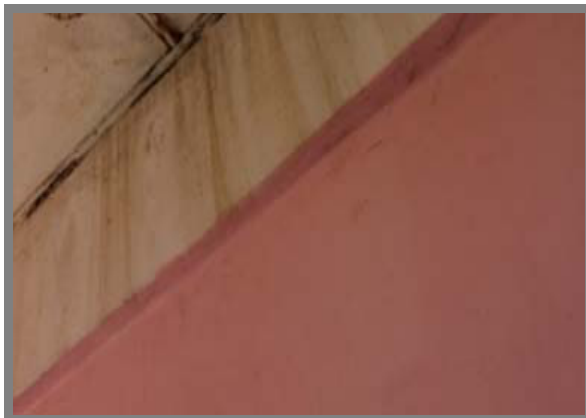
Dampness in schools resulted from water incursion either from internal sources (e.g. leaking pipes) or external sources (e.g. rainwater). This defect became a serious problem when various materials in the school buildings became soak for extended periods of time. Besides, excessive moisture in the air due to poor air ventilation system inside the buildings can also lead to dampness [10]. The common type of dampness found in school buildings is penetrating damp. Dampness was found on the ceiling and wall due to the ingress of water. The classrooms, especially on the top floor, were greatly affected by dampness of ceiling as the roof tiles were missing or blown away by wind. The rainwater penetrated directly into the building itself, resulting in dampness (Fig. 1).

**Figure 1:** Penetrating damp on the ceiling.

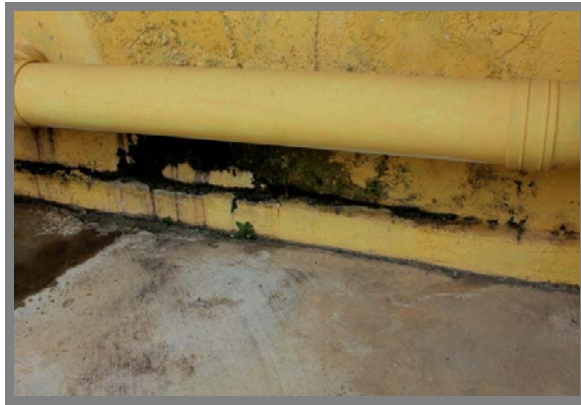
Dampness can arise from unintended water caused by leaking pipes, gutters and flashings [10]. The leaking water penetrated into the wall, resulting in horrible water stains. Under long term of dampness penetration and poor ventilation within the building, excessive moisture promoted the growth of mould on the surface of wall (Fig. 2).

**Figure 2:** Mould growth on wall caused by dampness due to leaking pipe.

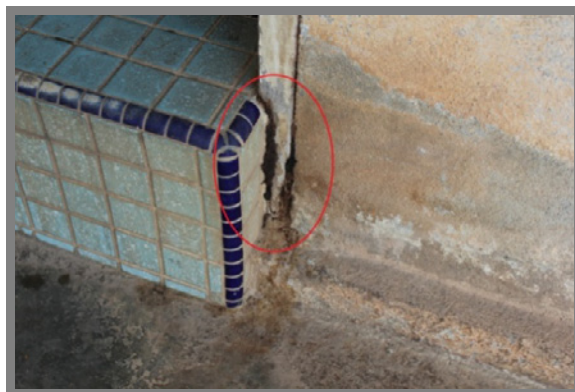
**Figure 3.** Timber decay on door frame in toilet.

The problem of timber decay was mainly found on door frames, window frames, timber roof struts and ceiling battens. Those components exposed to moisture which was the main critical element in the timber decay process. While, some timber materials decayed because of aging, e.g. ceiling battens. Fig. 3 illustrates the timber door frames in toilets that suffered from the worst situation because they were highly exposed to water and subsequently caused deterioration [6]. This type of timber decay was also known as wet rot. Wet rot was the most common type of timber decay in which the fungus feeds on timber; the timber must be damp or wet enough for the fungus to thrive and continue the rotting process. Timber decay occurred if the timber becomes sufficiently wet, with the present of oxygen and nutrients.

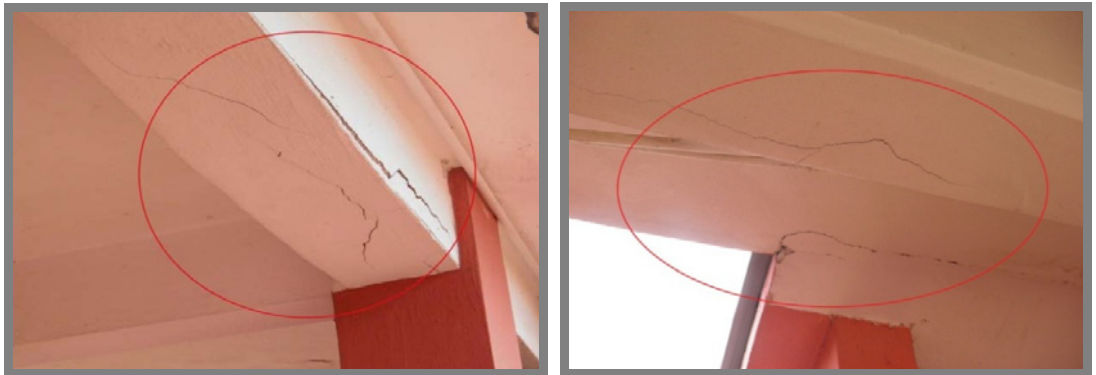
Cracks happened on the various elements in school buildings such as walls, ceilings, beams, columns and even floors (Fig. 4 and Fig. 5). There were many structural and non-structural cracks found. Structural cracks took place in walls, beams and columns. However, non-structural cracks usually happened in plaster or other finishes with cement rendering [7]. Different types of cracking such as vertical, horizontal, diagonal and hairline were found in the school buildings.

**Figure 4:** Horizontal crack on beam

Some parts of the inspected schools showed serious cracks while some only showed minor cracks. From the inspection, cracks in wall were in various directions and varying in width from fine hair cracks to 5mm or more. The hairline cracks in plaster and other finishes affected the appearance of the structure but fortunately did not pose any safety concern [7]. There were long and continuous cracks across the walls, beams, columns, ceilings and floors. Moreover, a diagonal crack was found at the corner of door where the crack tip was very thin with increased thickness at the initial point.

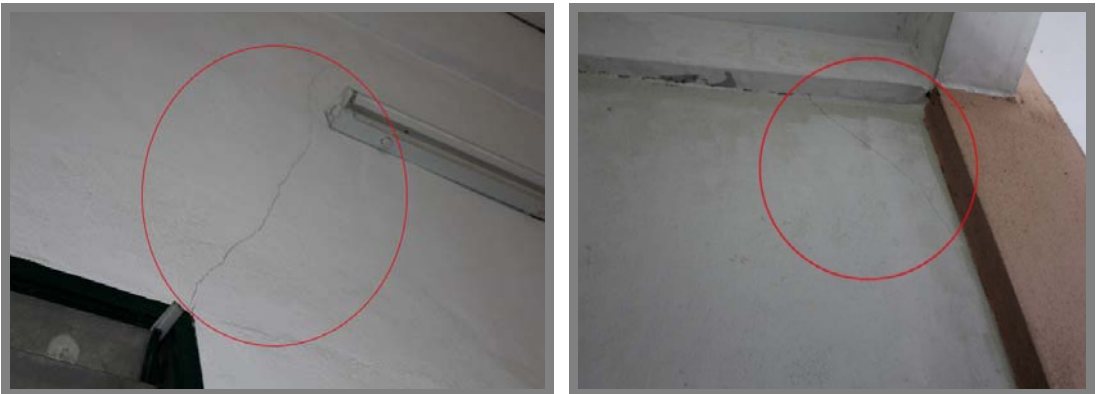
**Figure 5:** Diagonal crack on wall and at the corner of door

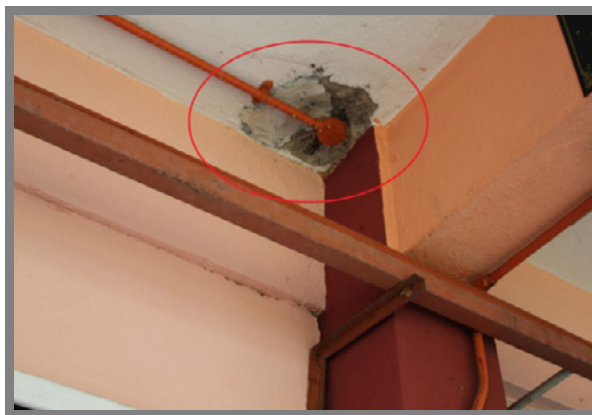
Figure 6: Broken plastered renderings.
