Citation: Watts, G (2012) A preliminary study of the characteristics of noisy vehicles under cruising conditions – results of roadside measurements. *Acta Acustica united with Acustica*. 98(2): 279-285.

A PRELIMINARY STUDY OF THE CHARACTERISTICS OF NOISY VEHICLES UNDER CRUISING CONDITIONS – RESULTS OF ROADSIDE MEASUREMENTS

by Greg Watts

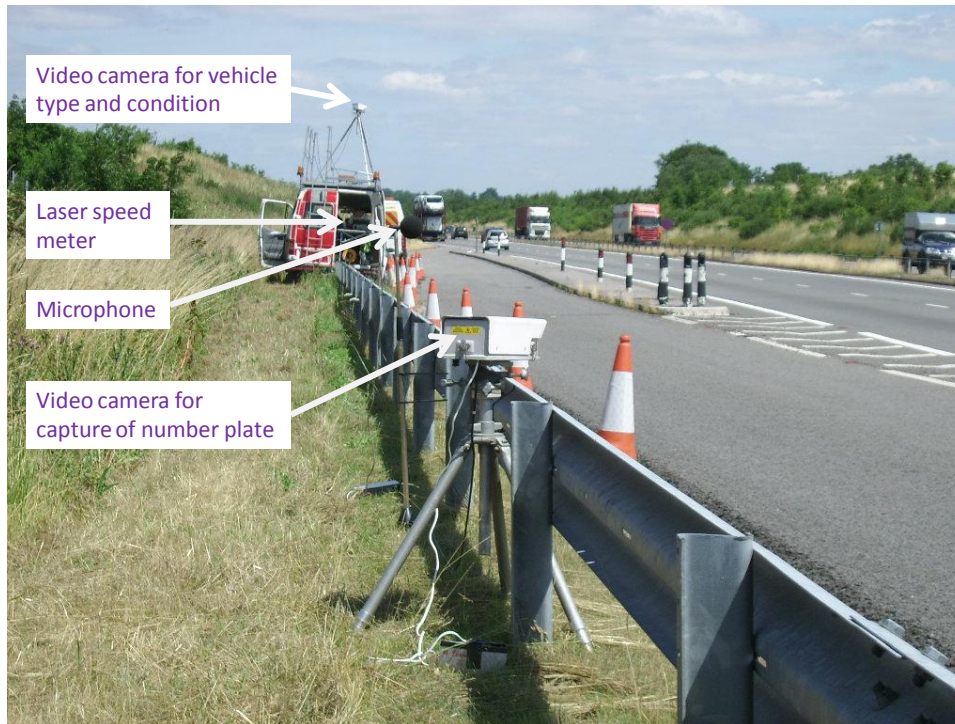
at random from the traffic stream. In this way it was expected to reduce the influence on recorded noise of other vehicles travelling on the carriageway. A view of the site is given in Figure 1. The cameras can be seen in the foreground and on top of the mobile laboratory. The microphone stand is just beyond the nearest camera and appears just to the right of the mobile laboratory.

Figure 1: View of measurement set up

Approaching vehicle speeds were obtained with a laser speed meter. The operator aimed the laser speed meter while seated out of sight in the back of the mobile laboratory. The video cameras were set up to capture images of passing vehicles in order to identify possible noise sources. One camera was mounted at a height of approximately 4m to obtain a view of the load carried by the HGVs and a lower camera at a height of 1.5m was used to obtain images of the rear of the vehicle to obtain information on the number plate, exhaust pipes and tyres.

A microphone was set up at a height of 1.2m and placed approximately 7.5 m from the centre of the nearside lane. This was used to record the maximum A-weighted noise level and the corresponding third-octave band spectra of the selected vehicles. For this purpose a Bruel and Kjaer third-octave real time analyser was used (B&K 2144). A DAT tape recorder was employed to provide a continuous sound record.

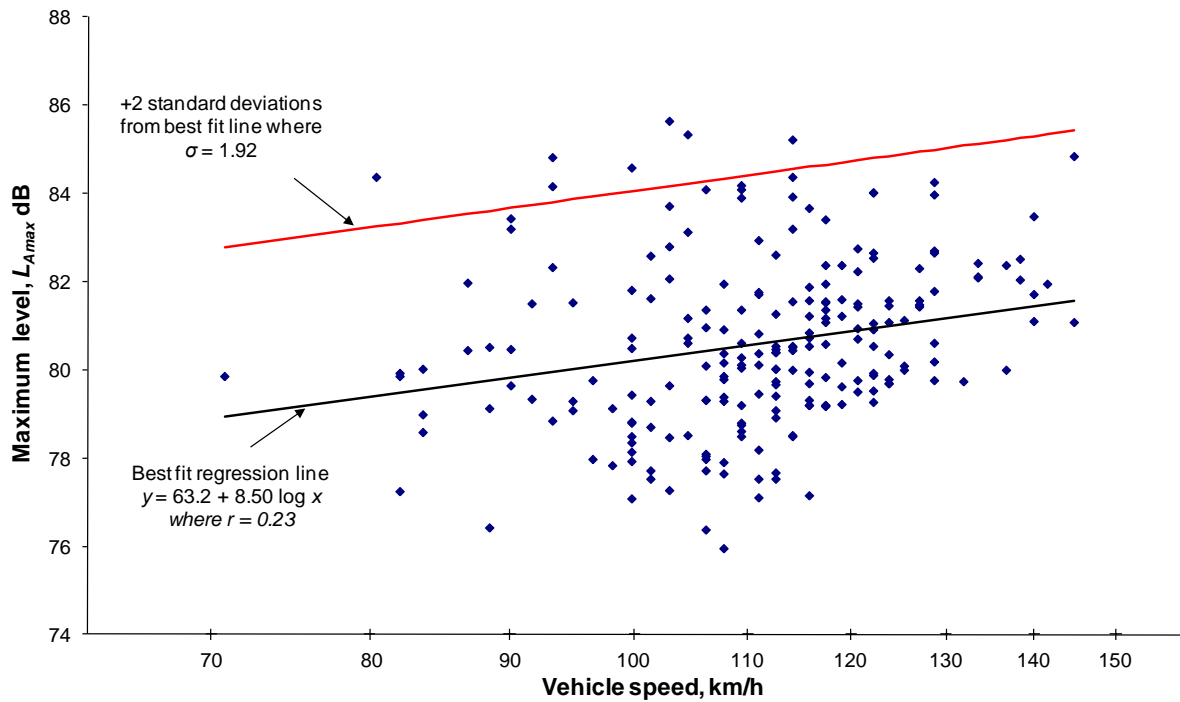
Figure 4 shows the scatterplot of maximum A-weighted pass-by noise levels against the logarithm of speed. The regression line has been added together with the line at 2 standard deviations above the regression line. Using normal (Gaussian) statistics it would be expected that approximately 2.3% of vehicles will exceed this line. With 219 vehicles in the sample the expected number is 5 vehicles. In Figure 4 it can be seen that 7 vehicles were above the line.

Figure 2: Category 1 (light vehicles) at Site 1

Examining overall levels for each vehicle category in Figures 2, 4 and 6 it can be seen that there is a tendency for L_{Amax} to increase with speed which is predicted with vehicle noise emission models that have examined both rolling and propulsion noise [6] and from roadside measurements [7]. However, although the speed coefficient (slope) is within the expected range for heavy vehicles it appears low in the case of light and medium heavy vehicles. The reasons for this are uncertain though it is clear that because the correlation coefficients are low the regression line is ill defined and the confidence limits for the slopes will be relatively large. The subsequent analysis was based mainly on the third octave analysis of pass-by noise together with the associated images from the video records. Body rattle noises were considered to cause the significant elevation of levels of around 5 dB(A) or more in several third-octave bands above 800Hz and above. In the case of exhaust noise levels were elevated by around the fundamental firing frequency of the engine (typically in the 63 to 125 Hz range). Recent work has shown that where body rattle noise is heard from passing vehicles the frequencies in a broad band above 800 Hz are significantly elevated above similar vehicles with no identifiable noise source (see section 8.3.1 of [7]). For discernable exhaust noise the frequencies are much lower e.g. in the 63Hz octave band levels were nearly 10 dB(A) higher. This is to be expected based on the fundamental firing frequency e.g. for a V8 four stroke diesel engine running at 1000 rpm the fundamental is at 67 Hz.

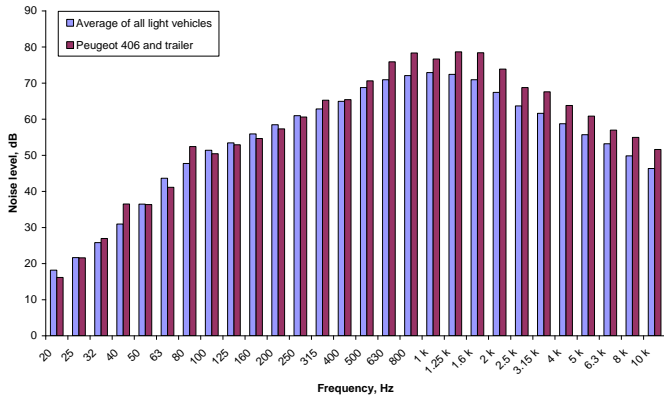
(a) Saloon car and trailer

It can be seen in Figure 3(a) that in the case of the saloon car towing the trailer there is an excess of noise above 630 Hz. This is consistent with rattle noises from the relatively old trailer. For the vintage sports car (Figure 3(b)) there is tonal noise around 160Hz. This is likely to be exhaust noise resulting from harmonics of the fundamental firing frequency of the engine.

Figure 3: A-weighted spectra for light vehicles captured at the maximum A-weighted level

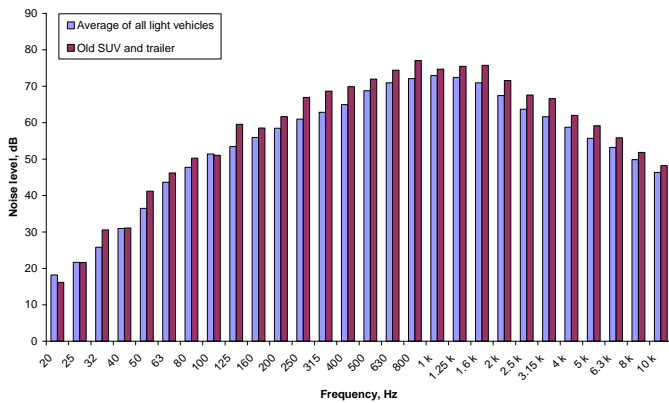
(c) Old SUV and trailer

Figure 3(c) shows that, for the SUV and trailer, the noise levels are generally higher than the average for a broad range of frequencies. This indicates that the main sources of noise on the vehicle, i.e. engine, exhaust, rolling noise, are all producing higher noise levels than the average vehicle in the sample. SUVs are generally noisier than saloon cars both in terms of propulsion noise and rolling noise. The fact that it was relatively old is also considered to be a factor. The trailer would also have produced additional noise especially rolling and rattle noises.

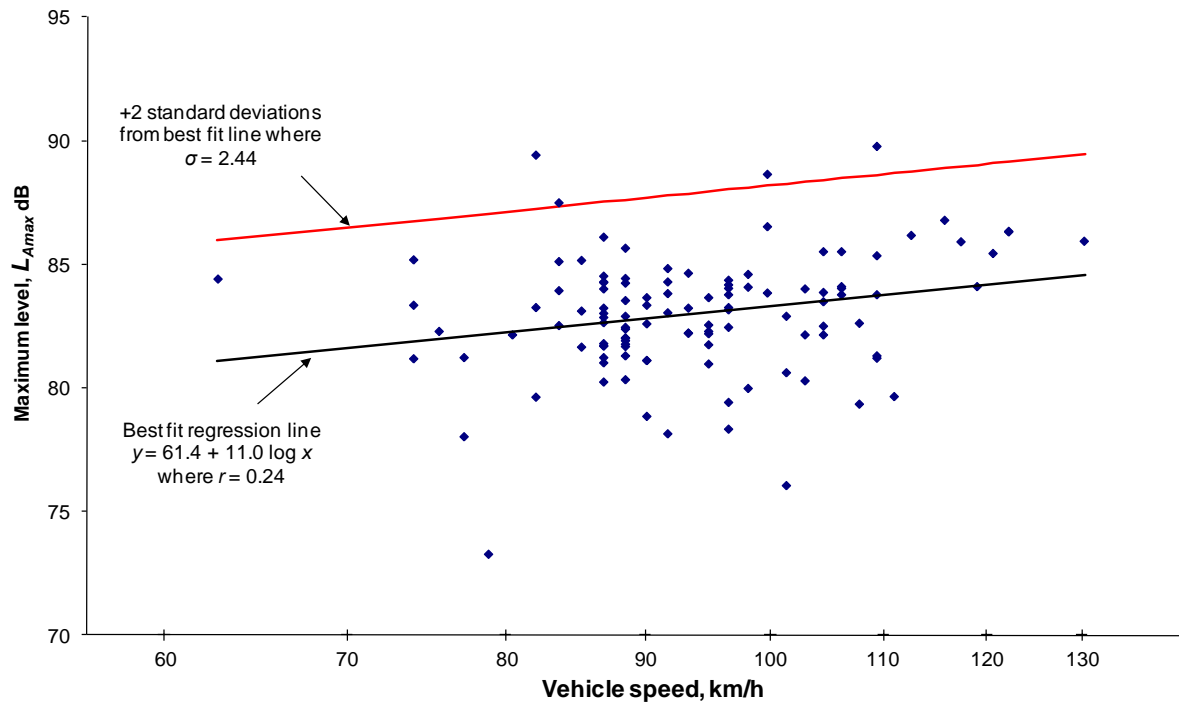
Figure 4 shows the scatterplot of maximum A-weighted pass-by noise levels for category 2 vehicles against the logarithm of speed. The regression line has been added and the line at 2 standard deviations above the regression line. Using normal statistics it would be expected that approximately 2.3% of vehicles will fall above this line. With 115 vehicles in the sample the expected number is 3 vehicles. In Figure 4 it can be seen that in fact 3 vehicles gave noise levels that were above the line.

Figure 4: Category 2 (medium heavy) vehicles

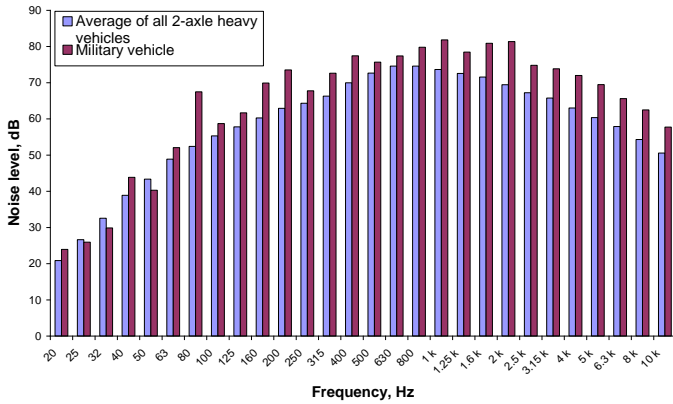
(a) Military truck

The third octave band spectra of these vehicles are given in Figure 5. It can be seen that the military vehicle (Figure 5(a)) is excessively noisy across the spectrum. There is a sharp peak at 80 Hz suggesting exhaust noise with possibly a harmonic occurring at 160 Hz. Above 800 Hz there is a general increase suggesting either tyre noise (from possibly off-road tyres with large tread blocks)) or body rattle noise from the mechanical digger. Possible exhaust noise peaks can also be seen in Figure 5(b) and (c) at the lower frequencies. The flapping canvas is probably responsible for the elevated levels shown in Figure 5(b). The tonal components at 1.25 and 1.6 kHz may result from transmission whine.

Figure 5: A-weighted spectra of medium heavy vehicles captured at the maximum A-weighted level

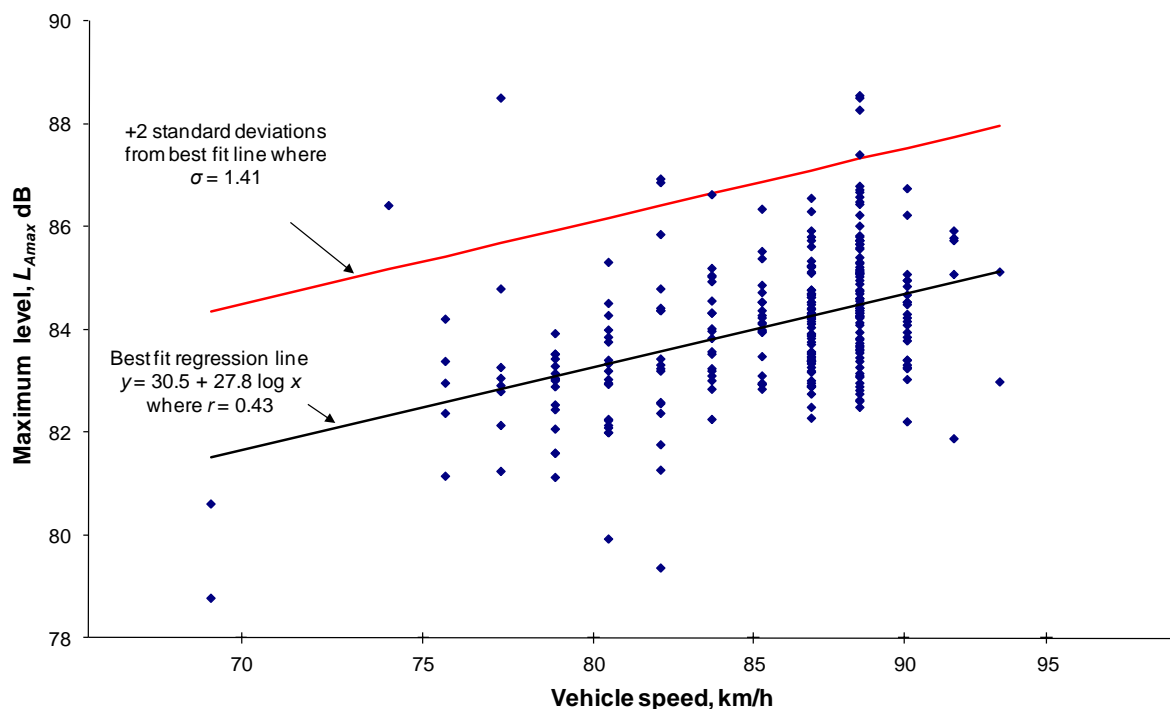
Figure 6 shows the scatterplot of maximum A-weighted pass-by noise levels for category 3 vehicles against the logarithm of speed. The regression line has been added and the line at 2 standard deviations above the regression line. Using normal statistics it would be expected that approximately 2.3% of vehicles will fall above this line. With 280 vehicles in the sample the expected number is 6 vehicles. In Figure 6 it can be seen that in fact the noise levels from 7 vehicles are on or above the line.

Figure 6: Category 3 (heavy vehicles)

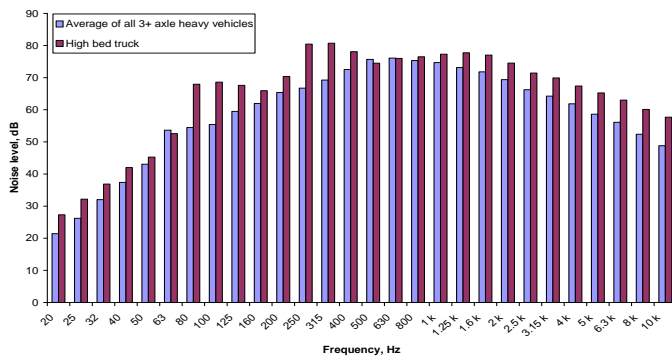
(a) High load bed truck (3 axles)

The third octave band spectra of these vehicles are given in Figure 7. It can be seen in Figure 7(a) that the high load bed truck with 3 axles is noisy at low, mid and high frequencies. The relatively high levels at low and mid frequencies are probably due to engine and exhaust noise though vibration of panels (body “boom”) may be a factor. At high frequencies rattle noises are probably responsible. The crane behind the cab would probably be a significant source of rattle noise. The remaining vehicles are all transporters with 4 of the 6 being unladen. Loose chains, safety fences around load beds, ramps are all source of rattle noise. The open frame and lack of streamlining would also contribute to increases in aerodynamic noise though this is thought to be relatively low at speeds around 90 km/h. The effect of these sources is a significant increase in noise levels above 800 Hz as can be seen in all the Figures 7(b) to 7(g).

Figure 7: A-weighted spectra of heavy vehicles captured at the maximum A-weighted level

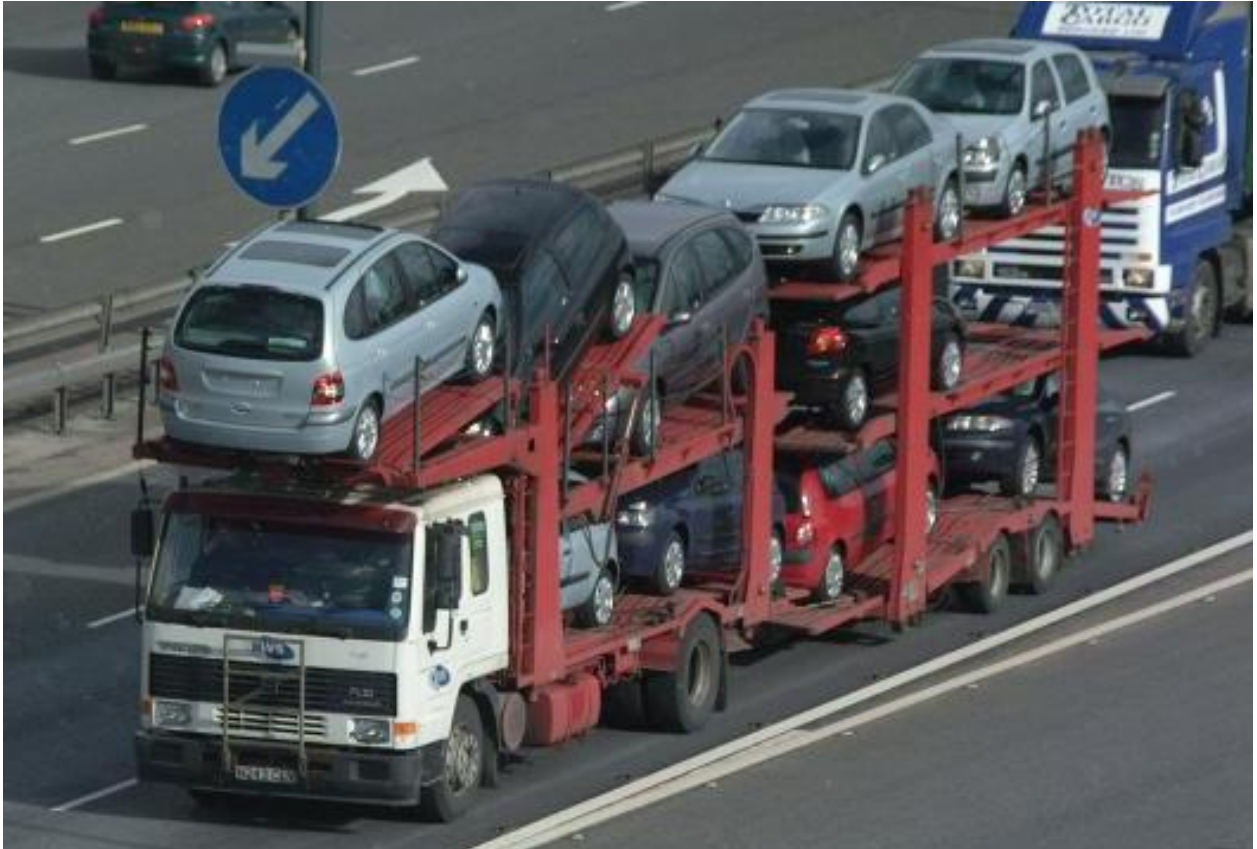
A typical car transporter is shown in Figure 8 where the loose chains are evident alongside the car decks.

Figure 8: Typical car transporter

Inspection of the images reveals some of the reasons for the rattle noises on transporters. The sources are likely to be metal to metal impact sounds due to loose:

- chain safety fences along the sides of the bays,
- vehicle securing chains,
- vehicle ramps,
- components on hydraulic hoists,
- components on the vehicles being transported (e.g. construction site vehicles).

The UK code of practice for body rattle noise [8] provides guidance on methods of preventing such noise. It is likely that there are particular challenges in reducing rattle noises for this type of vehicle because there are many loose metal components and more detailed investigations of the major sources and their elimination are required.
