Window Opening Effects on Structural Behavior of Historical Masonry Fatih Mosque

Abstract

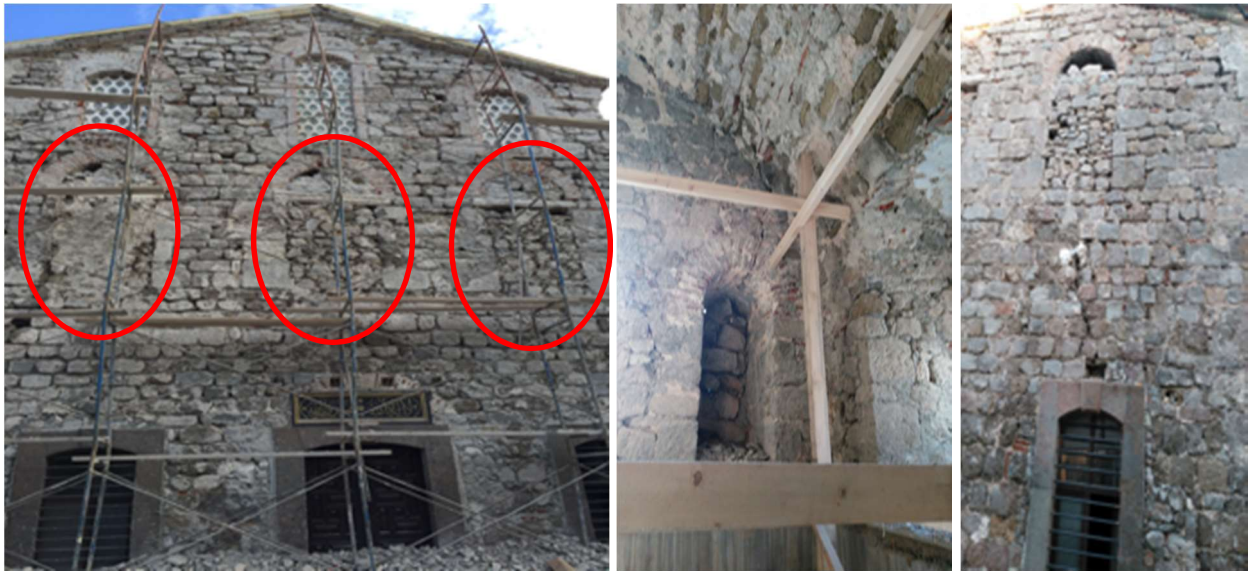
Fig. 5. Views of closed window openings on the exterior walls

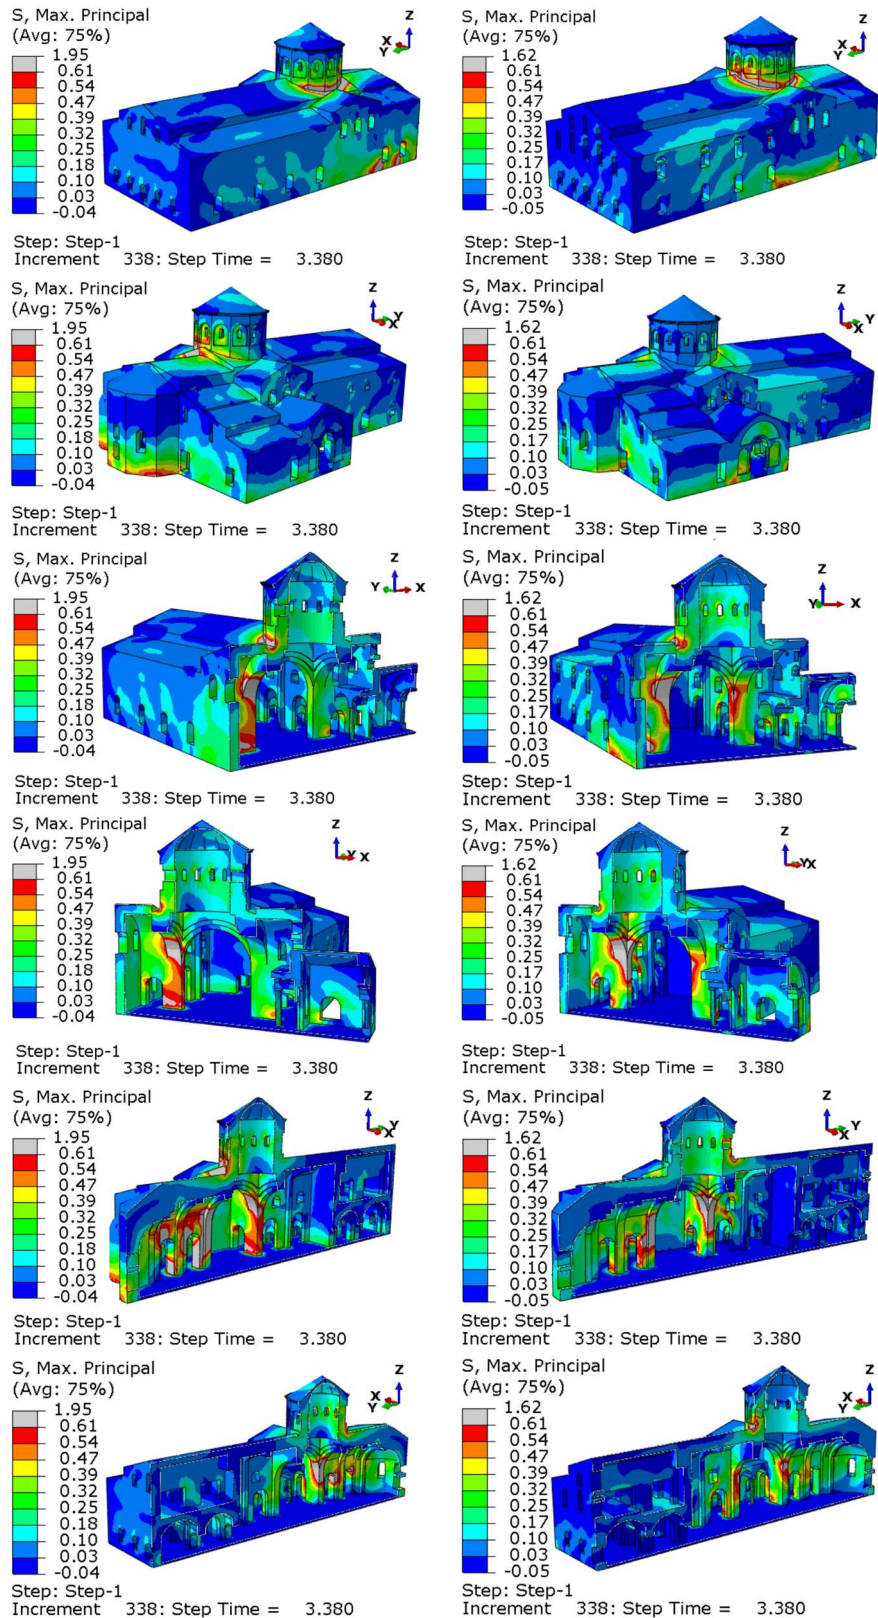
The minimum (compressive) and maximum (tensile) principal stresses obtained under self weight, live and earthquake loads are shown in Figs. 16 and 17 for blind and open window cases. The minimum and maximum principal stresses are calculated as -7.79MPa and 1.95MPa, respectively, in the case of blind windows. If the blind windows are open, the minimum and maximum principal stresses are obtained as -7.48MPa and 1.62MPa. In Figs. 16 and 17, the minimum and maximum principal stresses were scaled according to the wall compressive (6.1MPa) and tensile strengths (0.61MPa), respectively. The minimum and maximum principal stresses occur at different times in the cases of blind and open windows. The regions where the maximum and minimum principal stress values are formed are shown in gray and black colors, respectively, in the stress distributions. In other words, the areas where the stresses exceeded the wall compressive and tensile strengths are shown black and gray colors, respectively. As can be seen from Fig. 16, in the cases of the

blind and open windows, the minimum principal stress value only occurs in a localized zone and exceeds the wall compressive strength in this region. However, the maximum principal stresses exceed the wall tensile strength more widely in both blind and open window cases (Fig. 17). When the blind windows are opened, the maximum principal stress distributions with gray colors, which exceed the wall tensile strength, increase especially in the column elements bearing the dome, and the dome and body connection. The values of principal stress distributions in this regions show a significant increase from 0.61 to 1.95MPa.

Fig. 17. Propagations of maximum principal stresses under self weight, live and earthquake loads

- Under self weight, live and earthquake loads, the minimum (compressive) and maximum (tensile) principal stresses obtained in cases of with and without window openings decreases by 4% and 17%, respectively. The minimum (compressive) principal stress values only exceeds the wall compressive strength in a localized zone in both blind and open window cases. However, the maximum principal stresses exceed the wall tensile strength in larger areas in both blind and open window cases. The maximum principal stress distributions increase with considering window openings. The increase in maximum principal stresses distributions are particularly observed in column elements supporting the dome, and dome connection with the mosque walls. Besides, it is observed that the minimum and maximum principal stresses occur at different times in the cases of blind and open windows.
