IDENTIFICATION OF ZEOLITES IN CONCRETES AFFECTED BY ASR. EFFECT OF DIFFERENT AGGREGATES.

Maiza, P., Marfil, S. and Batic, O.
Geology Department, UNS. LEMIT-CIC.
CONICET. CIC. Argentina.

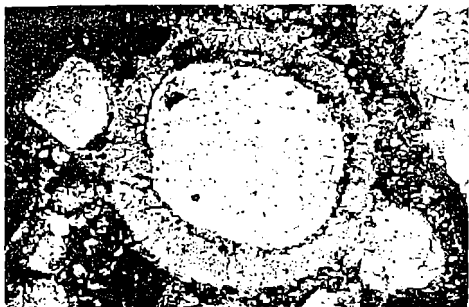
Micrograph 4 Aggregate with zeolites (z) at the external border. Internal zone with amorphous material (a). (x125).

Concrete N 2. The same as in Concrete N 1, aggregate has strained quartz, then it is considered potentially reactive. There also are small amounts of feldspars. Cement portland paste has many fissures. These microcracks can also be seen at the contact zone between grains and cement. Air voids are filled with a material identified, based on its optical properties, as zeolite (z). In some cases, zeolites cover the whole void, as it can be seen in Micrograph 3 (x125), meanwhile in other cases they grow only at the borders (Micrograph 4, x125), presenting calcite in their external part. Calcite also appears in the interior of the microfissures together with the zeolites.

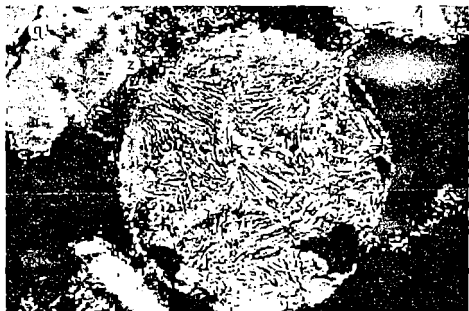
Micrograph 6 Detail of air void (c) with zeolite (z), and strained quartz with border of reaction (q). (x300).

Cement paste presents many fissures, with the microcracks filled with zeolites. There also are zeolites at the air voids (c) and at the borders of some grains of quartz (q), subordinated constituent of the aggregate as it can be seen in Micrographs 5 (x125) and 6 (x300).
