Artvin Çoruh Üniversitesi Orman Fakültesi Dergisi, 11 (2):30-42 (2010)
Artvin Çoruh University Faculty of Forestry Journal, 11 (2):30-42 (2010)

Evaluation of the Current State of Historical City Center of Erzurum and Production of Related Maps

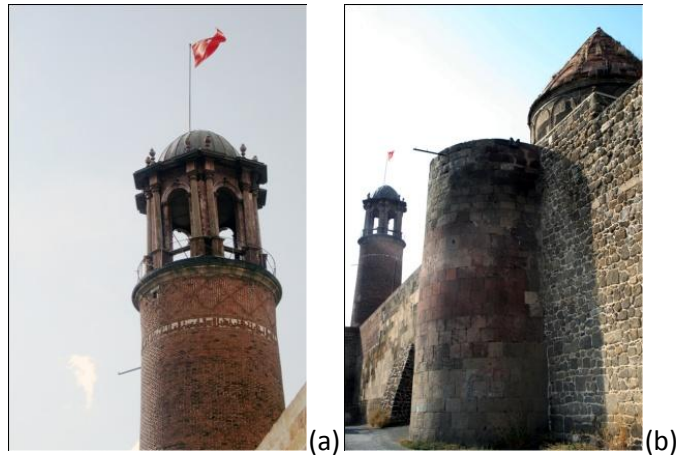
praying and they are smaller than mosques. They were important urban places in the social structure during the times they belonged to. Masjids which were built using stones have historical value and today they are protected carefully. The top of the clock tower, which was built in Saltuks times, had collapsed. This part was later restored in 19th century with wooden material in baroque style and a clock was mounted here. The castle fountain next to the walls outside the

castle has a stone structure. Its water is not running nowadays (Figure 3).

Figure 3.a) Clock Tower (Original, 2006) b) Castle Towers (Original, 2006)

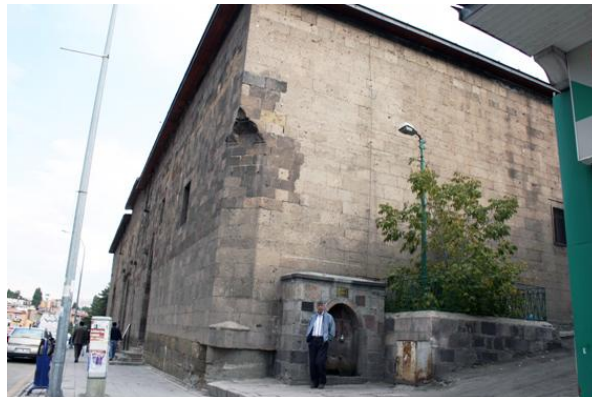
Ulucami: It is one of the oldest mosques in Erzurum. It was built by Saltuks in 1179 (Anonymous, 2005). Although the mosque and its minaret have been damaged several times along the history, they have been restored in different periods and succeeded to stand till present time (Figure 4).

Figure 4.The west side of Ulucami (Original, 2006)

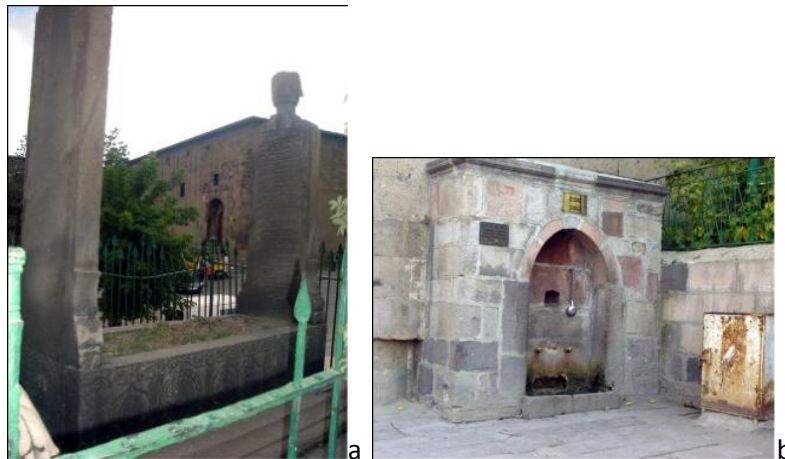
There are 3 graves in the 3rd degree archeological site. Although it is not known why these graves are here or who they belong to, they have reached our time and are still protected due to the convention that Turkish cities must be protected and they

must be handed on future generations as a historical heritage (Figure 6). There are three fountains and a dome among the social structures in this area. The domes, which are important structures of trimmed stone works, are tombs.

Figure 6. a) A view from the grave by the road in Cumhuriyet Street (Original, 2006) b) Fountain sample (Original, 2006)

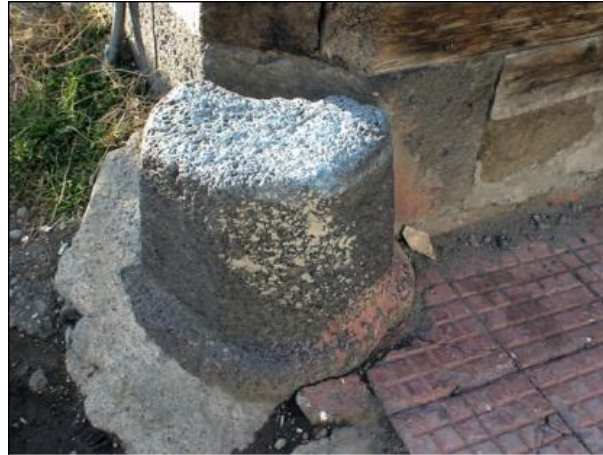
There were big corner stones almost at every corner of the houses in the old Erzurum city texture (Figure 7). These stones were used to prevent the phaetons

and carriages from hitting the house walls while they were turning the corners as there did not use to be pavements then. Now there is only one sample of these stones in

the 3rd degree archeological site as the restorations. texture has decayed because of the street

Figure 7. The corner stone at the corner of a historical house (Original,2006)

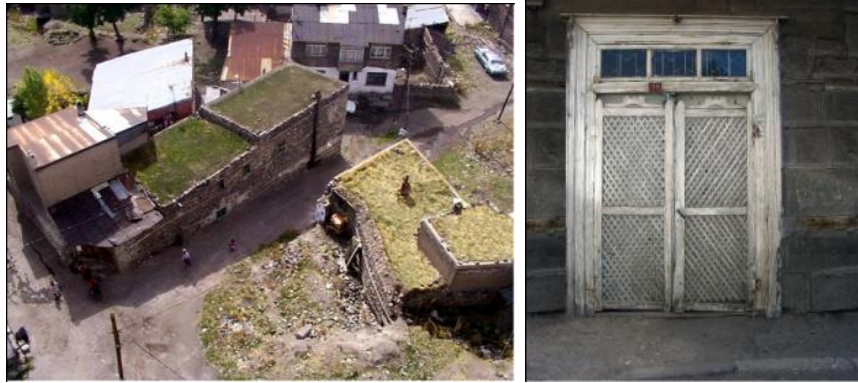
One of the most important details of traditional architecture of Erzurum houses is earthen roofs which constitute simple samples of extensive roof gardens and are a composition of floor covers and grass (Figure 9). There are 3 earthen roofs in the study area. Another important detail is the gates of the houses and gardens. The double winged doors, which are the most valuable elements of Erzurum houses, have two parts. On each part, there is a door knob

made of two different metals and these knobs have matching beds made of metal. In addition to these main entrance doors, some houses whose main entrance door open directly to street have a second door inside. These structures growing out of the cage style constructed doors are traditionally called as “tırhiç”. They replace the function of main entrance doors which are open along the day. These second doors prevent the inside of the house from being seen and

Figure 10. A sample of earthen roof (Original, 2006) and a sample of tırhiç (Original, 2006)

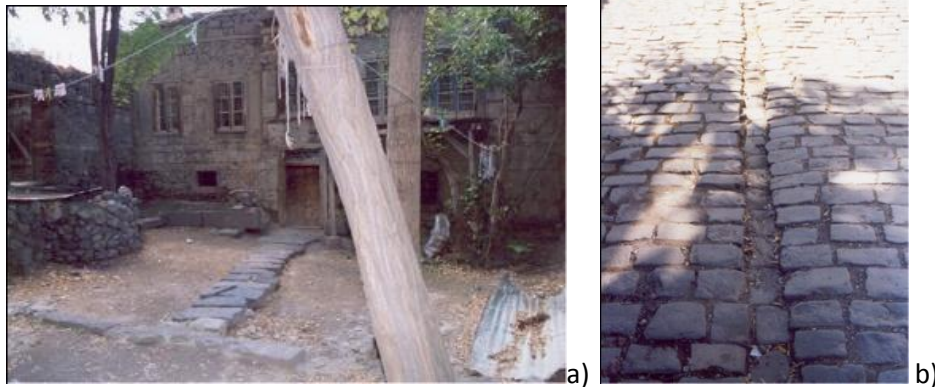
All these historical and architectural structures in combination form the traditional Erzurum Street. According to the scene emerging from remnants left behind the traditional street texture, the streets were situated in the north-south direction parallel to the topographic structure of the city. The streets, 5 meters wide in average, were covered with natural stone. Along the stone layer, there were some low trimmed stones in the middle parallel to the street for discharging water. There were circuitous and

dead end streets reflecting Ottoman street structure. There were also high garden walls, most of which were destroyed, and some places providing privacy. There used to be birch and maple trees and plants running over the garden walls which provided a beautiful perspective along the history for the people walking by but such sceneries are rarely met nowadays. Thin sharpened stones were used to build big garden walls and girders were used to fasten them (Figure 12.)

Figure 12. a) A sample of traditional garden (Original, 2006) b) A sample of street layer (Original, 2006)
