# Experimental study to identify premonitory factors of landslide dam failures

Fawu Wang<sup>a,\*</sup>, Zili Dai<sup>a</sup>, Chukwueloka Austin Udechukwu Okeke<sup>b</sup>, Yasuhiro Mitani<sup>a</sup>, Hufeng Yang<sup>c</sup>

Identifying premonitory factors before final failure for long-existing landslide dams is of high importance in disaster prevention and risk reduction. In this study, a series of large-scale (outdoor) experiments were designed and conducted to identify premonitory factors that may be used in failure prediction for actual landslide dams. Surface deformation, especially dam-crest settlement, dam seepage-water turbidity and self-potential across the dam crest were selected as the target parameters. Changes in these parameters showed apparent correlations between each other. Based on the monitoring data obtained and the observation performed during the tests, the deformation and failure sequence of the dam model can be separated into four time-sequential periods: 1) Emergence of seepage water and front wetting. In this period, the monitoring parameters did not show any obvious changes. However, wetting was observed in the downstream face. 2) Hyperconcentrated f

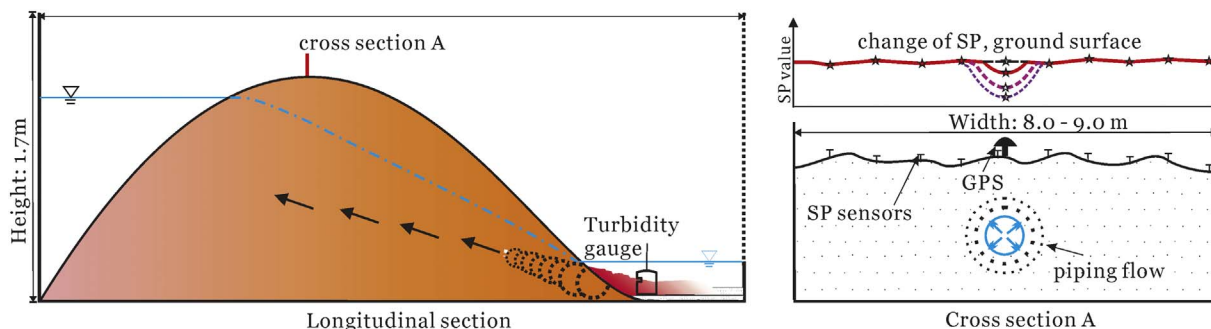
Fig. 1. Conceptual model of the experimental study on landslide dam failure.

To facilitate the possible applications of this study to actual landslide dam problems, multiple approaches were designed to measure the premonitory factors. Fig. 1 shows a conceptual model of the experimental study on landslide dam failure. A GPS sensor to monitor dam-crest settlement was scheduled for practical use. However, for high precision during the test, it was replaced by laser sensors. The following factors were considered as the targets:

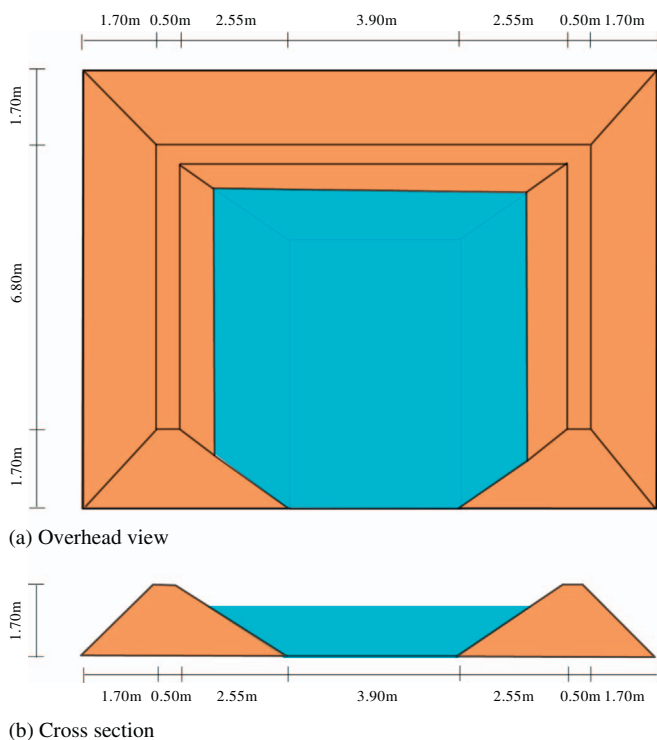
Fig. 3. Layout of the artificial reservoir surrounded by barrier: (a) overhead view; (b) cross section.

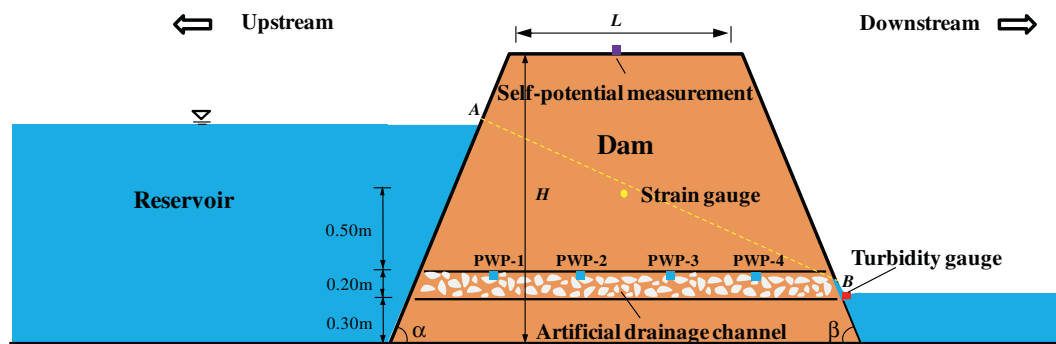
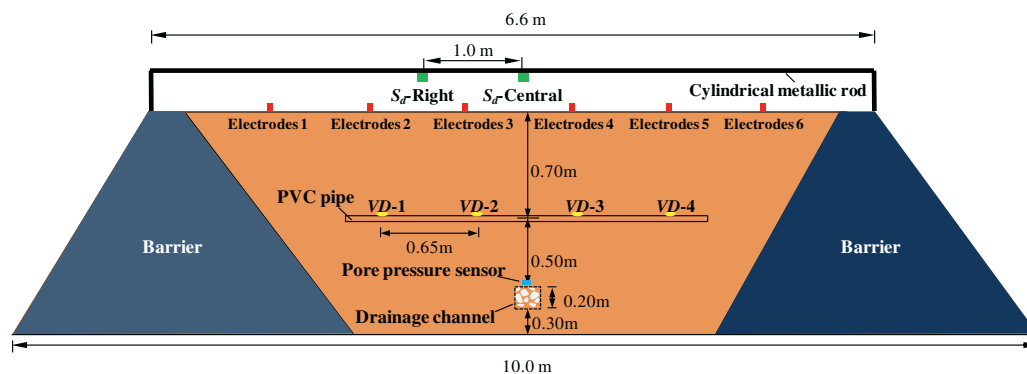
(a) Longitudinal section

(b) Cross section

Fig. 4. Layout of the landslide dam model: (a) longitudinal section; (b) cross section.

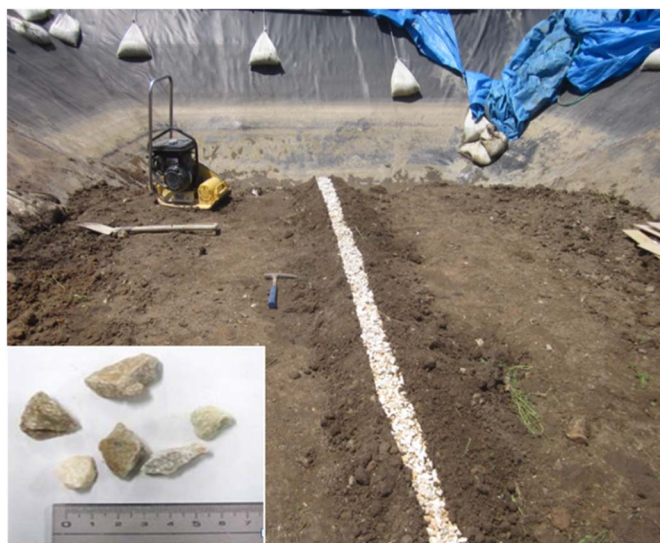
Fig. 5. Artificial drainage channel in the landslide dam model.

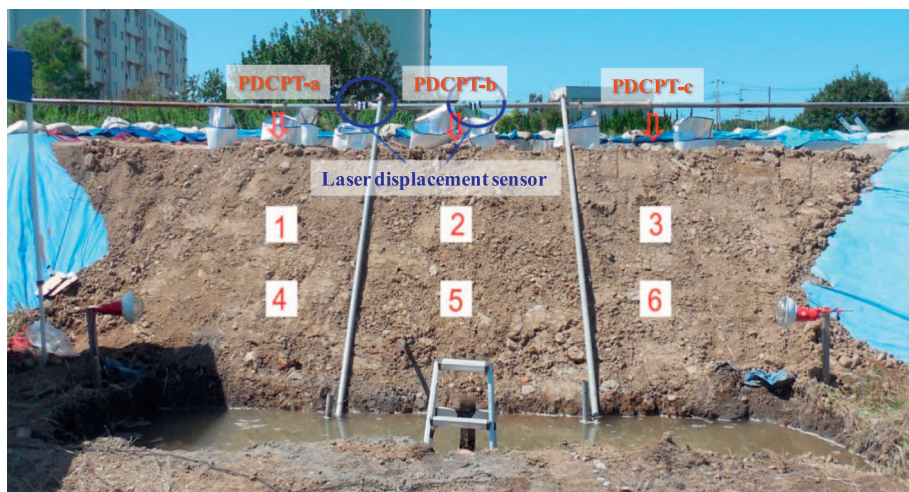
Fig. 6. Location of sampling points, laser displacement sensors and portable dynamic cone penetration tests (PDCPTs) on the landslide dam in Experiment 2.

The locations of the tests are shown in Fig. 6 by the labels PDCPT-a,

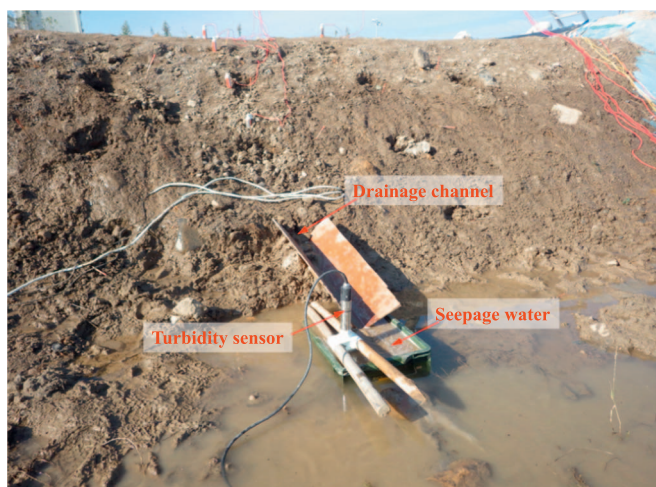
Fig. 7. Turbidity sensor to monitor the rate of internal erosion and piping.

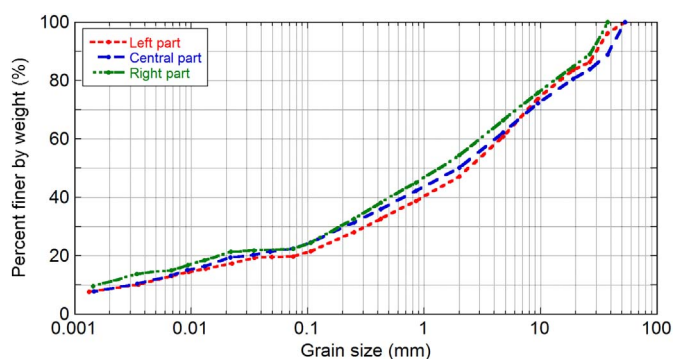
Fig. 8. Grain-size distribution curves of the landslide materials used in the experiments.

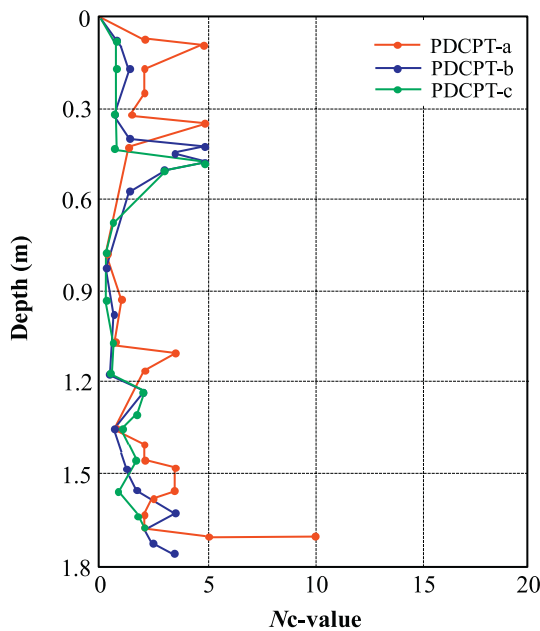
Fig. 9. Results of portable dynamic cone penetration tests (PDCPTs) on the dam crest in Experiment 4.

PDCPT-b and PDCPT-c. The blow-counts-versus-depth test results are shown in Fig. 9. The results show that for the soil material within 1.8 m of the dam crest, most of the  $N_c$ -values are less than 5, and the average  $N_c$ -value is about 3, indicating that the soil material is very loose. Combining the above physical parameters indicates that the soil material used in these tests was poorly compacted and with low shear strength.

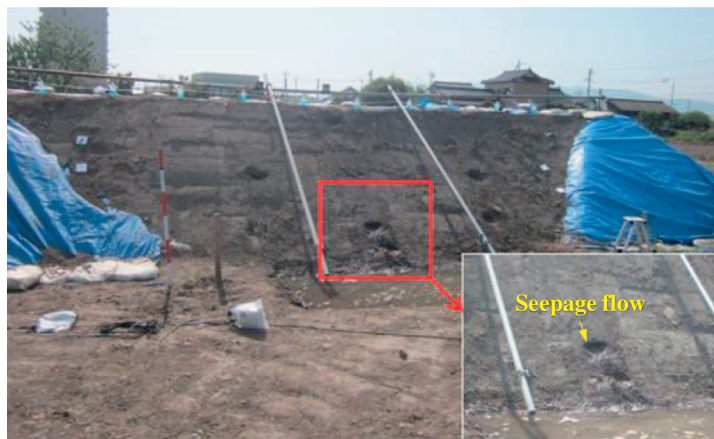
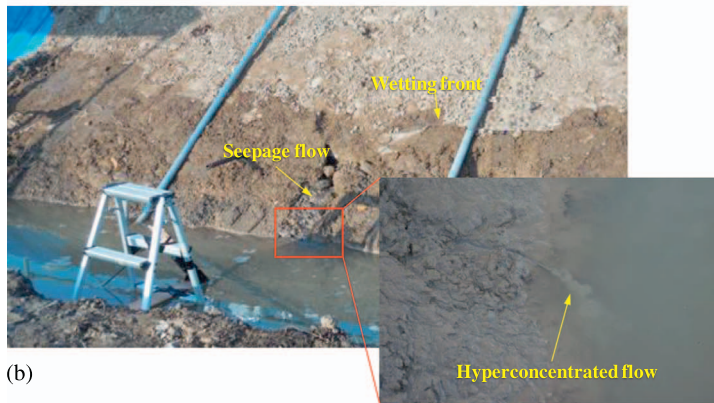
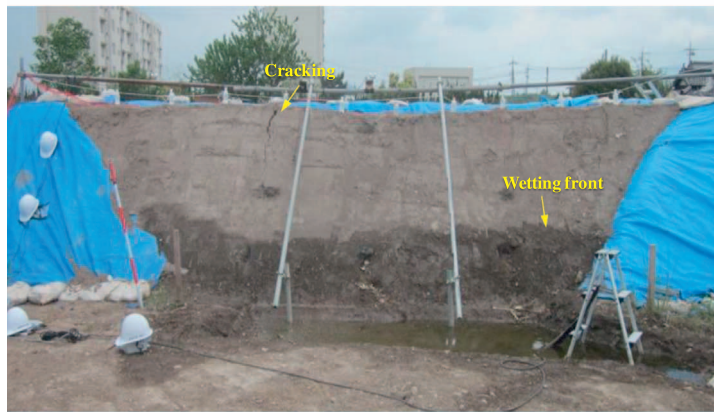
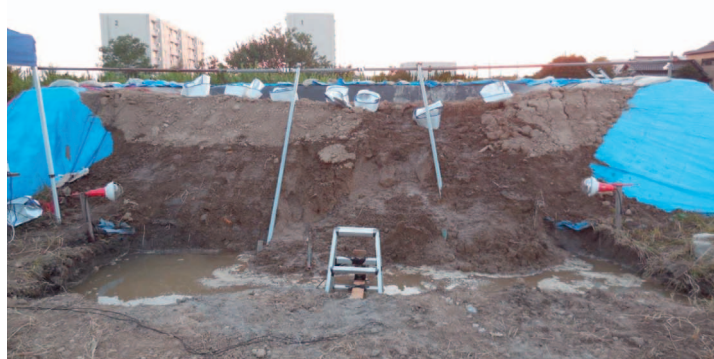
Fig. 10. Failure sequence of the landslide dam in Experiment 2: (a) seepage water at the downstream face at  $T_A$ ; (b) hyperconcentrated flow from drainage channel at  $T_B$ ; (c) emergence and evolution of cracks on the dam crest at  $T_C$ ; (d) settlement of the dam crest and sudden collapse of the dam body at  $T_D$ .

although wetting was observed on the downstream face. Seepage water emerged at the downstream face, and the wetting front propagated upwards. 2) Hyperconcentrated flow discharge. This moment is defined as  $T_B$ . In this period, water flowed out of the drainage channel, and the vertical deformation of the dam body became obvious, while the turbidity of the seepage water increased. 3) Emergence and development of cracks on the dam crest. This moment is defined as  $T_C$ . In this period, cracks emerged and developed on the dam crest, and the dam-crest settlement increased. 4) Sudden collapse and final failure of the dam model at moment  $T_D$ , together with a sharp increase in dam-crest settlement.

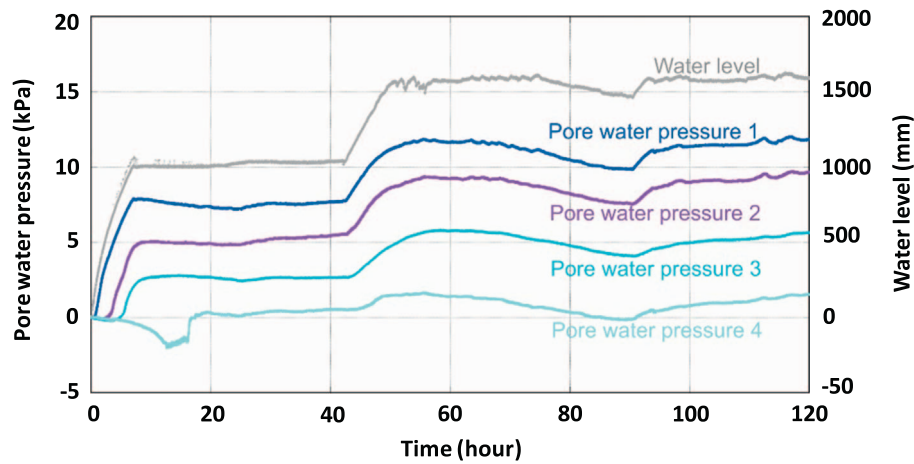
Fig. 11. Evolution of the upstream water level and pore-water pressure in Experiment 1.

The rapid rise in pore-water pressures from the upstream side to the downstream side of the dam resulted in the development of a high seepage gradient that caused abrupt erosion and outwash of the dam materials to an exit point on the downstream face. This was evidenced by the rapid increase in turbidity of the effluent seepage to more than 400 NTU (about 55 h after the test beginning). From 60 to 95 h, the hydraulic gradient stayed almost the same, and the turbidity of the seepage water was as low as about 40 NTU. At about 95 h after the test beginning, the hydraulic gradient increased, triggering another peak

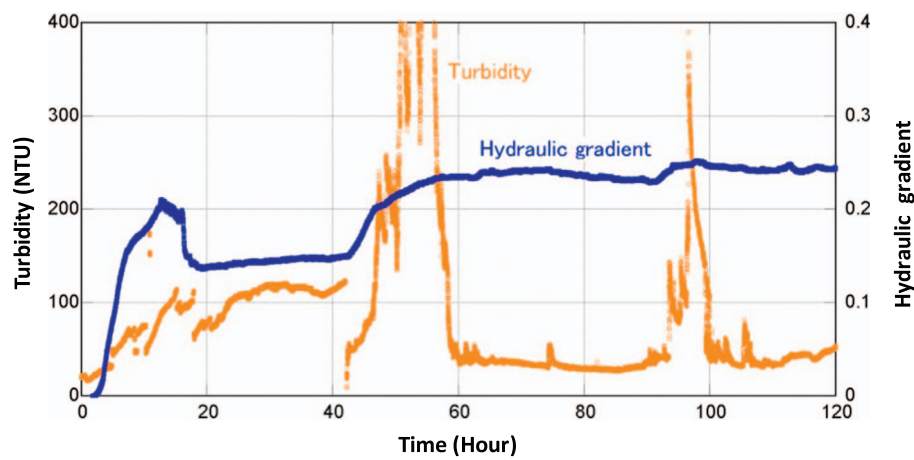
Fig. 12. Evolution of the hydraulic gradient and variation in turbidity of the seepage water in Experiment 1.

turbidity value of about 380 NTU. Therefore, the turbidity of seepage water could be an indicator of internal erosion through landslide dams, particularly in the early stages of the formation of the landslide dams.

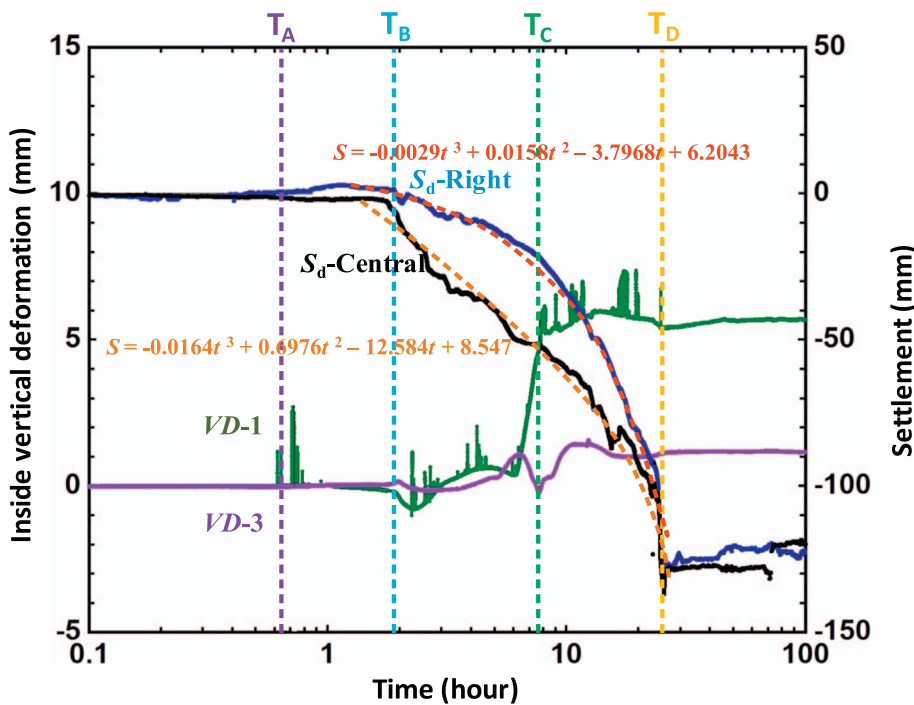
Fig. 13. Evolution of the dam-crest settlement  $S_d$  and the vertical deformation  $VD$  of the dam in Experiment 2.

Fig. 13 shows the evolution of dam-crest settlement and the deformation behaviour of the dam model used in Experiment 2. The critical moments marked by  $T_A$ ,  $T_B$ ,  $T_C$  and  $T_D$  in the figure correspond to the four periods shown in Fig. 10. The dam material was partially saturated prior to the filling of the upstream reservoir. The build-up of significantly high pore-water pressures and the subsequent reduction of the effective stress of the soil in the periphery of the drainage channel initiated minor deformation of the dam body (critical moment  $T_A$ ). The internal erosion process progressed into piping. The evidence is the gradual outwash of hyperconcentrated flows from a poorly developed hole at the toe of the downstream face. This was followed by a gradual settlement of the dam crest (critical moment  $T_B$ ). The erosion processes led to the further deformation of the dam that resulted in the cracks near the dam crest (critical moment  $T_C$ ). It is interesting to note that the outwash of the fluidized sediments from the evolving pipe coincided with the dam-body deformation recorded by the strain gauges. When the piping hole and cracks developed to a certain extent, the settlement of the dam crest suddenly increased, indicating the failure of the dam model (critical moment  $T_D$ ).

The relationship between the vertical deformation of the dam body and dam-crest settlement is shown in Fig. 13. Before critical moment  $T_B$ , the height of the dam stayed at almost the same value and the vertical deformation of the dam body was approximately equal to zero at that time. After critical moment  $T_B$ , the crest settlement increased rapidly, and the vertical deformation increased at the same time. After critical moment  $T_D$ , both vertical deformation and crest settlement began to stabilize. Therefore, the variation in the vertical deformation of the dam body basically corresponded to that of the crest settlement.

Based on the curve fitting, the settlement curve can be fitted to time by a cubic polynomial equation, as shown in Fig. 13. For example, the relationship between  $S_d$ -Right and time can be expressed as  $S = -0.0029 t^3 + 0.0158 t^2 - 3.7968 t + 6.2043$ , and the relationship between  $S_d$ -Central and time can be expressed as  $S = -0.0164 t^3 + 0.6976 t^2 - 12.5840 t + 8.5470$  (the units of settlement  $S$  and time  $t$  are millimetres and hours, respectively).

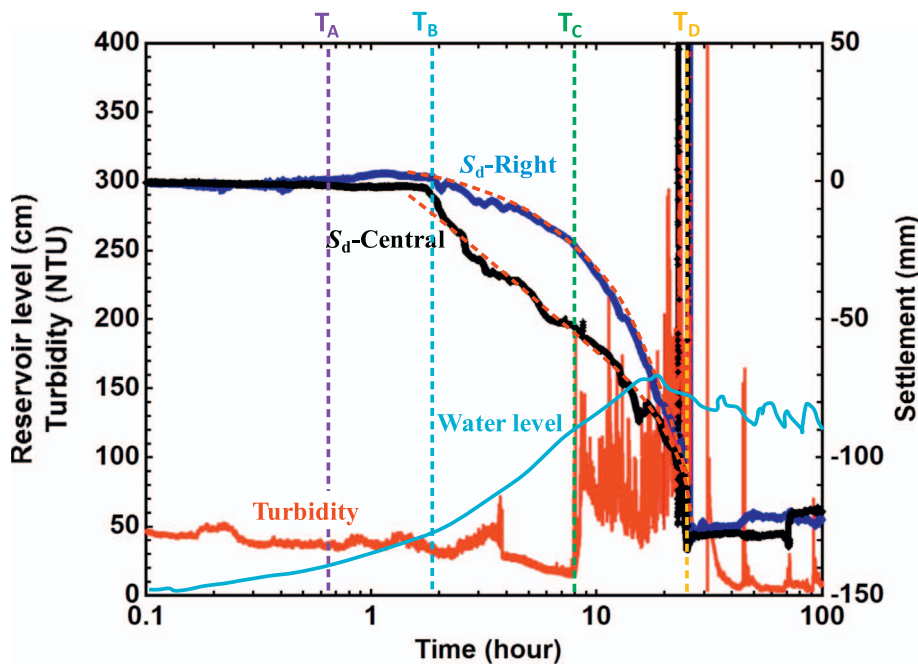
Fig. 14. Evolution of the dam-crest settlement  $S_d$  and the turbidity of the seepage water in Experiment 2.

Fig. 14 shows the relationship between seepage-flow turbidity and settlement behaviour of the dam crest. At the beginning of the experiment, there was almost no obvious settlement on the dam crest, and the turbidity of the effluent seepage was lower than 55 NTU. Between critical moments  $T_A$  and  $T_B$ , the turbidity fluctuated slightly. After critical moment  $T_B$ , the turbidity value increased from 55 NTU to about 70 NTU, marking the early onset of seepage in the dam. At this moment, the dam-crest settlement increased rapidly. This was followed by a rapid increase in seepage-flow turbidity, indicating the progression of piping and internal erosion through the dam (critical moment  $T_C$ ). The rate of enlargement of the piping hole under intense erosion can be directly related to the gradual settlement of the dam crest due to the removal of the underlying material. The pipe enlargement process reached its peak with a sharp increase in the dam-crest settlement, which corresponded to high turbidity values ranging from 350 to 400 NTU (critical moment  $T_D$ ).

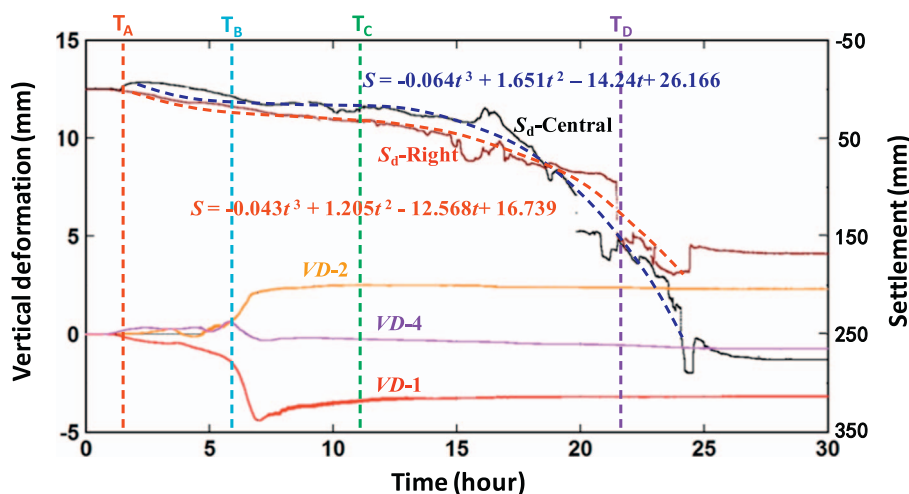
Fig. 15. Time-series data for the vertical deformation  $VD$  and dam-crest settlement  $S_d$  in Experiment 3.

Fig. 15 shows the time-series data for vertical deformation of the dam body (curves  $VD-1$ ,  $VD-2$  and  $VD-4$ ) and dam-crest settlement (curves  $S_d$ -Central and  $S_d$ -Right) recorded in Experiment 3. Similar to those in Experiment 2, the settlement curves could be fitted to time by cubic polynomial equations, as shown in Fig. 15. The gradual rise in the reservoir level and the subsequent increase in pore-water pressures

caused internal stress redistribution, which resulted in the formation of concave upward depressions (settlements) on the dam crest (critical moment  $T_A$  in Fig. 15). Early onset of internal deformation was detected via the strain of the pipe to which the four strain gauges were attached. It is estimated that the increase in seepage gradient around the artificial drainage channel triggered particle mobilization and entrainment, resulting in further redistribution of internal stresses as recorded by the strain gauges (critical moment  $T_B$  in Fig. 15). The vertical deformation inside the dam was measured through the strain gages on the upper surface of the PVC pipe. When the dam body vertically deformed due to the internal erosion, the PVC pipe bent in a vertical direction. However, the boundaries affected the deformation of the PVC pipe at both ends, which may have resulted in the deviation of the vertical deformation recorded by  $VD-1$  and  $VD-4$ . Therefore, the vertical deformation behaviours in Figs. 13 and 15 are slightly different.

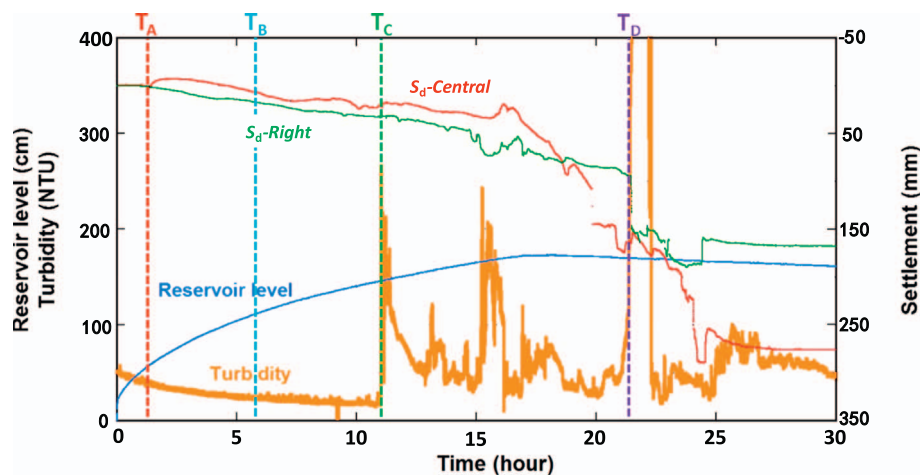
Fig. 16. Time-series data for the turbidity of seepage water and dam-crest settlement  $S_d$  in Experiment 3.

The onset of internal erosion was marked by the emergence of very turbid seepage water from the downstream toe and a sharp increase in the turbidity of the seepage water from 40 NTU to 270 NTU (critical moment  $T_C$  in Fig. 16). Consequently, the saturation of the downstream face under seepage resulted in the gradual undercutting of the

downstream toe, leading to slope instability and progressive failure. This phenomenon can be linked to very high turbidity values ( $T_D$  in Fig. 16) caused by the erosion and downstream transport of the mobilized materials. The turbidity reading reached its maximum value at around 22 h after the beginning of the experiment. At this moment, the settlement rate of the dam crest (the slope in the time-series curve of  $S_d$  around 22 h) increased. Hence, it could be concluded that seepage and internal erosion were the primary triggers for the failure of the landslide dam model.

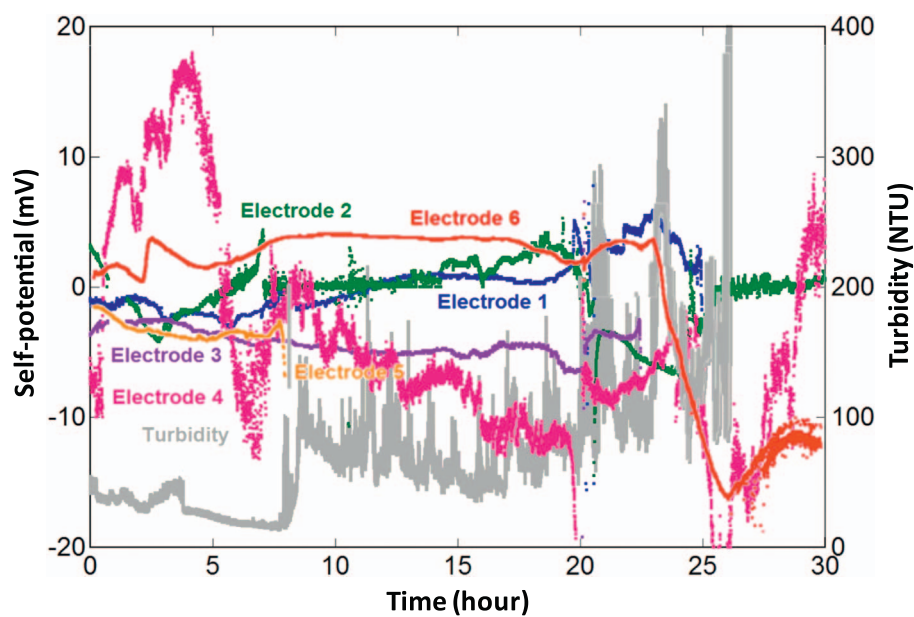
Fig. 17. Time-series data for the self-potentials at electrodes 1–6 and turbidity of seepage water in Experiment 4.

Ishido, 2012). This method is widely used in identifying seepage in dams and reservoirs (Al-Saigh et al., 1994; Panthulu et al., 2001; Bolève et al., 2009). Fig. 17 shows the variations in self-potential value and turbidity in Experiment 4. Self-potential ranged from  $-20$  mV to  $18$  mV during the test. After 7.5 h, the turbidity of the seepage flow started to increase. At this moment, the self-potential value gradually decreased (see curve for Electrode 4 in Fig. 17). When the self-potential value reached its minimum (around 26 h after the beginning of the test), the turbidity of the seepage flow reached a peak. Since Electrode 4 and Electrode 6 were positioned over the subsurface flow paths (the artificial drainage channel and the boundary), the self-potential responses measured by these two electrodes were more pronounced than the others.

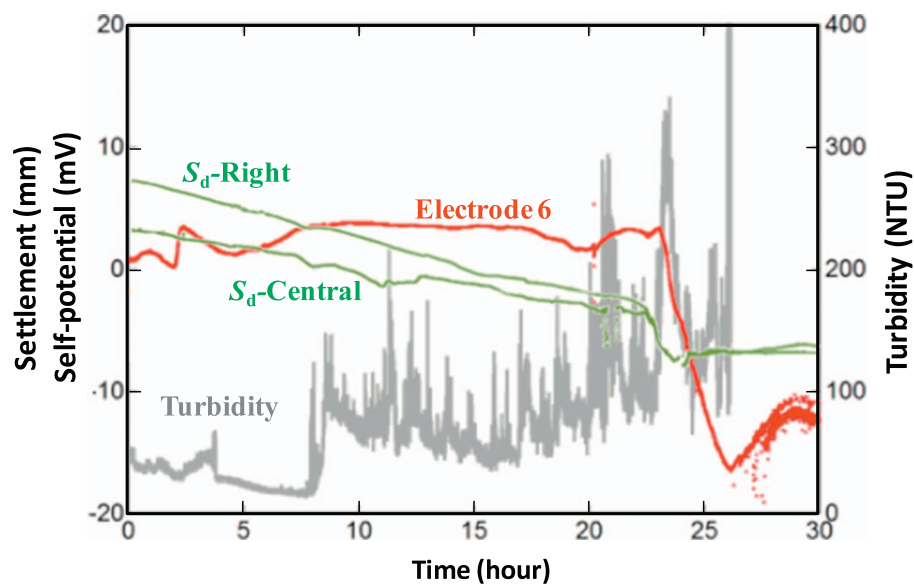
Fig. 18. Time-series data for the self-potential at Electrode 6, dam-crest settlement  $S_d$  and turbidity of seepage water in Experiment 4.

Fig. 18 shows the relationship between self-potential of Electrode 6, seepage-water turbidity and dam-crest settlement in Experiment 4. Variation trends in the self-potential, turbidity and dam-crest settlement were approximately the same. At around 23 h after the beginning of the experiment, the dam-crest settlement increased sharply. At the same time, the self-potential dropped steeply from  $2.4$  mV to  $-18$  mV, and the turbidity increased. Therefore, the reasonable correspondence between the negative self-potential anomalies, the emergence of highly turbid hyperconcentrated flows on the downstream face and the dam-crest settlement gives credence to the notion that the self-potential changes could be regarded as one of the premonitory factors of the failure of the landslide dam model induced by seepage.
