## Probabilistic life-cycle assessment and rehabilitation strategies for deteriorating structures: a case study

Elsa Garavaglia, Noemi Basso, and Luca Sgambi

This study analyzes the steel frame roof structure of  
the old pig abattoir within the complex of the municip-  
al slaughterhouse in Monza (close to Milan, Northern  
120 Italy). The construction was built in 1902, and aban-  
doned in 1984. The second phase of life, still ongoing,  
has significantly sped up the degradation process.

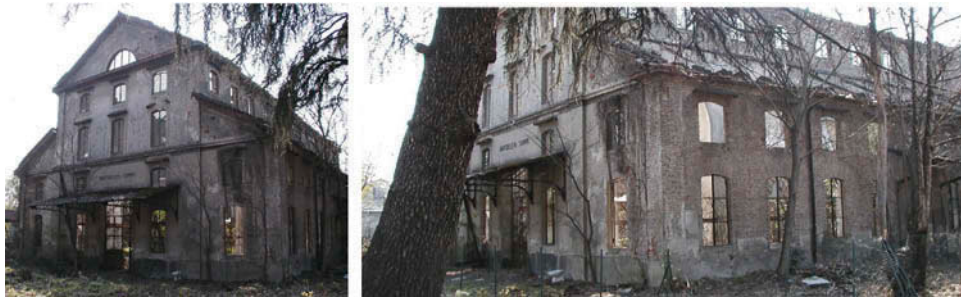
**Figure 4.** Pig slaughterhouse at present time.

In 2015, the roof covering was almost completely collapsed, the corrosion spread out, and tie-rods were affected by mild steel relaxation. Furthermore, timber elements appeared to be wholly degraded, and the masonry structure presented significant instability problems mainly due to wild vegetation (Figure 4).

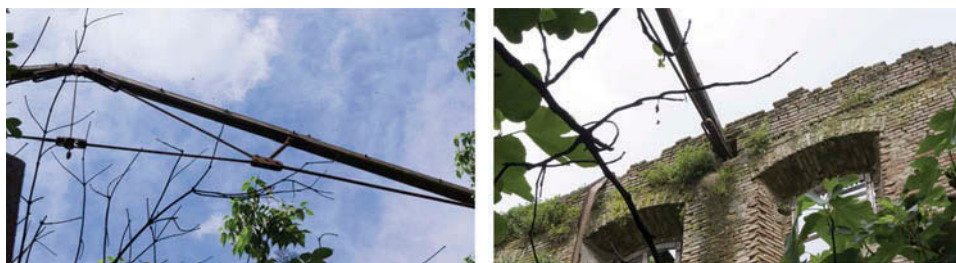
Figure 6. Roof truss system details (Dall'Orto, Sanchez, Suma, 2015).

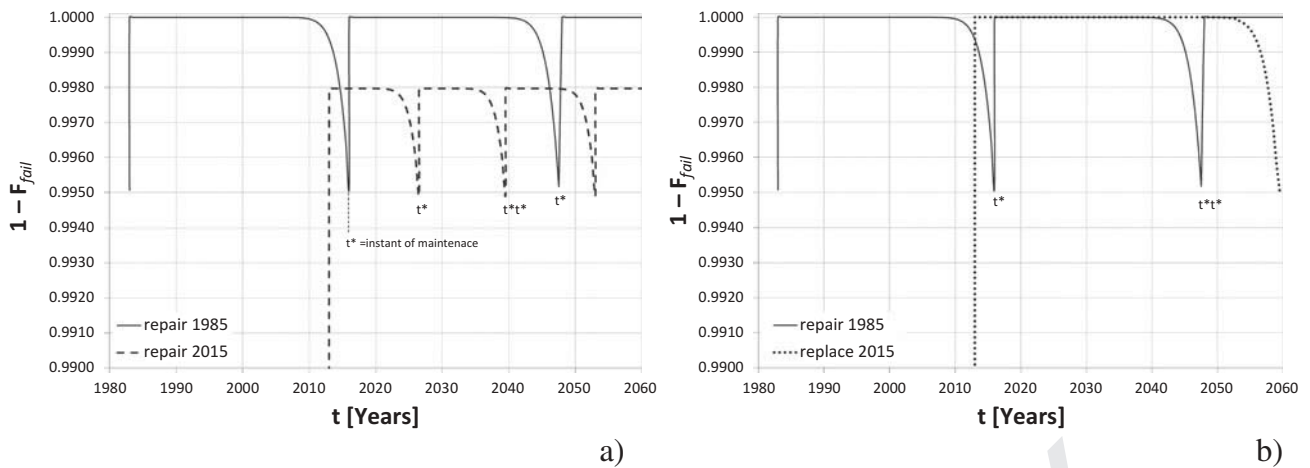
**Figure 12.** Maintenance scenarios: (a) 1985 total repair compared to 2015 total repair (performance 99.8%); and (b) 1985 total repair compared to 2015 total replacement.  $t^*$  refers to future instants of maintenance.
