ASSESSMENT OF WATERPROOFING FAILURES IN CONCRETE BUILDINGS AND STRUCTURES

Md Azree Othuman Mydin¹, Mohd Nasrun Mohd Nawi², Muhammad Arkam Che Munaaim³

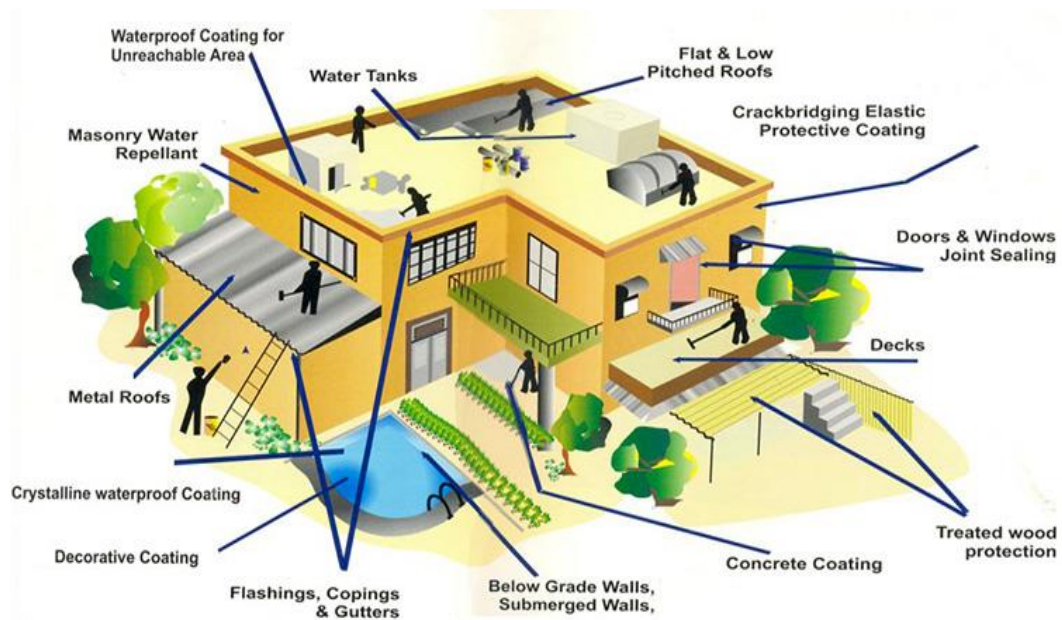
Figure 3. Complete waterproofing solution for a building

Waterproofing is a coating or membrane applied to a surface, such as foundation wall, to prevent the intrusion of water under pressure; materials may include asphalt, felt, tar or various synthetic membranes. As to increase the reliability and durability of building it is a must to install a waterproofing membrane. The structural component and building need a protection from the penetration of water or either from the construction material itself that can harm the concrete through seepage of water or other corrosive fluids. Waterproofing is a relatively impervious membrane, coating or sealant used in concealed locations to prevent water from entering or passing through either the horizontal or vertical building material. Waterproofing is design to exclude water even when the water is under a hydrostatic head. Waterproofing prevents the entrance of water that is under pressure by forming a continuous membrane around walls, through concrete footings and under the concrete slab. There shall be no openings are present that allow leakage or passage of water and water vapor. Figure 1 shows the complete waterproofing solution for a building

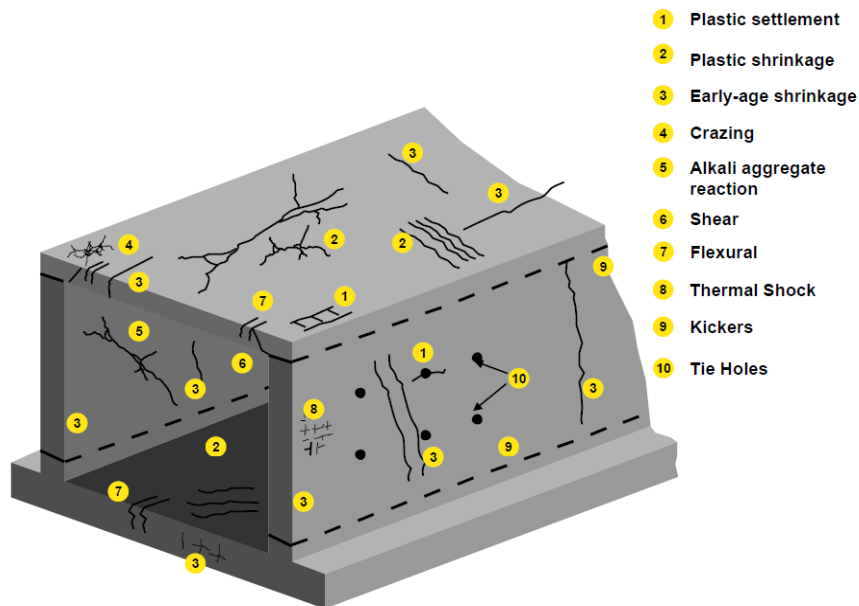
Figure 4. Types of crack building which will lead to water penetration

Meanwhile for crack that is more than 1/16, the crack shall be filled up with joint filler to fill up the crack area. Among all the option of waterproofing system either cementitious, membrane or natural clay, the ability to seal existing and future crack are limited. Another factor of cracking is due to the inadequate mixture, application, and curing process. These defects can lead to failure of waterproofing system and lack of protection that allows water to penetrate into the structure. Water seepage rate through cracks is depending on the crack geometry (Kubal, 2008). The seepage rate through horizontal cracks is larger than those through a vertical crack of the same width. Figure 2 shows the types of crack in building which will lead to water penetration.

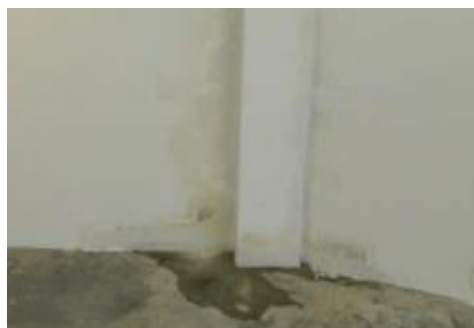
The new Mydin giant hypermarket is built with multi-storey car park consists of several number of floors. The waterproofing failure can be detected on the ground floor and also along the ramp that acts as connecting routes to two different levels. Figure 4 shows the water stain that arises from the water below the structure. The stain can be seen along the wall. As discussed earlier, water can penetrate into the permeable building by capillary action. This moisture can dissolve soluble salts from the building materials such as calcium sulfate. From the figure above, we can see that there is a large evaporative surface where it allows the salt deposition to concentrated and forming thick crystalline deposits.

Figure 0. Imprint of water caused from rising damp

The sources of moisture penetration in the base of the walls are probably from the defective ground and defective design to protect the floor surface. Figure 5 shows the proper way layering involves in protecting the water from penetrating into the slab. The crack of the

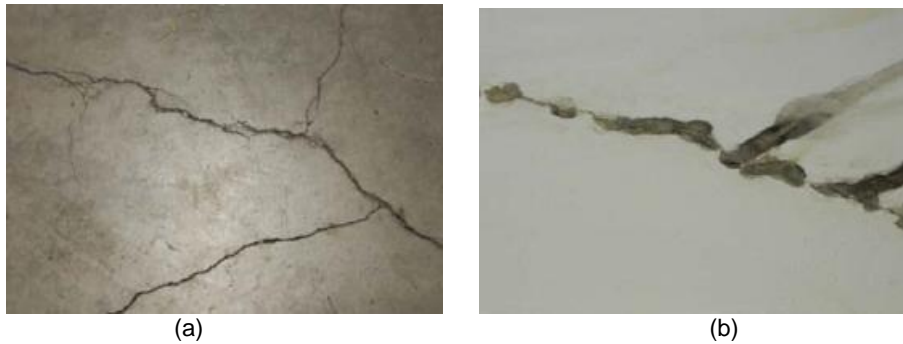
concrete structure can be caused by many factors. One of them itself is from the presence of moisture in the concrete. Once a structure crack, automatically the waterproofing system of the structure is failed and it attracts more water to seeped through the structure. Figure 5(a) portrays the crack that can be seen on the surface of a ramp installed in the multi-storey car park. And Figure 6(b) is the picture of spalled concrete that can be found in the structure below the ramp. Figure 6 shows the way how spalling of concrete can happen.

Figure 5. (a) Cracking on the floor (b) spalled concrete

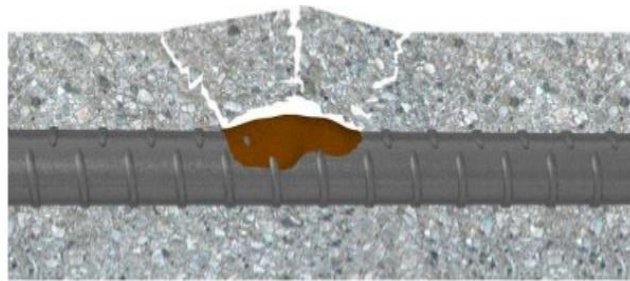
Figure 6. Occurrence of corrosion due to the presence of water in concrete structure

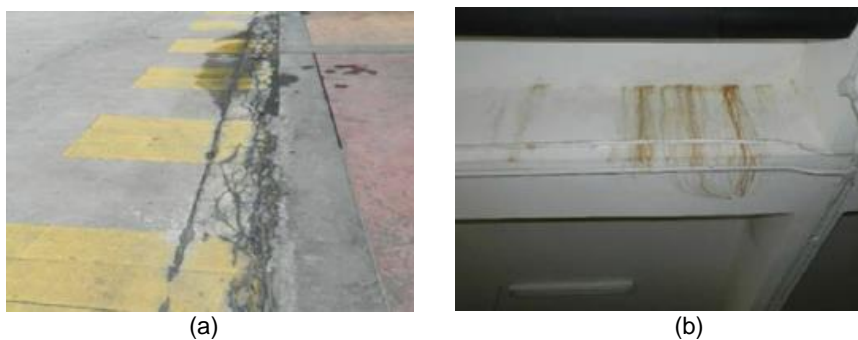
Figure 7. (a) Expansion Joint on the Parking lot surface and (b) the effect on structure below

From Figure 7, we can observe that the sealant of the gap or joint is deteriorated. Off all factors that affecting sealant performance, installation and workmanship are the most critical and most often causes joint failures. No matter how expensive the sealant selected and how well the joint is designed, an improper installation will lead to failures. A proper installation of joint should consider a backer rod in the design stage. Leaking stain can be seen on the below structure of the car park. The stain produced is in brown color which probably the steel

inside the structure is corroded. Expansion joint that is exposed to wear and moisture are usually used the closed-cell rod as a way to add insulation and waterproofing.

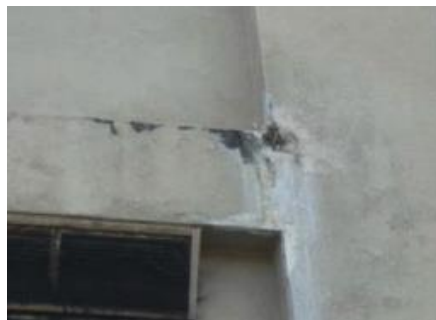
The equatorial hotel is located in Malacca. The building was probably aged around 18 to 20 years old. The area where leaking stain can be detected and the most critical area is at mechanical & electrical floor of the building. It accommodates the water tank that serves water to the guests and also electrical panel room of the building. Figure 8 show the water stain that can be seen from the outside of the building. From this picture, it can be said that the water has been penetrating for quite some time. Waterproofing layer has a maximum 10 years life span. As for this building, the waterproofing system installed has exceeded its timeframe and the effect of waterproofing failure can be detected through the emergence of whities along the wall. Figures 9 show the condition of structure inside the M&E room.

Figure 8. The exterior condition of M&E room

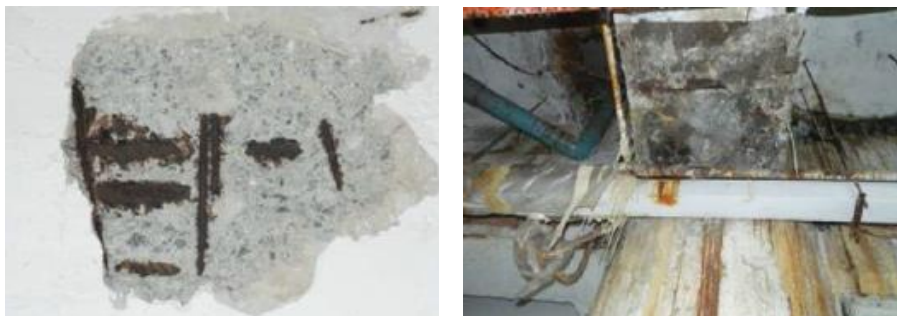
Figure 9. The condition of structure inside the M&E room

Due to the age of Equatorial Hotel has been more than a decade, many of defects can be found in the structure. The emergence of mold, stalactite, and spalled concrete can be proved that damaged of insulation, waterproofing system. Deterioration of waterproofing will not only allow leaks but it also allows rain to be absorbed into the various concrete layers. Depending on types and technology of waterproofed used, some of the waterproofing company claims 30 years of life span guarantees.

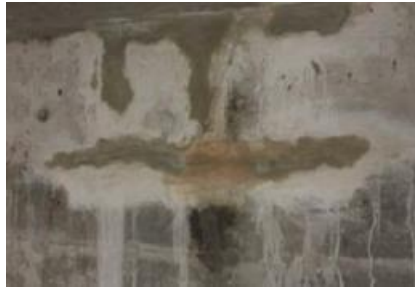
Figure 10. Leaking that can be found on the swimming pool wall

The newly built swimming pool is facing a critical leaking problem on the structure. It has been rectified for a few times and yet there is still a watermark can be seen on the surface structure. This is probably due to highly porous or the presence of honeycomb inside the concrete. It is usually caused by using concrete that is too stiff or by not vibrating it sufficiently after the concrete has been poured. In addition, the most serious kind of leaks often entangles error in structural design. As seen in Figure 10, the remedial work has been done wrongly as they only applied a layer of plaster cement to prevent the pool structure from leaking. In addition, many construction techniques of swimming pool nowadays are not incorporating the used of water stop as they only connecting the structure directly.

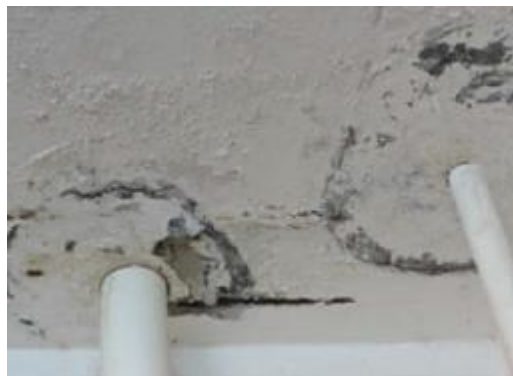
What we can interpret from Figures 11, it is proven that the waterproofing for the planter box of the hard landscape is deteriorated. This is mainly due to the aging factor of the structure. Cyberjaya Commercial Office has been built roughly for more than 10 years. Thus, it is common where the waterproofing system of the deck is deteriorated and some cracks can be observed. There is sign of blistering of concrete at the drain pipe of the planter box. This is due to the continuous moisture content in the structure. Below figure shows the construction layer of the planter box.

Figure 11. Cracking on the edge of planter box and deterioration of waterproofing on slab surface
