Procunier Remodel Project

724 Orinda Ln, Walnut Creek, CA 94597

Architectural Engineering Department
California Polytechnic State University, San Luis Obispo
Advisor: Dr. Craig Baltimore, PhD, SE

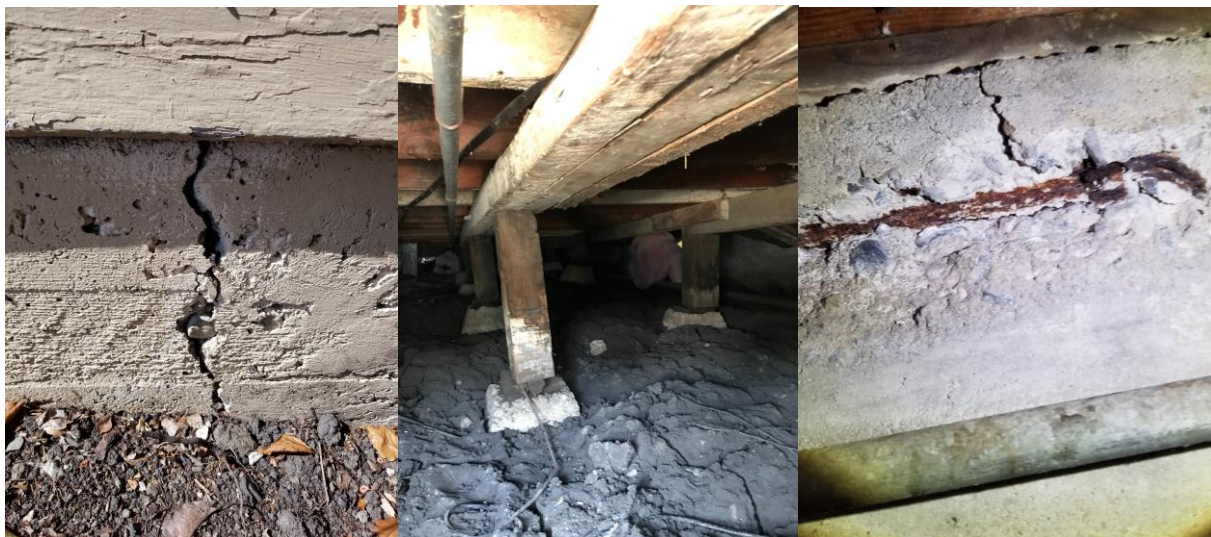
Figure 1: Condition of Existing Foundations

From left to right: A large crack, posts sliding from footings, and exposed, corroded rebar

Overall, the house was in poor condition. Apart from the wear and tear that comes with a 70 year old house, there were severe structural concerns. Nancy informed the team that the original owner was a contractor who had made several additions to the house while he lived there. The result was a host of poor construction practices. Large cracks were found throughout the foundation of the house and many of the posts supporting the floor were either completely corroded or were no longer attached to their footings. This created problems with the floor above which was severely warped due to the settlement of the foundation. Upon inspecting the roof framing, it was discovered that there was no actual roof diaphragm connecting the lateral system components. Wood shingles were nailed directly to the rafters. These wood shingles were eventually covered in at least one layer of asphalt shingles.

Originally, the team planned to keep one corner of the front room, about 30 linear feet of wall line, and rebuild the renovated house around these existing walls. However, after seeing the condition of the existing structure, this plan had to be amended to keep just one wall, about 12 linear feet. That being said, this original wall was still in need of repairs and would require not only a new foundation but also a new roof.

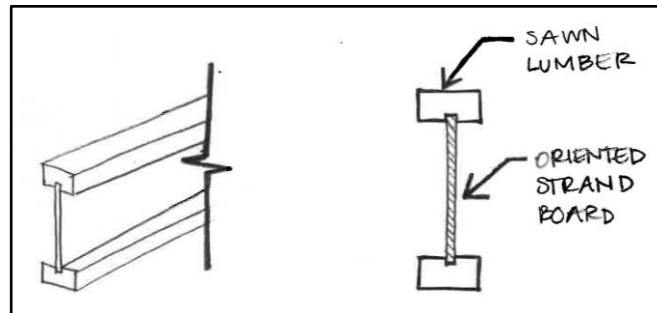
Figure 5: Engineered Wood Joists

Early on Nancy requested that the noise transfer from footfalls on level two be kept to a minimum. Based on a recommendation from the design team's advisor, Dr. Baltimore, the team looked into using engineered wood joists to support the floors. An image of engineered wood joists are shown below. Engineered wood joists limit the amount of creaking in floors as opposed to typical sawn lumber. Sawn lumber begins to creak as it shrinks over time. Engineered wood joists limit the amount of shrinkage because they are composed of smaller manufactured pieces of wood that shrink less than a large sawn lumber cross section. Because of the efficient shape of the engineered wood joist and the ability to use many small members, they are also able to span further distances. This helped the design team when designing the large first floor open room. Another additional measure that was taken to limit the sound of footfalls was a thick subfloor that acts as a sort of cushion when walking across the floor.

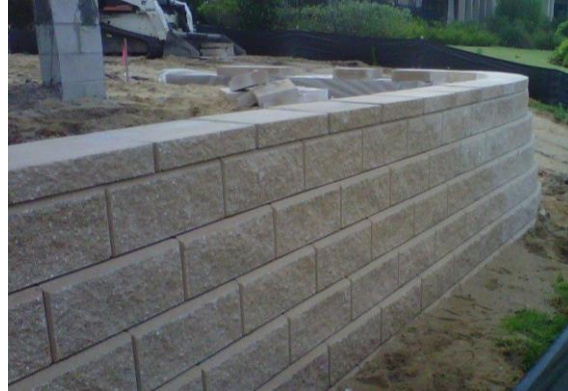
Figure 6: Typical Allan Block Retaining Wall

The team knew that the retaining wall on the west side of the property was going to have to be fairly large. It had to be at least 7 feet tall to hold back the existing soil and also had to support the extra load from the structure on the other side of the property line. After considering these loads and doing some research, the team decided that a block type wall would be more cost efficient than a concrete retaining wall. Similar to the pre-manufactured trusses, the block wall is designed by the manufacturer based on loads provided. This was a simple solution to a large design challenge.

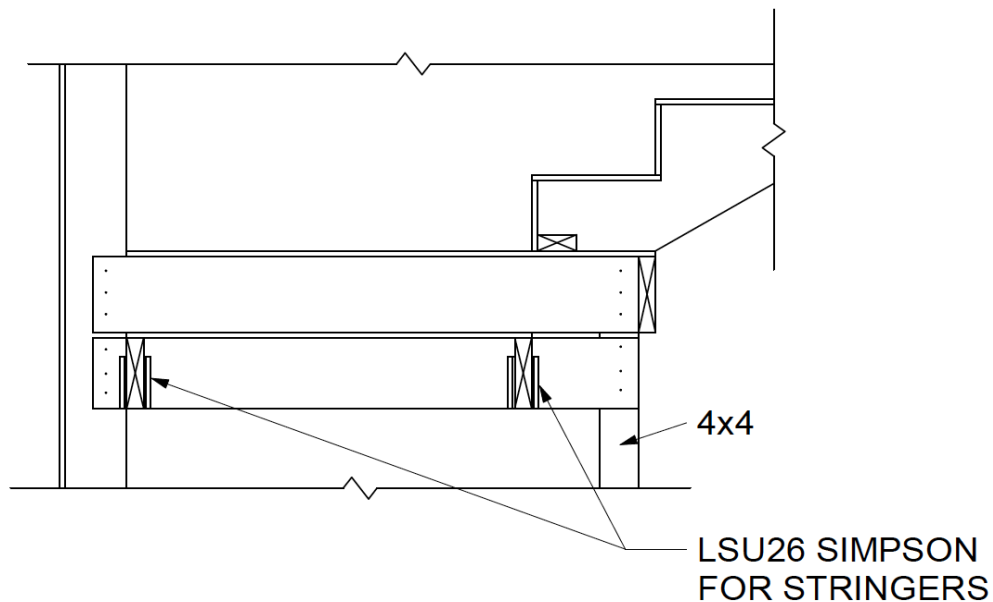
Figure 7: Detail of Interior Stair Supports

What revealed itself to be one of the more complicated elements of the house was the interior stairs. This may have been attributed to the fact that stairs, unlike many of the other elements in the house, are not covered in the Cal Poly Architectural Engineering design classes. The design team used their knowledge of other structures to come up with a support systems for the stairs that limited movement as people ascended. Some post were required here, but other than that the stairs were supported by the studs already in the walls. This caused these studs to be the most likely to fail because they had the stairs attached, but also extended from the ground floor up to the top of level two. Therefore, the studs were designed for loads coming from the stairs, floor two and the roof at the same time.
