TAMU Project

**Energy Consumption Data Quality Assurance/Quality
Control Assessment Report for the
Month of December 2016**

**Utility & Energy Services
Division of Administration
Texas A&M University**

January 2017

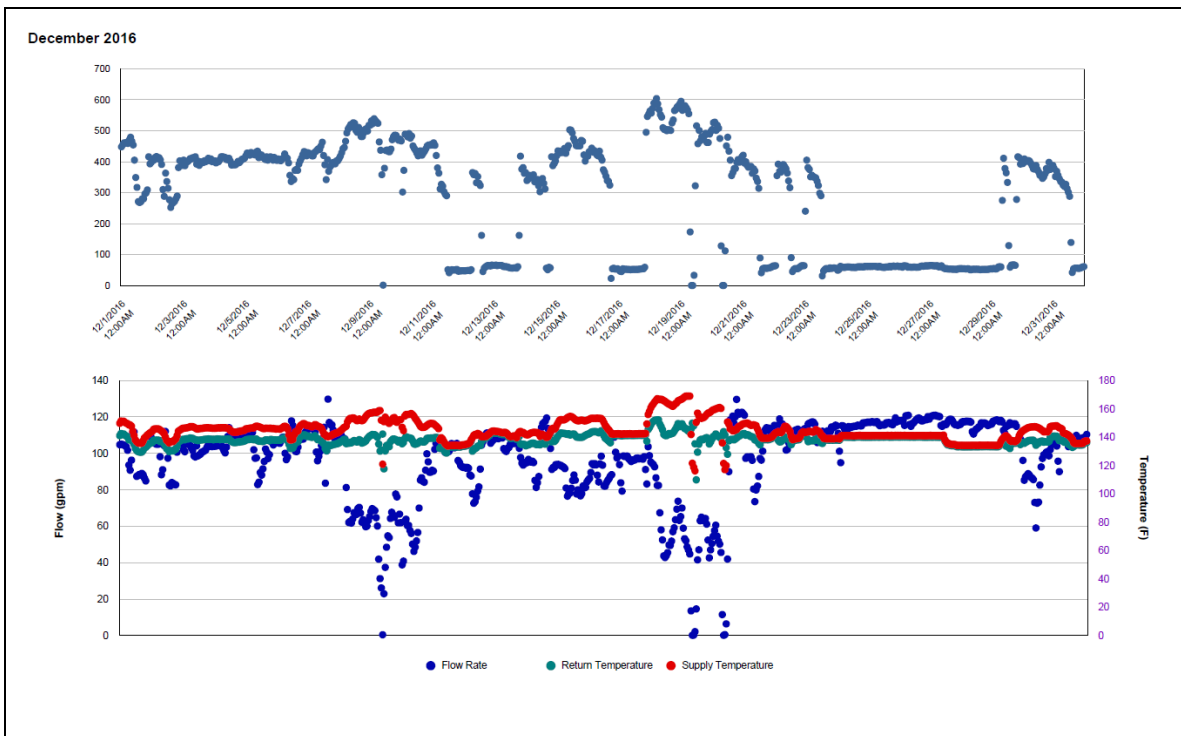
Explanatory Figure: Time series plots of MID 006917 hourly HHW energy consumption, flow, and supply/return temperatures from utilities office. (December 2016)

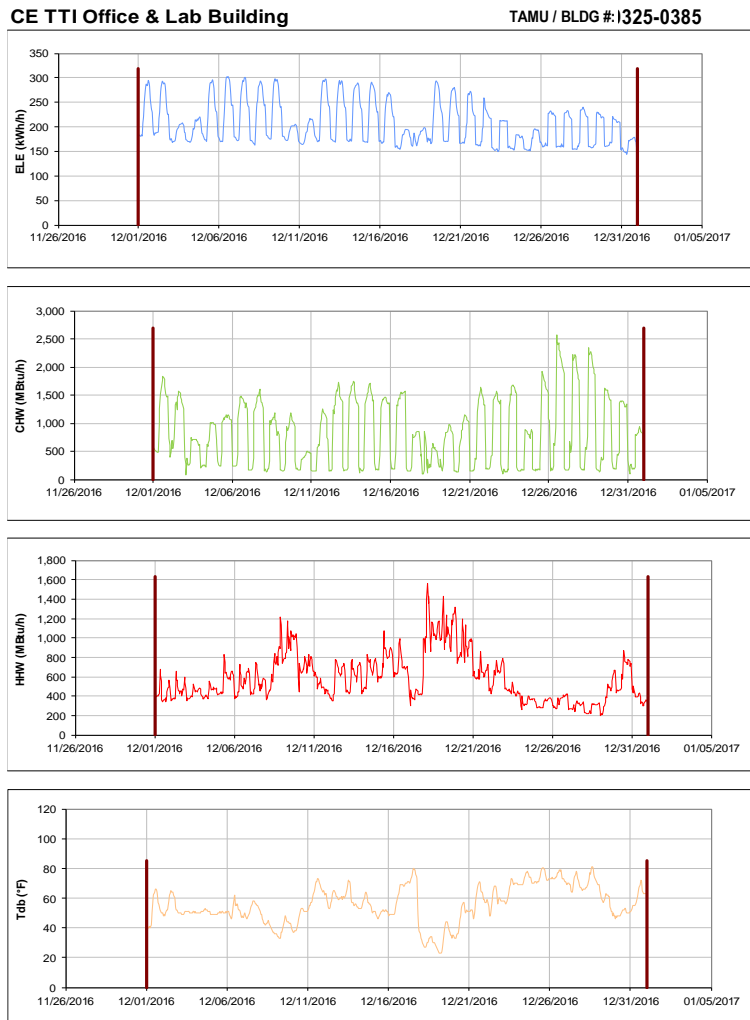
Figure III-9 Hourly Whole Building Electricity, Chilled Water, and Hot Water Consumption for CE TTI Office & Lab Building during the Month of December 2016 and the Corresponding Hourly Outdoor Dry Bulb Temperature for College Station, TX

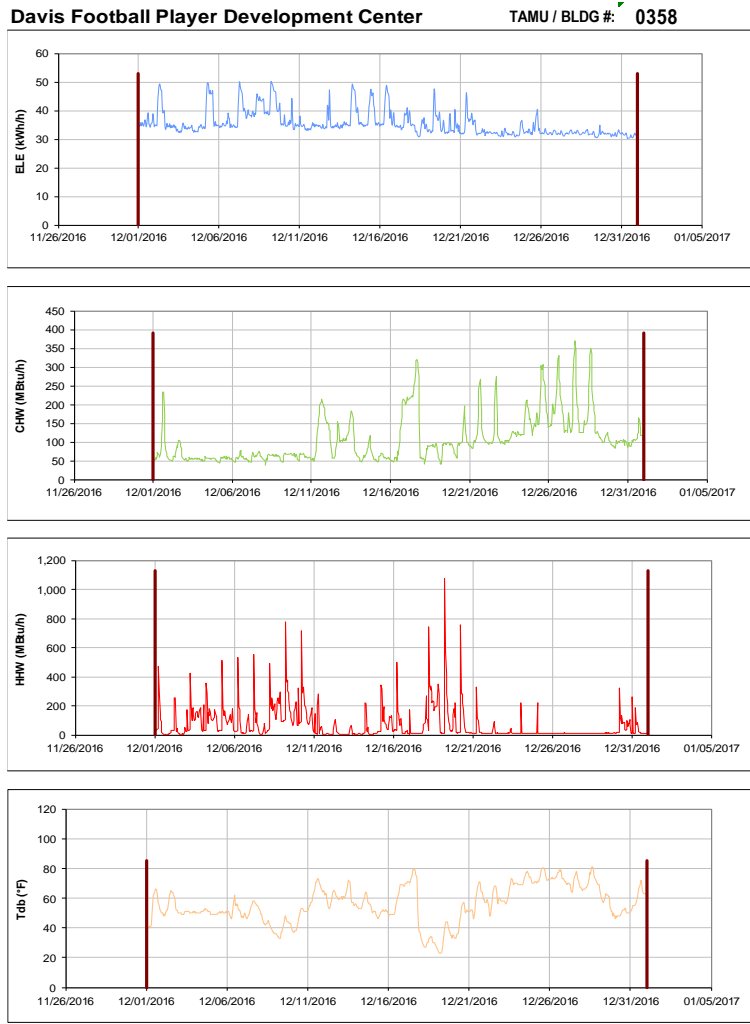
Figure III-11 Hourly Whole Building Electricity, Chilled Water, and Hot Water Consumption for Davis Football Player Development Center during the Month of December 2016 and the Corresponding Hourly Outdoor Dry Bulb Temperature for College Station, TX

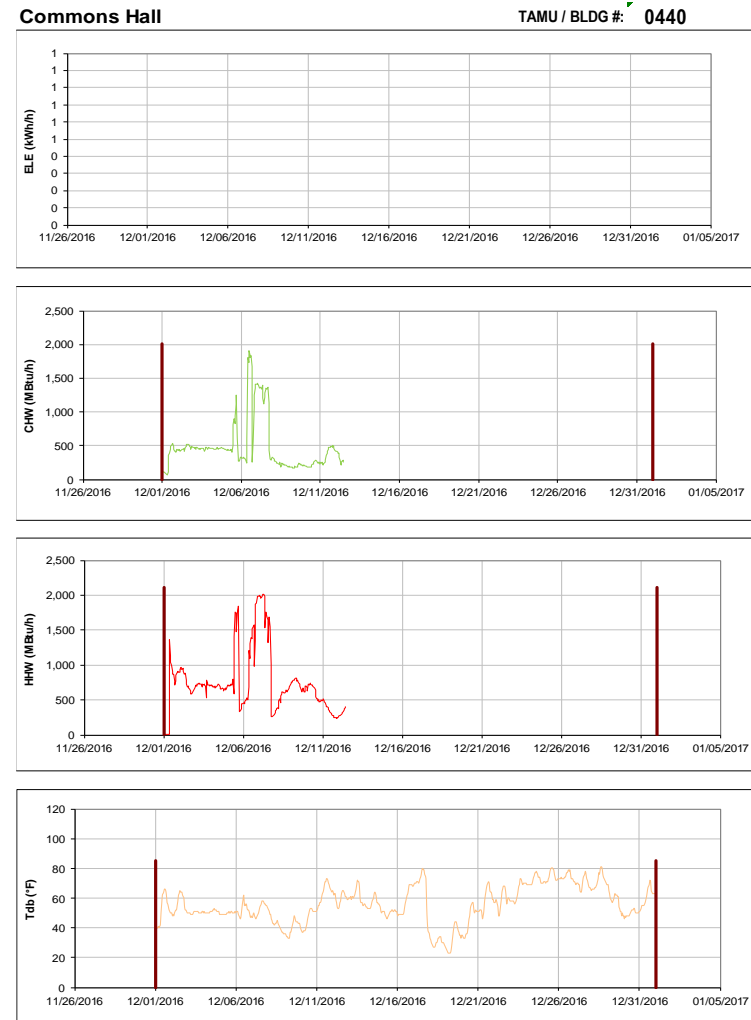
Figure III-52 Hourly Whole Building Electricity, Chilled Water, and Hot Water Consumption for Commons Hall during the Month of December 2016 and the Corresponding Hourly Outdoor Dry Bulb Temperature for College Station, TX

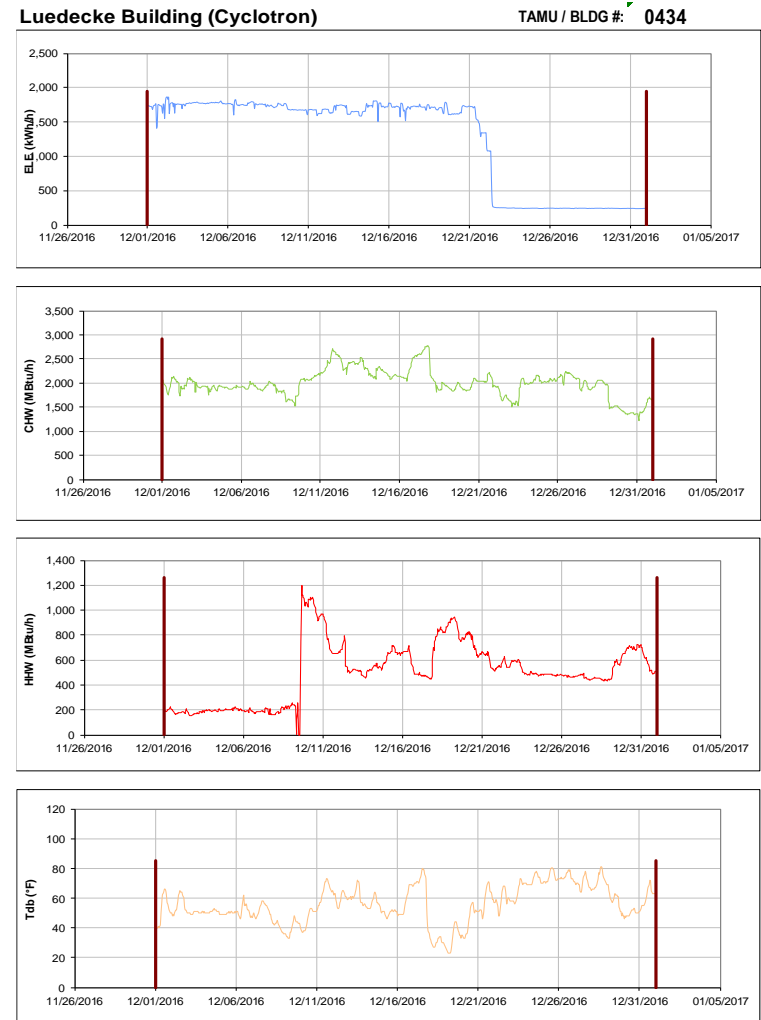
Figure III-56 Hourly Whole Building Electricity, Chilled Water, and Hot Water Consumption for Luedecke Building (Cyclotron) during the Month of December 2016 and the Corresponding Hourly Outdoor Dry Bulb Temperature for College Station, TX

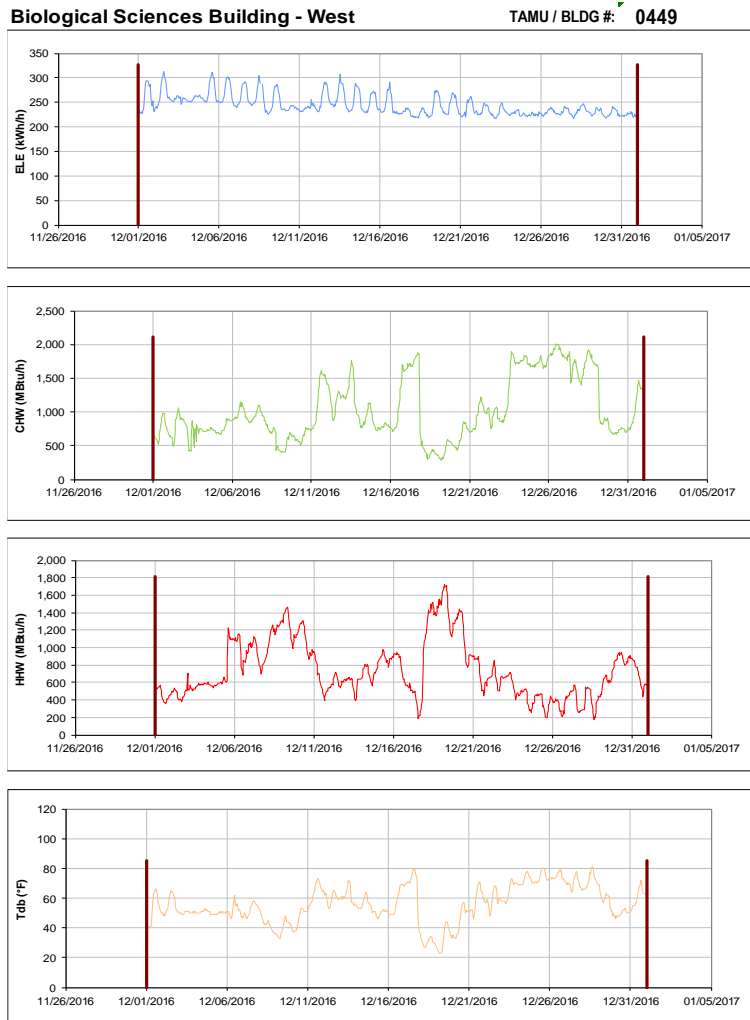
Figure III-71 Hourly Whole Building Electricity, Chilled Water, and Hot Water Consumption for Biological Sciences Building - West during the Month of December 2016 and the Corresponding Hourly Outdoor Dry Bulb Temperature for College Station, TX

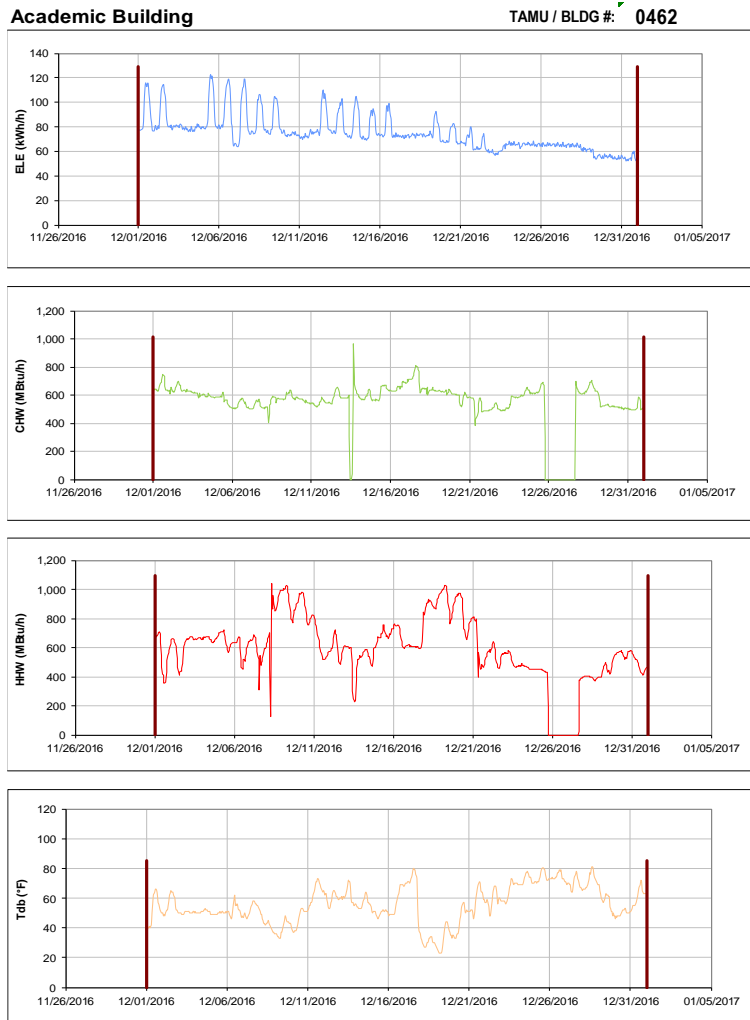
Figure III-77 Hourly Whole Building Electricity, Chilled Water, and Hot Water Consumption for Academic Building during the Month of December 2016 and the Corresponding Hourly Outdoor Dry Bulb Temperature for College Station, TX

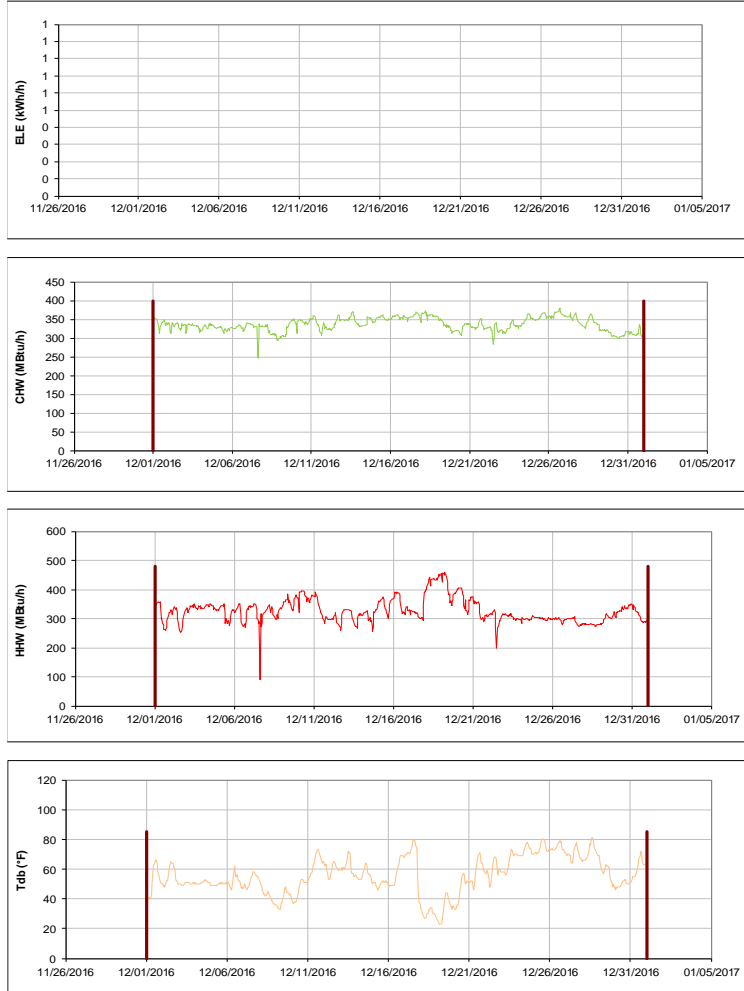
TAMU / BLDG #: 0481

Figure III-93 Hourly Whole Building Electricity, Chilled Water, and Hot Water Consumption for Heaton Hall during the Month of December 2016 and the Corresponding Hourly Outdoor Dry Bulb Temperature for College Station, TX

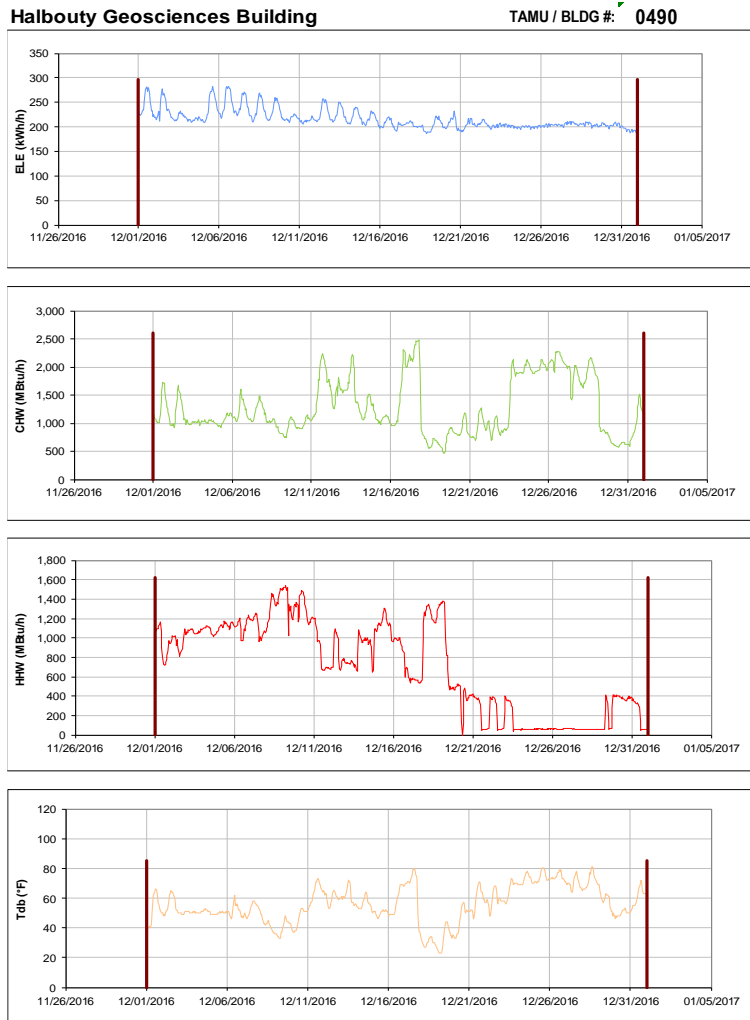
Figure III-97 Hourly Whole Building Electricity, Chilled Water, and Hot Water Consumption for Halbutoy Geosciences Building during the Month of December 2016 and the Corresponding Hourly Outdoor Dry Bulb Temperature for College Station, TX

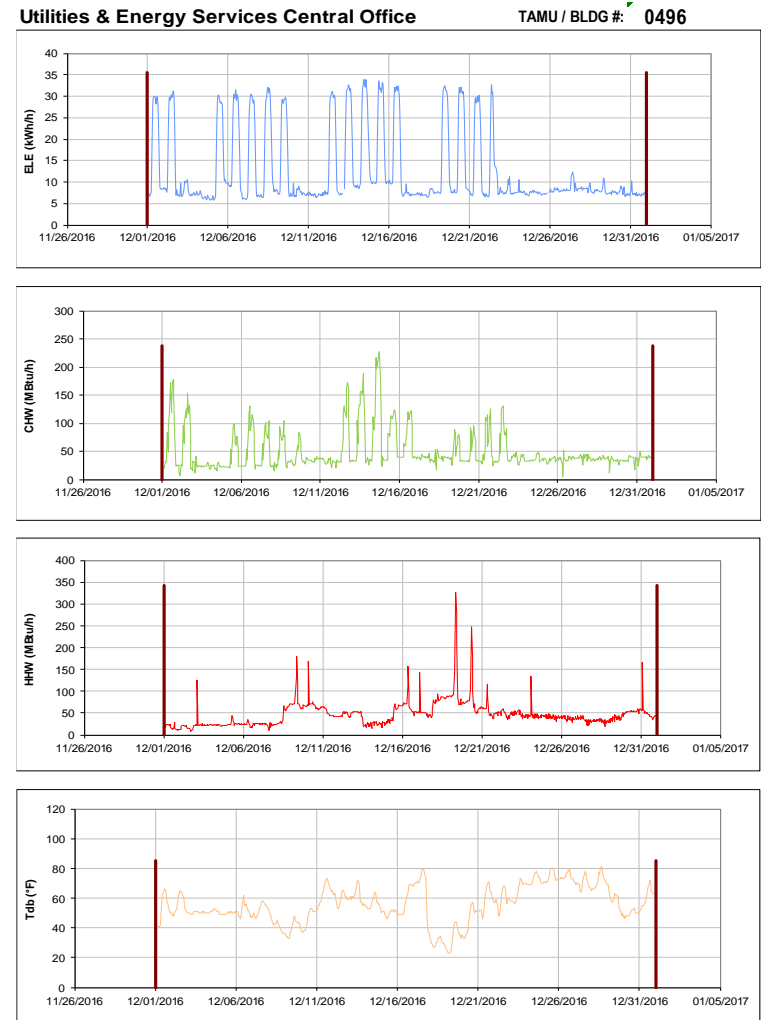
Figure III-100 Hourly Whole Building Electricity, Chilled Water, and Hot Water Consumption for Utilities & Energy Services Central Office during the Month of December 2016 and the Corresponding Hourly Outdoor Dry Bulb Temperature for College Station, TX

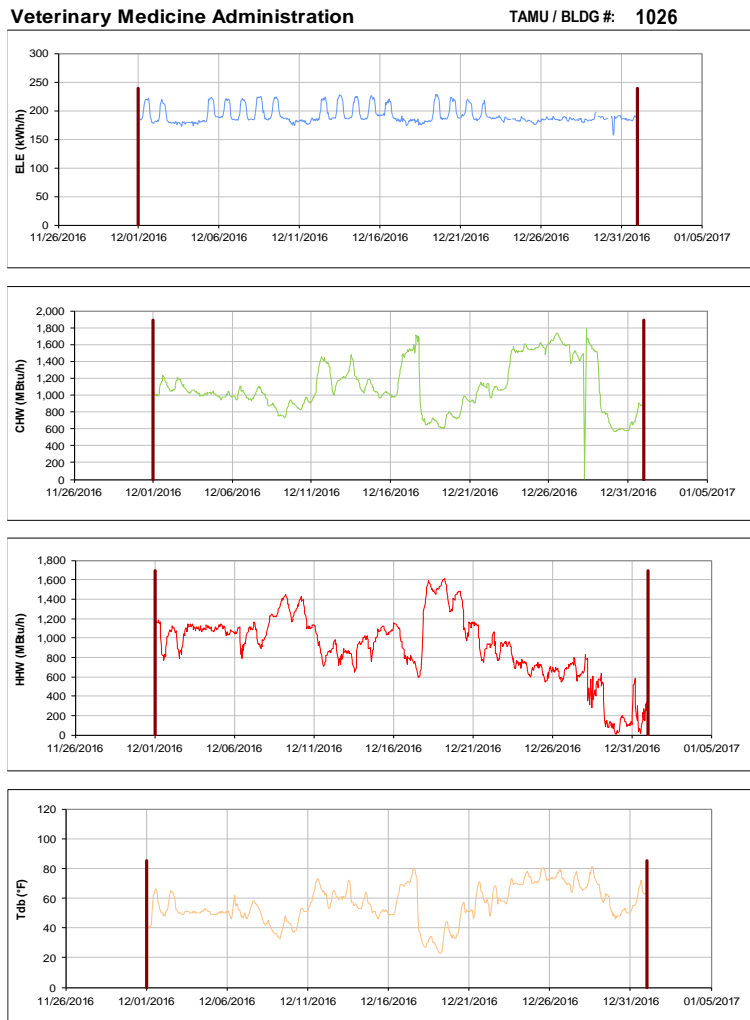
Figure III-105 Hourly Whole Building Electricity, Chilled Water, and Hot Water Consumption for Veterinary Medicine Administration during the Month of December 2016 and the Corresponding Hourly Outdoor Dry Bulb Temperature for College Station, TX

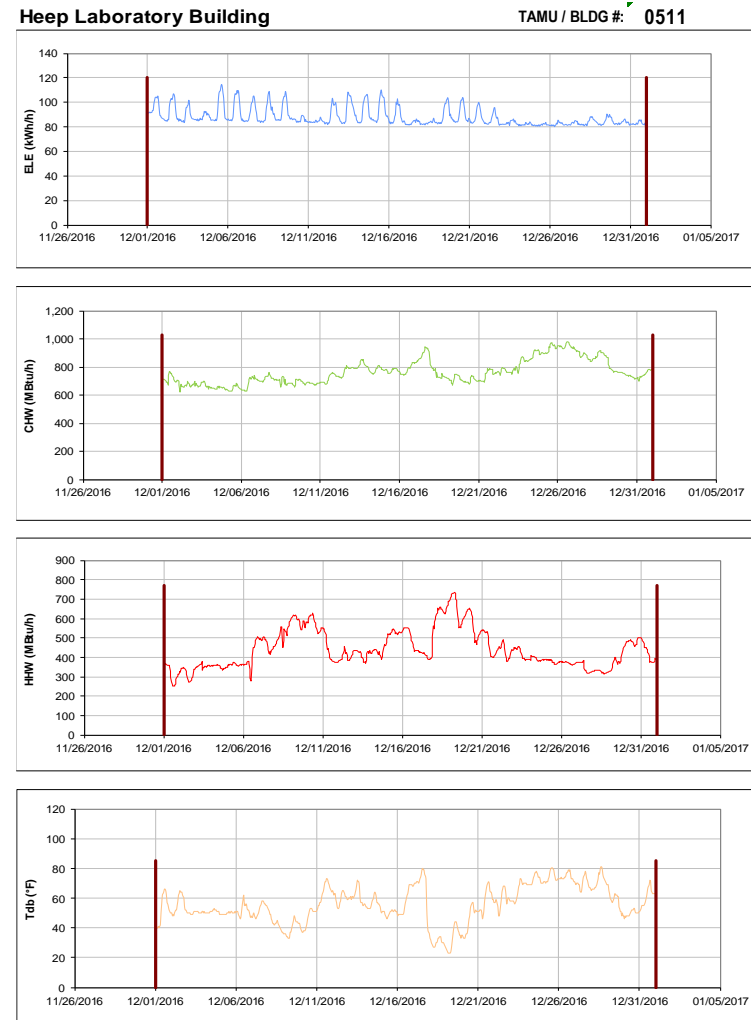
Figure III-106 Hourly Whole Building Electricity, Chilled Water, and Hot Water Consumption for Heep Laboratory Building during the Month of December 2016 and the Corresponding Hourly Outdoor Dry Bulb Temperature for College Station, TX

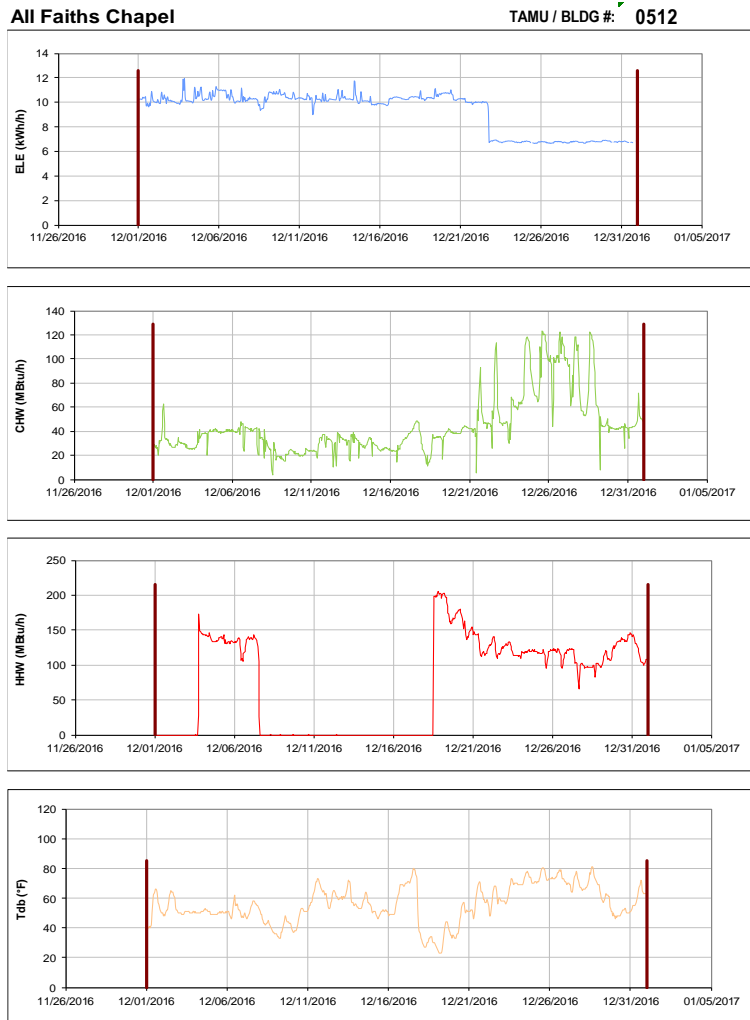
Figure III-107 Hourly Whole Building Electricity, Chilled Water, and Hot Water Consumption for All Faiths Chapel during the Month of December 2016 and the Corresponding Hourly Outdoor Dry Bulb Temperature for College Station, TX

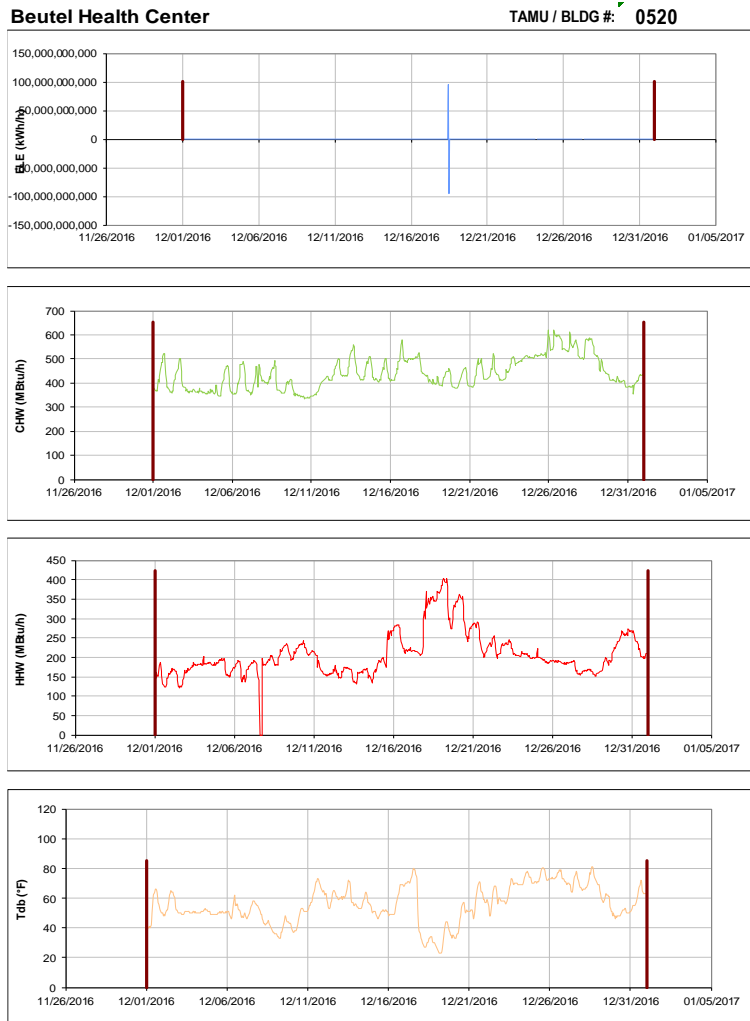
Figure III-111 Hourly Whole Building Electricity, Chilled Water, and Hot Water Consumption for Beutel Health Center during the Month of December 2016 and the Corresponding Hourly Outdoor Dry Bulb Temperature for College Station, TX

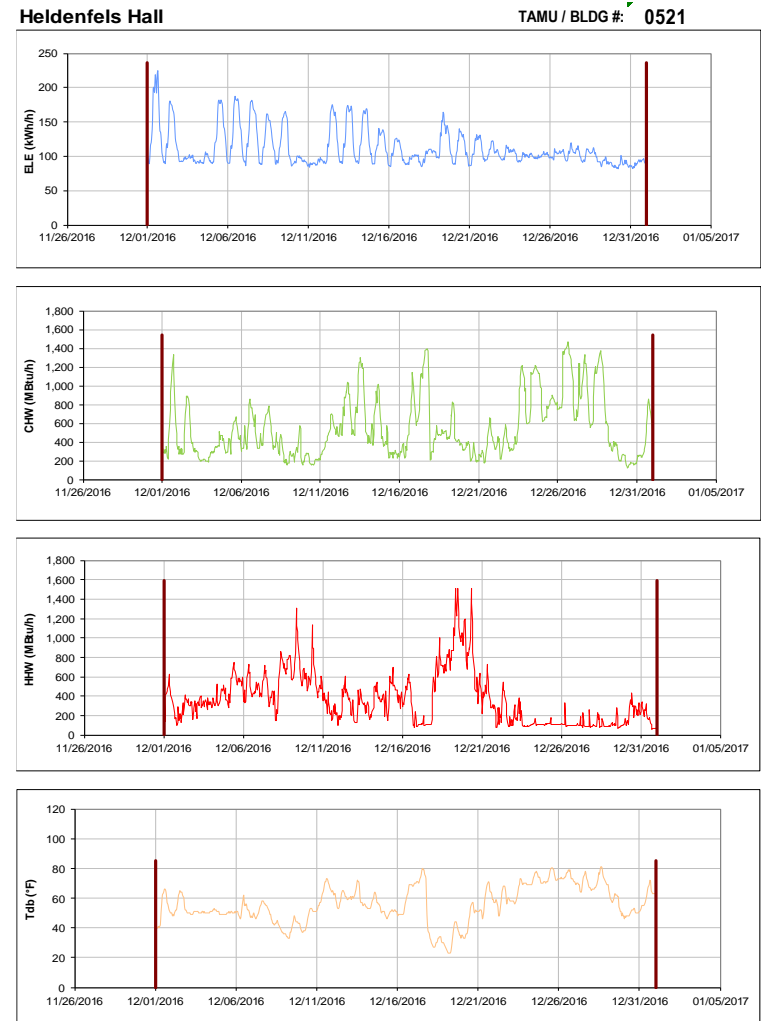
Figure III-112 Hourly Whole Building Electricity, Chilled Water, and Hot Water Consumption for Heldenfels Hall during the Month of December 2016 and the Corresponding Hourly Outdoor Dry Bulb Temperature for College Station, TX

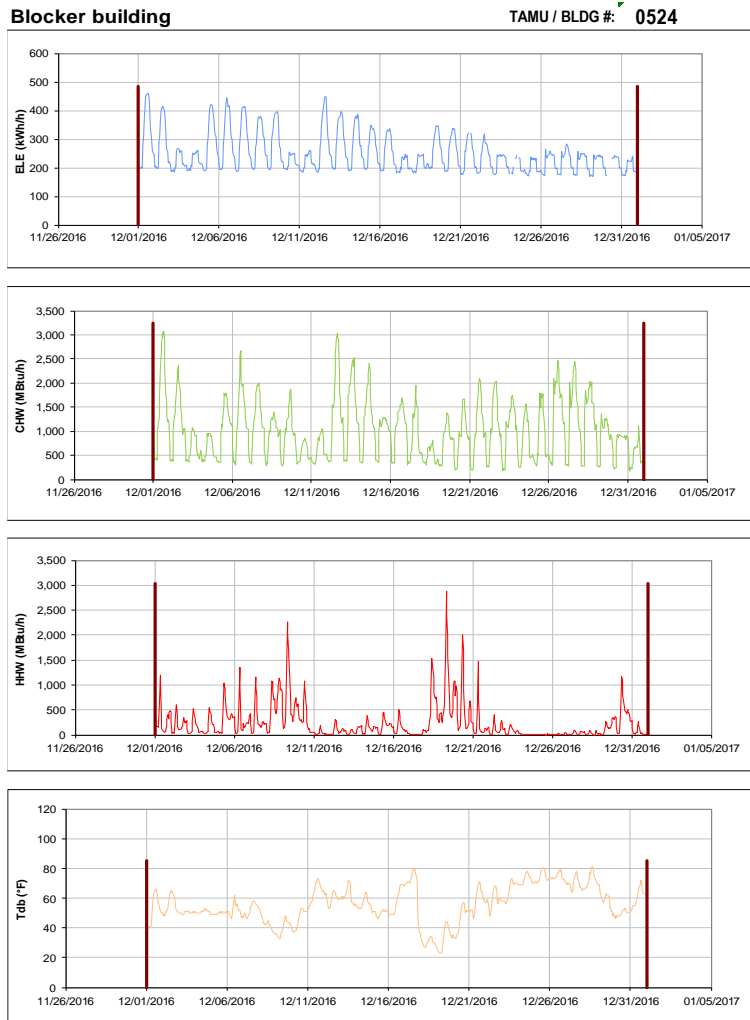
Figure III-113 Hourly Whole Building Electricity, Chilled Water, and Hot Water Consumption for Blocker building during the Month of December 2016 and the Corresponding Hourly Outdoor Dry Bulb Temperature for College Station, TX

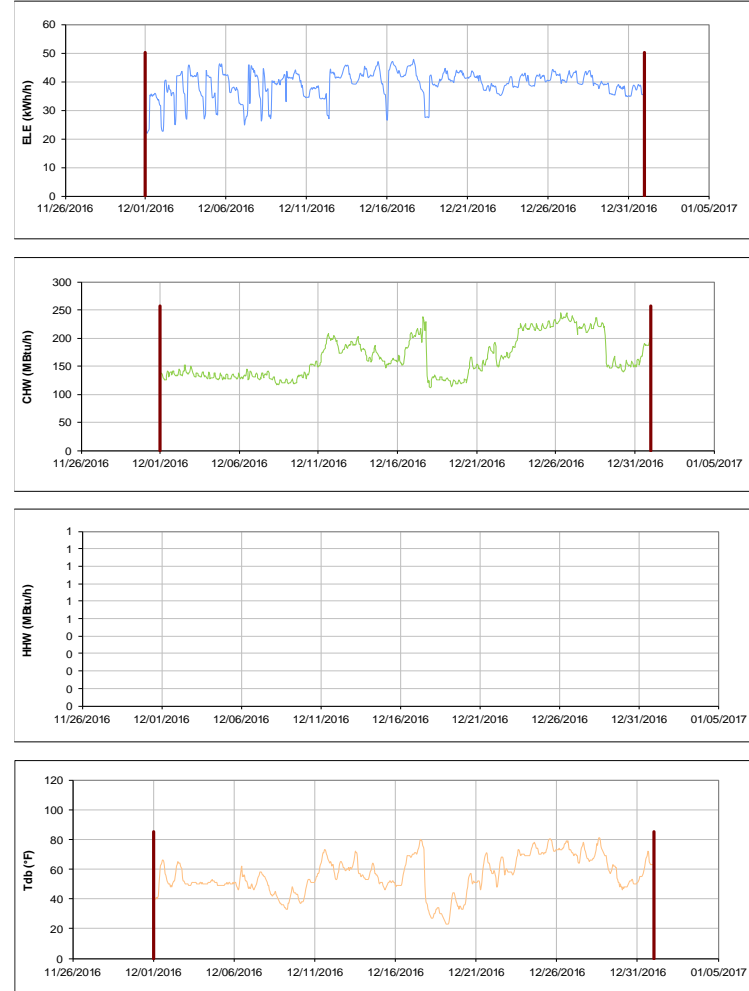
TAMU / BLDG #: 0815

Figure III-122 Hourly Whole Building Electricity, Chilled Water, and Hot Water Consumption for Entomology Research Lab during the Month of December 2016 and the Corresponding Hourly Outdoor Dry Bulb Temperature for College Station, TX

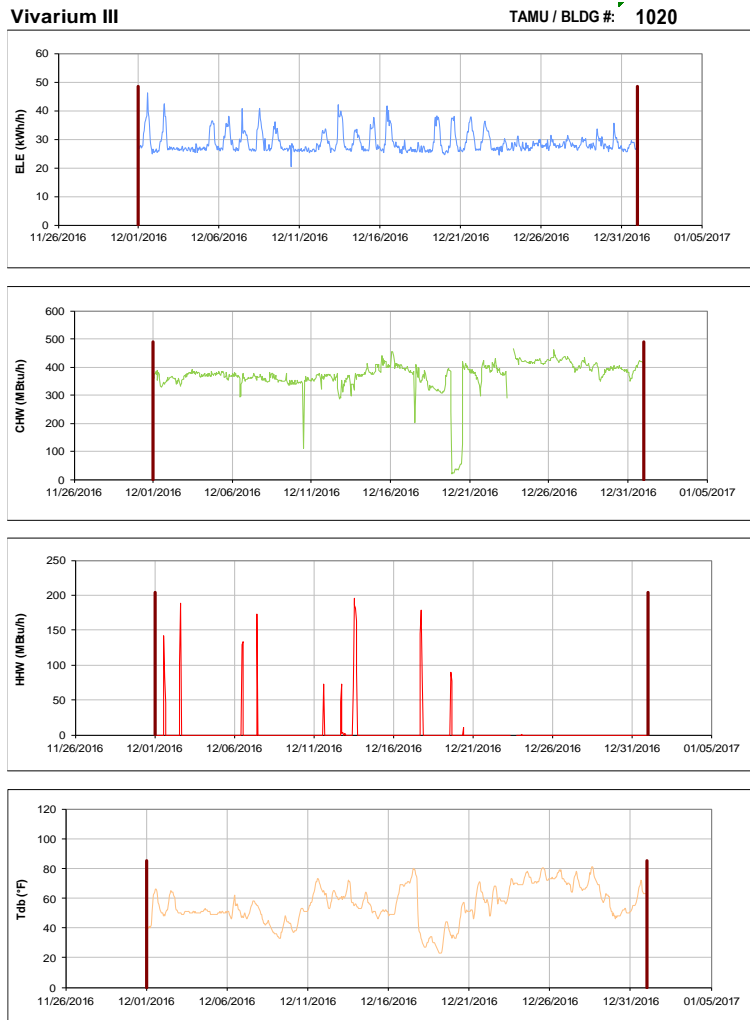
Figure III-125 Hourly Whole Building Electricity, Chilled Water, and Hot Water Consumption for Vivarium III during the Month of December 2016 and the Corresponding Hourly Outdoor Dry Bulb Temperature for College Station, TX

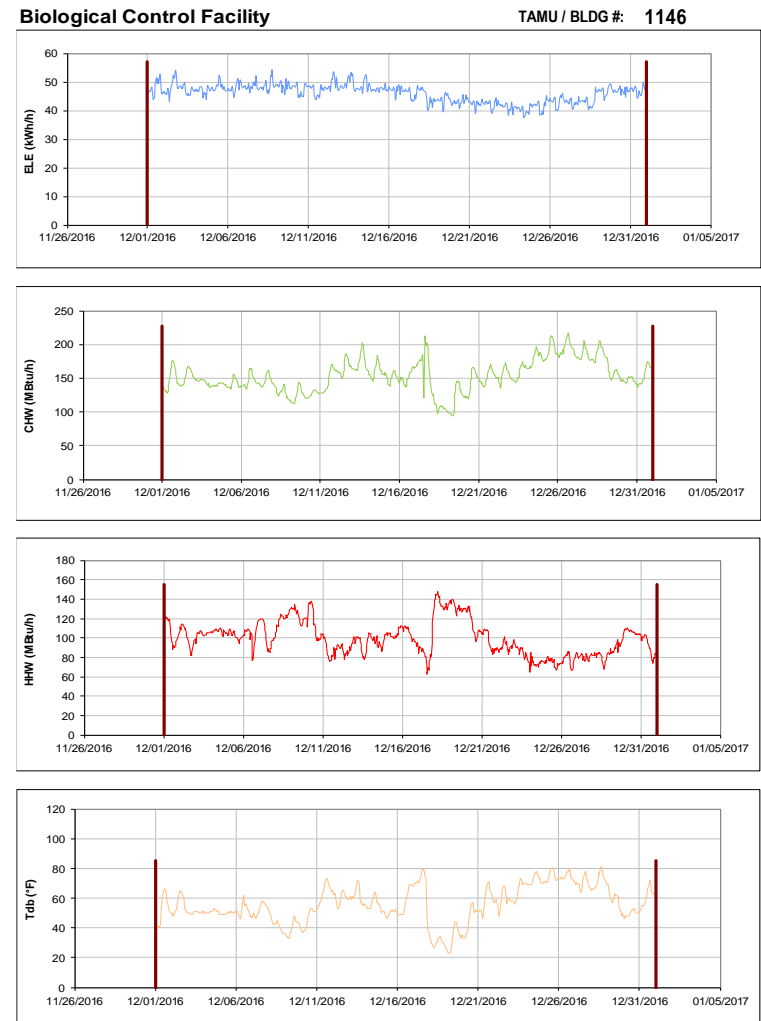
Figure III-130 Hourly Whole Building Electricity, Chilled Water, and Hot Water Consumption for Biological Control Facility during the Month of December 2016 and the Corresponding Hourly Outdoor Dry Bulb Temperature for College Station, TX

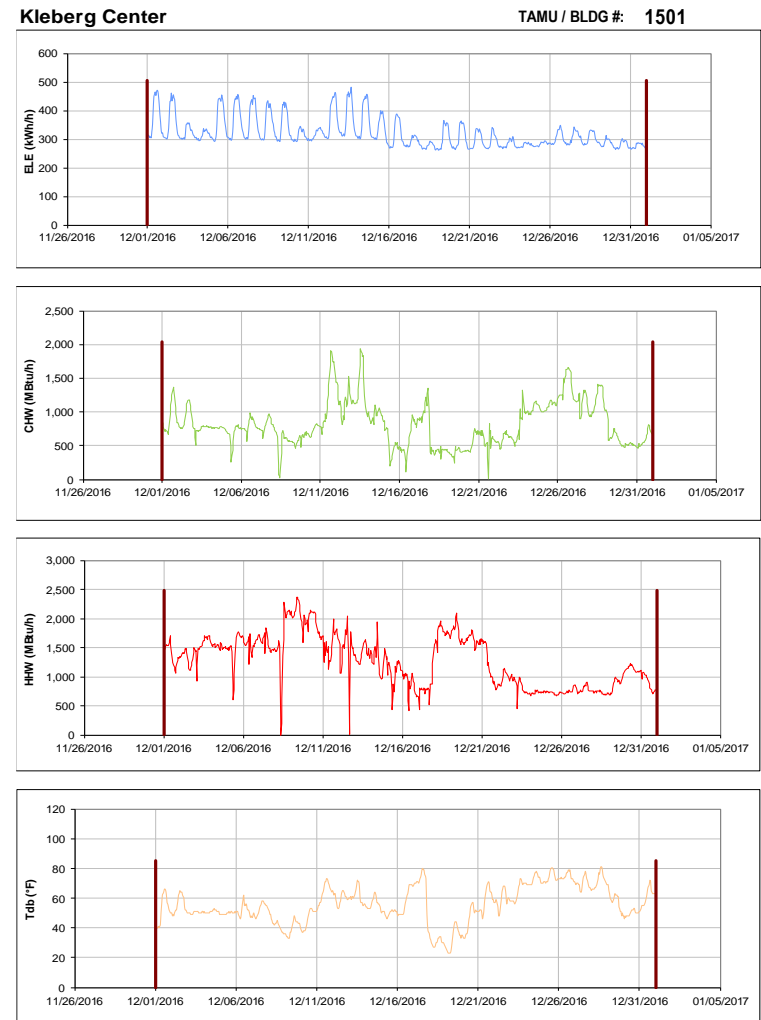
Figure III-148 Hourly Whole Building Electricity, Chilled Water, and Hot Water Consumption for Kleberg Center during the Month of December 2016 and the Corresponding Hourly Outdoor Dry Bulb Temperature for College Station, TX

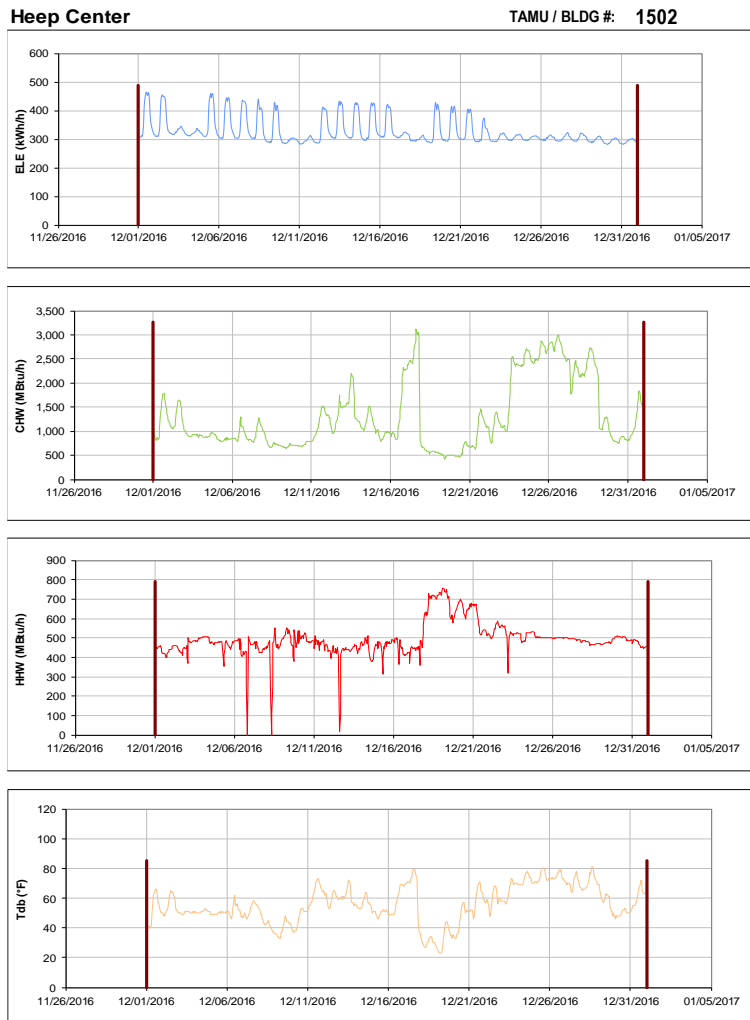
Figure III-149 Hourly Whole Building Electricity, Chilled Water, and Hot Water Consumption for Heep Center during the Month of December 2016 and the Corresponding Hourly Outdoor Dry Bulb Temperature for College Station, TX

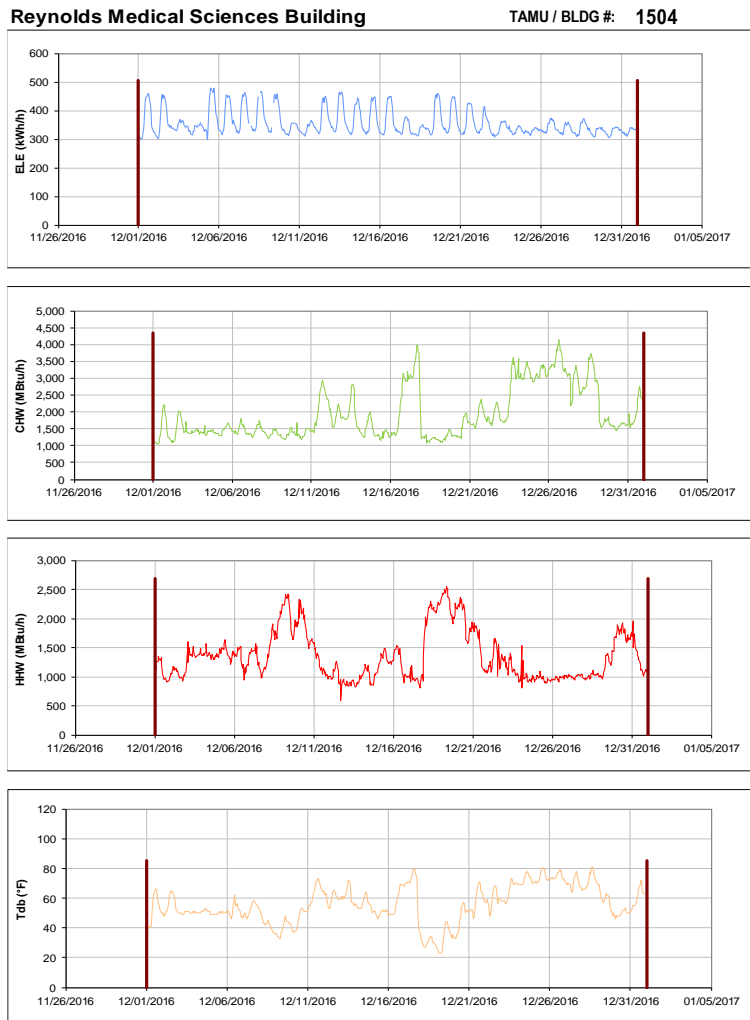
Figure III-151 Hourly Whole Building Electricity, Chilled Water, and Hot Water Consumption for Reynolds Medical Sciences Building during the Month of December 2016 and the Corresponding Hourly Outdoor Dry Bulb Temperature for College Station, TX

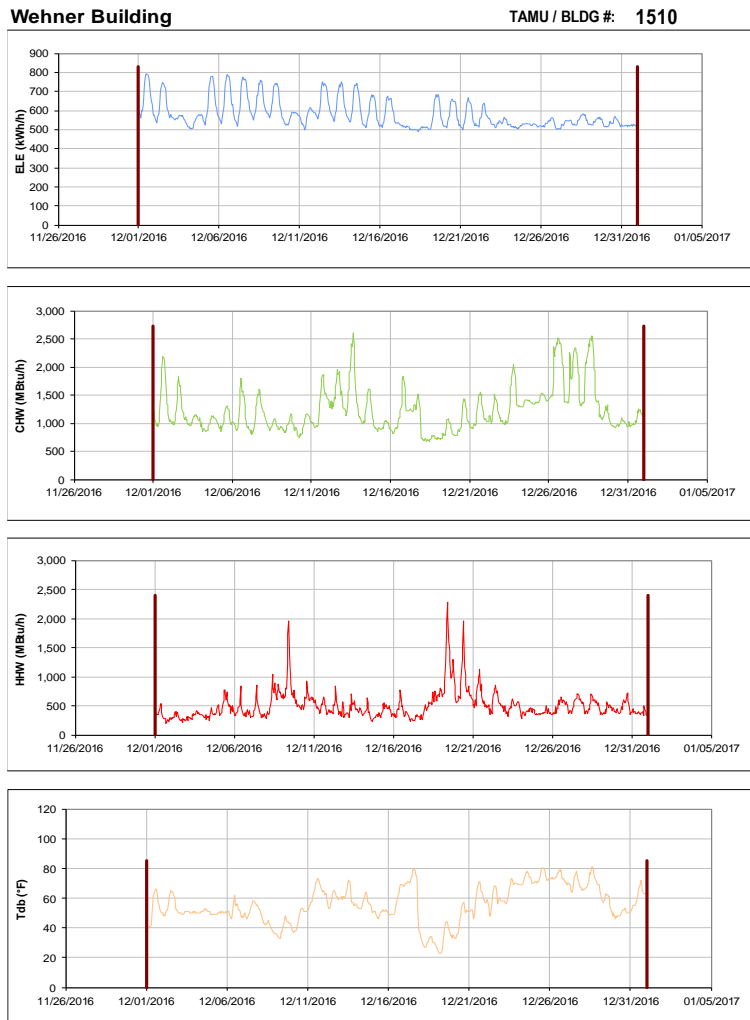
Figure III-157 Hourly Whole Building Electricity, Chilled Water, and Hot Water Consumption for Wehner Building during the Month of December 2016 and the Corresponding Hourly Outdoor Dry Bulb Temperature for College Station, TX

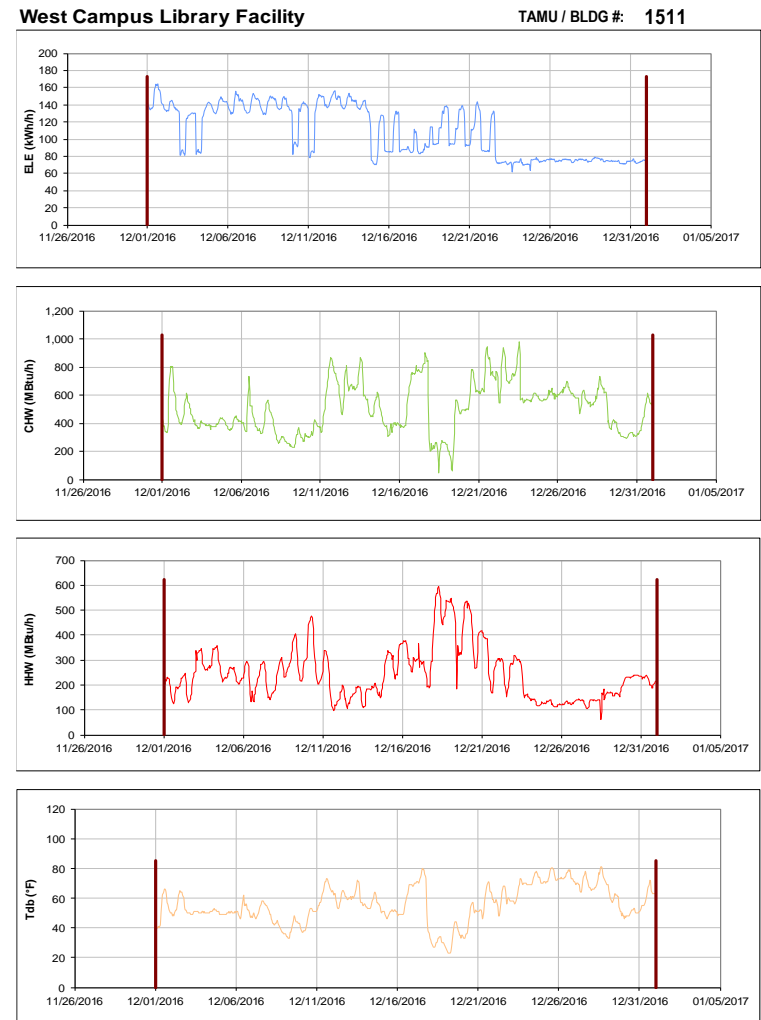
Figure III-158 Hourly Whole Building Electricity, Chilled Water, and Hot Water Consumption for West Campus Library Facility during the Month of December 2016 and the Corresponding Hourly Outdoor Dry Bulb Temperature for College Station, TX

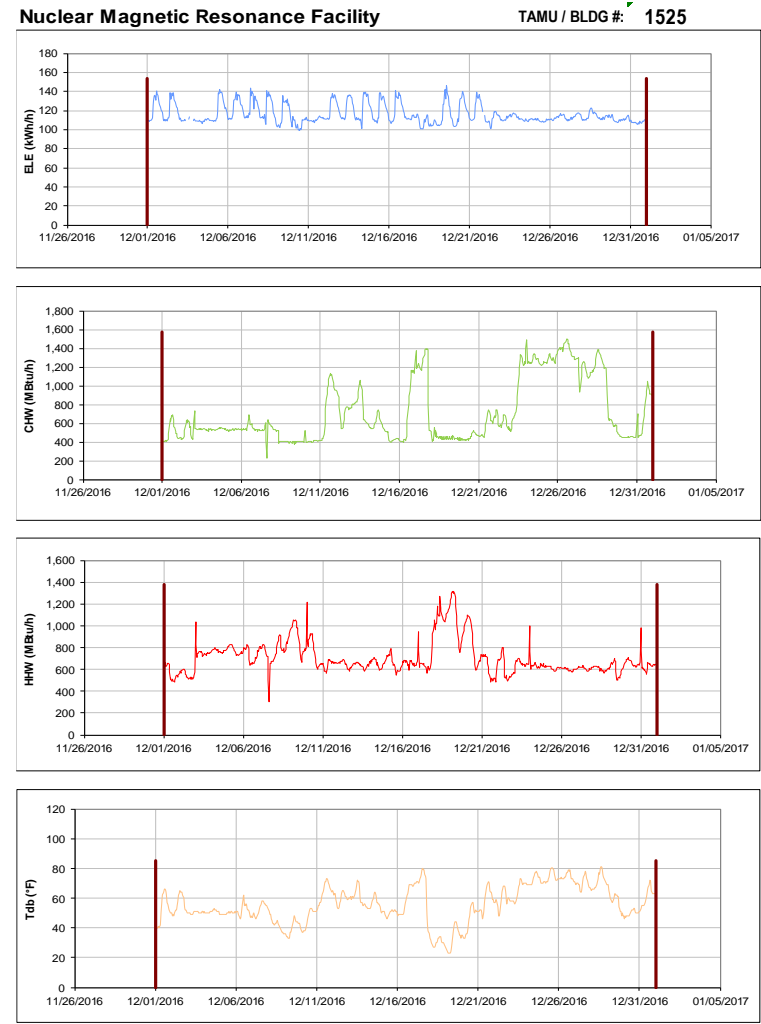
Figure III-162 Hourly Whole Building Electricity, Chilled Water, and Hot Water Consumption for Nuclear Magnetic Resonance Facility during the Month of December 2016 and the Corresponding Hourly Outdoor Dry Bulb Temperature for College Station, TX

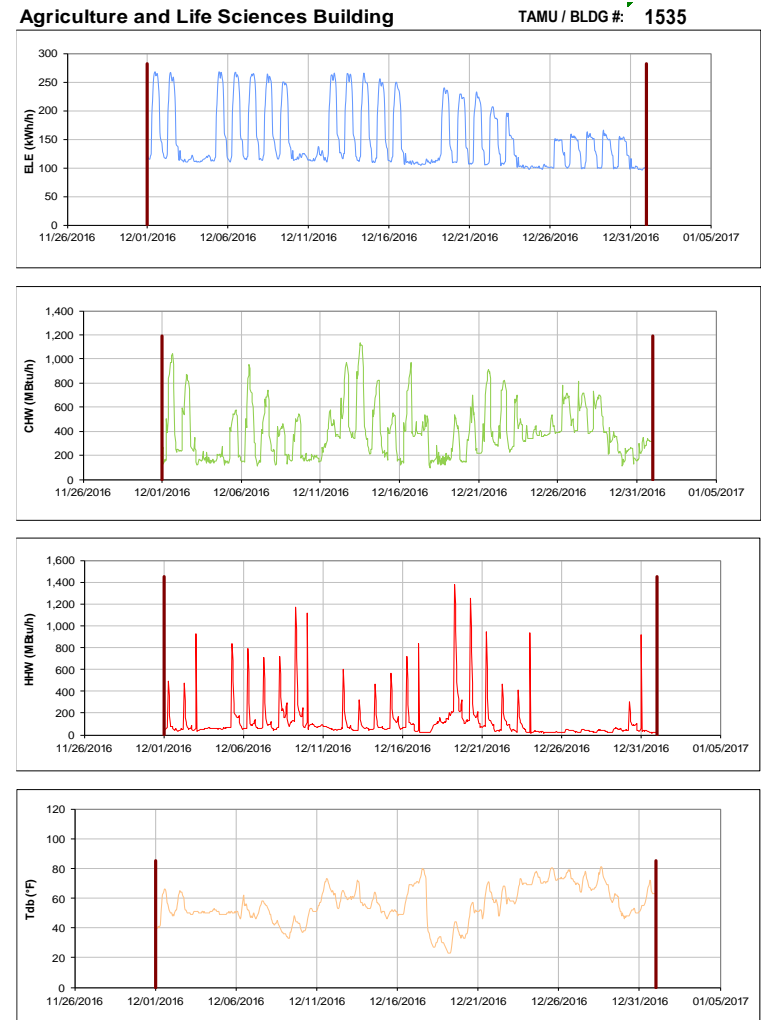
Figure III-164 Hourly Whole Building Electricity, Chilled Water, and Hot Water Consumption for Agriculture and Life Sciences Building during the Month of December 2016 and the Corresponding Hourly Outdoor Dry Bulb Temperature for College Station, TX

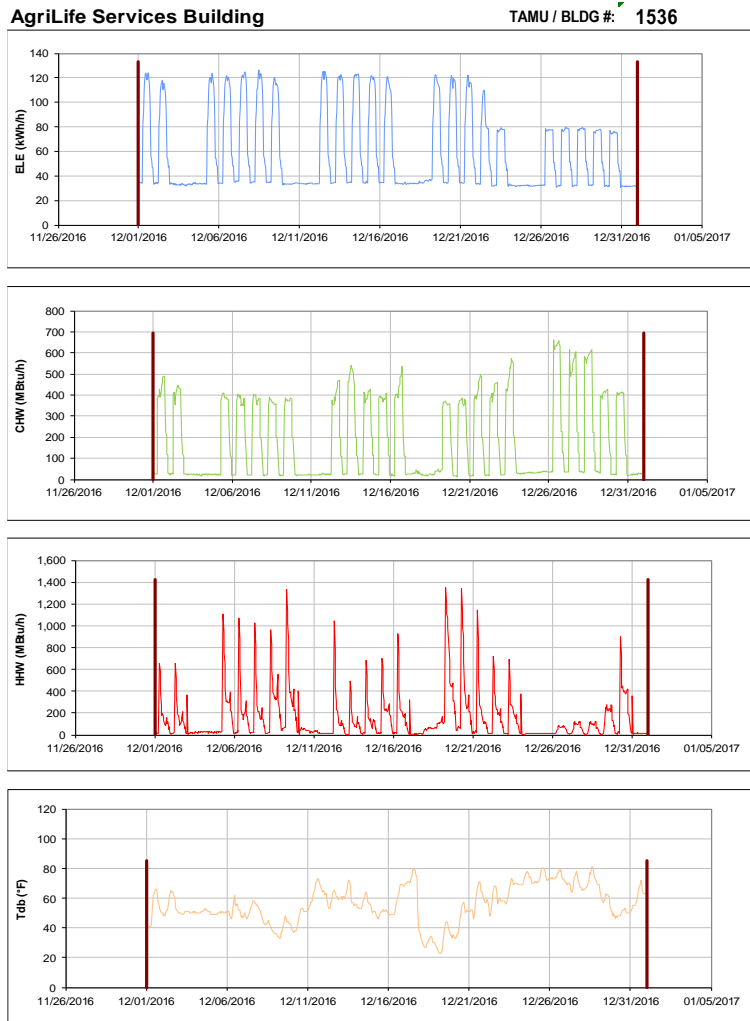
Figure III-165 Hourly Whole Building Electricity, Chilled Water, and Hot Water Consumption for AgriLife Services Building during the Month of December 2016 and the Corresponding Hourly Outdoor Dry Bulb Temperature for College Station, TX
