TAMU Project

**Energy Consumption Data Quality Assurance/Quality
Control Assessment Report for the
Month of December 2016**

**Utility & Energy Services
Division of Administration
Texas A&M University**

January 2017

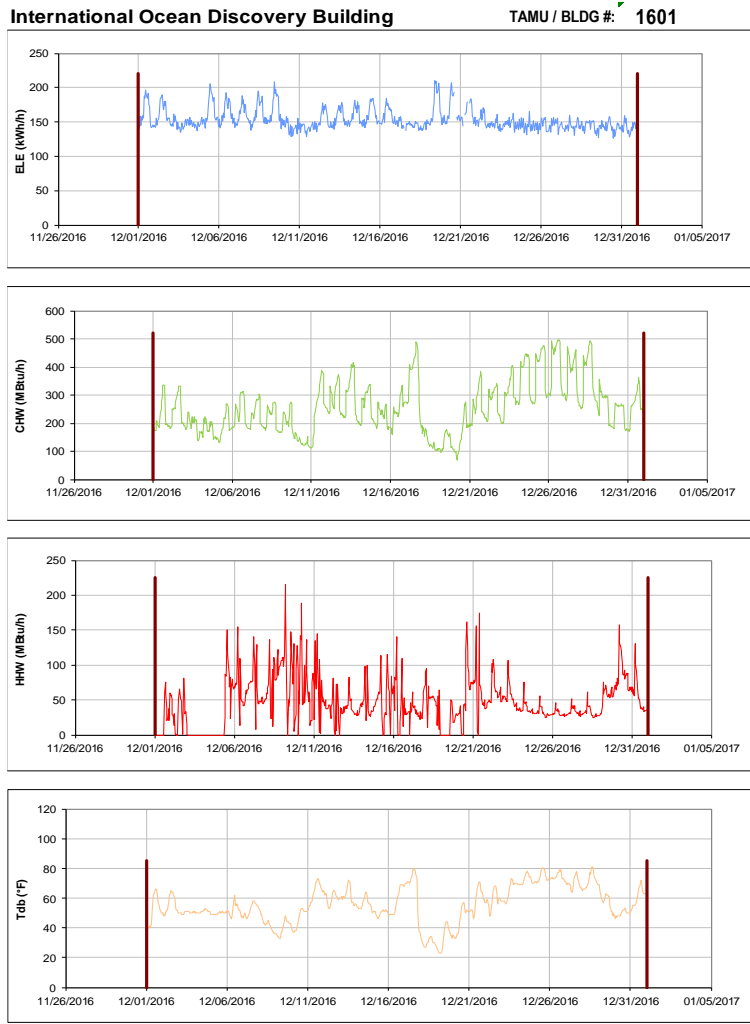
Figure III-179 Hourly Whole Building Electricity, Chilled Water, and Hot Water Consumption for International Ocean Discovery Building during the Month of December 2016 and the Corresponding Hourly Outdoor Dry Bulb Temperature for College Station, TX

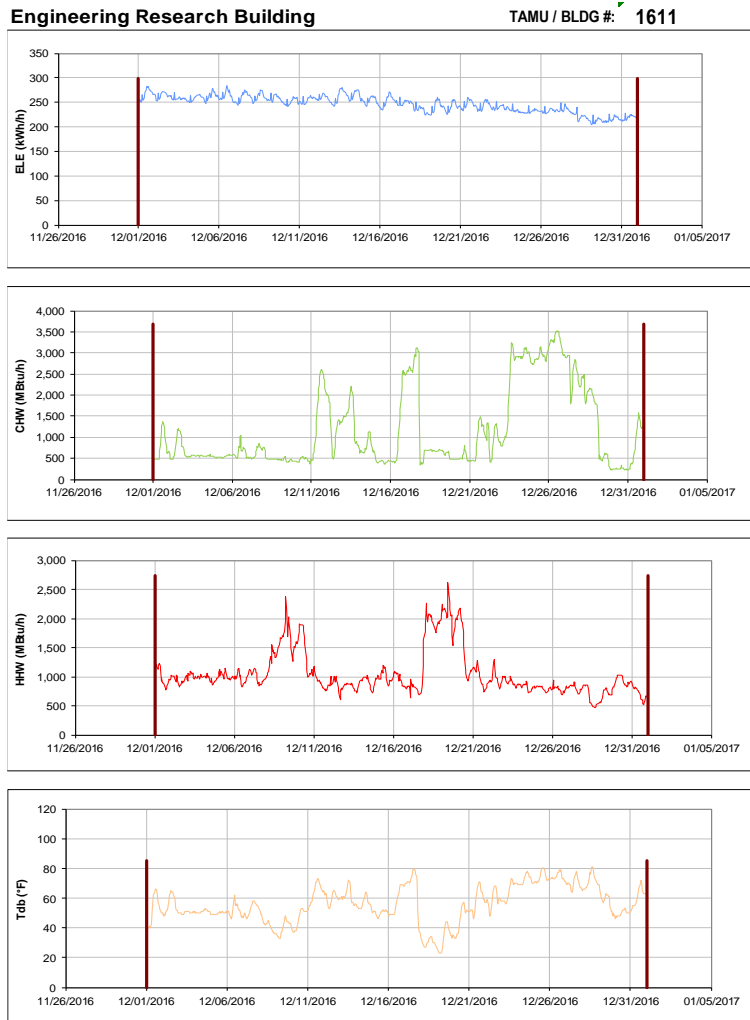
Figure III-185 Hourly Whole Building Electricity, Chilled Water, and Hot Water Consumption for Engineering Research Building during the Month of December 2016 and the Corresponding Hourly Outdoor Dry Bulb Temperature for College Station, TX

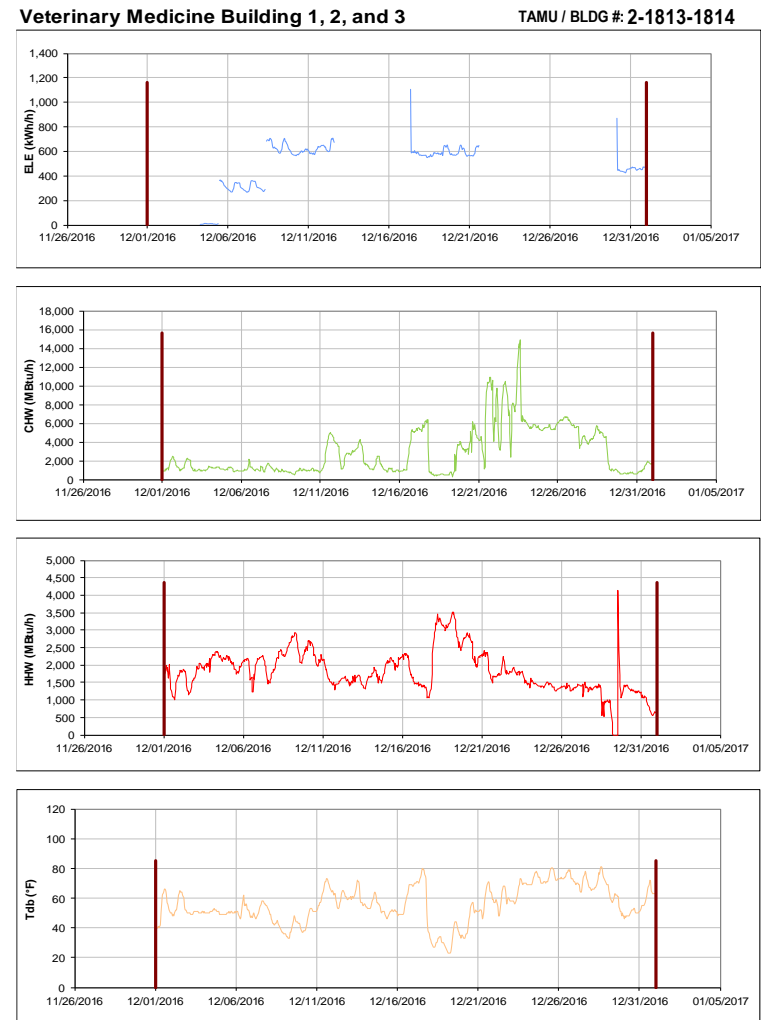
Figure III-190 Hourly Whole Building Electricity, Chilled Water, and Hot Water Consumption for Veterinary Medicine Building 1, 2, and 3 during the Month of December 2016 and the Corresponding Hourly Outdoor Dry Bulb Temperature for College Station, TX

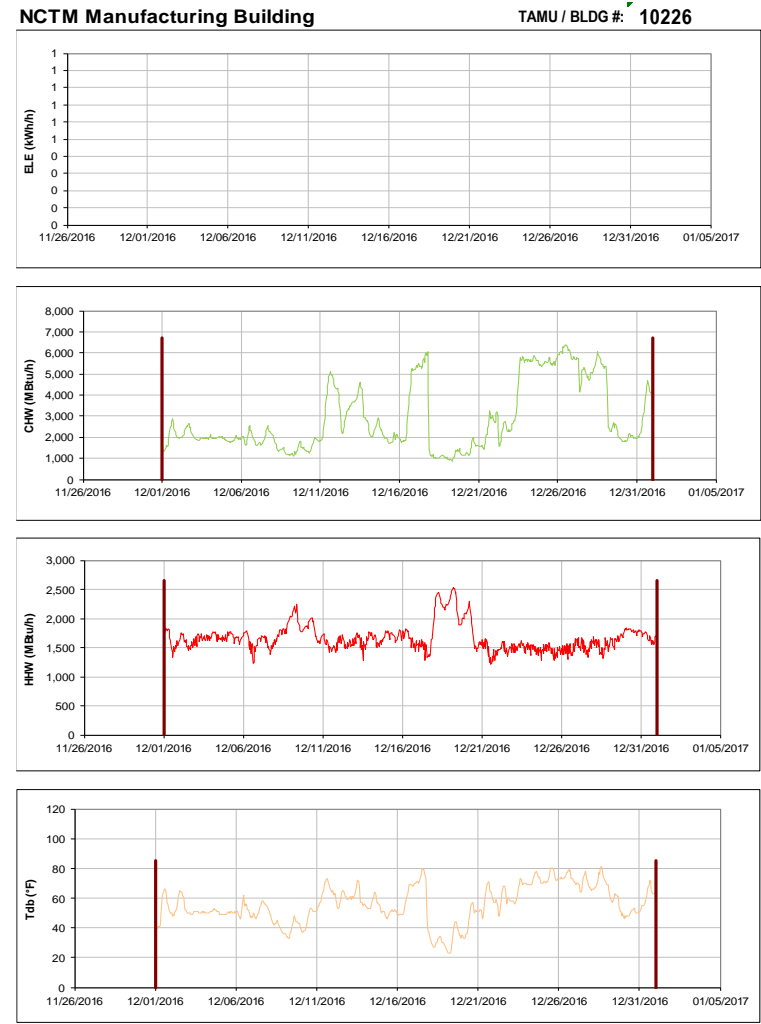
Figure III-196 Hourly Whole Building Electricity, Chilled Water, and Hot Water Consumption for NCTM Manufacturing Building during the Month of December 2016 and the Corresponding Hourly Outdoor Dry Bulb Temperature for College Station, TX
