TAMU Project

**Energy Consumption Data Quality Assurance/Quality
Control Assessment Report for the
Month of May 2017**

**Utility & Energy Services
Division of Administration
Texas A&M University**

June 2017

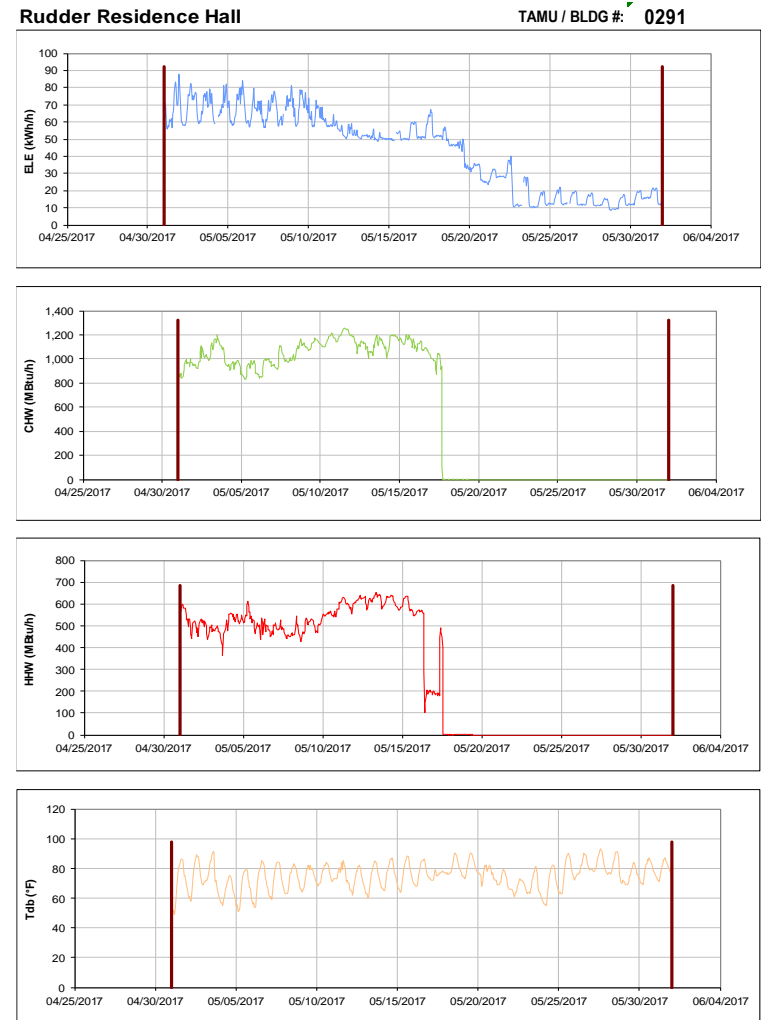
Figure III-4 Hourly Whole Building Electricity, Chilled Water, and Hot Water Consumption for Rudder Residence Hall during the Month of May 2017 and the Corresponding Hourly Outdoor Dry Bulb Temperature for College Station, TX

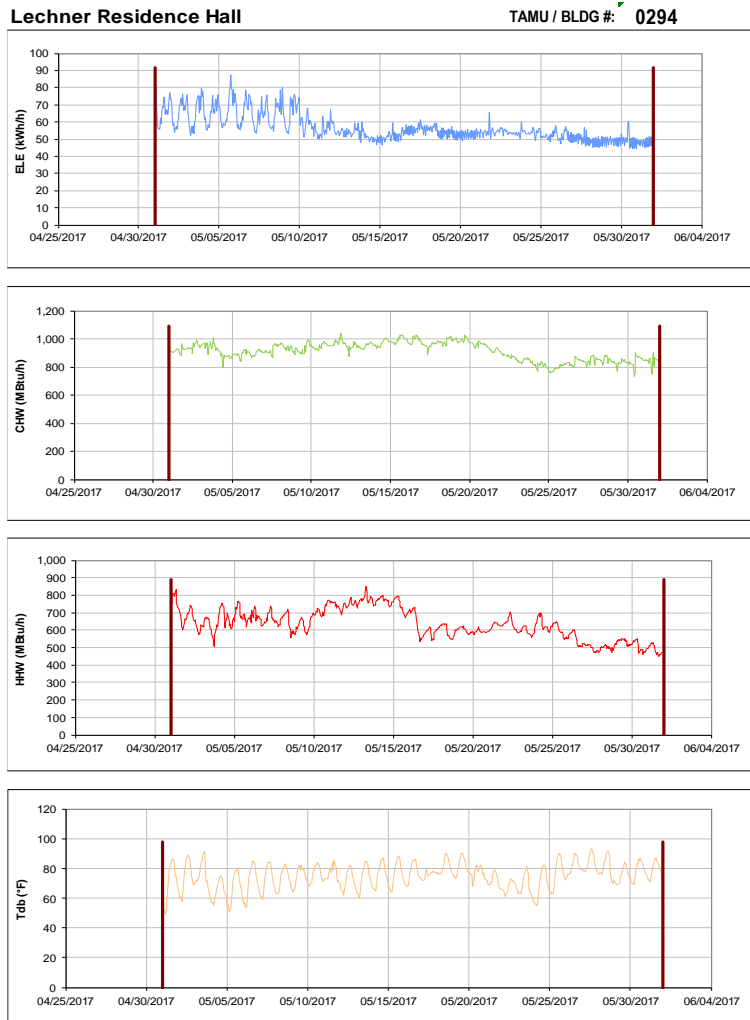
Figure III-7 Hourly Whole Building Electricity, Chilled Water, and Hot Water Consumption for Lechner Residence Hall during the Month of May 2017 and the Corresponding Hourly Outdoor Dry Bulb Temperature for College Station, TX

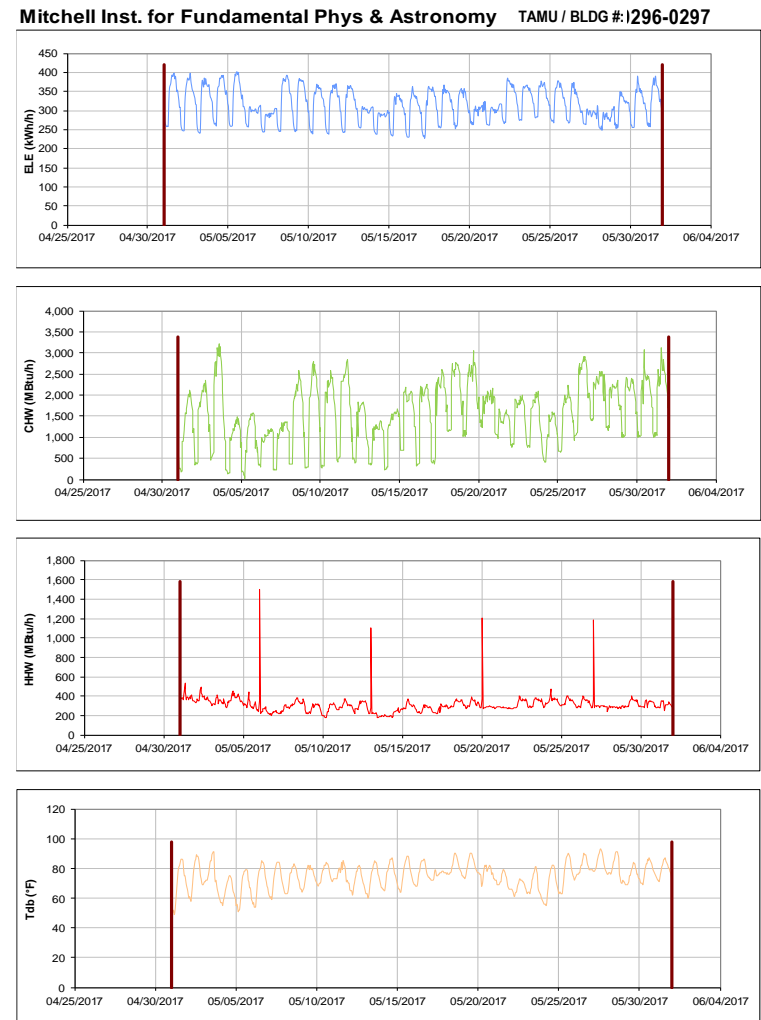
Figure III-8 Hourly Whole Building Electricity, Chilled Water, and Hot Water Consumption for Mitchell Inst. for Fundamental Phys & Astronomy during the Month of May 2017 and the Corresponding Hourly Outdoor Dry Bulb Temperature for College Station, TX

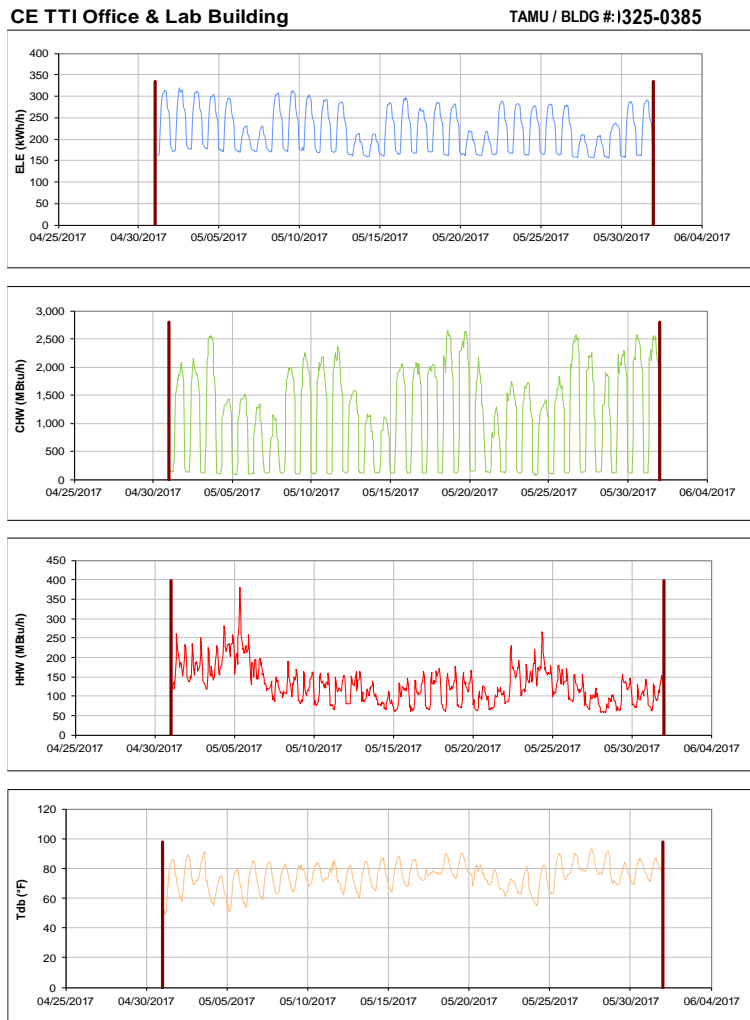
Figure III-9 Hourly Whole Building Electricity, Chilled Water, and Hot Water Consumption for CE TTI Office & Lab Building during the Month of May 2017 and the Corresponding Hourly Outdoor Dry Bulb Temperature for College Station, TX

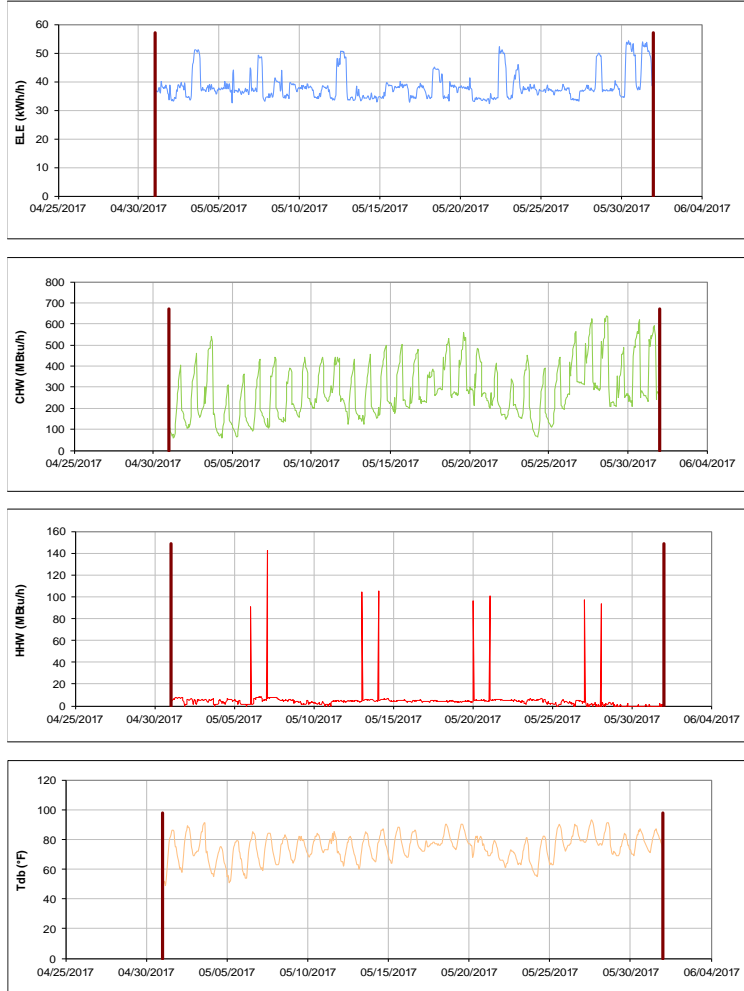
Davis Football Player Development Center TAMU / BLDG #: 0358

Figure III-11 Hourly Whole Building Electricity, Chilled Water, and Hot Water Consumption for Davis Football Player Development Center during the Month of May 2017 and the Corresponding Hourly Outdoor Dry Bulb Temperature for College Station, TX

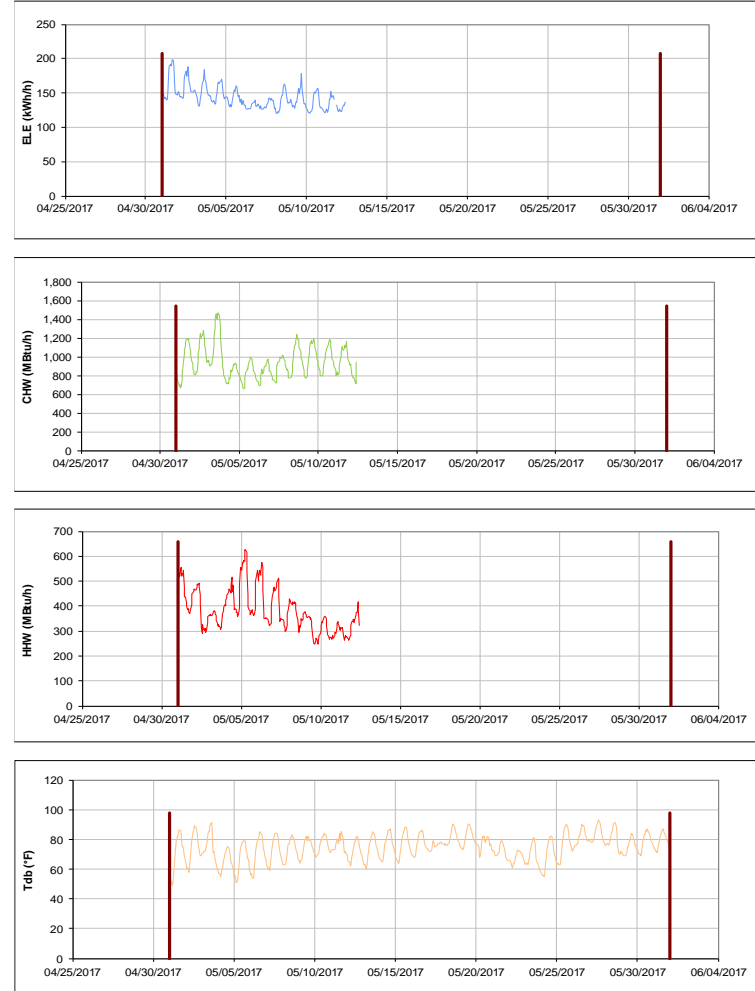
Architecture Building B&C TAMU / BLDG #: 1359-0432

Figure III-12 Hourly Whole Building Electricity, Chilled Water, and Hot Water Consumption for Architecture Building B&C during the Month of May 2017 and the Corresponding Hourly Outdoor Dry Bulb Temperature for College Station, TX

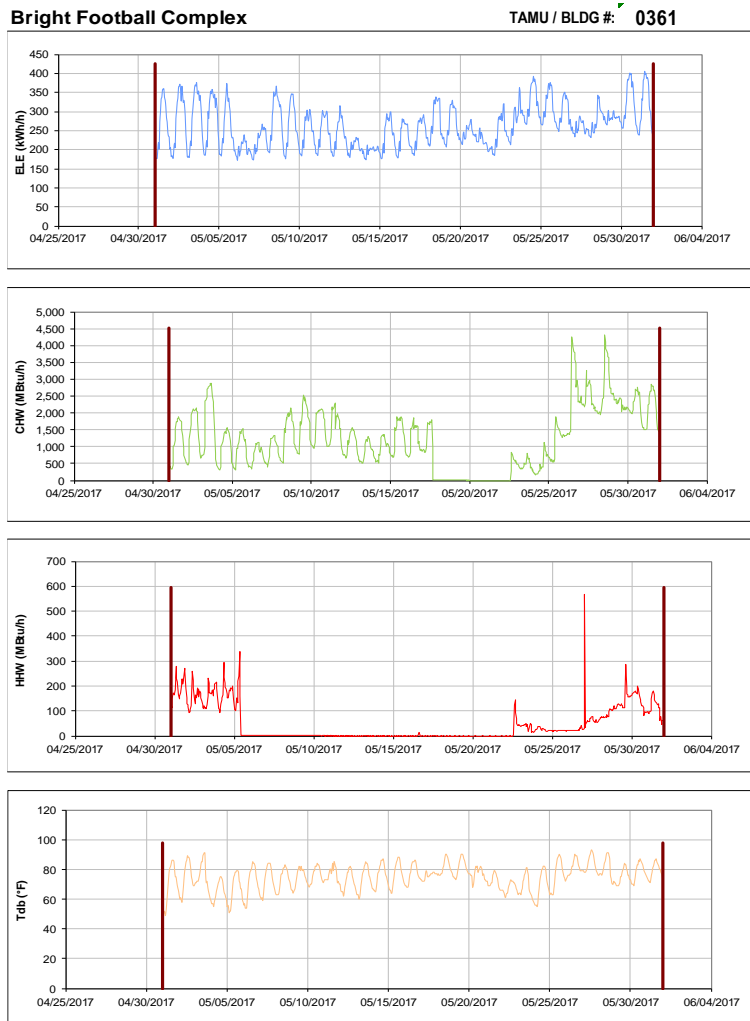
Figure III-15 Hourly Whole Building Electricity, Chilled Water, and Hot Water Consumption for Bright Football Complex during the Month of May 2017 and the Corresponding Hourly Outdoor Dry Bulb Temperature for College Station, TX

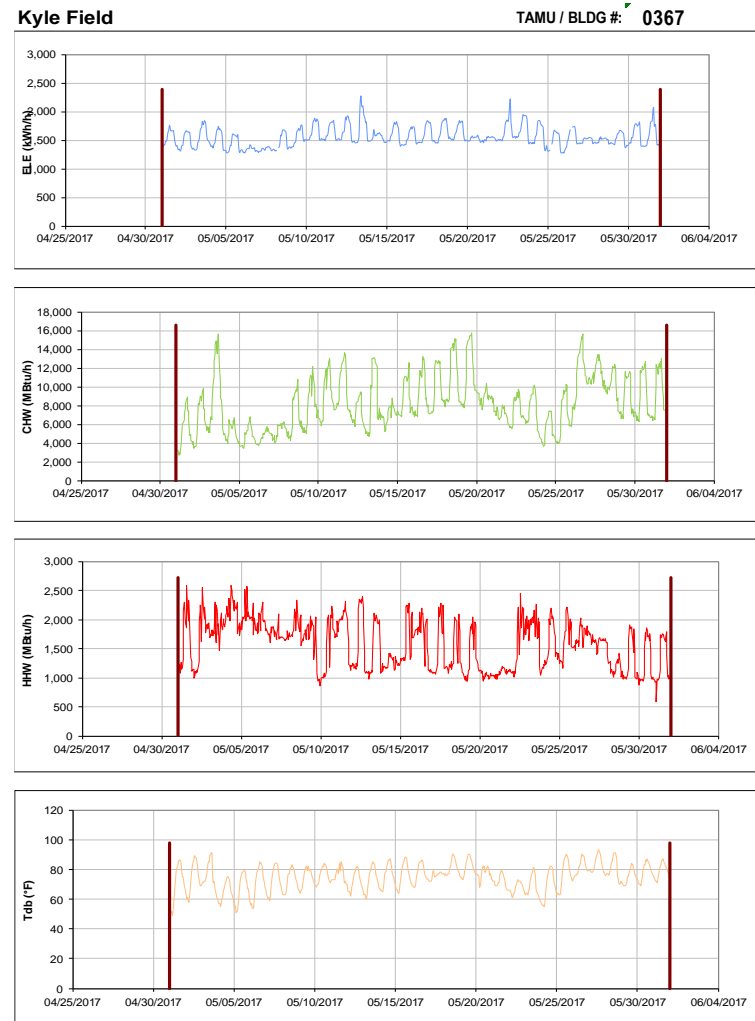
Figure III-16 Hourly Whole Building Electricity, Chilled Water, and Hot Water Consumption for Kyle Field during the Month of May 2017 and the Corresponding Hourly Outdoor Dry Bulb Temperature for College Station, TX

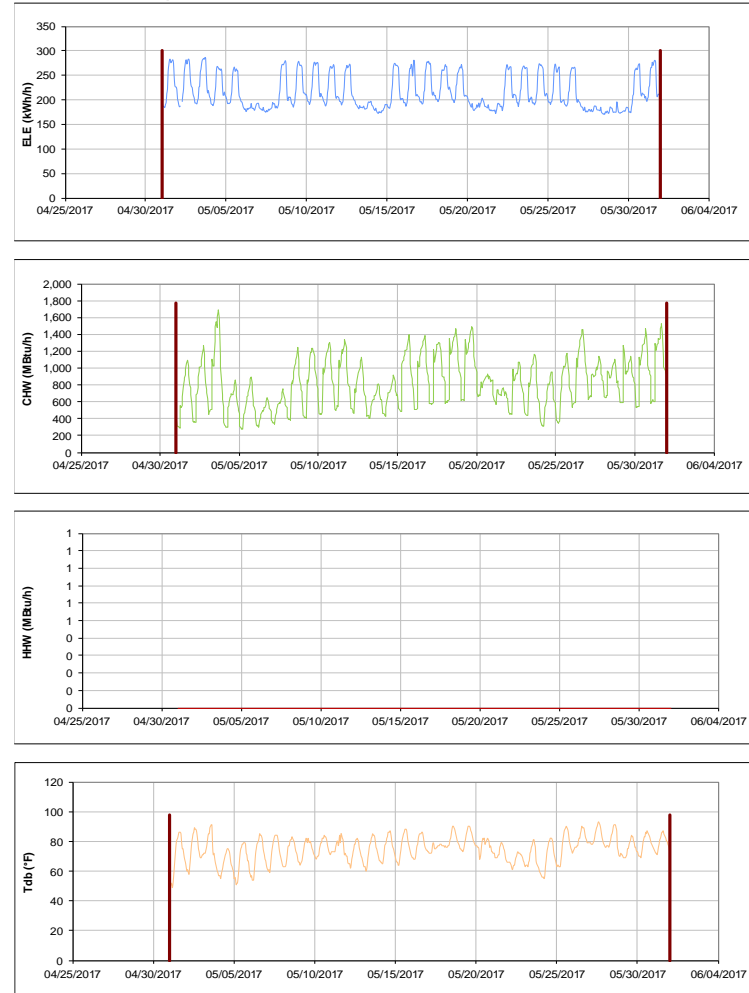
TAMU / BLDG #: 0383

Figure III-18 Hourly Whole Building Electricity, Chilled Water, and Hot Water Consumption for Koldus Building during the Month of May 2017 and the Corresponding Hourly Outdoor Dry Bulb Temperature for College Station, TX

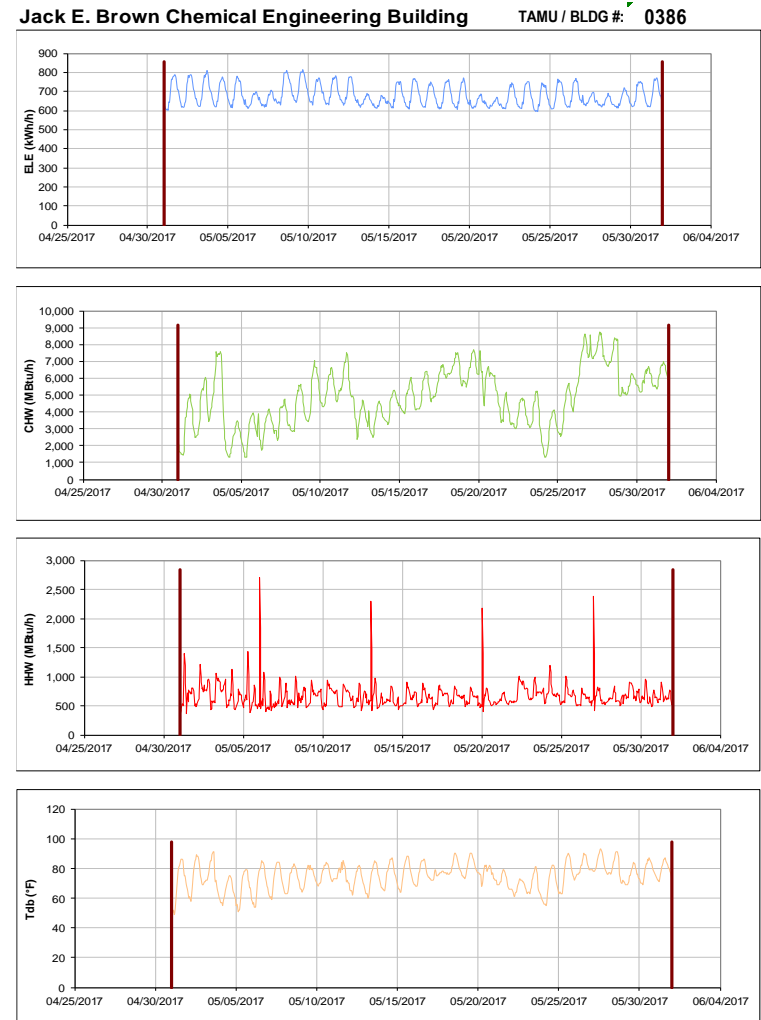
Figure III-20 Hourly Whole Building Electricity, Chilled Water, and Hot Water Consumption for Jack E. Brown Chemical Engineering Building during the Month of May 2017 and the Corresponding Hourly Outdoor Dry Bulb Temperature for College Station, TX

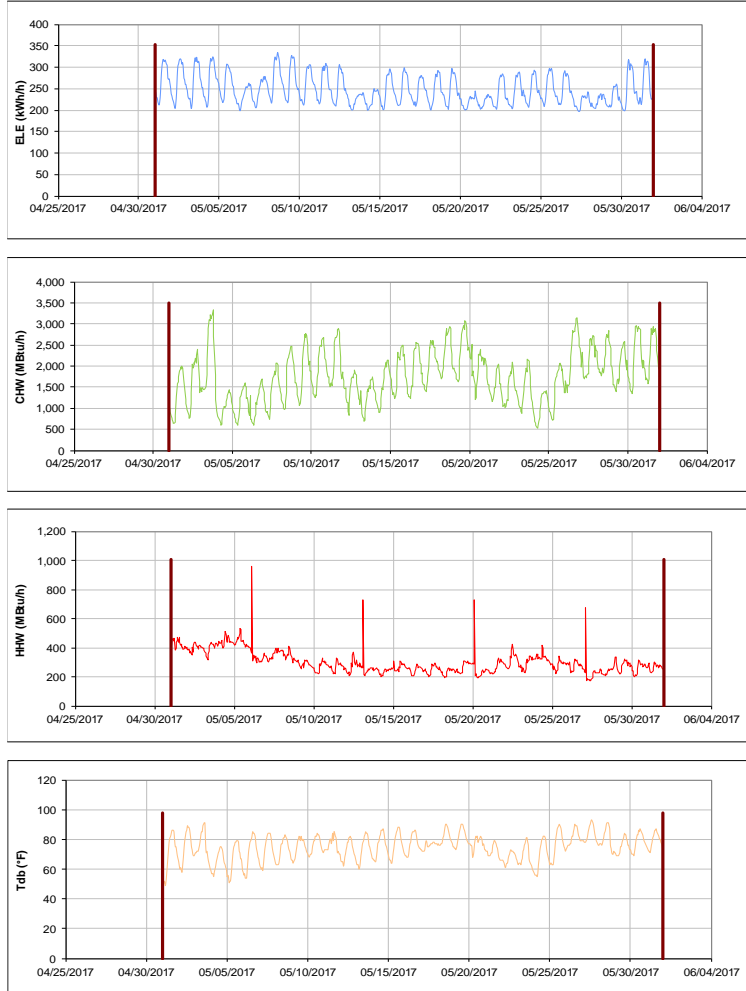
Richardson Petroleum Engineering Building TAMU / BLDG #: 0387

Figure III-21 Hourly Whole Building Electricity, Chilled Water, and Hot Water Consumption for Richardson Petroleum Engineering Building during the Month of May 2017 and the Corresponding Hourly Outdoor Dry Bulb Temperature for College Station, TX

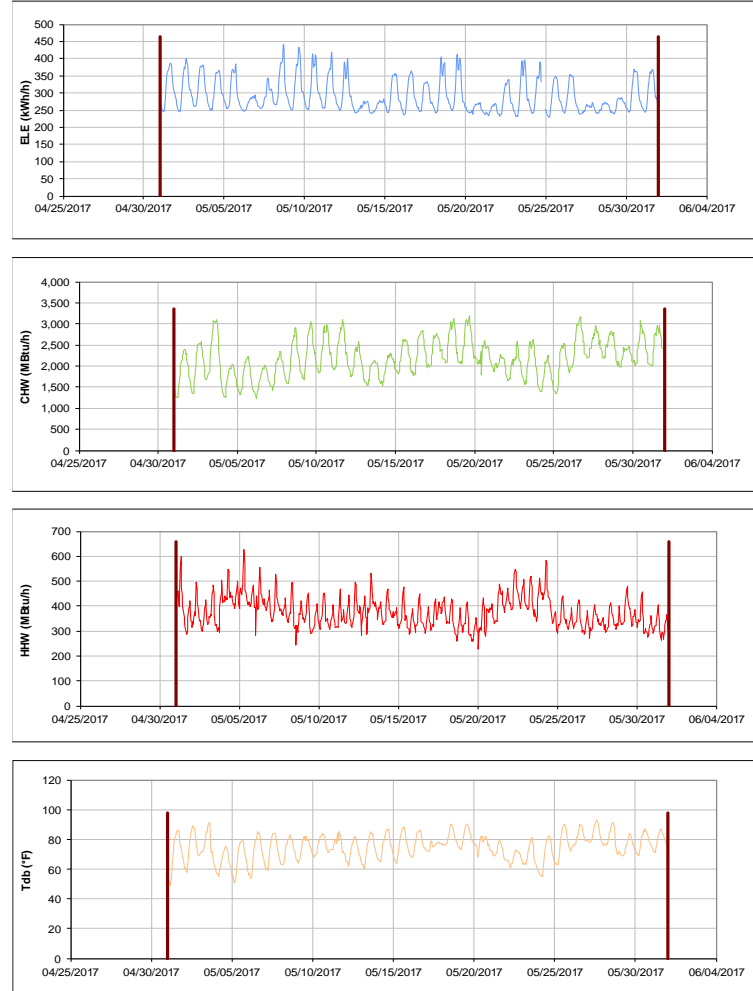
James J. Cain'51 and Mechanical Engineering Office Building TAMU / BLDG #: 1391-0392

Figure III-22 Hourly Whole Building Electricity, Chilled Water, and Hot Water Consumption for James J. Cain'51 and Mechanical Engineering Office Building during the Month of May 2017 and the Corresponding Hourly Outdoor Dry Bulb Temperature for College Station, TX

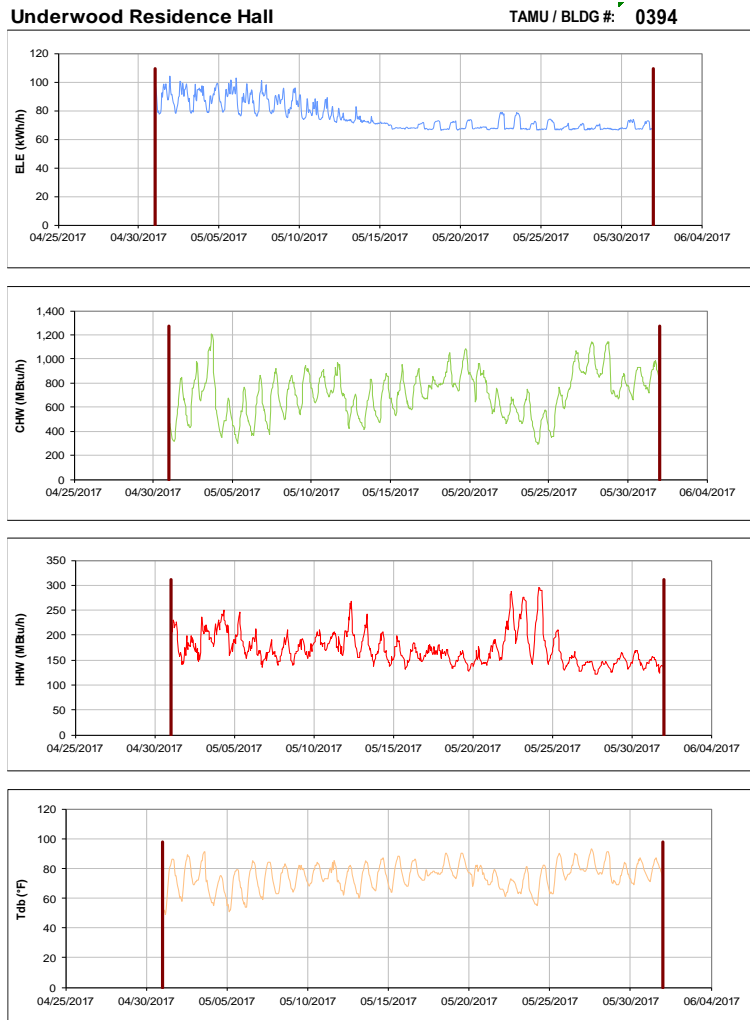
Figure III-23 Hourly Whole Building Electricity, Chilled Water, and Hot Water Consumption for Underwood Residence Hall during the Month of May 2017 and the Corresponding Hourly Outdoor Dry Bulb Temperature for College Station, TX

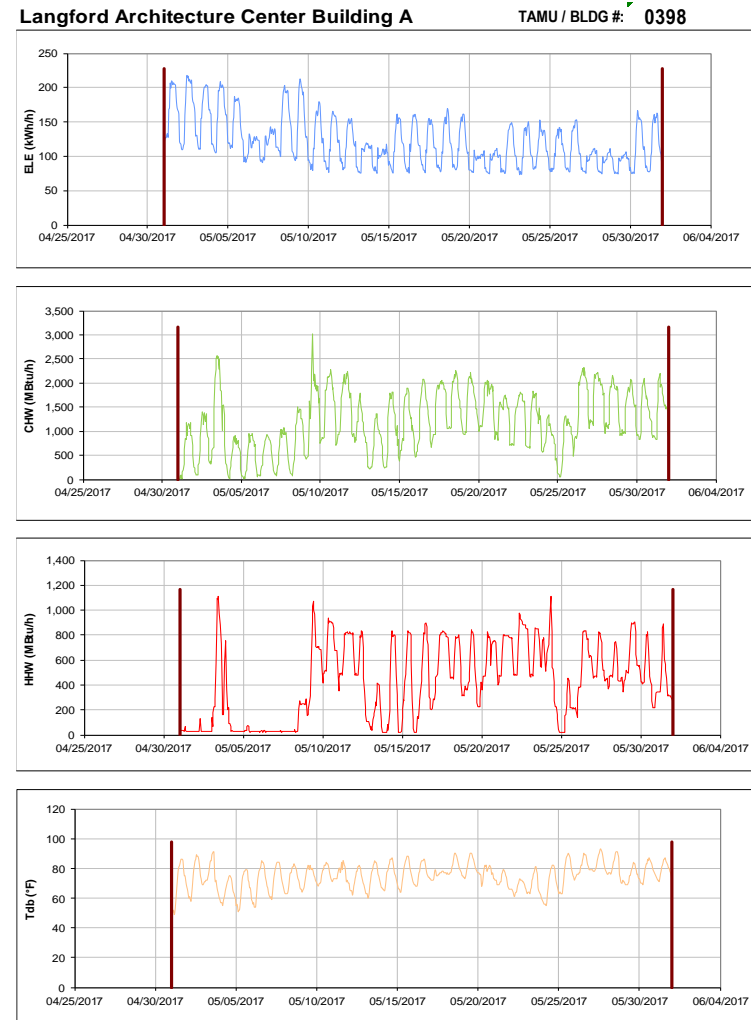
Figure III-24 Hourly Whole Building Electricity, Chilled Water, and Hot Water Consumption for Langford Architecture Center Building A during the Month of May 2017 and the Corresponding Hourly Outdoor Dry Bulb Temperature for College Station, TX

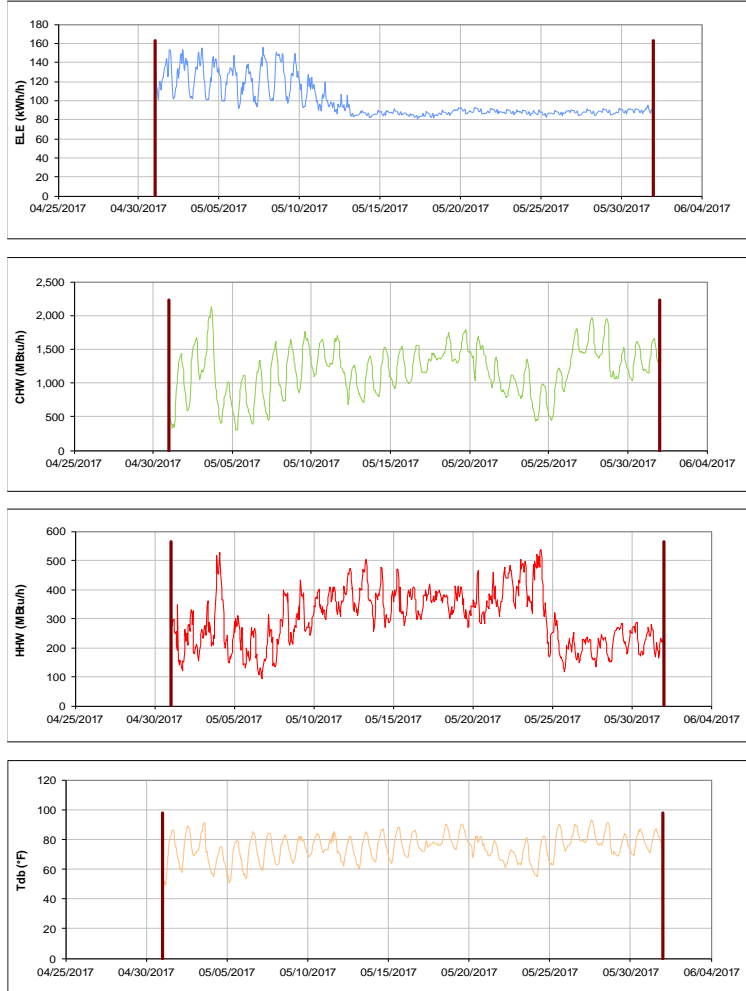
Spence Hall, Briggs Hall, and Ash II LLC TAMU / BLDG #: 0-0402-1405

Figure III-25 Hourly Whole Building Electricity, Chilled Water, and Hot Water Consumption for Spence Hall, Briggs Hall, and Ash II LLC during the Month of May 2017 and the Corresponding Hourly Outdoor Dry Bulb Temperature for College Station, TX

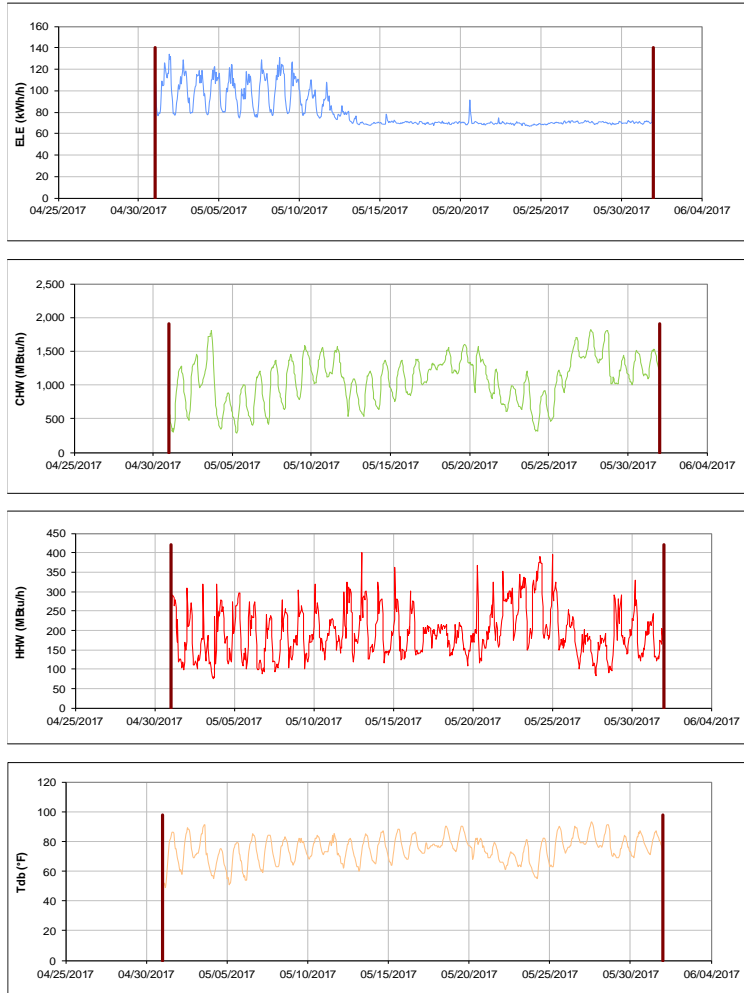
Gainer Hall, Leonard Hall and Ash LLC TAMU / BLDG #: 4-0406-1403

Figure III-33 Hourly Whole Building Electricity, Chilled Water, and Hot Water Consumption for Gainer Hall, Leonard Hall and Ash LLC during the Month of May 2017 and the Corresponding Hourly Outdoor Dry Bulb Temperature for College Station, TX

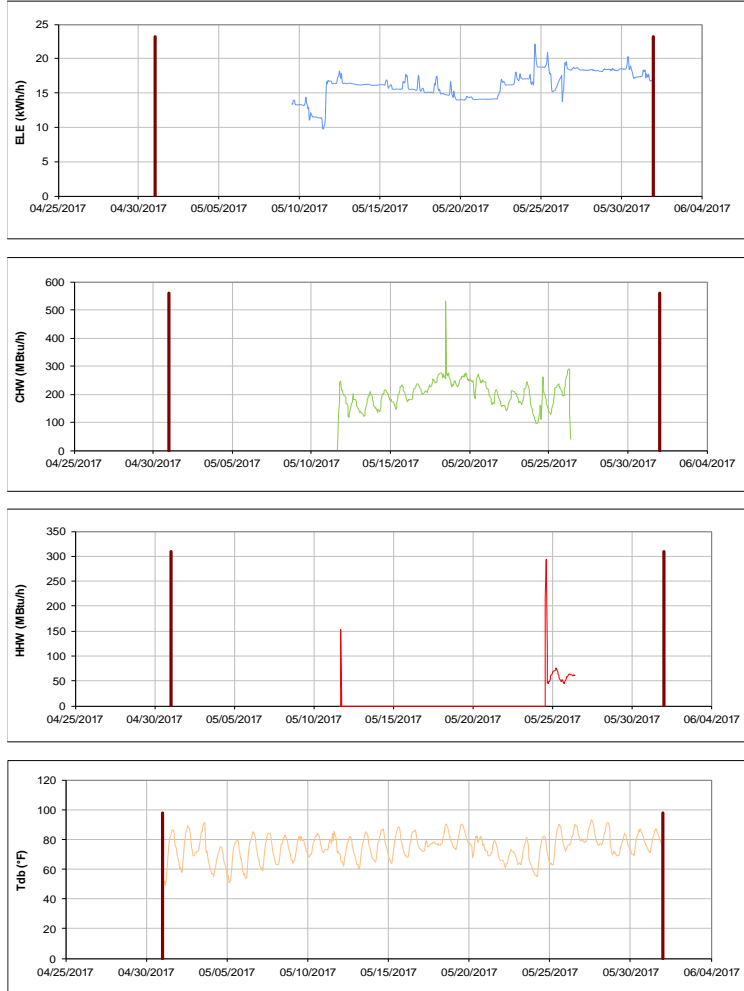
TAMU / BLDG #: 0408

Figure III-41 Hourly Whole Building Electricity, Chilled Water, and Hot Water Consumption for Whitely Hall - Dorm 9 during the Month of May 2017 and the Corresponding Hourly Outdoor Dry Bulb Temperature for College Station, TX

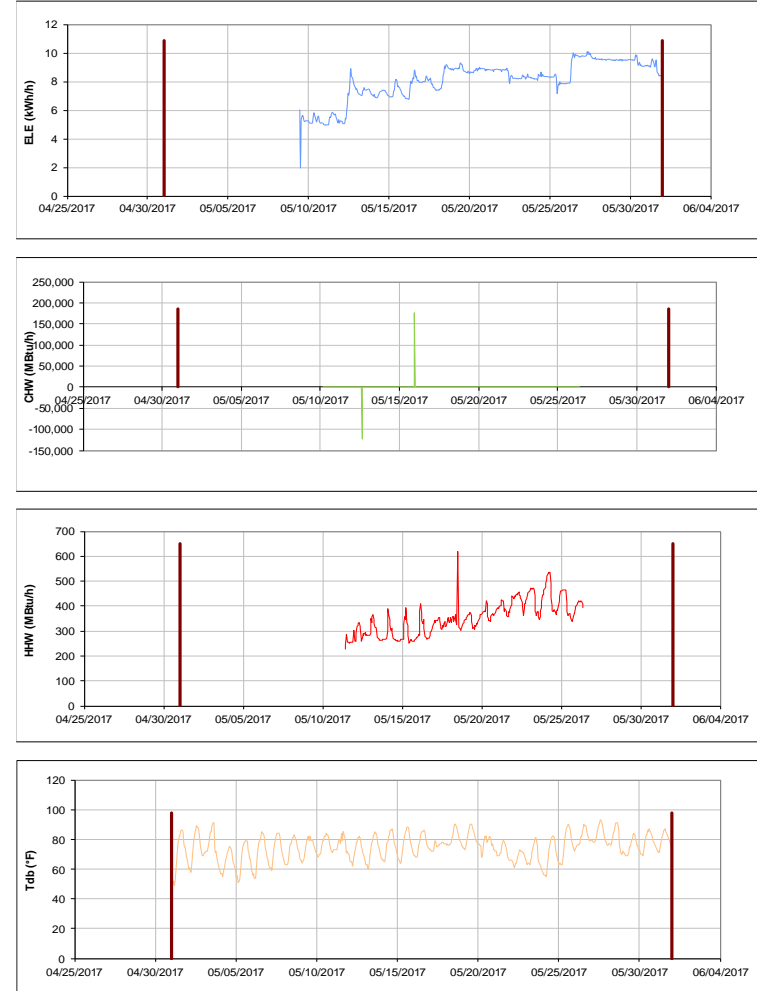
TAMU / BLDG #: 0409

Figure III-42 Hourly Whole Building Electricity, Chilled Water, and Hot Water Consumption for White Hall - Dorm 10 during the Month of May 2017 and the Corresponding Hourly Outdoor Dry Bulb Temperature for College Station, TX

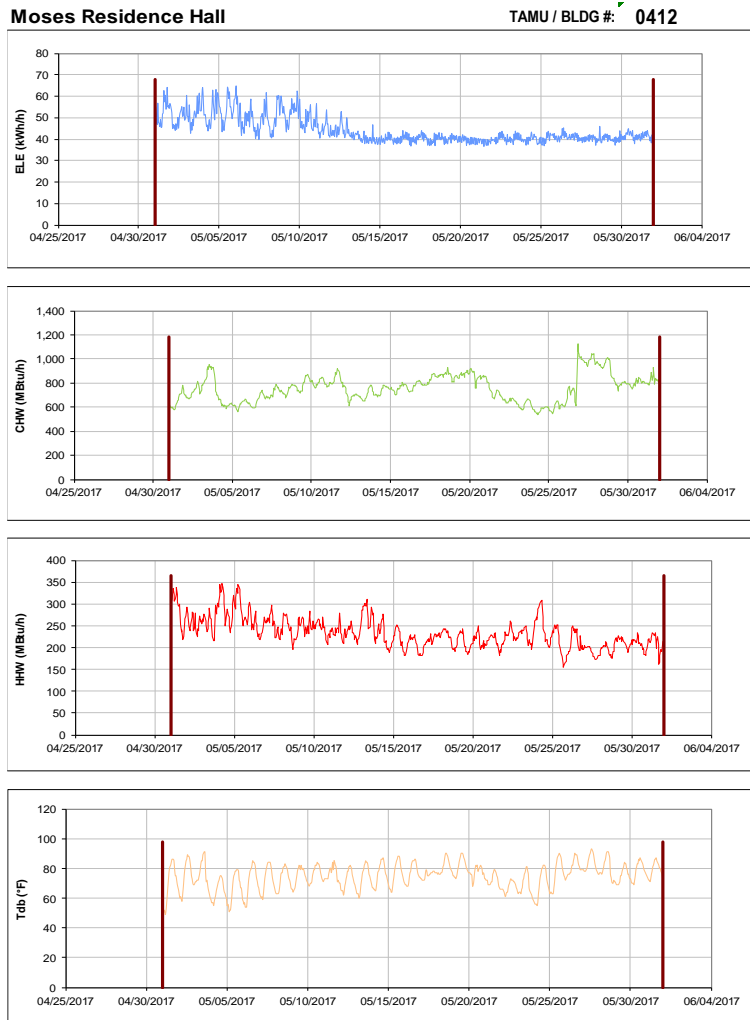
Figure III-45 Hourly Whole Building Electricity, Chilled Water, and Hot Water Consumption for Moses Residence Hall during the Month of May 2017 and the Corresponding Hourly Outdoor Dry Bulb Temperature for College Station, TX

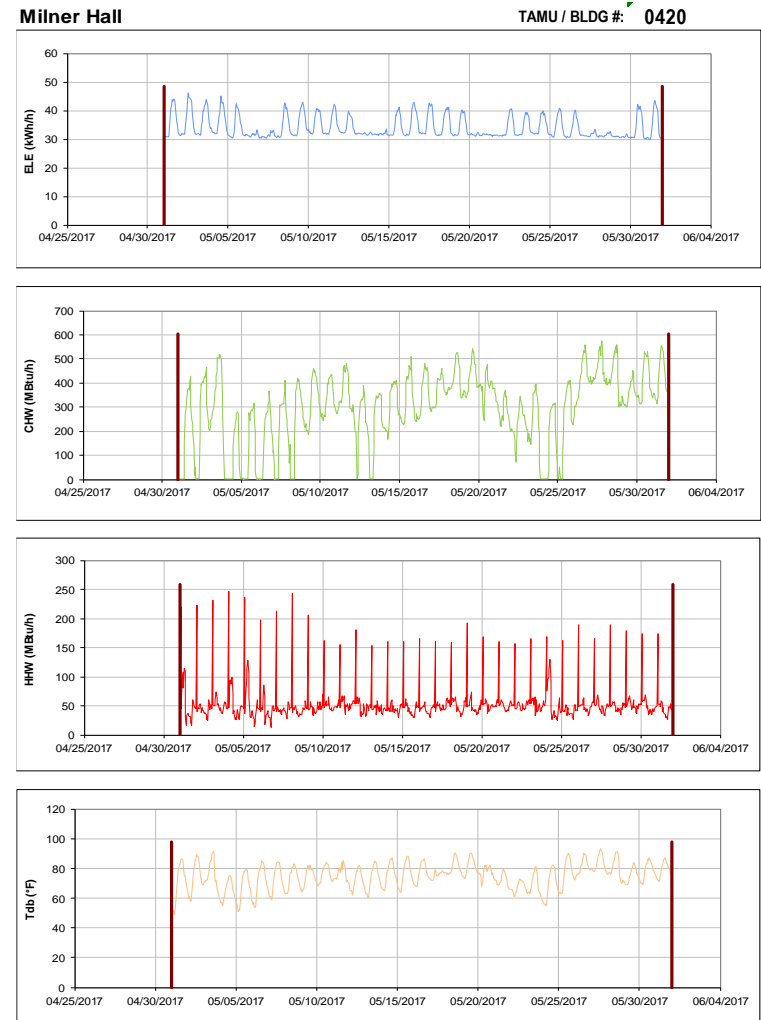
Figure III-48 Hourly Whole Building Electricity, Chilled Water, and Hot Water Consumption for Milner Hall during the Month of May 2017 and the Corresponding Hourly Outdoor Dry Bulb Temperature for College Station, TX

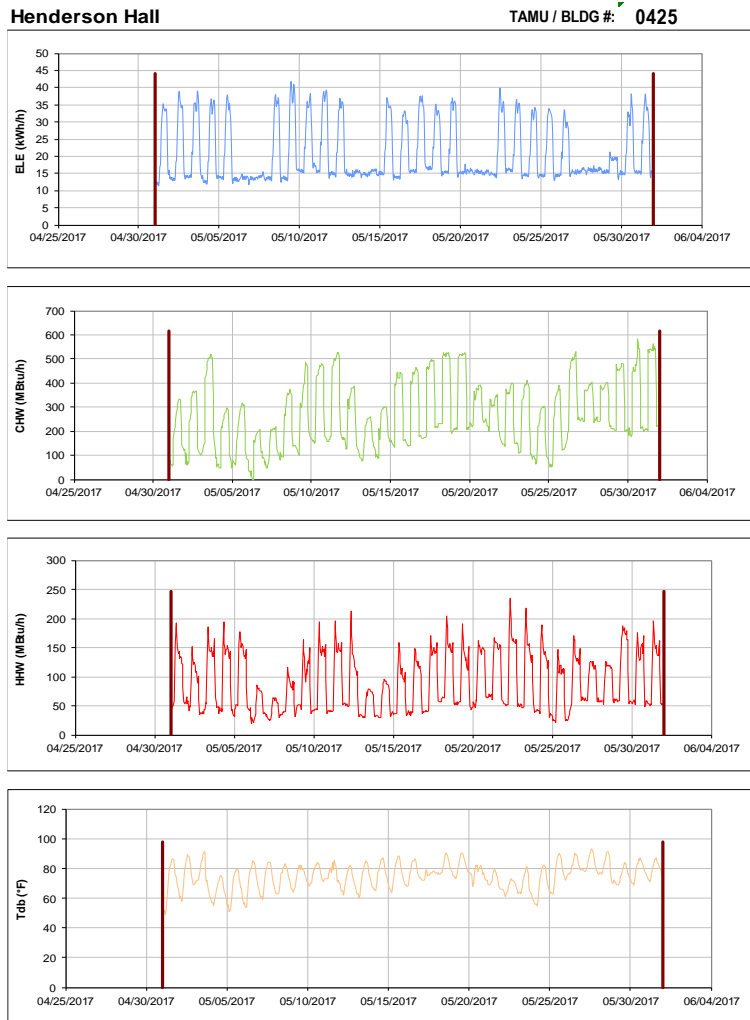
Figure III-51 Hourly Whole Building Electricity, Chilled Water, and Hot Water Consumption for Henderson Hall during the Month of May 2017 and the Corresponding Hourly Outdoor Dry Bulb Temperature for College Station, TX

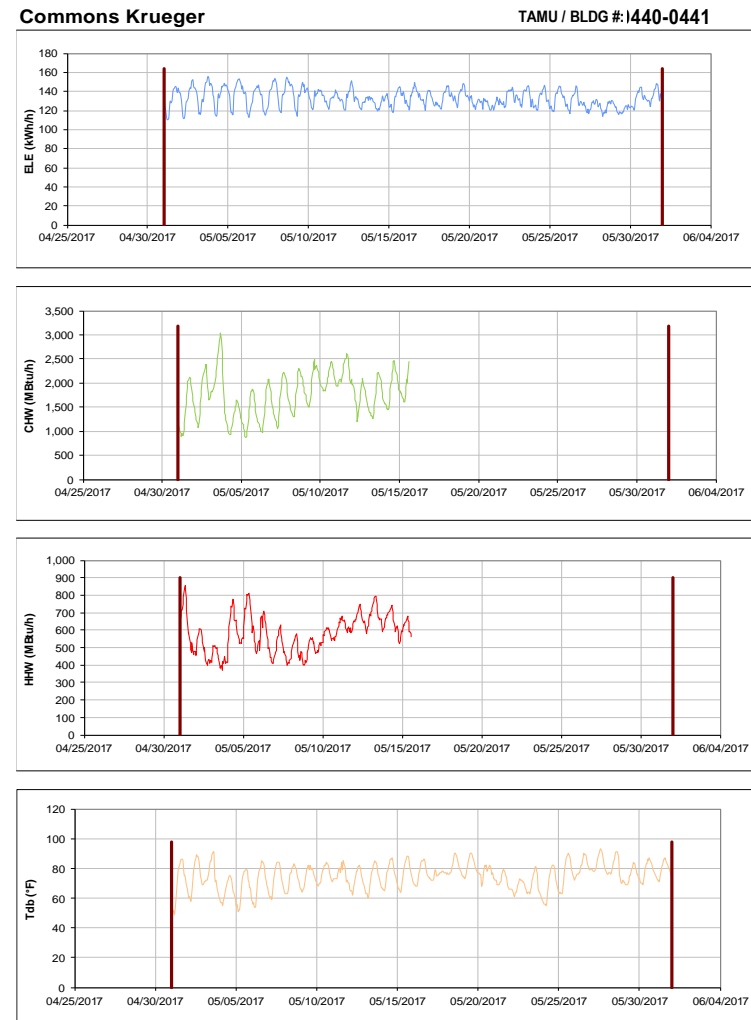
Figure III-56 Hourly Whole Building Electricity, Chilled Water, and Hot Water Consumption for Commons Krueger during the Month of May 2017 and the Corresponding Hourly Outdoor Dry Bulb Temperature for College Station, TX

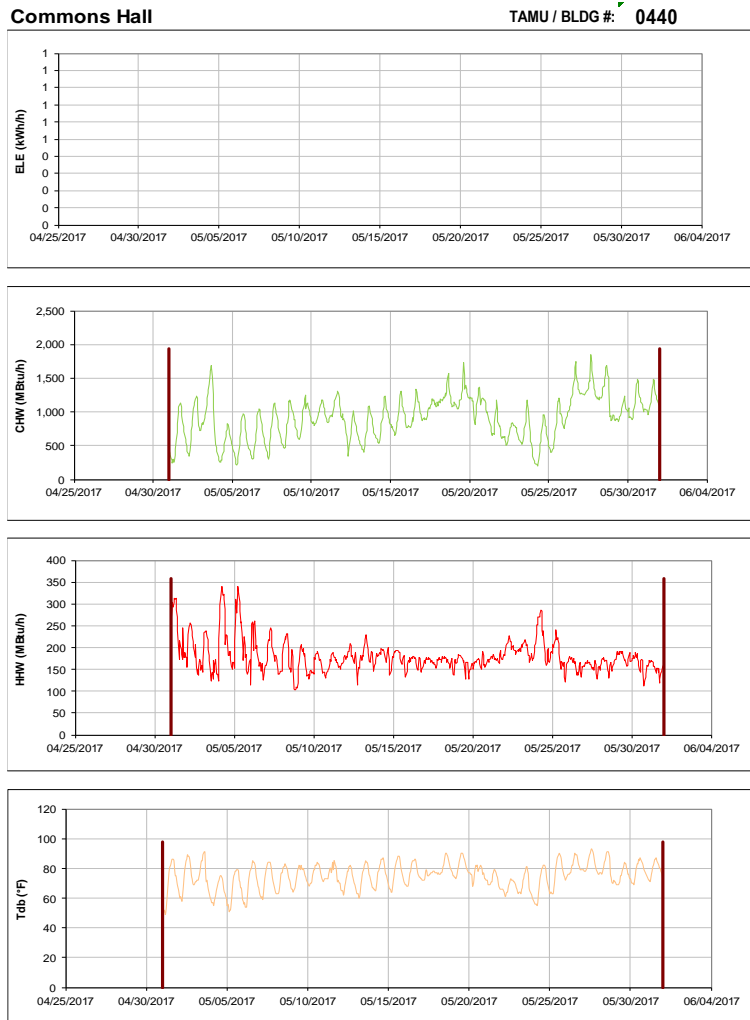
Figure III-57 Hourly Whole Building Electricity, Chilled Water, and Hot Water Consumption for Commons Hall during the Month of May 2017 and the Corresponding Hourly Outdoor Dry Bulb Temperature for College Station, TX

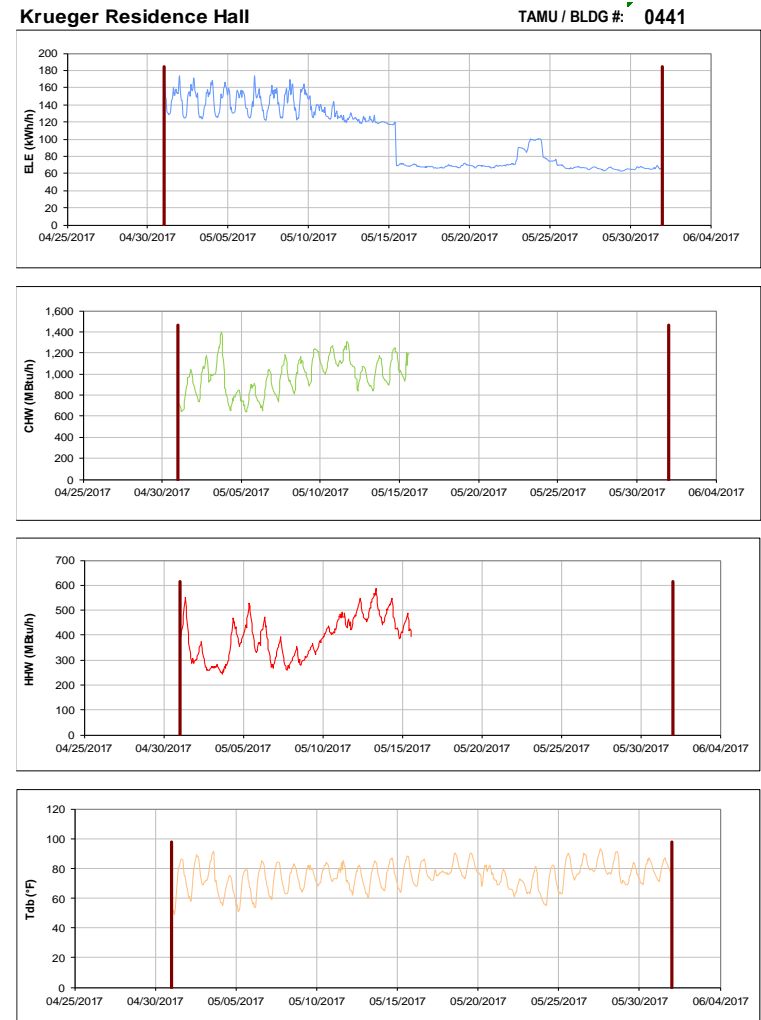
Figure III-58 Hourly Whole Building Electricity, Chilled Water, and Hot Water Consumption for Krueger Residence Hall during the Month of May 2017 and the Corresponding Hourly Outdoor Dry Bulb Temperature for College Station, TX

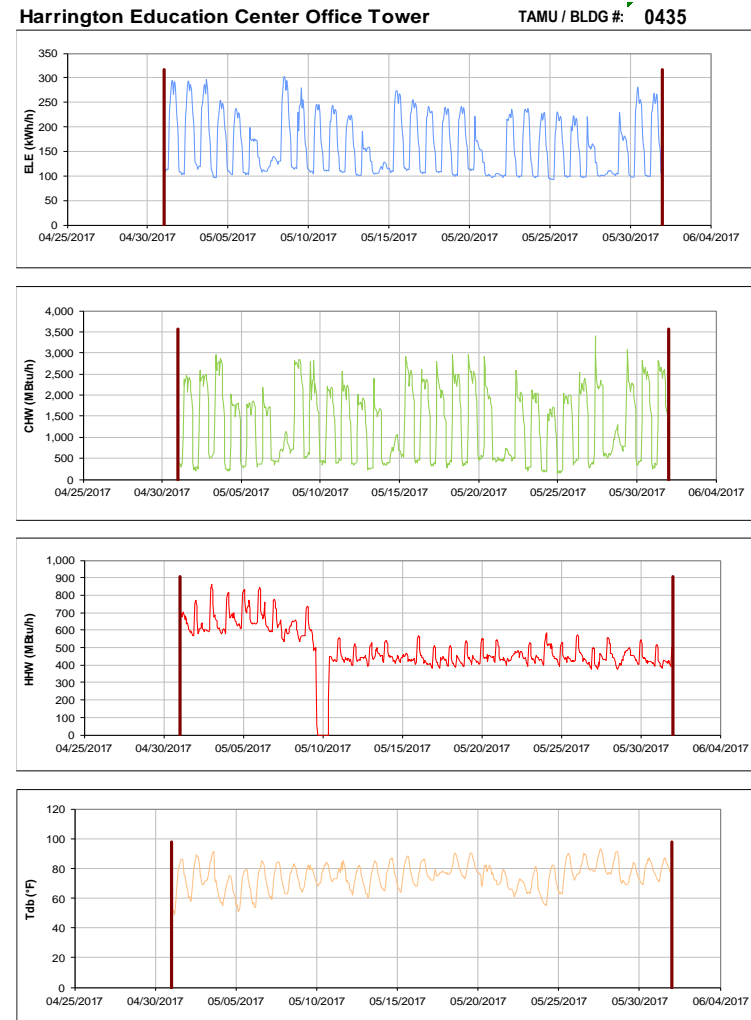
Figure III-62 Hourly Whole Building Electricity, Chilled Water, and Hot Water Consumption for Harrington Education Center Office Tower during the Month of May 2017 and the Corresponding Hourly Outdoor Dry Bulb Temperature for College Station, TX

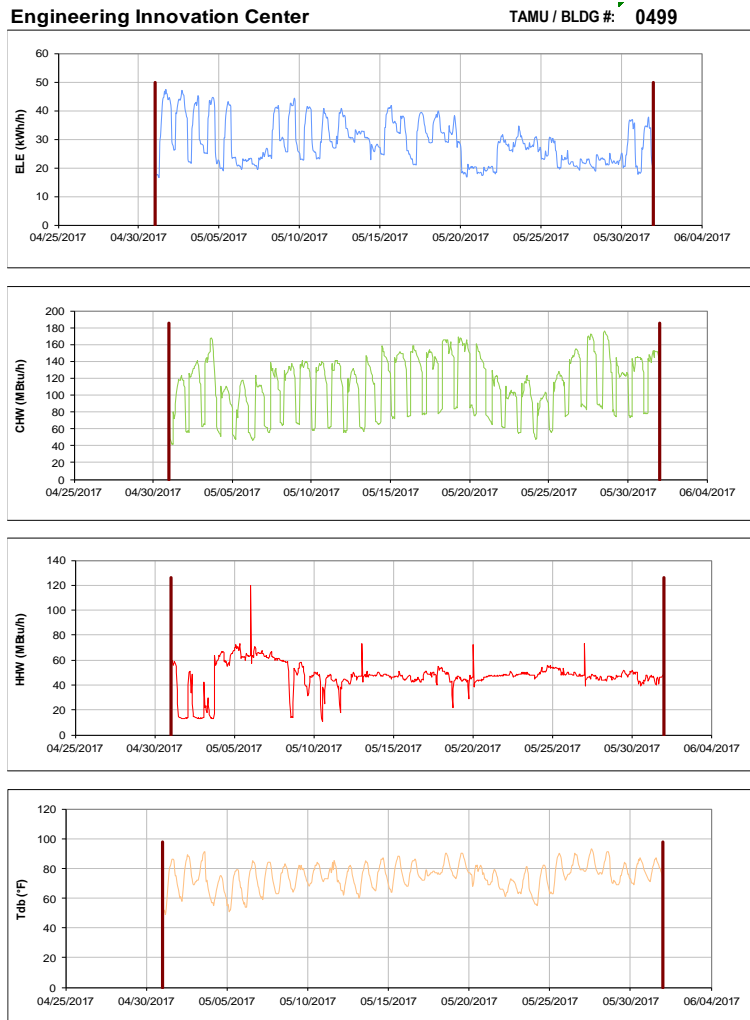
Figure III-65 Hourly Whole Building Electricity, Chilled Water, and Hot Water Consumption for Engineering Innovation Center during the Month of May 2017 and the Corresponding Hourly Outdoor Dry Bulb Temperature for College Station, TX

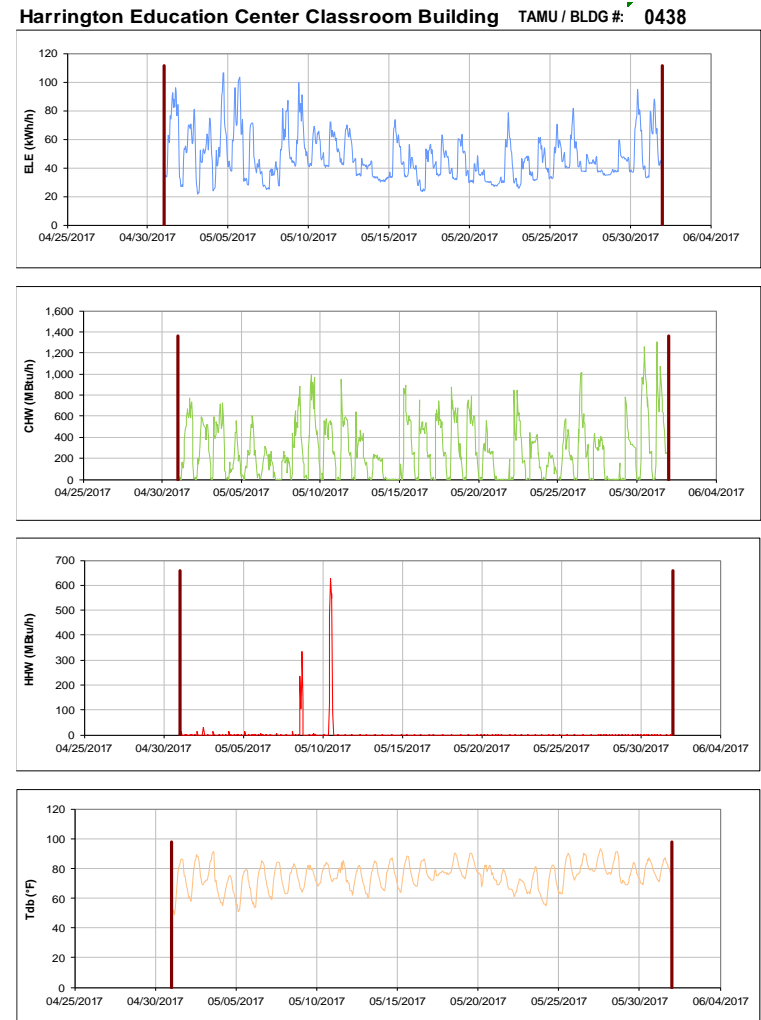
Figure III-66 Hourly Whole Building Electricity, Chilled Water, and Hot Water Consumption for Harrington Education Center Classroom Building during the Month of May 2017 and the Corresponding Hourly Outdoor Dry Bulb Temperature for College Station, TX
