TAMU Project

**Energy Consumption Data Quality Assurance/Quality
Control Assessment Report for the
Month of May 2017**

**Utility & Energy Services
Division of Administration
Texas A&M University**

June 2017

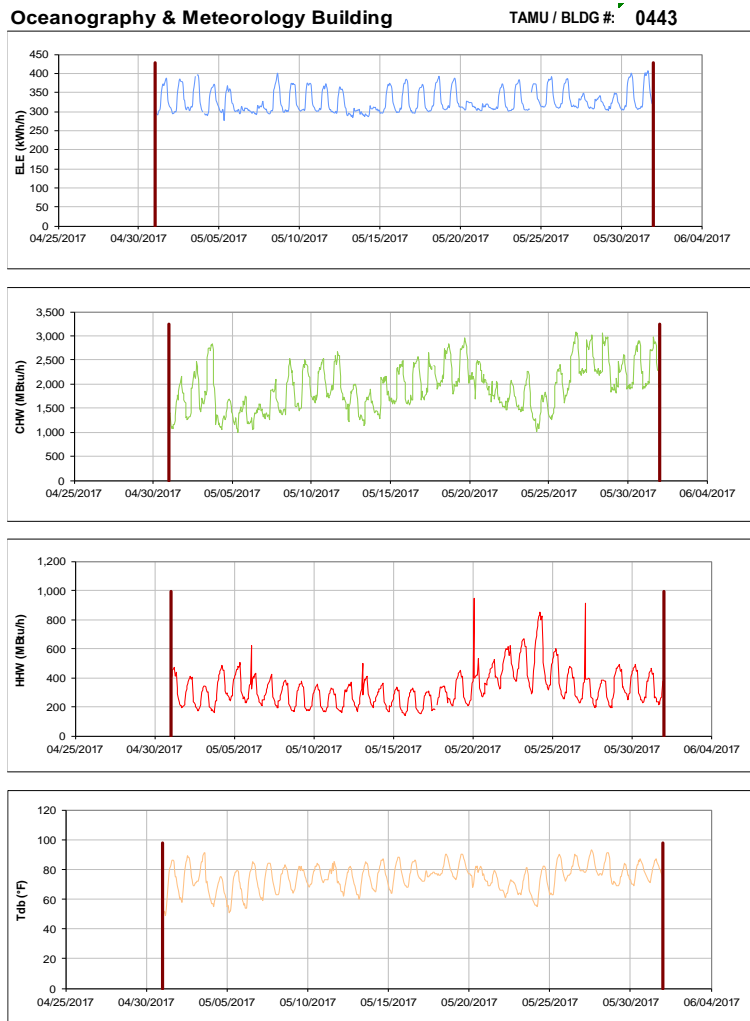
Figure III-67 Hourly Whole Building Electricity, Chilled Water, and Hot Water Consumption for Oceanography & Meteorology Building during the Month of May 2017 and the Corresponding Hourly Outdoor Dry Bulb Temperature for College Station, TX

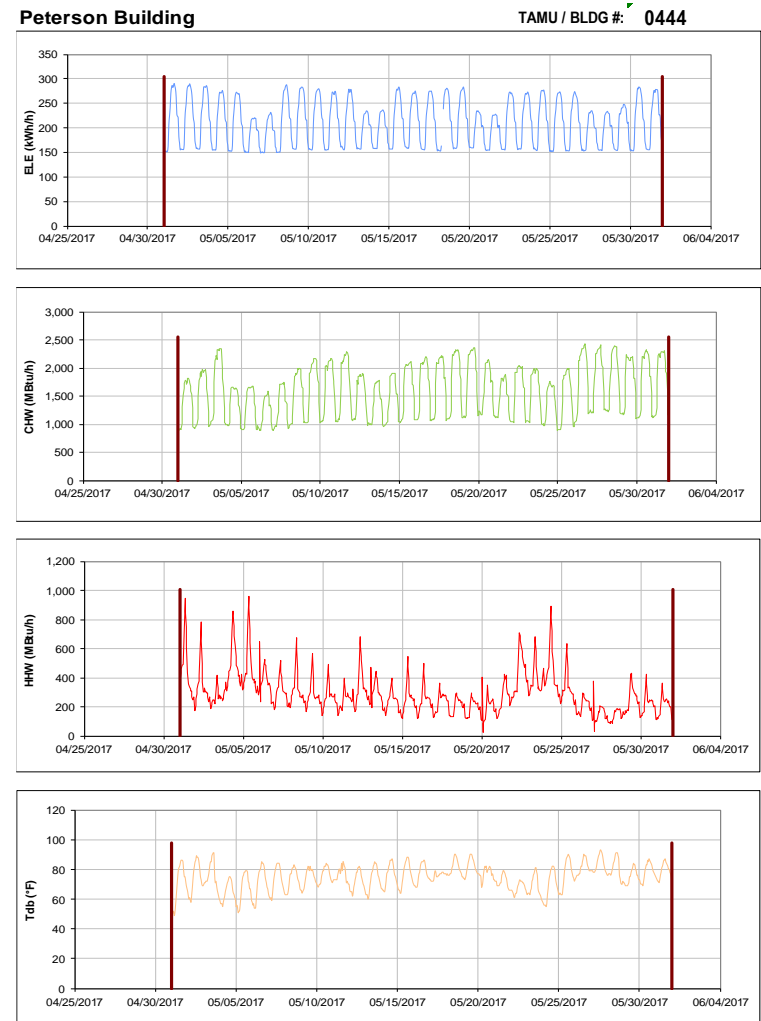
Figure III-68 Hourly Whole Building Electricity, Chilled Water, and Hot Water Consumption for Peterson Building during the Month of May 2017 and the Corresponding Hourly Outdoor Dry Bulb Temperature for College Station, TX

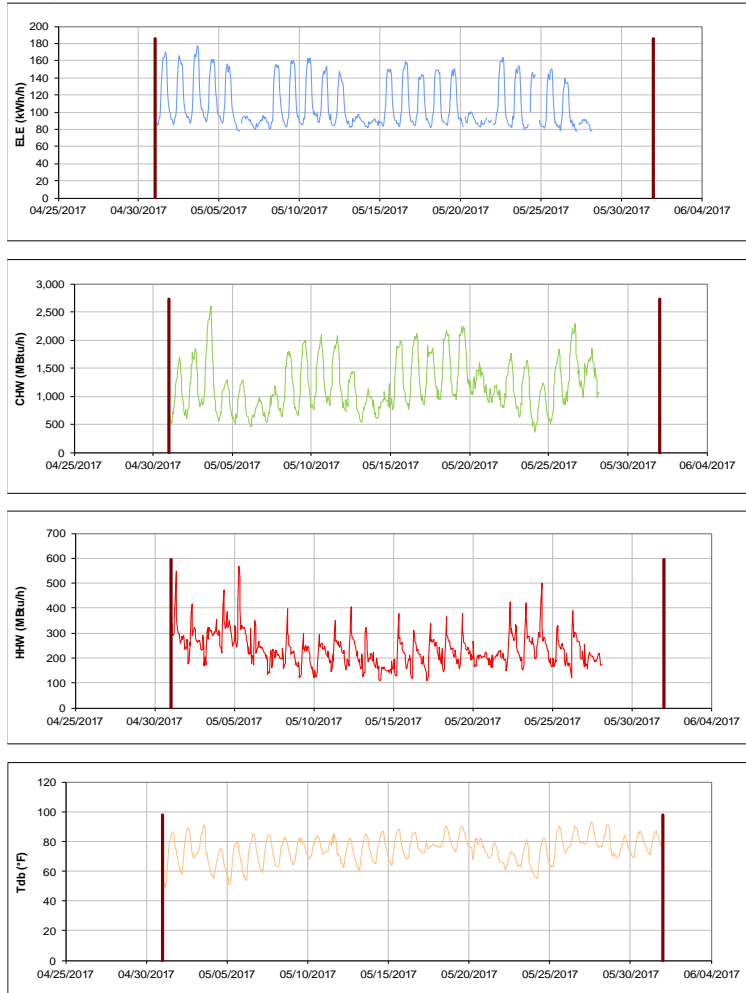
Teague Research Center and DPC Annex TAMU / BLDG #: 1445-0517

Figure III-69 Hourly Whole Building Electricity, Chilled Water, and Hot Water Consumption for Teague Research Center and DPC Annex during the Month of May 2017 and the Corresponding Hourly Outdoor Dry Bulb Temperature for College Station, TX

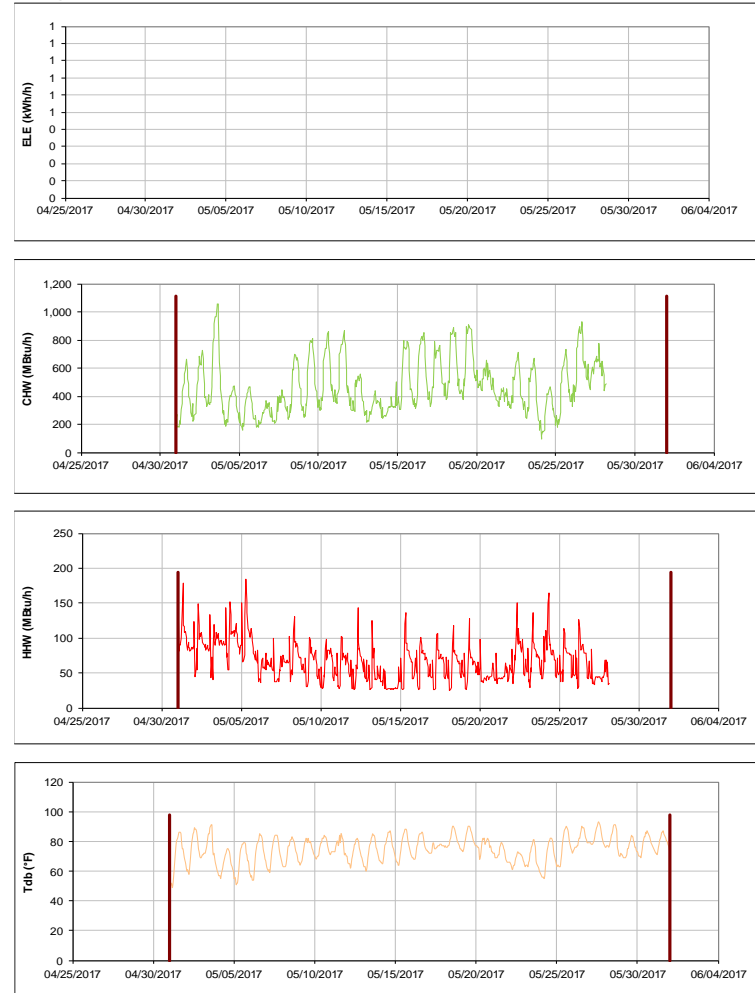
Teague Research Center TAMU / BLDG #: 0445

Figure III-70 Hourly Whole Building Electricity, Chilled Water, and Hot Water Consumption for Teague Research Center during the Month of May 2017 and the Corresponding Hourly Outdoor Dry Bulb Temperature for College Station, TX

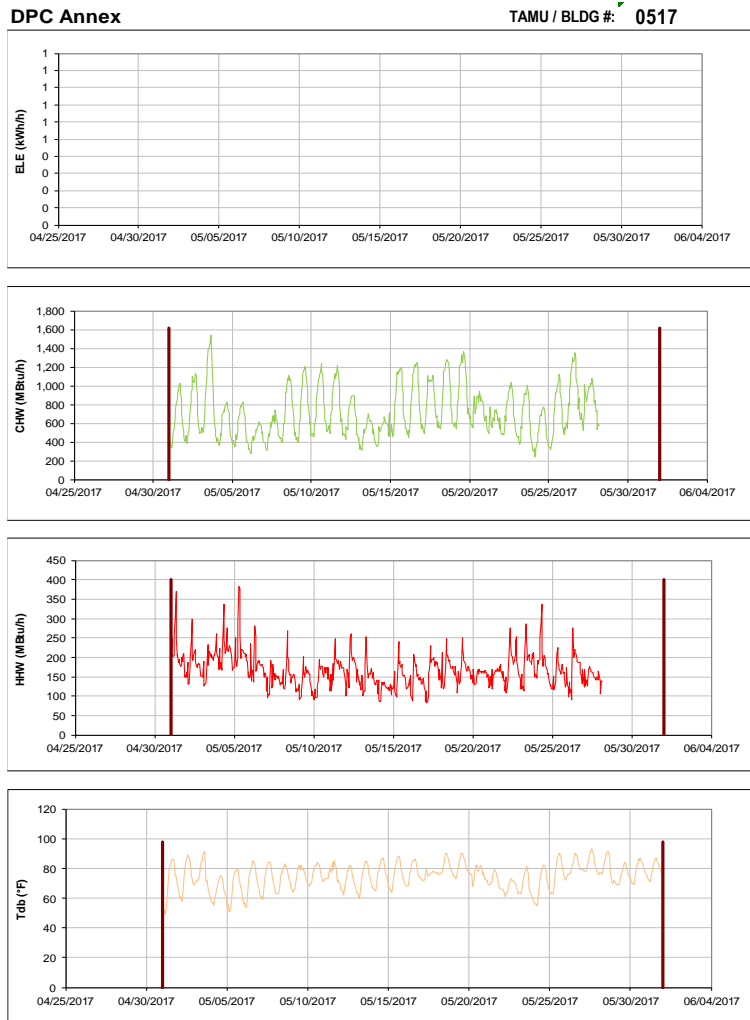
Figure III-71 Hourly Whole Building Electricity, Chilled Water, and Hot Water Consumption for DPC Annex during the Month of May 2017 and the Corresponding Hourly Outdoor Dry Bulb Temperature for College Station, TX

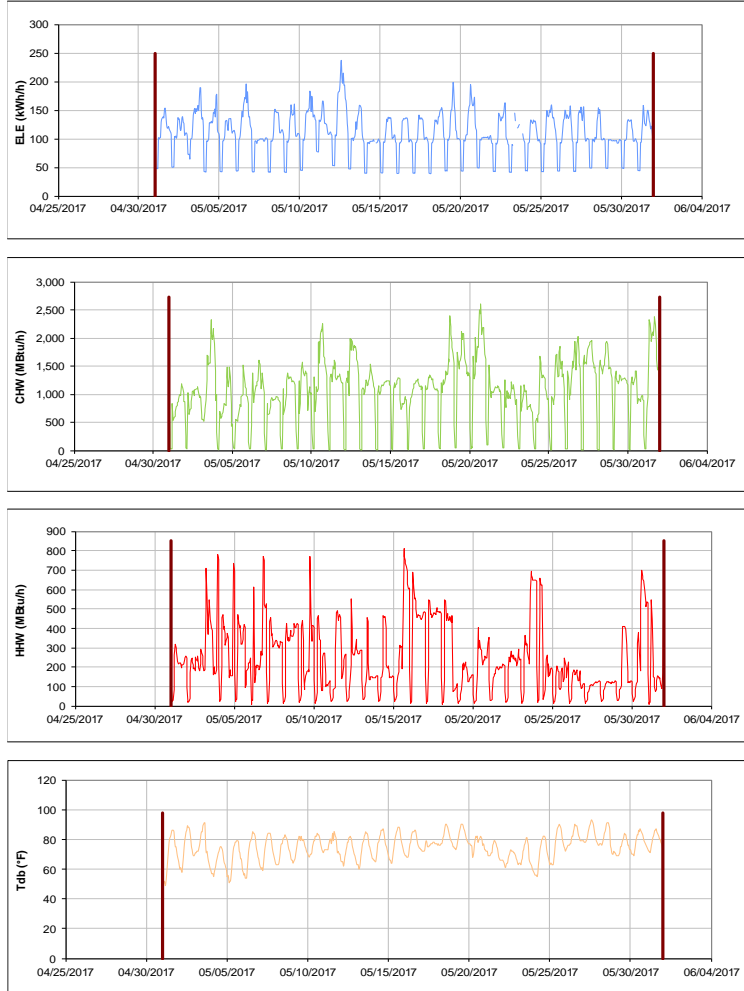
TAMU / BLDG #: 0446-A

Figure III-73 Hourly Whole Building Electricity, Chilled Water, and Hot Water Consumption for Rudder Theatre Complex during the Month of May 2017 and the Corresponding Hourly Outdoor Dry Bulb Temperature for College Station, TX

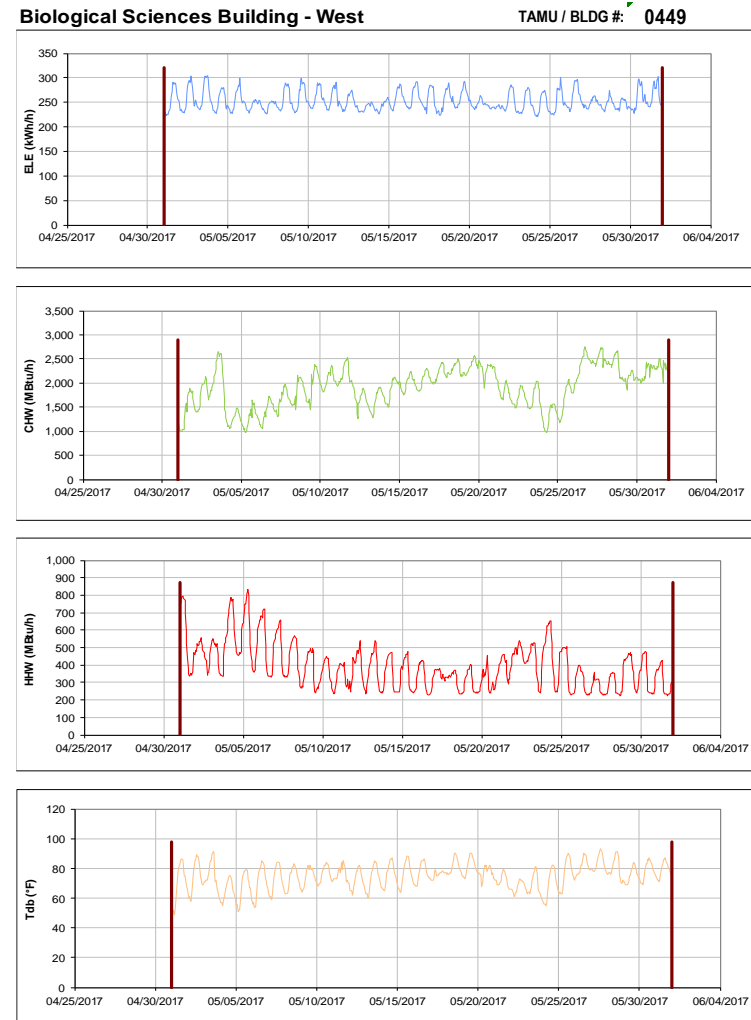
Figure III-76 Hourly Whole Building Electricity, Chilled Water, and Hot Water Consumption for Biological Sciences Building - West during the Month of May 2017 and the Corresponding Hourly Outdoor Dry Bulb Temperature for College Station, TX

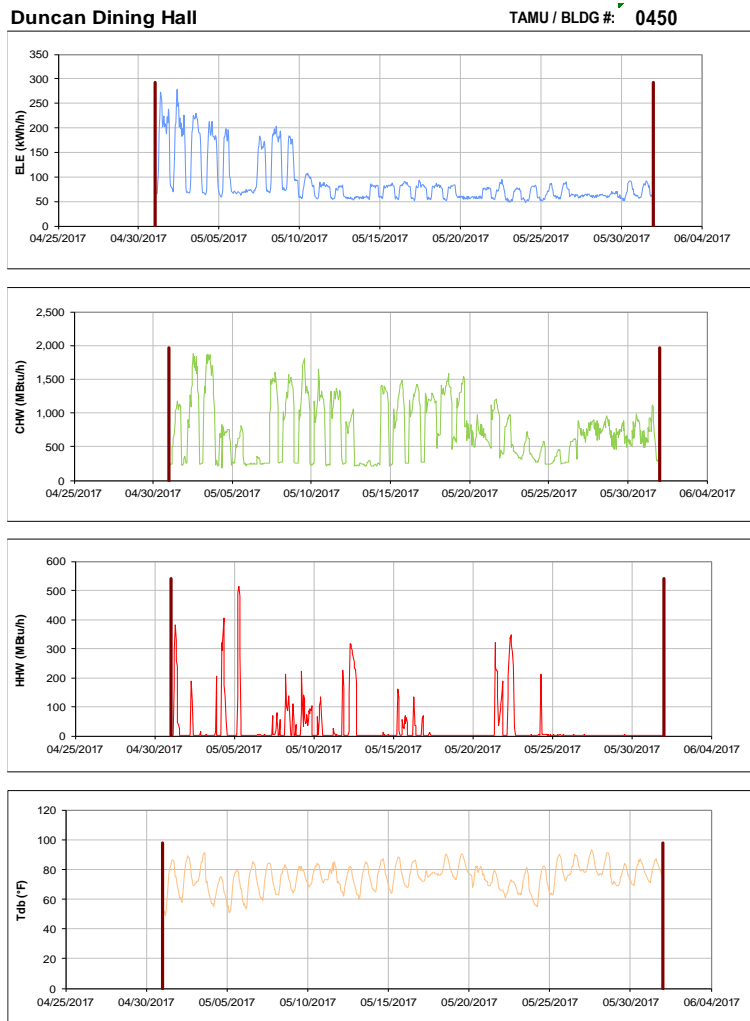
Figure III-77 Hourly Whole Building Electricity, Chilled Water, and Hot Water Consumption for Duncan Dining Hall during the Month of May 2017 and the Corresponding Hourly Outdoor Dry Bulb Temperature for College Station, TX

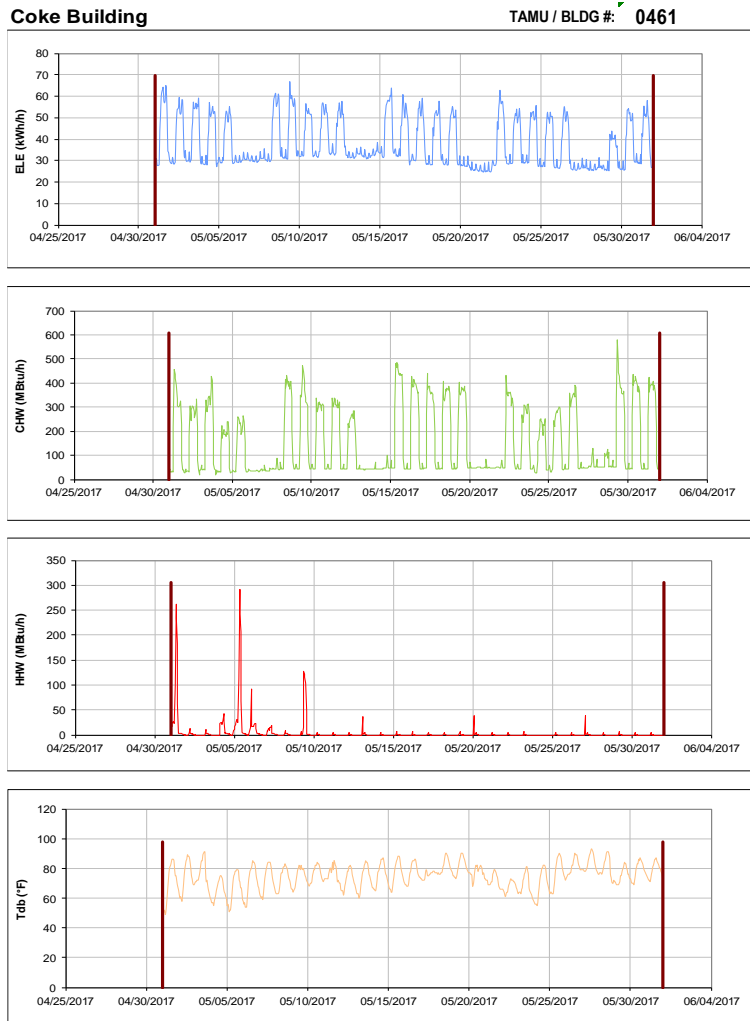
Figure III-81 Hourly Whole Building Electricity, Chilled Water, and Hot Water Consumption for Coke Building during the Month of May 2017 and the Corresponding Hourly Outdoor Dry Bulb Temperature for College Station, TX

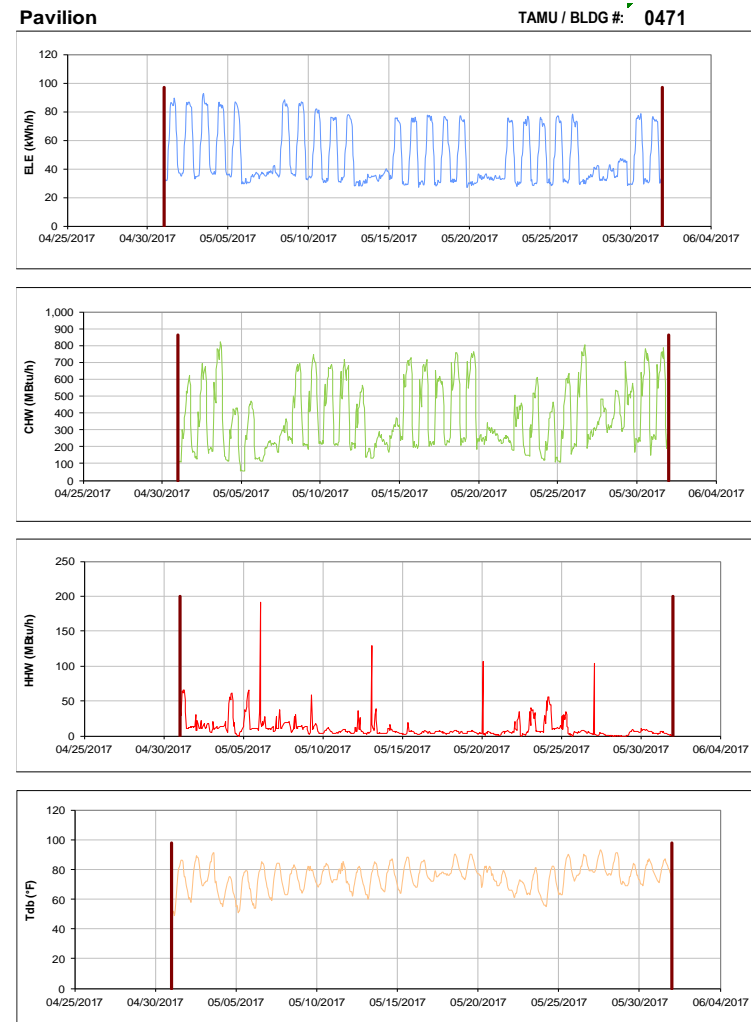
Figure III-90 Hourly Whole Building Electricity, Chilled Water, and Hot Water Consumption for Pavilion during the Month of May 2017 and the Corresponding Hourly Outdoor Dry Bulb Temperature for College Station, TX

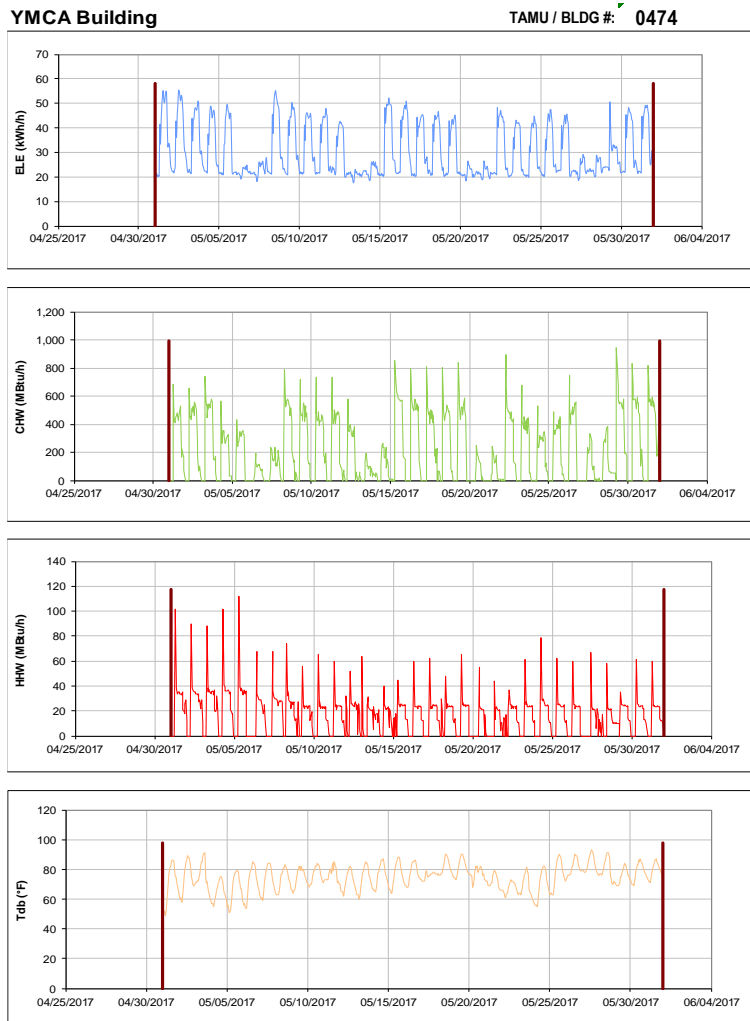
Figure III-93 Hourly Whole Building Electricity, Chilled Water, and Hot Water Consumption for YMCA Building during the Month of May 2017 and the Corresponding Hourly Outdoor Dry Bulb Temperature for College Station, TX

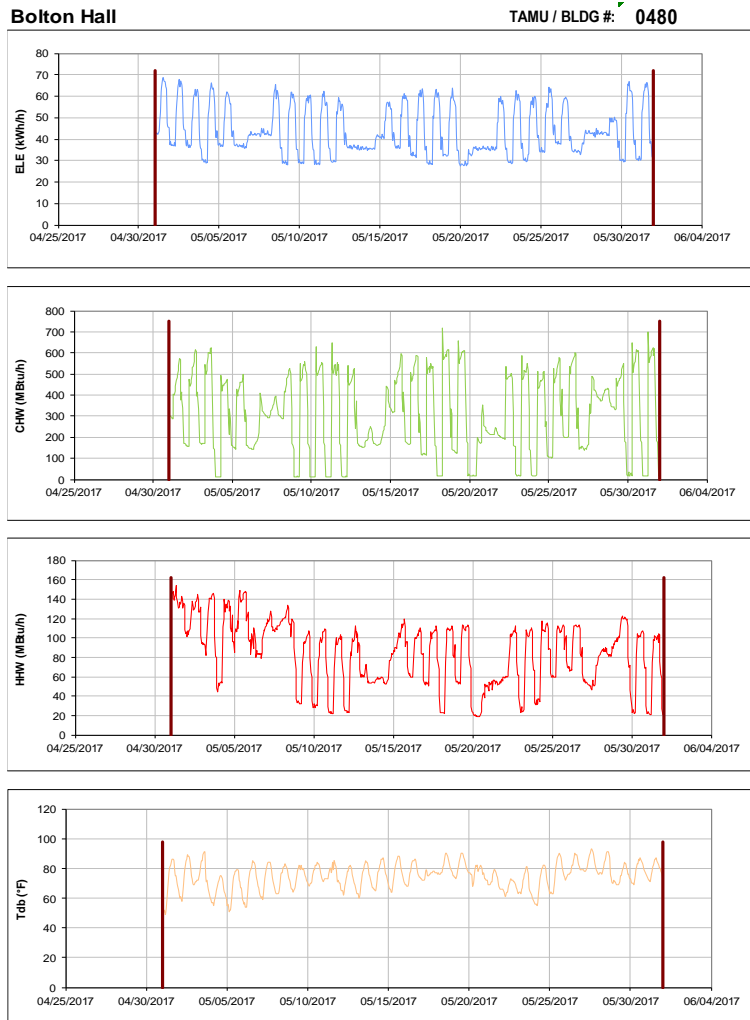
Figure III-97 Hourly Whole Building Electricity, Chilled Water, and Hot Water Consumption for Bolton Hall during the Month of May 2017 and the Corresponding Hourly Outdoor Dry Bulb Temperature for College Station, TX

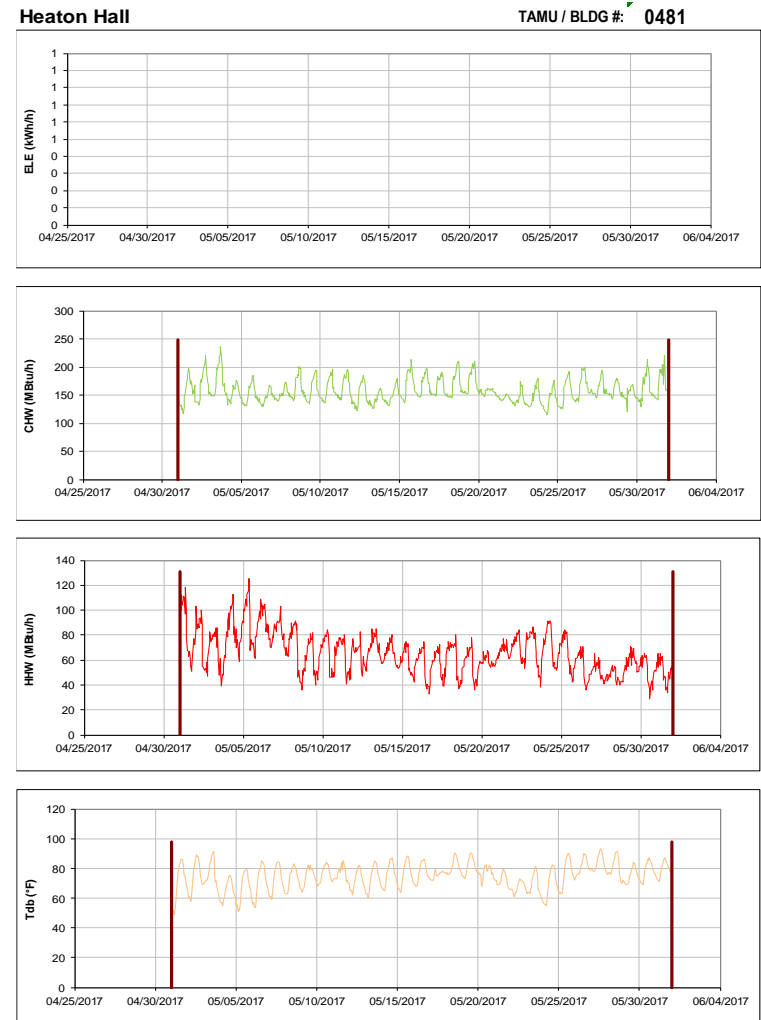
Figure III-98 Hourly Whole Building Electricity, Chilled Water, and Hot Water Consumption for Heaton Hall during the Month of May 2017 and the Corresponding Hourly Outdoor Dry Bulb Temperature for College Station, TX

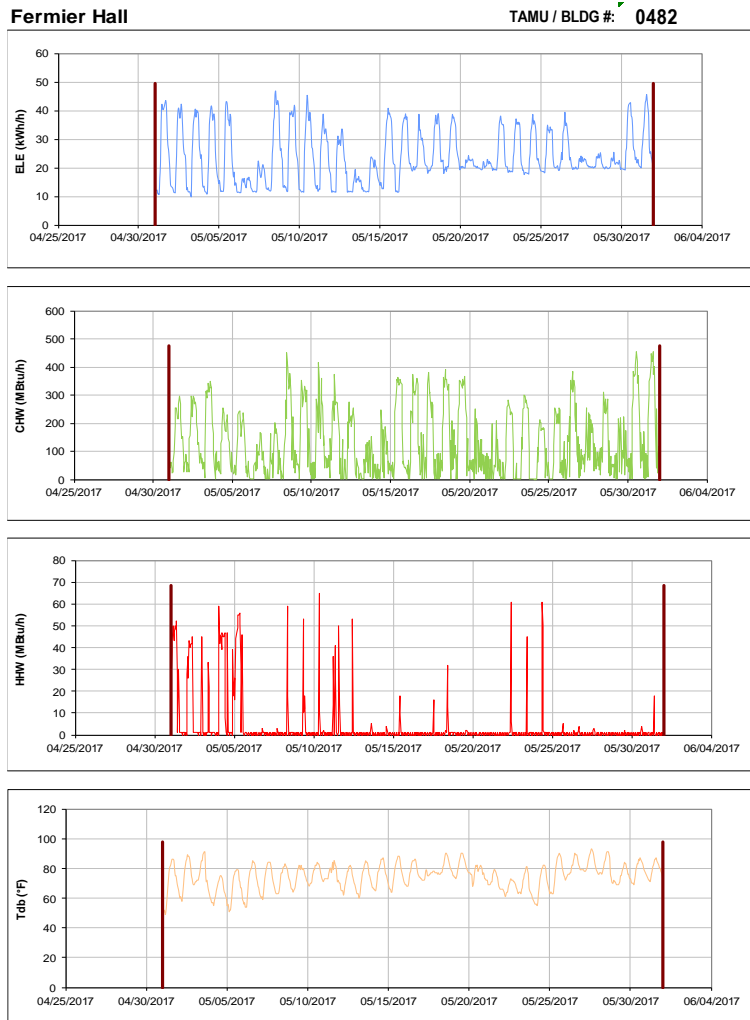
Figure III-99 Hourly Whole Building Electricity, Chilled Water, and Hot Water Consumption for Fermier Hall during the Month of May 2017 and the Corresponding Hourly Outdoor Dry Bulb Temperature for College Station, TX

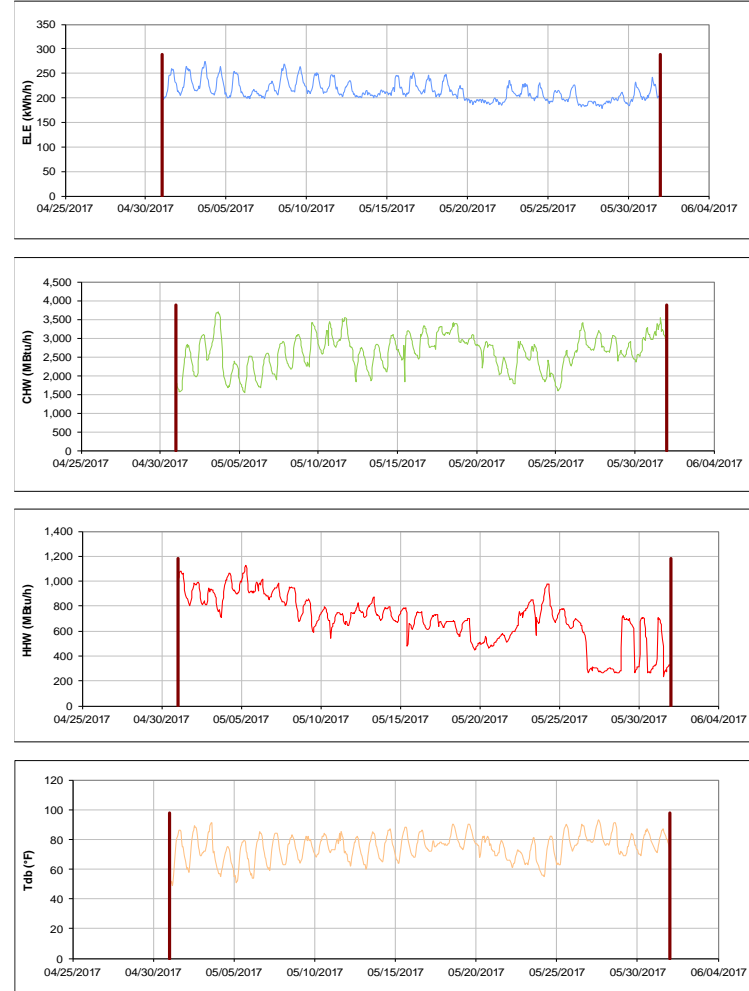
TAMU / BLDG #: 0490

Figure III-102 Hourly Whole Building Electricity, Chilled Water, and Hot Water Consumption for Halbuty Geosciences Building during the Month of May 2017 and the Corresponding Hourly Outdoor Dry Bulb Temperature for College Station, TX

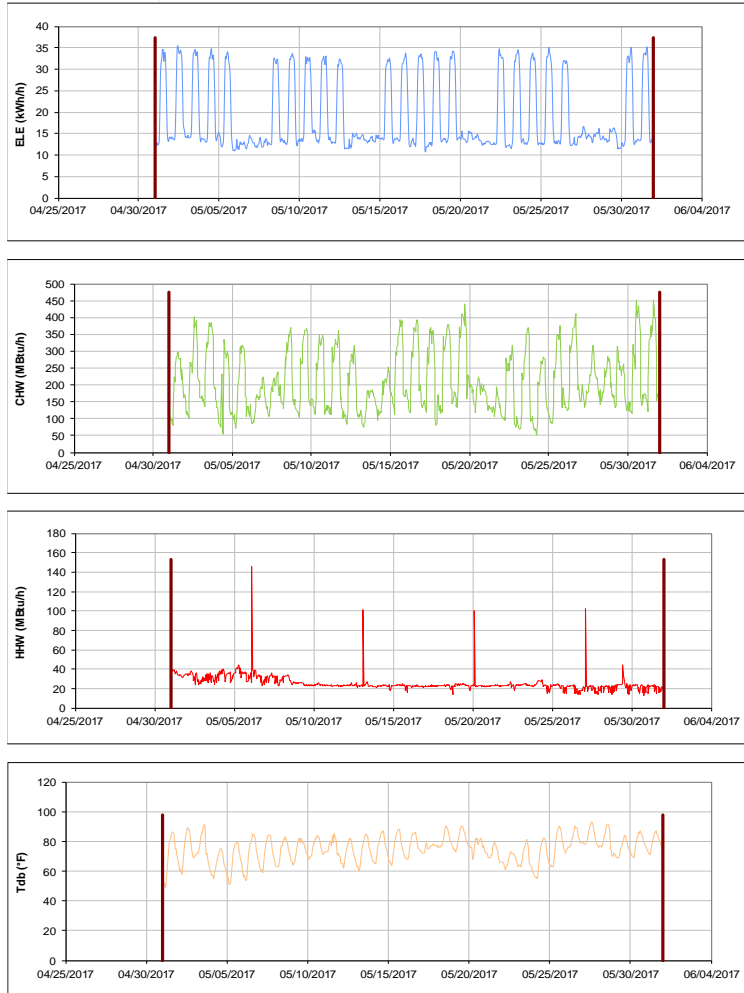
Utilities & Energy Services Central Office TAMU / BLDG #: 0496

Figure III-105 Hourly Whole Building Electricity, Chilled Water, and Hot Water Consumption for Utilities & Energy Services Central Office during the Month of May 2017 and the Corresponding Hourly Outdoor Dry Bulb Temperature for College Station, TX

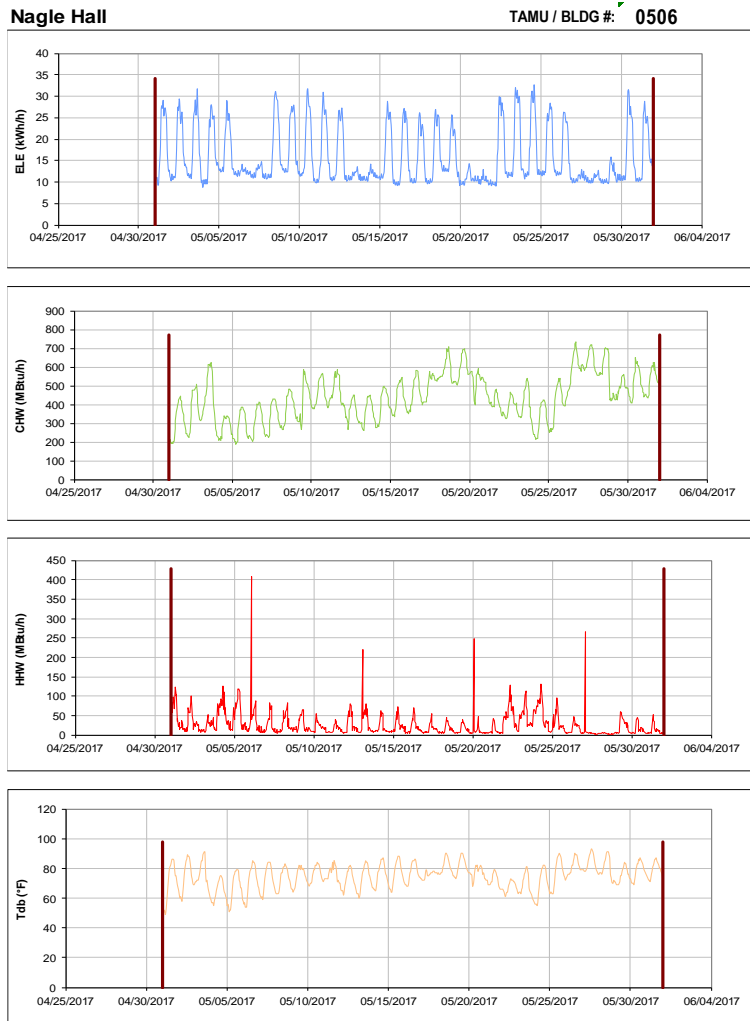
Figure III-107 Hourly Whole Building Electricity, Chilled Water, and Hot Water Consumption for Nagle Hall during the Month of May 2017 and the Corresponding Hourly Outdoor Dry Bulb Temperature for College Station, TX

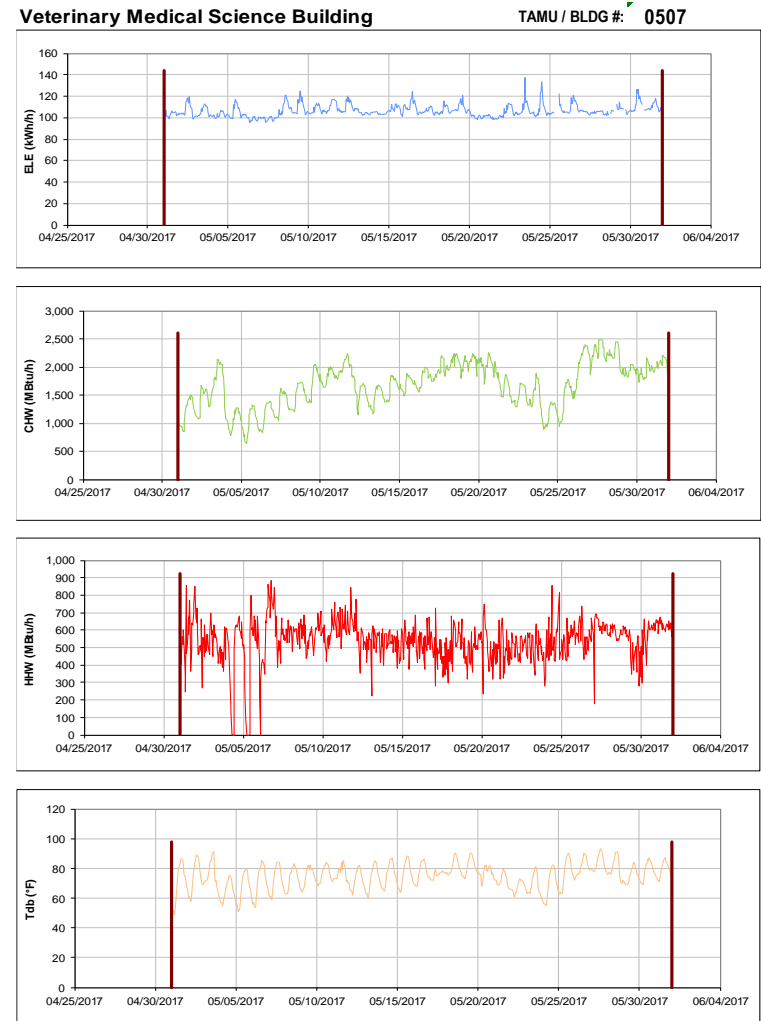
Figure III-108 Hourly Whole Building Electricity, Chilled Water, and Hot Water Consumption for Veterinary Medical Science Building during the Month of May 2017 and the Corresponding Hourly Outdoor Dry Bulb Temperature for College Station, TX

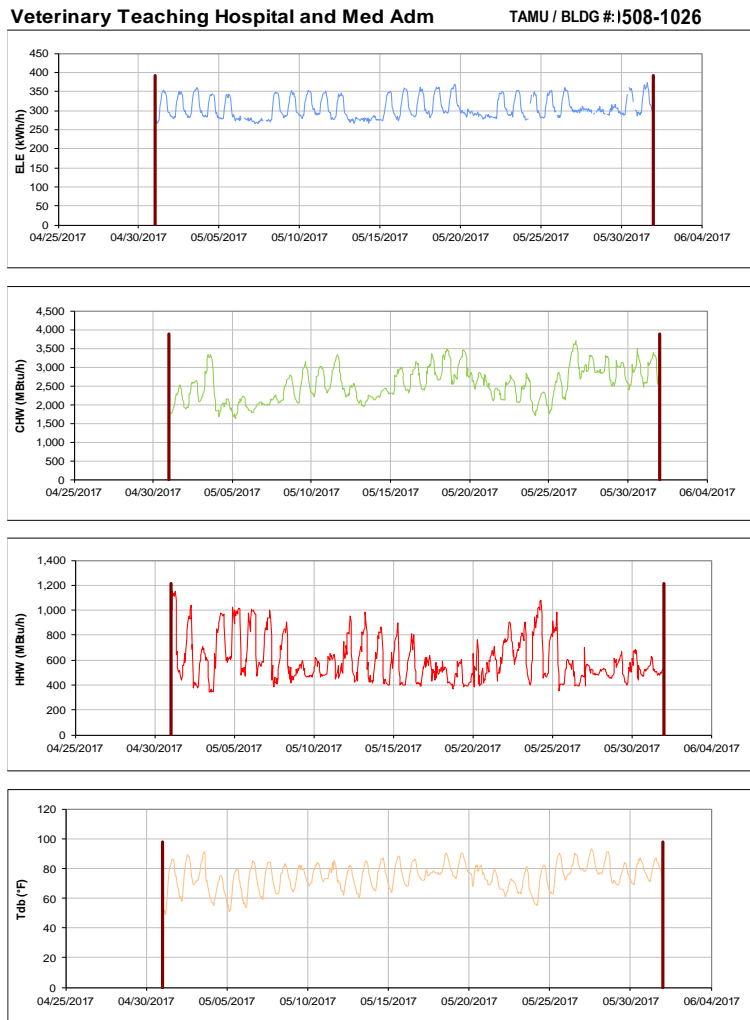
Figure III-109 Hourly Whole Building Electricity, Chilled Water, and Hot Water Consumption for Veterinary Teaching Hospital and Med Adm during the Month of May 2017 and the Corresponding Hourly Outdoor Dry Bulb Temperature for College Station, TX

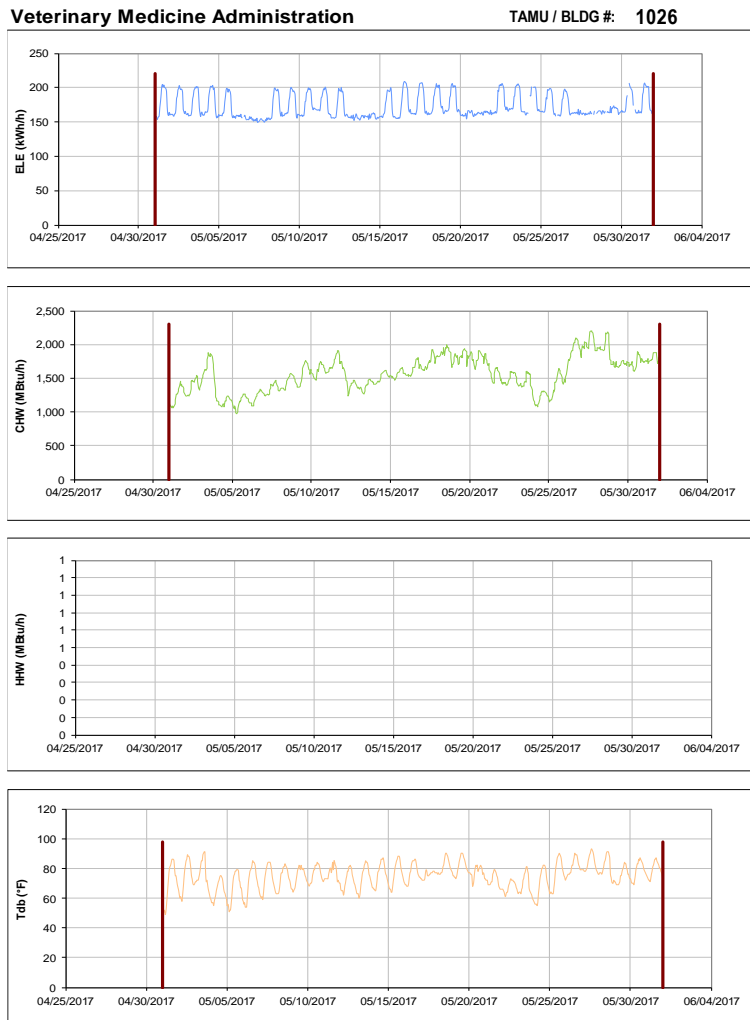
Figure III-111 Hourly Whole Building Electricity, Chilled Water, and Hot Water Consumption for Veterinary Medicine Administration during the Month of May 2017 and the Corresponding Hourly Outdoor Dry Bulb Temperature for College Station, TX

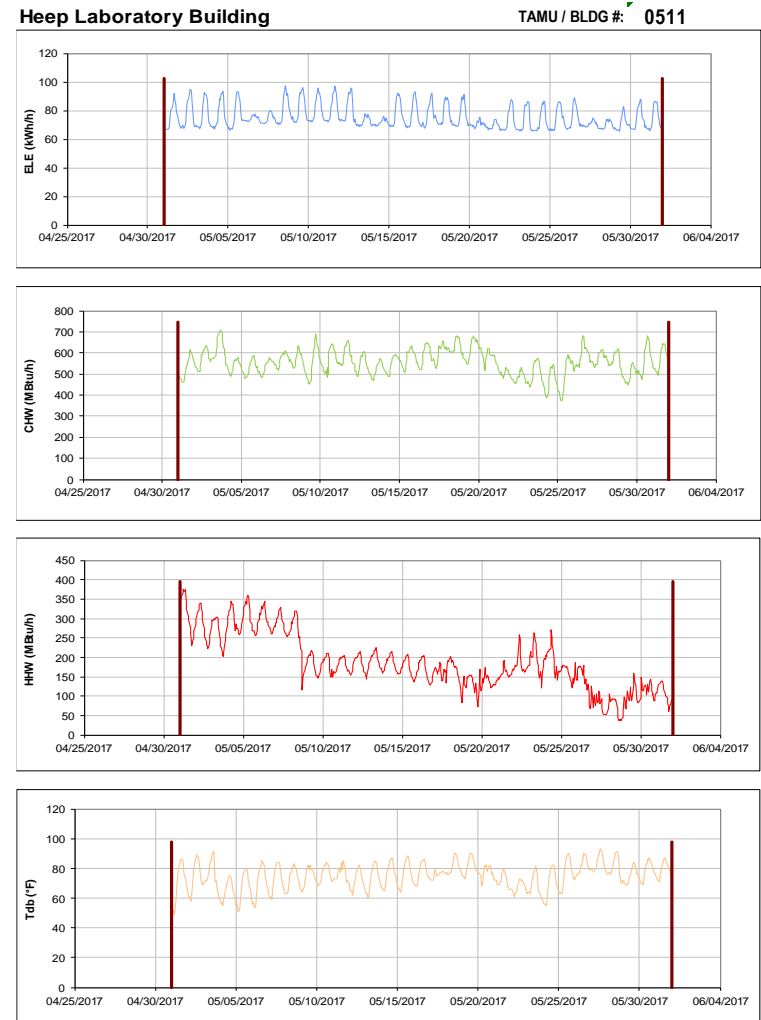
Figure III-112 Hourly Whole Building Electricity, Chilled Water, and Hot Water Consumption for Heep Laboratory Building during the Month of May 2017 and the Corresponding Hourly Outdoor Dry Bulb Temperature for College Station, TX

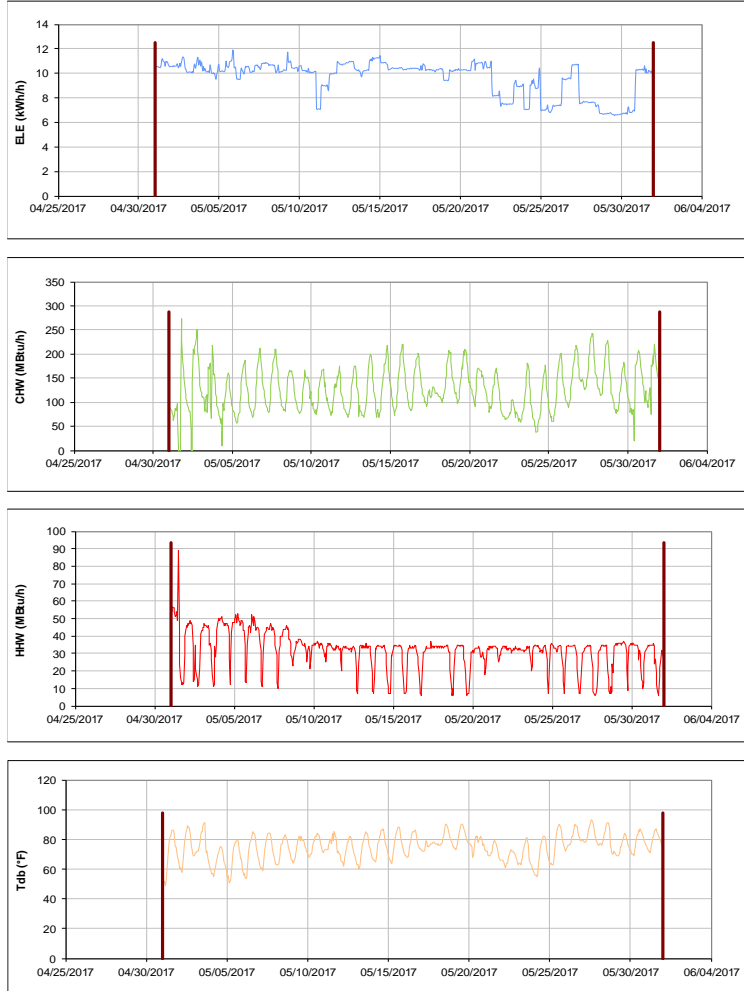
TAMU / BLDG #: 0512

Figure III-113 Hourly Whole Building Electricity, Chilled Water, and Hot Water Consumption for All Faiths Chapel during the Month of May 2017 and the Corresponding Hourly Outdoor Dry Bulb Temperature for College Station, TX

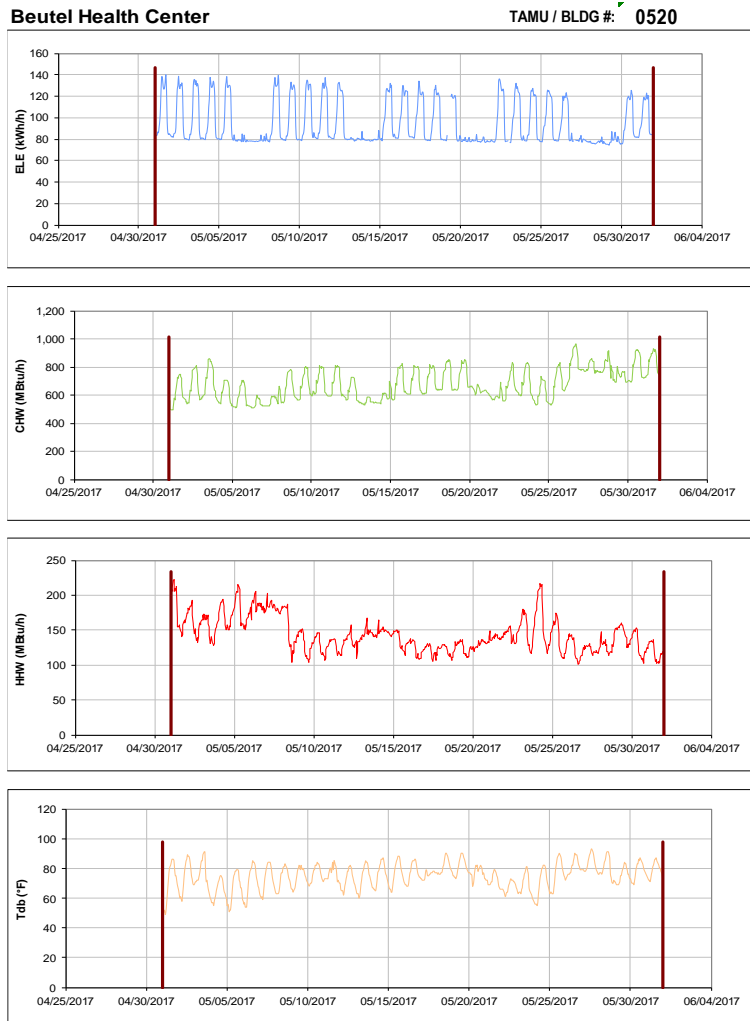
Figure III-117 Hourly Whole Building Electricity, Chilled Water, and Hot Water Consumption for Beutel Health Center during the Month of May 2017 and the Corresponding Hourly Outdoor Dry Bulb Temperature for College Station, TX

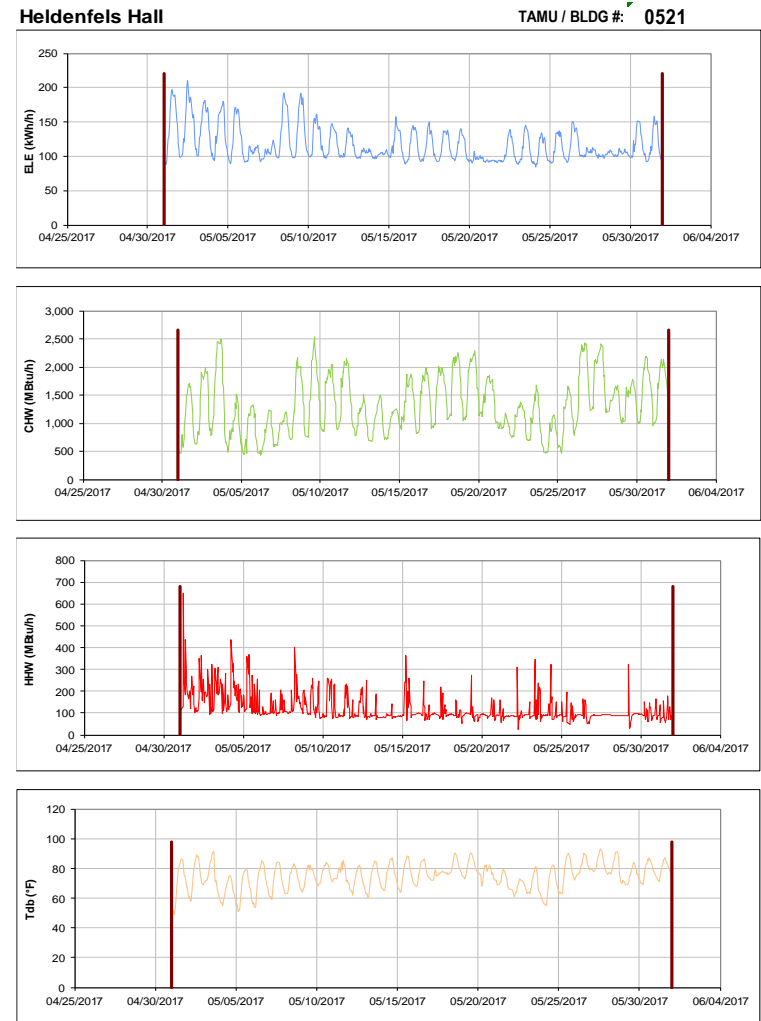
Figure III-118 Hourly Whole Building Electricity, Chilled Water, and Hot Water Consumption for Heldenfels Hall during the Month of May 2017 and the Corresponding Hourly Outdoor Dry Bulb Temperature for College Station, TX

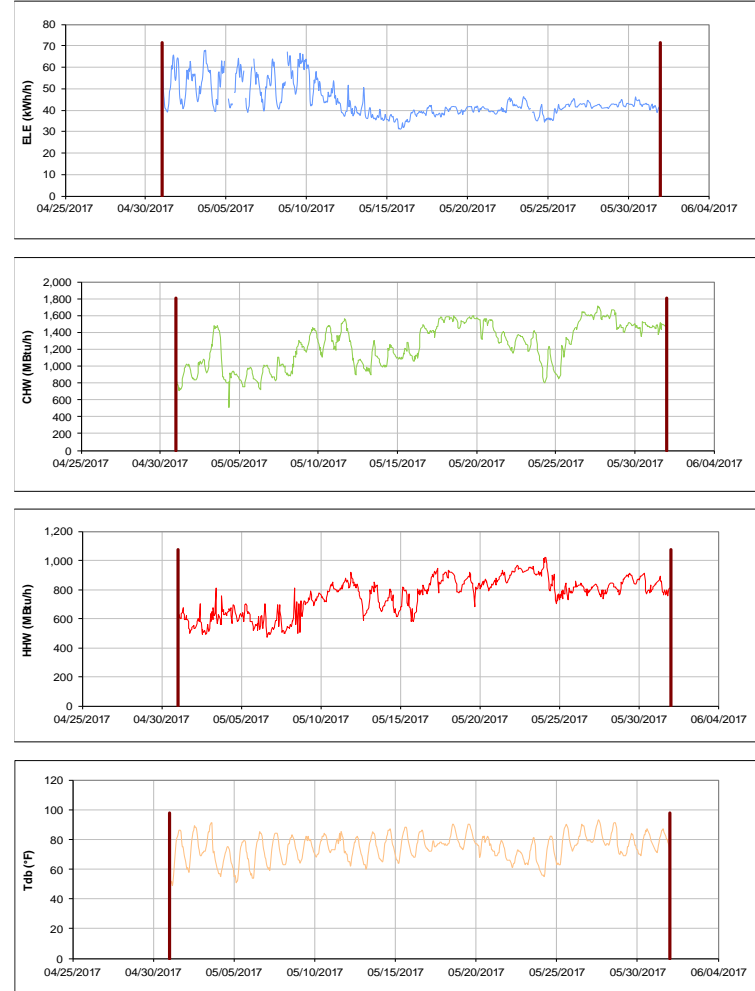
TAMU / BLDG #: 0550

Figure III-122 Hourly Whole Building Electricity, Chilled Water, and Hot Water Consumption for McFadden Residence Hall during the Month of May 2017 and the Corresponding Hourly Outdoor Dry Bulb Temperature for College Station, TX

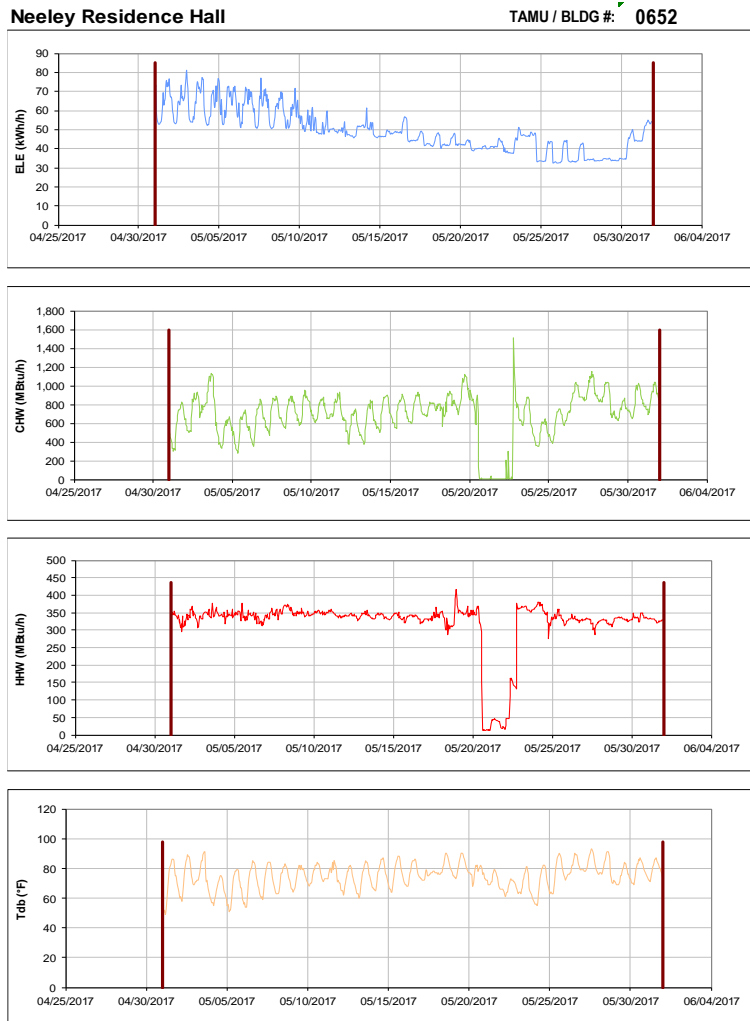
Figure III-123 Hourly Whole Building Electricity, Chilled Water, and Hot Water Consumption for Neeley Residence Hall during the Month of May 2017 and the Corresponding Hourly Outdoor Dry Bulb Temperature for College Station, TX

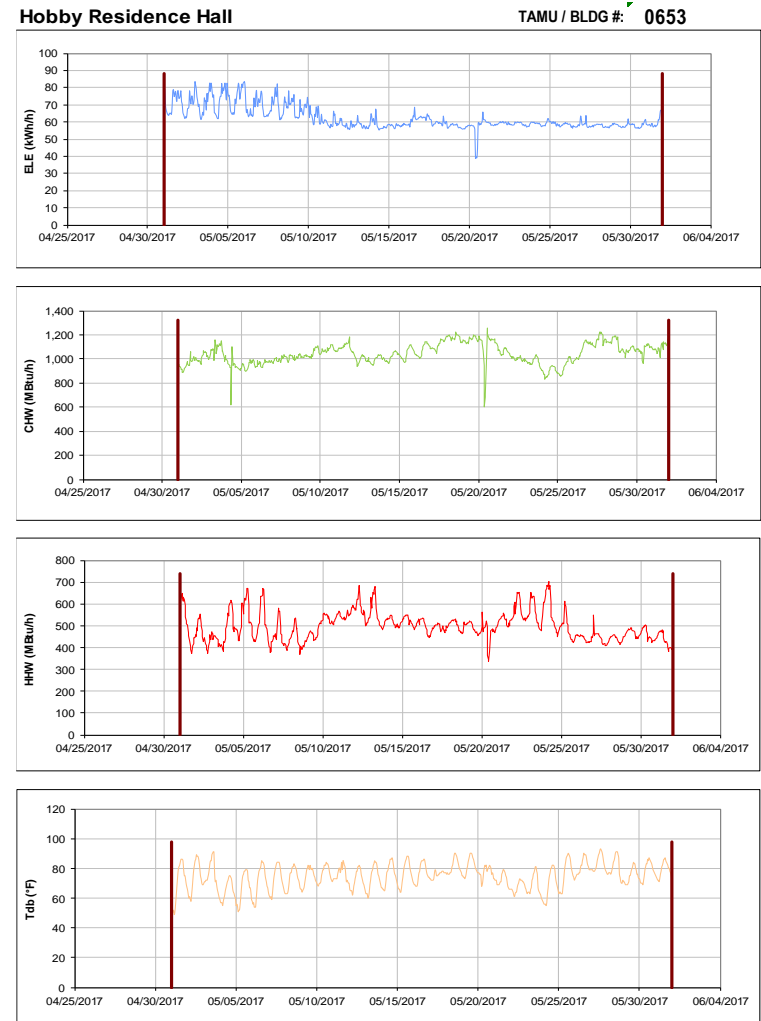
Figure III-124 Hourly Whole Building Electricity, Chilled Water, and Hot Water Consumption for Hobby Residence Hall during the Month of May 2017 and the Corresponding Hourly Outdoor Dry Bulb Temperature for College Station, TX

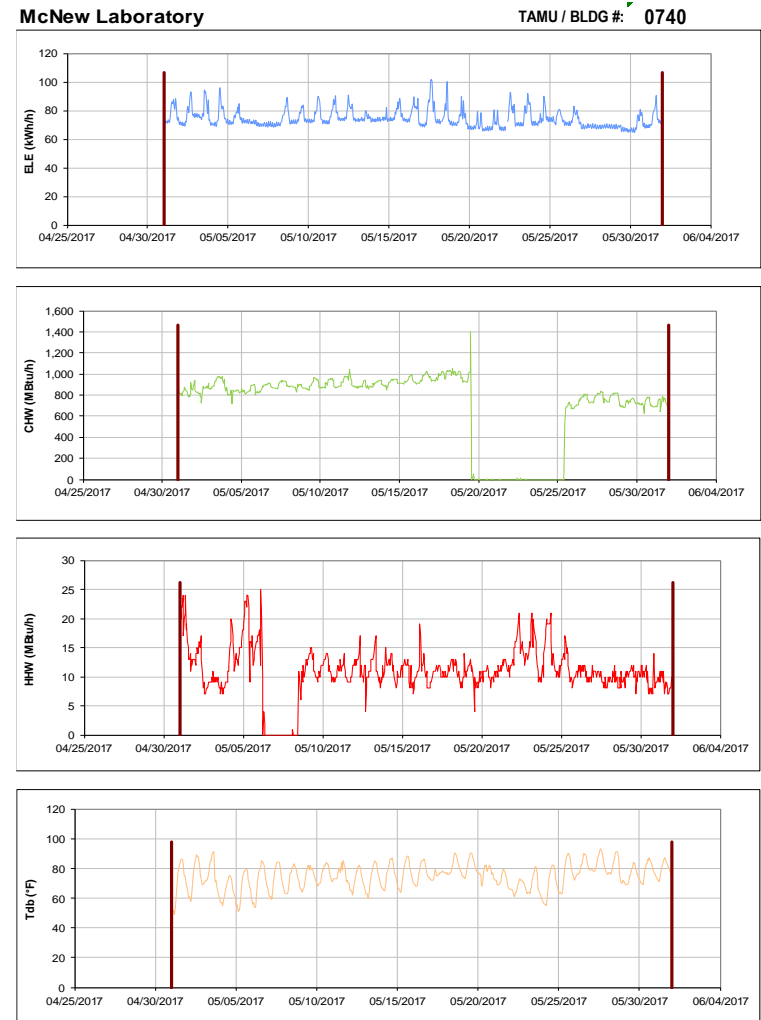
Figure III-126 Hourly Whole Building Electricity, Chilled Water, and Hot Water Consumption for McNew Laboratory during the Month of May 2017 and the Corresponding Hourly Outdoor Dry Bulb Temperature for College Station, TX
