TAMU Project

**Energy Consumption Data Quality Assurance/Quality
Control Assessment Report for the
Month of May 2017**

**Utility & Energy Services
Division of Administration
Texas A&M University**

June 2017

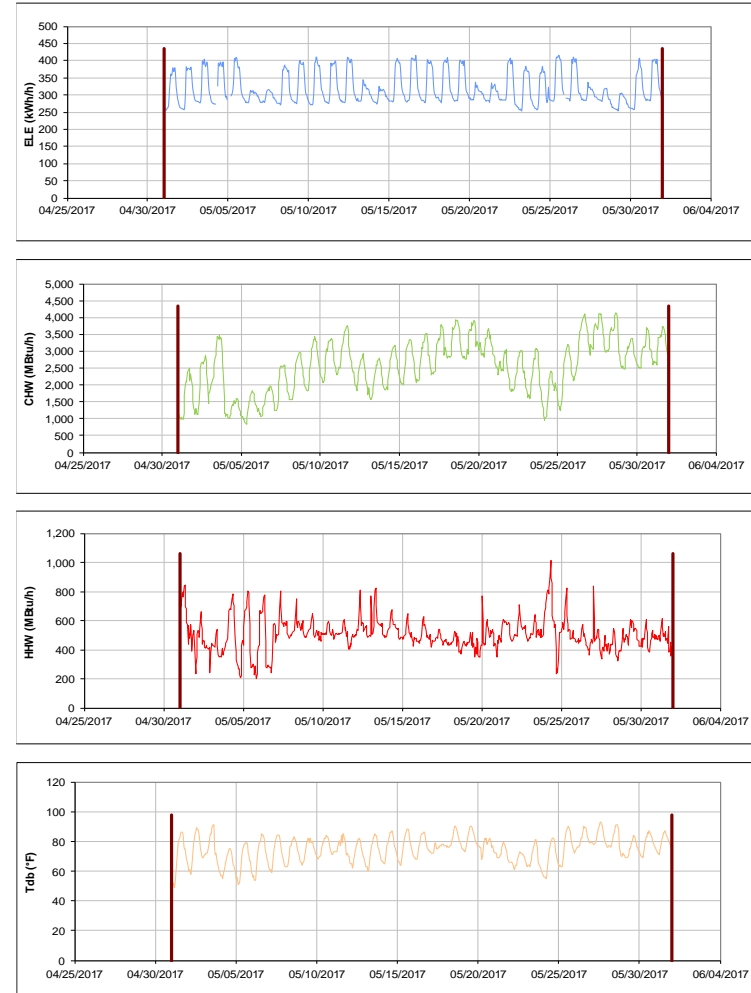
TAMU / BLDG #: 1085

Figure III-134 Hourly Whole Building Electricity, Chilled Water, and Hot Water Consumption for Veterinary Small Animal Hospital during the Month of May 2017 and the Corresponding Hourly Outdoor Dry Bulb Temperature for College Station, TX

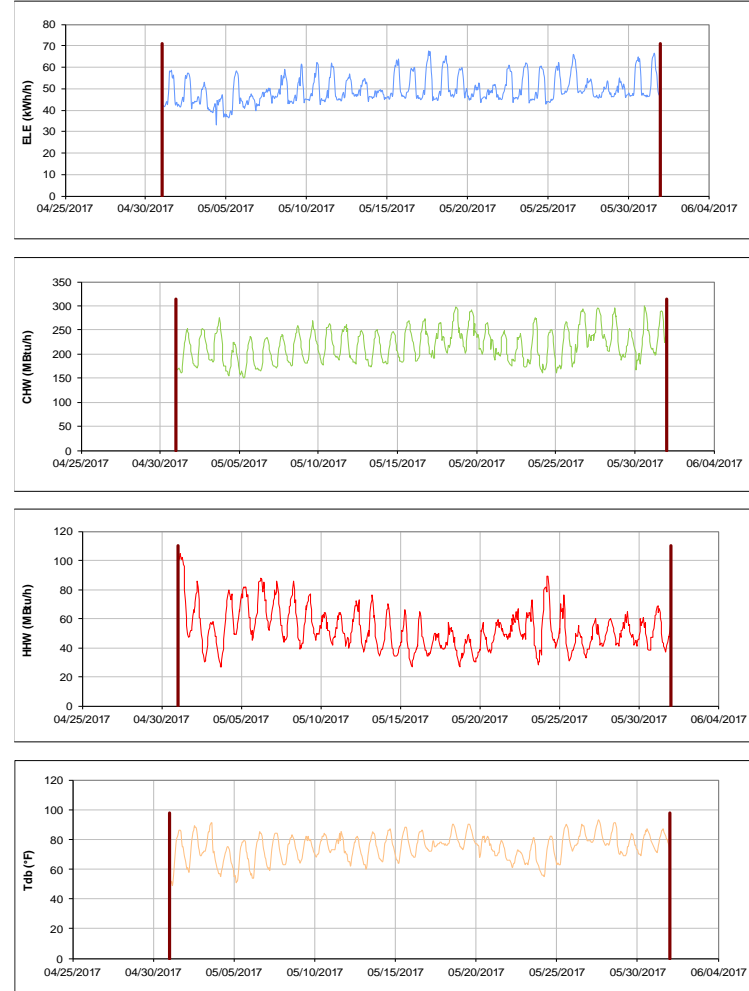
TAMU / BLDG #: 1146

Figure III-136 Hourly Whole Building Electricity, Chilled Water, and Hot Water Consumption for Biological Control Facility during the Month of May 2017 and the Corresponding Hourly Outdoor Dry Bulb Temperature for College Station, TX

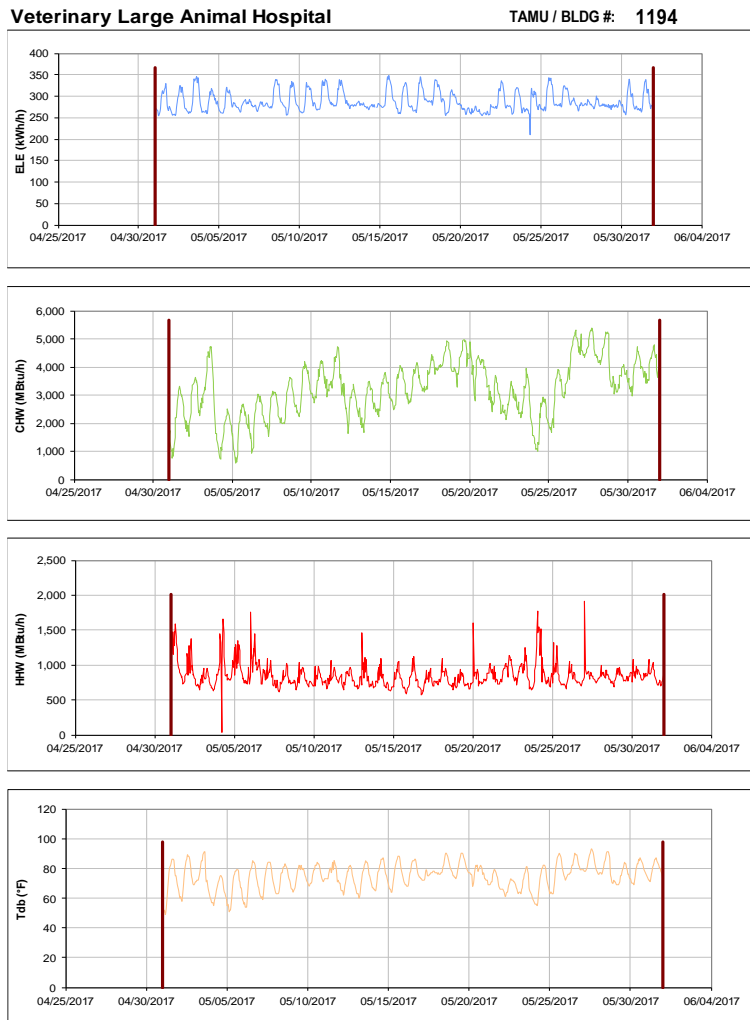
Figure III-139 Hourly Whole Building Electricity, Chilled Water, and Hot Water Consumption for Veterinary Large Animal Hospital during the Month of May 2017 and the Corresponding Hourly Outdoor Dry Bulb Temperature for College Station, TX

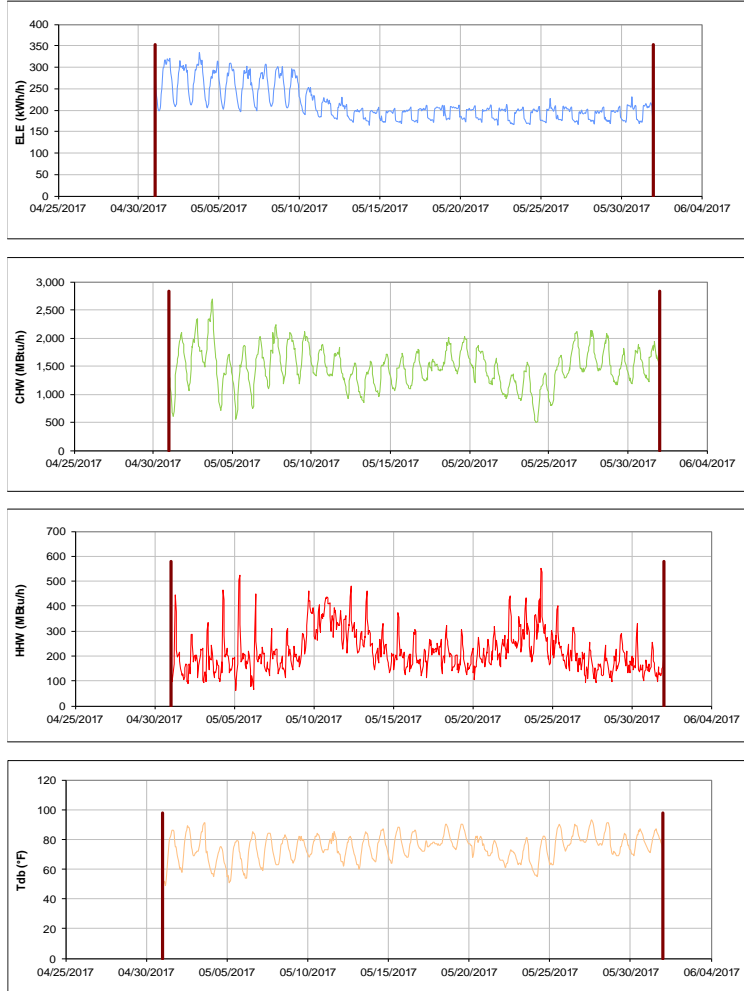
TAMU / BLDG #: 1416

Figure III-141 Hourly Whole Building Electricity, Chilled Water, and Hot Water Consumption for Hullabaloo Residence Hall during the Month of May 2017 and the Corresponding Hourly Outdoor Dry Bulb Temperature for College Station, TX

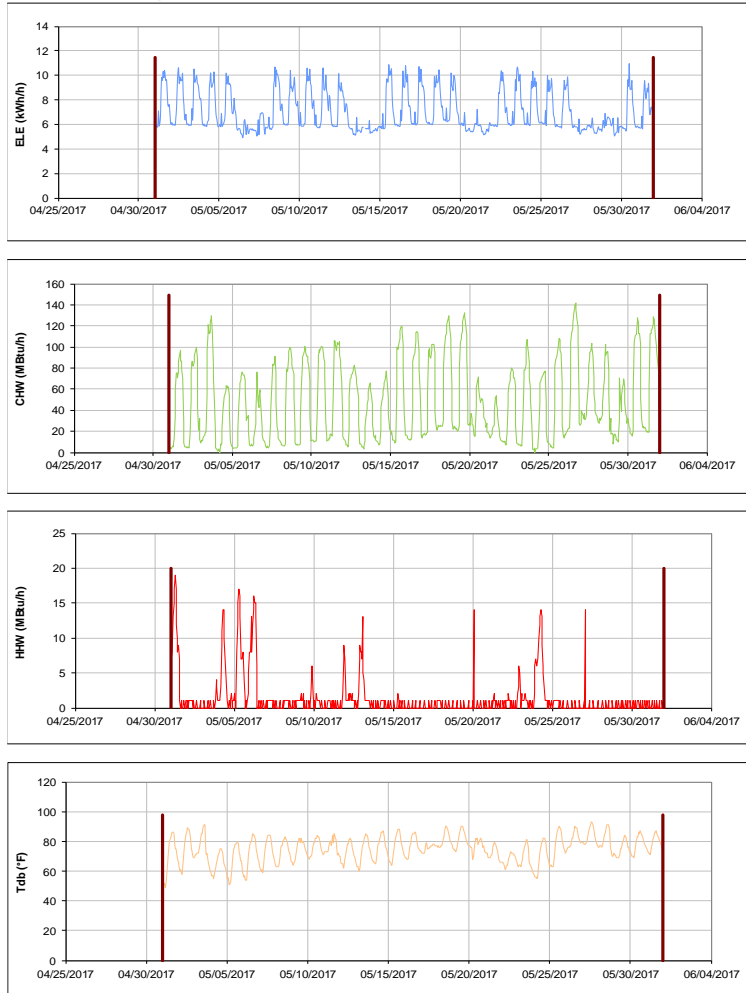
Utilities & Energy Services Business Office TAMU / BLDG #: 1497

Figure III-153 Hourly Whole Building Electricity, Chilled Water, and Hot Water Consumption for Utilities & Energy Services Business Office during the Month of May 2017 and the Corresponding Hourly Outdoor Dry Bulb Temperature for College Station, TX

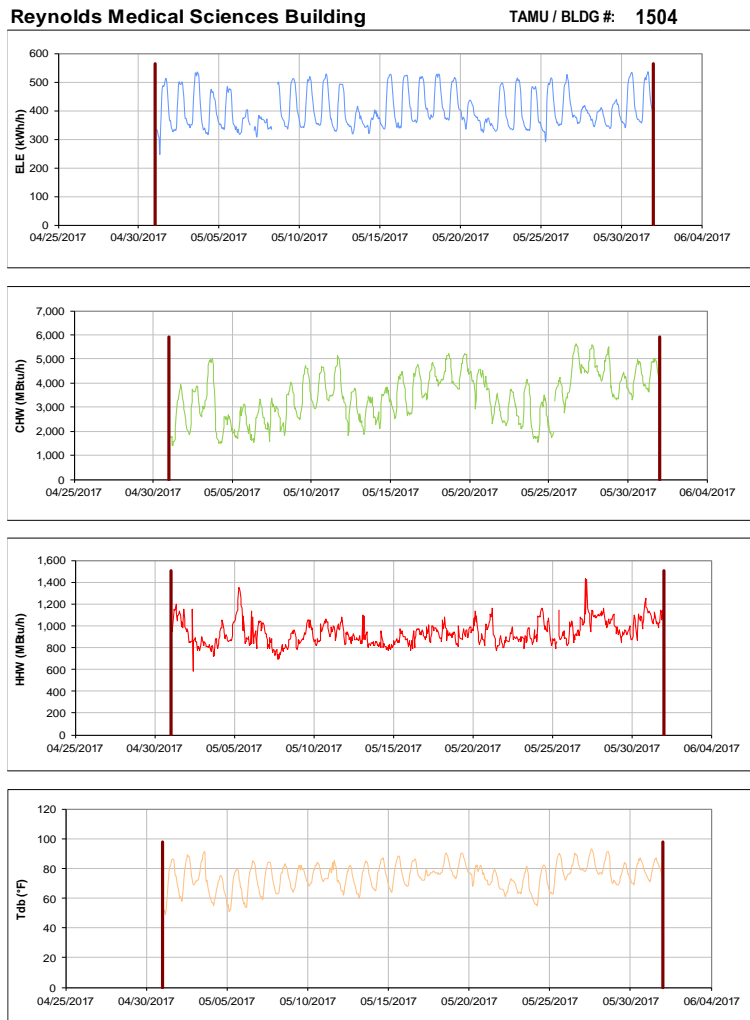
Figure III-157 Hourly Whole Building Electricity, Chilled Water, and Hot Water Consumption for Reynolds Medical Sciences Building during the Month of May 2017 and the Corresponding Hourly Outdoor Dry Bulb Temperature for College Station, TX

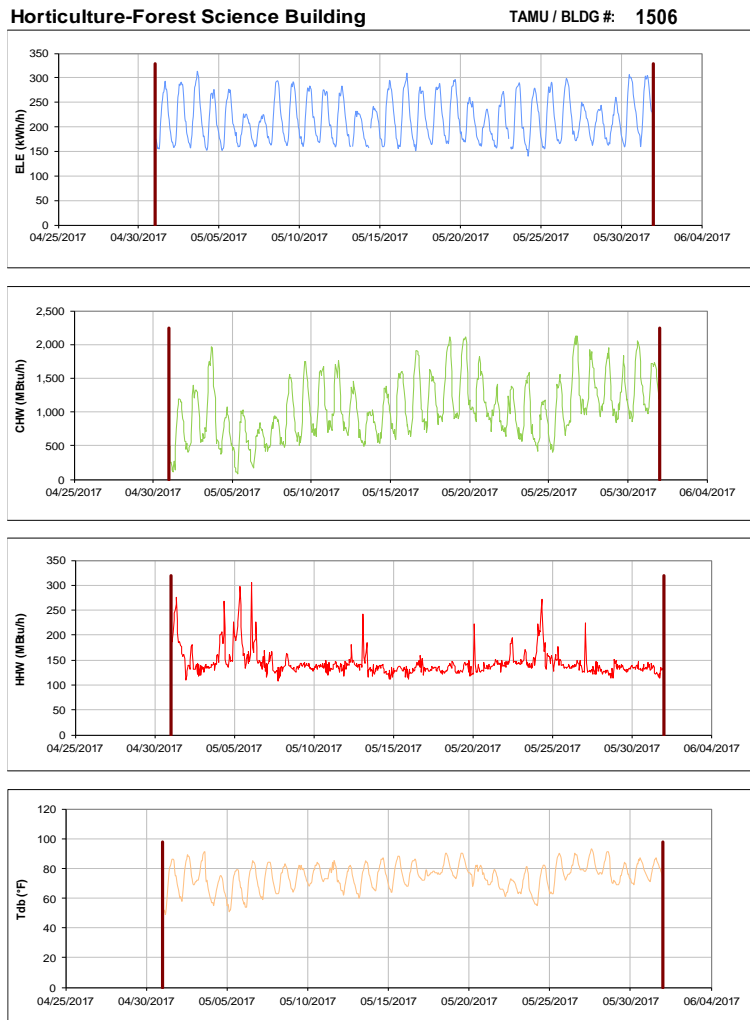
Figure III-159 Hourly Whole Building Electricity, Chilled Water, and Hot Water Consumption for Horticulture-Forest Science Building during the Month of May 2017 and the Corresponding Hourly Outdoor Dry Bulb Temperature for College Station, TX

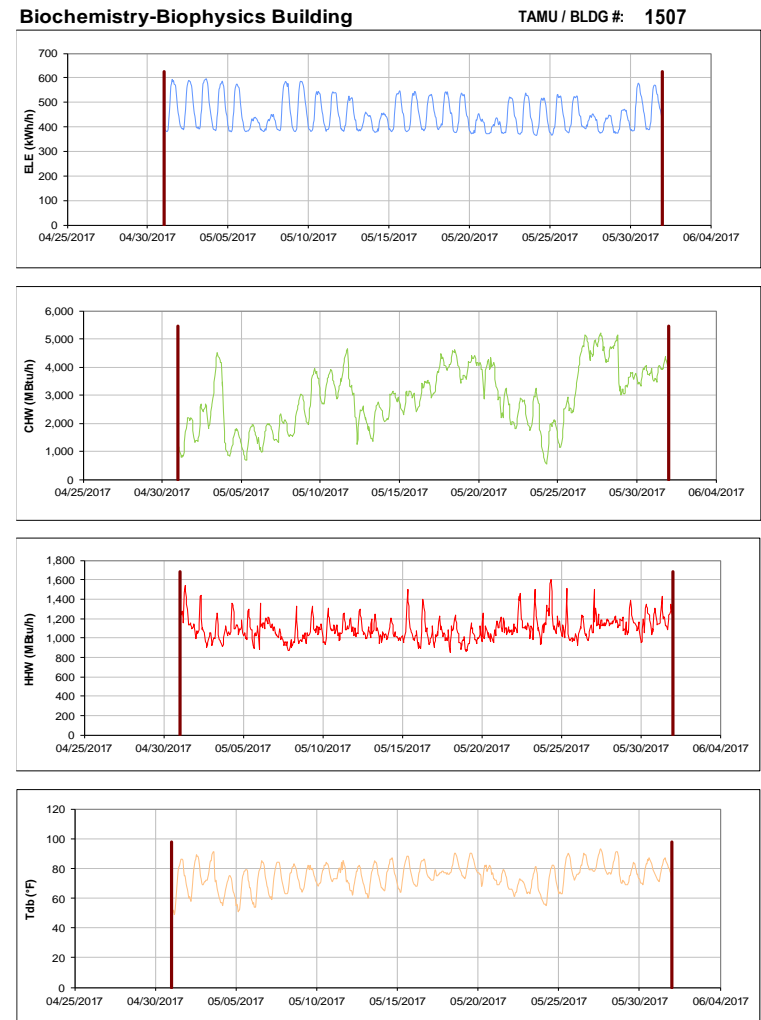
Figure III-160 Hourly Whole Building Electricity, Chilled Water, and Hot Water Consumption for Biochemistry-Biophysics Building during the Month of May 2017 and the Corresponding Hourly Outdoor Dry Bulb Temperature for College Station, TX

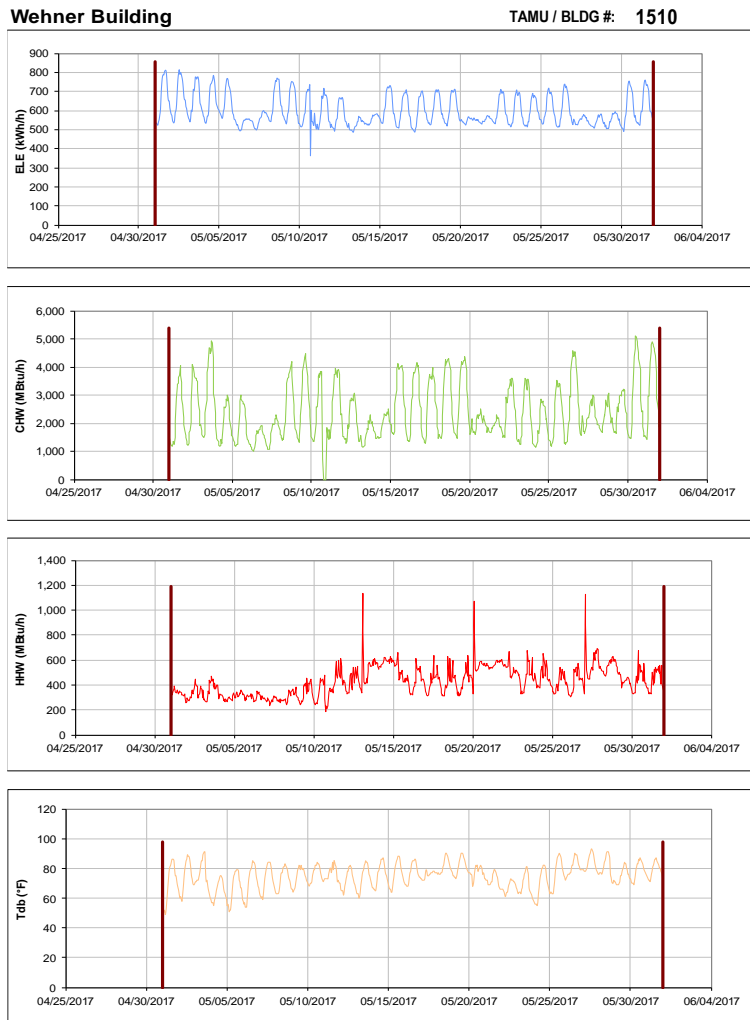
Figure III-163 Hourly Whole Building Electricity, Chilled Water, and Hot Water Consumption for Wehner Building during the Month of May 2017 and the Corresponding Hourly Outdoor Dry Bulb Temperature for College Station, TX

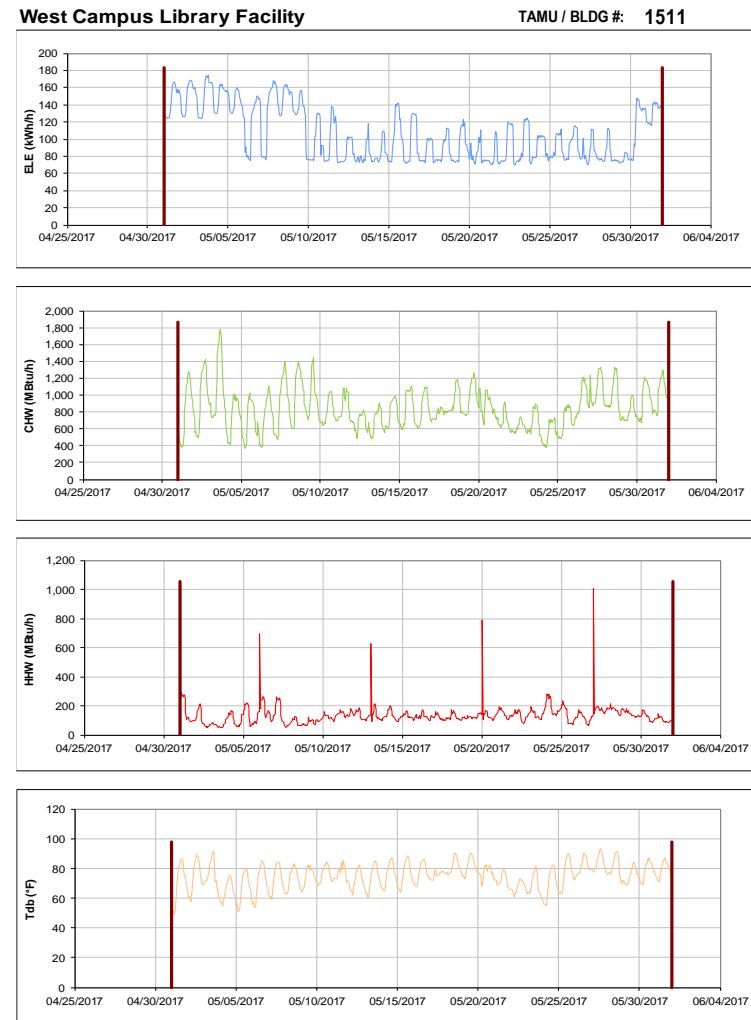
Figure III-164 Hourly Whole Building Electricity, Chilled Water, and Hot Water Consumption for West Campus Library Facility during the Month of May 2017 and the Corresponding Hourly Outdoor Dry Bulb Temperature for College Station, TX

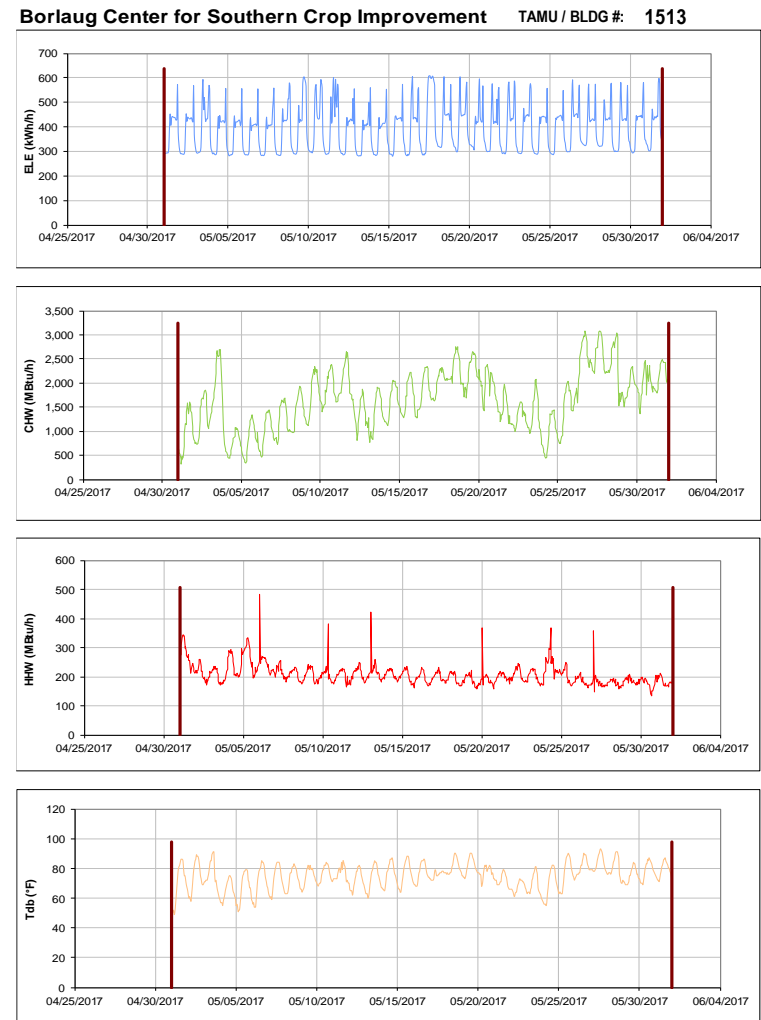
Figure III-166 Hourly Whole Building Electricity, Chilled Water, and Hot Water Consumption for Borlaug Center for Southern Crop Improvement during the Month of May 2017 and the Corresponding Hourly Outdoor Dry Bulb Temperature for College Station, TX

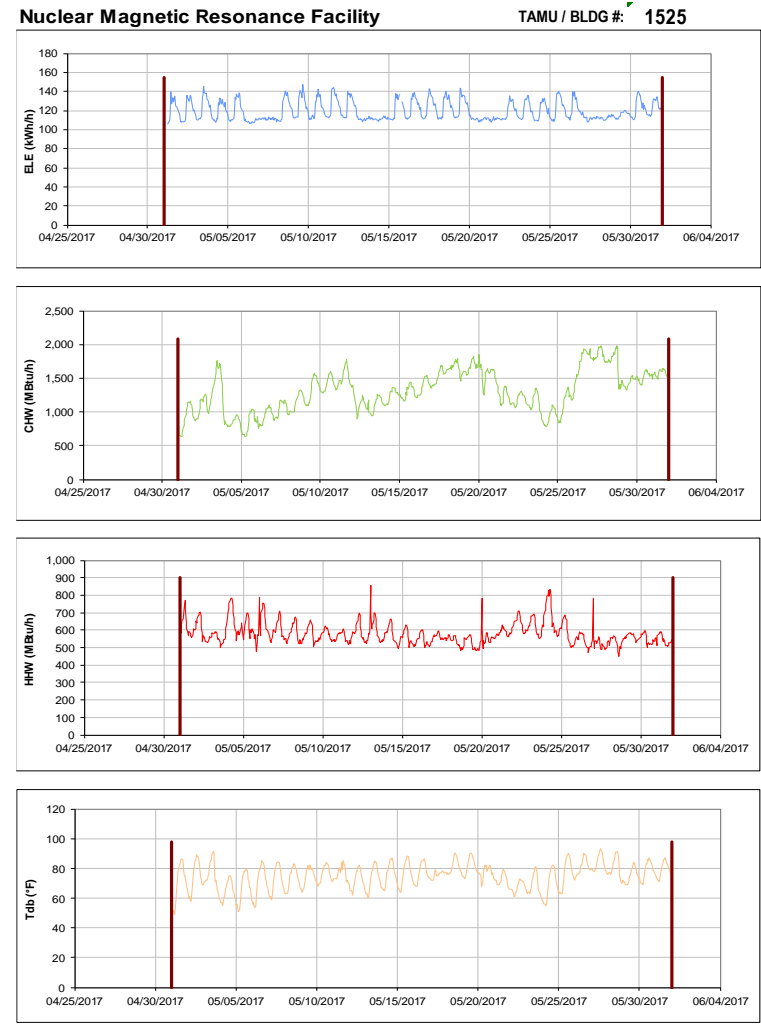
Figure III-168 Hourly Whole Building Electricity, Chilled Water, and Hot Water Consumption for Nuclear Magnetic Resonance Facility during the Month of May 2017 and the Corresponding Hourly Outdoor Dry Bulb Temperature for College Station, TX

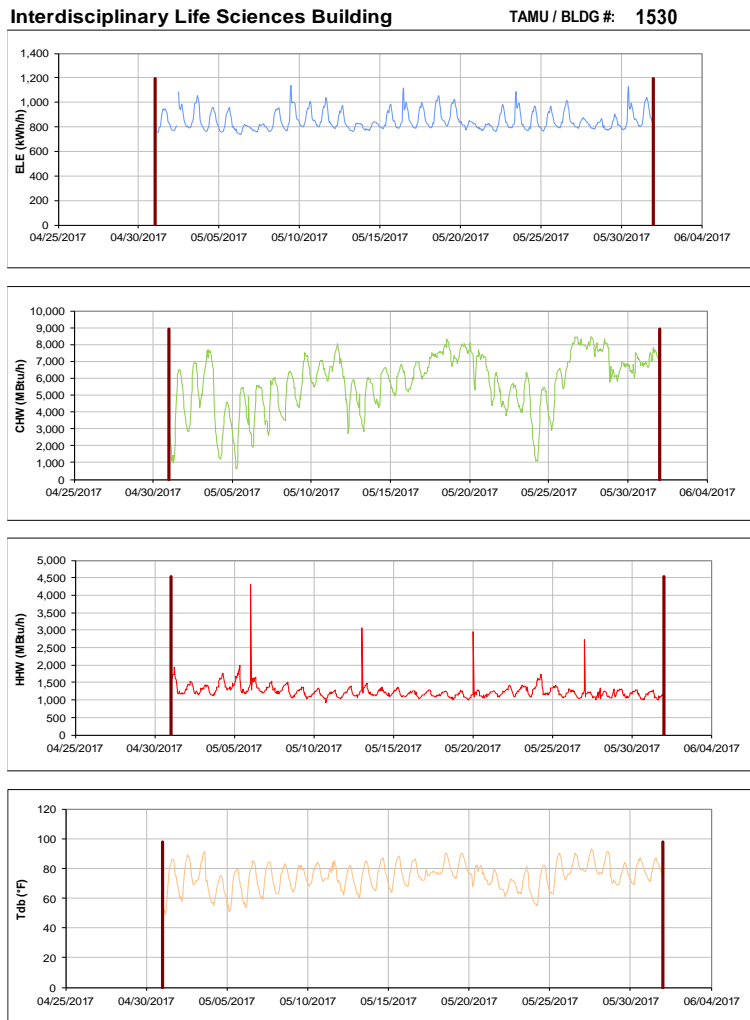
Figure III-169 Hourly Whole Building Electricity, Chilled Water, and Hot Water Consumption for Interdisciplinary Life Sciences Building during the Month of May 2017 and the Corresponding Hourly Outdoor Dry Bulb Temperature for College Station, TX

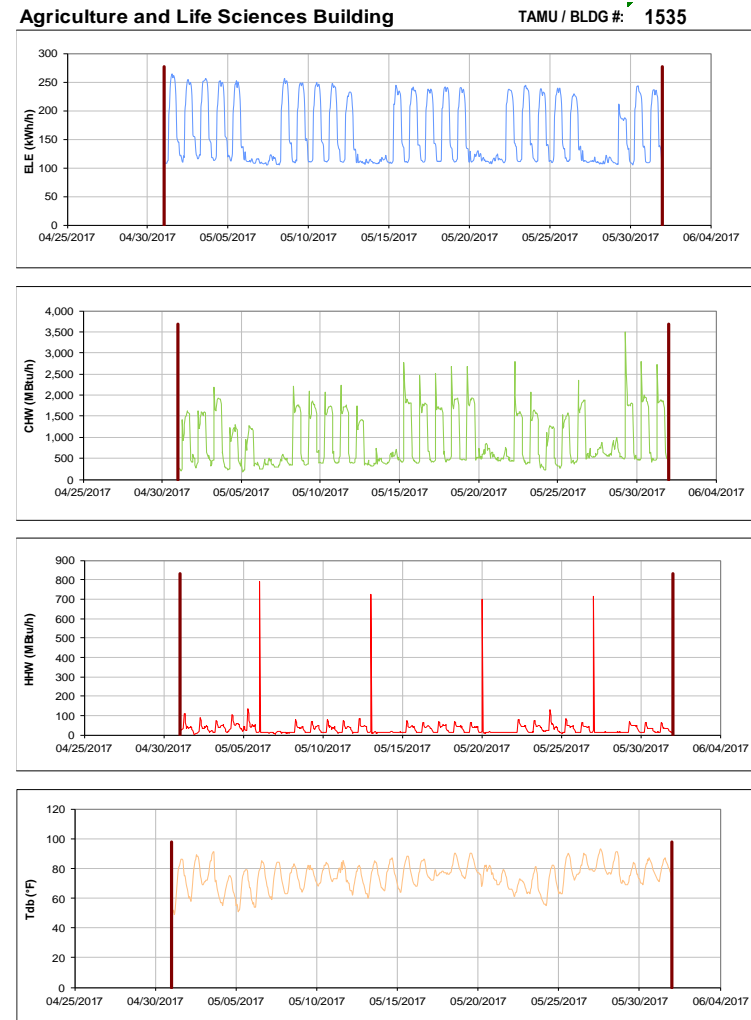
Figure III-170 Hourly Whole Building Electricity, Chilled Water, and Hot Water Consumption for Agriculture and Life Sciences Building during the Month of May 2017 and the Corresponding Hourly Outdoor Dry Bulb Temperature for College Station, TX

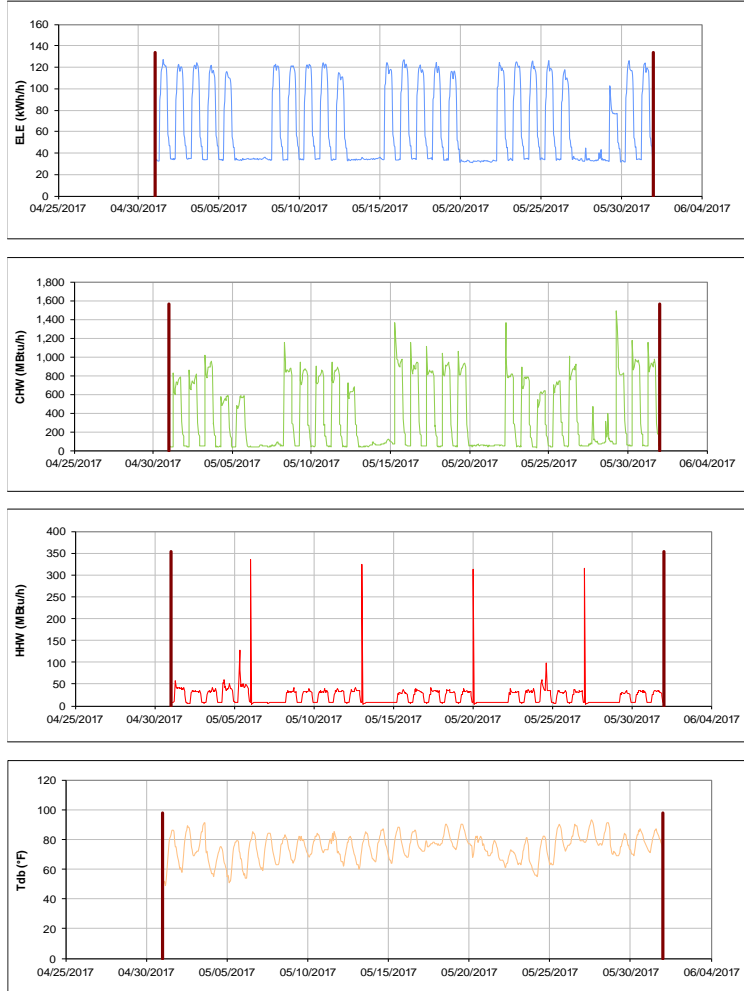
TAMU / BLDG #: 1536

Figure III-171 Hourly Whole Building Electricity, Chilled Water, and Hot Water Consumption for AgriLife Services Building during the Month of May 2017 and the Corresponding Hourly Outdoor Dry Bulb Temperature for College Station, TX

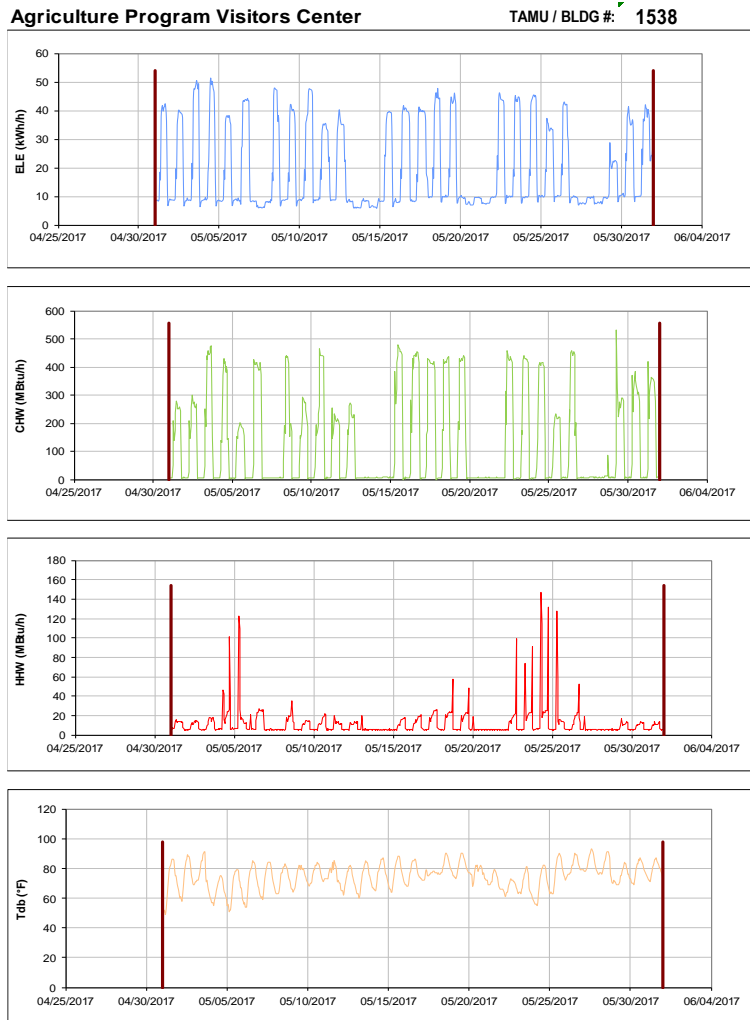
Figure III-173 Hourly Whole Building Electricity, Chilled Water, and Hot Water Consumption for Agriculture Program Visitors Center during the Month of May 2017 and the Corresponding Hourly Outdoor Dry Bulb Temperature for College Station, TX

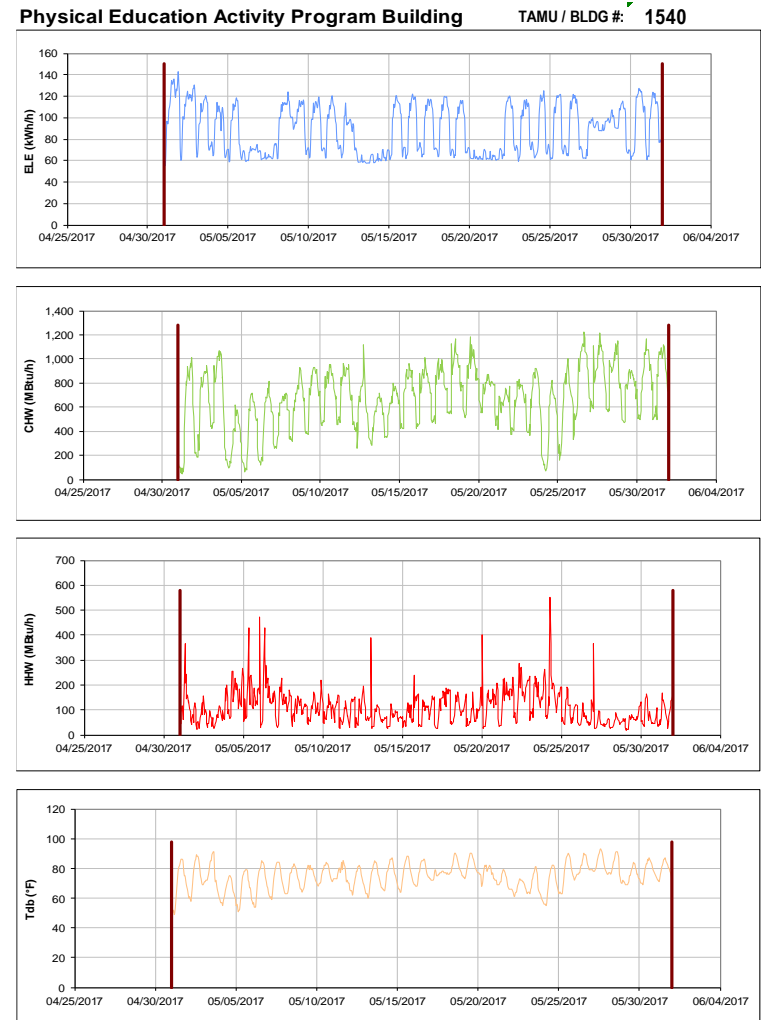
Figure III-174 Hourly Whole Building Electricity, Chilled Water, and Hot Water Consumption for Physical Education Activity Program Building during the Month of May 2017 and the Corresponding Hourly Outdoor Dry Bulb Temperature for College Station, TX

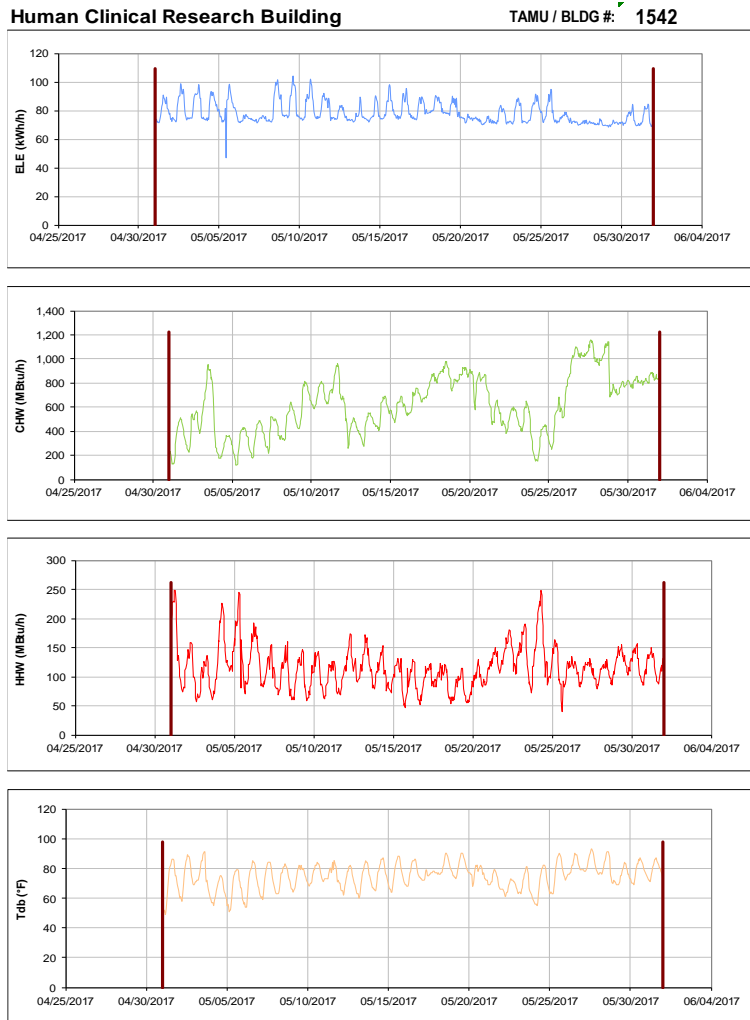
Figure III-175 Hourly Whole Building Electricity, Chilled Water, and Hot Water Consumption for Human Clinical Research Building during the Month of May 2017 and the Corresponding Hourly Outdoor Dry Bulb Temperature for College Station, TX

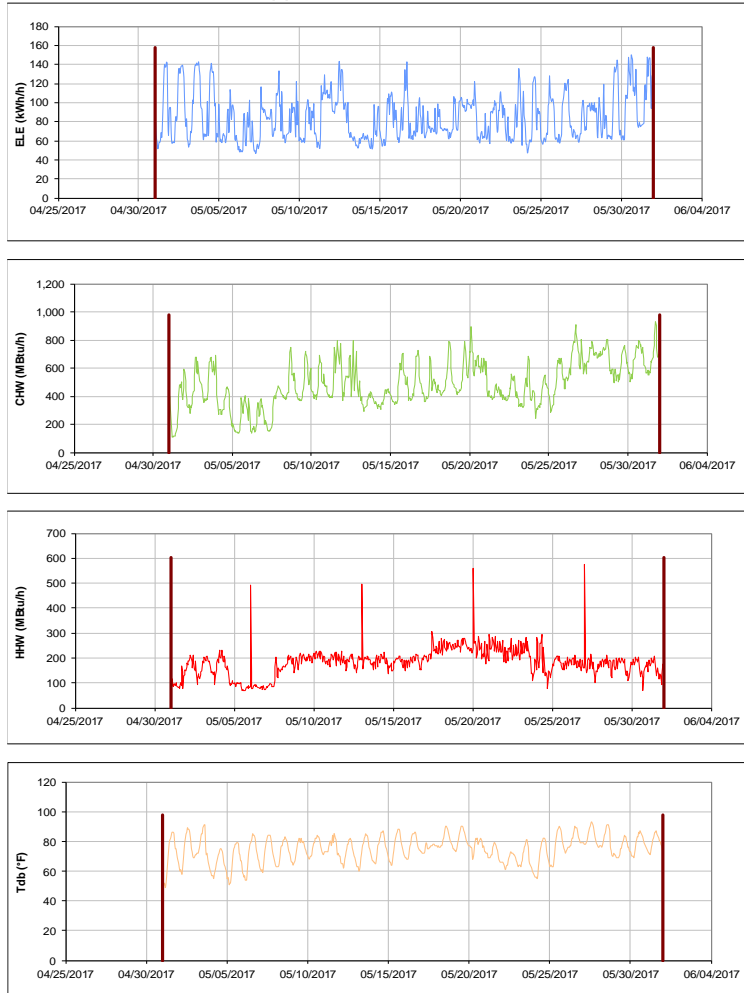
Cox-McFerrin Center for Aggie Basketball TAMU / BLDG #: 1558

Figure III-179 Hourly Whole Building Electricity, Chilled Water, and Hot Water Consumption for Cox-McFerrin Center for Aggie Basketball during the Month of May 2017 and the Corresponding Hourly Outdoor Dry Bulb Temperature for College Station, TX

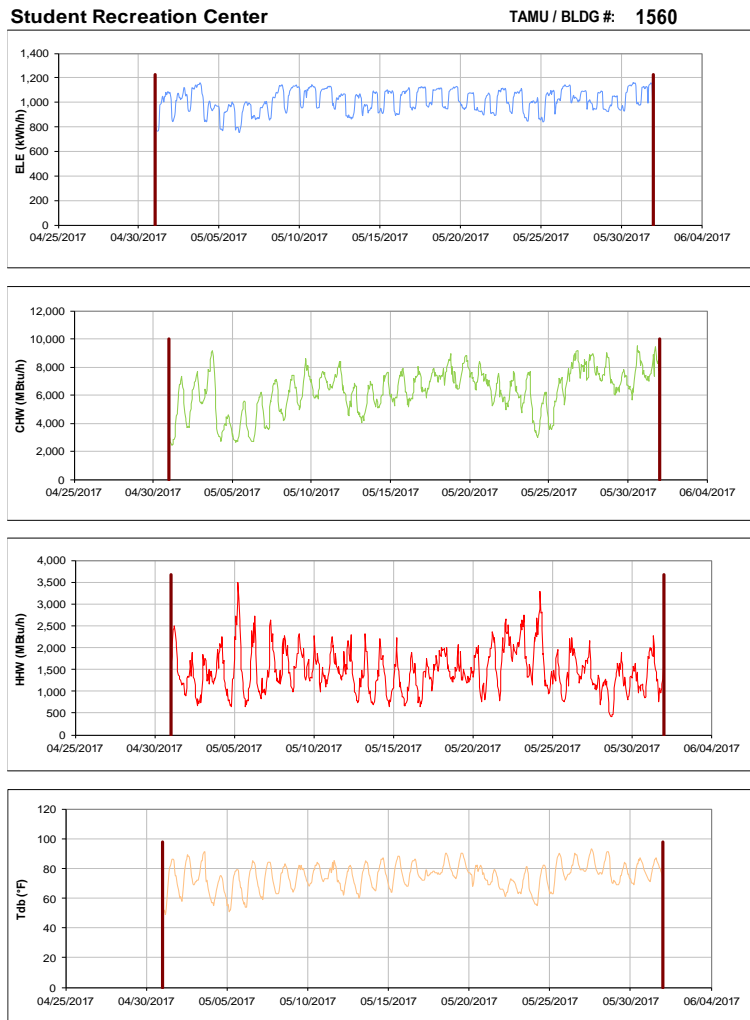
Figure III-181 Hourly Whole Building Electricity, Chilled Water, and Hot Water Consumption for Student Recreation Center during the Month of May 2017 and the Corresponding Hourly Outdoor Dry Bulb Temperature for College Station, TX

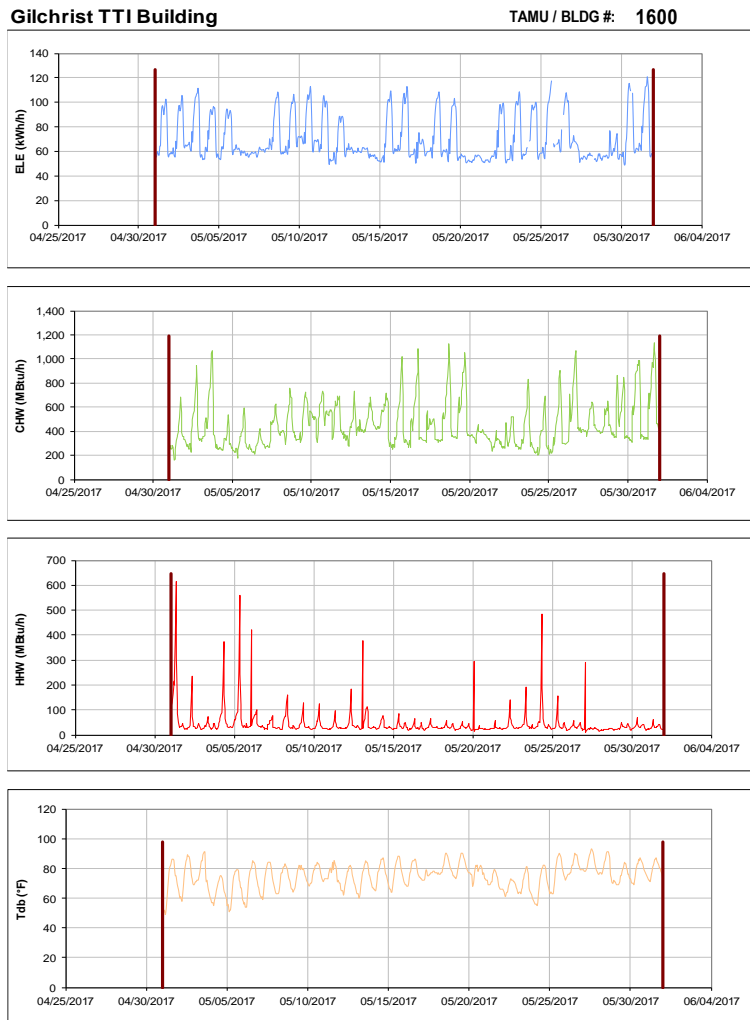
Figure III-185 Hourly Whole Building Electricity, Chilled Water, and Hot Water Consumption for Gilchrist TTI Building during the Month of May 2017 and the Corresponding Hourly Outdoor Dry Bulb Temperature for College Station, TX

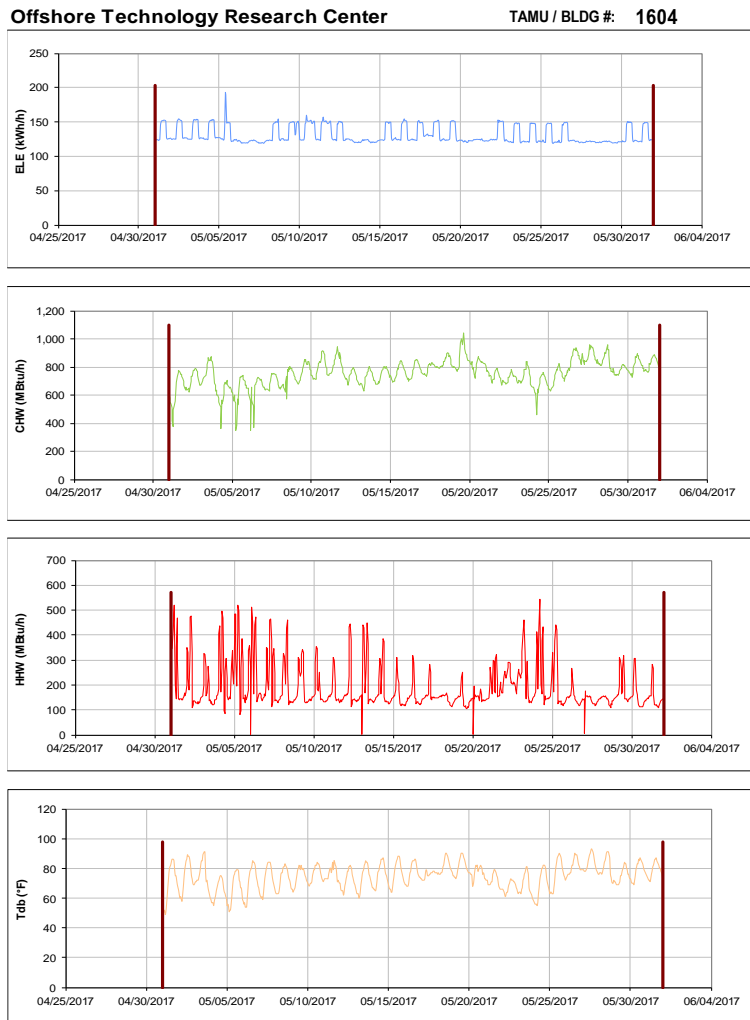
Figure III-187 Hourly Whole Building Electricity, Chilled Water, and Hot Water Consumption for Offshore Technology Research Center during the Month of May 2017 and the Corresponding Hourly Outdoor Dry Bulb Temperature for College Station, TX

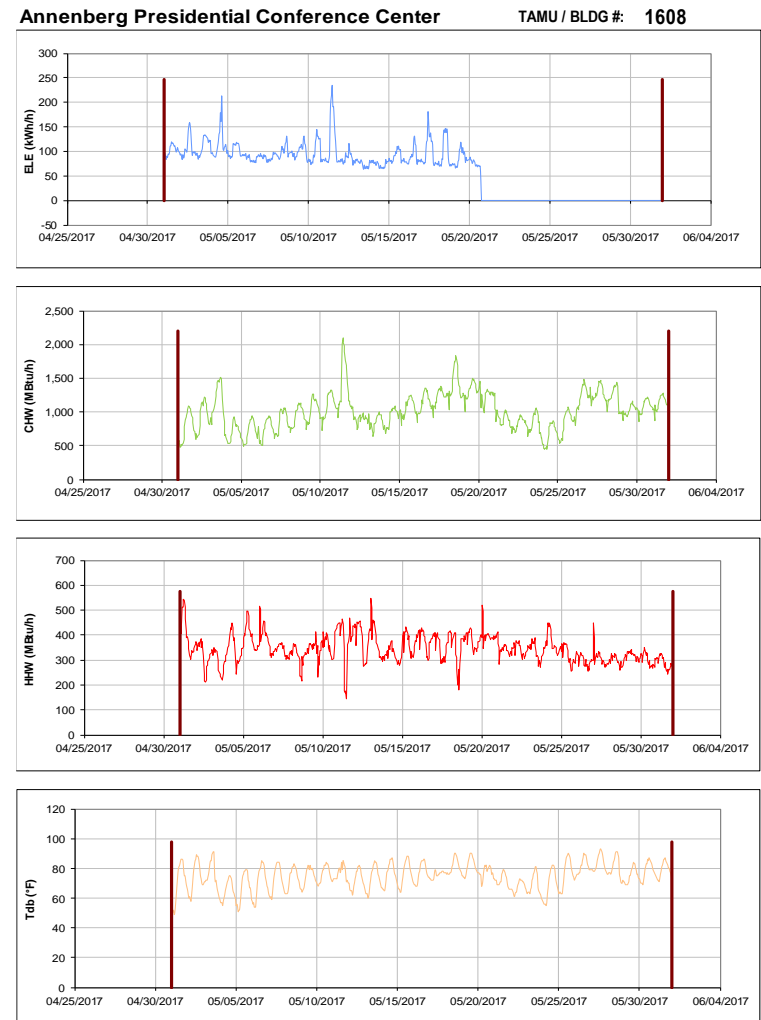
Figure III-190 Hourly Whole Building Electricity, Chilled Water, and Hot Water Consumption for Annenberg Presidential Conference Center during the Month of May 2017 and the Corresponding Hourly Outdoor Dry Bulb Temperature for College Station, TX

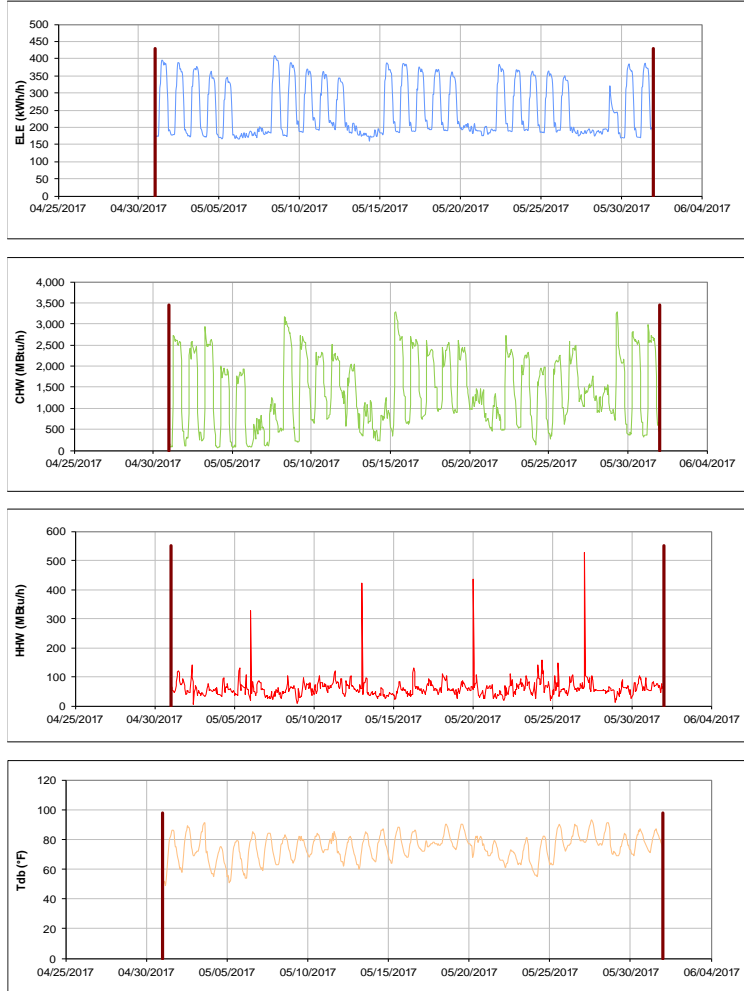
TAMU / BLDG #: 1800

Figure III-193 Hourly Whole Building Electricity, Chilled Water, and Hot Water Consumption for General Services Complex during the Month of May 2017 and the Corresponding Hourly Outdoor Dry Bulb Temperature for College Station, TX

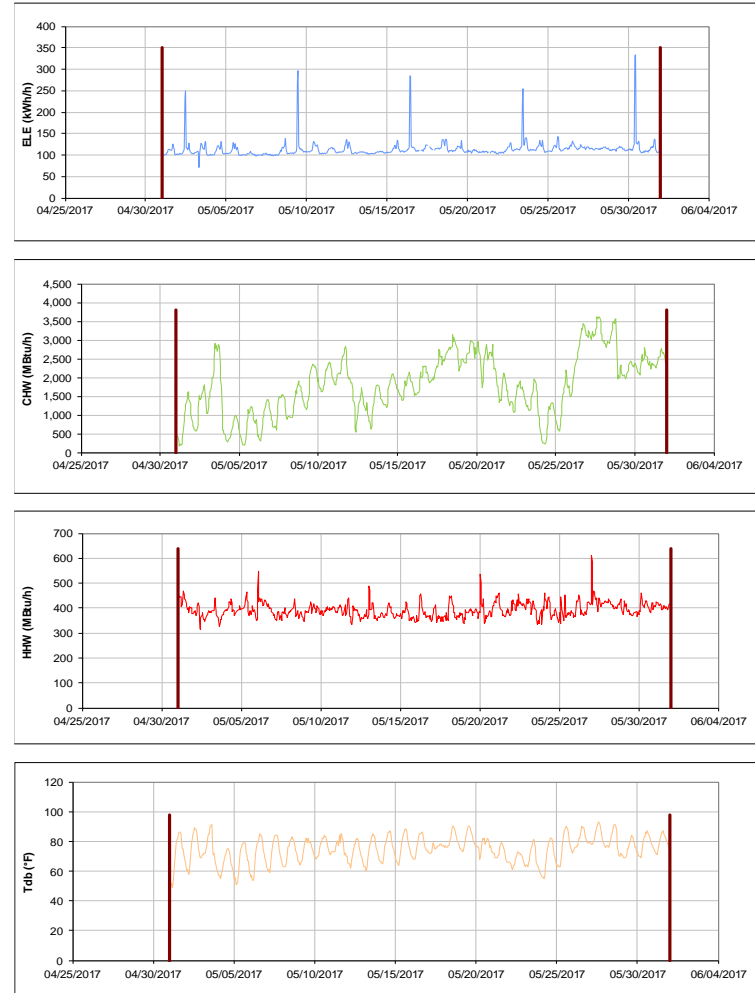
Texas Institute for Genomic Medicine TAMU / BLDG #: 1900

Figure III-198 Hourly Whole Building Electricity, Chilled Water, and Hot Water Consumption for Texas Institute for Genomic Medicine during the Month of May 2017 and the Corresponding Hourly Outdoor Dry Bulb Temperature for College Station, TX

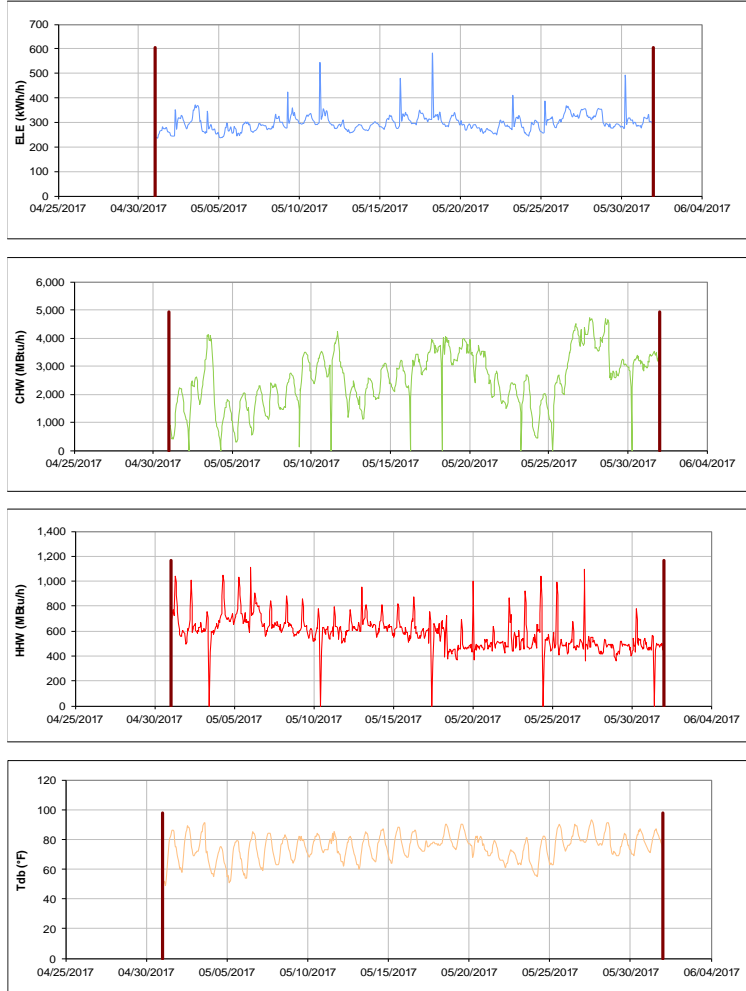
Texas A&M Institute for Preclinical Studies A TAMU / BLDG #: 1904

Figure III-199 Hourly Whole Building Electricity, Chilled Water, and Hot Water Consumption for Texas A&M Institute for Preclinical Studies A during the Month of May 2017 and the Corresponding Hourly Outdoor Dry Bulb Temperature for College Station, TX

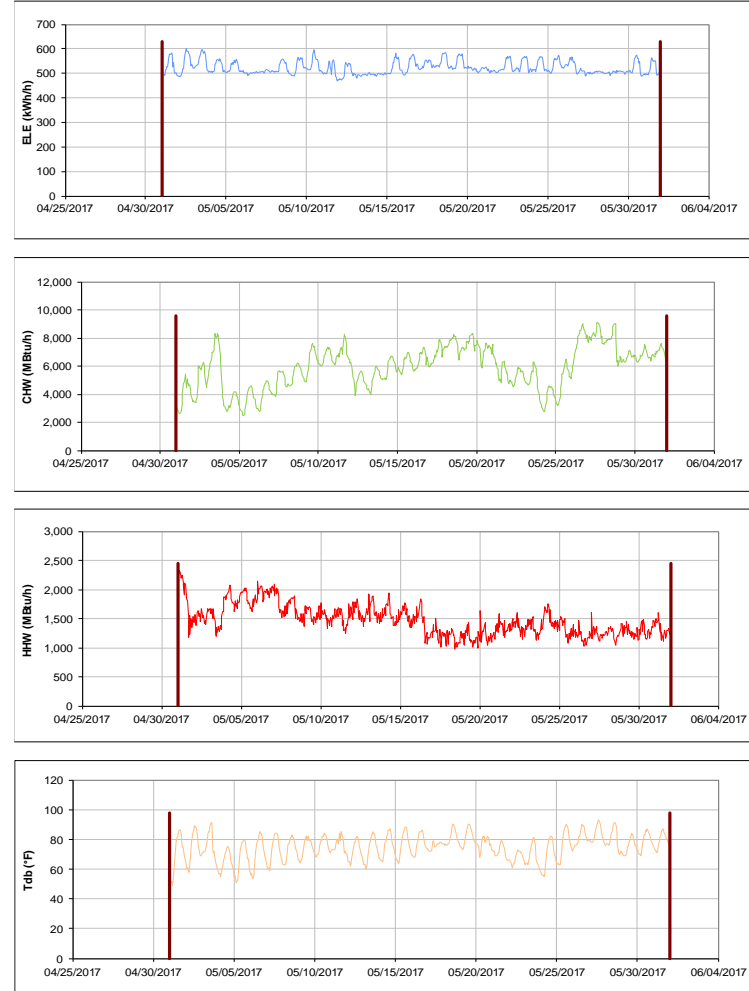
National Center for Therapeutics Manufacturing TAMU / BLDG #: 1910

Figure III-200 Hourly Whole Building Electricity, Chilled Water, and Hot Water Consumption for National Center for Therapeutics Manufacturing during the Month of May 2017 and the Corresponding Hourly Outdoor Dry Bulb Temperature for College Station, TX
