## **TAMU Project**

**Energy Consumption Data Quality Assurance/Quality  
Control Assessment Report for the  
Month of July 2017**

**Utility & Energy Services  
Division of Administration  
Texas A&M University**

**August 2017**

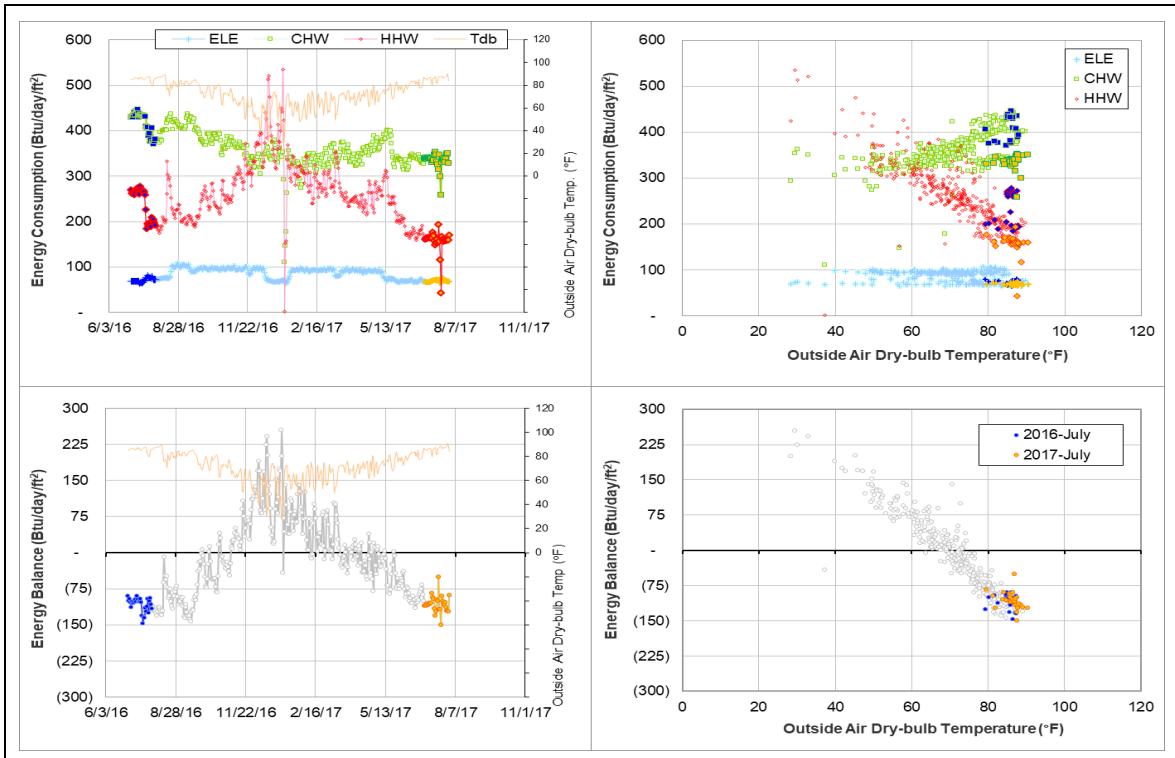
### Explanatory Figure: 13 months energy balance plot with original data.

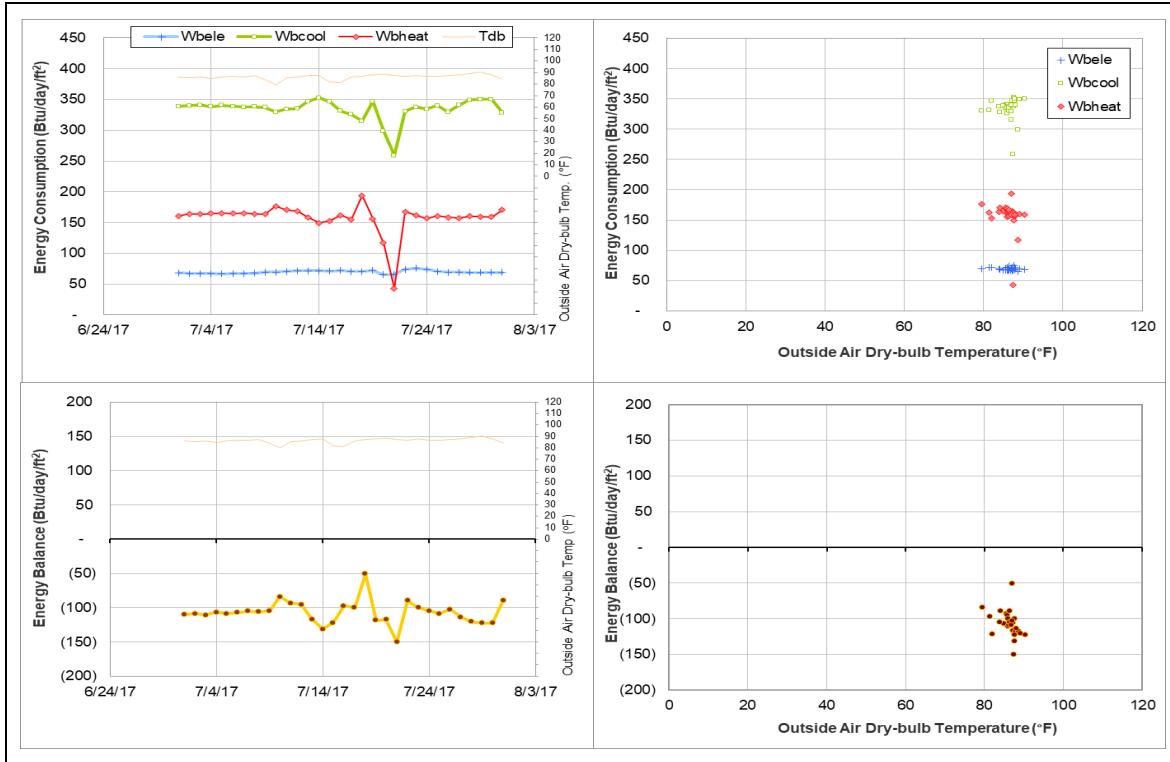
**Energy balance plot using the original data for the month of analysis. Missing data have been filled in, if any.**

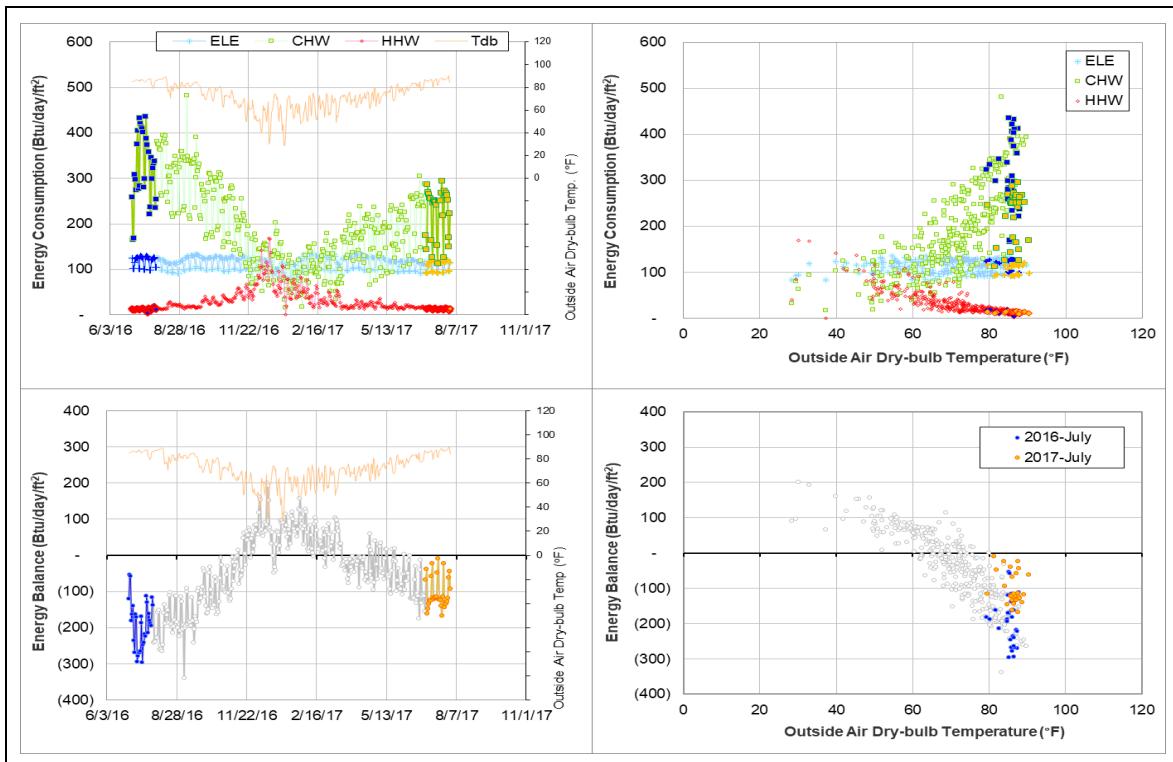
CHW consumption gradually dropped to a level that is lower than the past year by 50 – 75 Btu/day/ft<sup>2</sup>. No obvious sensor reading behavior anomaly is observed. The whole month is estimated using a model.

### *Explanatory Figure: 13 months energy balance plot with original data.*

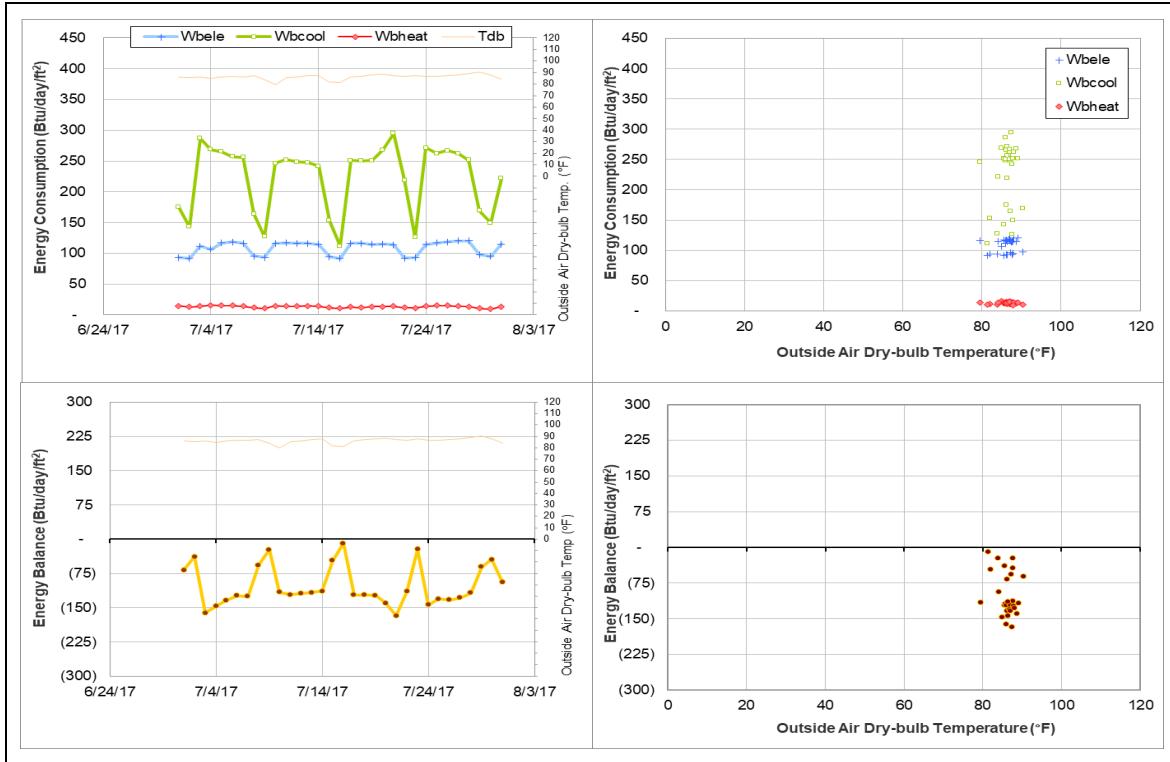
**Energy balance plot using the original data for the month of analysis. Missing data have been filled in, if any.**

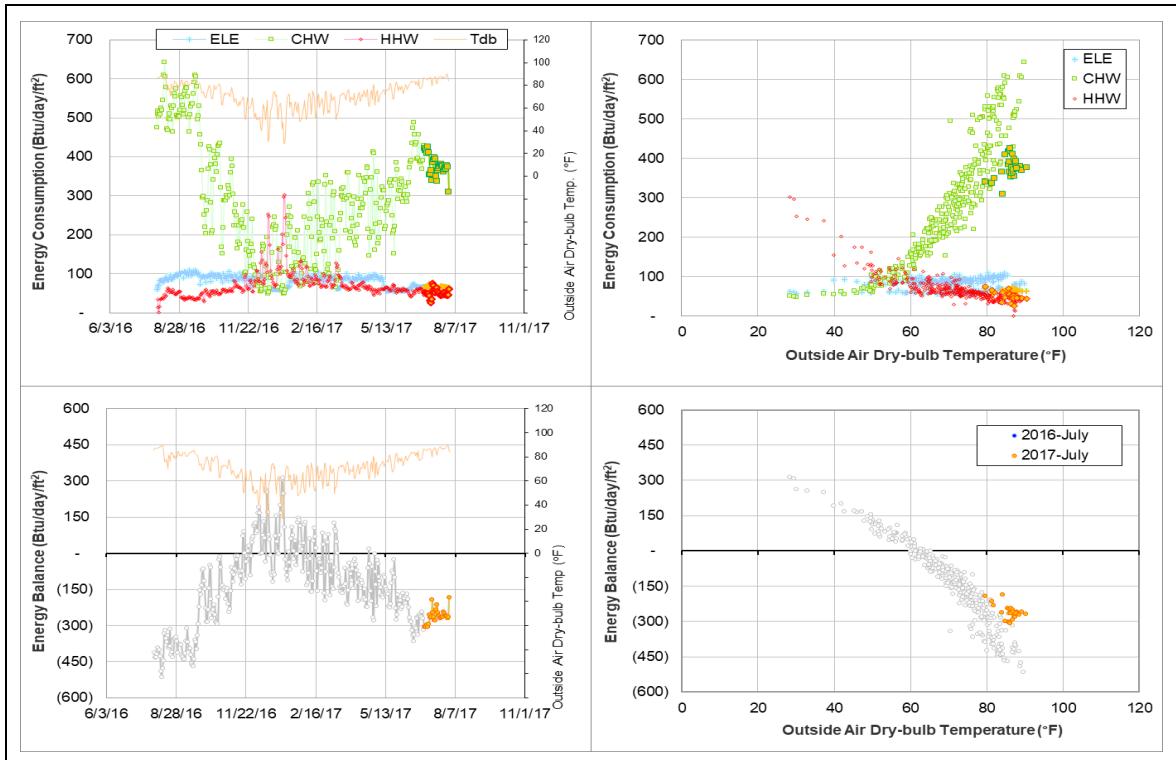
The CHW consumption is lower than the past year by about 200 Btu/day/ft<sup>2</sup>. No obvious sensor reading behavior anomaly is observed. The whole month is estimated using a model.

### Explanatory Figure: 13 months energy balance plot with original data.

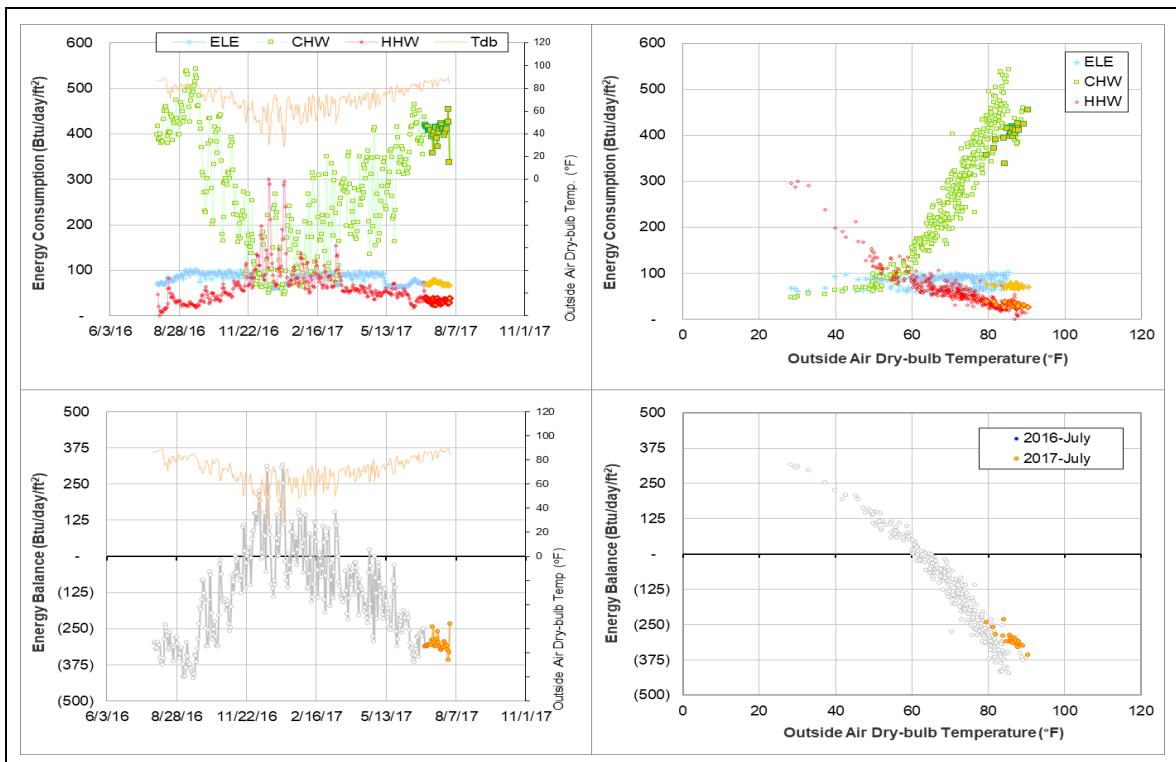
The CHW consumption is lower than the past year by about 150 Btu/day/ft<sup>2</sup>. No obvious sensor reading behavior anomaly is observed. The whole month is estimated using a model.

### Explanatory Figure: 13 months energy balance plot with original data.(Gainer Hall, Leonard Hall and Ash LLC TAMU Bldg #404-406-1403)

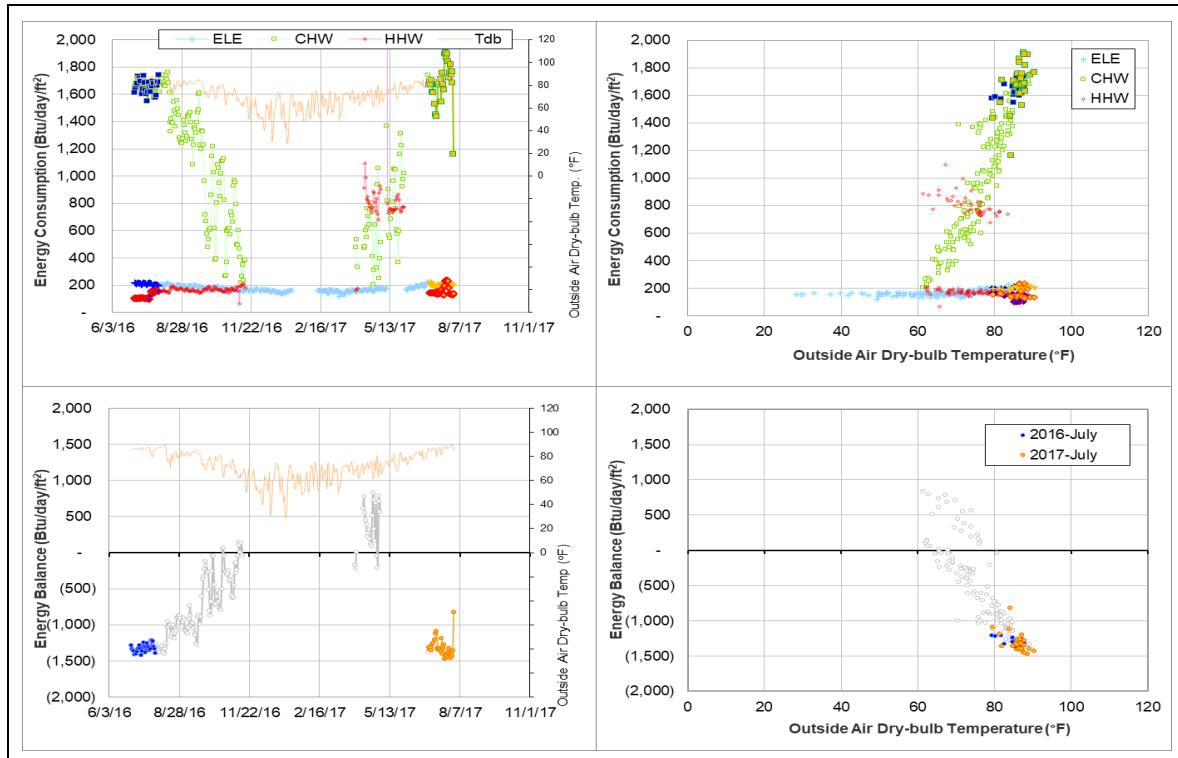
This building has four electric meters. Data for ELE meter #007152 was missing for 6/1/2017-6/2/2017. When the data return on 6/3/2017, the electric consumption experienced a continual increase to well above its normal pattern. An explanatory figure is provided below. The electric consumption for this meter was estimated by model.

### Explanatory Figure: 13 months energy balance plot with original data

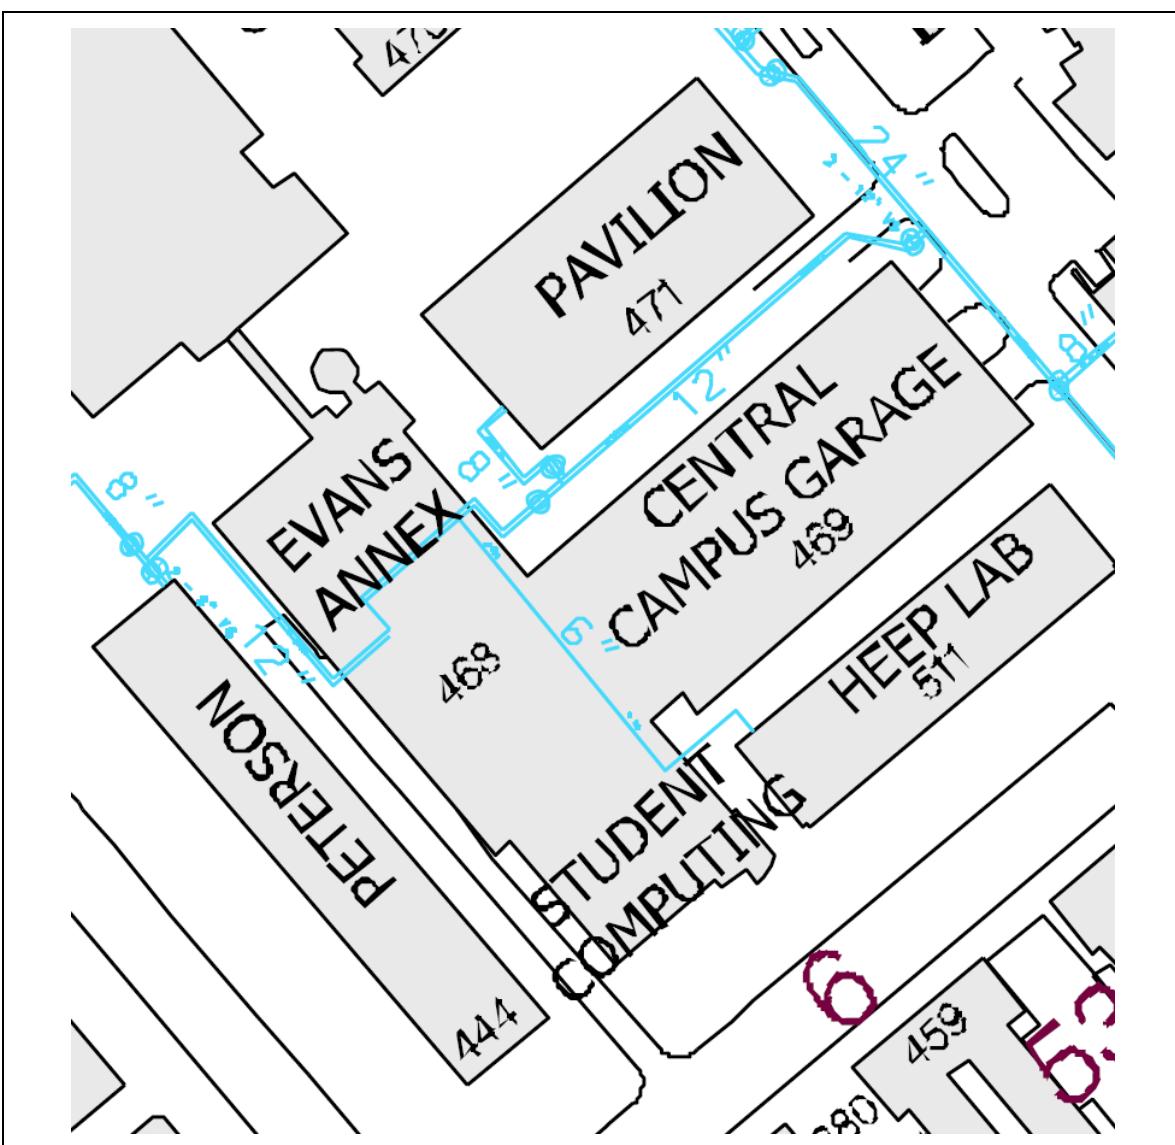
*Explanatory Figure: CHW pipeline map near #0511.*

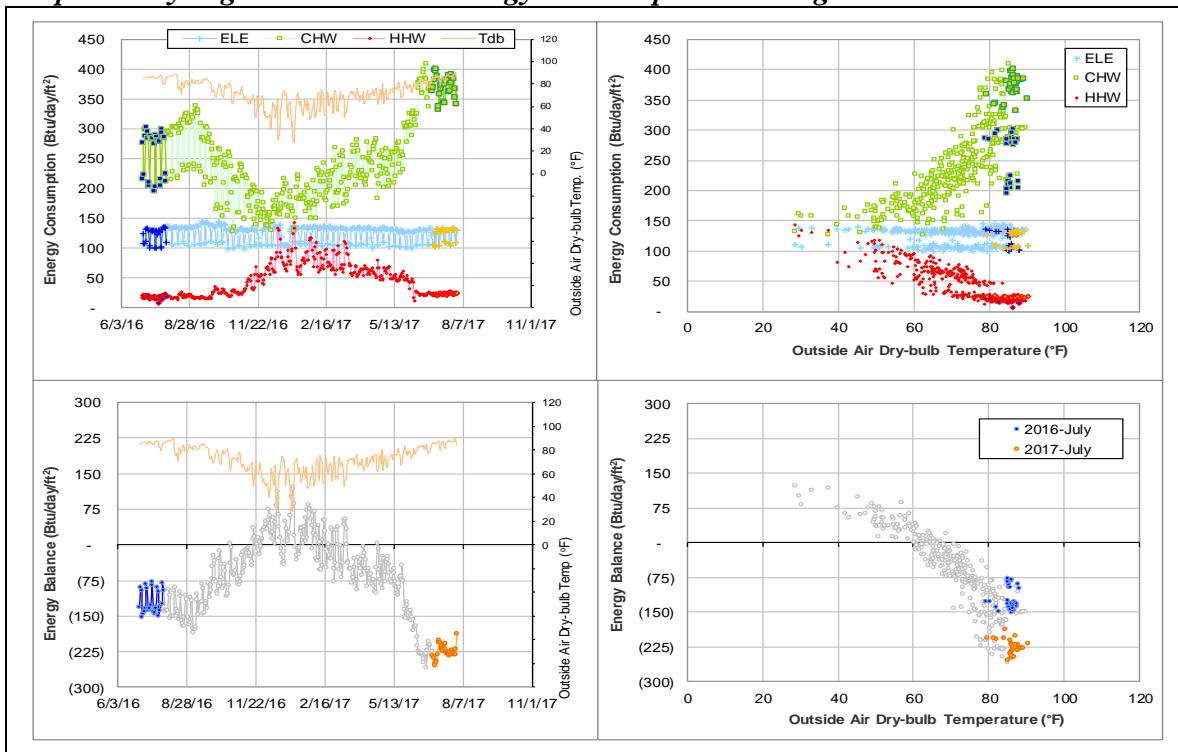
CHW consumption of June this year is 50 – 100 Btu/day-ft<sup>2</sup> higher than the previous year. There is no obvious meter reading anomaly observed. The consumption of this month is estimated by model.

### Explanatory Figure: 13 months energy balance plot with original data.

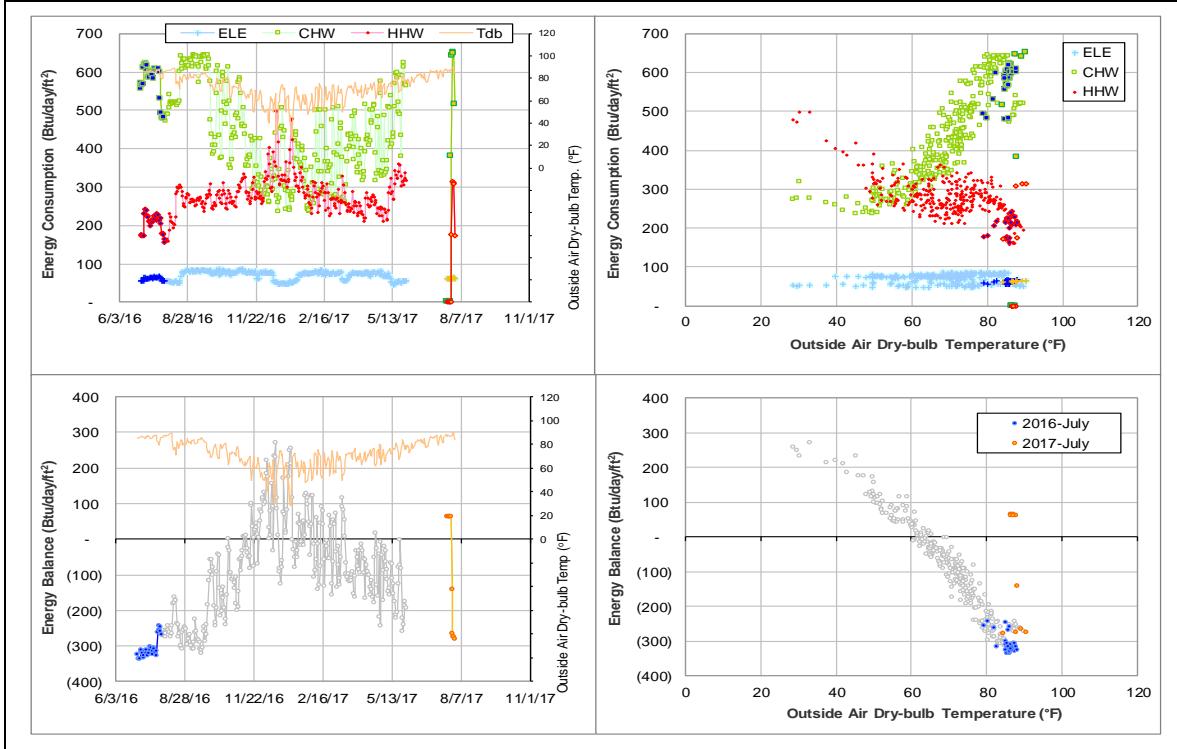
Both CHW and HHW consumption was missing during 6/1/2017 – 7/21/2017. After the missing, all meter readings remained constant during 7/22/2017 – 7/27/2017. CHW readings appear normal since 7/28/2017. HHW readings, however, showed higher flow rate (180 gpm) on 7/28/2017 – 7/30/2017 compared to last year (160 gpm). Its flow rate dropped to zero on 7/31/2017.

**Explanatory Figure: 13 months energy balance plot with original data.**

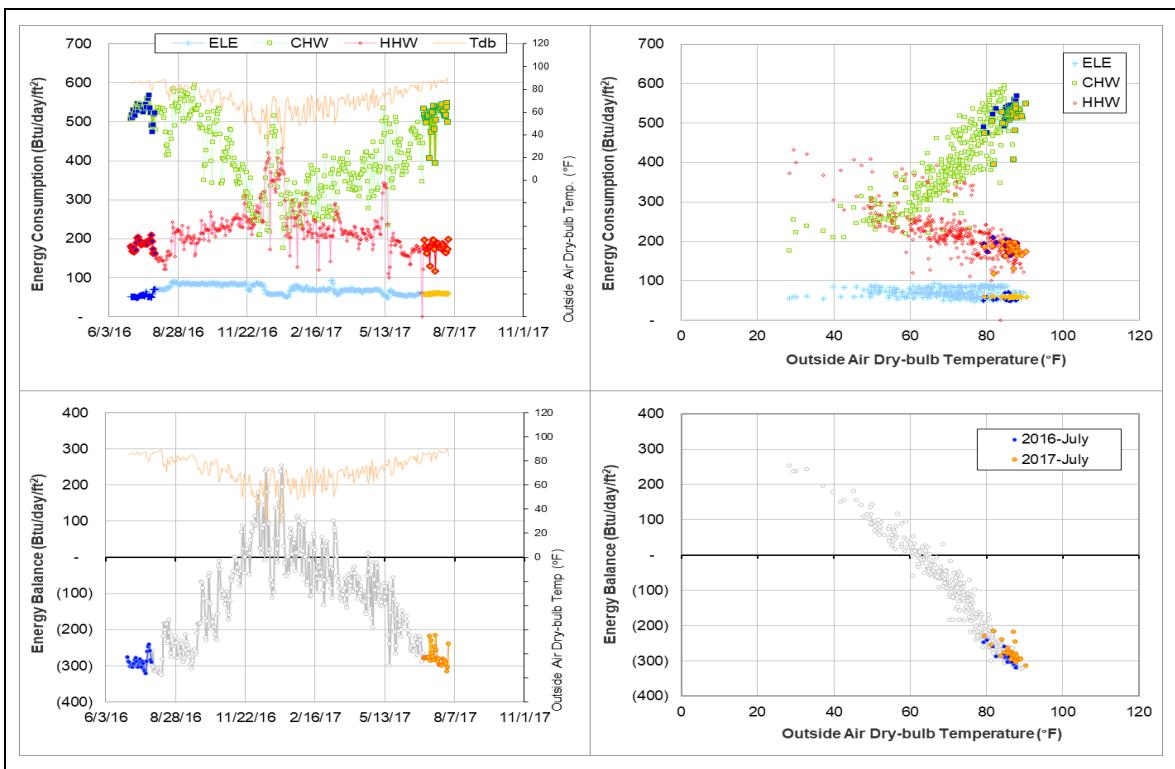
This building has a low level of energy balance load with the cross-point temperature around 60°F. The low E<sub>BL</sub> level suggests an imbalance of metered energy use in the building, but we are not able to determine the cause.

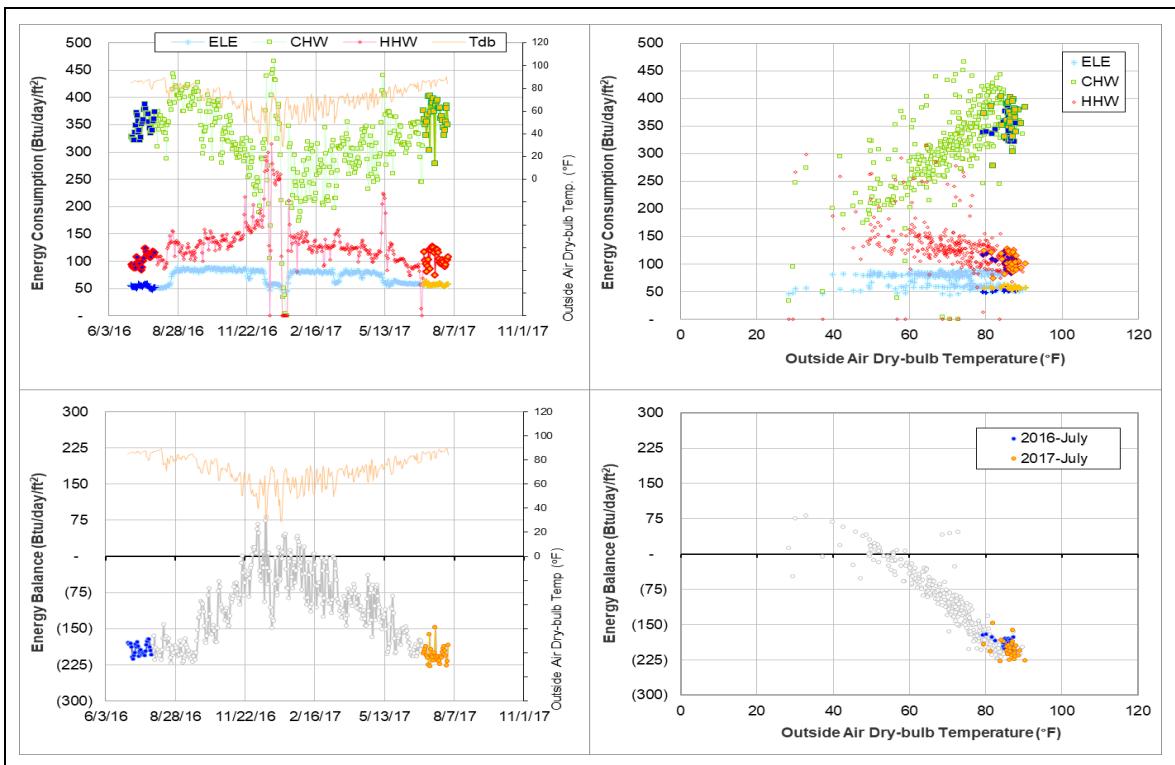
Both the CHW and HHW consumption levels have been unstable and changing frequently. The energy balance load was low with the cross-point temperature around 55°F. The low  $E_{BL}$  level suggests an imbalance of metered energy use in the building, but we are not able to determine the cause.

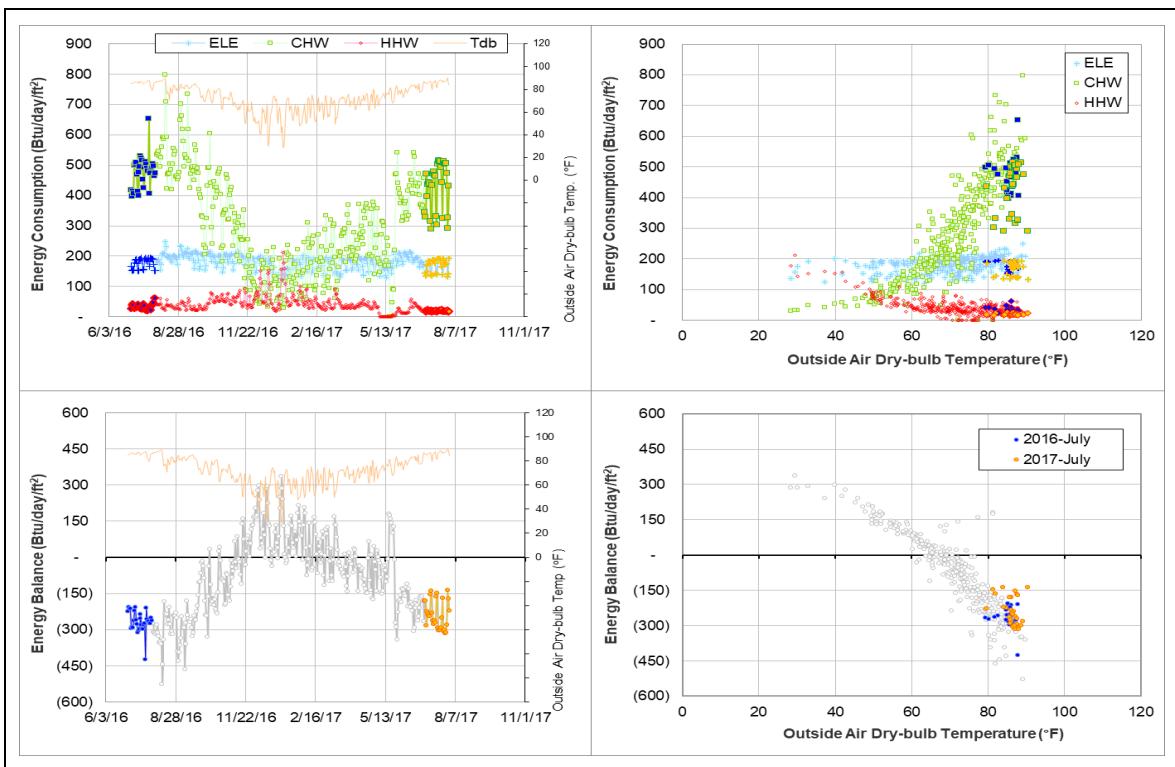
The CHW consumption has a weekday/weekend pattern during July 2017 however the weekend consumption is around 75 – 100 Btu/day/ft<sup>2</sup> lower than the previous year. Also, there is not a weekday/weekend pattern during the previous months. No obvious sensor reading behavior anomaly is observed.

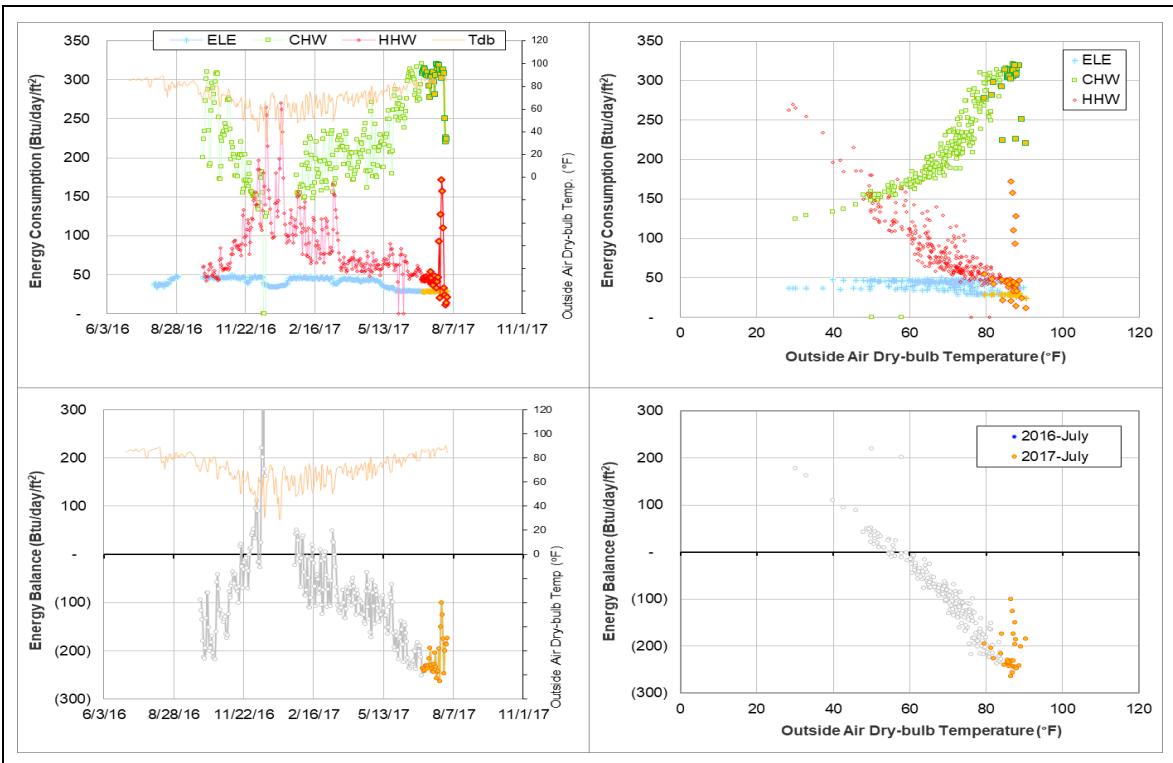
After the missing period from May to October 2016, ELE and HHW consumption decreased and CHW consumption increased. EB cross-point moved from 68°F to 55°F since then.

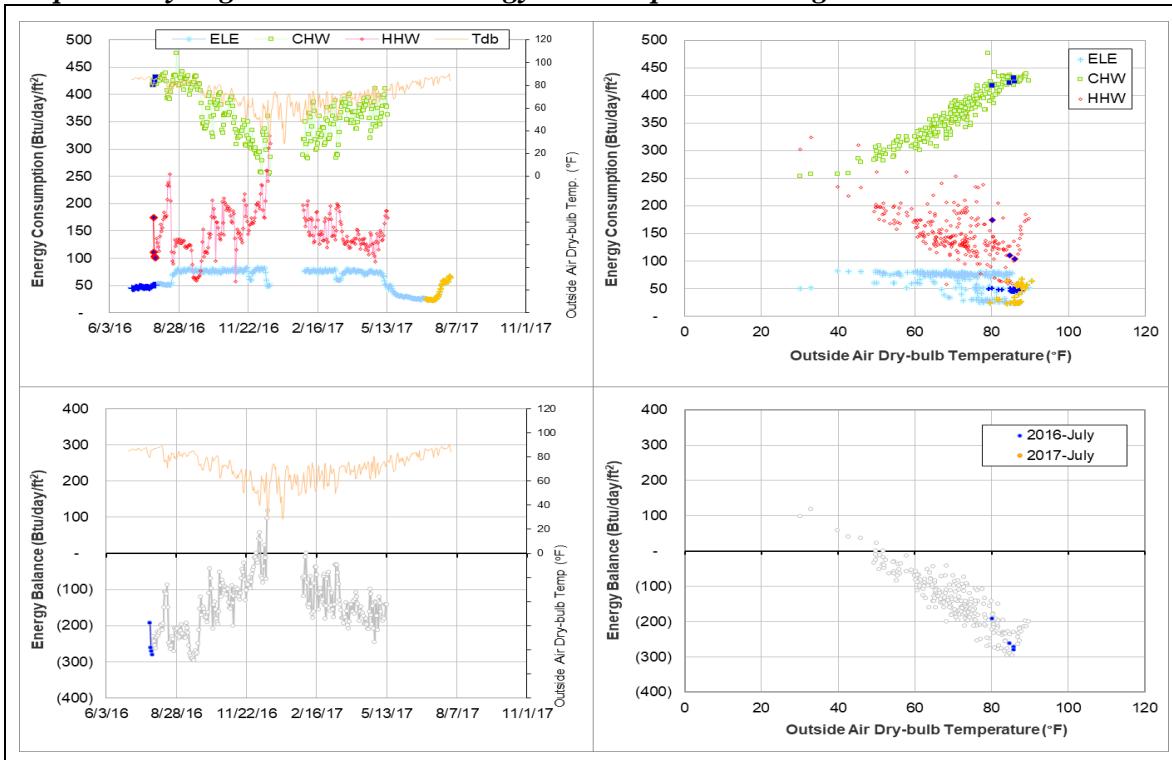
The ELE meter (MID 009083) replaced old meter (MID 000290) since January 2016. After that, the consumption decreased from 105 Btu/day/ft<sup>2</sup> to 80 Btu/day/ft<sup>2</sup> (approximately 25%). At near 40°F compared to 11/2014, CHW increased slightly by about 25 Btu/day/ft<sup>2</sup> and HHW decreased slightly by about 25 Btu/day/ft<sup>2</sup>. HHW started to scatter since 5/2016 (shortly before the missing period). The cross-point temperature decreased further from near 55°F to lower than 50°F now. Starting 5/15/2017, the CHW and HHW meter data has not been available. This recent change in data is believed to be due to building renovation.

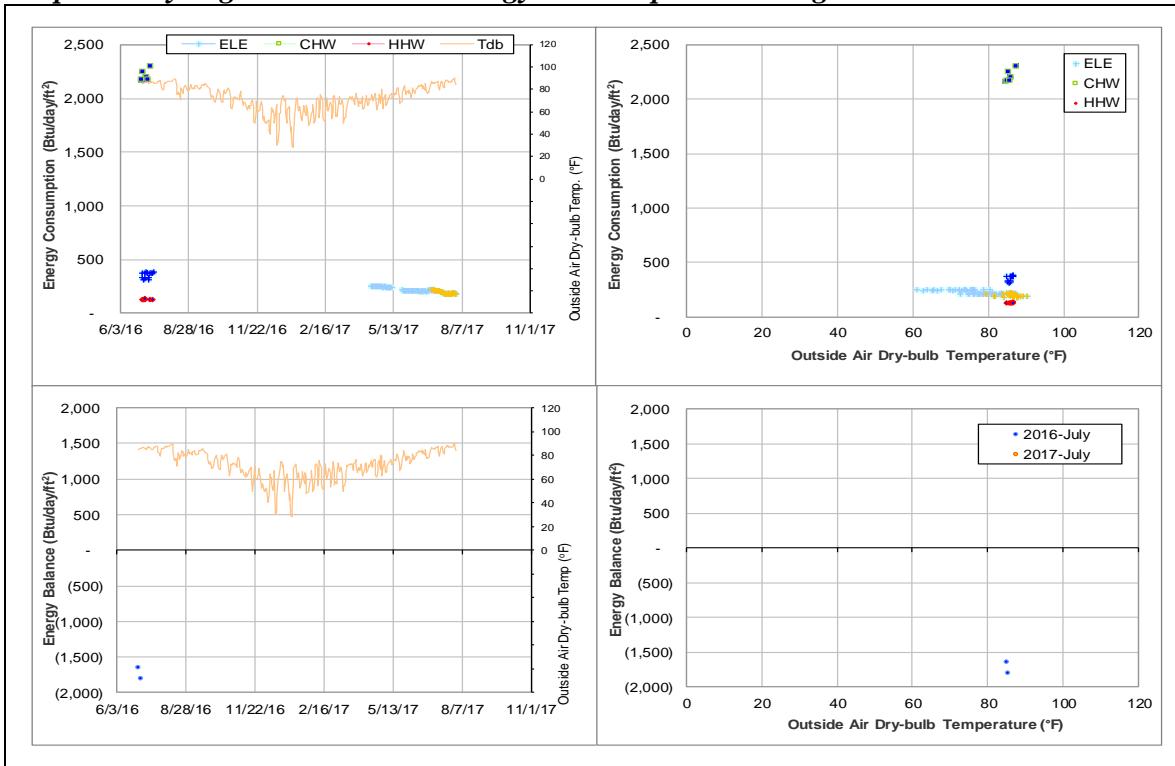
ELE MID 001466 decreased from a level ranging from 110 to 180 kWh/h to a stable 100 kWh/h level. ELE MID 001539 decreased from a level ranging from 100 to 130 kWh/h to 64 – 72 kWh/h level, and decreased further after a short missing period of 5/12/2017 – 5/24/2017 to 45 kWh/h. This building's total ELE consumption decreased by 33% in daily average value.

CHW and HHW data are still missing. To reflect the decreased level as ELE suggests, CHW and HHW consumption is estimated by first using models based on 8/1/2015 – 7/13/2016 data and then scaling down to 66%.

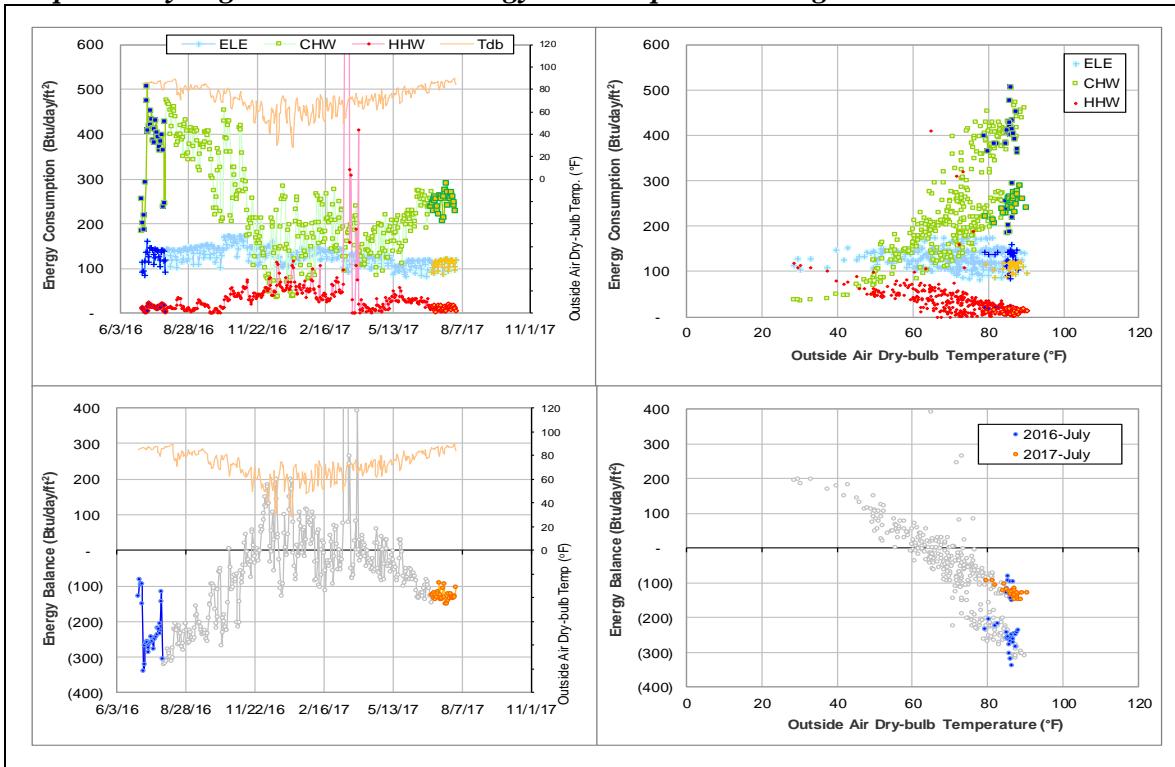
CHW flow rate has been unstable for a long time. On 3/24/2017, the flow rate dropped to and remained at the 20 – 80 gpm level, which is significantly lower than the beginning of Mar 2017 at near 300 gpm. The CHW consumption thus has a considerable decrease in the following months. This building is on the ESCO list, which is a probable cause of the change. More data are needed to verify new pattern.

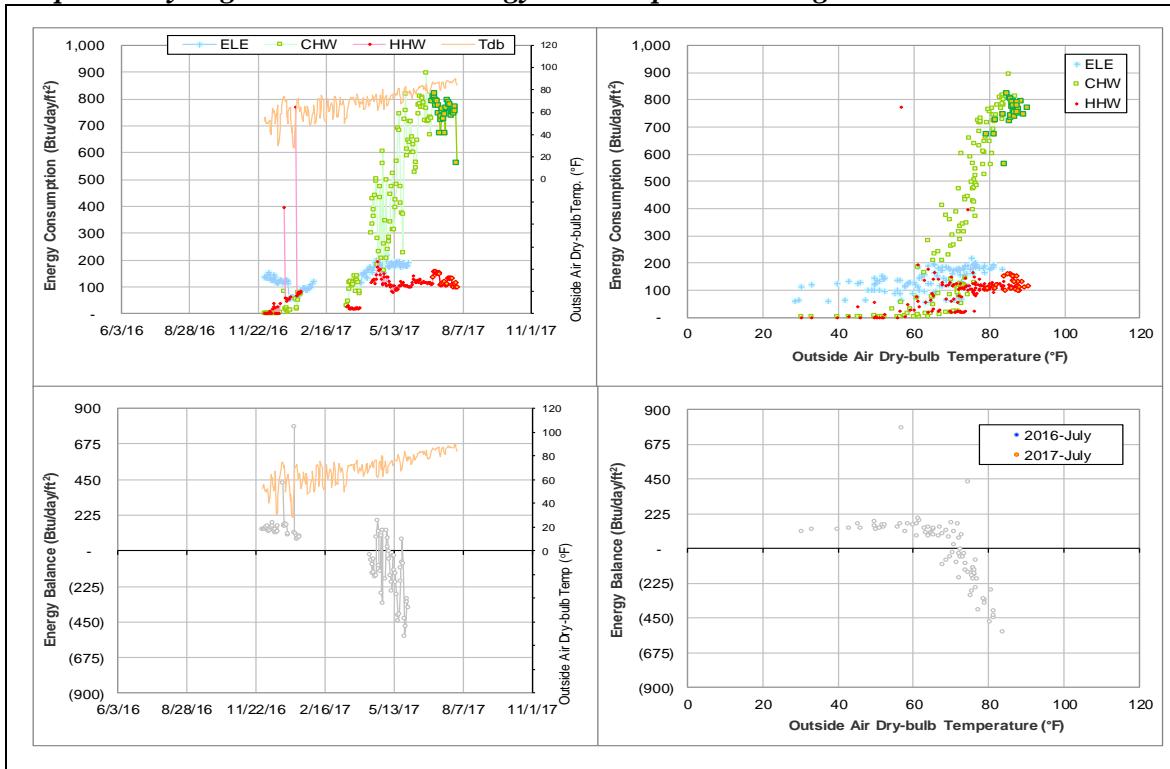
The MID's of this building changed from ELE 009620 & 009621, CHW 009622, and HHW 009623 to ELE 009982, CHW 009983, and HHW 009984. The ELE consumption of this whole month is missing. The consumption is estimated using combined consumption of the models of the previous two MID's.

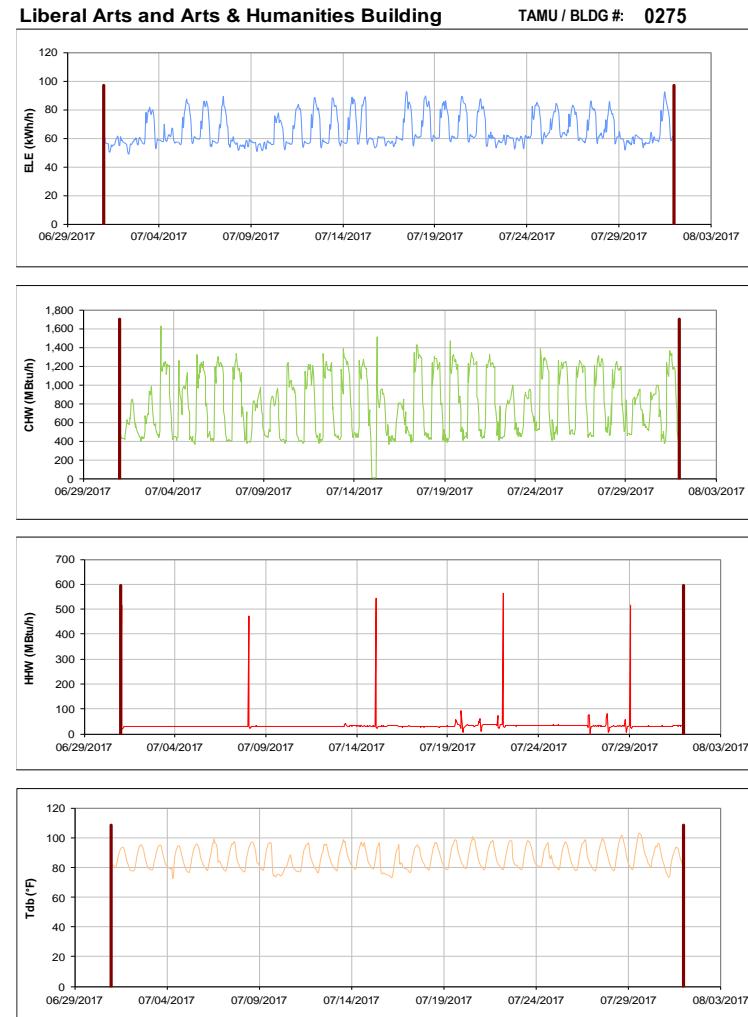
Figure III-2 Hourly Whole Building Electricity, Chilled Water, and Hot Water Consumption for Liberal Arts and Arts & Humanities Building during the Month of July 2017 and the Corresponding Hourly Outdoor Dry Bulb Temperature for College Station, TX

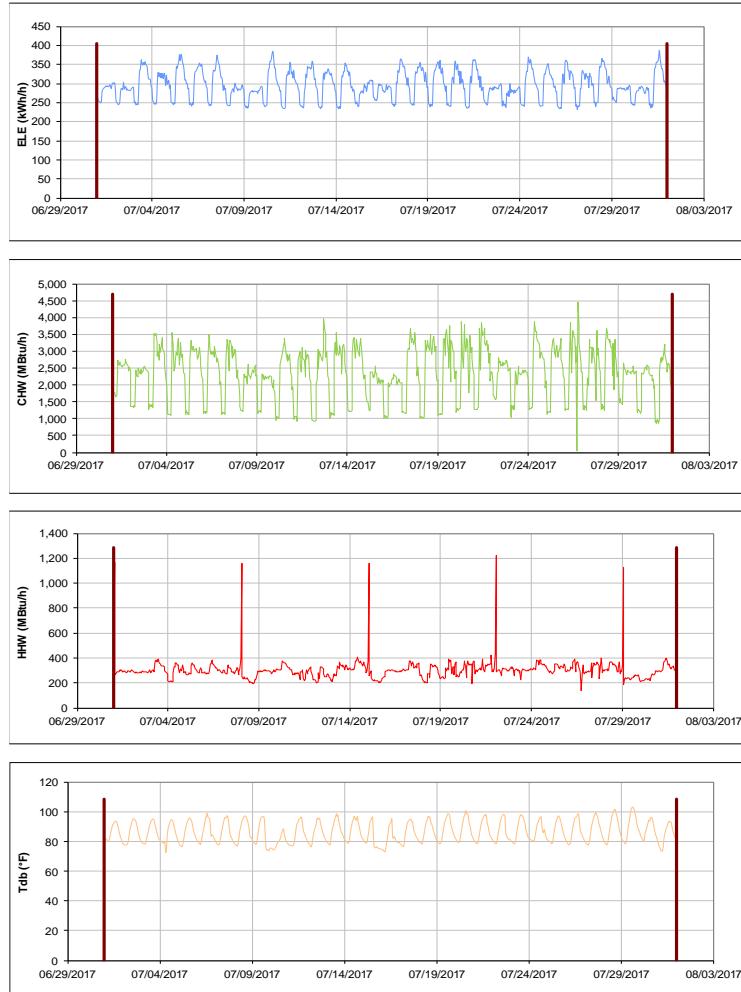
**Mitchell Inst. for Fundamental Phys & Astronomy** TAMU / BLDG #: 1296-0297

Figure III-8 Hourly Whole Building Electricity, Chilled Water, and Hot Water Consumption for Mitchell Inst. for Fundamental Phys & Astronomy during the Month of July 2017 and the Corresponding Hourly Outdoor Dry Bulb Temperature for College Station, TX

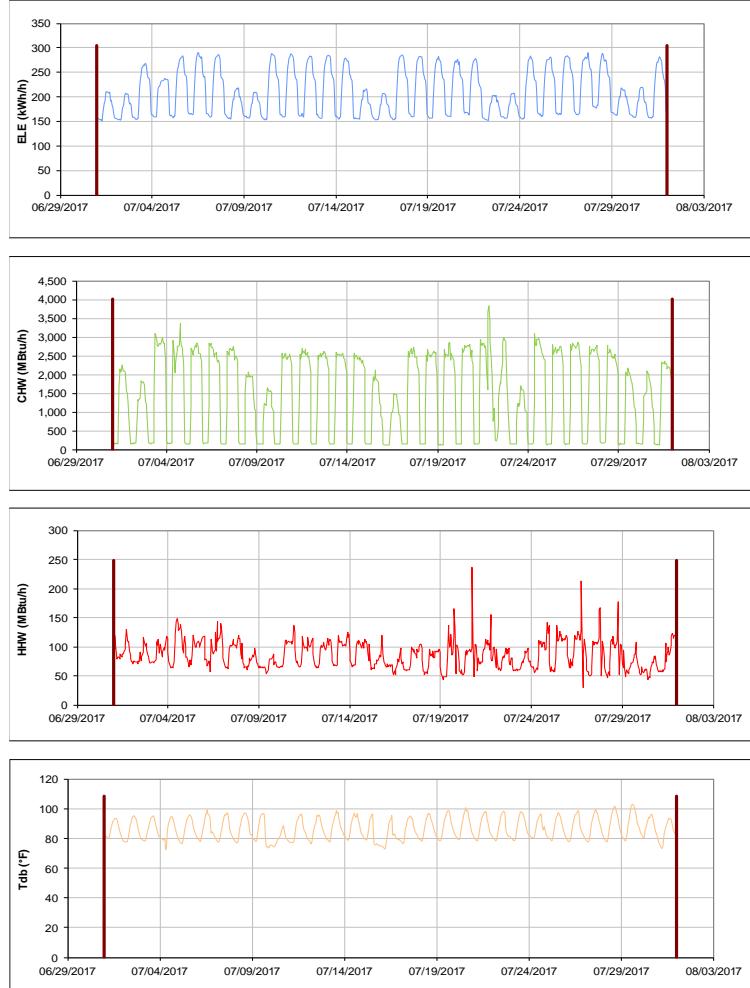
TAMU / BLDG #: 1325-0385

Figure III-9 Hourly Whole Building Electricity, Chilled Water, and Hot Water Consumption for CE TTI Office & Lab Building during the Month of July 2017 and the Corresponding Hourly Outdoor Dry Bulb Temperature for College Station, TX

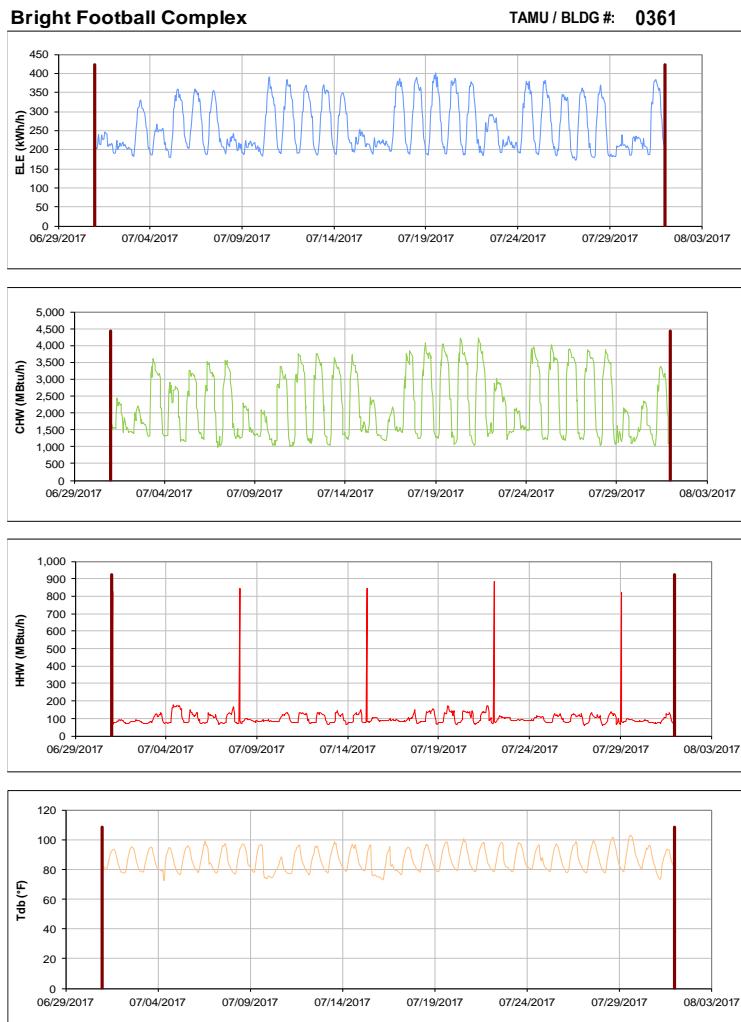
Figure III-14 Hourly Whole Building Electricity, Chilled Water, and Hot Water Consumption for Bright Football Complex during the Month of July 2017 and the Corresponding Hourly Outdoor Dry Bulb Temperature for College Station, TX

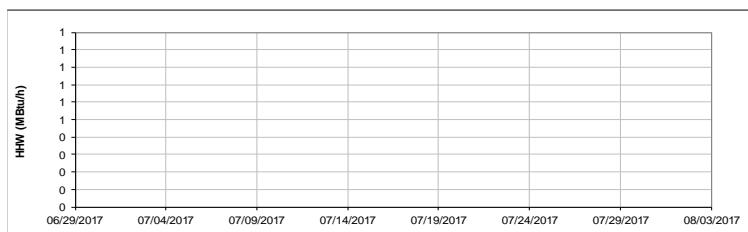
TAMU / BLDG #: 0407

Figure III-35 Hourly Whole Building Electricity, Chilled Water, and Hot Water Consumption for Harrell Hall - Dorm 8 during the Month of July 2017 and the Corresponding Hourly Outdoor Dry Bulb Temperature for College Station, TX

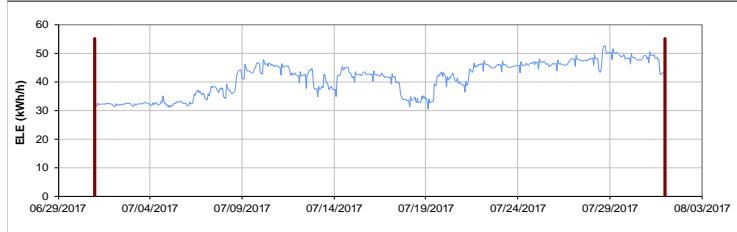
TAMU / BLDG #: 0408

Figure III-36 Hourly Whole Building Electricity, Chilled Water, and Hot Water Consumption for Whitely Hall - Dorm 9 during the Month of July 2017 and the Corresponding Hourly Outdoor Dry Bulb Temperature for College Station, TX

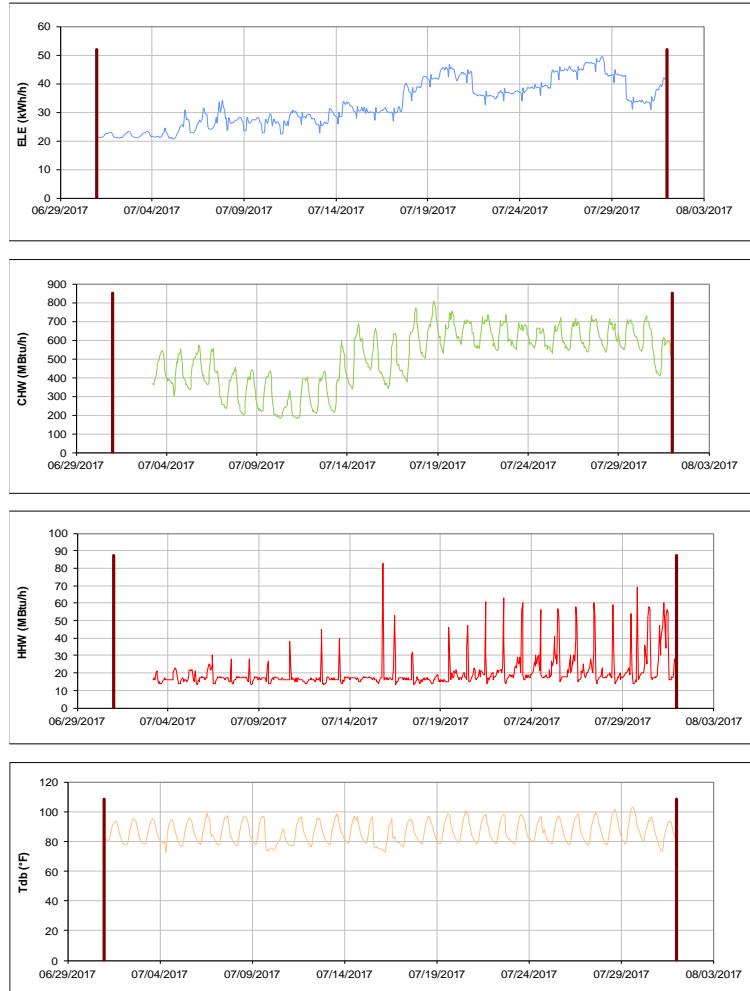
TAMU / BLDG #: 0411

Figure III-39 Hourly Whole Building Electricity, Chilled Water, and Hot Water Consumption for Utay Hall - Dorm 12 during the Month of July 2017 and the Corresponding Hourly Outdoor Dry Bulb Temperature for College Station, TX
