## **TAMU Project**

**Energy Consumption Data Quality Assurance/Quality  
Control Assessment Report for the  
Month of July 2017**

**Utility & Energy Services  
Division of Administration  
Texas A&M University**

**August 2017**

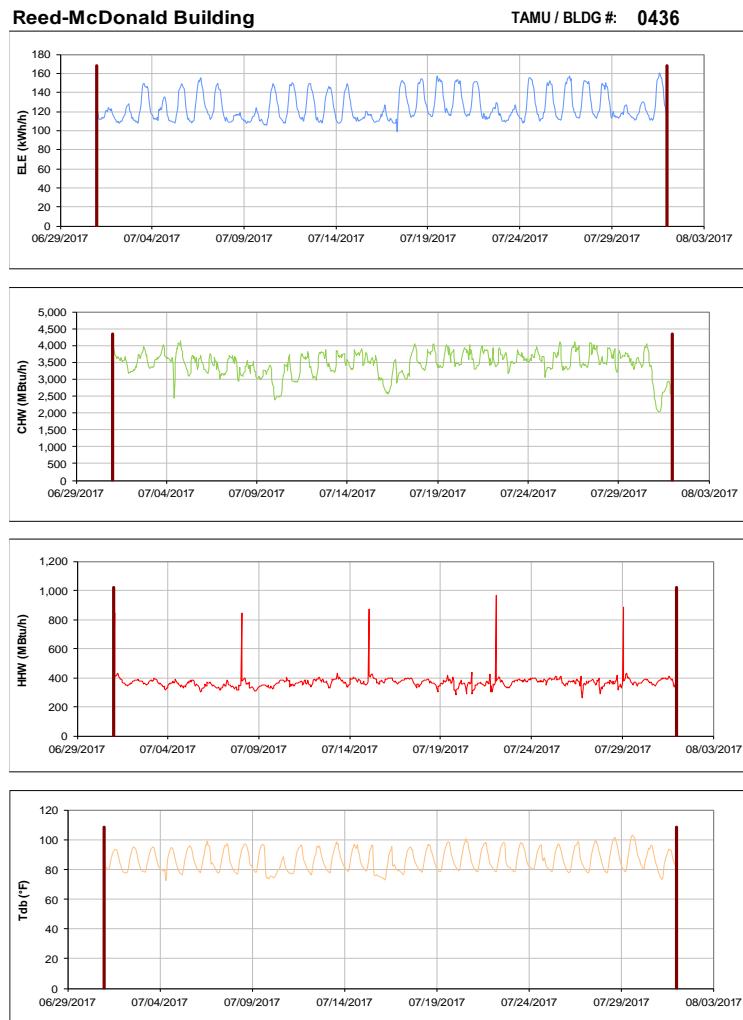
Figure III-54 Hourly Whole Building Electricity, Chilled Water, and Hot Water Consumption for Reed-McDonald Building during the Month of July 2017 and the Corresponding Hourly Outdoor Dry Bulb Temperature for College Station, TX

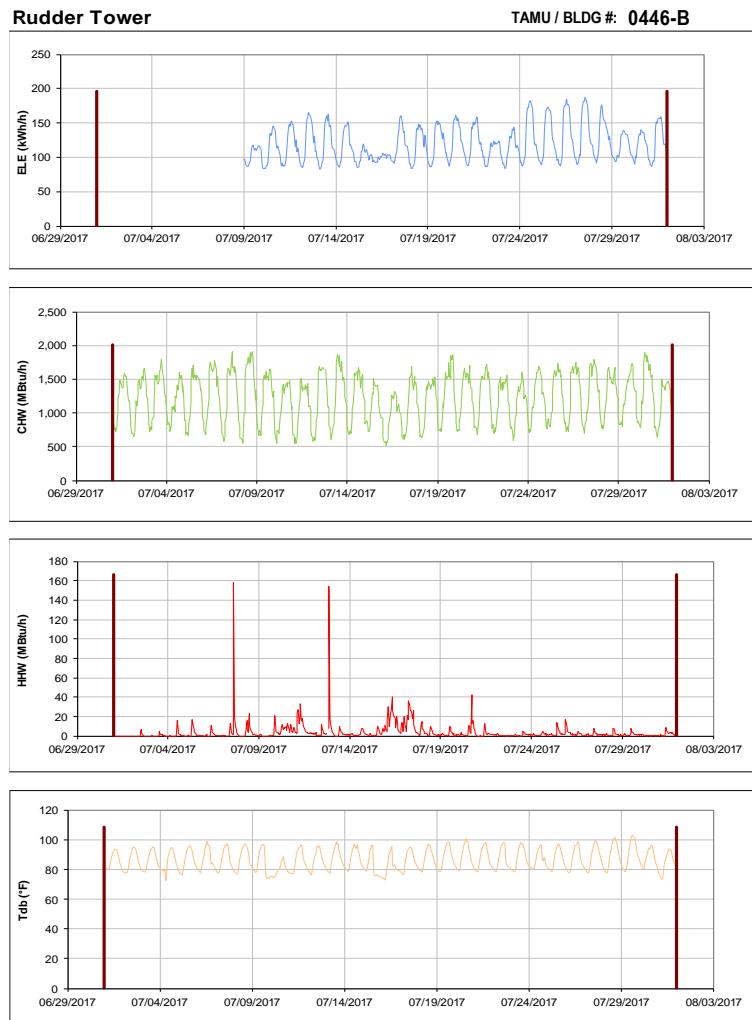
Figure III-67 Hourly Whole Building Electricity, Chilled Water, and Hot Water Consumption for Rudder Tower during the Month of July 2017 and the Corresponding Hourly Outdoor Dry Bulb Temperature for College Station, TX

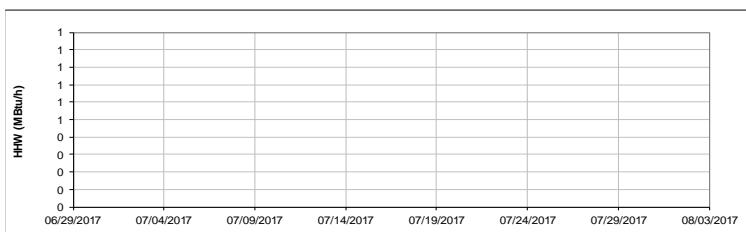
TAMU / BLDG #: 0456

Figure III-73 Hourly Whole Building Electricity, Chilled Water, and Hot Water Consumption for Military Sciences Building during the Month of July 2017 and the Corresponding Hourly Outdoor Dry Bulb Temperature for College Station, TX

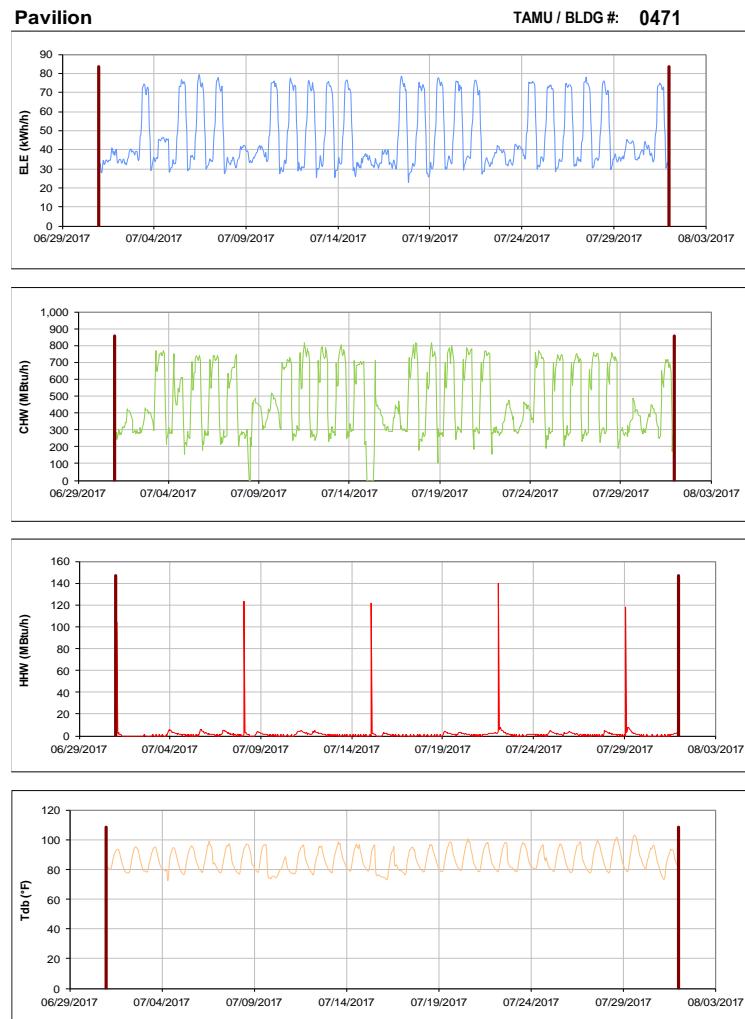
Figure III-84 Hourly Whole Building Electricity, Chilled Water, and Hot Water Consumption for Pavilion during the Month of July 2017 and the Corresponding Hourly Outdoor Dry Bulb Temperature for College Station, TX

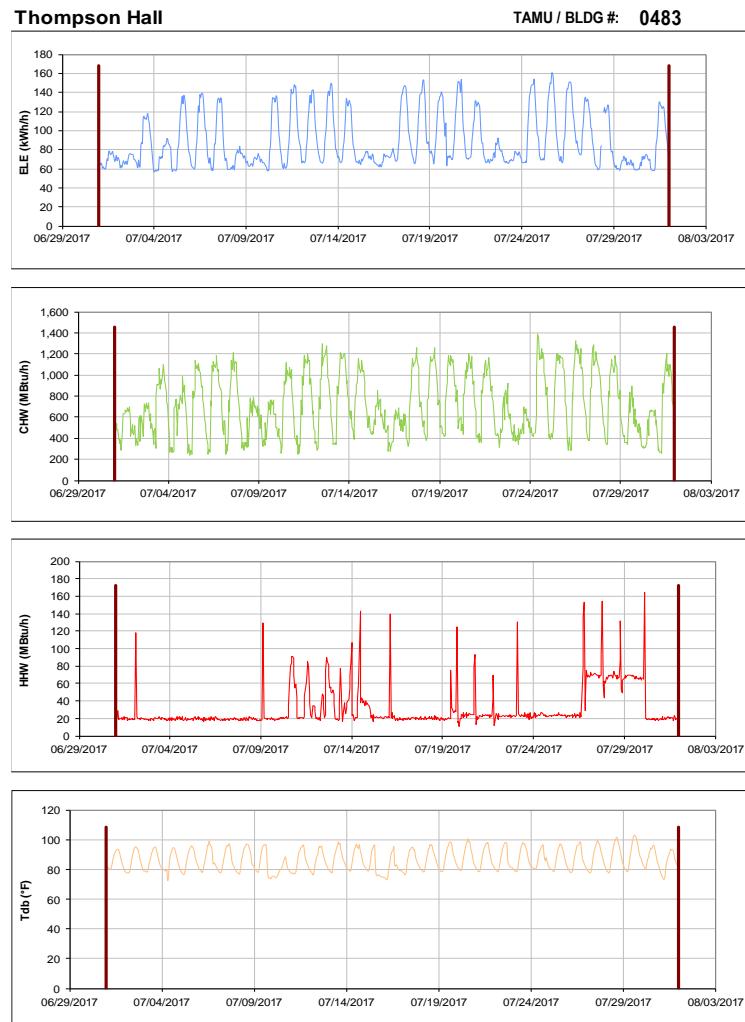
Figure III-94 Hourly Whole Building Electricity, Chilled Water, and Hot Water Consumption for Thompson Hall during the Month of July 2017 and the Corresponding Hourly Outdoor Dry Bulb Temperature for College Station, TX

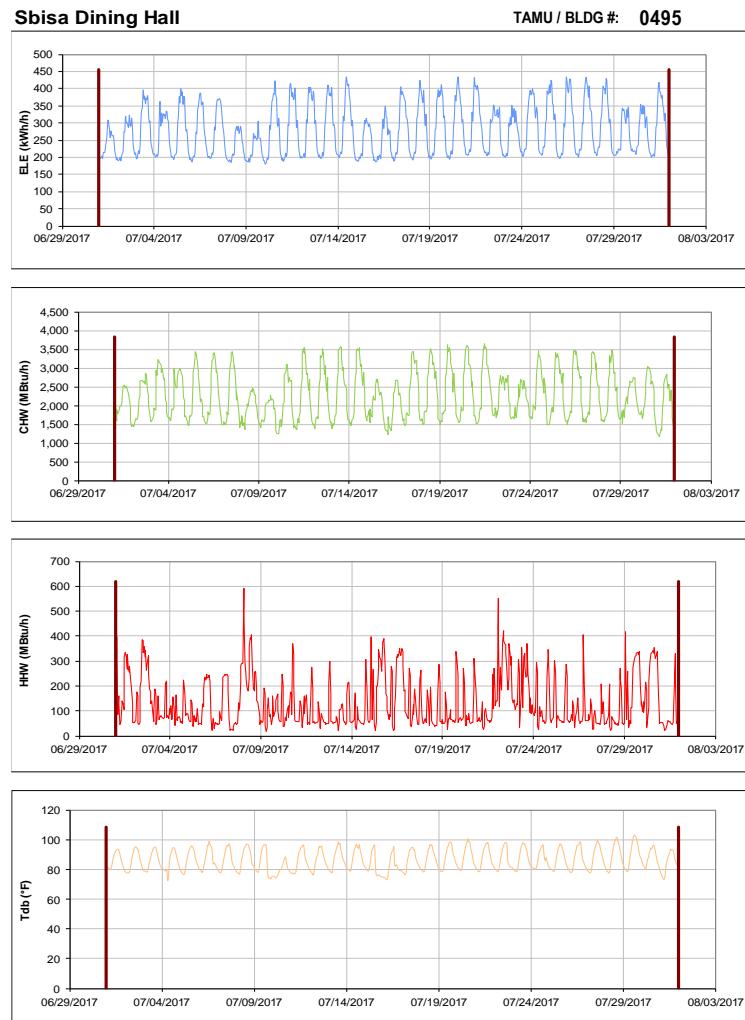
Figure III-98 Hourly Whole Building Electricity, Chilled Water, and Hot Water Consumption for Sbisa Dining Hall during the Month of July 2017 and the Corresponding Hourly Outdoor Dry Bulb Temperature for College Station, TX

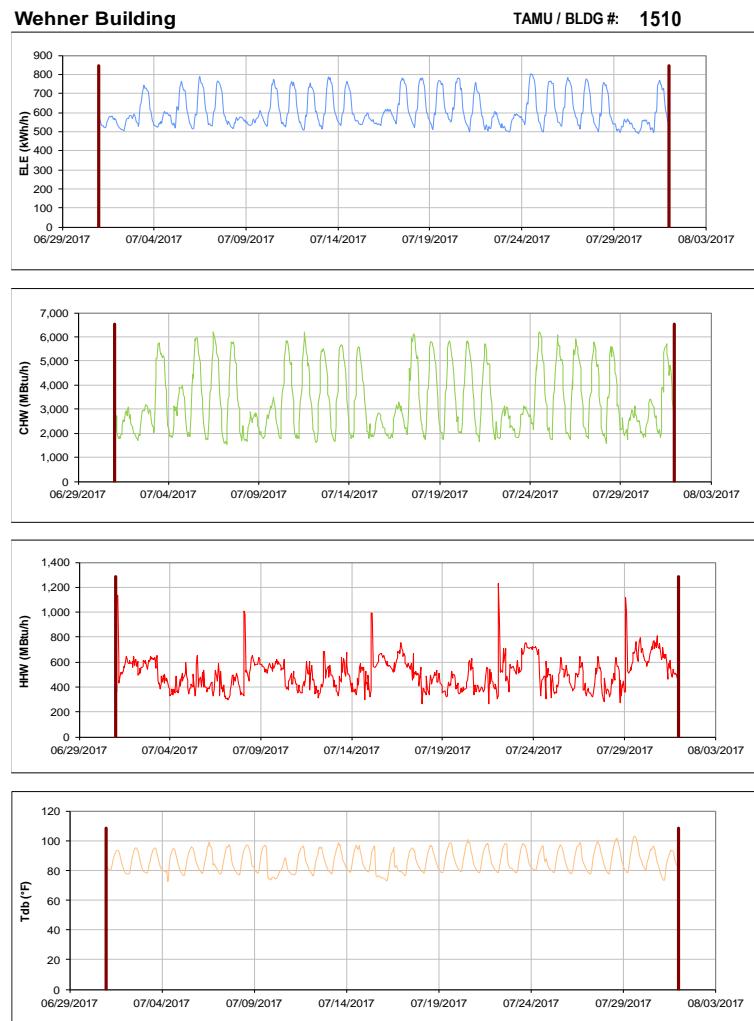
Figure III-163 Hourly Whole Building Electricity, Chilled Water, and Hot Water Consumption for Wehner Building during the Month of July 2017 and the Corresponding Hourly Outdoor Dry Bulb Temperature for College Station, TX

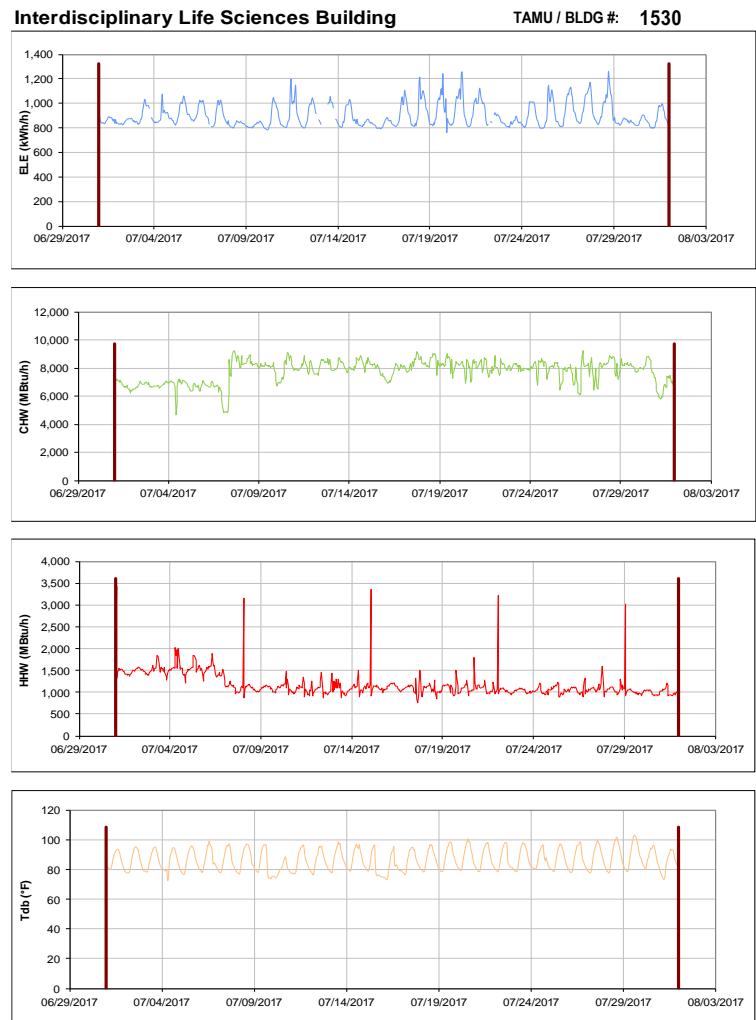
Figure III-169 Hourly Whole Building Electricity, Chilled Water, and Hot Water Consumption for Interdisciplinary Life Sciences Building during the Month of July 2017 and the Corresponding Hourly Outdoor Dry Bulb Temperature for College Station, TX
